Expertise

Protocol number: 46602530  
Order No. / Reference: 26740746  
Inspection date: 14 Jul 2026

Manufacturer: Volkswagen

Model: Tiguan 1.5 TSI OPF DSG R-Line

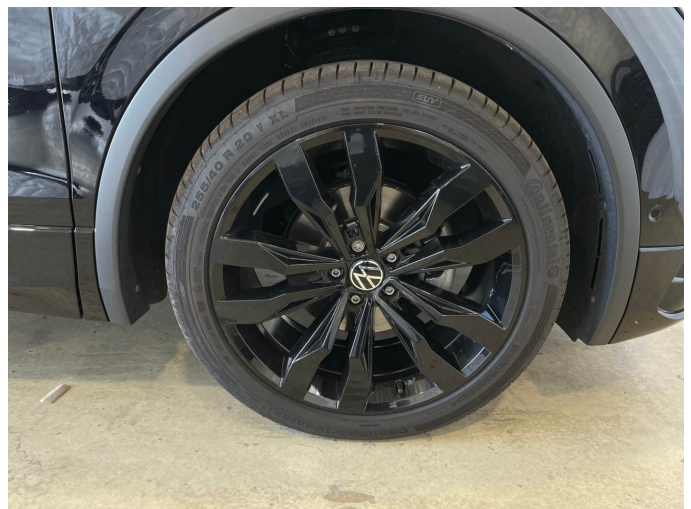
Figure 12: Mounted tyres

| # | Tyre size | Type of tyre | Manufacturer | Tread depth |
|---|---|---|---|---|
| 1) | 255/40 R20 101V | Summer tires (with run-flat tires) on Light alloy | Continental | 6mm / 6mm |
| 2) | 255/40 R20 101V | Summer tires (with run-flat tires) on Light alloy | Continental | 6mm / 6mm |

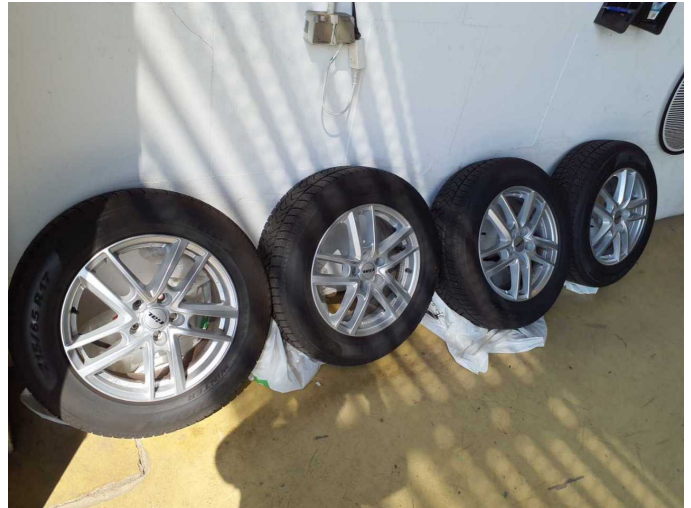
Figure 14: Additional tyres

| # | Tyre size | Type of tyre | Manufacturer | Tread depth |
|---|---|---|---|---|
| 1) | 215/65 R17 99H | Winter tires (with run-flat tires) on Light alloy | Pirelli | 6mm / 6mm |
| 2) | 215/65 R17 99H | Winter tires (with run-flat tires) on Light alloy | Pirelli | 7mm / 7mm |

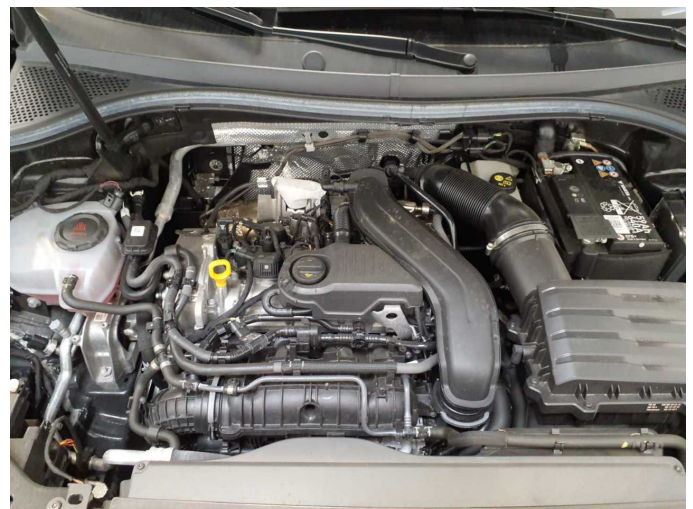
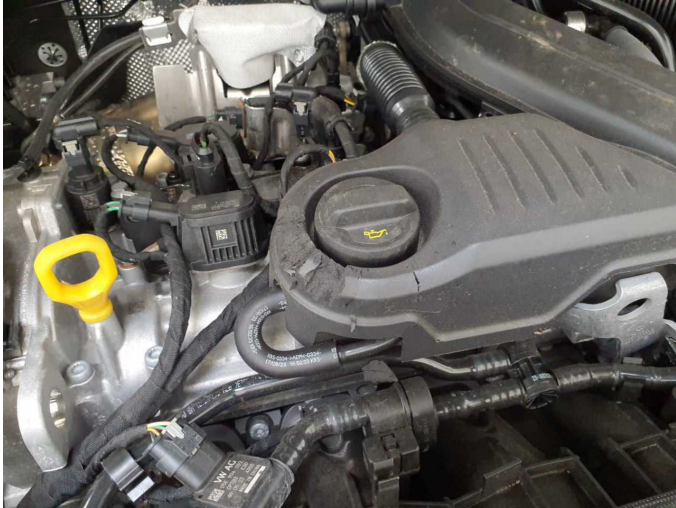
| No. | Component group | Description |
|---|---|---|
| 3 | Engine | Engine cover - Damage caused by marten / rodent - Replace |

**Damage 3:** Engine: Engine cover - Damage caused by marten / rodent - Replace

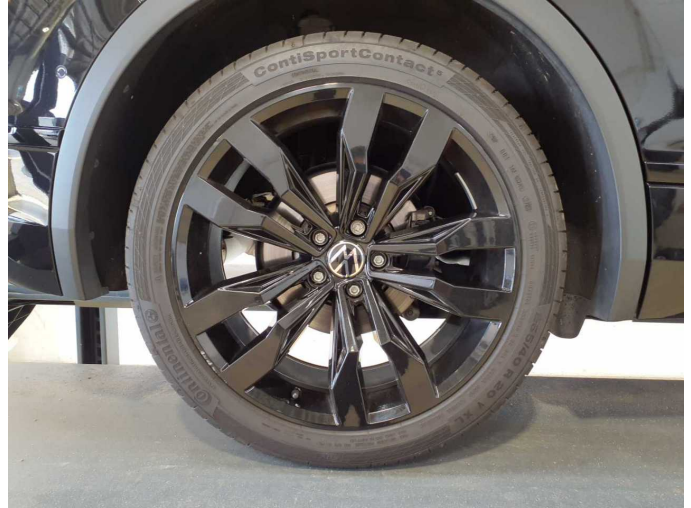
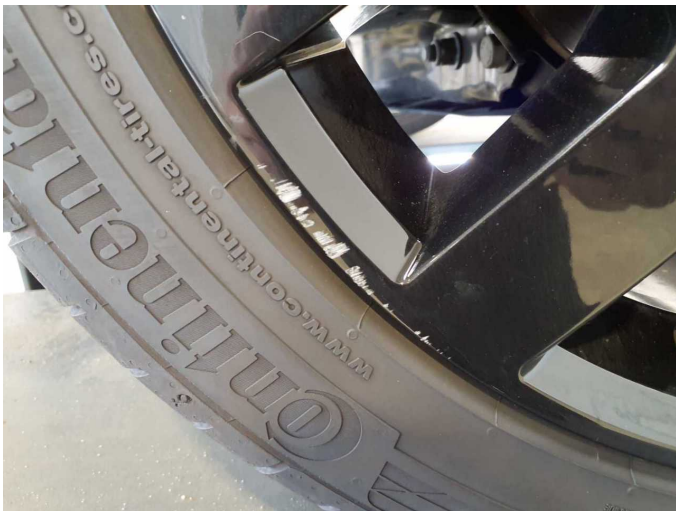
| No. | Component group | Description |
|---|---|---|
| 4 | Wheel / tyres | Alloy rim - rear right side - Scratch(es) - Loss in value |

**Damage 4:** Wheel / tyres: Alloy rim - rear right side - Scratch(es) - Loss in value

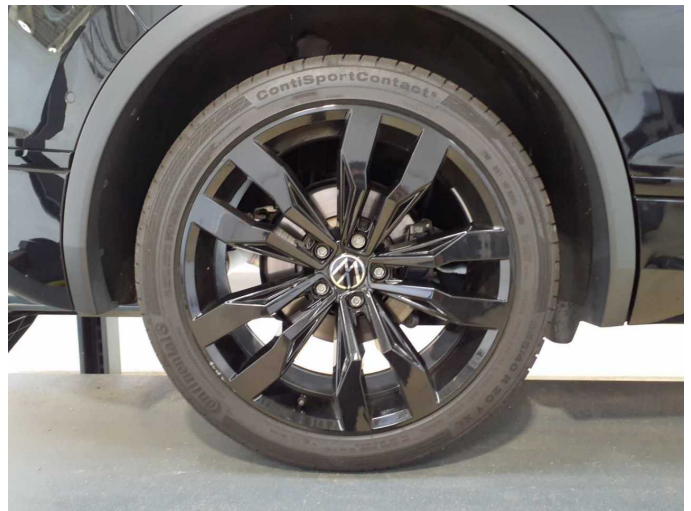
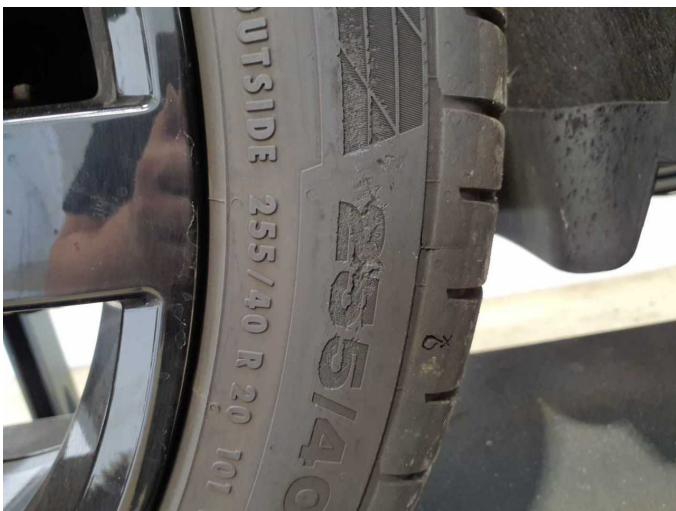
| No. | Component group | Description |
|---|---|---|
| 5 | Wheel / tyres | Tyre - rear right side - Scratch(es) - Replace |

**Damage 5:** Wheel / tyres: Tyre - rear right side - Scratch(es) - Replace

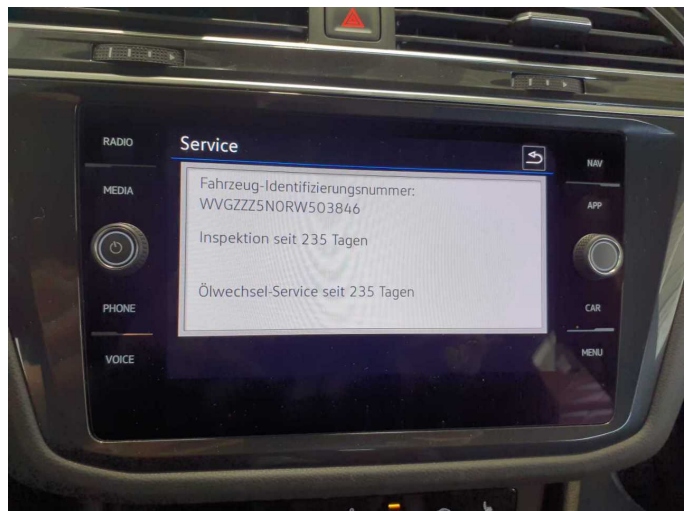
| No. | Component group | Description |
|---|---|---|
| 6 | Misc. | Inspection / maintenance - Due - Perform |

**Damage 6:** Misc.: Inspection / maintenance - Due - Perform

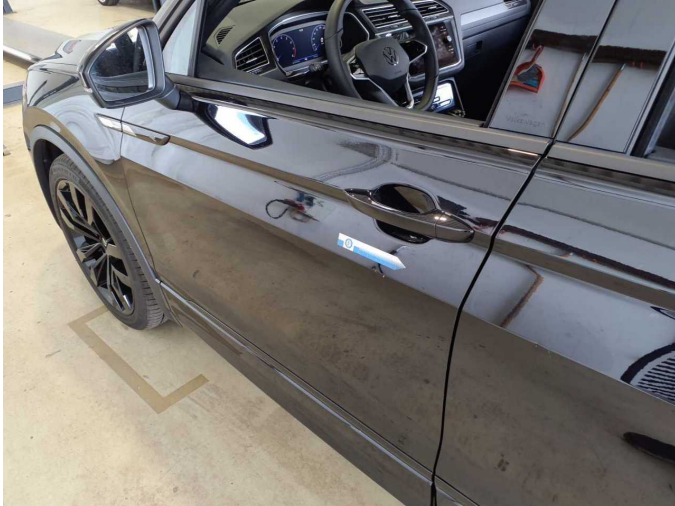
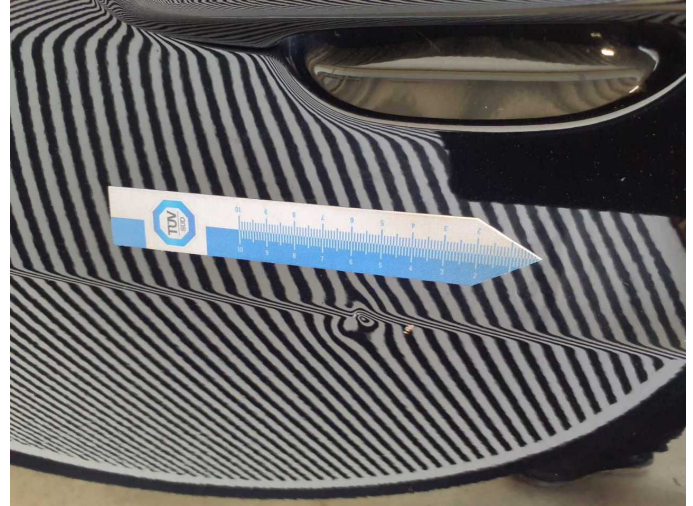
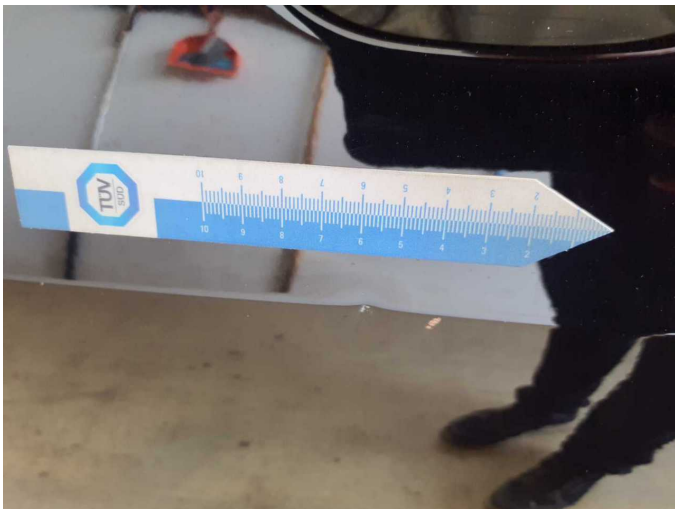
| No. | Component group | Description |
|---|---|---|
| 8 | Door - front left side | Door - Dent / paintcoat damage - repair according to calculation |

**Damage 8:** Door - front left side: Door - Dent / paintcoat damage - repair according to calculation

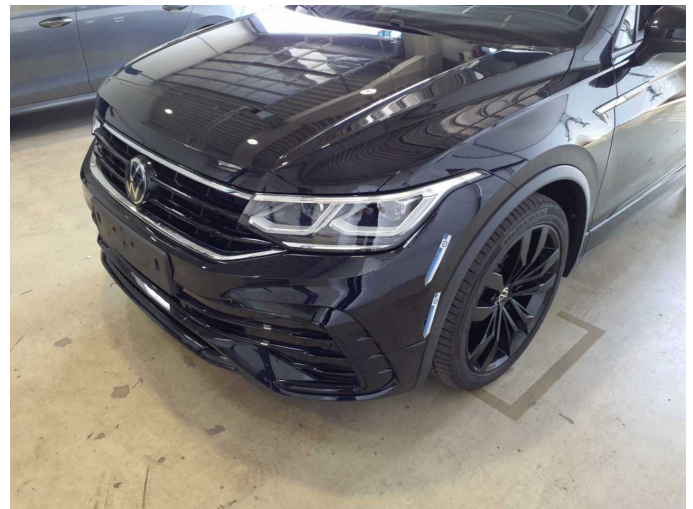
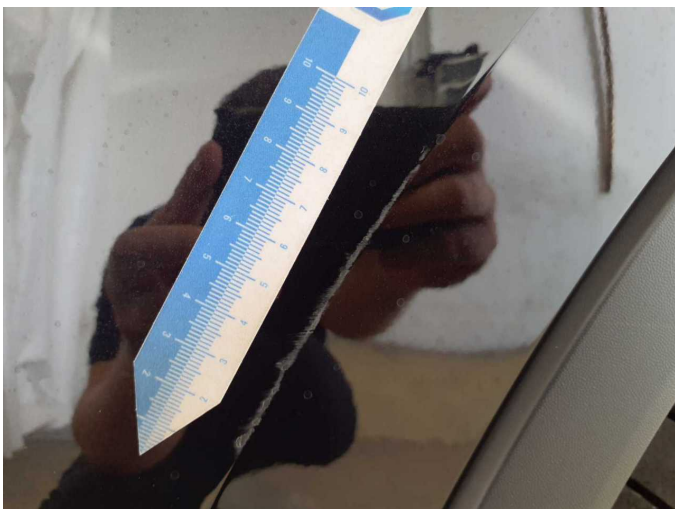
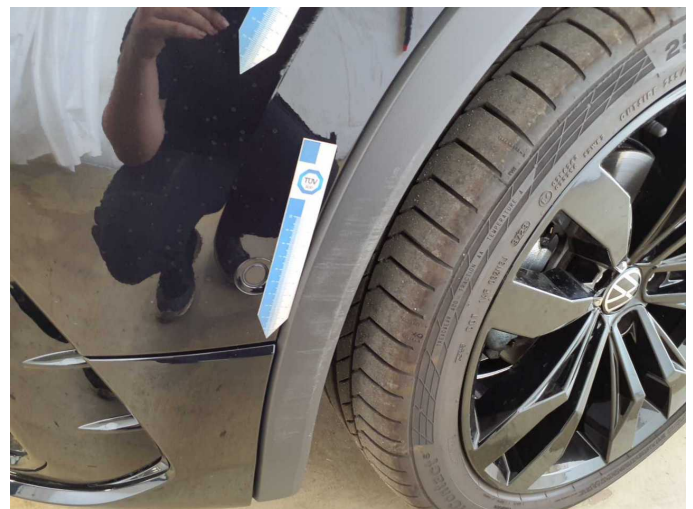
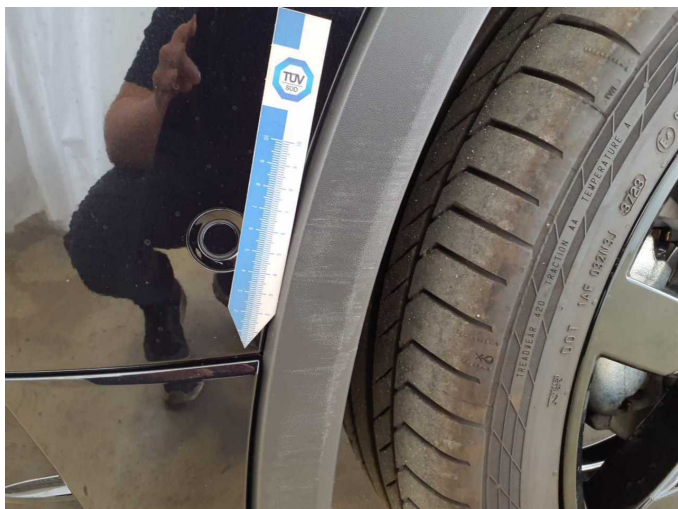
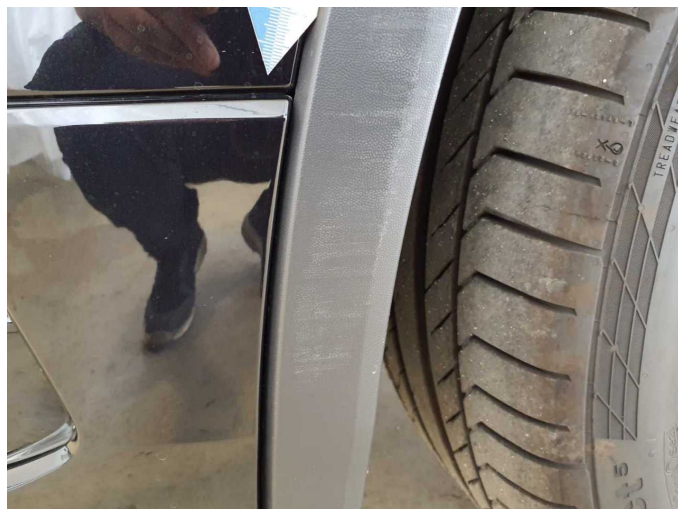
| No. | Component group | Description |
|---|---|---|
| 9 | Front bumper | Front bumper (+ Radhausverbreiterung) - Scratch(es) - Paint |

**Damage 9:** Front bumper: Front bumper (+ Radhausverbreiterung) - Scratch(es) - Paint

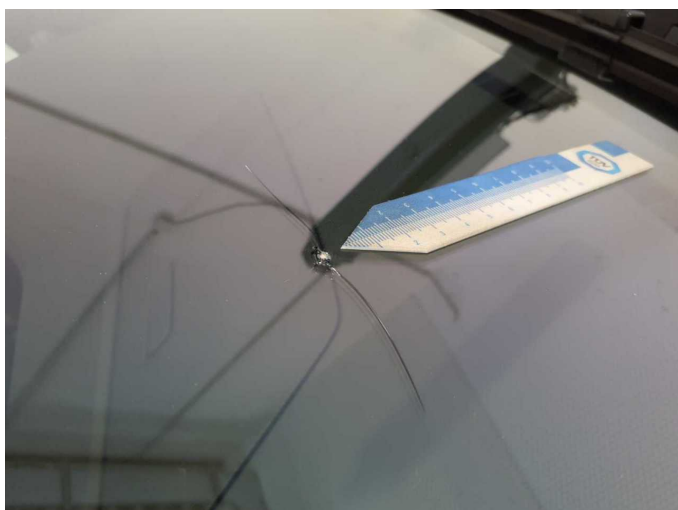
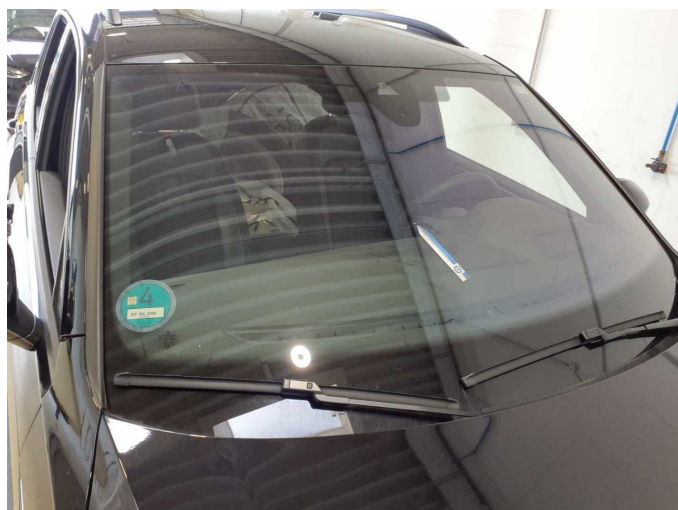
| No. | Component group | Description |
|---|---|---|
| 10 | Vehicle glazing | Windscreen - Broken / torn - Replace |

**Damage 10:** Vehicle glazing: Windscreen - Broken / torn - Replace
