Expertise

Protocol number: 46543735  
Order No. / Reference: 26712222  
Inspection date: 16 Jul 2026

Manufacturer: Ford

Model: S-Max 2.0 EcoBlue Aut. TITANIUM

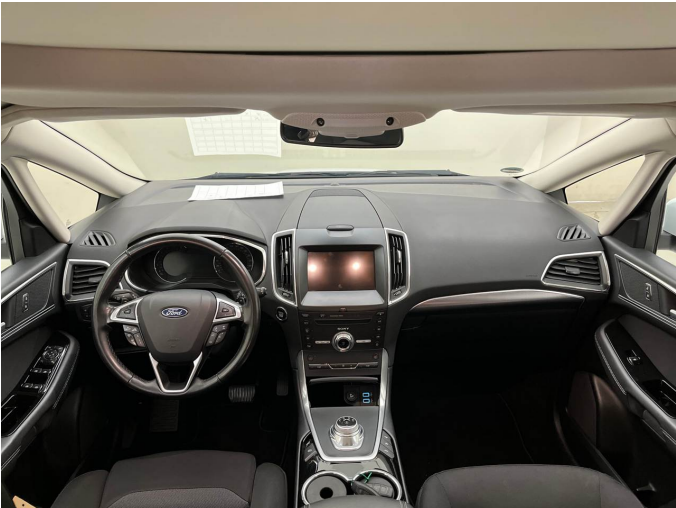
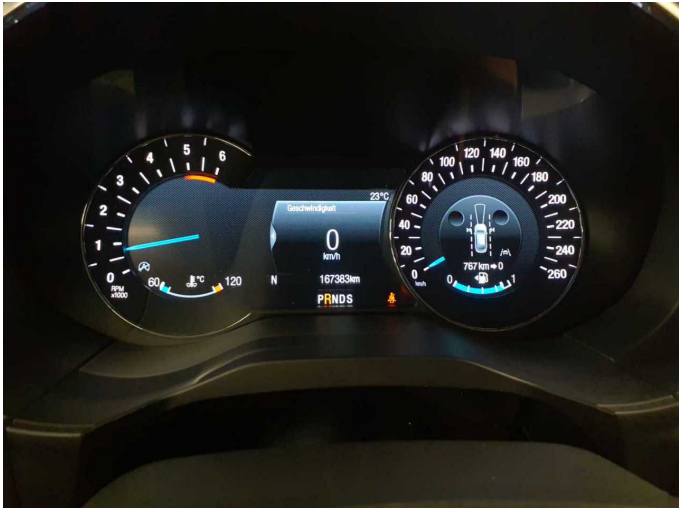
| Mileage (Read) | 167,383 km |

Figure 7: Instrument cluster

Figure 8: Instrument cluster

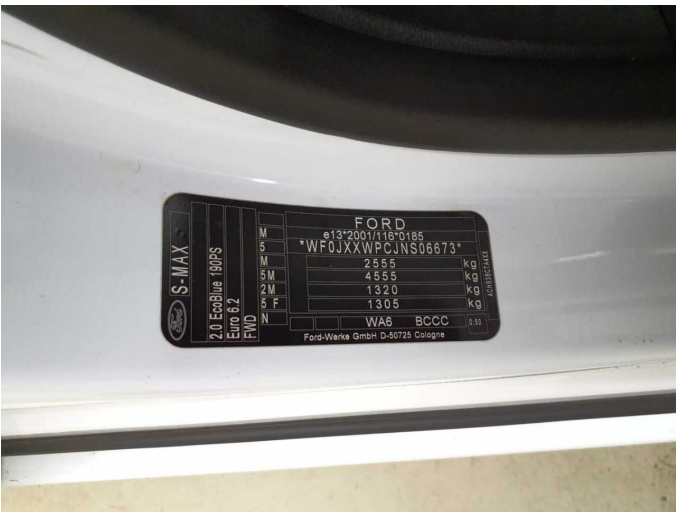
| VIN comparison | The vehicle identification number (VIN) was read from the vehicle and its conformity with the submitted documents was confirmed by the undersigned during the inspection. |

Figure 11: VIN

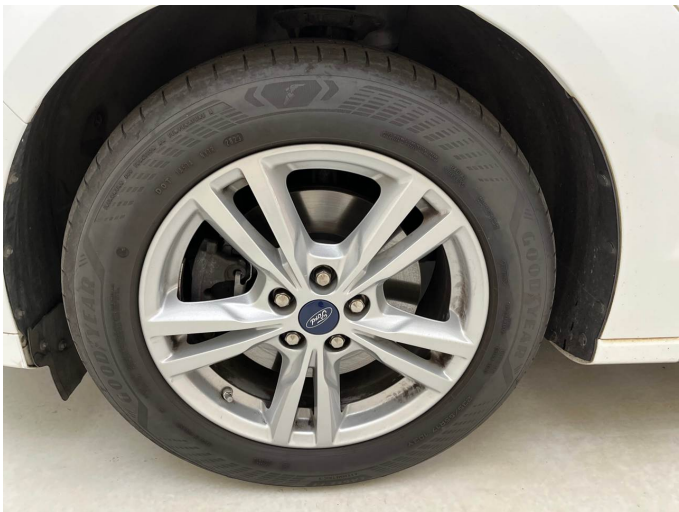
Figure 12: Mounted tyres

| # | Tyre size | Type of tyre | Manufacturer | Tread depth |
|---|---|---|---|---|
| 1) | 235/55 R17 103Y | Summer tyres on Light alloy | Goodyear | 4mm / 4mm |
| 2) | 235/55 R17 103Y | Summer tyres on Light alloy | Goodyear | 4mm / 4mm |

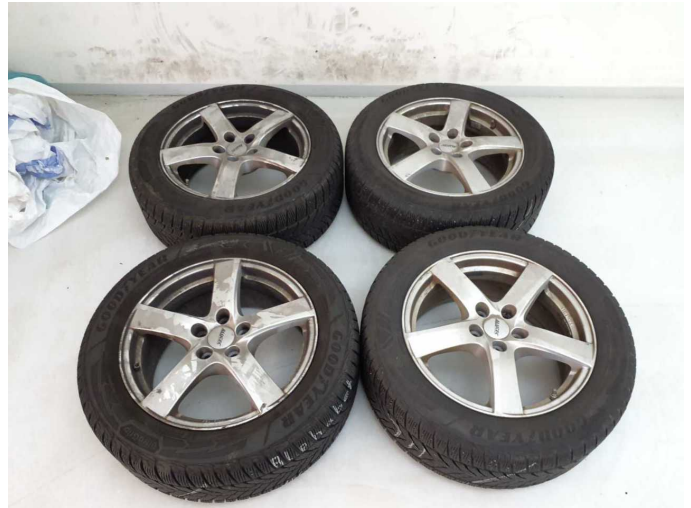
Figure 14: Additional tyres

| # | Tyre size | Type of tyre | Manufacturer | Tread depth |
|---|---|---|---|---|
| 1) | 235/55 R17 103V | Winter tyres on Light alloy | Goodyear | 5mm / 5mm |
| 2) | 235/55 R17 103V | Winter tyres on Light alloy | Goodyear | 5mm / 5mm |

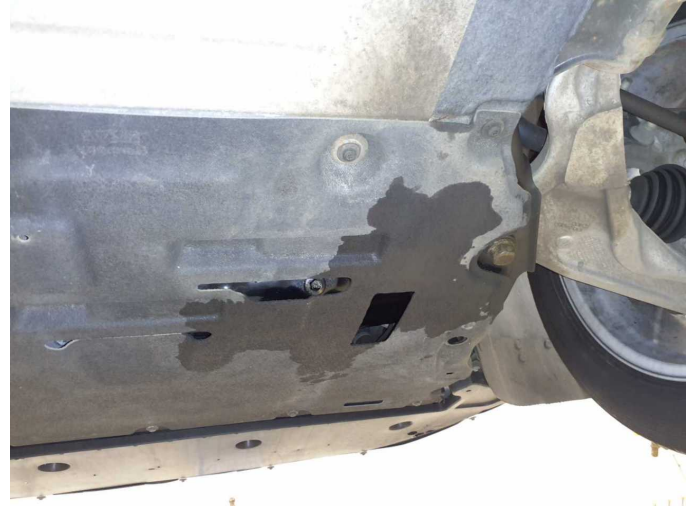
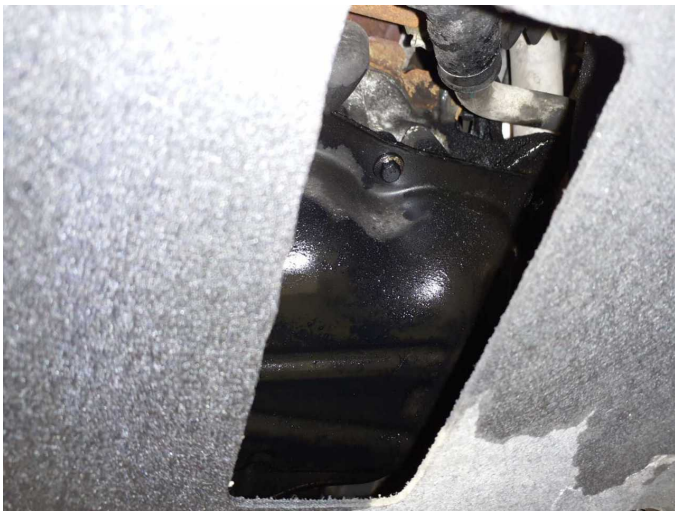
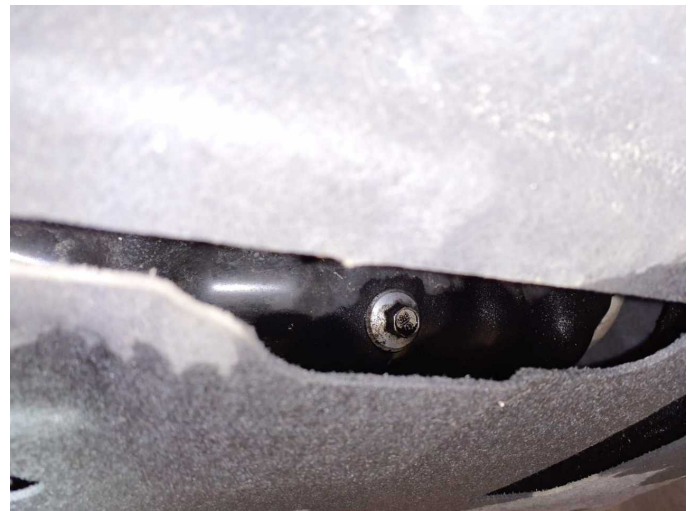
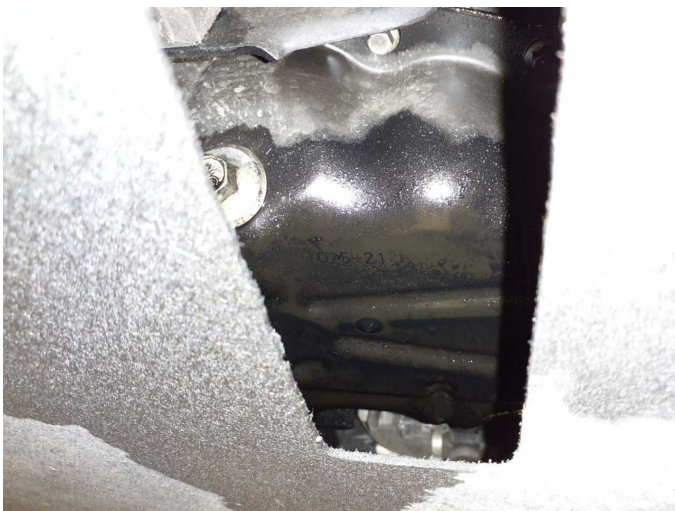
| No. | Component group | Description |
|---|---|---|
| 1 | Engine | Engine - Leaking - Perform diagnosis |

**Damage 1:** Engine: Engine - Leaking - Perform diagnosis

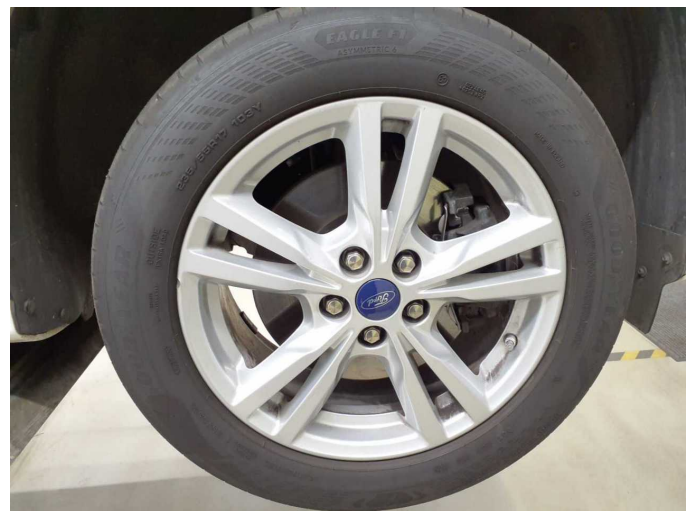
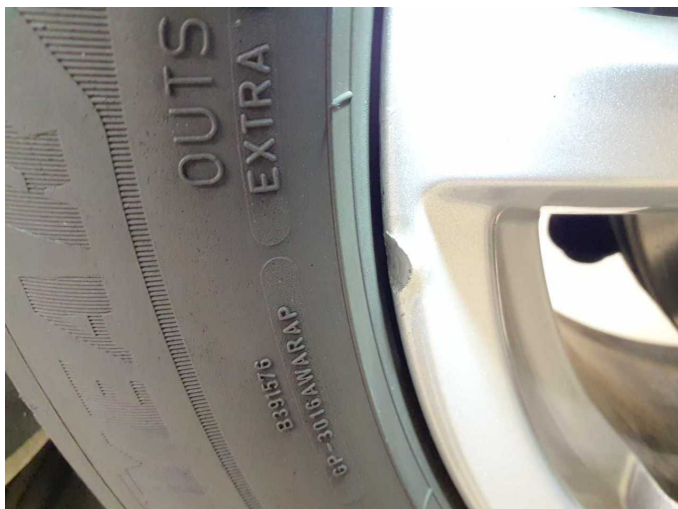
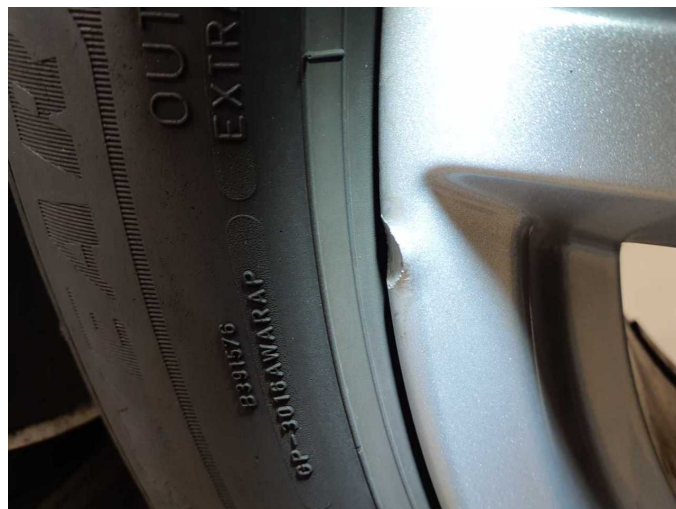
| No. | Component group | Description |
|---|---|---|
| 2 | Wheel / tyres | Alloy rim - front right side (Materialabtrag) - Damaged - Replace |

**Damage 2:** Wheel / tyres: Alloy rim - front right side (Materialabtrag) - Damaged - Replace

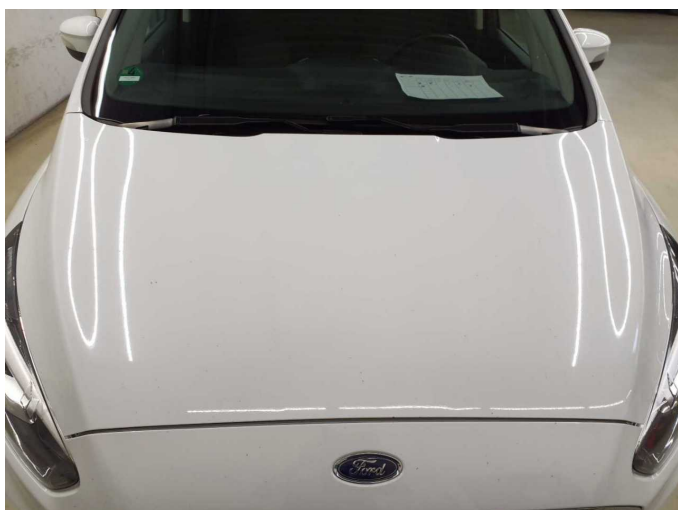
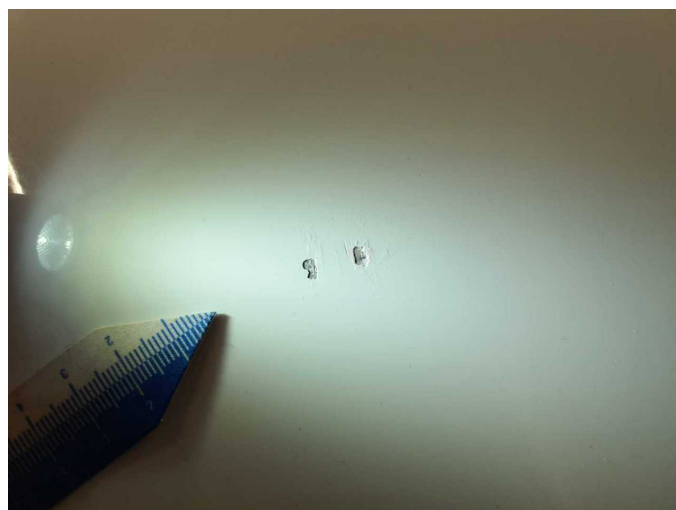
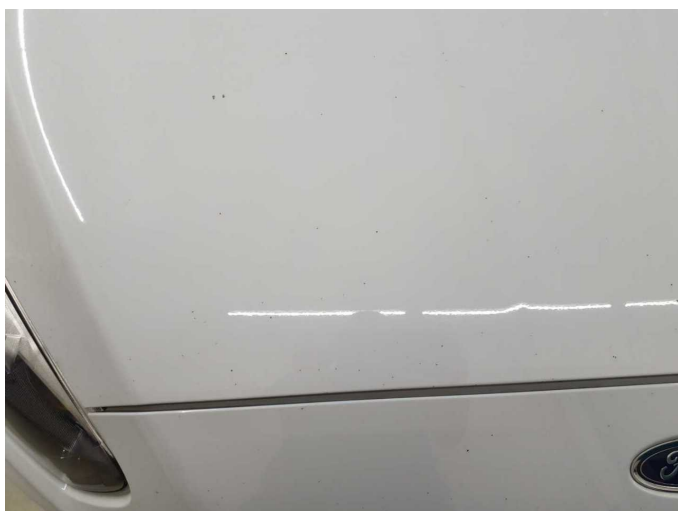
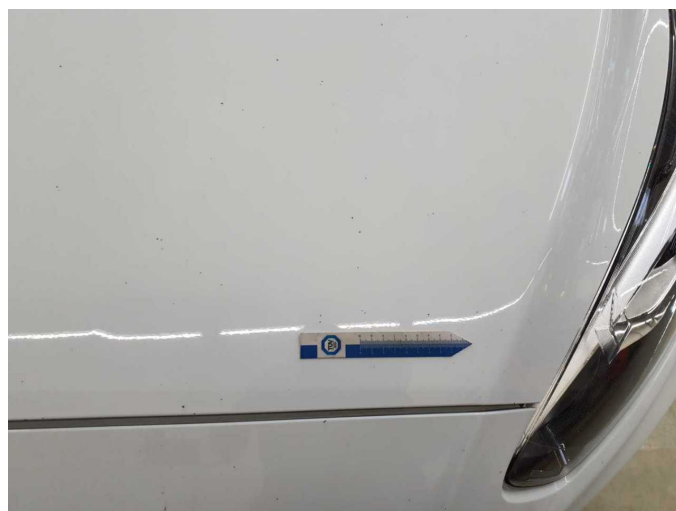
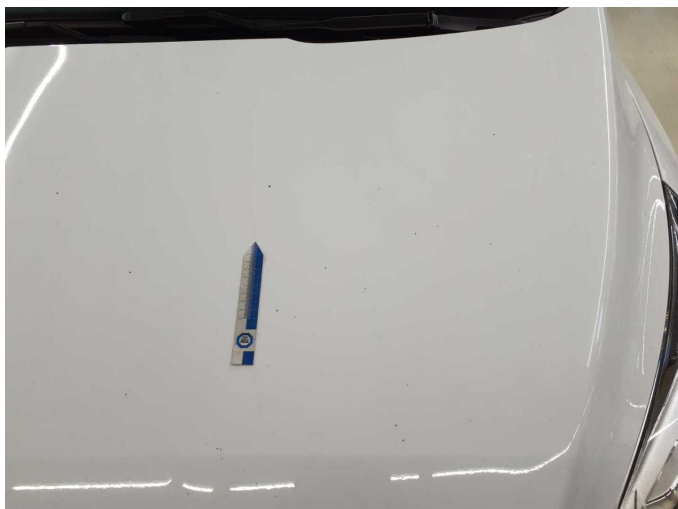
| No. | Component group | Description |
|---|---|---|
| 3 | Bonnet | Bonnet - Stone chips - Paint |

**Damage 3:** Bonnet: Bonnet - Stone chips - Paint
