Expertise

Manufacturer: Ford

Model: Focus Turnier 1.5 EcoBlue Start-Stopp-System Aut. TITANIUM X

VIN: WF0PXXGCHPNA25070

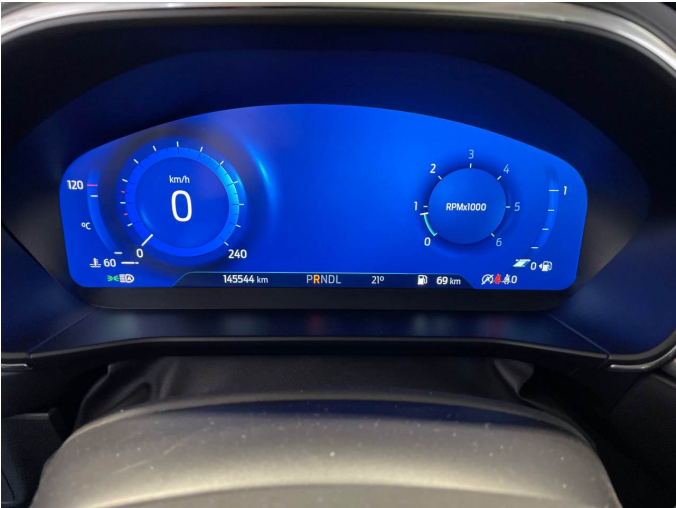
| Vehicle details | |
|---|---|
| Mileage (Read) | 145,543 km |

Figure 7: Instrument cluster

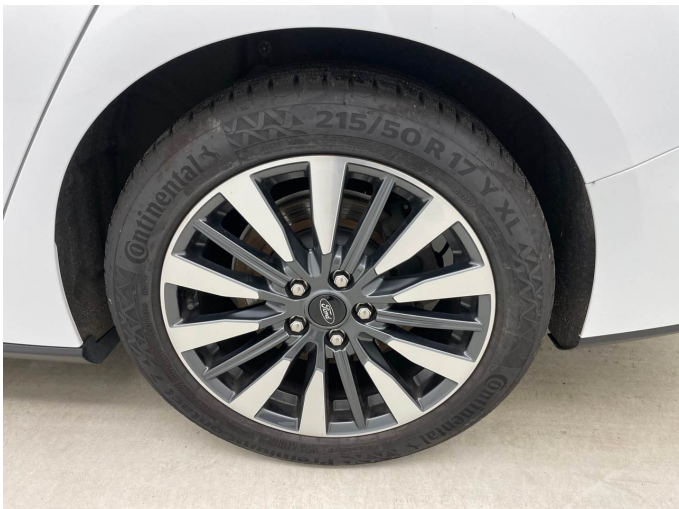
| Tyres | | | | |
|---|---|---|---|---|
| 1) | 215/50 R17 95W | Summer tyres on Light alloy | Continental | 6mm / 6mm |
| 2) | 215/50 R17 95W | Summer tyres on Light alloy | Continental | 5mm / 5mm |

Figure 12: Mounted tyres

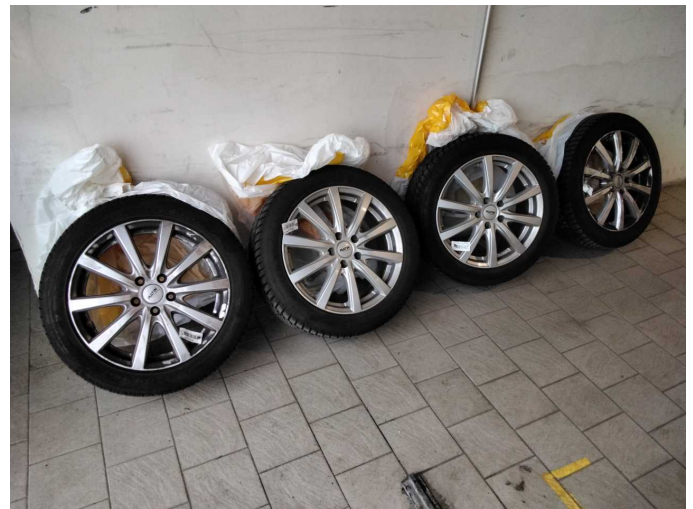
| Tyres | | | | |
|---|---|---|---|---|
| 1) | 215/50 R17 95V | Winter tyres on Light alloy | Dunlop | 8mm / 8mm |
| 2) | 215/50 R17 95V | Winter tyres on Light alloy | Dunlop | 7mm / 7mm |

Figure 16: Additional tyres

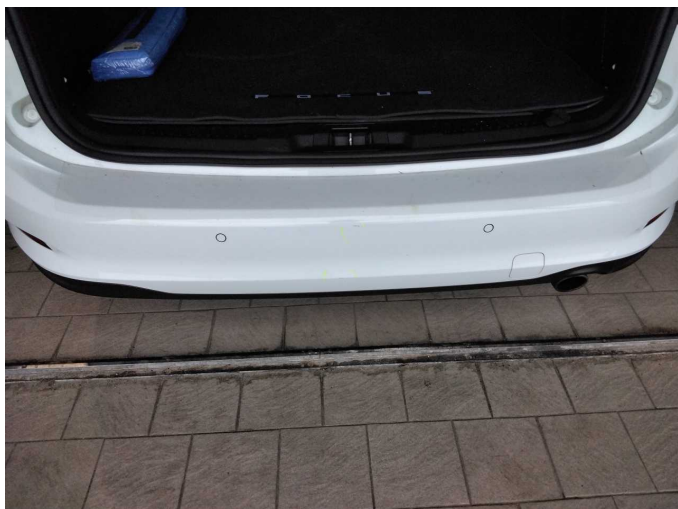
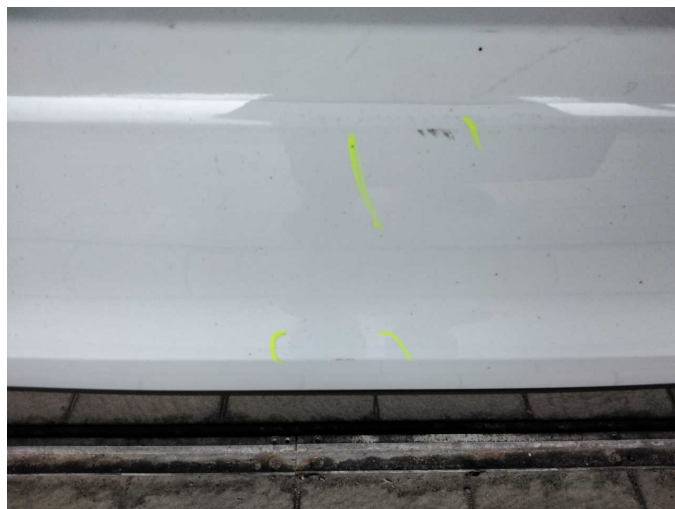
| No. | Component group | Description |
|---|---|---|
| 1 | Rear bumper | Rear bumper - Scratch(es) - Smart repair |

**Damage 1:** Rear bumper: Rear bumper - Scratch(es) - Smart repair

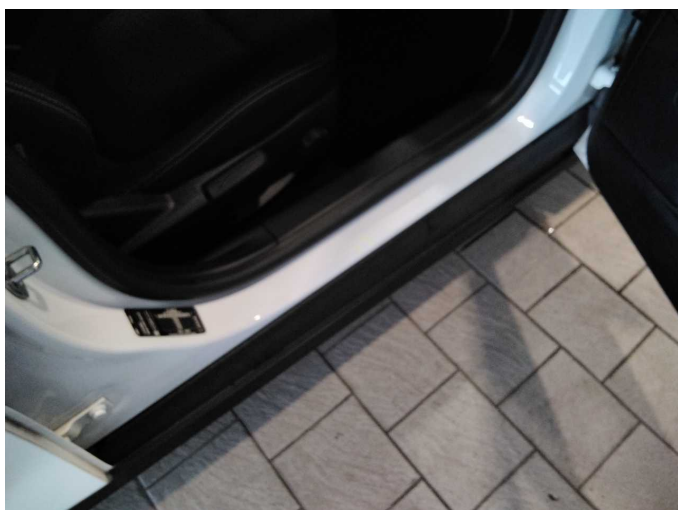
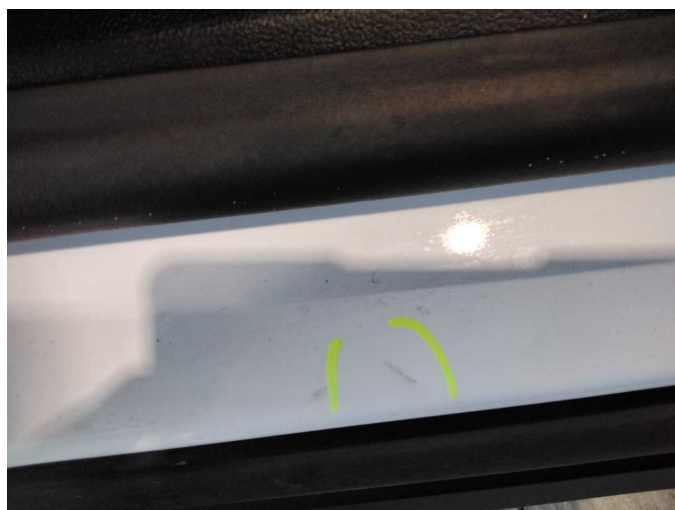
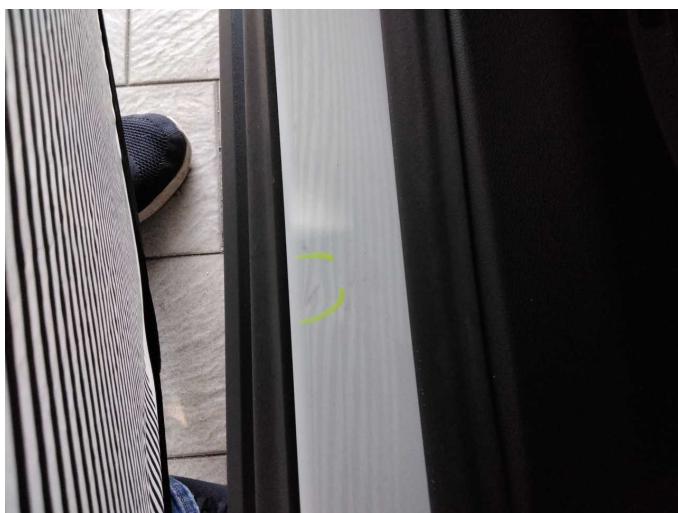
| No. | Component group | Description |
|---|---|---|
| 2 | Sill - right side | Sill - Dent / paintcoat damage - Smart repair |

**Damage 2:** Sill - right side: Sill - Dent / paintcoat damage - Smart repair
