Expertise

Protocol number: 46391945  
Order No. / Reference: 26543765  
Inspection date: 8 Jul 2026

Manufacturer: Peugeot

Model: 3008 BlueHDi 130 Stop & Start Allure

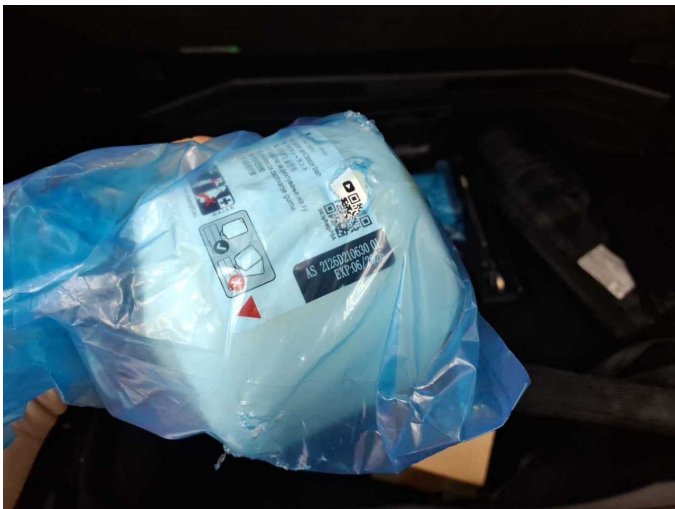
**Damage 2:** Equipment: Tirefit filler - Expired - Replace

| No. | Component group | Description |
|---|---|---|
| 2 | Equipment | Tirefit filler - Expired - Replace |

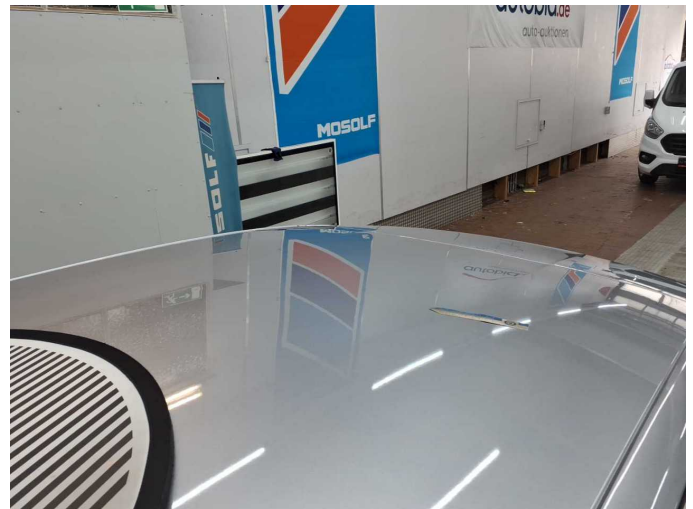
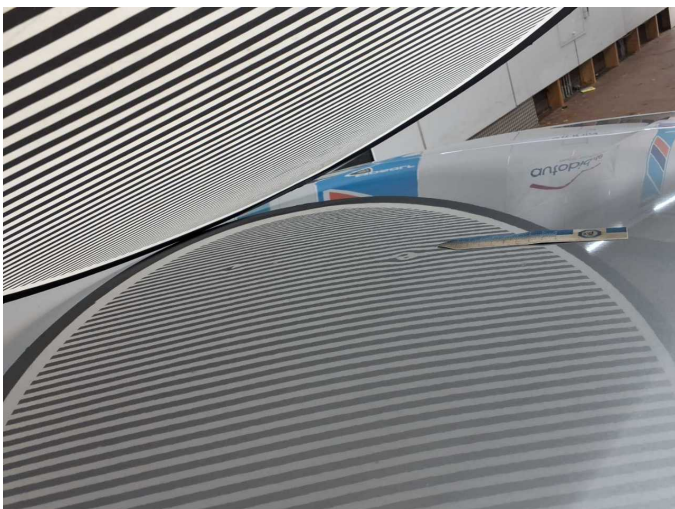
**Damage 3:** Roof: Roof - dent(s) - Smart repair

| No. | Component group | Description |
|---|---|---|
| 3 | Roof | Roof - dent(s) - Smart repair |

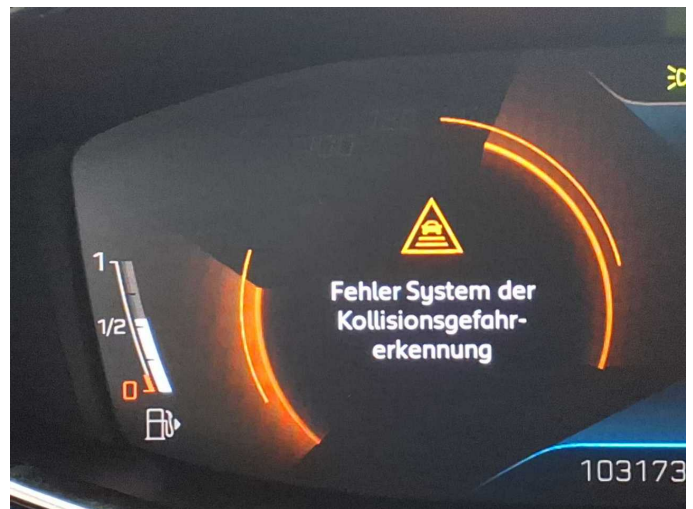
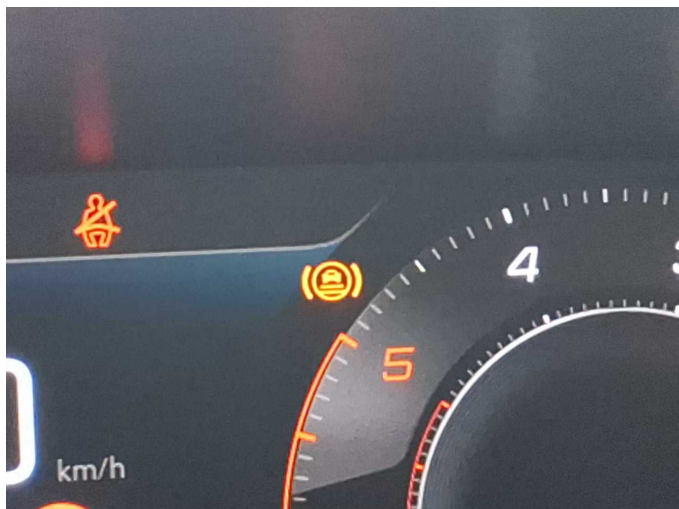
**Damage 4:** Instrument panel: Indicator light (Kollisionsgefahrerkennung) - on - Perform diagnosis

| No. | Component group | Description |
|---|---|---|
| 4 | Instrument panel | Indicator light (Kollisionsgefahrerkennung) - on - Perform diagnosis |
