Expertise

Protocol number: 45890953
Order No. / Reference: 26478882
Inspection date: 10 Jun 2026

Model: Q5 40 TDI quattro S tronic advanced

An order was placed to prepare a sales report for the described vehicle. This report includes the following:

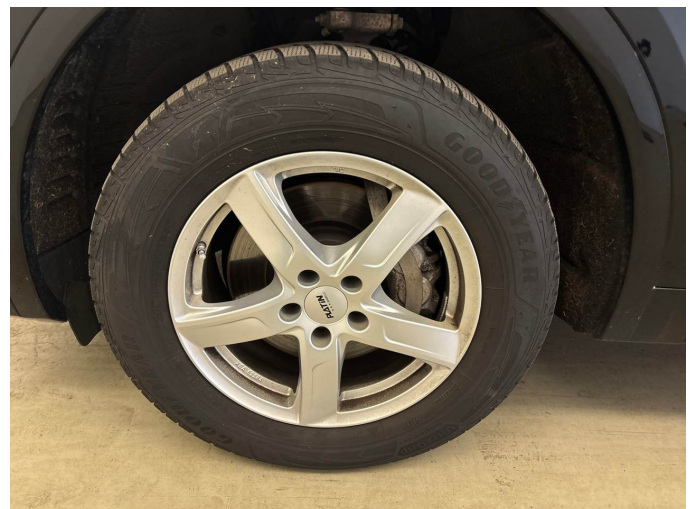
Figure 12: Mounted tyres

#	Tyre size	Type of tyre	Manufacturer	Tread depth
1)	235/65 R17 108H	Winter tyres on Light alloy	Goodyear	6mm / 6mm
2)	235/65 R17 108H	Winter tyres on Light alloy	Goodyear	7mm / 7mm

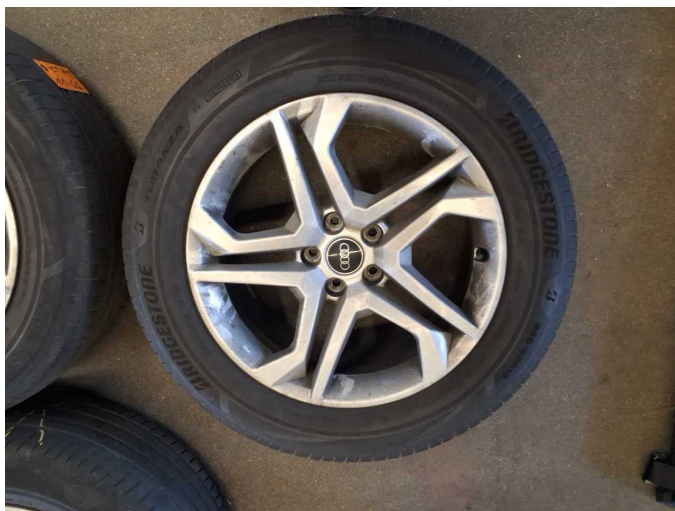
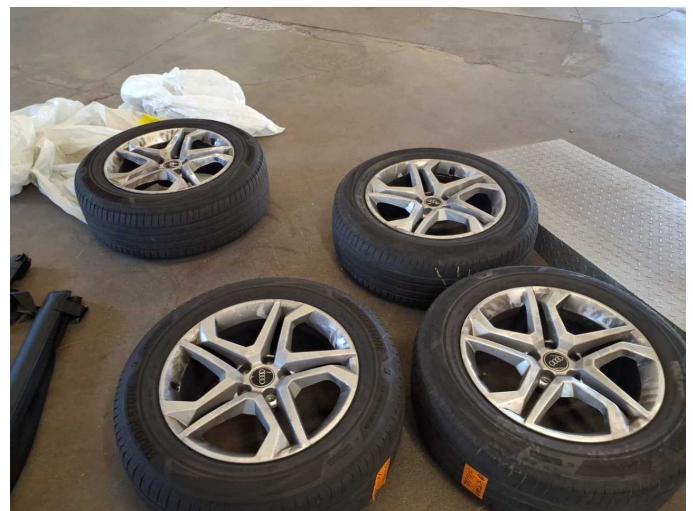
#	Tyre size	Type of tyre	Manufacturer	Tread depth
1)	235/60 R18 107W	Summer tyres on Light alloy	Bridgestone	5mm / 5mm
2)	235/60 R18 107W	Summer tyres on Light alloy	Bridgestone	6mm / 6mm

Figure 15: Additional tyres

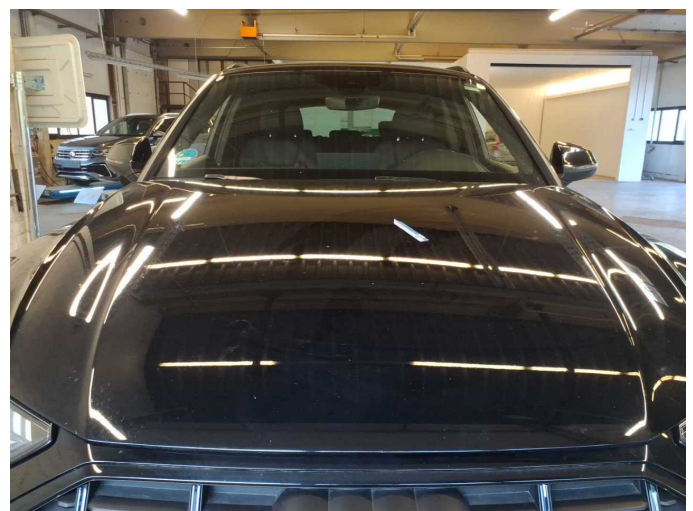
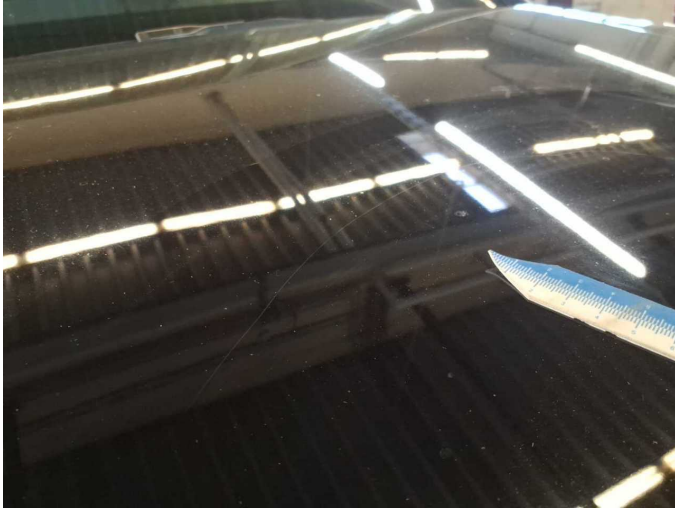
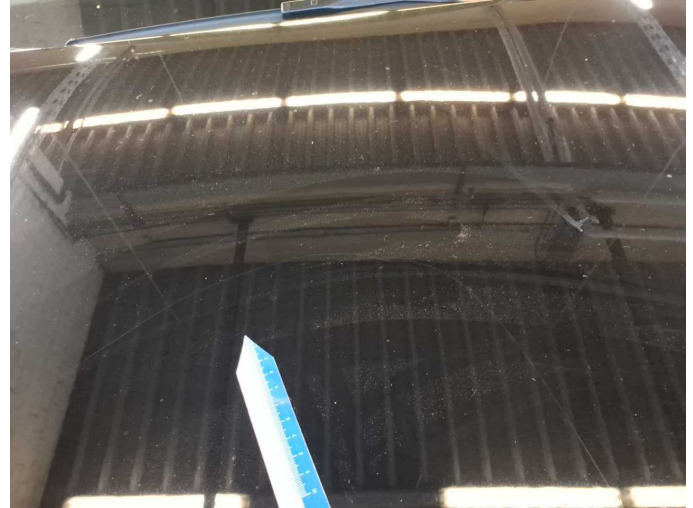
Damage 3: Bonnet: Bonnet (aufpolieren) - Scratch(es) - Smart repair

No.	Component group	Description
1	Front bumper	Front bumper - Stone chips - No deduction
2	Misc.	Inspection / maintenance (Intervall mehrfach überzogen) - No deduction
3	Bonnet	Bonnet (aufpolieren) - Scratch(es) - Smart repair
4	Bonnet	Insulation lining - Missing - Replace
5	Mudguard - right side	Mudguard - right side - Scratched - Paint
6	Door - front left side	Door - Scratched - Paint

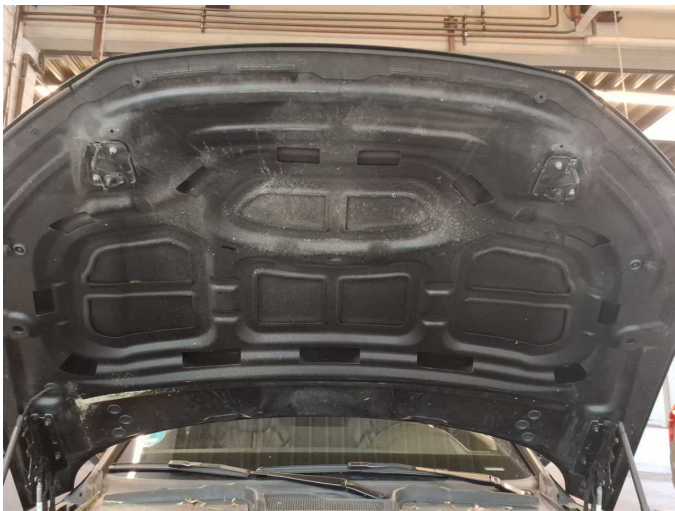
Damage 4: Bonnet: Insulation lining - Missing - Replace

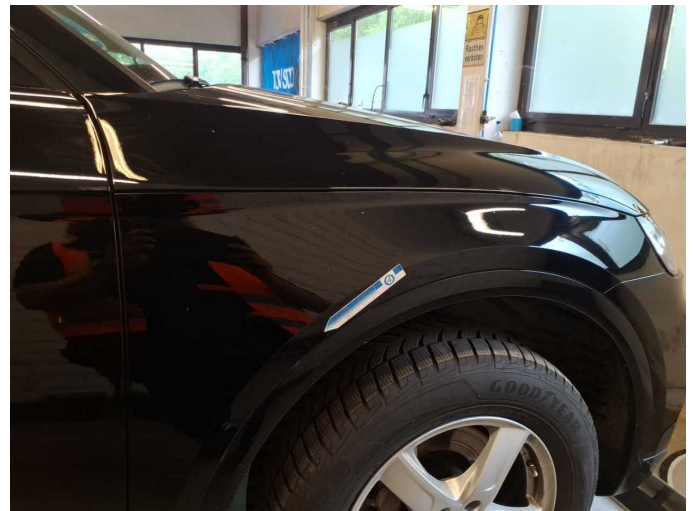
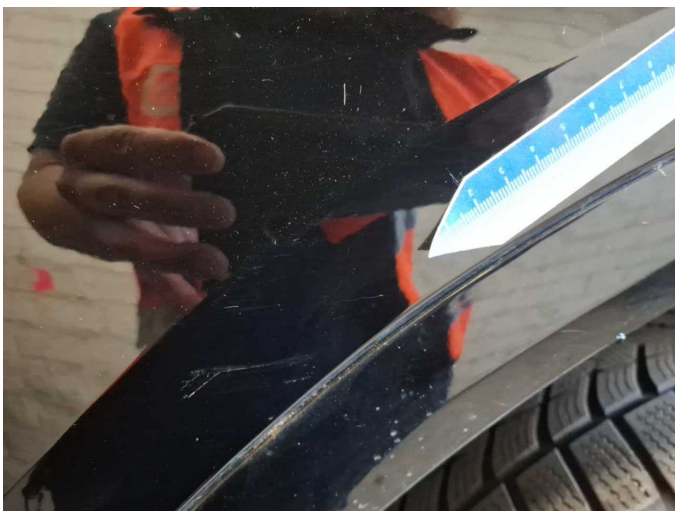
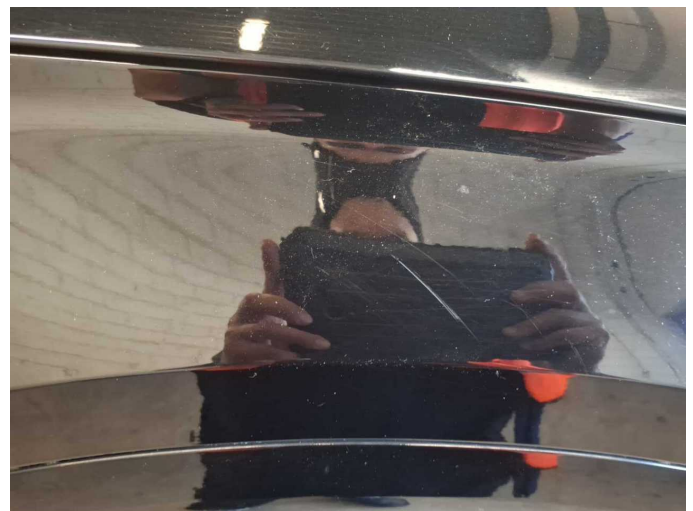
Damage 5: Mudguard - right side: Mudguard - right side - Scratched - Paint

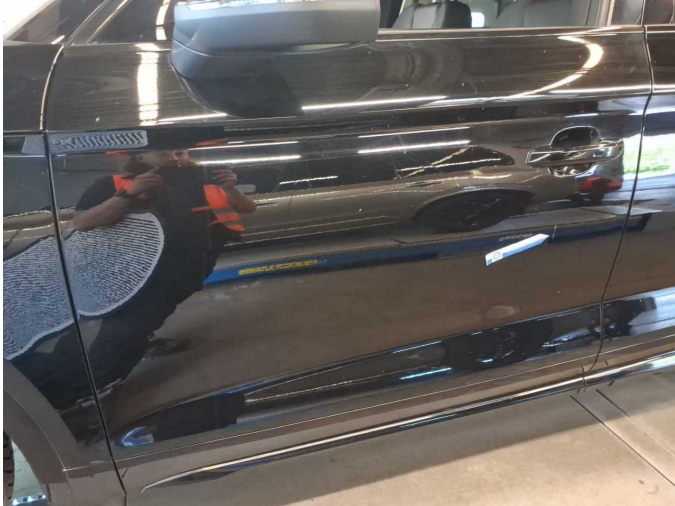
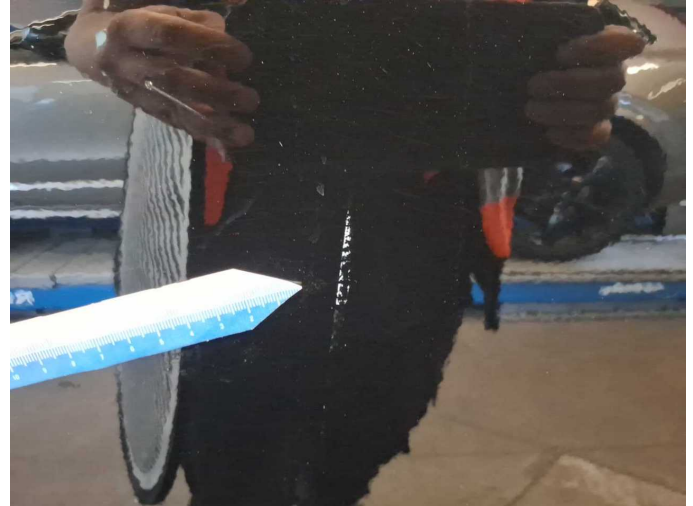
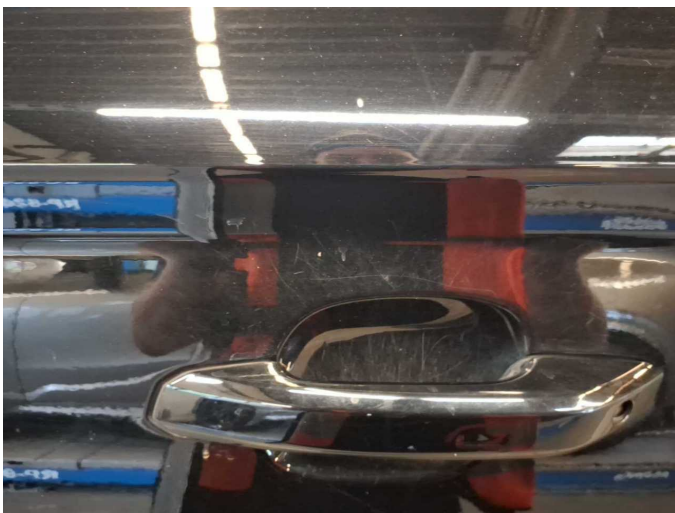
Damage 6: Door - front left side: Door - Scratched - Paint

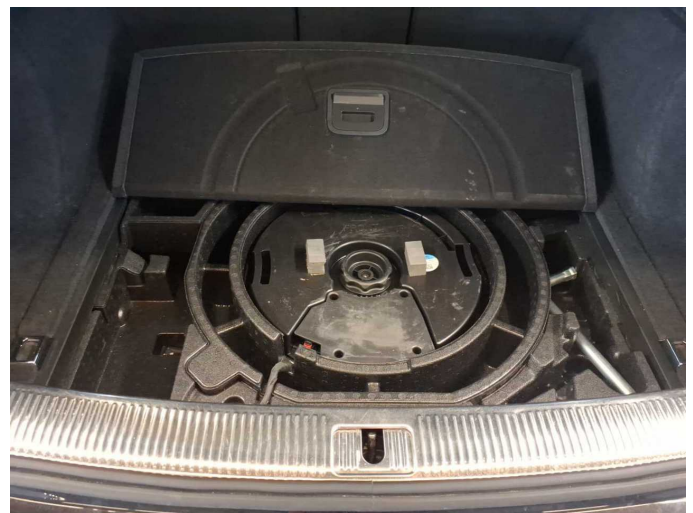
Missing part 2: Equipment: Tirefit complete - Missing - Replace

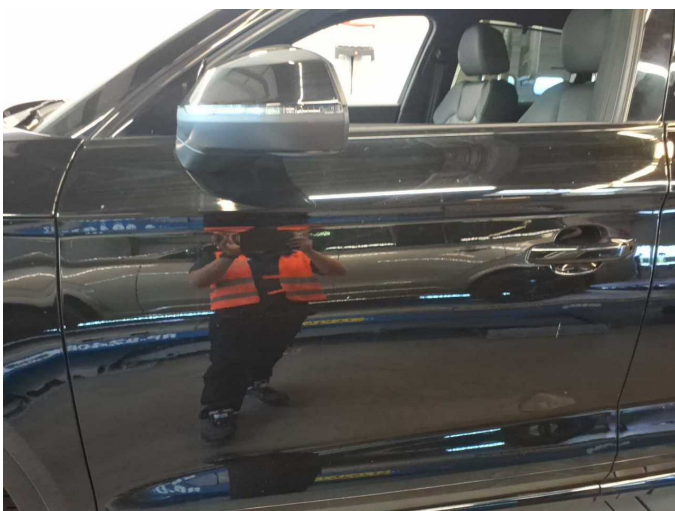
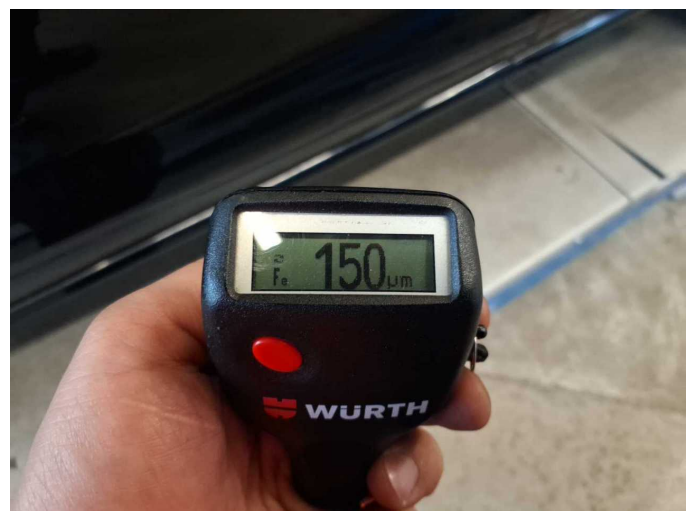
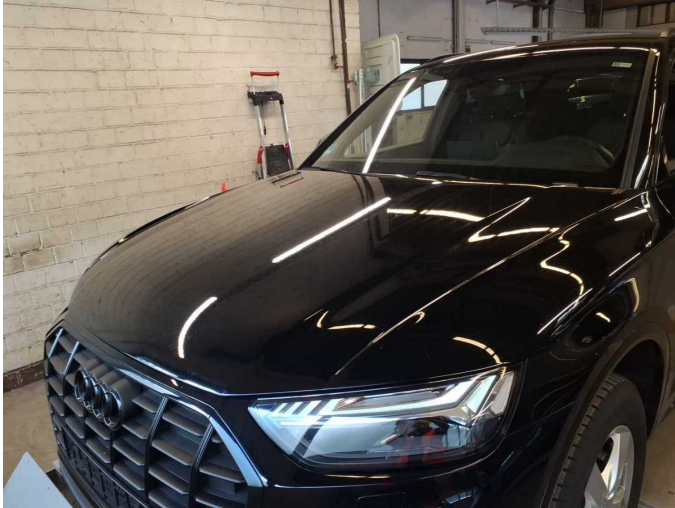
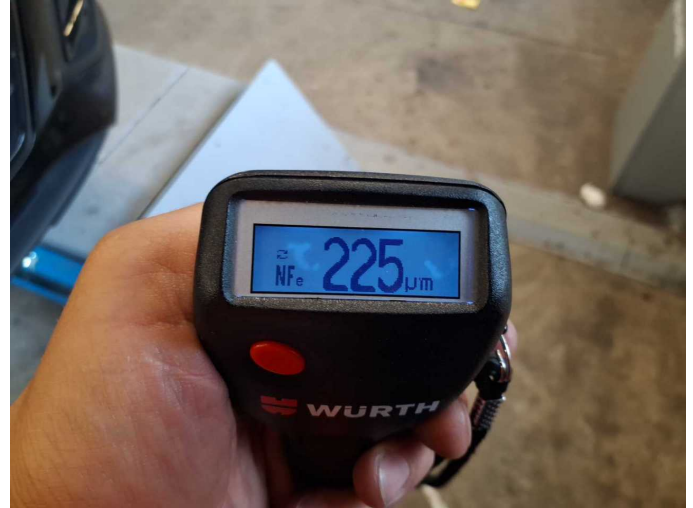
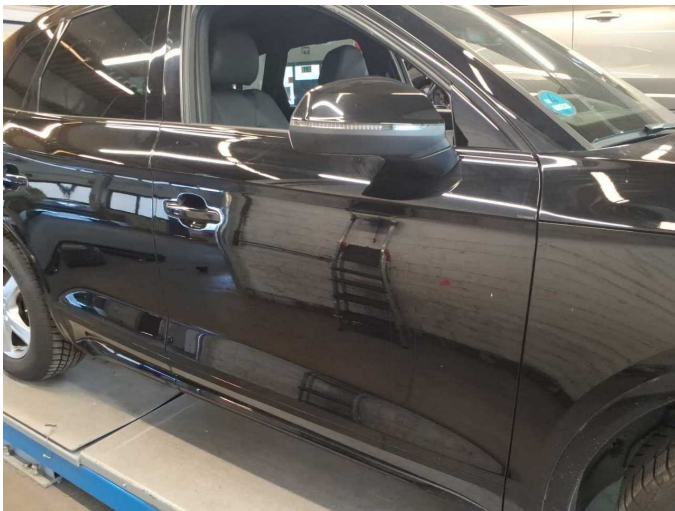
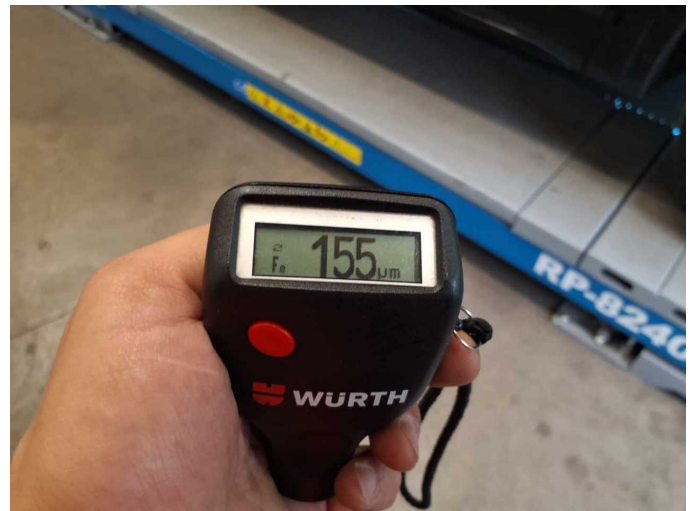
1 Bonnet, Door - front left side, Door - front right side, Professionally carried out, Invoice of repair done Non-existent

Bonnet	213 µm	Door - front left side	149 µm
Door - front right side	163 µm

Repainting 1: Bonnet, Door - front left side, Door - front right side
