Expertise

Protocol number: 46396192  
Order No. / Reference: 26615144  
Inspection date: 8 Jul 2026

Manufacturer: Mercedes-Benz  
VIN: W1N9N0CB1RJ086490

Model: EQA 250+ Electric Art

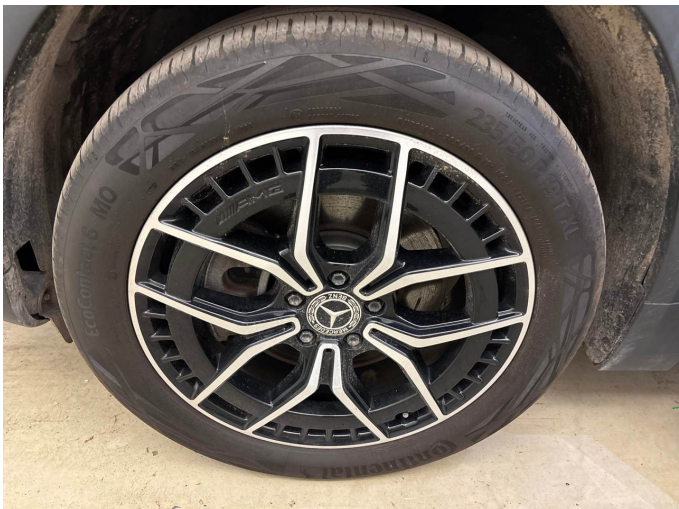
Figure 12: Mounted tyres

| # | Tyre size | Type of tyre | Manufacturer | Tread depth |
|---|---|---|---|---|
| 1) | 235/50 R19 103T | Summer tyres on Light alloy | Continental | 3mm / 3mm |
| 2) | 235/50 R19 103T | Summer tyres on Light alloy | Continental | 4mm / 4mm |

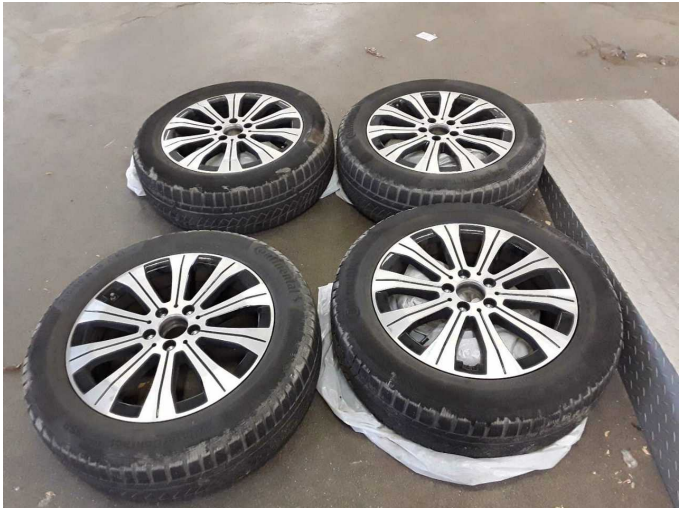
Figure 16: Additional tyres

| # | Tyre size | Type of tyre | Manufacturer | Tread depth |
|---|---|---|---|---|
| 1) | 215/60 R18 102T | Winter tyres on Light alloy | Continental | 3mm / 3mm |
| 2) | 215/60 R18 102T | Winter tyres on Light alloy | Continental | 5mm / 5mm |

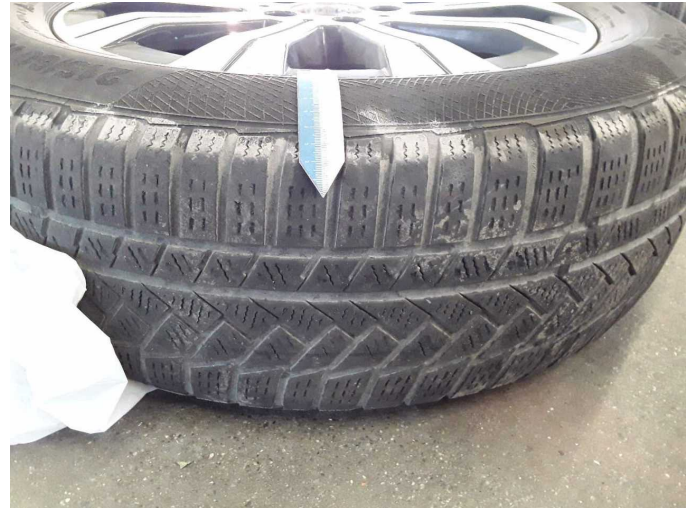
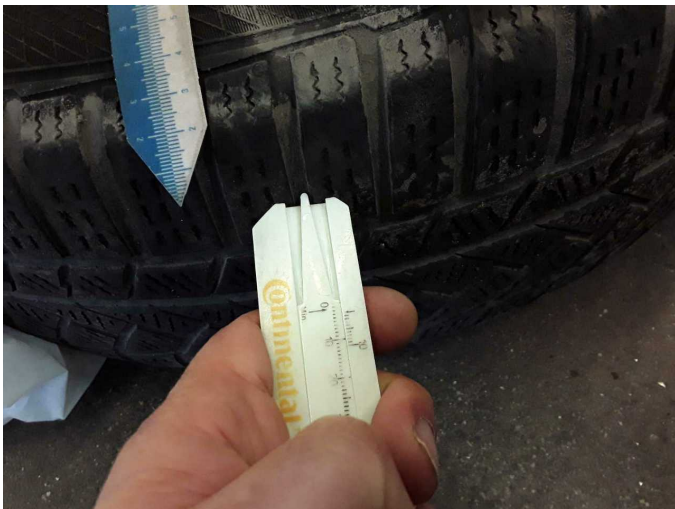
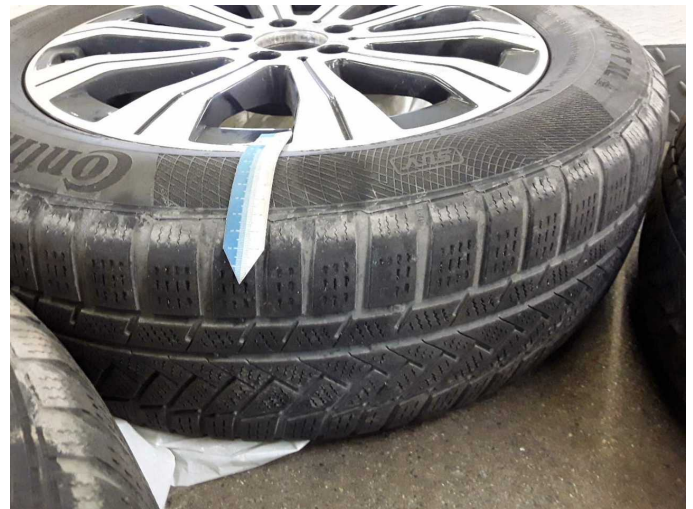
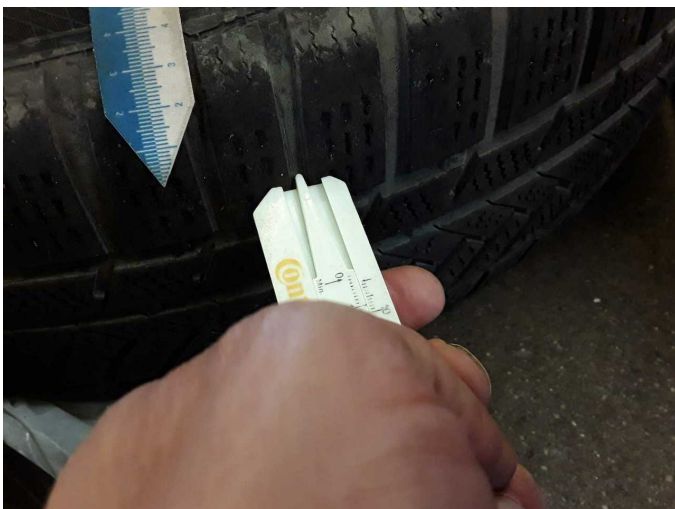
| No. | Component group | Description |
|---|---|---|
| 1 | 2nd wheel set | 2 tyres - Worn - Replace |

**Damage 1:** 2nd wheel set: 2 tyres - Worn - Replace

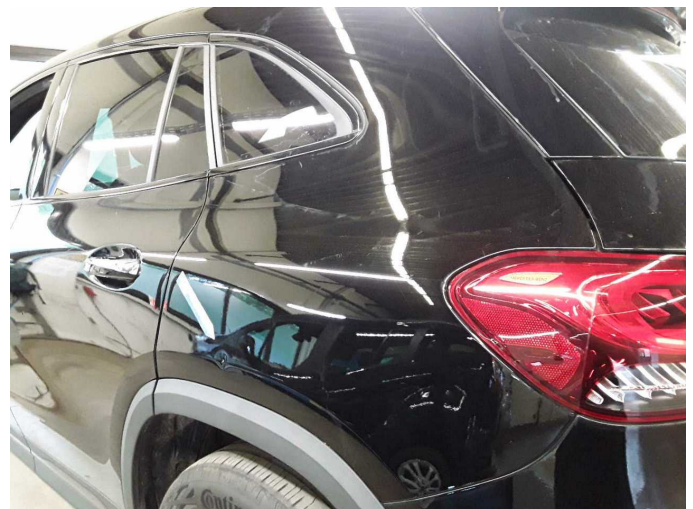
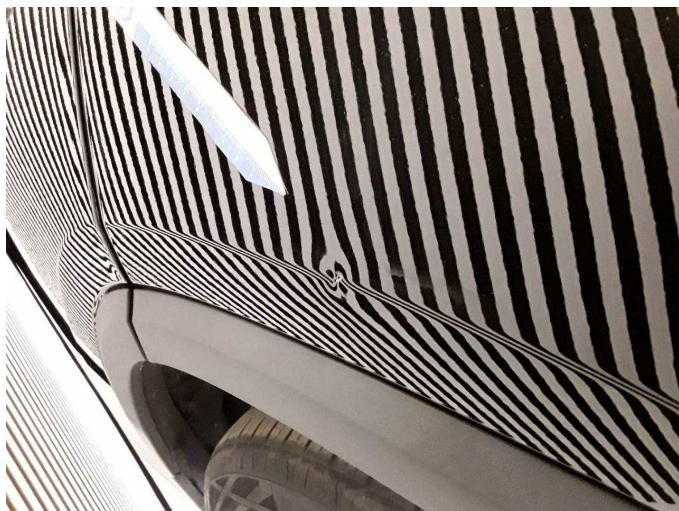
| No. | Component group | Description |
|---|---|---|
| 2 | Side panel - rear left side | Side panel - Dent / paintcoat damage - Repair and paint |

**Damage 2:** Side panel - rear left side: Side panel - Dent / paintcoat damage - Repair and paint

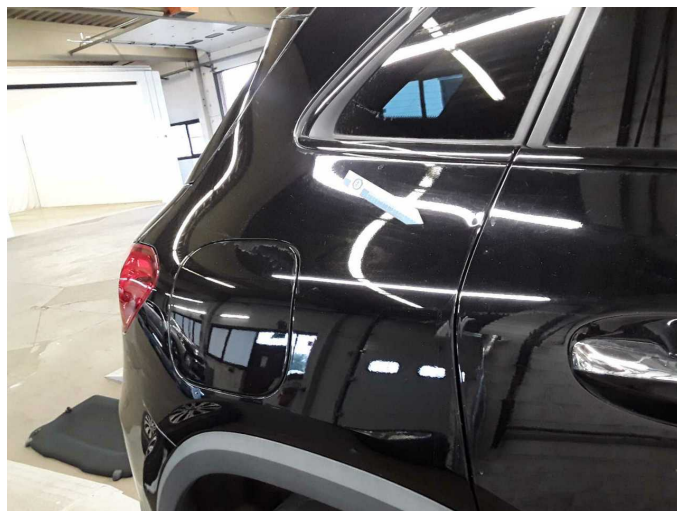
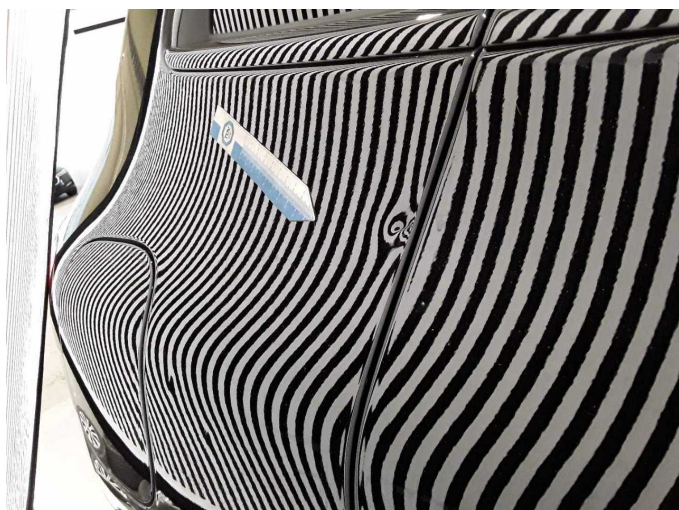
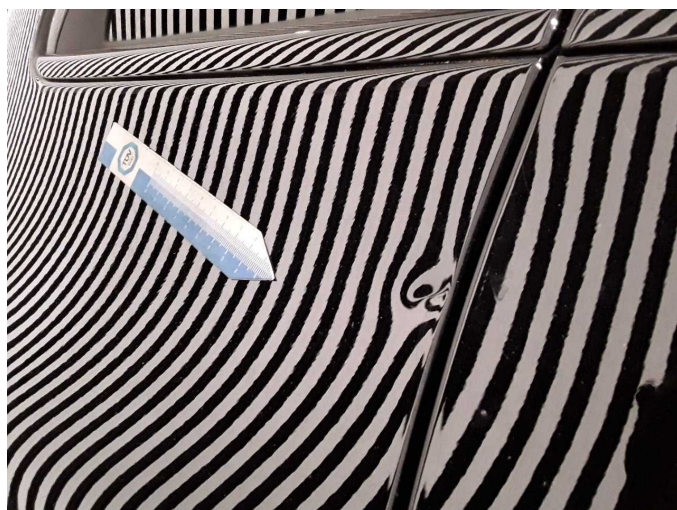
| No. | Component group | Description |
|---|---|---|
| 3 | Side panel - rear right side | Side panel - Deformed - Repair and paint |

**Damage 3:** Side panel - rear right side: Side panel - Deformed - Repair and paint

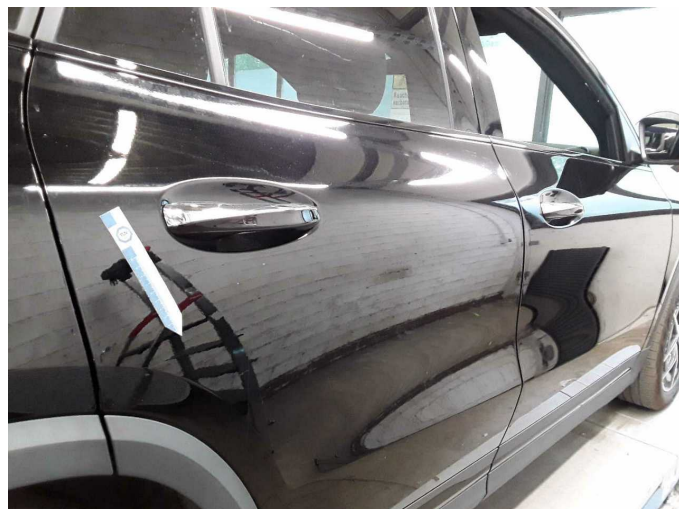
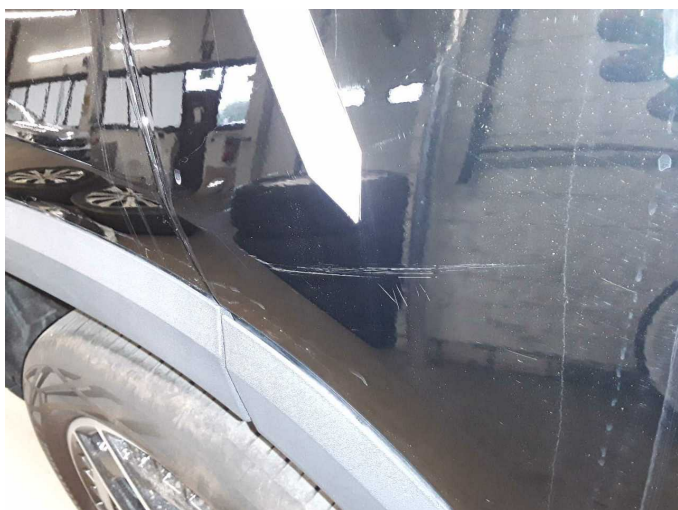
| No. | Component group | Description |
|---|---|---|
| 5 | Door - rear right side | Door - Scratch(es) - Paint |

**Damage 5:** Door - rear right side: Door - Scratch(es) - Paint

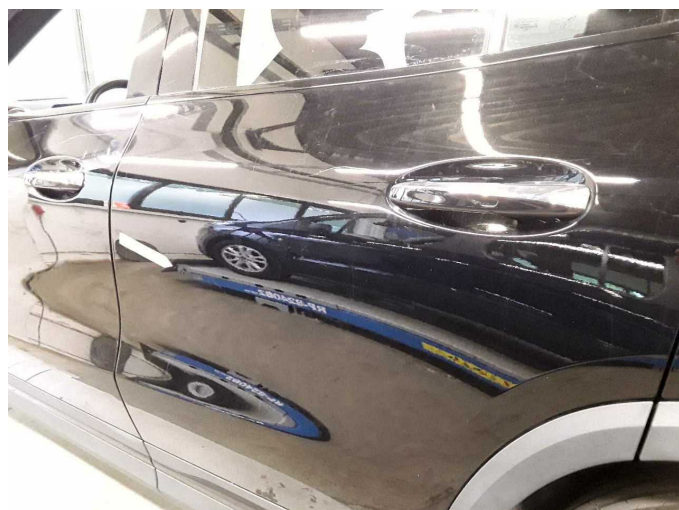
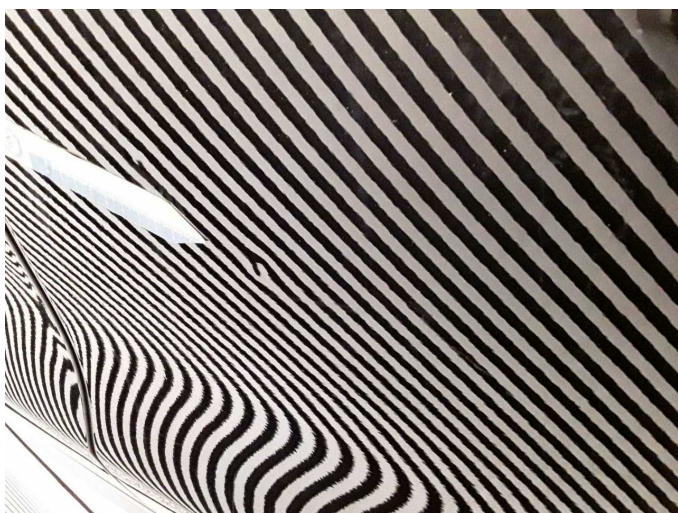
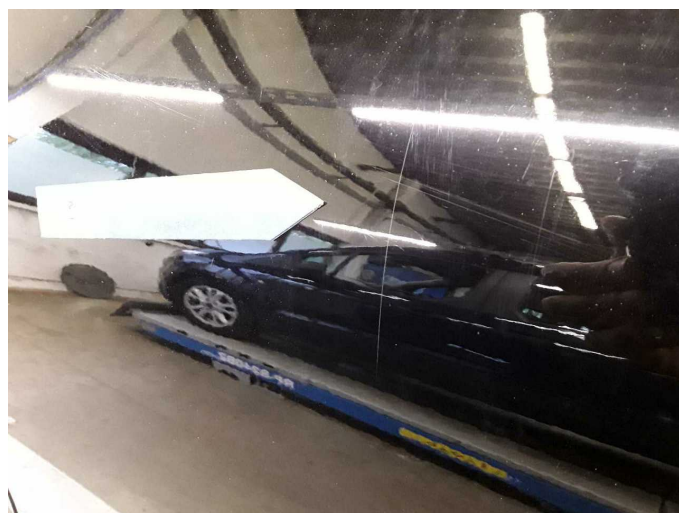
| No. | Component group | Description |
|---|---|---|
| 6 | Door - rear left side | Door - Dent / paintcoat damage - Repair and paint |

**Damage 6:** Door - rear left side: Door - Dent / paintcoat damage - Repair and paint

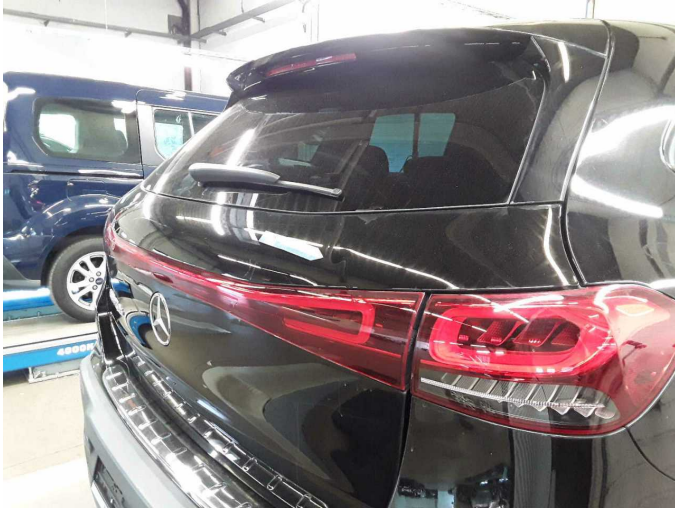
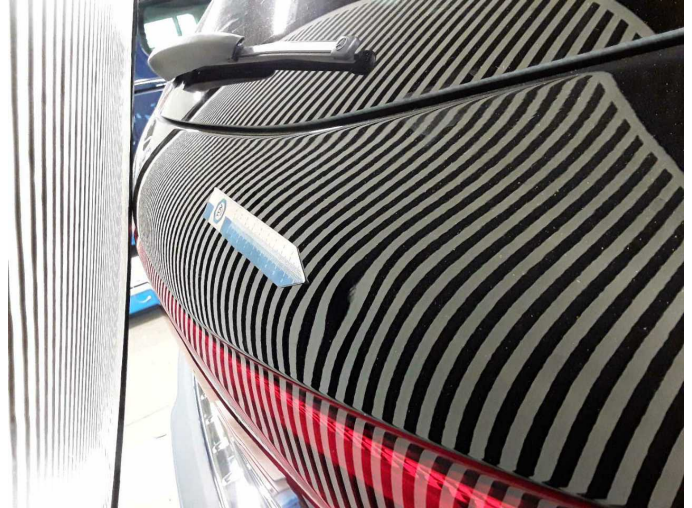
| No. | Component group | Description |
|---|---|---|
| 4 | Boot lid / rear door | Boot lid - dent(s) - No deduction |

**Wear and tear 4:** Boot lid / rear door: Boot lid - dent(s) - No deduction
