Expertise

Protocol number: 46262229
Order No. / Reference: 26617045
Inspection date: 1 Jul 2026

Model: Focus Turnier 1.5 EcoBlue Start-Stopp-System Aut. TITANIUM

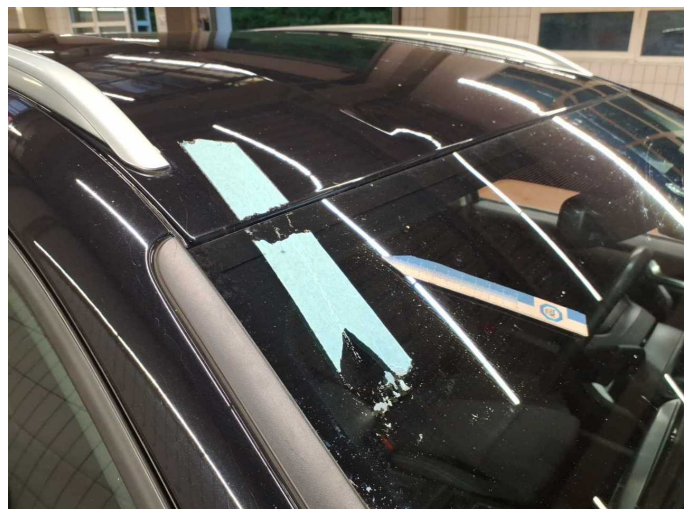
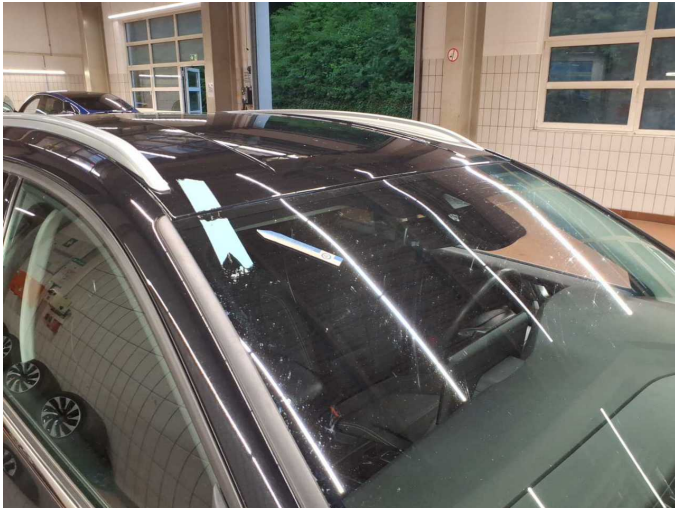
| No. | Component group | Description |
|---|---|--|
| 1 | Body | Body - Glued / labelled - De-glue / neutralise |

Damage 1: Body: Body - Glued / labelled - De-glug / neutralise

Damage 1: Body: Body - Glued / labelled - De-glude / neutralise

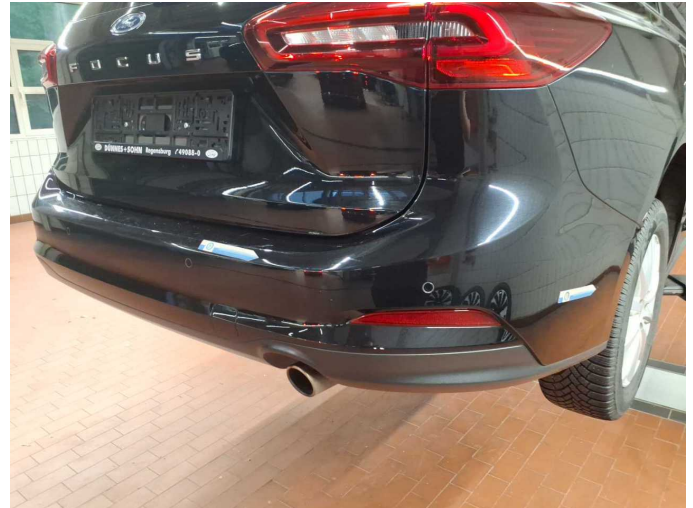
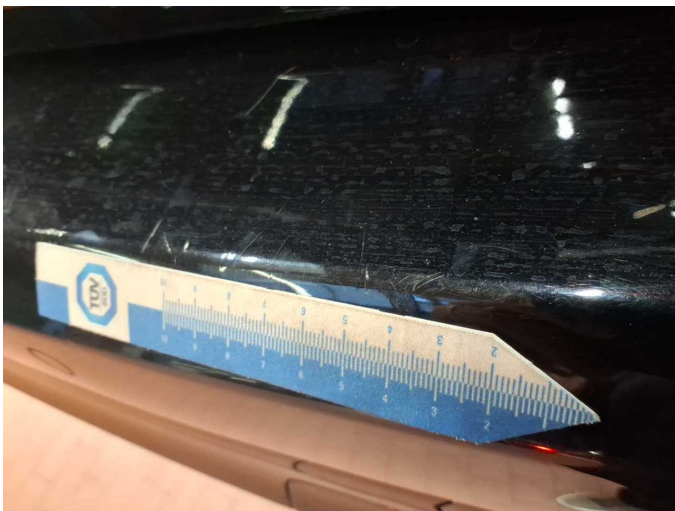
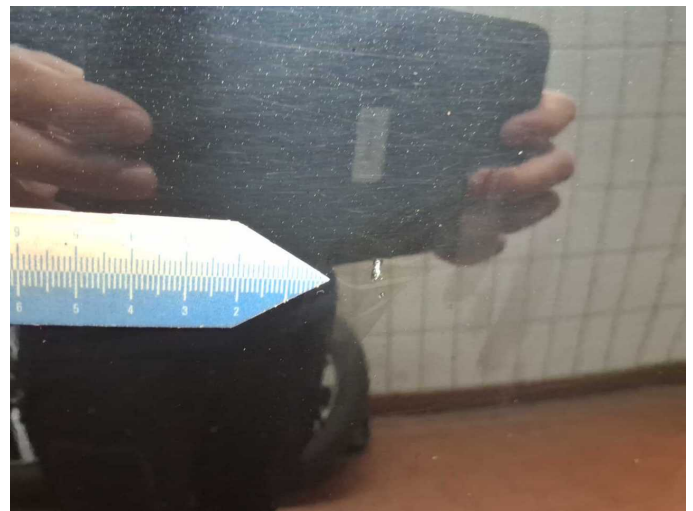
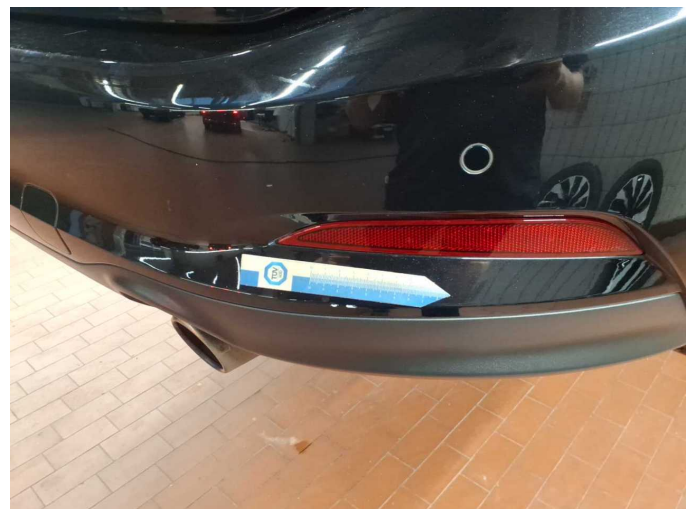
| No. | Component group | Description |
|---|---|--|
| 2 | Rear bumper | Rear bumper - Scratch(es) - Paint |

Damage 2: Rear bumper: Rear bumper - Scratch(es) - Paint

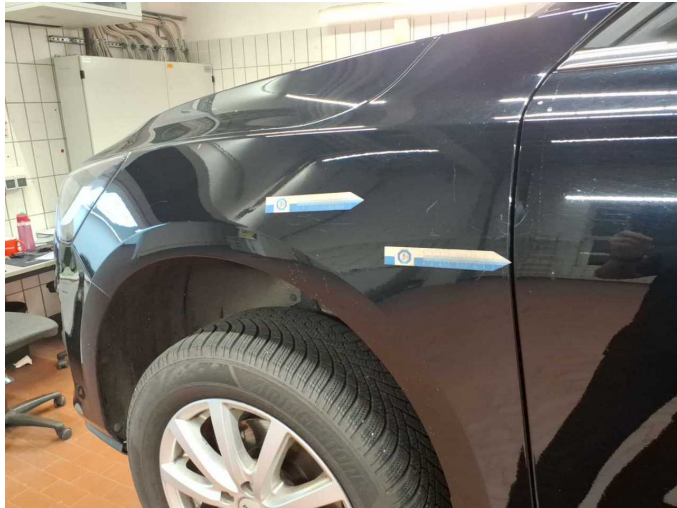
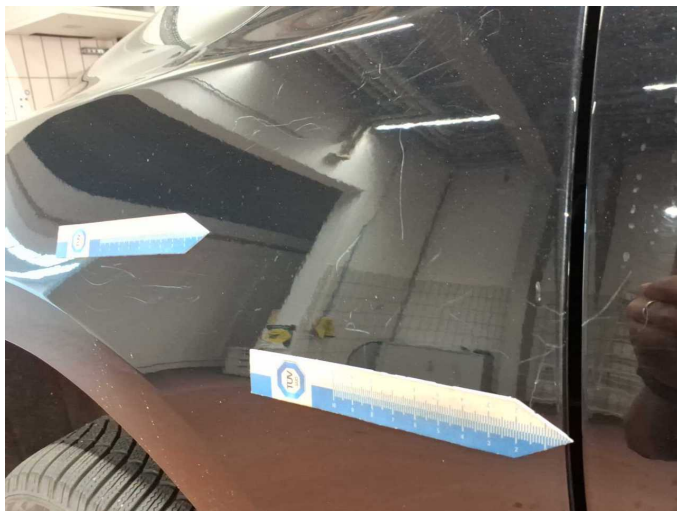
| No. | Component group | Description |
|---|---|--|
| 3 | Mudguard - left side | Mudguard - left side - Scratch(es) - Paint |

Damage 3: Mudguard - left side: Mudguard - left side - Scratch(es) - Paint

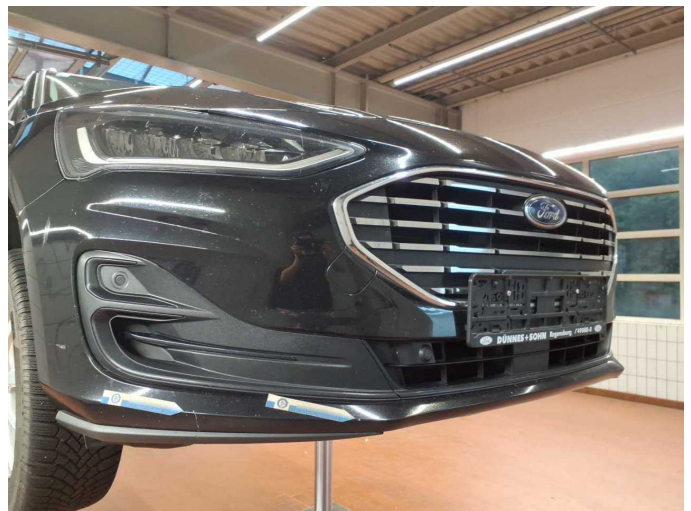
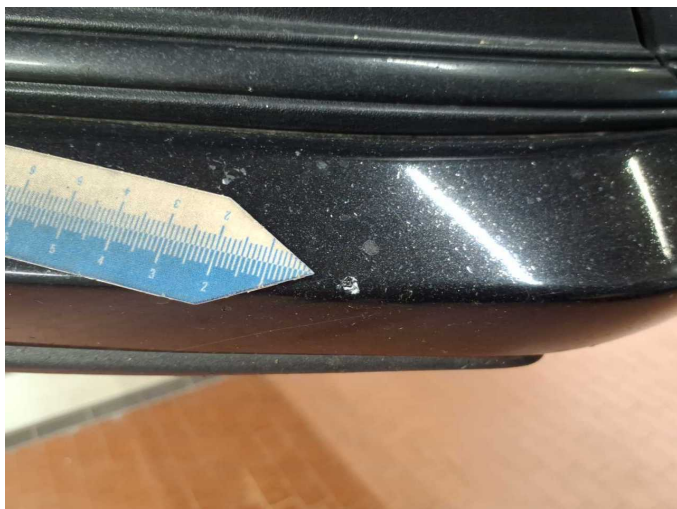
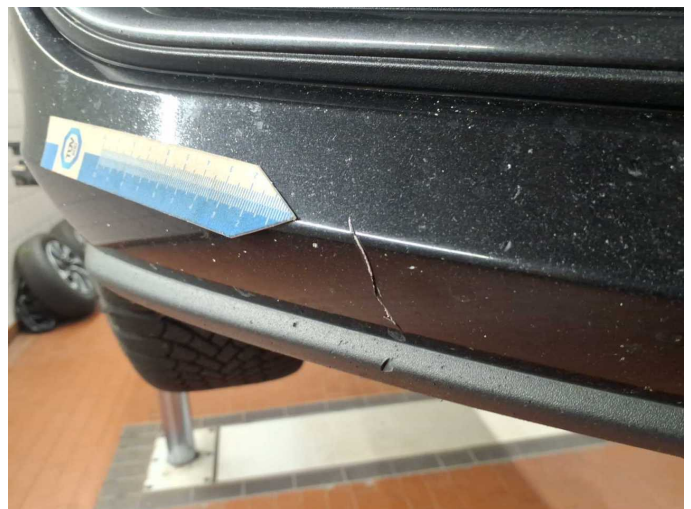
| No. | Component group | Description |
|---|---|--|
| 4 | Front bumper | Front bumper - Scratch(es) - Repair and paint |

Damage 4: Front bumper: Front bumper - Scratch(es) - Repair and paint

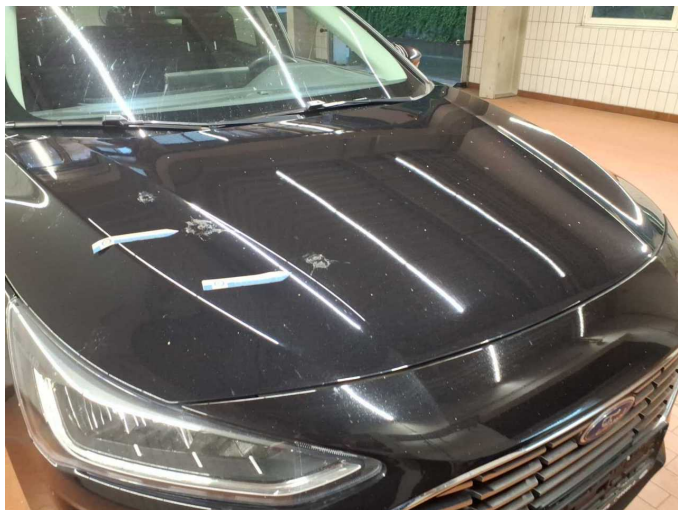
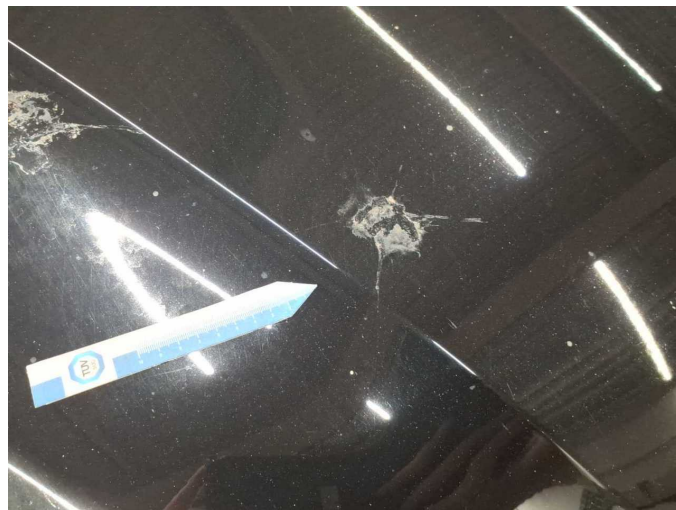
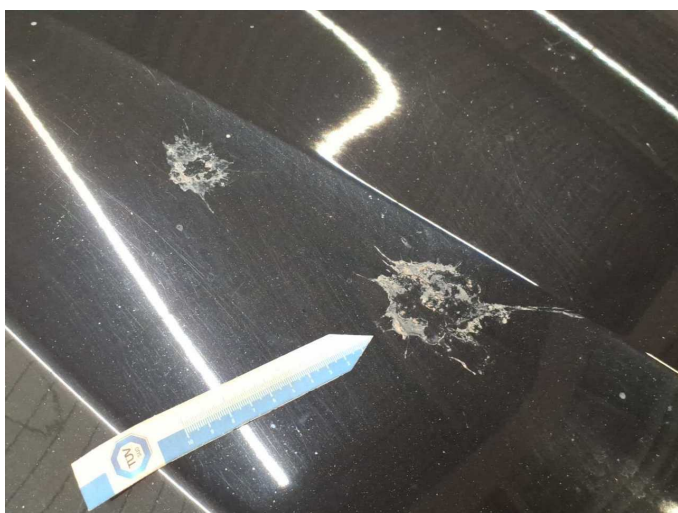
| No. | Component group | Description |
|---|---|--|
| 5 | Bonnet | Bonnet (Verätzung) - Soiled - Paint |

Damage 5: Bonnet: Bonnet (Verätzung) - Soiled - Paint
