Expertise

Protocol number: 46358638
Order No. / Reference: 26566424
Inspection date: 6 Jul 2026

Manufacturer: Opel

Model: Combo Life 1.2 Turbo Start/Stop Edition

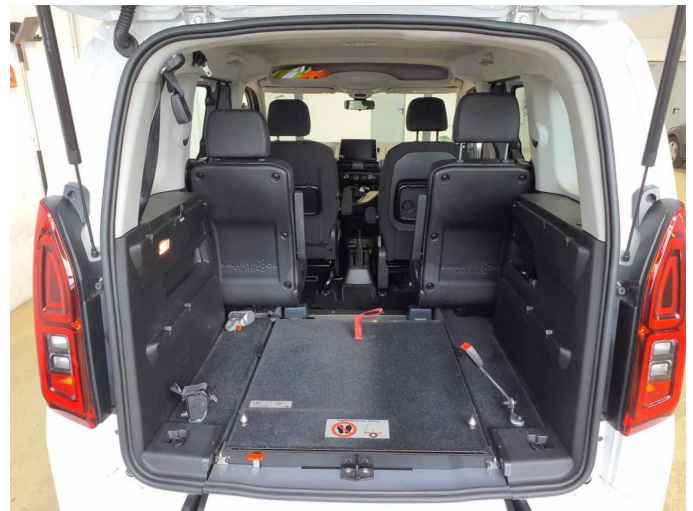
Figure 10: Cargo area

Das Fahrzeug verfügt über einen behindertengerechten Umbau zur Rollstuhlbeförderung/Transport; im Heckbereich sind hierzu eine Rampe sowie diverse erforderlichen Systeme nachgerüstet, die Sitze im Fond welche ab Werk vorhanden waren, sind hier mitgeliefert.

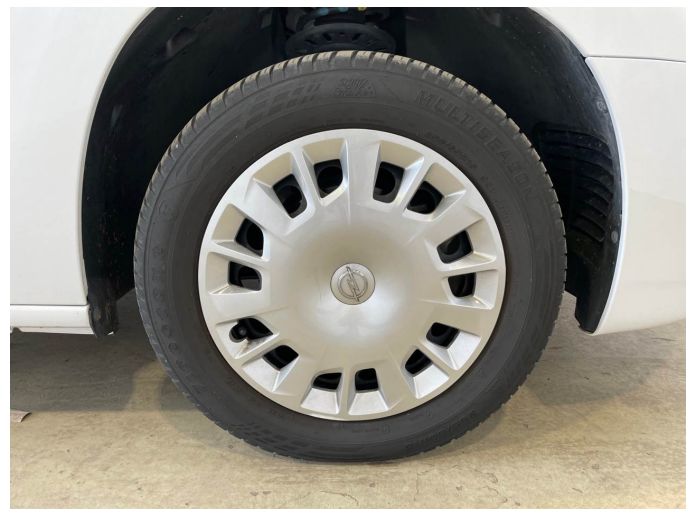
Figure 12: Mounted tyres

#	Tyre size	Type of tyre	Manufacturer	Tread depth
1)	205/60 R16 96V	All-season tyres on Steel rim with wheel cover	Firestone	5mm / 5mm
2)	205/60 R16 96V	All-season tyres on Steel rim with wheel cover	Firestone	5mm / 5mm

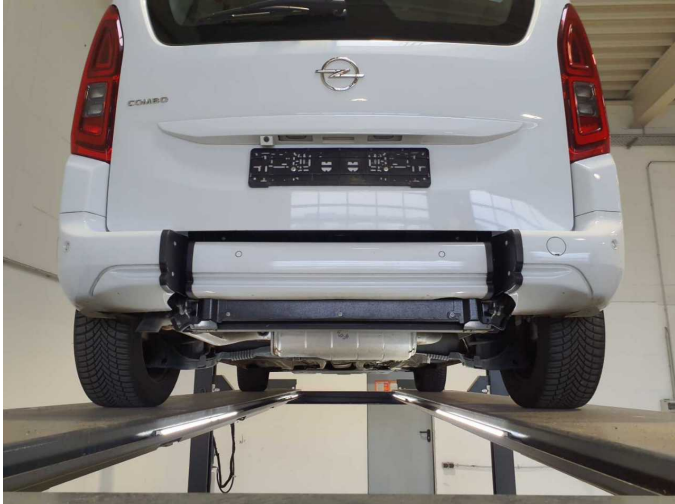
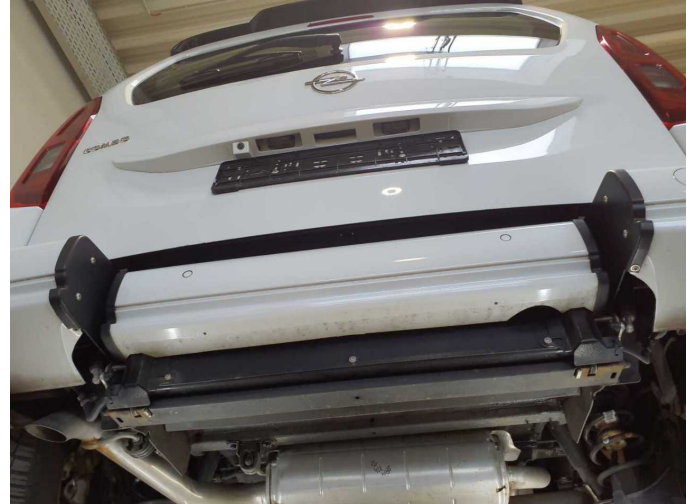
Wear and tear 2: Rear bumper: Rear bumper (Umbau Behindertentransport) - No deduction

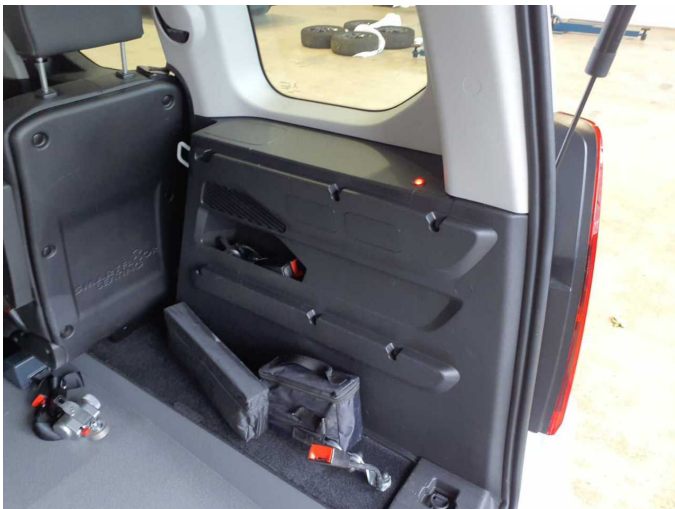
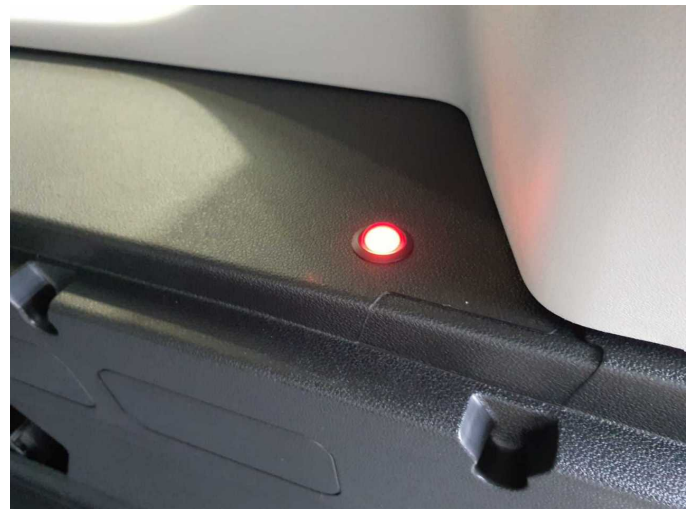
Wear and tear 3: Trim / covers: Cargo area - lining - right side (Schalter) - No deduction
