Expertise

Protocol number: 44397073
Order number / reference: 25890783
Inspection date: 12 Mar 2026

Model: C 220 d 9G-TRONIC Avantgarde

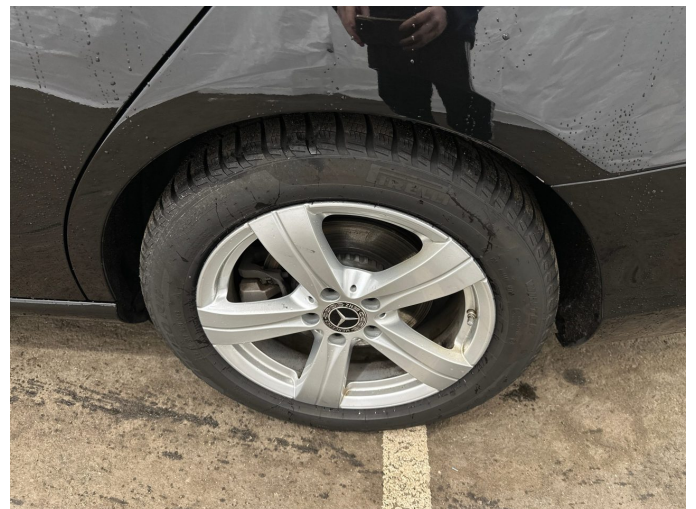
#	Tyre size	Type of tyre	Manufacturer	Tread depth
1)	225/50 R17 98H	Winter tyres on Light alloy	Pirelli	5mm / 5mm
2)	225/50 R17 98H	Winter tyres on Light alloy	Pirelli	6mm / 6mm

Figure 12: Mounted tyres

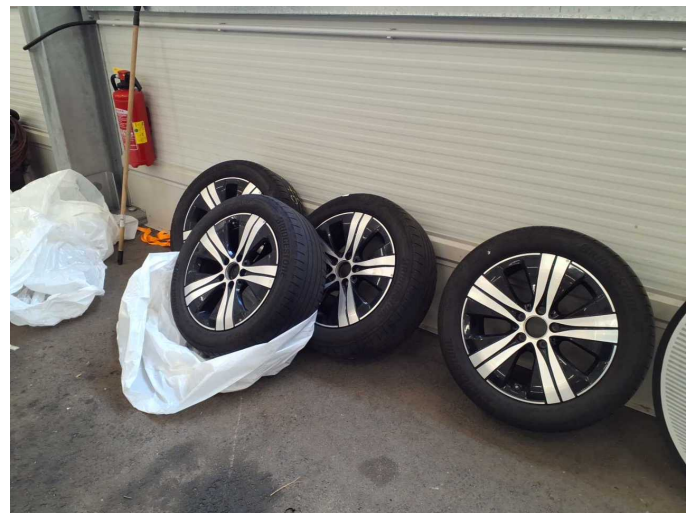
#	Tyre size	Type of tyre	Manufacturer	Tread depth
1)	225/50 R17 94Y	Summer tyres on Light alloy	Bridgestone	4mm / 4mm
2)	225/50 R17 94Y	Summer tyres on Light alloy	Bridgestone	5mm / 5mm

Figure 16: Additional tyres

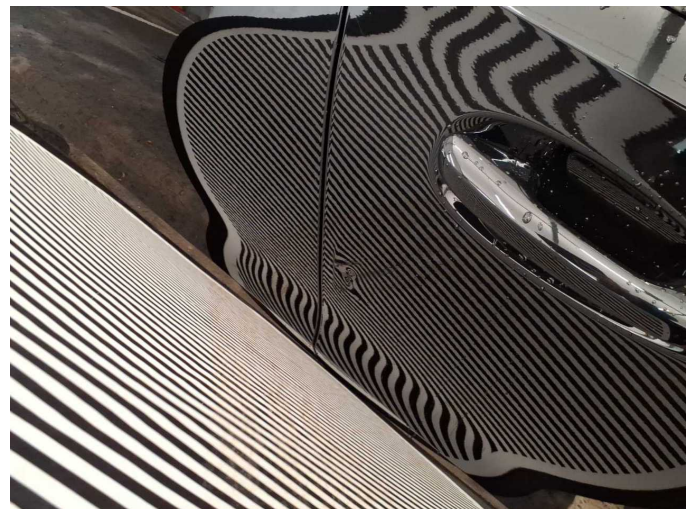
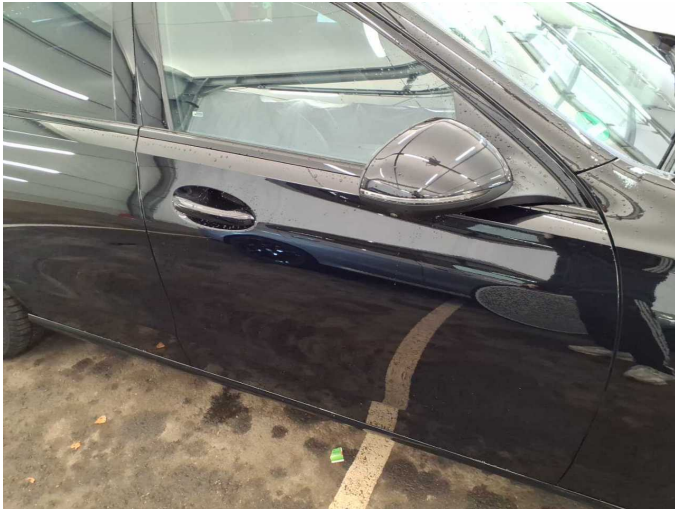
Damage 2: Door - front right side: Door - Dent / paintcoat damage - Smart repair
