Expertise

Protocol number: 46383102  
Order No. / Reference: 26522116  
Inspection date: 7 Jul 2026

Manufacturer: Mercedes-Benz  
VIN: W1KAF0GB6PR076439

Model: C 300 d 9G-TRONIC Avantgarde

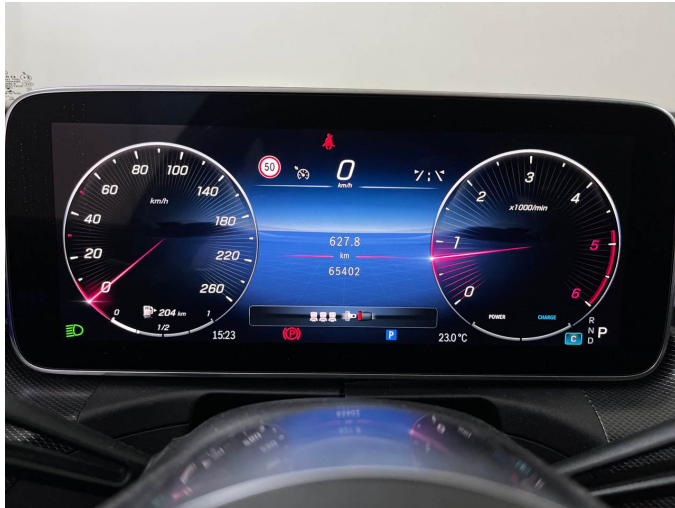
**Figure 7: Instrument cluster**

| Vehicle details | |
|---|---|
| Mileage (Read) | 65,402 km |

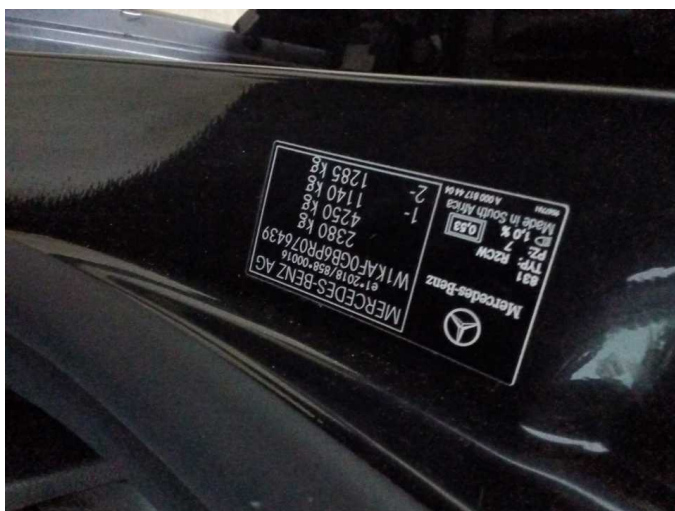
Figure 11: VIN

| VIN comparison | The vehicle identification number (VIN) was read from the vehicle and its conformity with the submitted documents was confirmed by the undersigned during the inspection. |

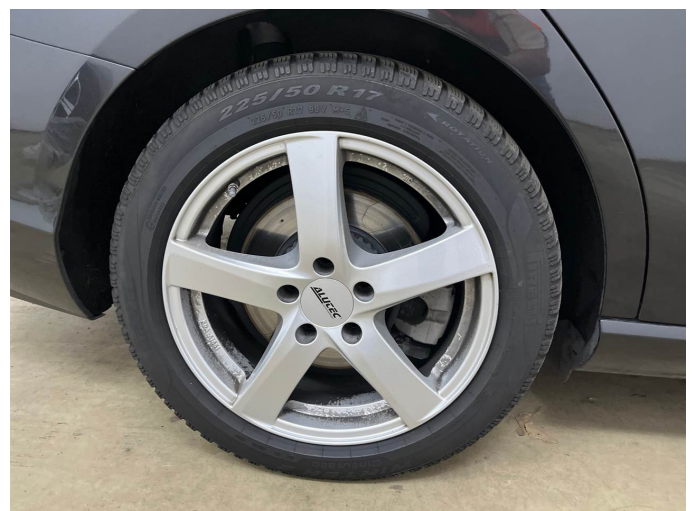
**Figure 12: Mounted tyres**

| # | Tyre size | Type of tyre | Manufacturer | Tread depth |
|---|---|---|---|---|
| 1) | 225/50 R17 98V | Winter tyres on Light alloy | Pirelli | 4mm / 4mm |
| 2) | 225/50 R17 98V | Winter tyres on Light alloy | Pirelli | 4mm / 4mm |

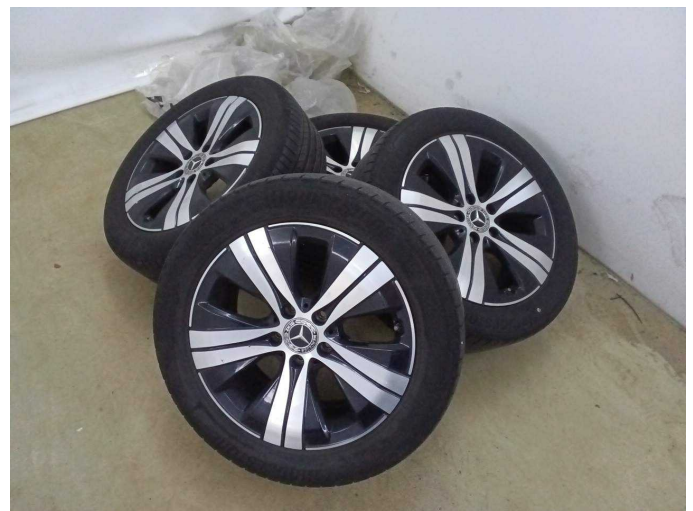
Figure 18: Additional tyres

| # | Tyre size | Type of tyre | Manufacturer | Tread depth |
|---|---|---|---|---|
| 1) | 225/50 R17 94Y | Summer tyres on Light alloy | Bridgestone | 6mm / 6mm |
| 2) | 225/50 R17 94Y | Summer tyres on Light alloy | Bridgestone | 3mm / 3mm |

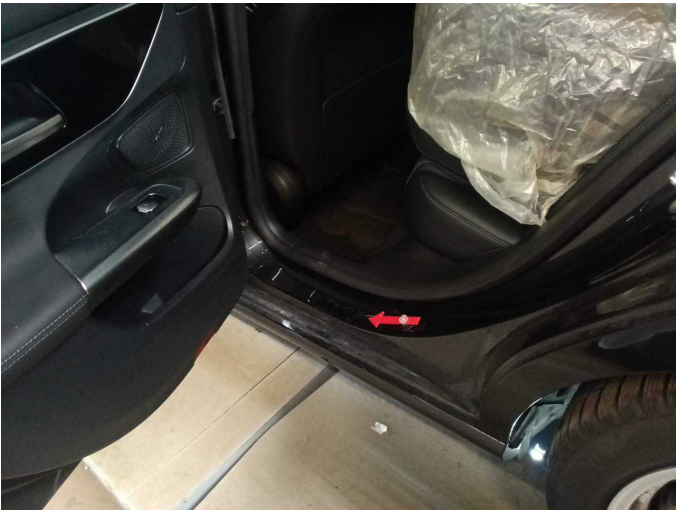
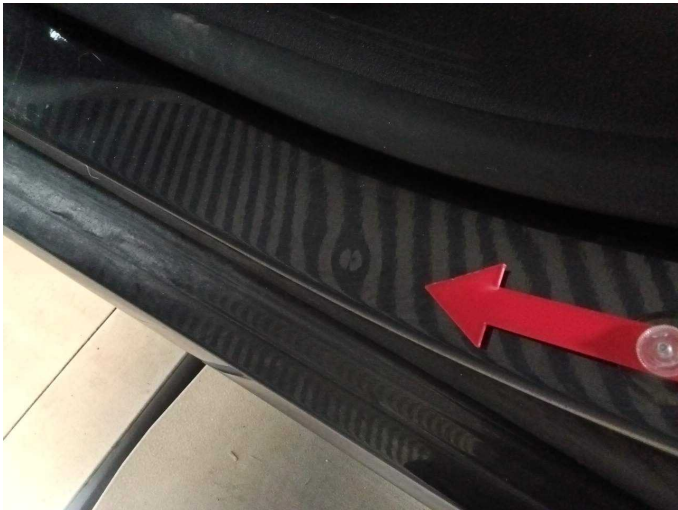
| No. | Component group | Description |
|---|---|---|
| 1 | Sill - left side | Sill - dent(s) - Smooth repair work |

Damage 1: Sill - left side: Sill - dent(s) - Smooth repair work

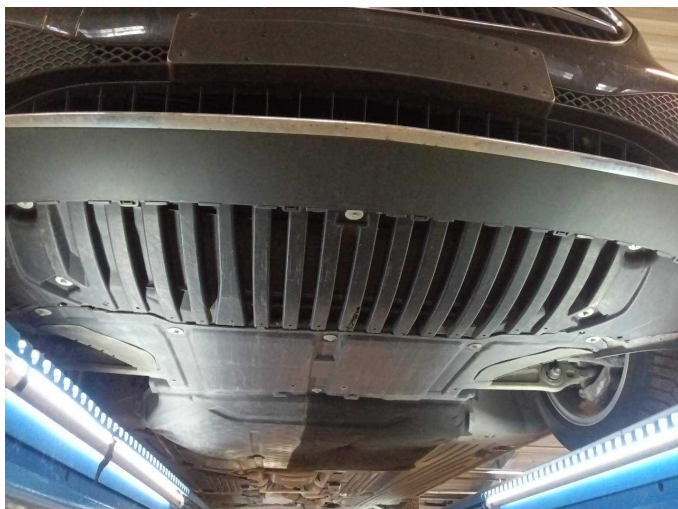
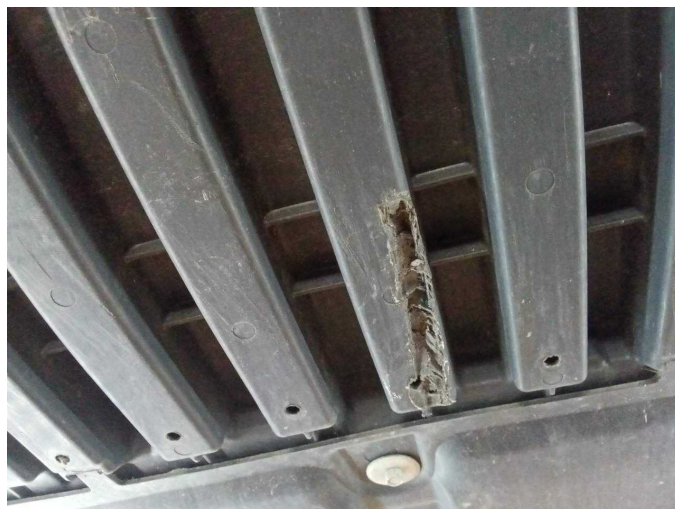
| No. | Component group | Description |
|---|---|---|
| 2 | Body | Underbody panelling - Scratched - Replace |

**Damage 2:** Body: Underbody panelling - Scratched - Replace

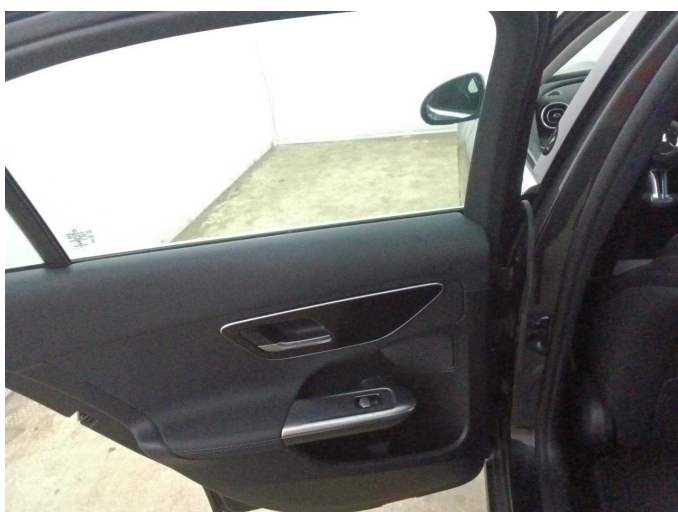
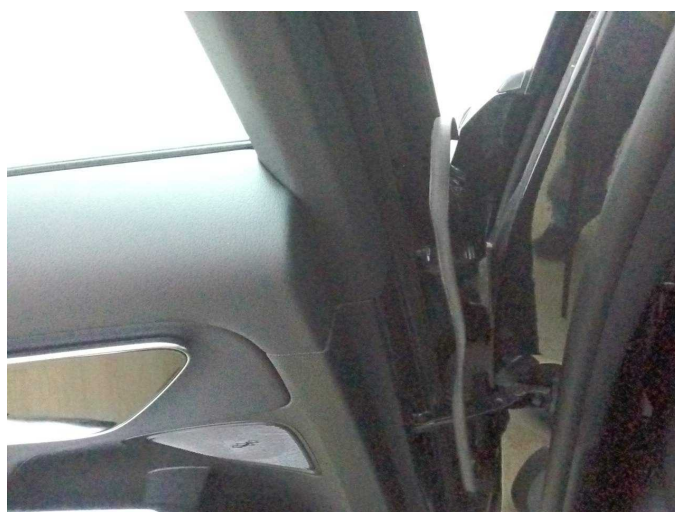
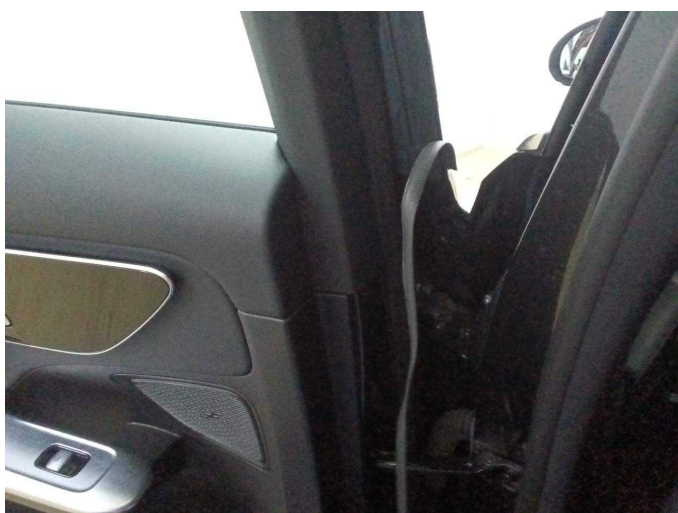
| No. | Component group | Description |
|---|---|---|
| 3 | Door - rear left side | Door seal - Damaged - Replace |

**Damage 3:** Door - rear left side: Door seal - Damaged - Replace

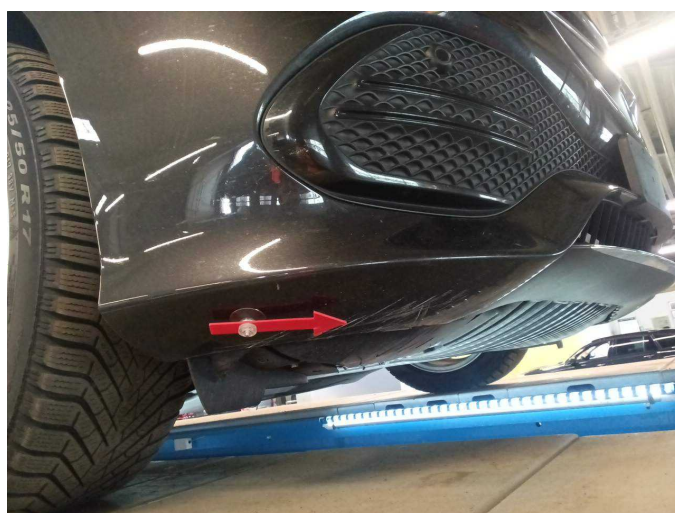
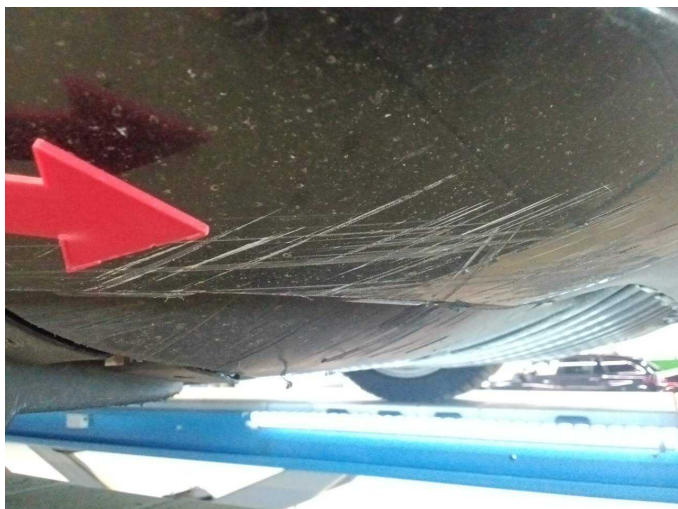
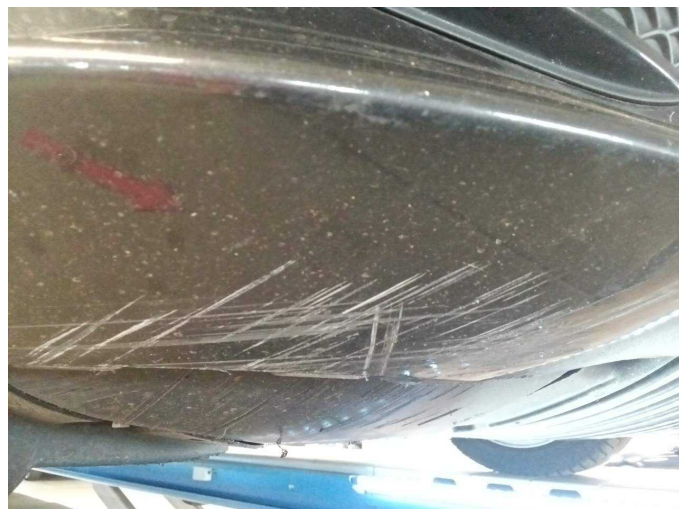
| No. | Component group | Description |
|---|---|---|
| 4 | Front bumper | Front bumper - Scratched - Paint |

**Damage 4:** Front bumper: Front bumper - Scratched - Paint

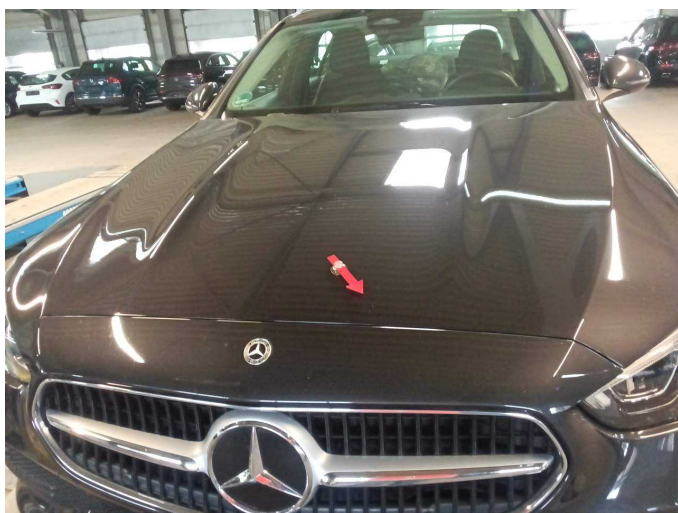
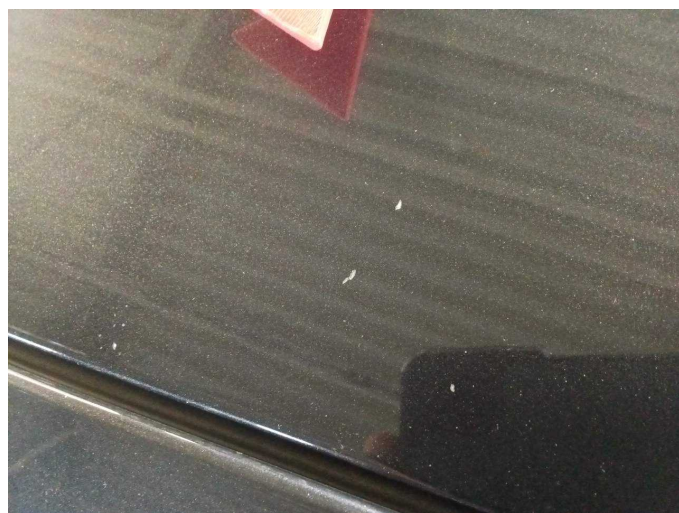
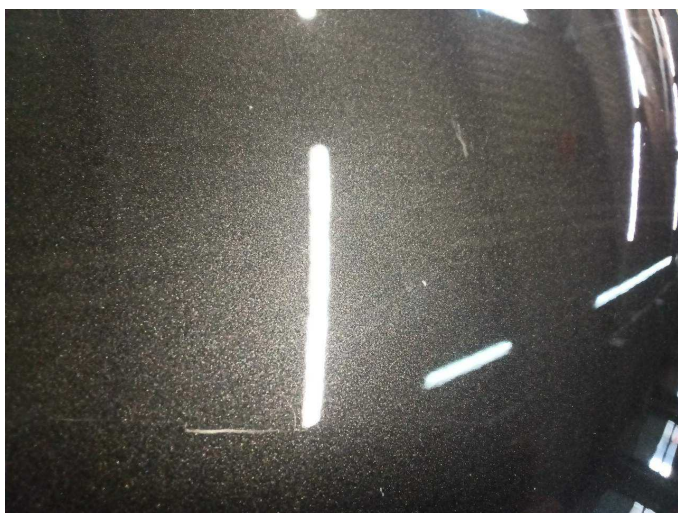
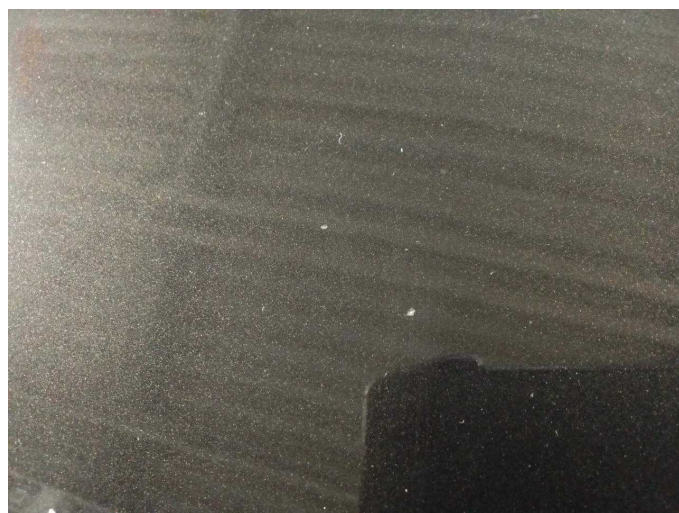
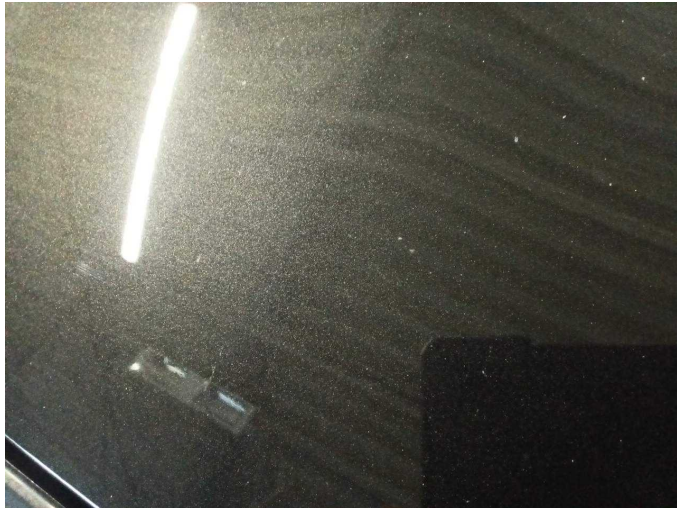
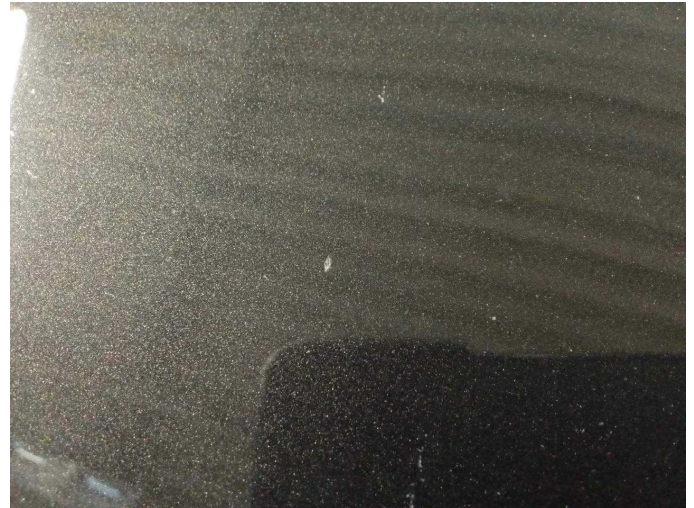
| No. | Component group | Description |
|---|---|---|
| 5 | Bonnet | Bonnet - Stone chips - Paint |

**Damage 5:** Bonnet: Bonnet - Stone chips - Paint

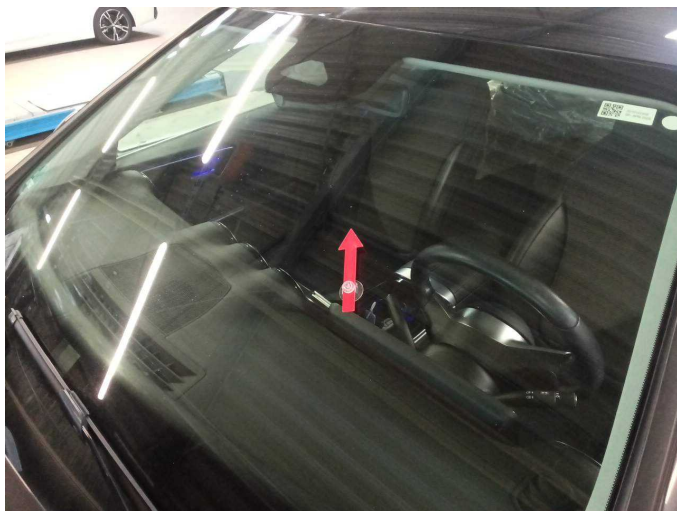
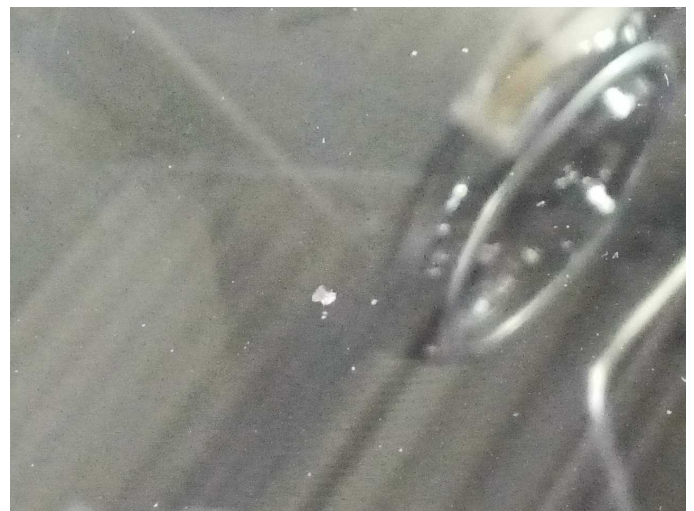
| No. | Component group | Description |
|---|---|---|
| 1 | Vehicle glazing | Windscreen - Stone chips - No deduction |

**Wear and tear 1:** Vehicle glazing: Windscreen - Stone chips - No deduction
