Expertise

Protocol number: 46531153  
Order No. / Reference: 26604539  
Inspection date: 13 Jul 2026

| Manufacturer: Audi | Model: A5 Sportback 40 TFSI S tronic advanced |

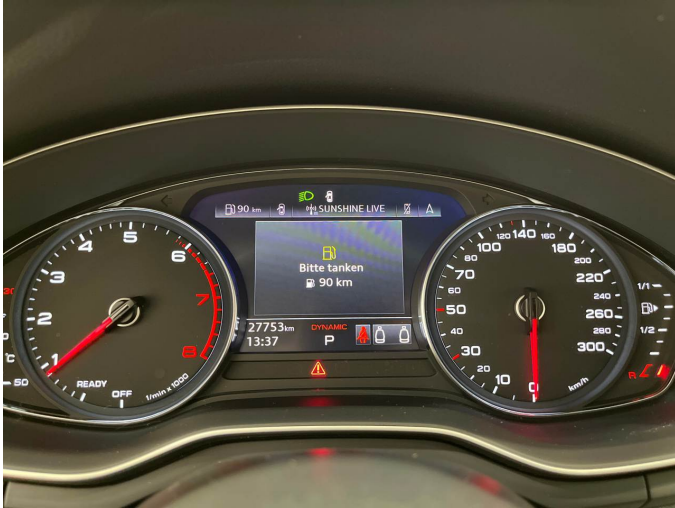
Figure 7: Instrument cluster

| Vehicle details | |
|---|---|
| Mileage (Read) | 27,753 km |

- Die Unterbodenbesichtigung war nur ebenerdig & eingeschränkt möglich. Mehrkosten möglich.
- letzter Serviceeintrag im digitalen Servicenachweis unplausibel. Serviceeintrag bei 28580km, KM Stand abgelesen am Tag der Besichtigung: 27753, KM Stand bei HU am 20.05.2026 27626 lt HU Bericht.

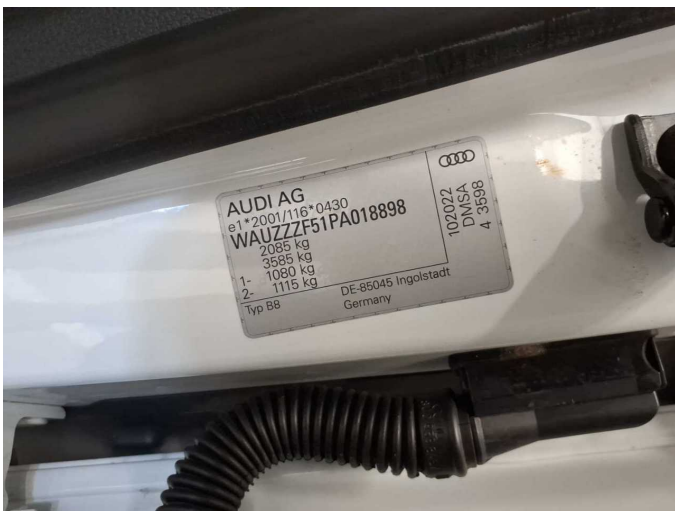
Figure 11: VIN

| VIN comparison | The vehicle identification number (VIN) was read from the vehicle and its conformity with the submitted documents was confirmed by the undersigned during the inspection. |

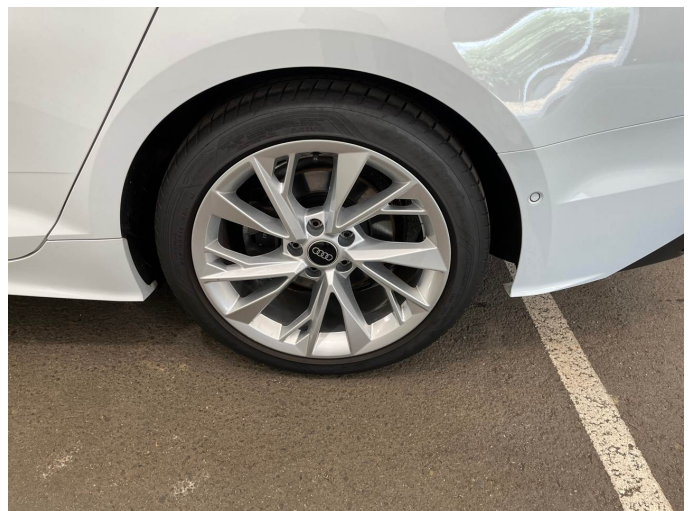
Figure 12: Mounted tyres

| # | Tyre size | Type of tyre | Manufacturer | Tread depth |
|---|---|---|---|---|
| 1) | 245/40 R18 93H | Summer tyres on Light alloy | Goodyear | 5mm / 5mm |
| 2) | 245/40 R18 93H | Summer tyres on Light alloy | Goodyear | 5mm / 5mm |

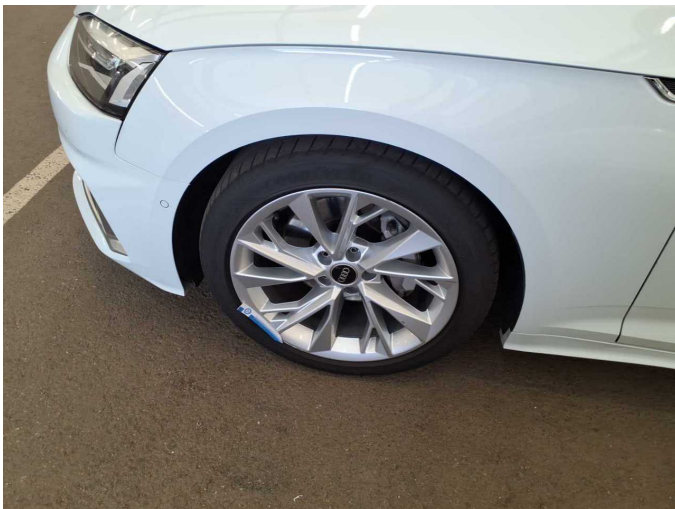
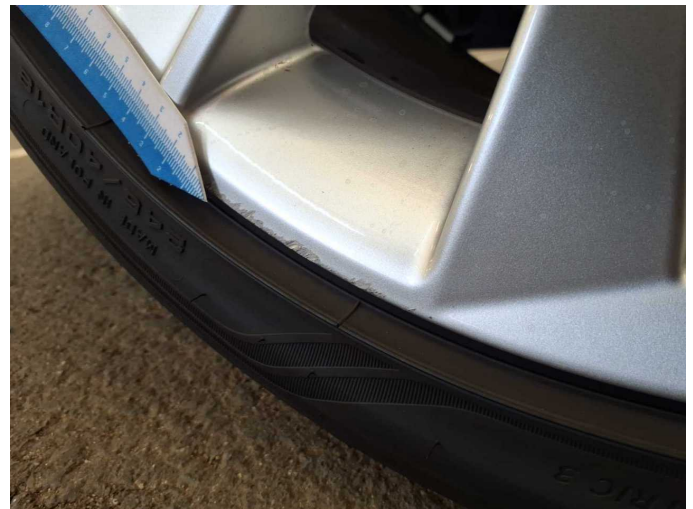
**Damage 3:** Wheel / tyres: Alloy rim - front left side - Scratch(es) - Loss in value

| No. | Component group | Description |
|---|---|---|
| 3 | Wheel / tyres | Alloy rim - front left side - Scratch(es) - Loss in value |
