Expertise

Protocol number: 46625639  
Order No. / Reference: 26521611  
Inspection date: 16 Jul 2026

Manufacturer: Ford

Model: Focus Turnier 1.5 EcoBlue Start-Stopp-System Aut.  
COOL&CONNECT

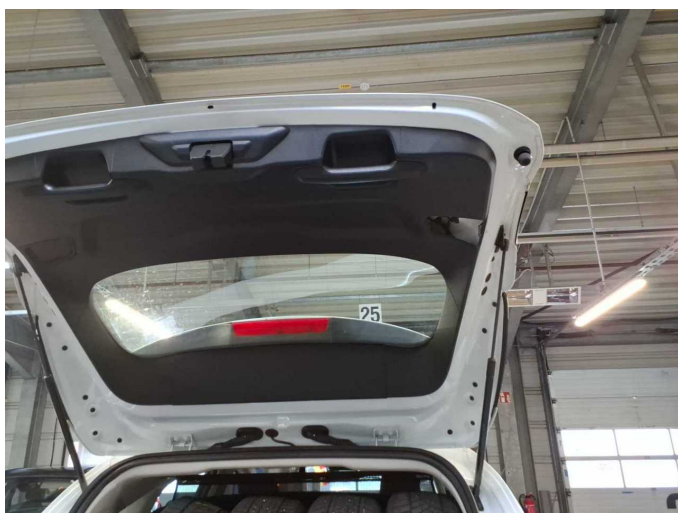
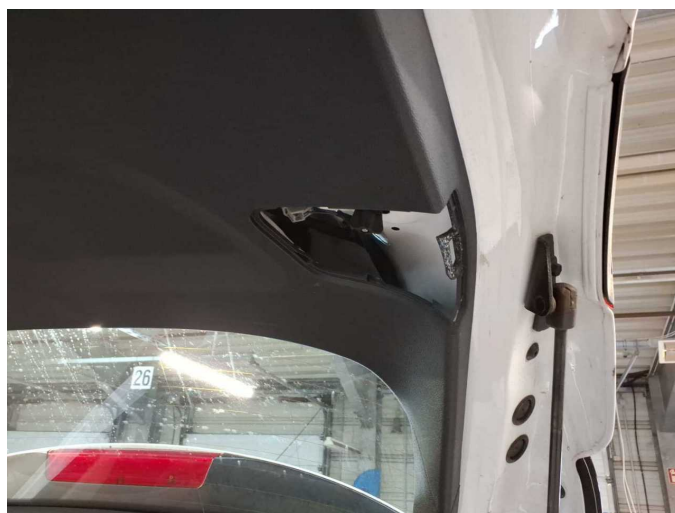
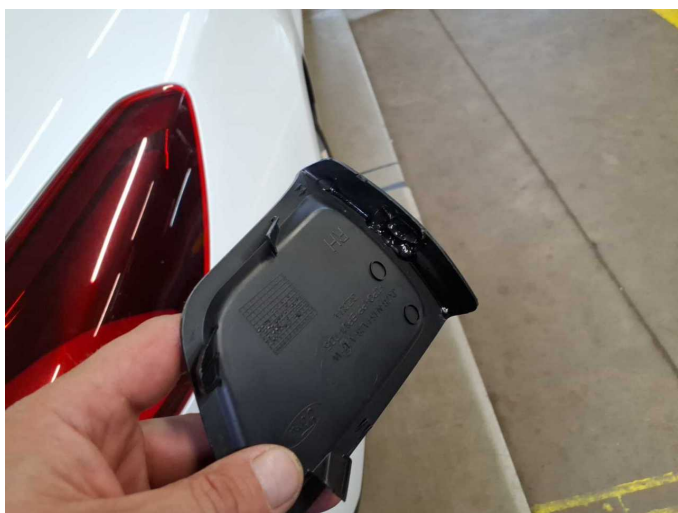
**Damage 1:** Trim / covers: Boot lid - interior trim - Loose - Replace

| No. | Component group | Description |
|---|---|---|
| 1 | Trim / covers | Boot lid - interior trim - Loose - Replace |

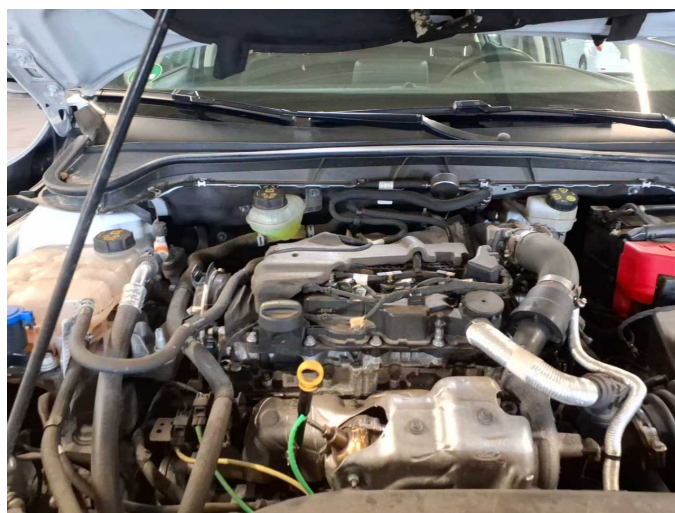
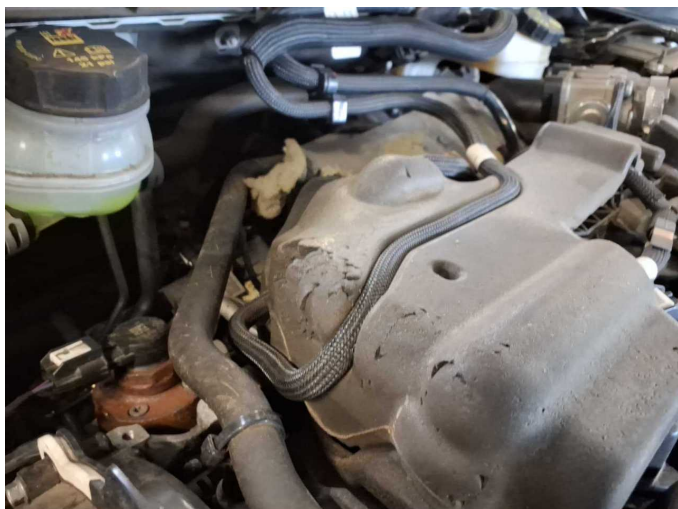
**Damage 2:** Engine: Engine cover (Dämmung) - Damage caused by marten / rodent - Replace

| No. | Component group | Description |
|---|---|---|
| 2 | Engine | Engine cover (Dämmung) - Damage caused by marten / rodent - Replace |

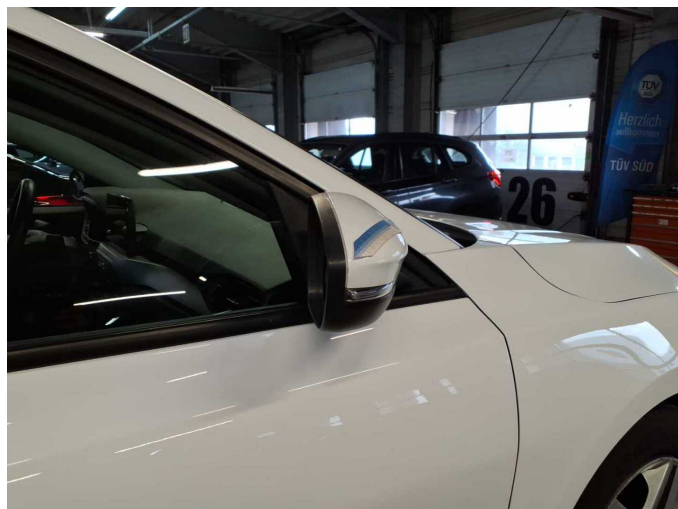
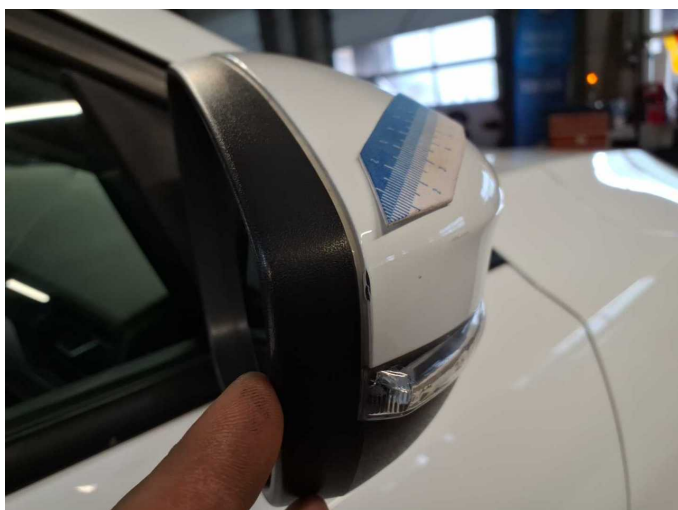
**Damage 3:** Wing mirror - right side: Cap - Scratch(es) - Smart repair

| No. | Component group | Description |
|---|---|---|
| 3 | Wing mirror - right side | Cap - Scratch(es) - Smart repair |

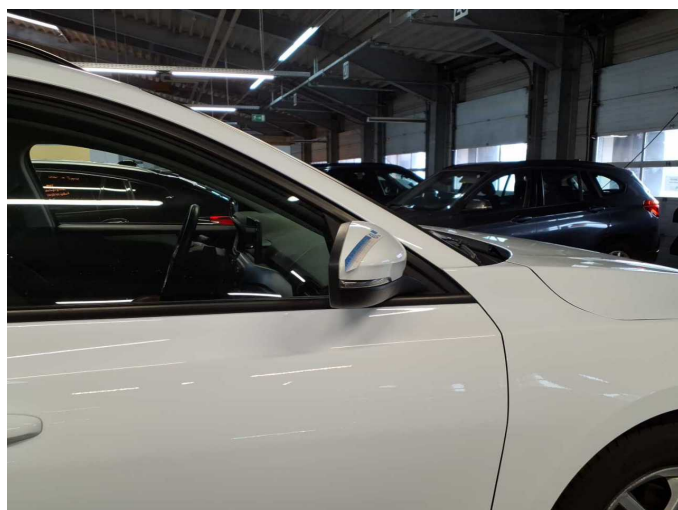
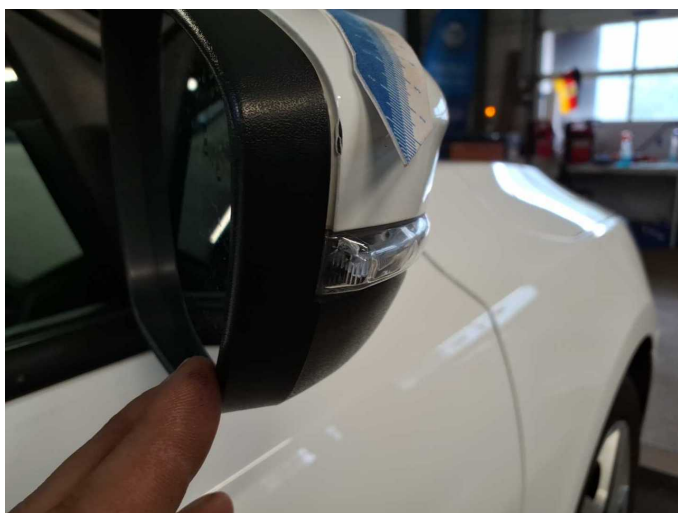
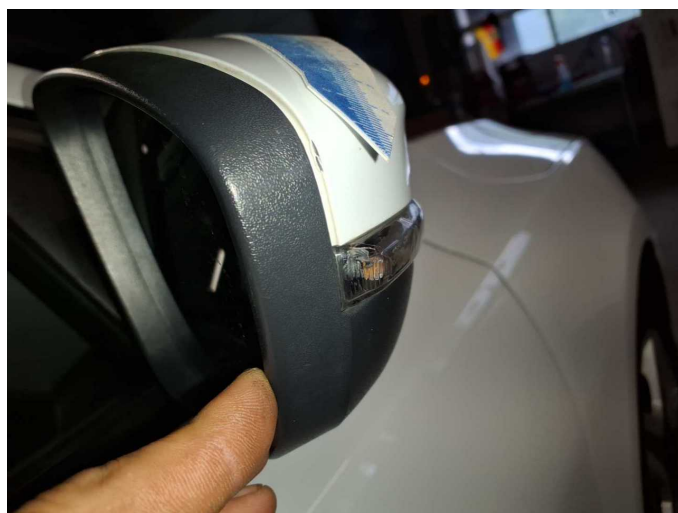
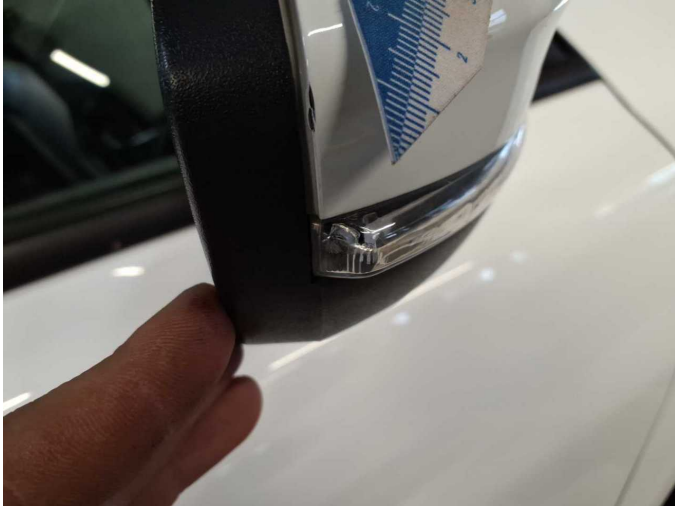
**Damage 4:** Indicator - front: Mirror - right side - Broken / torn - Replace

| No. | Component group | Description |
|---|---|---|
| 4 | Indicator - front | Mirror - right side - Broken / torn - Replace |

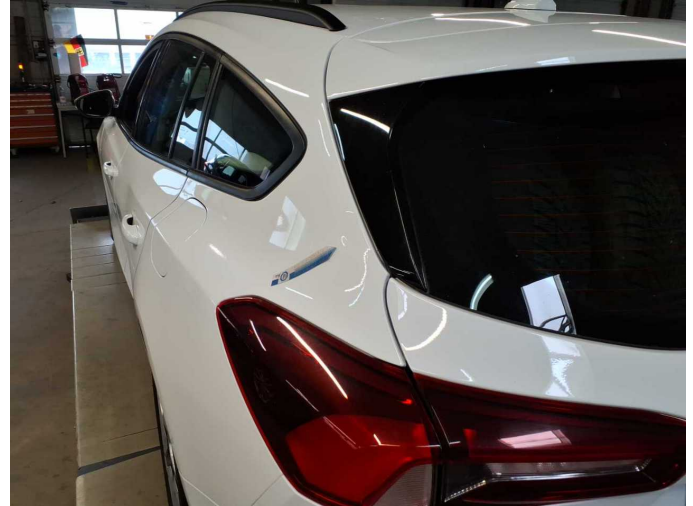
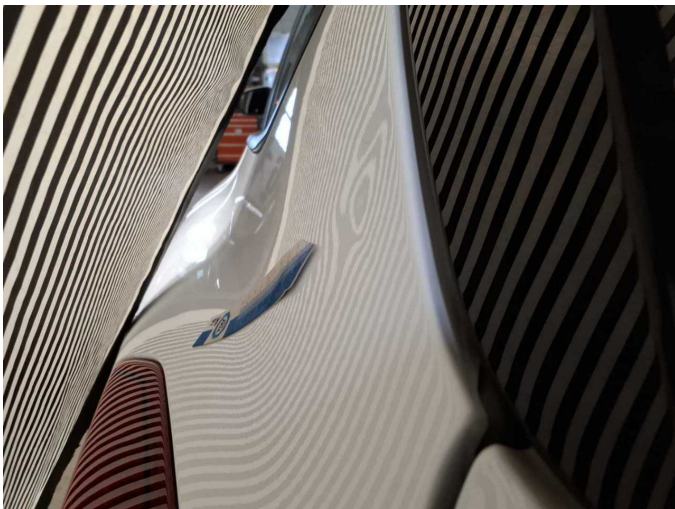
**Damage 5:** Side panel - rear left side: Side panel - dent(s) - Smooth repair work

| No. | Component group | Description |
|---|---|---|
| 5 | Side panel - rear left side | Side panel - dent(s) - Smooth repair work |

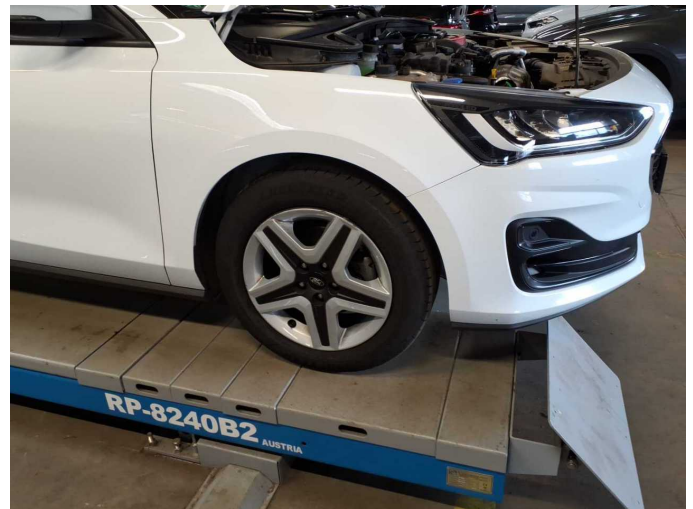
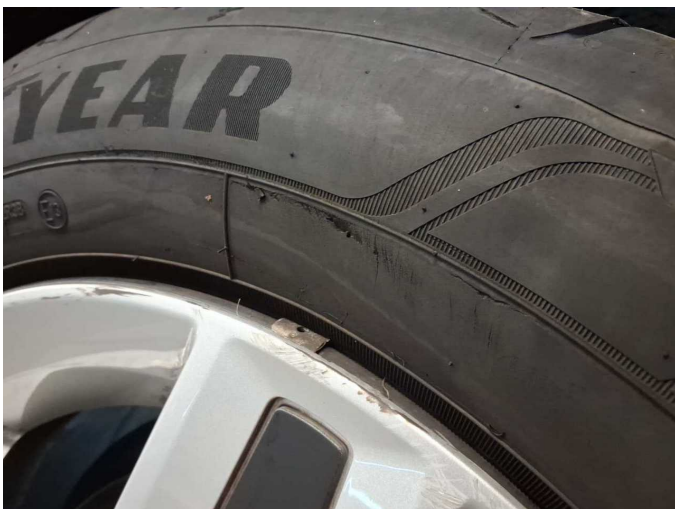
**Damage 6:** Wheel / tyres: Tyre - front right side (Flanke) - Damaged - Replace

| No. | Component group | Description |
|---|---|---|
| 6 | Wheel / tyres | Tyre - front right side (Flanke) - Damaged - Replace |

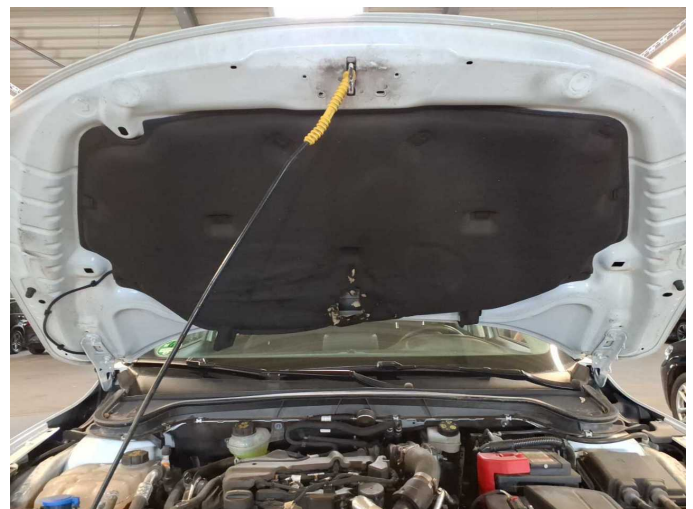
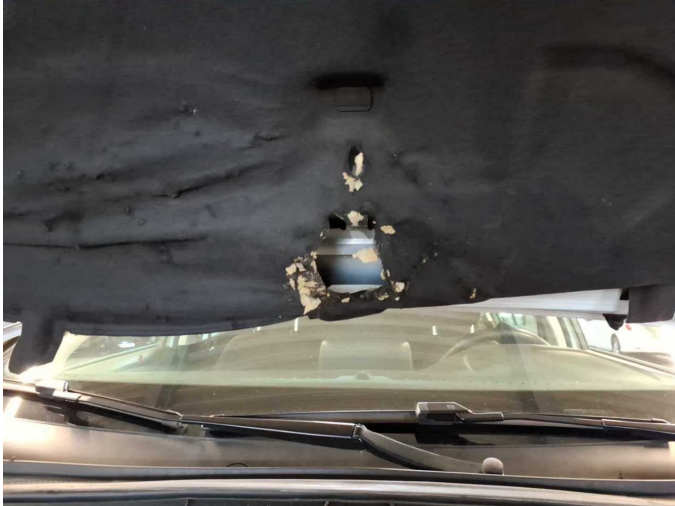
**Damage 7:** Bonnet: Insulation lining - Damage caused by marten / rodent - Replace

| No. | Component group | Description |
|---|---|---|
| 7 | Bonnet | Insulation lining - Damage caused by marten / rodent - Replace |

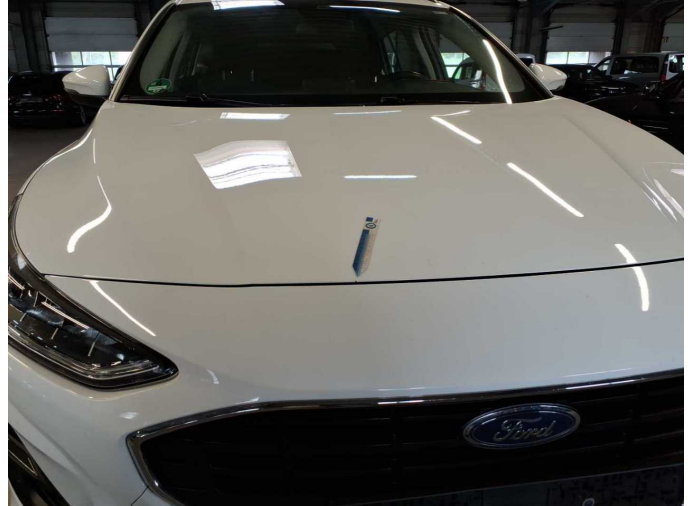
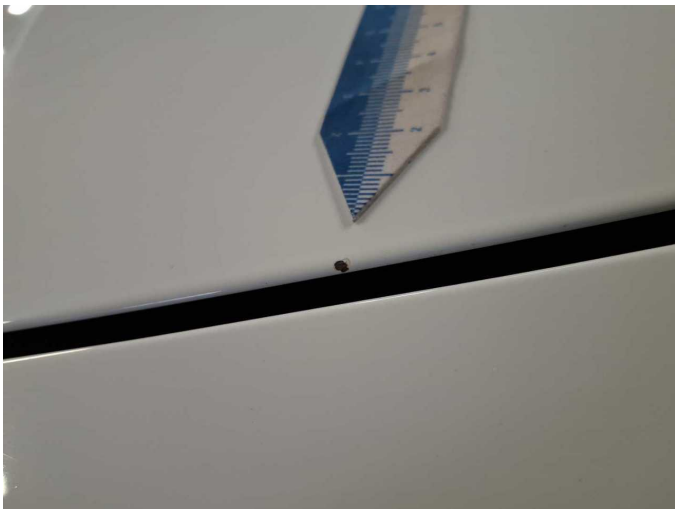
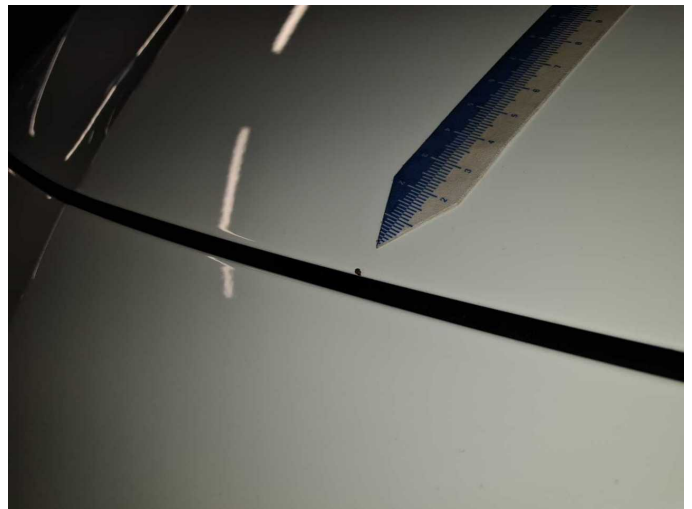
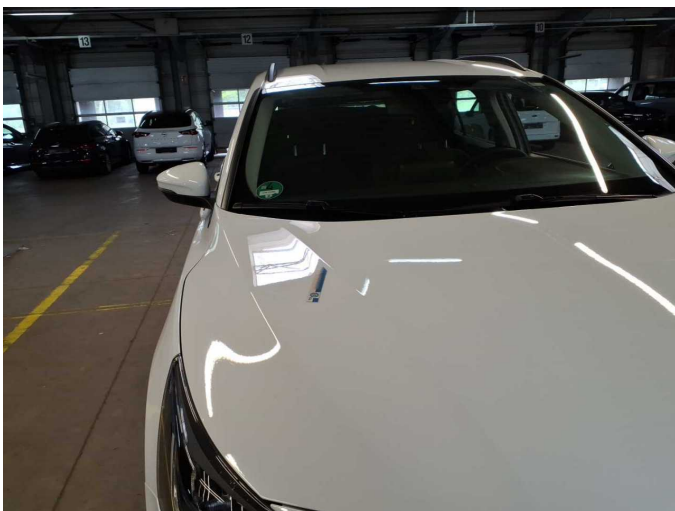
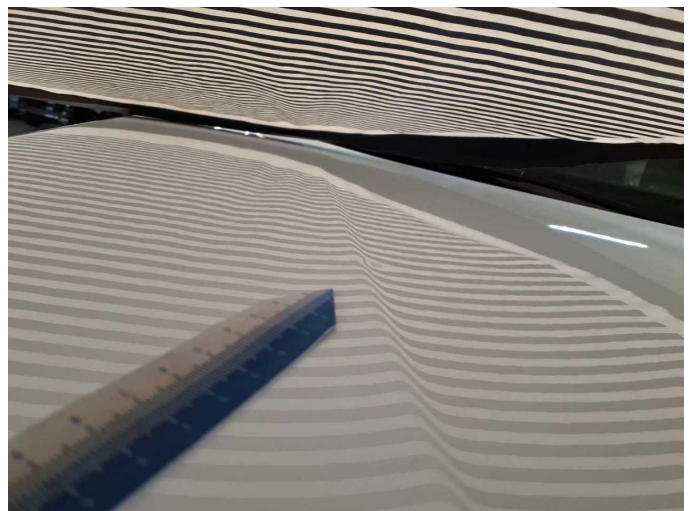
**Damage 8:** Bonnet: Bonnet - Dent / paintcoat damage - Repair and paint

| No. | Component group | Description |
|---|---|---|
| 8 | Bonnet | Bonnet - Dent / paintcoat damage - Repair and paint |

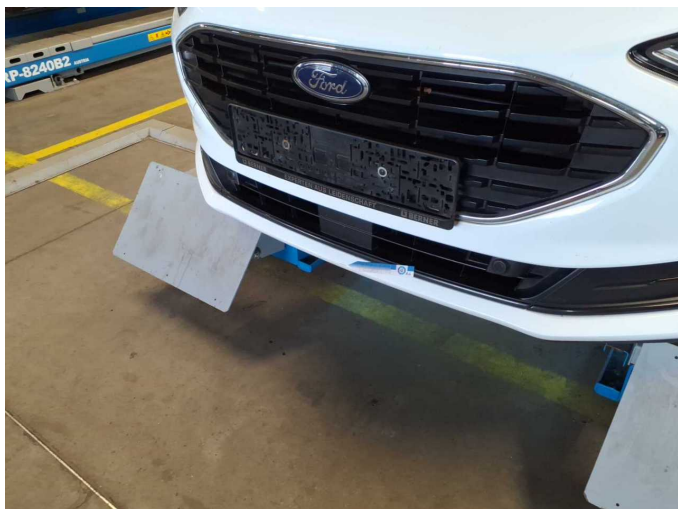
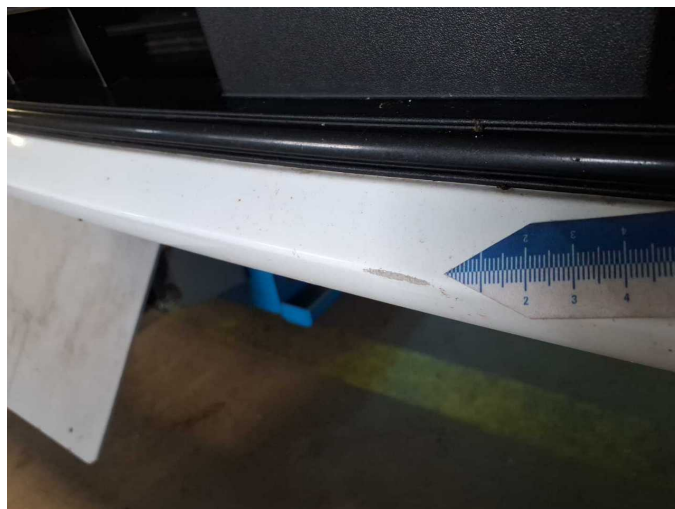
**Wear and tear 2:** Front bumper: Front bumper - Scratch(es) - No deduction

| No. | Component group | Description |
|---|---|---|
| 2 | Front bumper | Front bumper - Scratch(es) - No deduction |

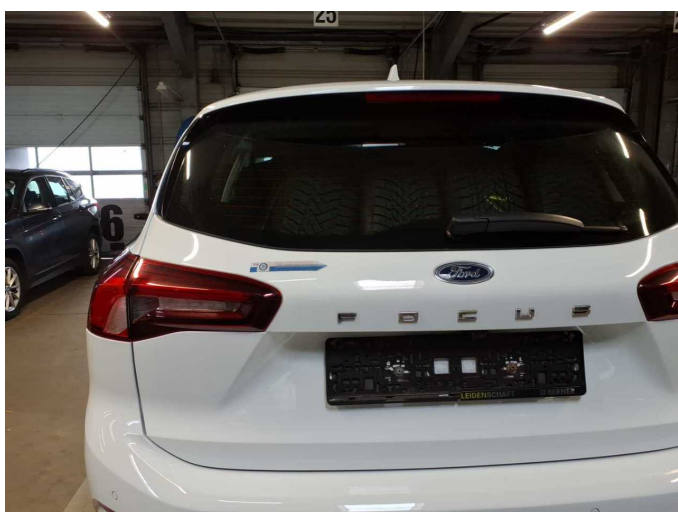
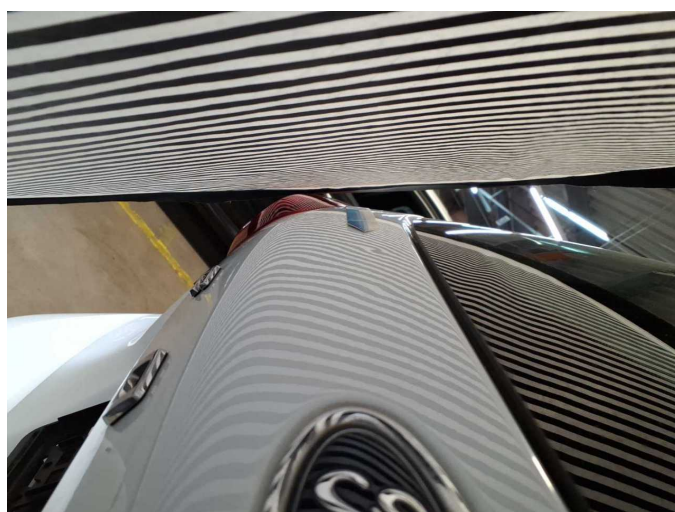
**Wear and tear 3:** Boot lid / rear door: Boot lid - dent(s) - No deduction

| No. | Component group | Description |
|---|---|---|
| 3 | Boot lid / rear door | Boot lid - dent(s) - No deduction |

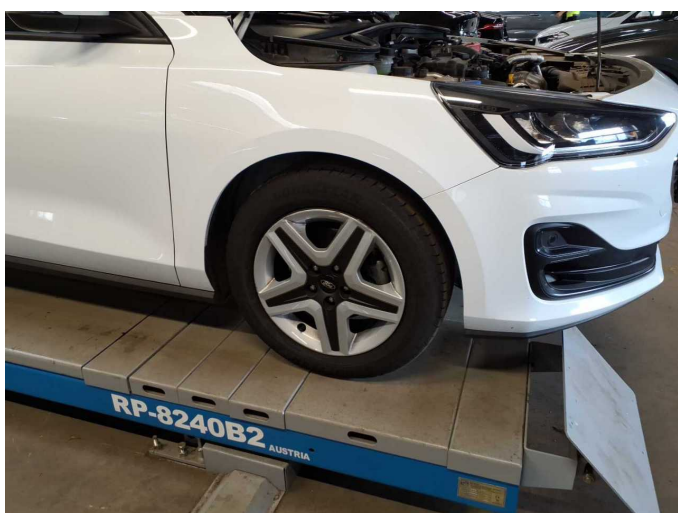
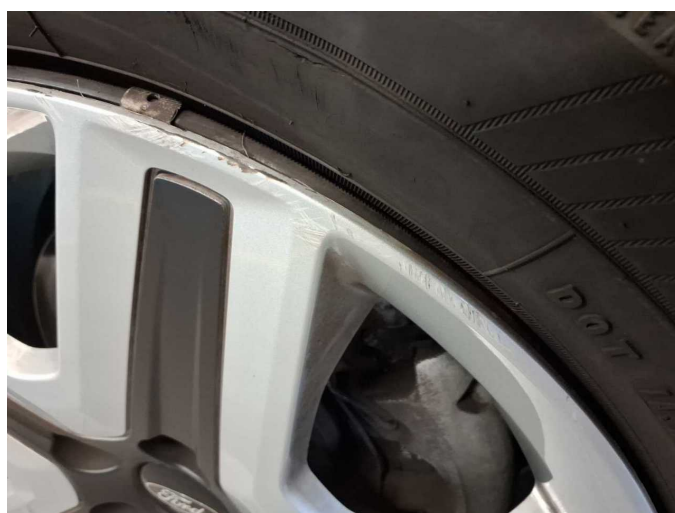
**Wear and tear 4:** Wheel / tyres: Wheel cover - front right side - Scratch(es) - No deduction

| No. | Component group | Description |
|---|---|---|
| 4 | Wheel / tyres | Wheel cover - front right side - Scratch(es) - No deduction |

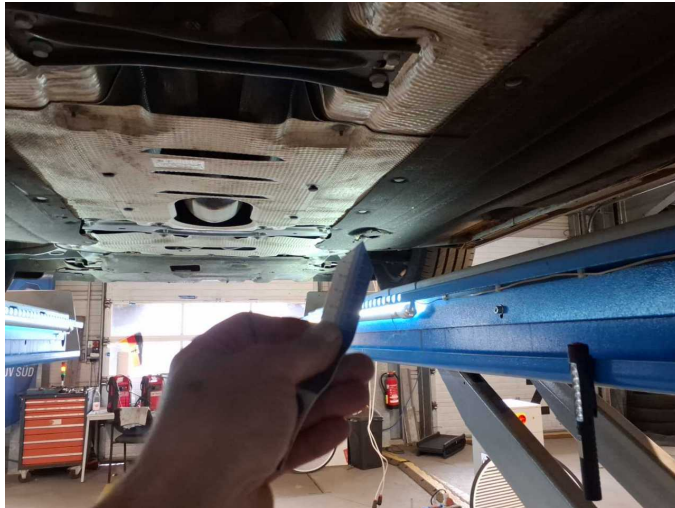
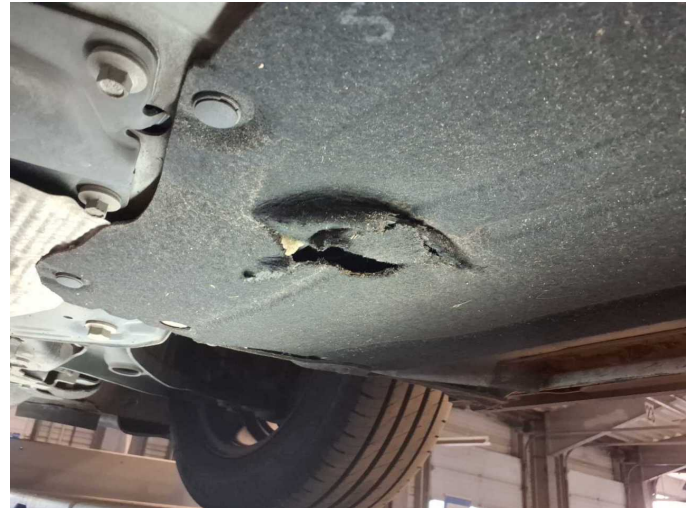
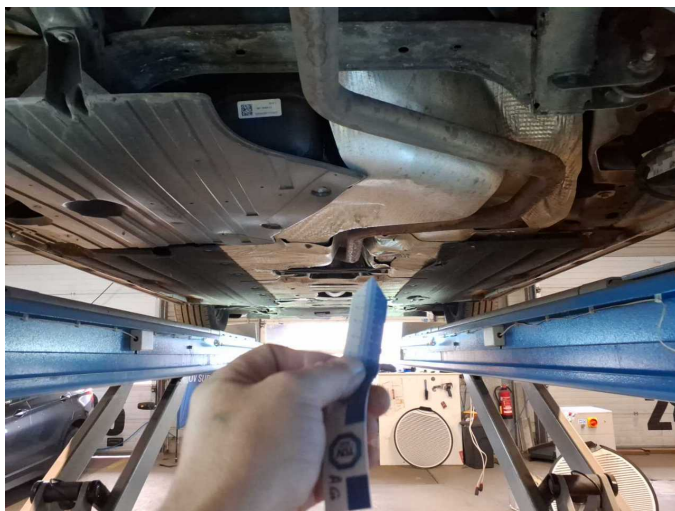
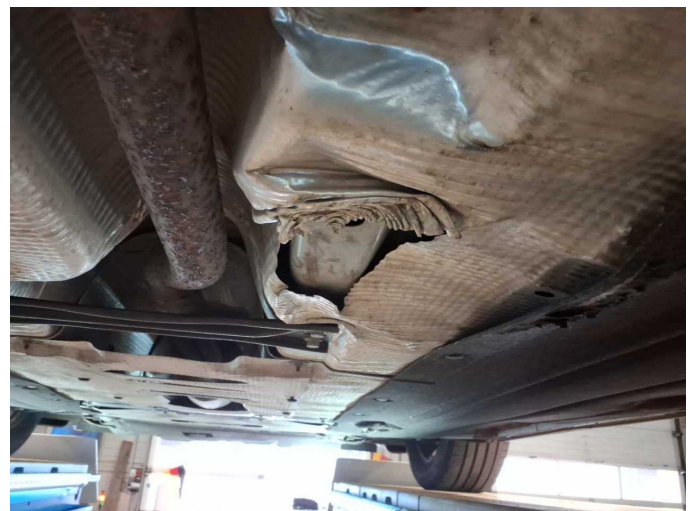
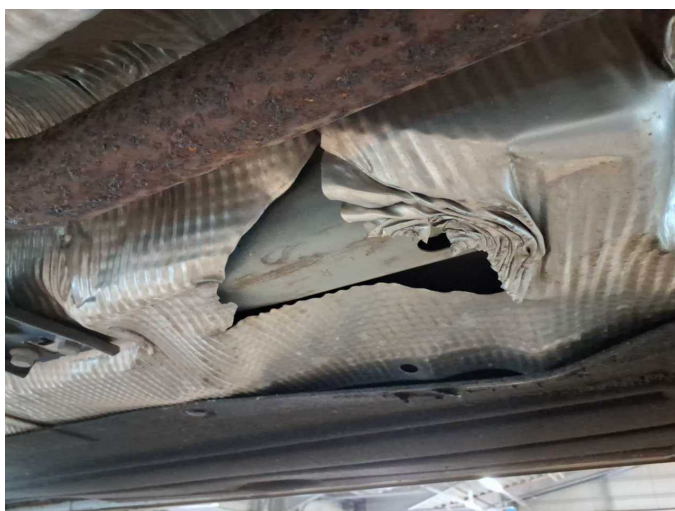
**Accident 1: Underbody**

- 1 Underbody

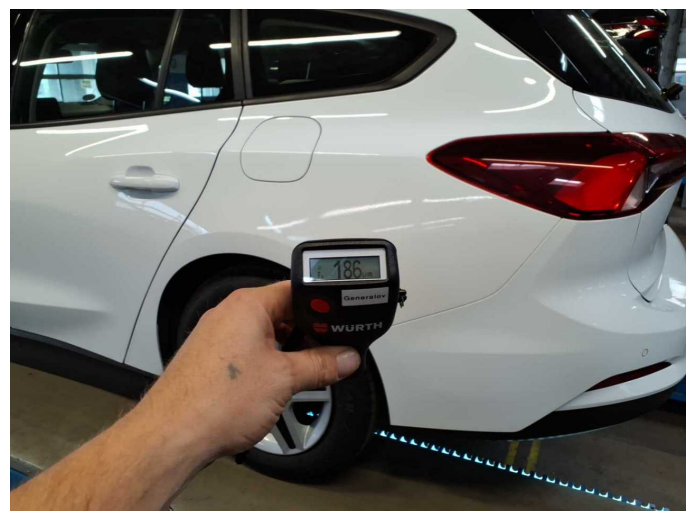
**Repainting 1: Side panel - rear left side**

- 1 Side panel - rear left side, Professionally carried out, Invoice of repair done Non-existent
- 2 Door - rear right side, Professionally carried out, Invoice of repair done Non-existent

Side panel - rear left side

186 µm

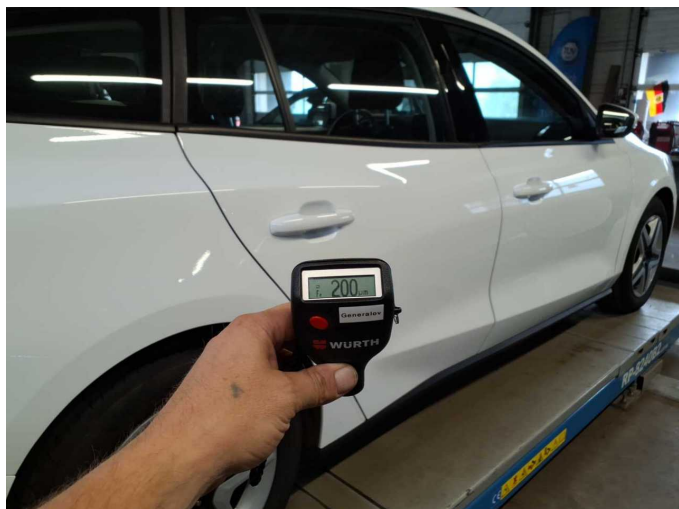
**Repainting 2:** Door - rear right side

Door - rear right side

200 µm
