Expertise

Protocol number: 46609631  
Order No. / Reference: 26276543  
Inspection date: 20 Jul 2026

Manufacturer: Volkswagen

Model: ID.4 Performance Upgrade Pro

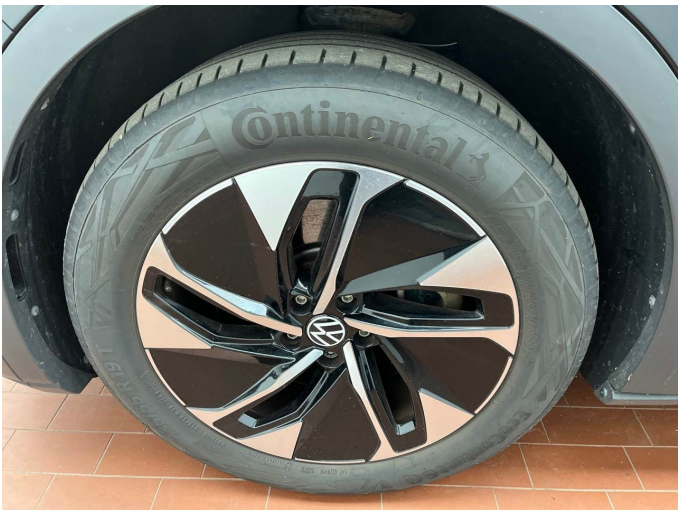
Figure 12: Mounted tyres

| # | Tyre size | Type of tyre | Manufacturer | Tread depth |
|---|---|---|---|---|
| 1) | 235/55 R19 101T | Summer tyres on Light alloy | Continental | 5mm / 5mm |
| 2) | 255/50 R19 103T | Summer tyres on Light alloy | Continental | 4mm / 4mm |

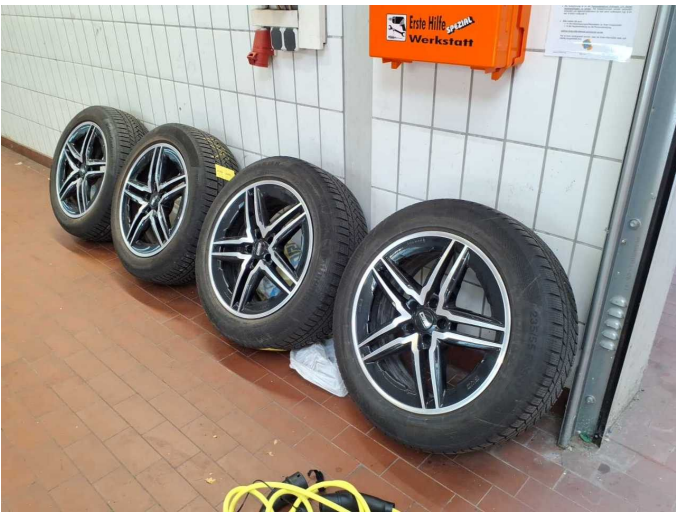
Figure 17: Additional tyres

| # | Tyre size | Type of tyre | Manufacturer | Tread depth |
|---|---|---|---|---|
| 1) | 235/55 R19 101T | Winter tyres on Light alloy | Continental | 6mm / 6mm |
| 2) | 255/50 R19 103T | Winter tyres on Light alloy | Continental | 4mm / 4mm |

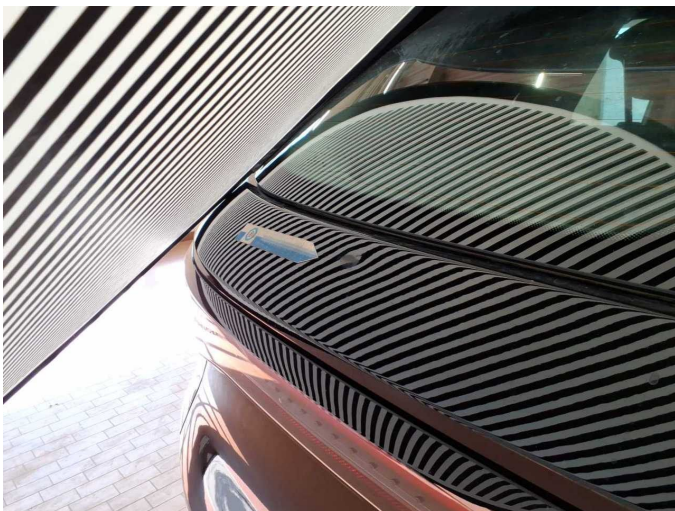
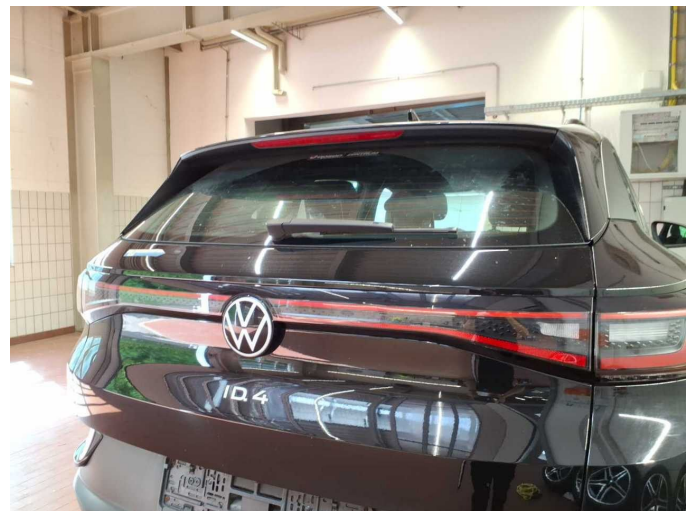
| No. | Component group | Description |
|---|---|---|
| 1 | Boot lid / rear door | Boot lid - dent(s) - Smooth repair work |

Damage 1: Boot lid / rear door: Boot lid - dent(s) - Smooth repair work

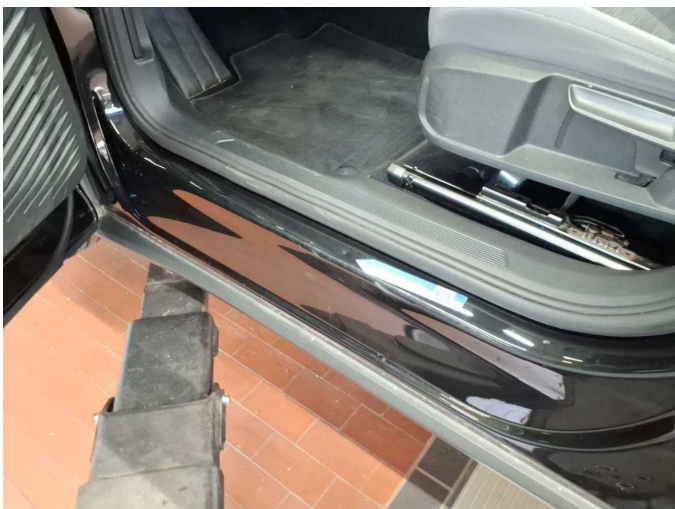
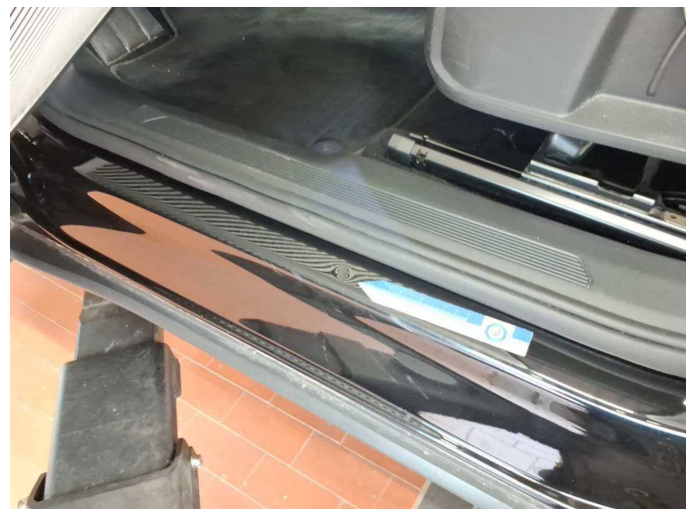
| No. | Component group | Description |
|---|---|---|
| 2 | Sill - left side | Sill - dent(s) - Smooth repair work |

Damage 2: Sill - left side: Sill - dent(s) - Smooth repair work

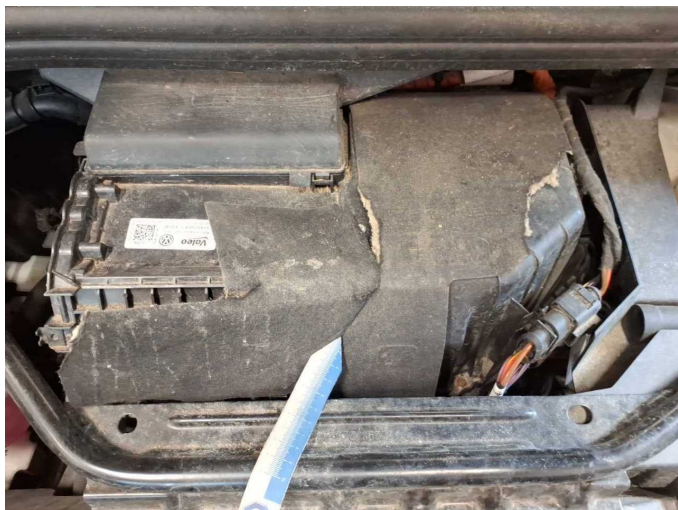
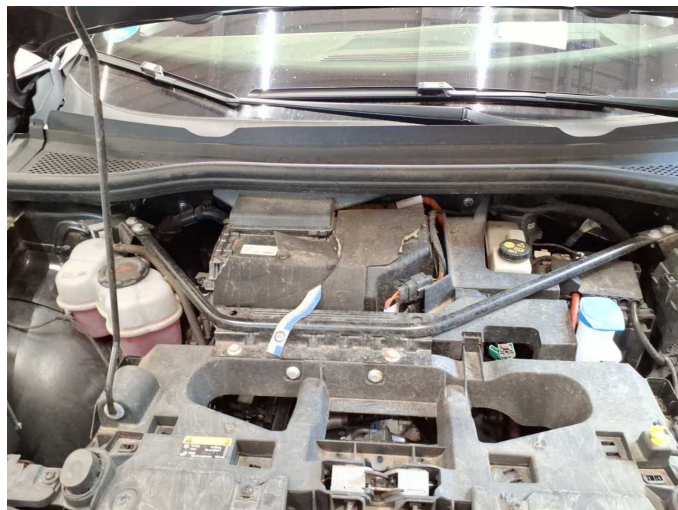
| No. | Component group | Description |
|---|---|---|
| 3 | Engine | Engine cover - Damage caused by marten / rodent - Replace |

**Damage 3:** Engine: Engine cover - Damage caused by marten / rodent - Replace

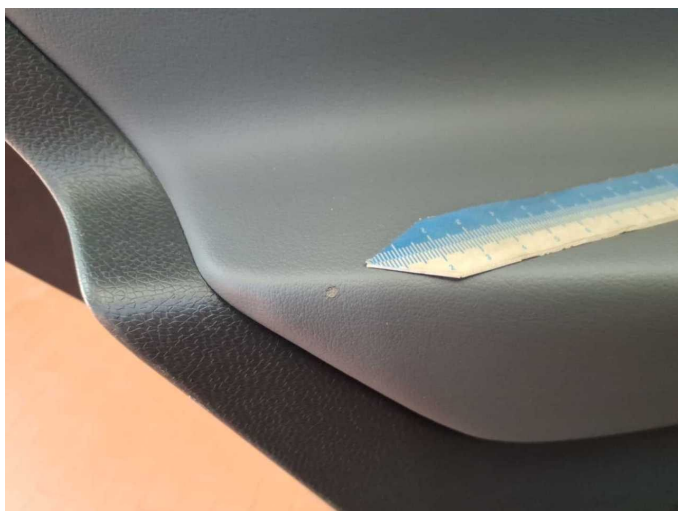
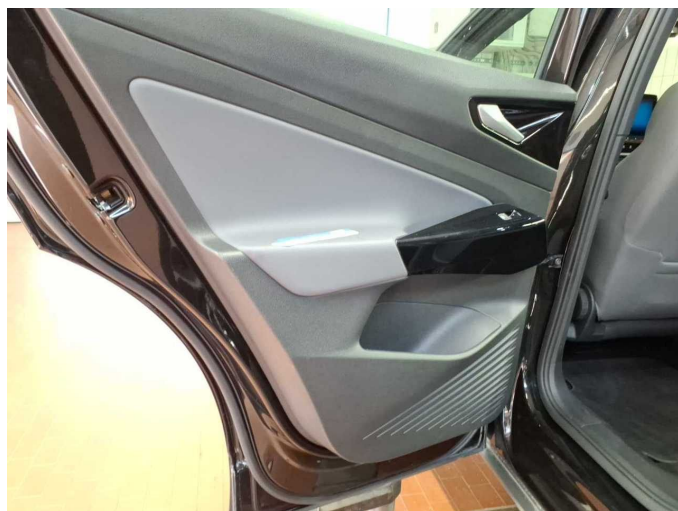
| No. | Component group | Description |
|---|---|---|
| 4 | Trim / covers | Door trim - rear left side - Burn hole (cigarettes) - Smart repair |

**Damage 4:** Trim / covers: Door trim - rear left side - Burn hole (cigarettes) - Smart repair

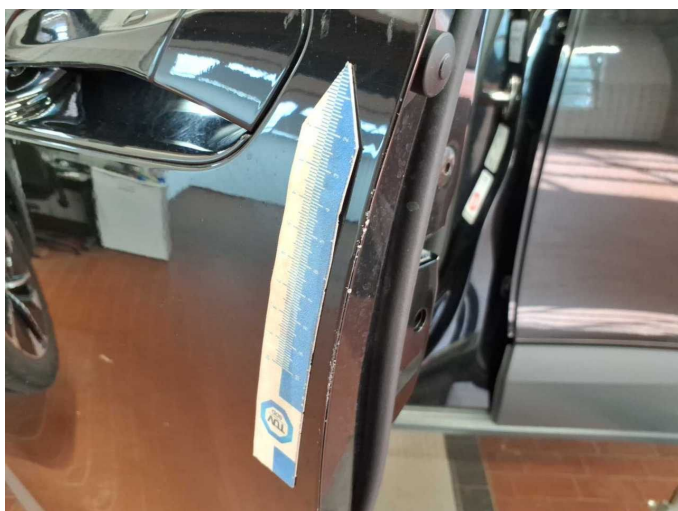
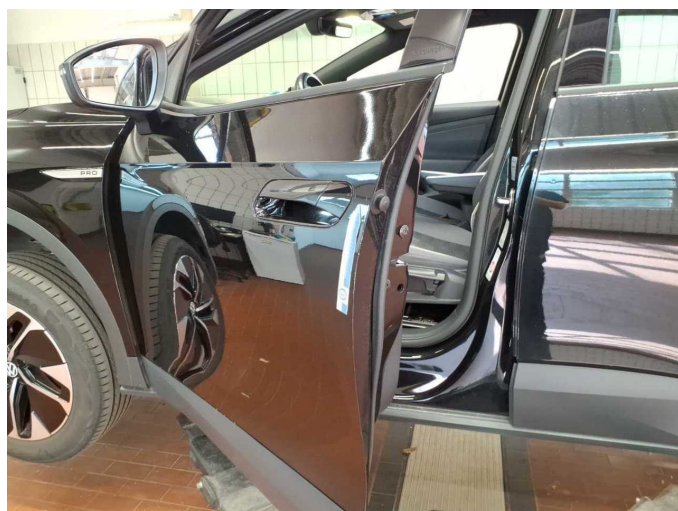
| No. | Component group | Description |
|---|---|---|
| 5 | Door - front left side | Door edge - Scratch(es) - Smart repair |

**Damage 5:** Door - front left side: Door edge - Scratch(es) - Smart repair

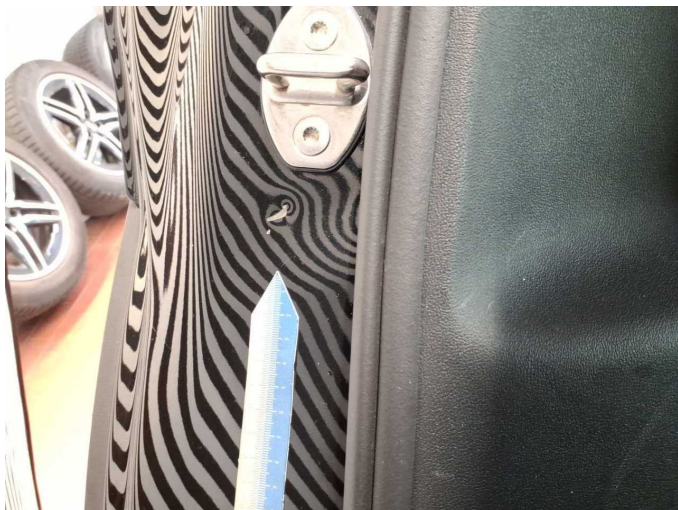
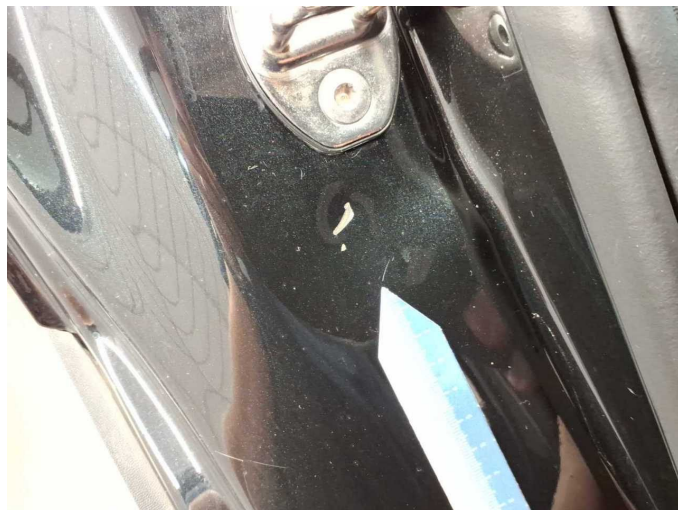
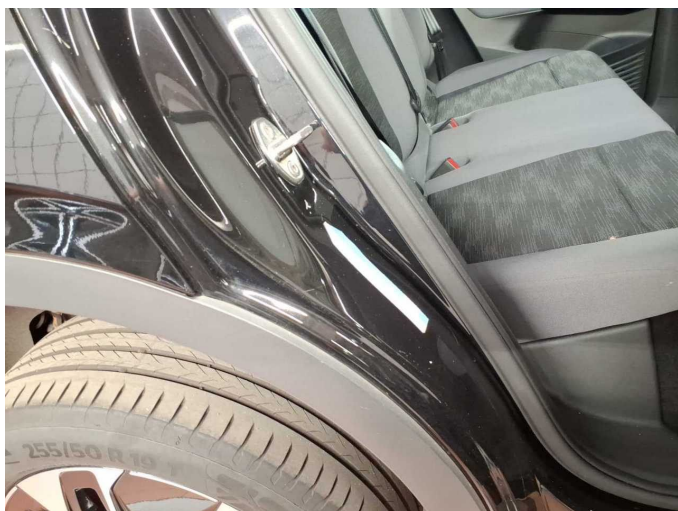
| No. | Component group | Description |
|---|---|---|
| 6 | Side panel - rear right side | Sill - Dent / paintcoat damage - Smart repair |

**Damage 6:** Side panel - rear right side: Sill - Dent / paintcoat damage - Smart repair

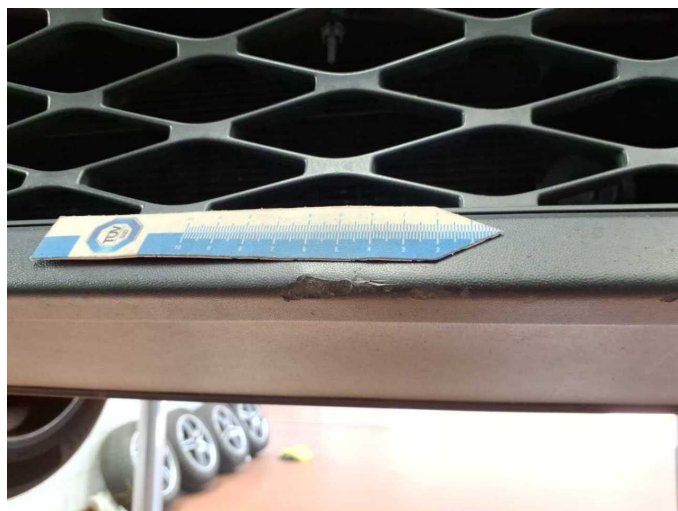
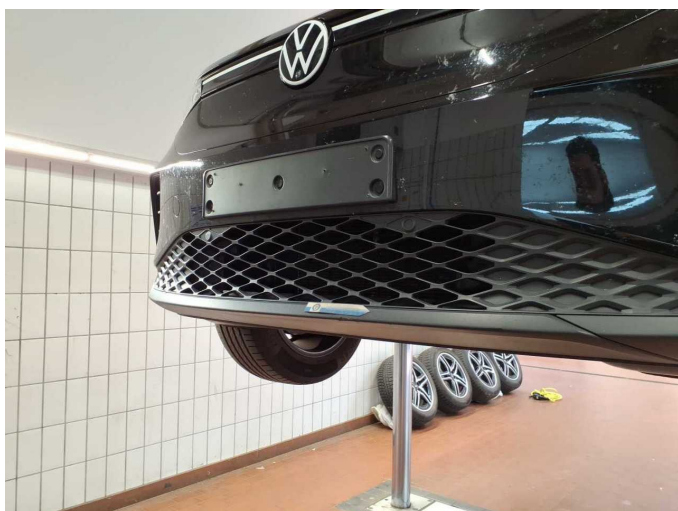
| No. | Component group | Description |
|---|---|---|
| 7 | Front bumper | Spoiler - Scratched - Replace |

**Damage 7:** Front bumper: Spoiler - Scratched - Replace

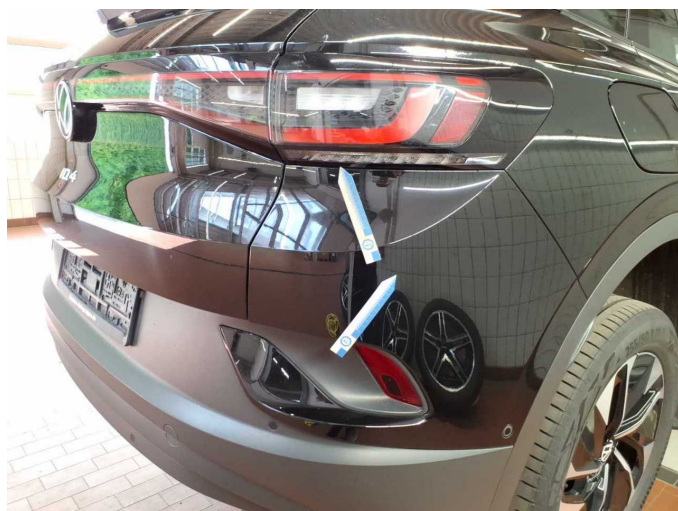
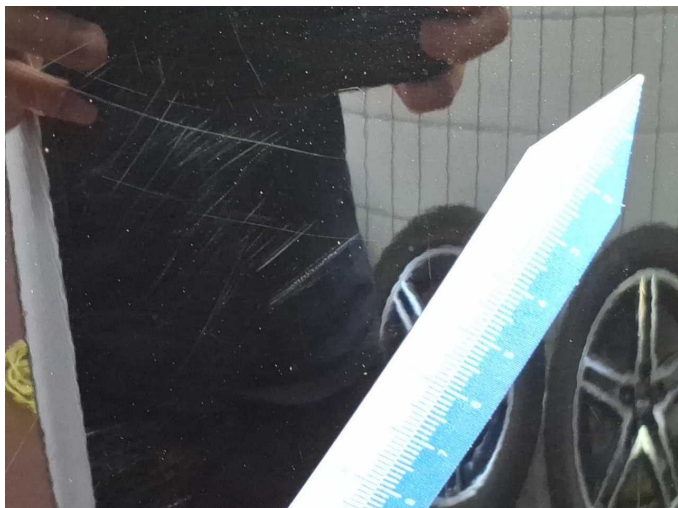
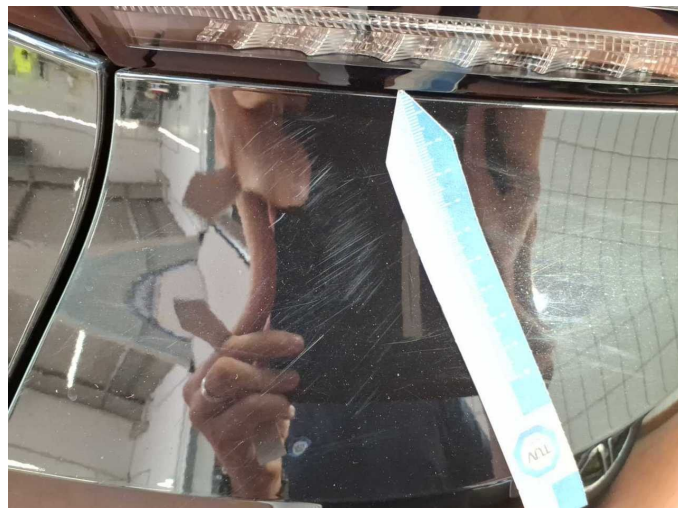
| No. | Component group | Description |
|---|---|---|
| 8 | Rear bumper | Rear bumper (Hinten Rechts) - Scratch(es) - Paint |

**Damage 8:** Rear bumper: Rear bumper (Hinten Rechts) - Scratch(es) - Paint

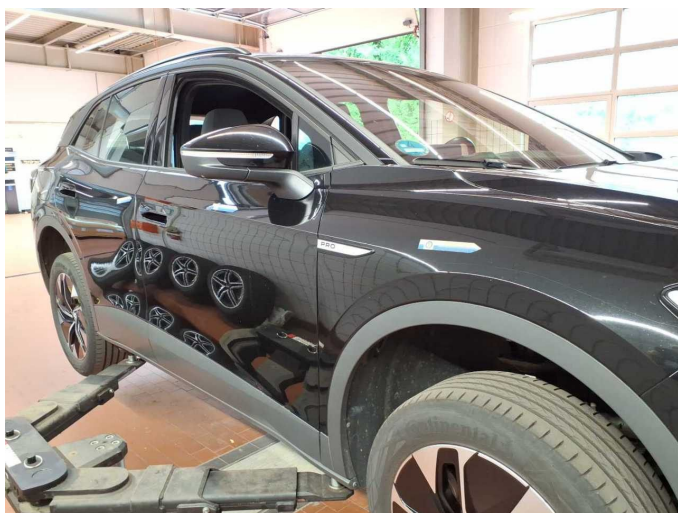
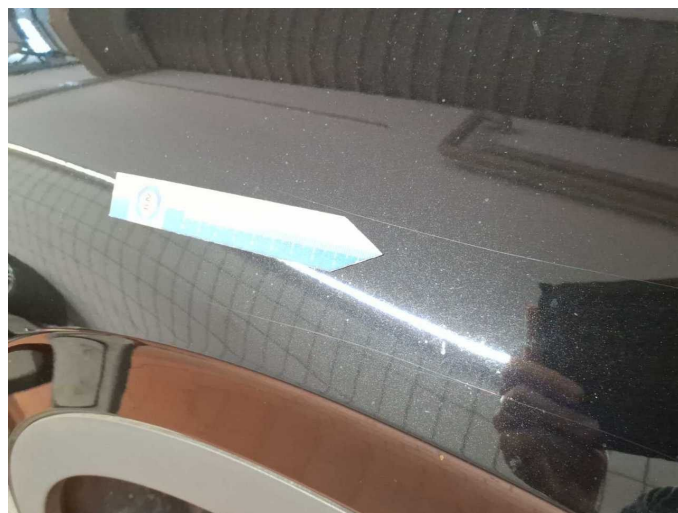
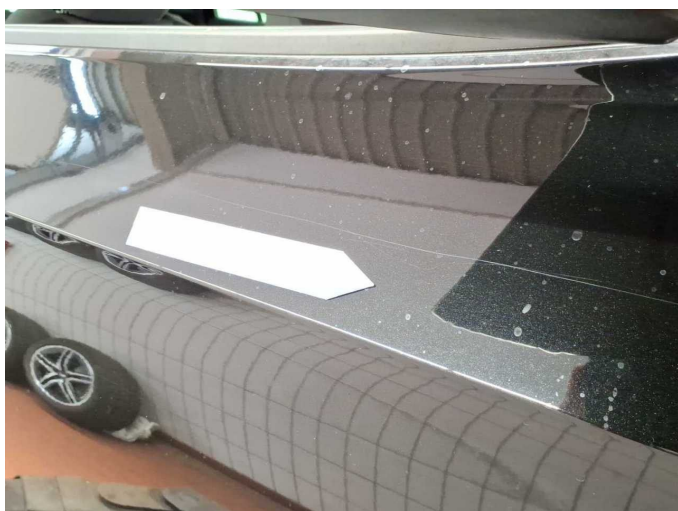
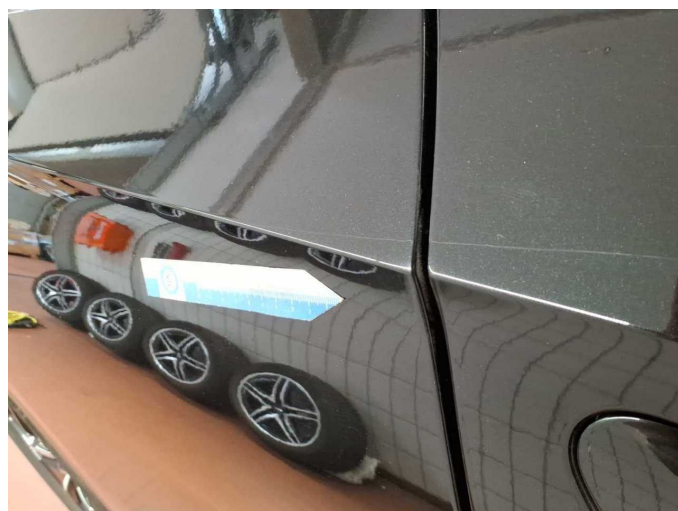
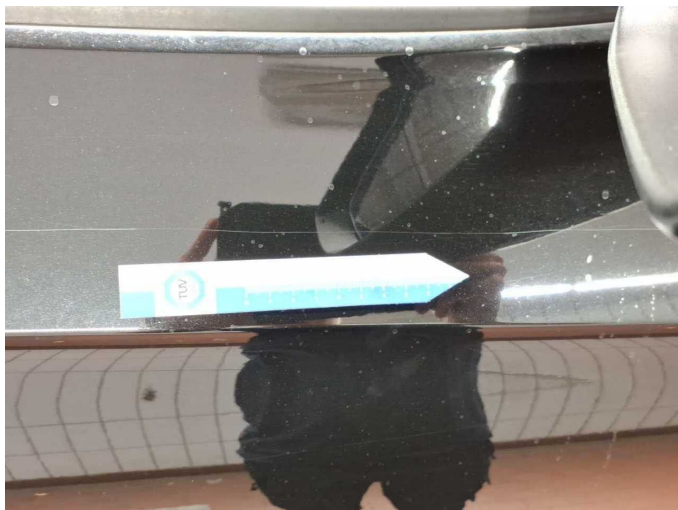
| No. | Component group | Description |
|---|---|---|
| 3 | Body | Body - Scratch(es) - No deduction |

**Wear and tear 3:** Body: Body - Scratch(es) - No deduction

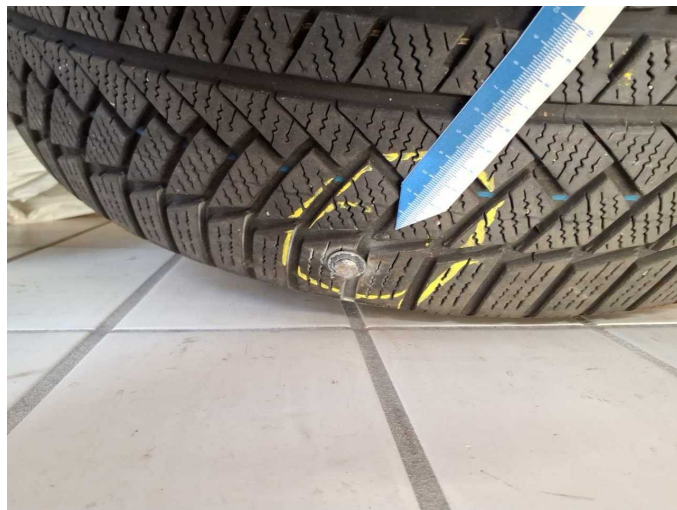
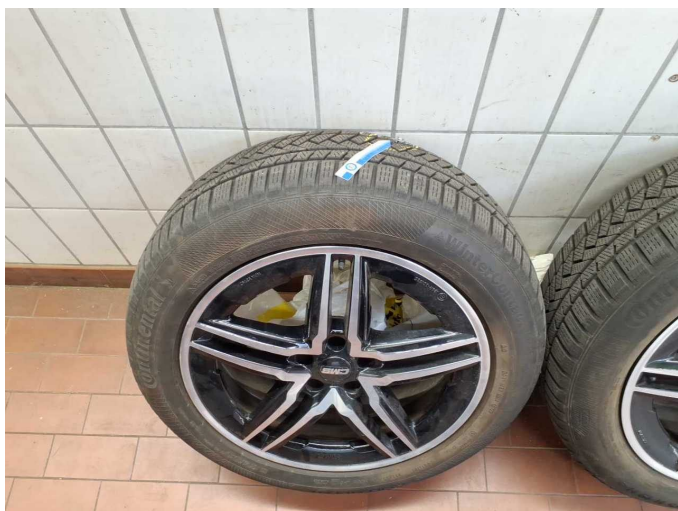
| No. | Component group | Description |
|---|---|---|
| 4 | 2nd wheel set | 1 tyre (Fremdkörper) - Broken / torn - No deduction |

**Wear and tear 4:** 2nd wheel set: 1 tyre (Fremdkörper) - Broken / torn - No deduction

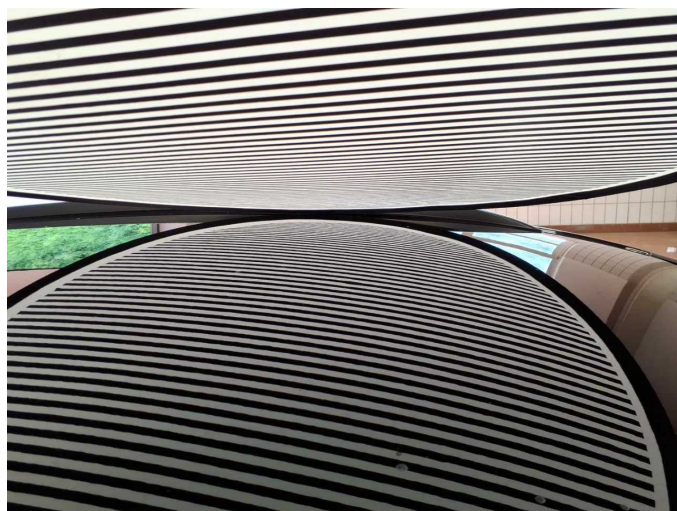
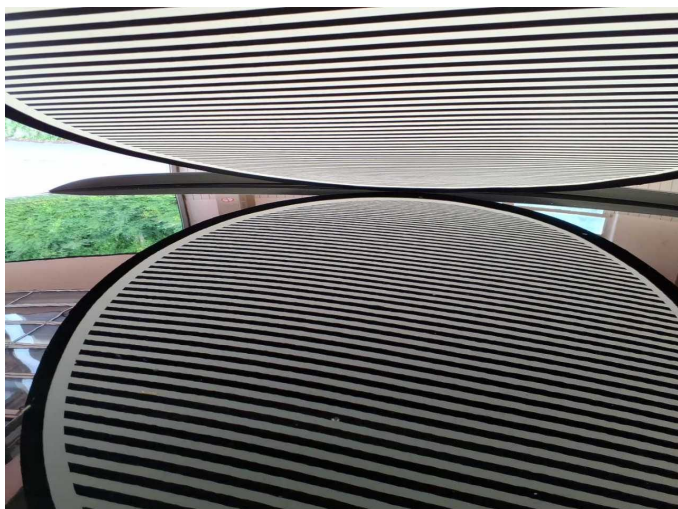
| No. | Component group | Description |
|---|---|---|
| 5 | Roof | Roof - dent(s) - No deduction |

**Wear and tear 5:** Roof: Roof - dent(s) - No deduction
