Expertise

Protocol number: 46252523  
Order No. / Reference: 26605484  
Inspection date: 25 Jun 2026

Model: Passat Variant 2.0 TDI SCR DSG Business

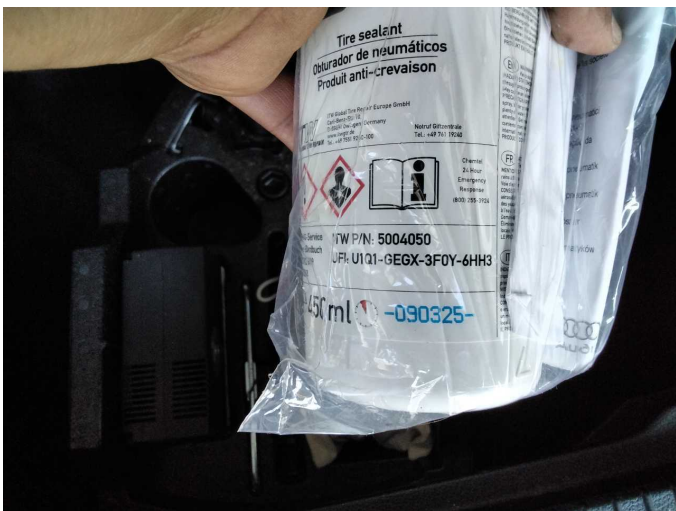
Damage 2: Equipment: Tirefit filler - Expired - Replace

| No. | Component group | Description |
|---|---|---|
| 2 | Equipment | Tirefit filler - Expired - Replace |

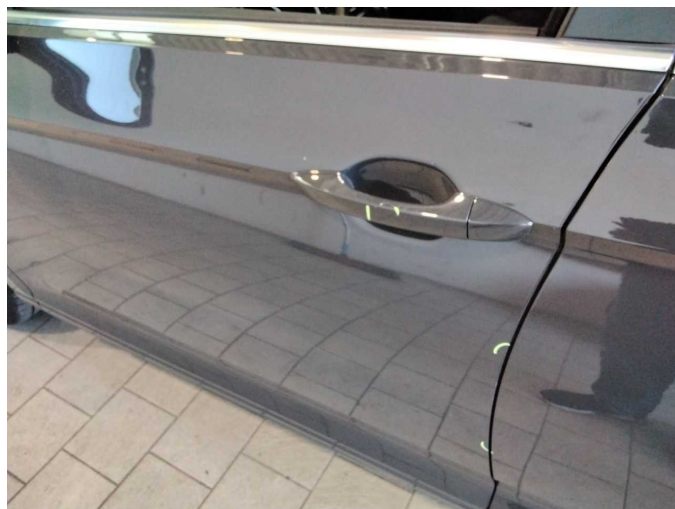
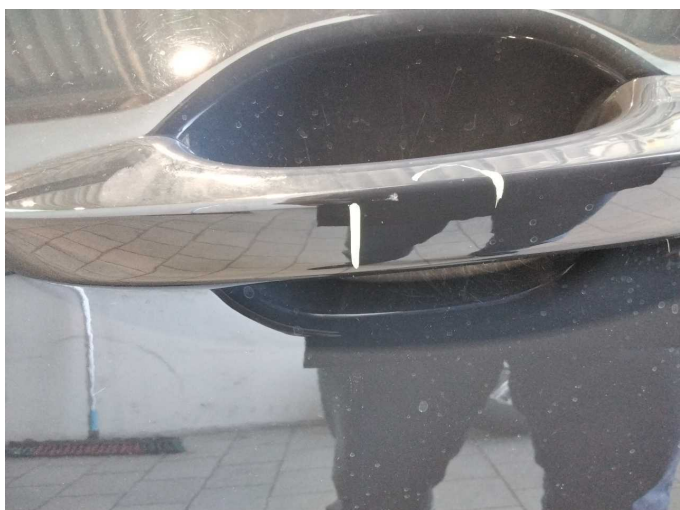
**Damage 4:** Door - front left side: Door handle - outside - Scratch(es) - Smart repair

| No. | Component group | Description |
|---|---|---|
| 4 | Door - front left side | Door handle - outside - Scratch(es) - Smart repair |

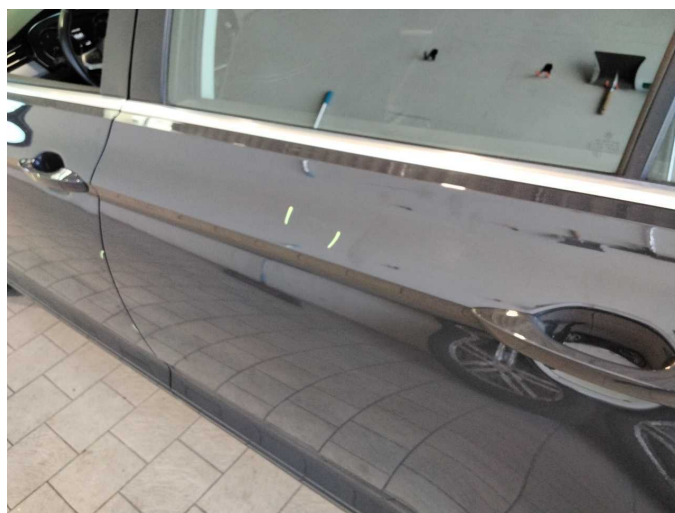
**Damage 6:** Door - rear left side: Door - Scratch(es) - Smart repair

| No. | Component group | Description |
|---|---|---|
| 6 | Door - rear left side | Door - Scratch(es) - Smart repair |

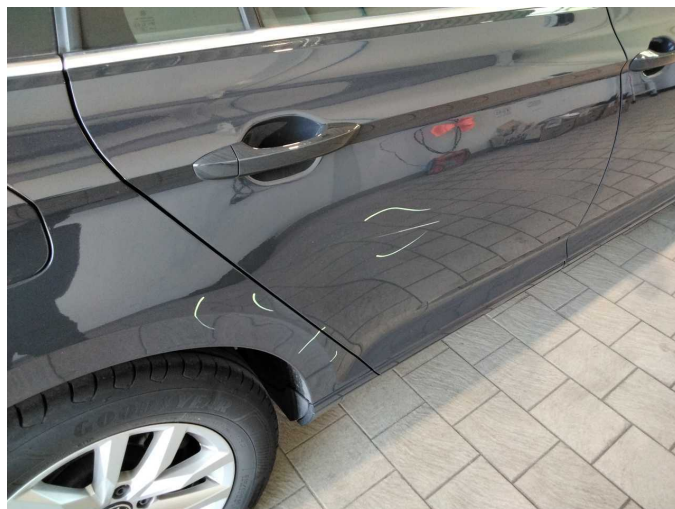
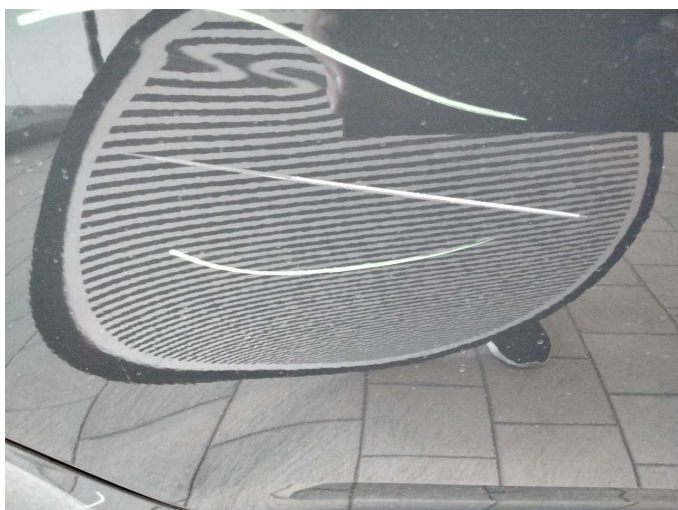
**Damage 7:** Door - rear right side: Door - Dent / paintcoat damage - Repair and paint

| No. | Component group | Description |
|---|---|---|
| 7 | Door - rear right side | Door - Dent / paintcoat damage - Repair and paint |

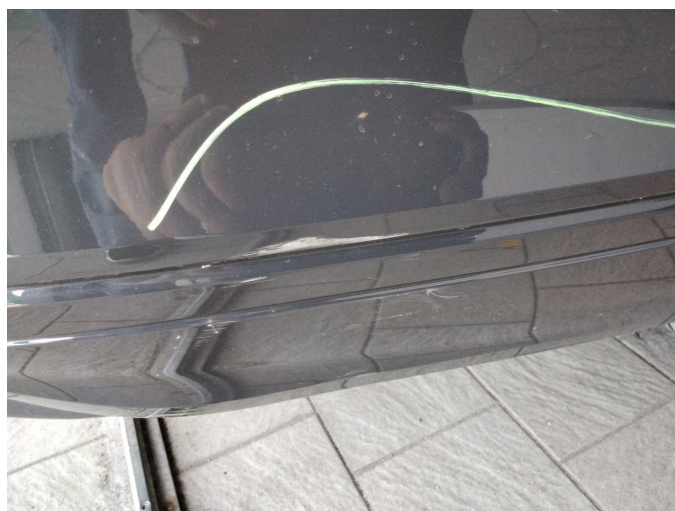
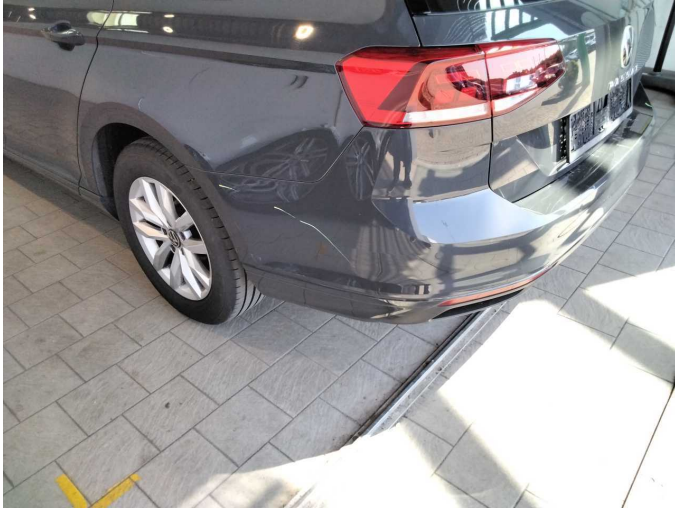
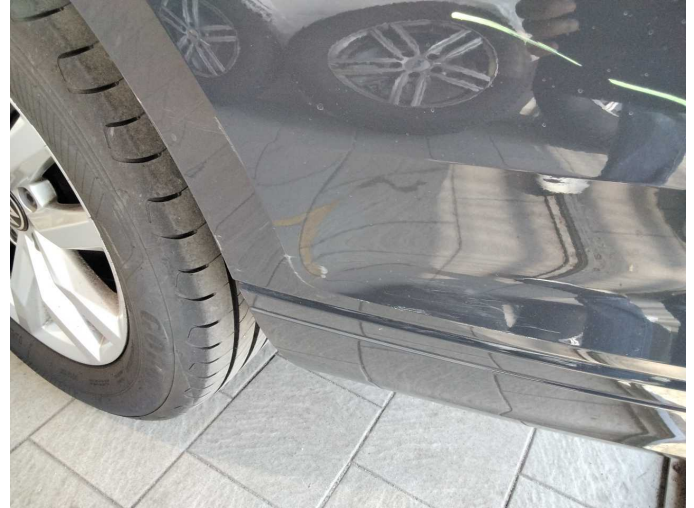
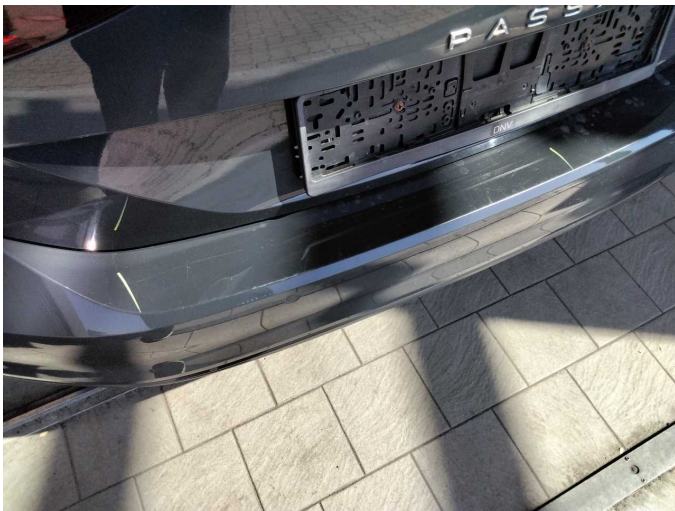
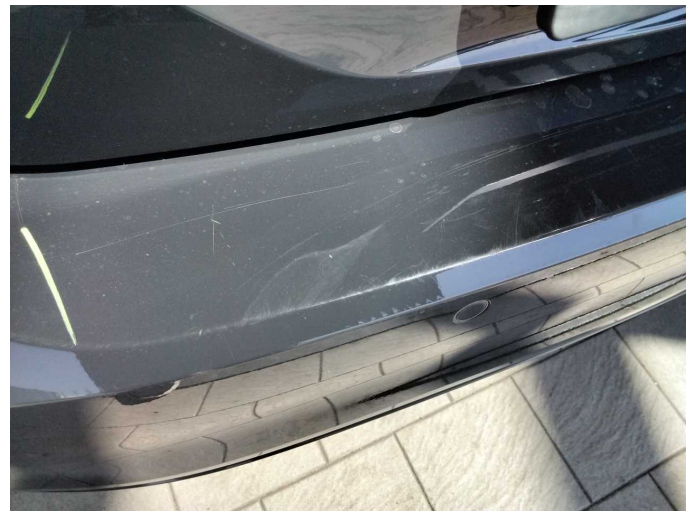
**Damage 8:** Rear bumper: Rear bumper - Scratch(es) - Paint

| No. | Component group | Description |
|---|---|---|
| 8 | Rear bumper | Rear bumper - Scratch(es) - Paint |

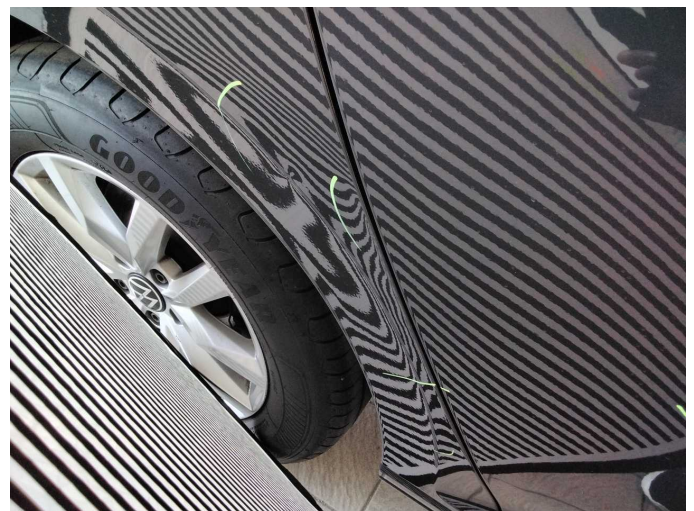
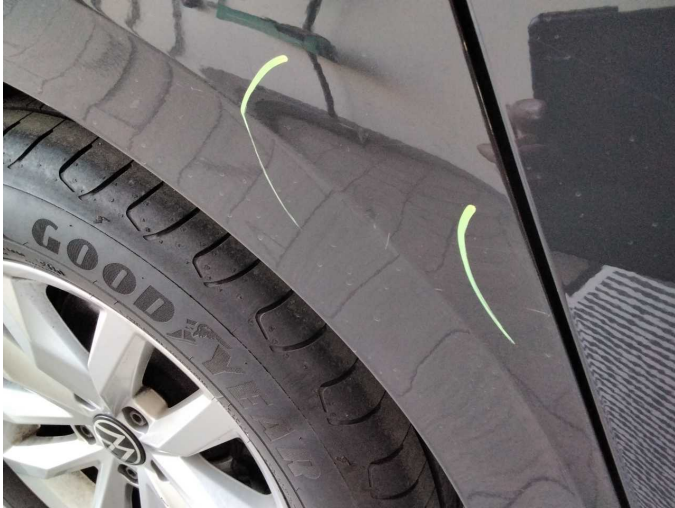
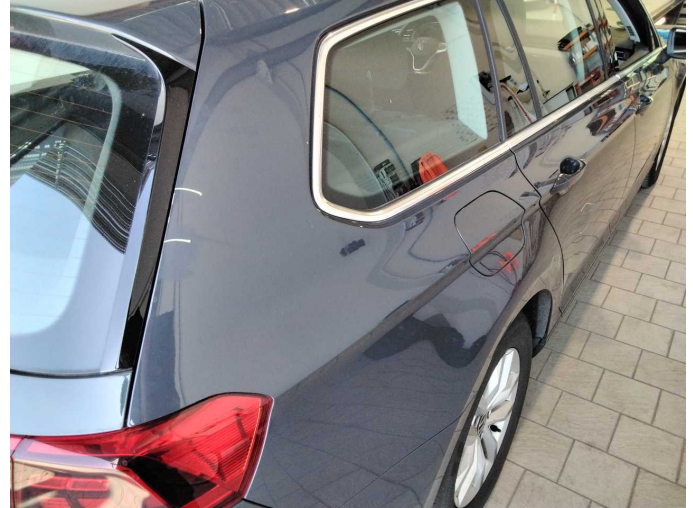
**Damage 9:** Side panel - rear right side: Side panel - Dent / paintcoat damage - Repair and paint

| No. | Component group | Description |
|---|---|---|
| 9 | Side panel - rear right side | Side panel - Dent / paintcoat damage - Repair and paint |

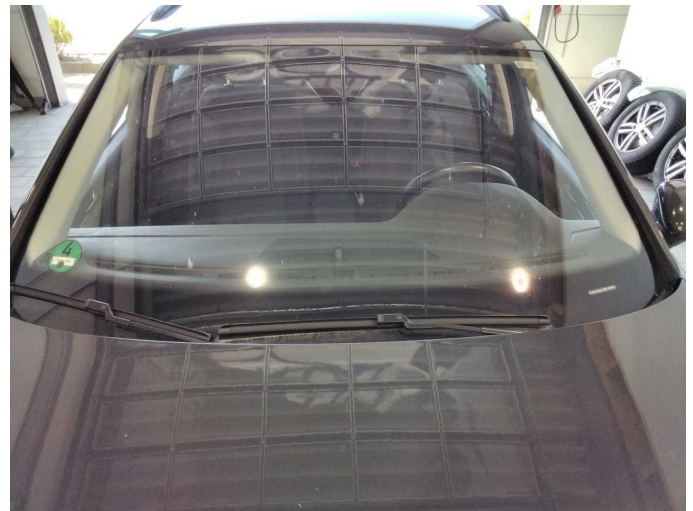
**Wear and tear 1:** Vehicle glazing: Windscreen - Stone chips - No deduction

| No. | Component group | Description |
|---|---|---|
| 1 | Vehicle glazing | Windscreen - Stone chips - No deduction |
