Expertise

Protocol number: 47136362  
Order No. / Reference: 26845560  
Inspection date: 19 Aug 2026

Manufacturer: Peugeot

Model: 208 GT Elektromotor 136

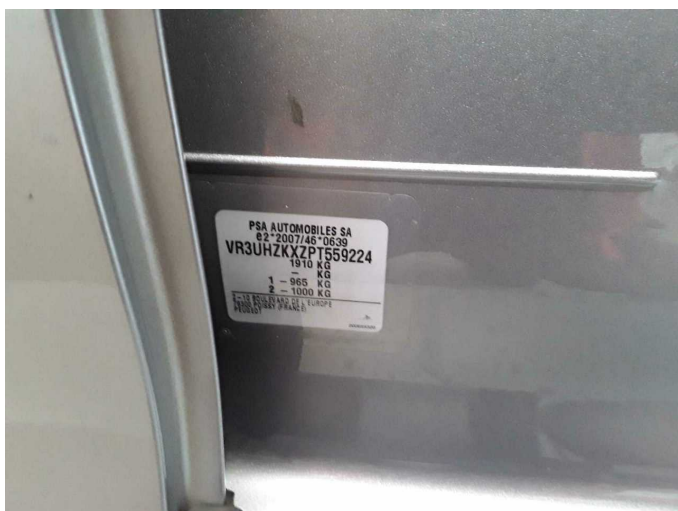
Figure 11: VIN

| VIN comparison | The vehicle identification number (VIN) was read from the vehicle and its conformity with the submitted documents was confirmed by the undersigned during the inspection. |

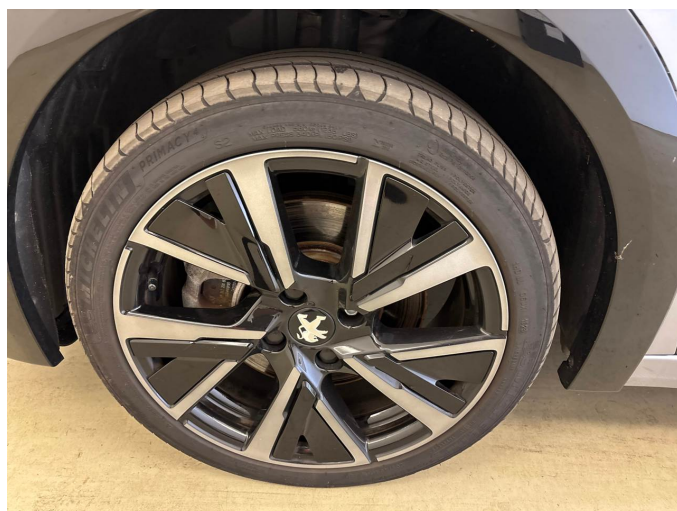
Figure 12: Mounted tyres

| # | Tyre size | Type of tyre | Manufacturer | Tread depth |
|---|---|---|---|---|
| 1) | 205/45 R17 88H | Summer tyres on Light alloy | Michelin | 5mm / 5mm |
| 2) | 205/45 R17 88H | Summer tyres on Light alloy | Michelin | 6mm / 6mm |

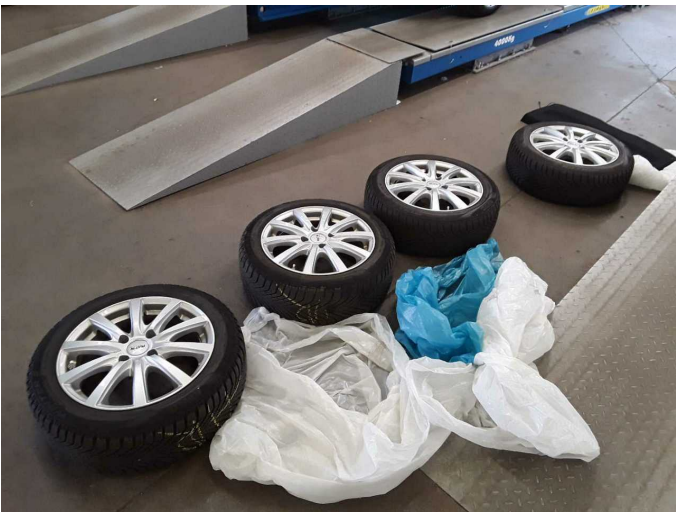
Figure 17: Additional tyres

| # | Tyre size | Type of tyre | Manufacturer | Tread depth |
|---|---|---|---|---|
| 1) | 195/55 R16 91H | Winter tyres on Light alloy | Pirelli | 5mm / 5mm |
| 2) | 195/55 R16 91H | Winter tyres on Light alloy | Pirelli | 6mm / 6mm |

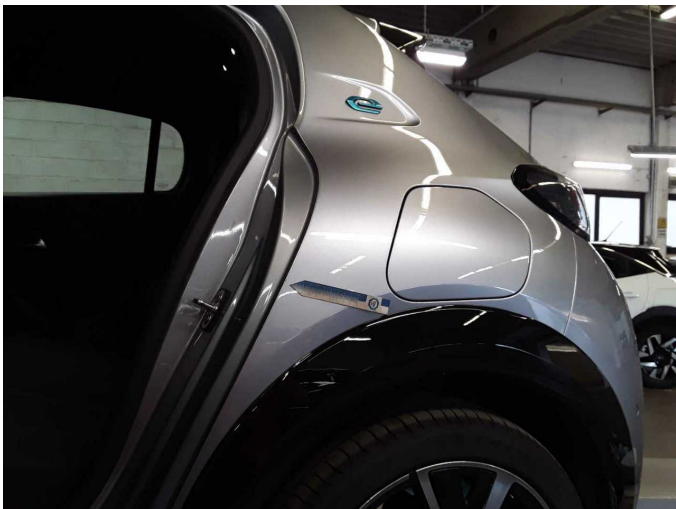
| No. | Component group | Description |
|---|---|---|
| 1 | Side panel - rear left side | Side panel - Scratched - Smart repair |

Damage 1: Side panel - rear left side: Side panel - Scratched - Smart repair

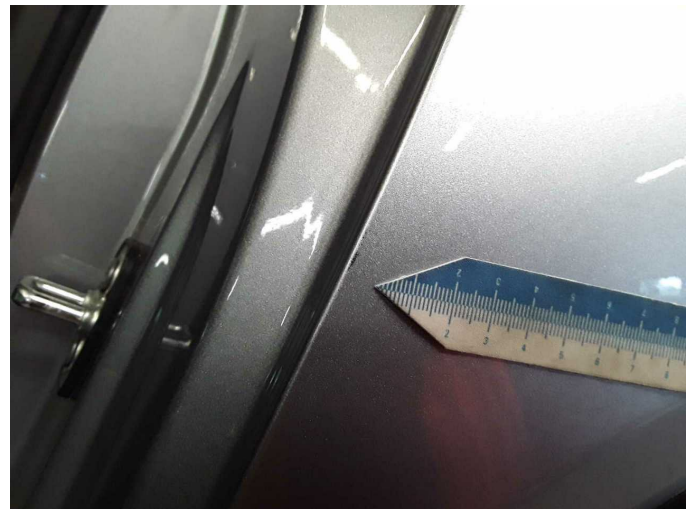
Damage 1: Side panel - rear left side: Side panel - Scratched - Smart repair

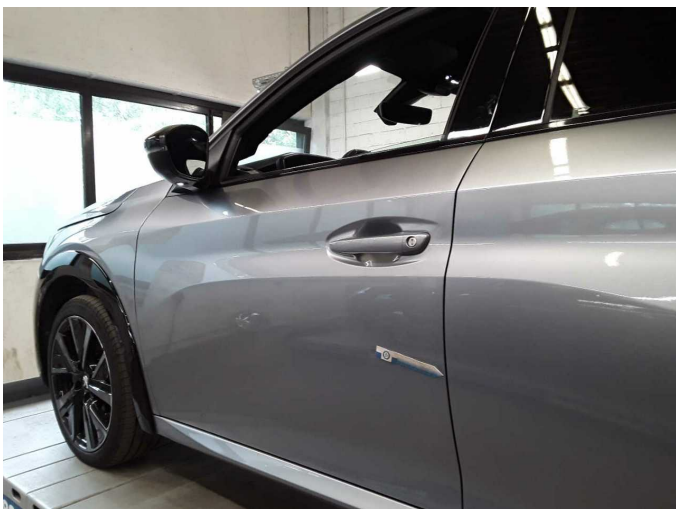
| No. | Component group | Description |
|---|---|---|
| 2 | Door - front left side | Door edge - Scratched - Smart repair |

Damage 2: Door - front left side: Door edge - Scratched - Smart repair

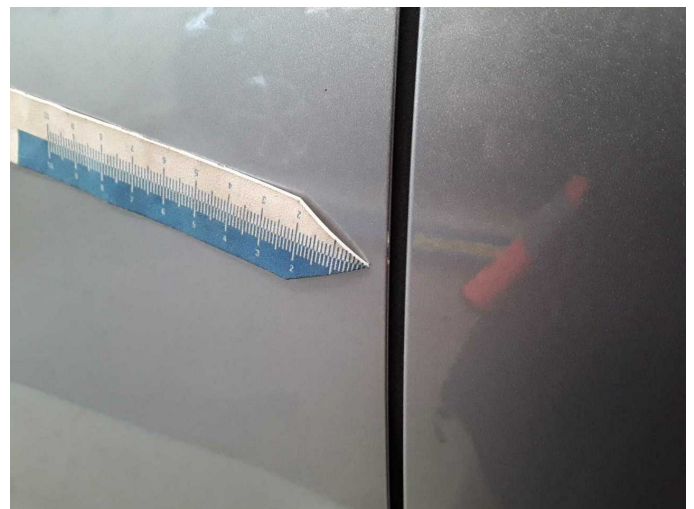
Damage 2: Door - front left side: Door edge - Scratched - Smart repair

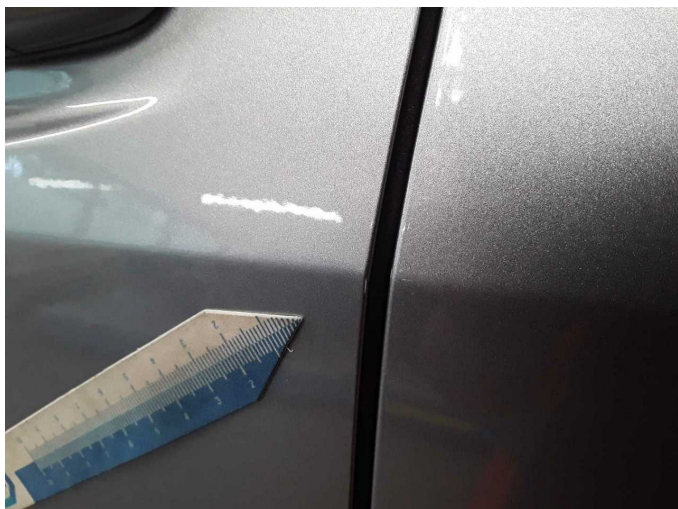
**Damage 2:** Door - front left side: Door edge - Scratched - Smart repair

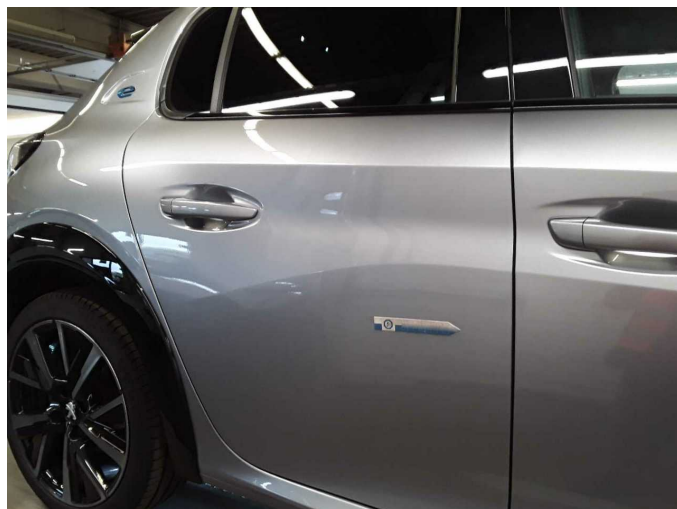
| No. | Component group | Description |
|---|---|---|
| 3 | Door - rear right side | Door (Einschlüsse) - Paint defect - Paint |

**Damage 3:** Door - rear right side: Door (Einschlüsse) - Paint defect - Paint

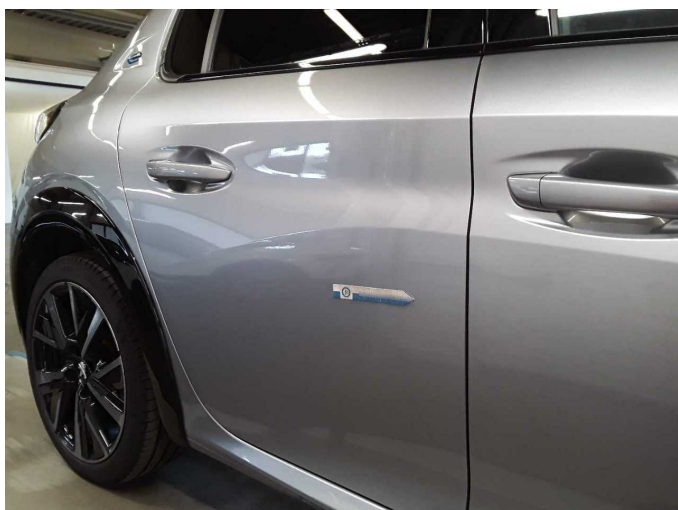
**Damage 3:** Door - rear right side: Door (Einschlüsse) - Paint defect - Paint

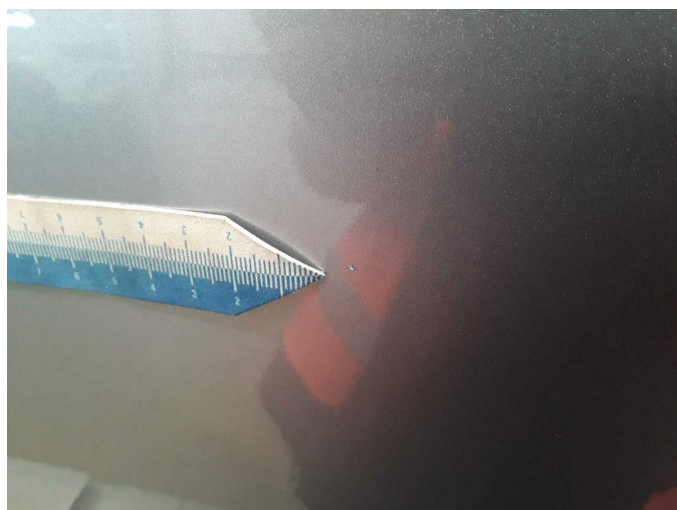
**Damage 3:** Door - rear right side: Door (Einschlüsse) - Paint defect - Paint

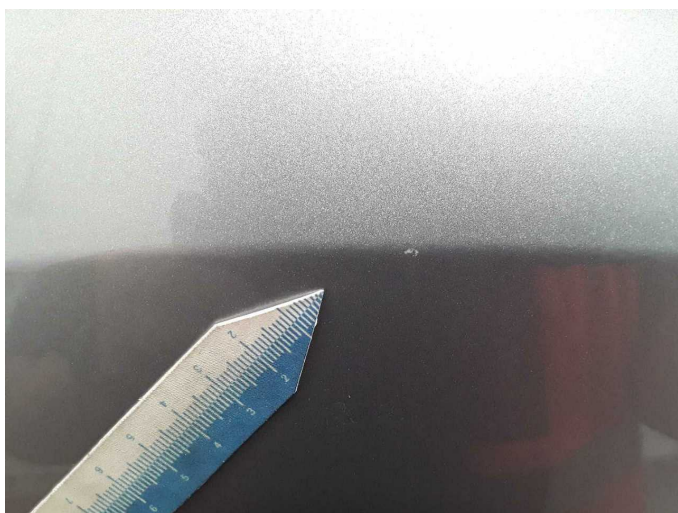
**Damage 3:** Door - rear right side: Door (Einschlüsse) - Paint defect - Paint

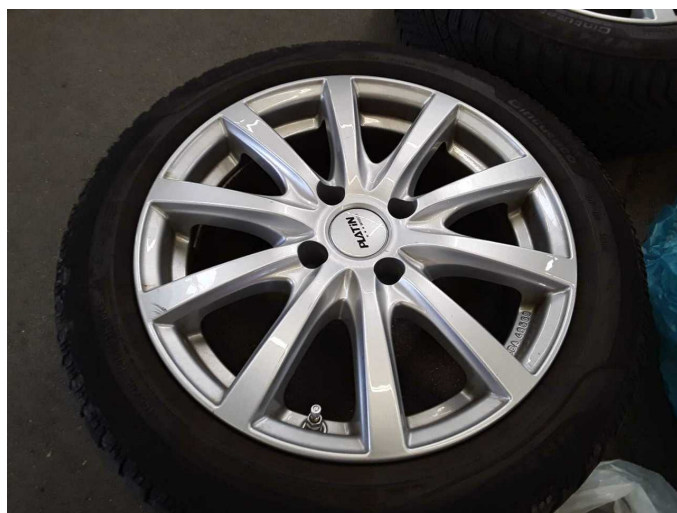
| No. | Component group | Description |
|---|---|---|
| 1 | 2nd wheel set | 1 alloy rim - Scratched - No deduction |

**Wear and tear 1:** 2nd wheel set: 1 alloy rim - Scratched - No deduction

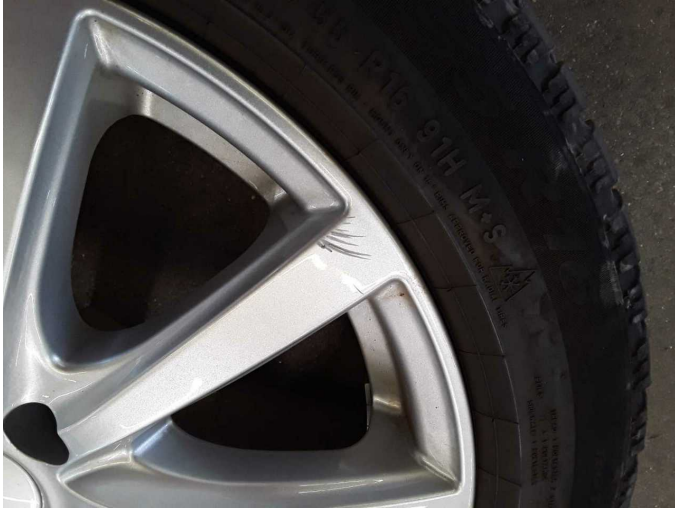
**Wear and tear 1:** 2nd wheel set: 1 alloy rim - Scratched - No deduction

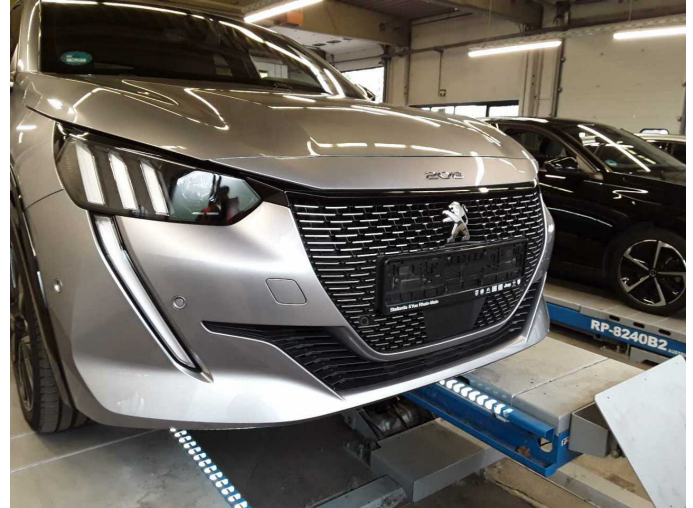
| No. | Component group | Description |
|---|---|---|
| 2 | Front bumper | Front bumper - Stone chips - No deduction |

**Wear and tear 2:** Front bumper: Front bumper - Stone chips - No deduction
