Expertise

Protocol number: 46489798  
Order No. / Reference: 26609212  
Inspection date: 14 Jul 2026

Model: Focus Turnier 1.0 EcoBoost Hybrid Aut. ST-LINE VIGNALE

VIN: WF0PXXGCHPNB00259

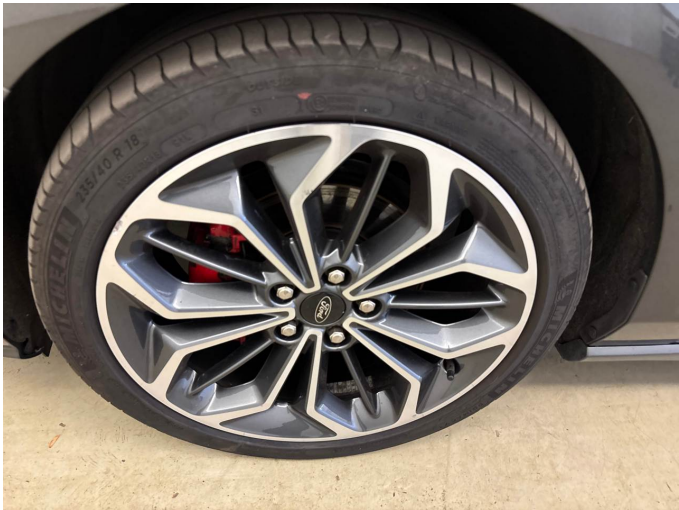
| Tyres | | | | |
|---|---|---|---|---|
| 1) | 235/40 R18 91W | Summer tyres on Light alloy | Michelin | 3mm / 3mm |
| 2) | 235/40 R18 91W | Summer tyres on Light alloy | Michelin | 3mm / 3mm |

Figure 12: Mounted tyres

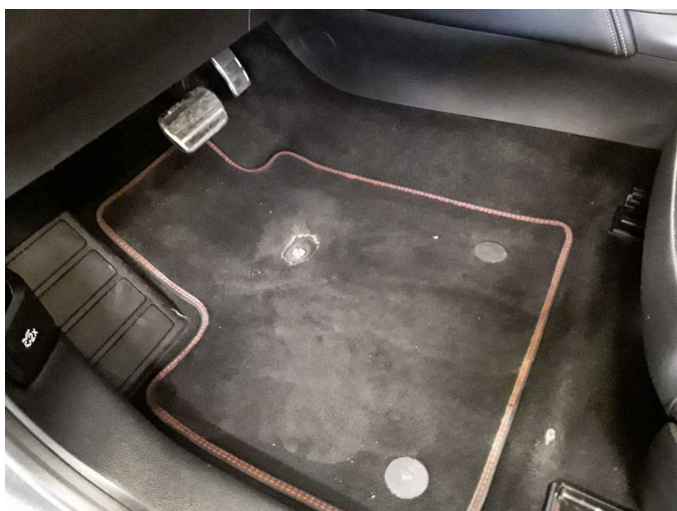
Damage 1: Trim / covers: Floor mats - Damaged - Replace

| No. | Component group | Description |
|---|---|---|
| 1 | Trim / covers | Floor mats - Damaged - Replace |

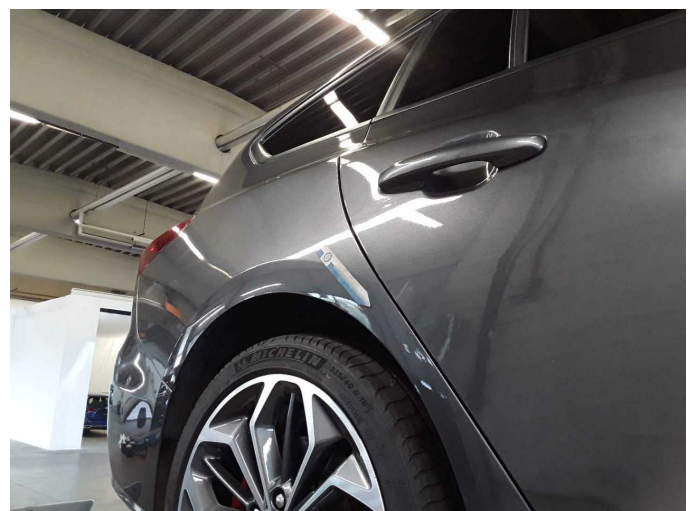
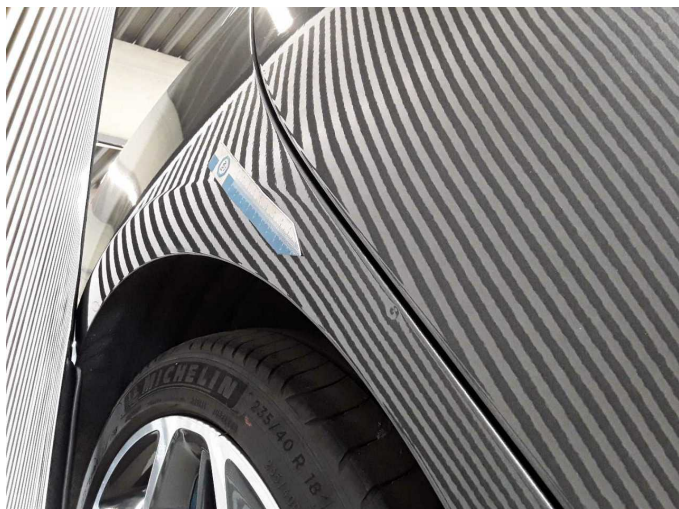
Damage 2: Side panel - rear right side: Side panel - dent(s) - Smooth repair work

**Damage 2:** Side panel - rear right side: Side panel - dent(s) - Smooth repair work

| No. | Component group | Description |
|---|---|---|
| 2 | Side panel - rear right side | Side panel - dent(s) - Smooth repair work |

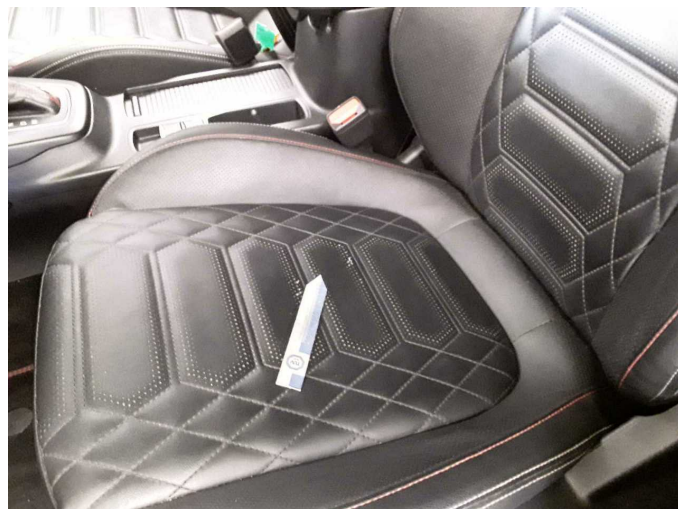
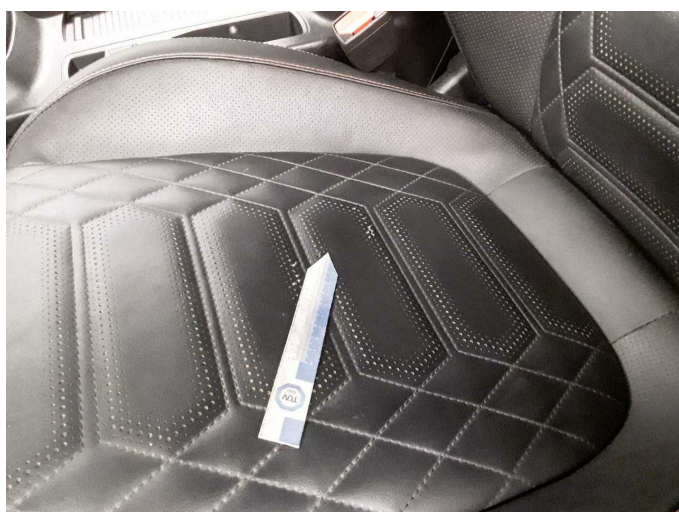
**Damage 3:** Seat - front: Seat cover - left side - Worn - Loss in value

| No. | Component group | Description |
|---|---|---|
| 3 | Seat - front | Seat cover - left side - Worn - Loss in value |

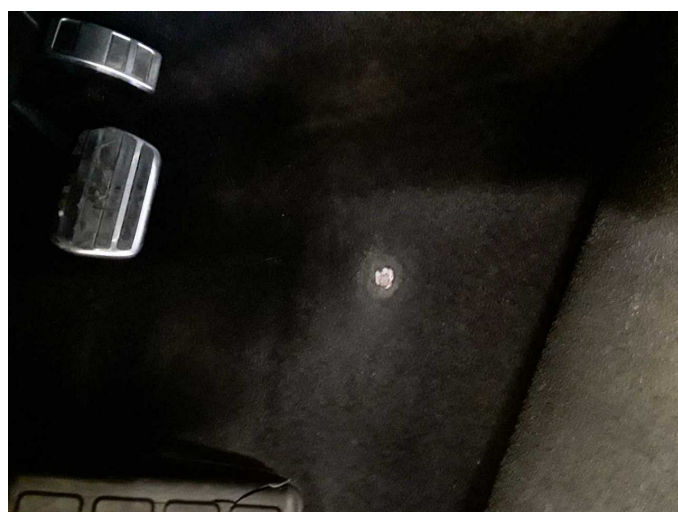
**Damage 4:** Trim / covers: Carpet - front left side - Holes - Loss in value

| No. | Component group | Description |
|---|---|---|
| 4 | Trim / covers | Carpet - front left side - Holes - Loss in value |

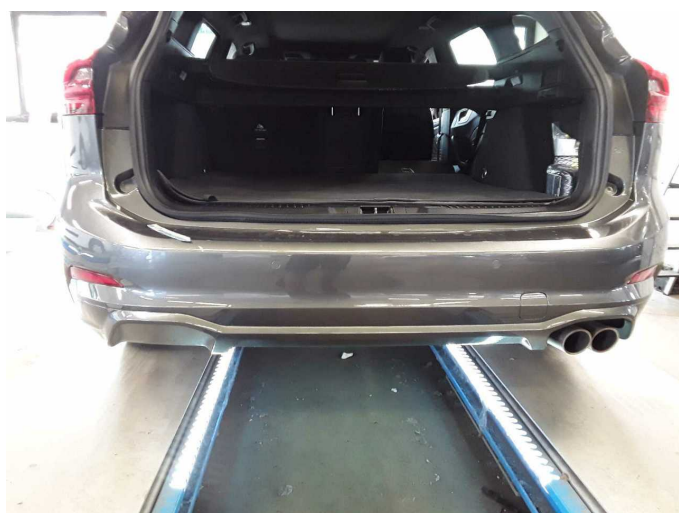
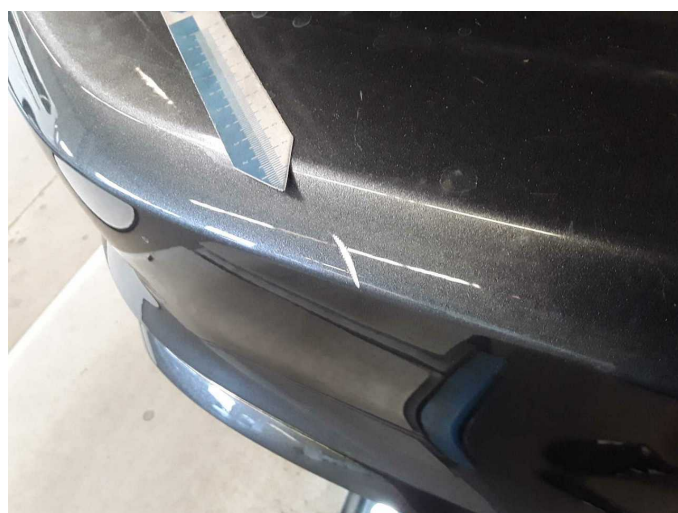
**Damage 5:** Rear bumper: Rear bumper - Scratch(es) - Paint

| No. | Component group | Description |
|---|---|---|
| 5 | Rear bumper | Rear bumper - Scratch(es) - Paint |

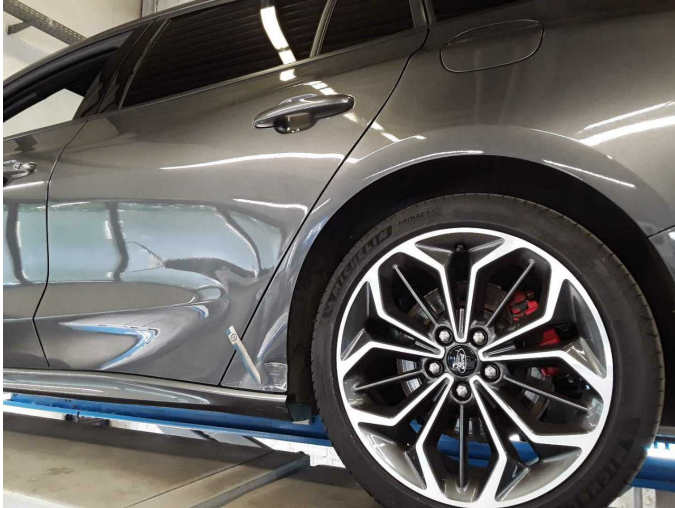
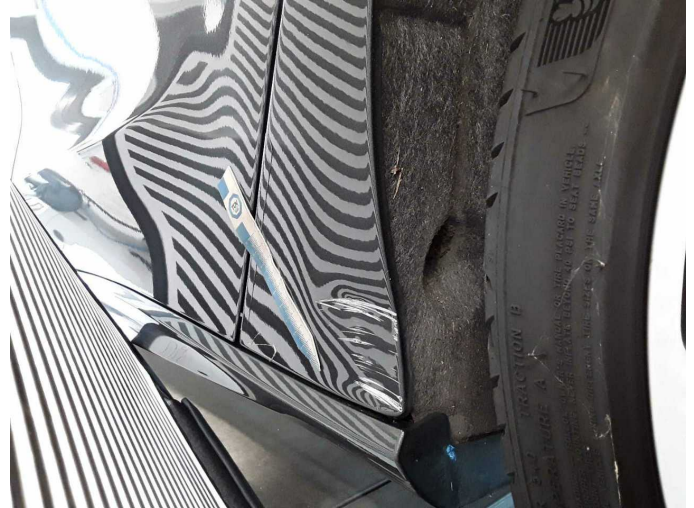
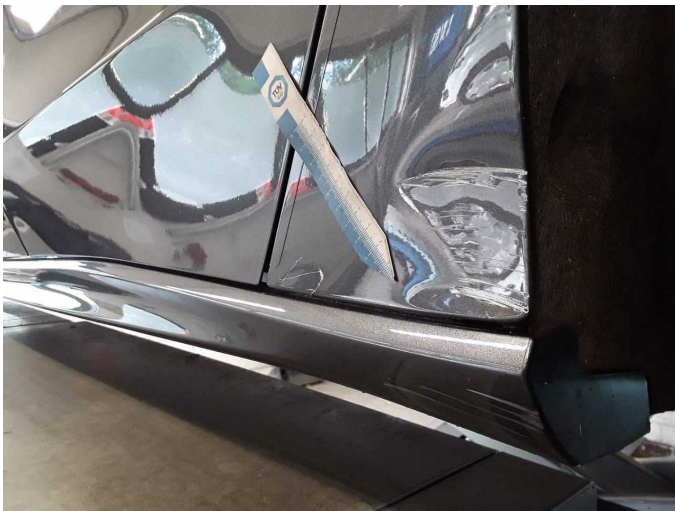
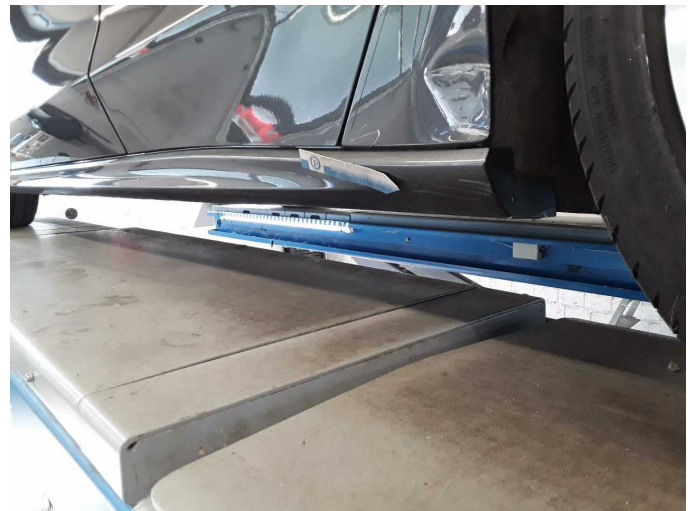
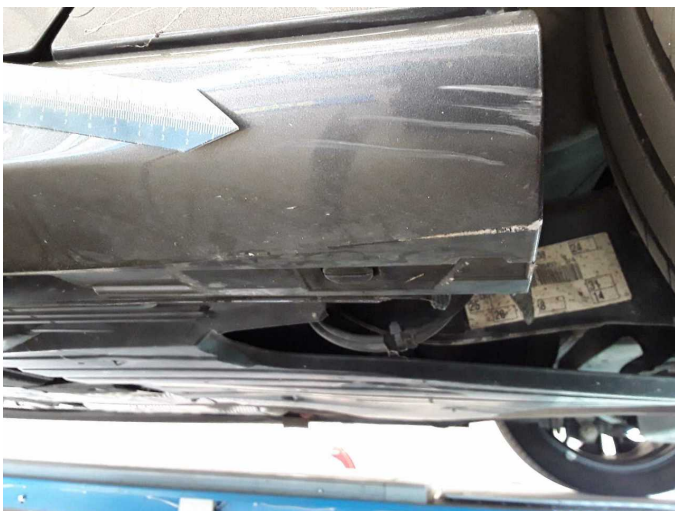
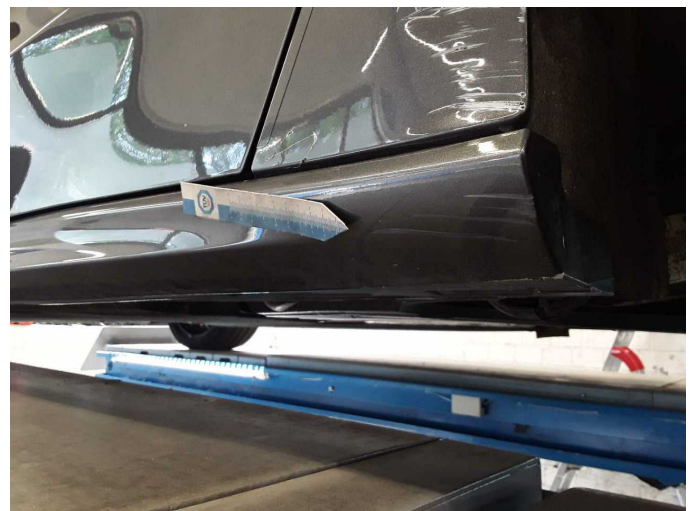
- 1 Side - left

Non-repaired previous damages were found at the vehicle. The necessary repair costs are listed in the expert report or if necessary, are listed in detail in a separately enclosed repair cost calculation.

**Accident 1: Side - left**
