Expertise

Protocol number: 46826944  
Order No. / Reference: 26703274  
Inspection date: 29 Jul 2026

Model: GLC 300 de 4Matic 9G-TRONIC AMG Line

VIN: W1N2539111F981700

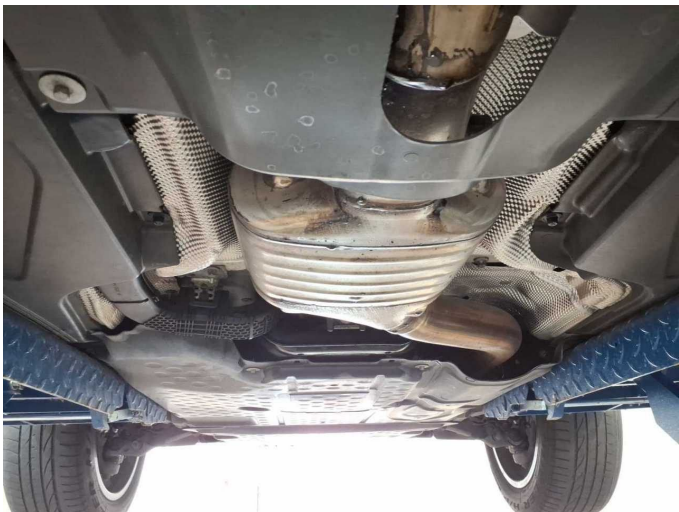
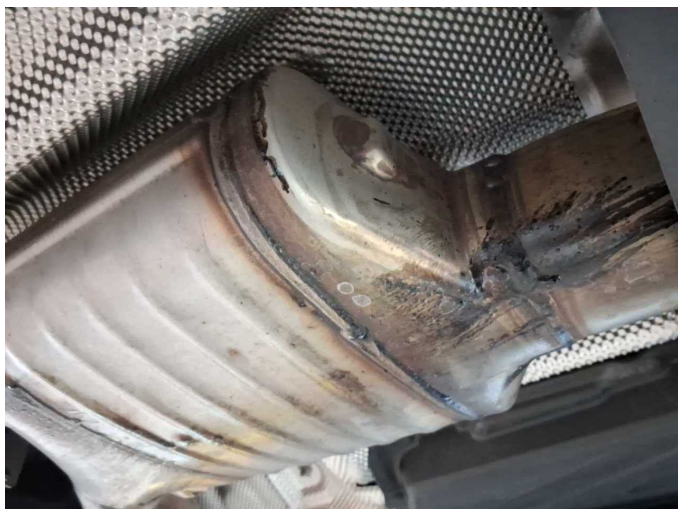
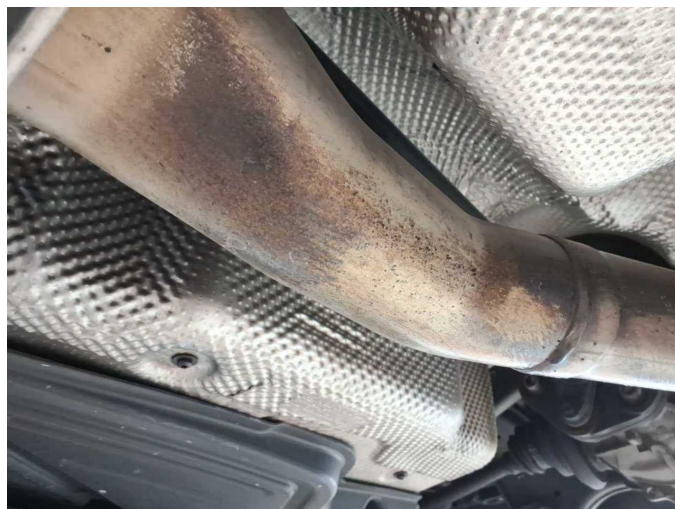
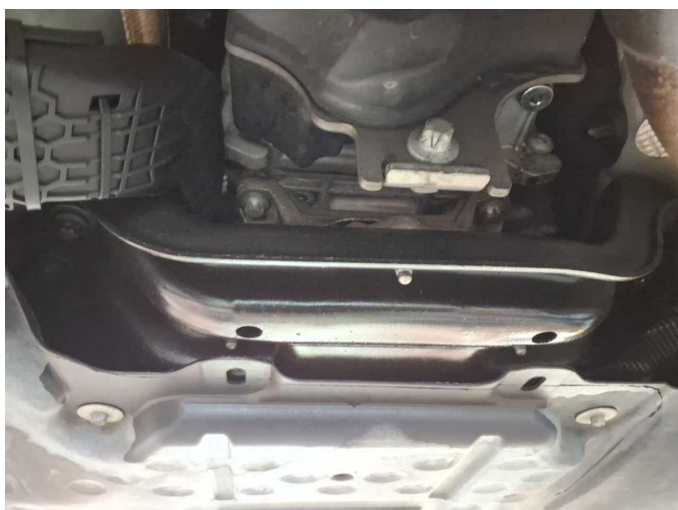
| No. | Component group | Description |
|---|---|---|
| 1 | Body | Underbody (Verölt) - Leaking - Perform diagnosis |

Damage 1: Body: Underbody (Verölt) - Leaking - Perform diagnosis

**Damage 1:** Body: Underbody (Verölt) - Leaking - Perform diagnosis

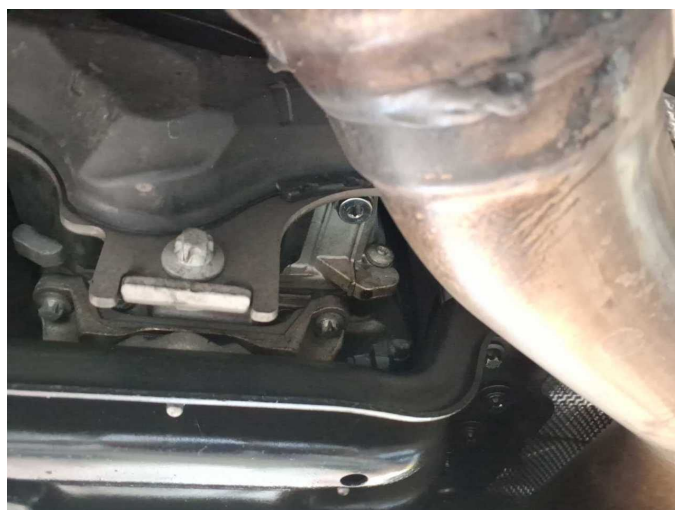
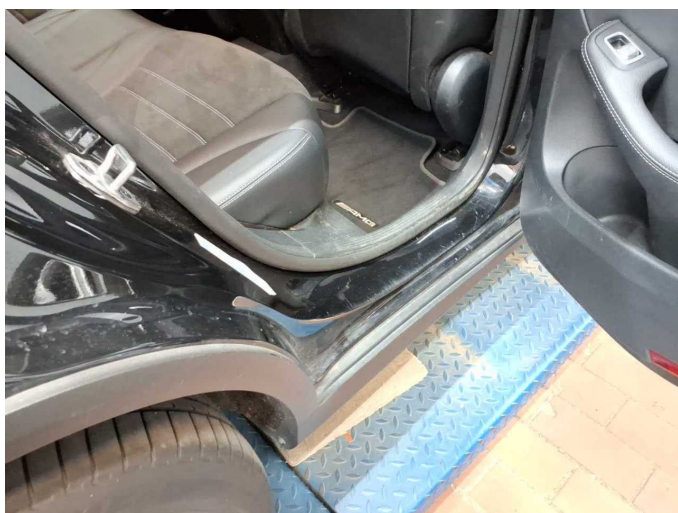
| No. | Component group | Description |
|---|---|---|
| 2 | Sill - right side | Sill - Scratched - Smart repair |

**Damage 1:** Body: Underbody (Verölt) - Leaking - Perform diagnosis

**Damage 2:** Sill - right side: Sill - Scratched - Smart repair

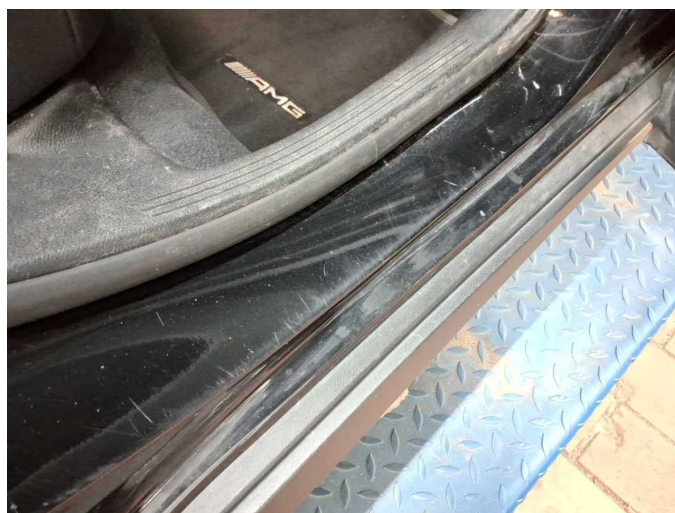
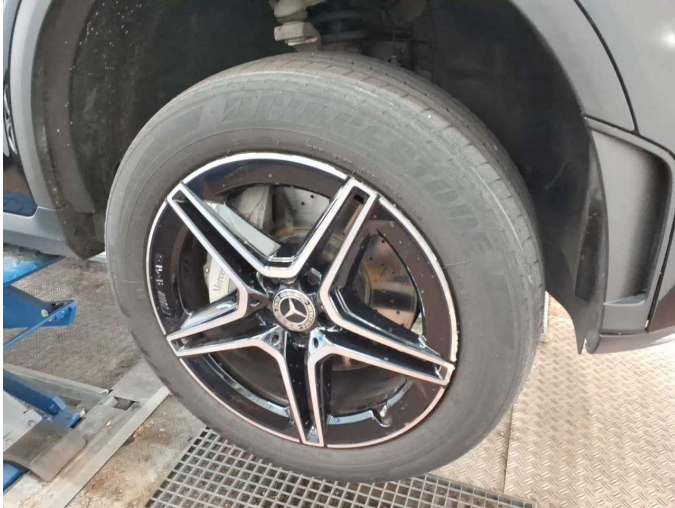
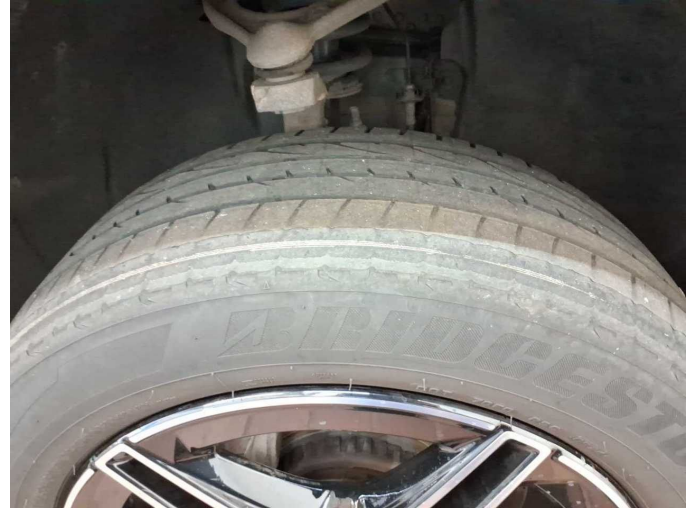
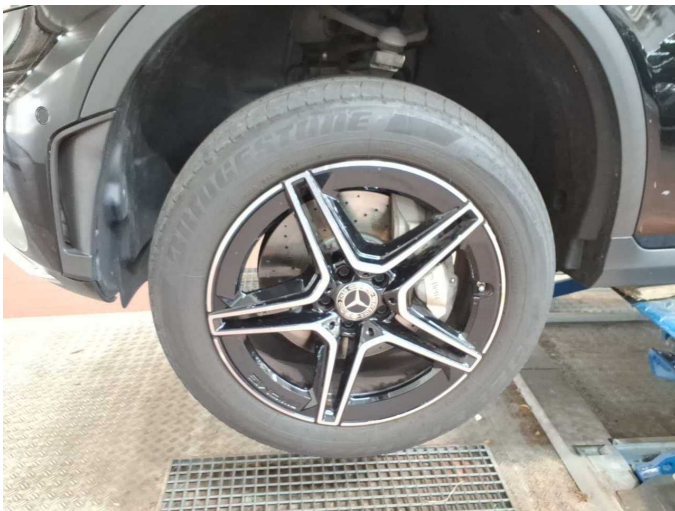
| No. | Component group | Description |
|---|---|---|
| 3 | Front axle | Axles / undercarriage (wegen der einseitig abgefahrenen Reifen) - Specify findings - Measure |
| 4 | Wheel / tyres | Tyre - front (einseitig abgefahren) - Worn - Replace |

**Damage 2:** Sill - right side: Sill - Scratched - Smart repair

**Damage 4:** Wheel / tyres: Tyre - front (einseitig abgefahren) - Worn - Replace

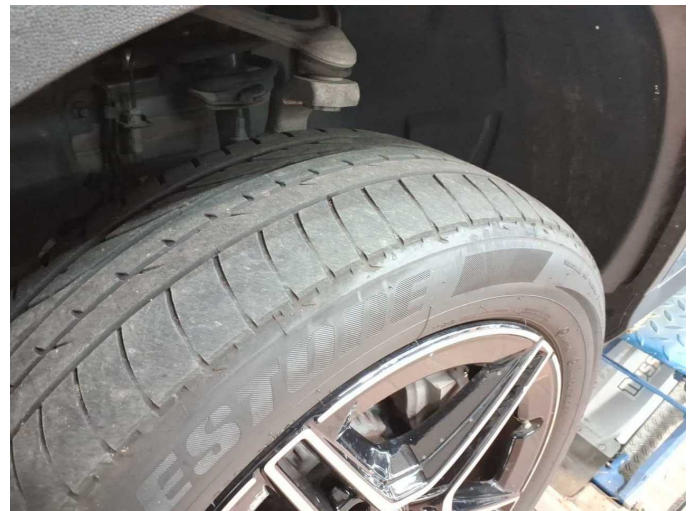
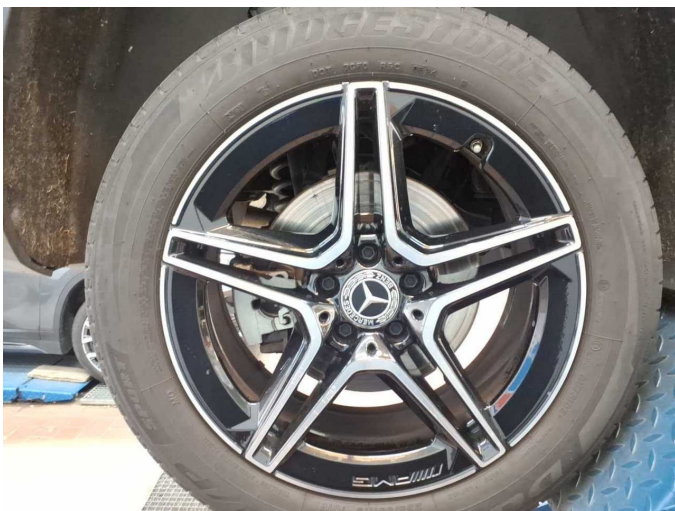
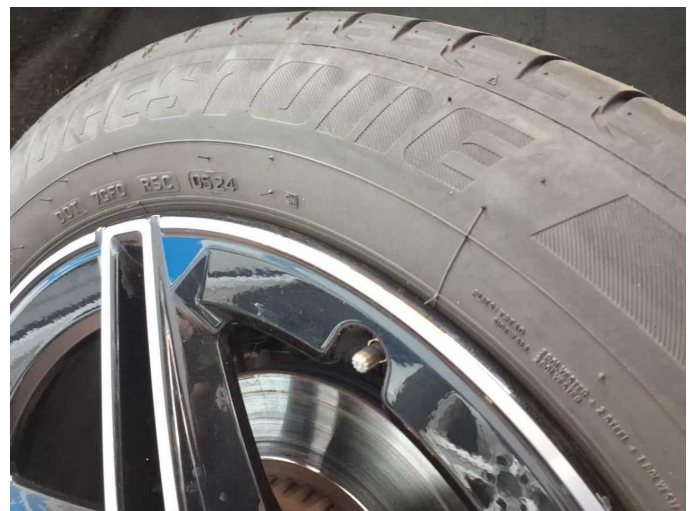
| No. | Component group | Description |
|---|---|---|
| 5 | Wheel / tyres | Alloy rim - rear right side - Scratch(es) - Loss in value |

**Damage 4:** Wheel / tyres: Tyre - front (einseitig abgefahren) - Worn - Replace

**Damage 5:** Wheel / tyres: Alloy rim - rear right side - Scratch(es) - Loss in value

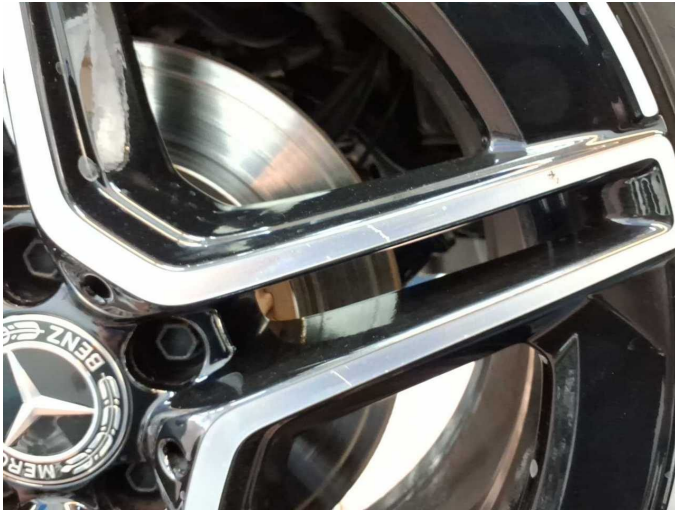
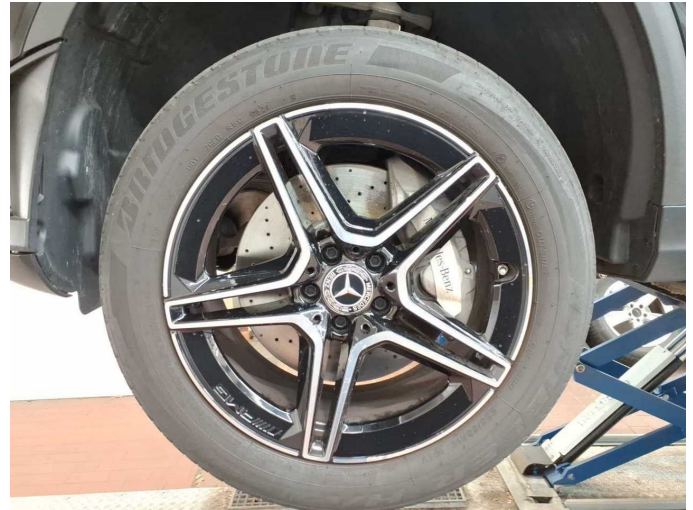
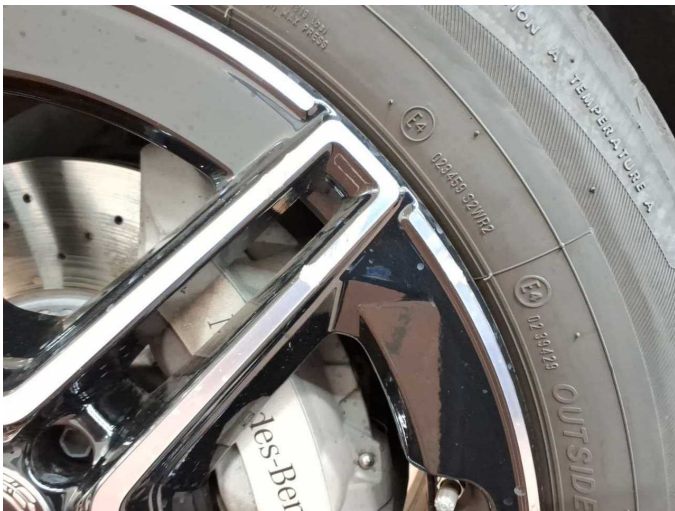
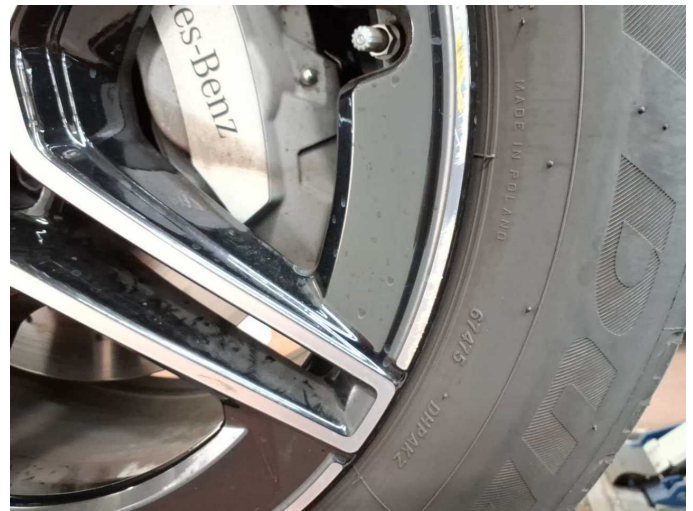
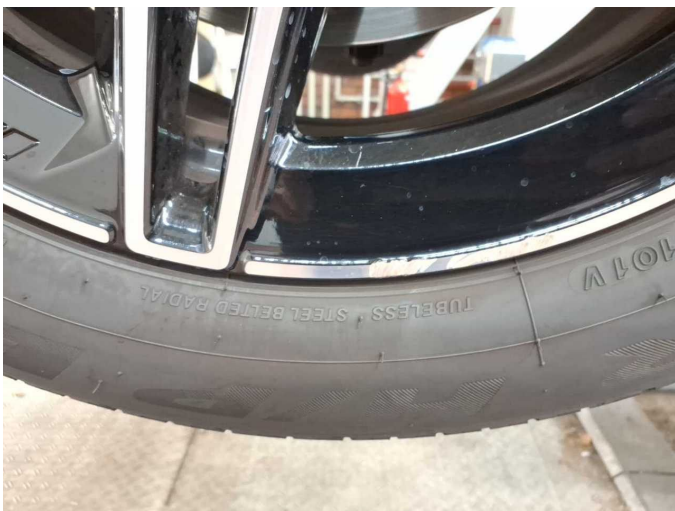
| No. | Component group | Description |
|---|---|---|
| 6 | Wheel / tyres | Alloy rim - front left side - Damaged - Loss in value |

**Damage 5:** Wheel / tyres: Alloy rim - rear right side - Scratch(es) - Loss in value

**Damage 6:** Wheel / tyres: Alloy rim - front left side - Damaged - Loss in value

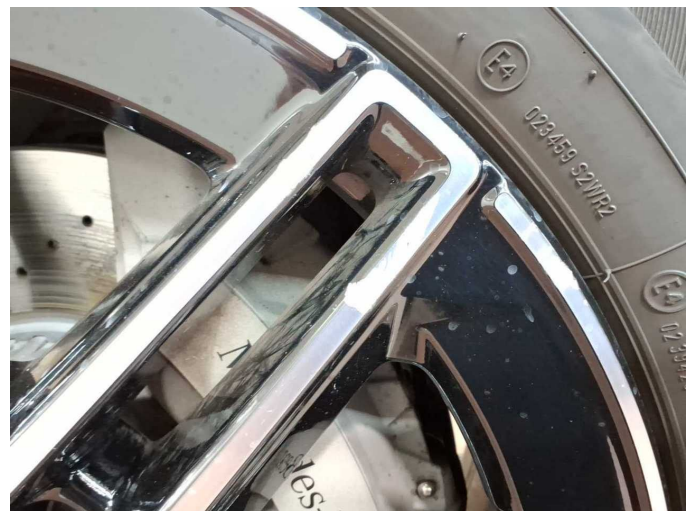
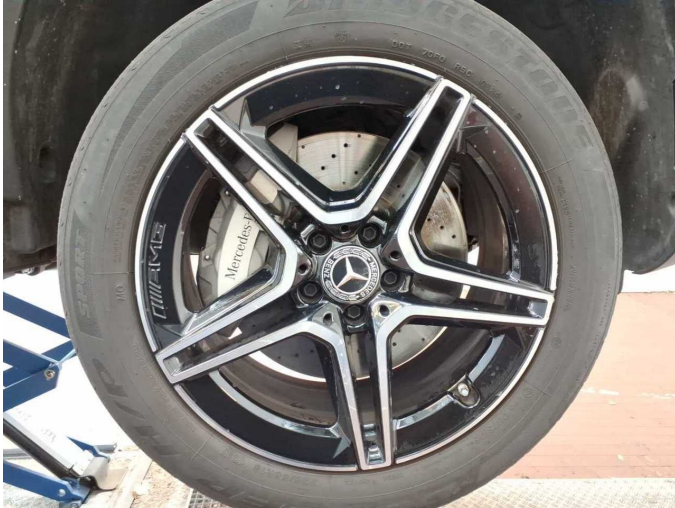
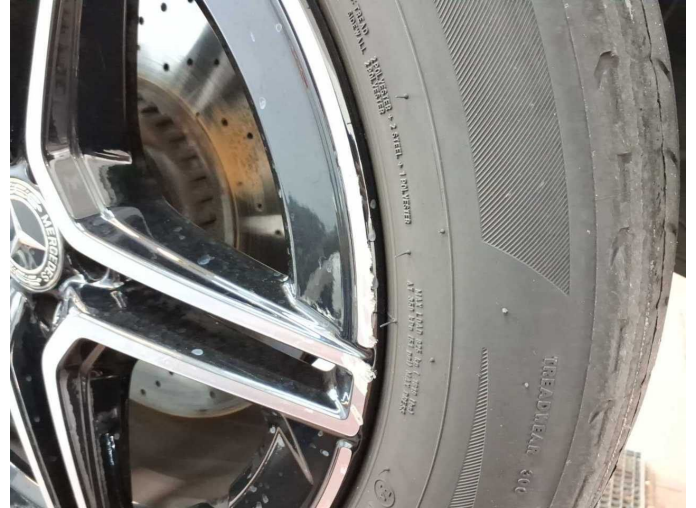
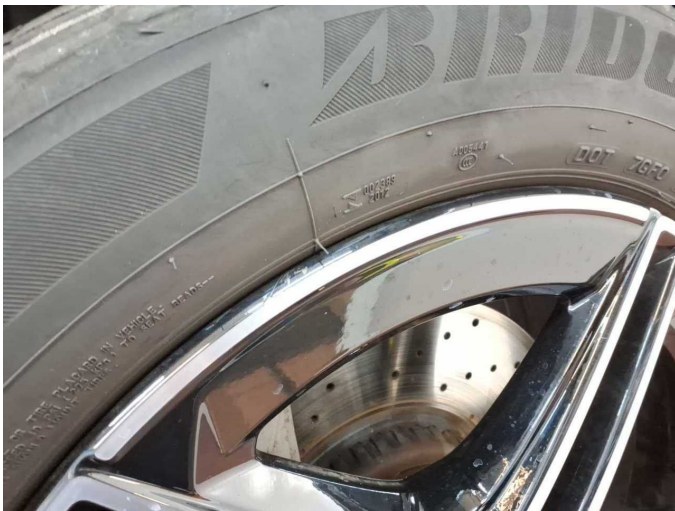
| No. | Component group | Description |
|---|---|---|
| 7 | Wheel / tyres | Alloy rim - front right side - Damaged - Loss in value |

**Damage 6:** Wheel / tyres: Alloy rim - front left side - Damaged - Loss in value

**Damage 7:** Wheel / tyres: Alloy rim - front right side - Damaged - Loss in value

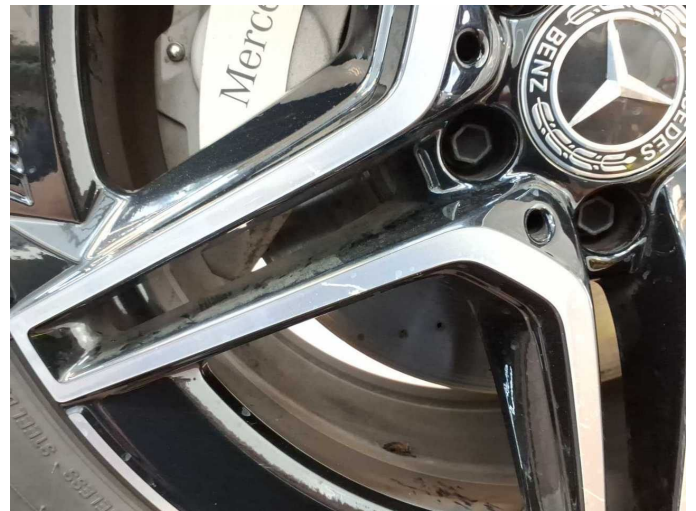
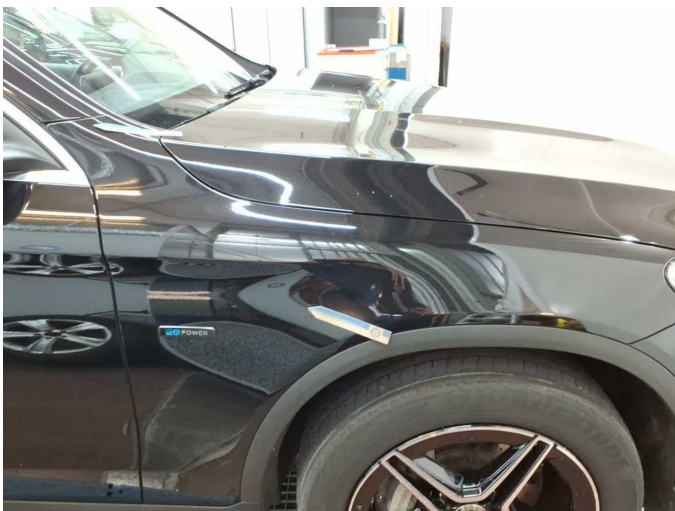
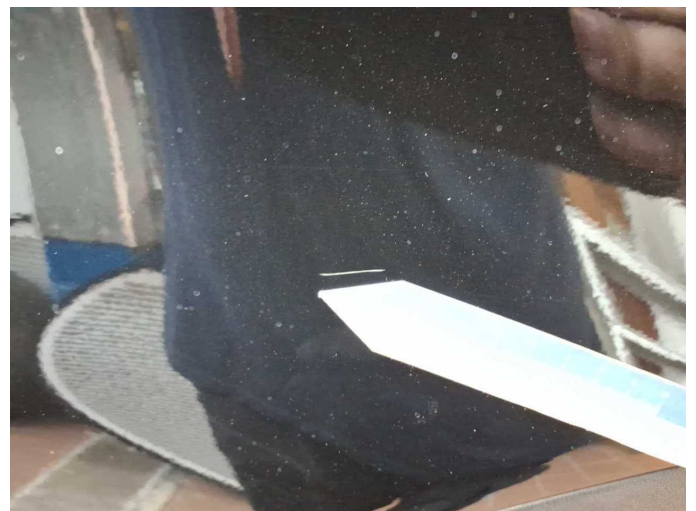
| No. | Component group | Description |
|---|---|---|
| 8 | Mudguard - right side | Mudguard - right side - Scratch(es) - Paint |

**Damage 7:** Wheel / tyres: Alloy rim - front right side - Damaged - Loss in value

**Damage 8:** Mudguard - right side: Mudguard - right side - Scratch(es) - Paint

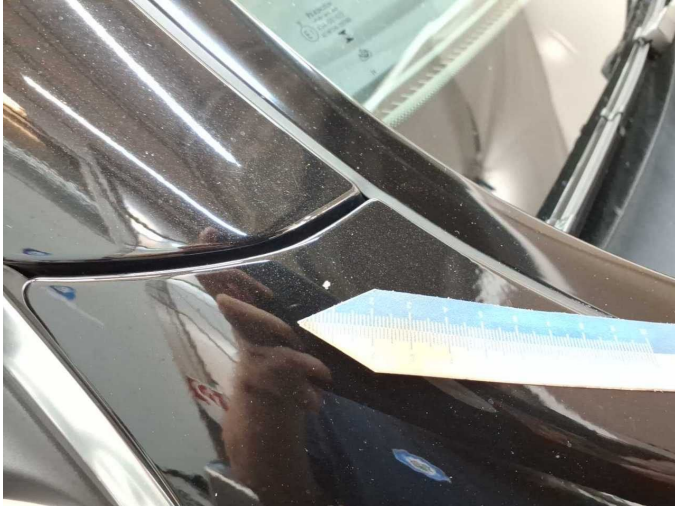
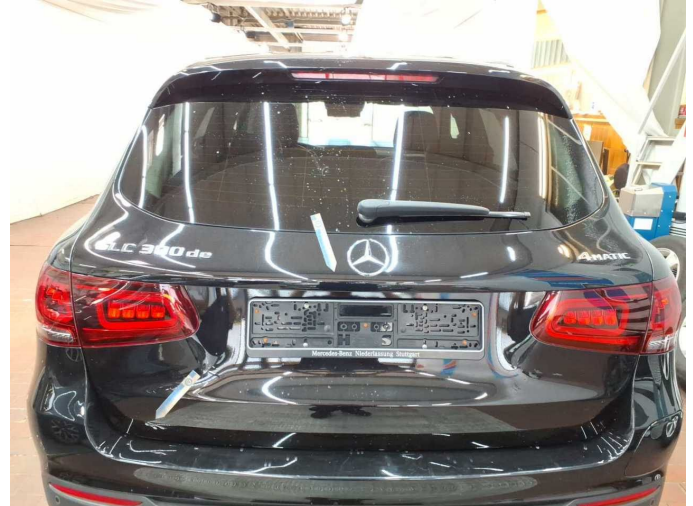
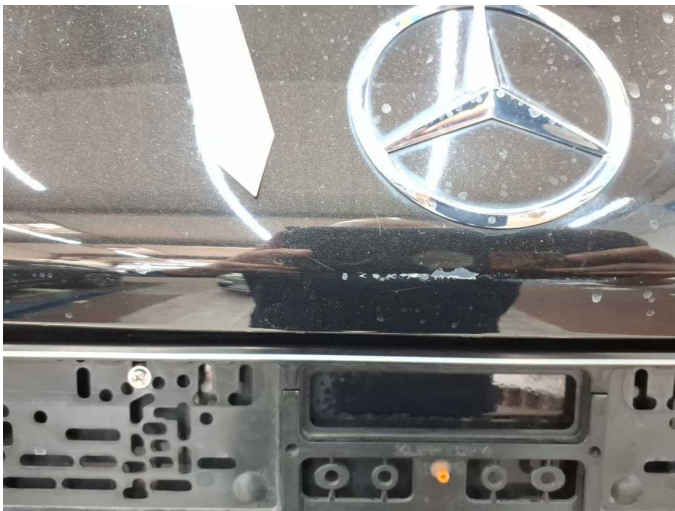
| No. | Component group | Description |
|---|---|---|
| 9 | Boot lid / rear door | Boot lid - Scratch(es) - Paint |

**Damage 8:** Mudguard - right side: Mudguard - right side - Scratch(es) - Paint

**Damage 9:** Boot lid / rear door: Boot lid - Scratch(es) - Paint

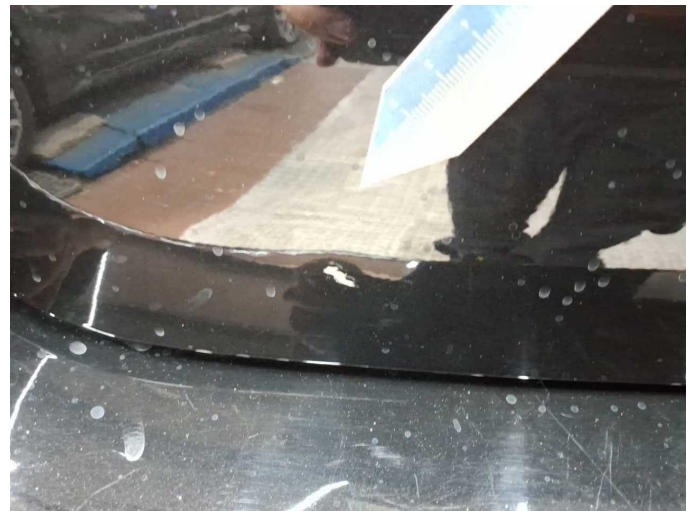
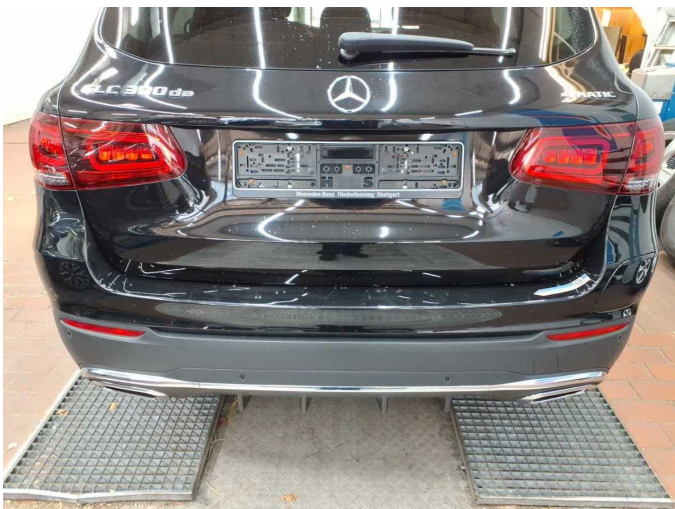
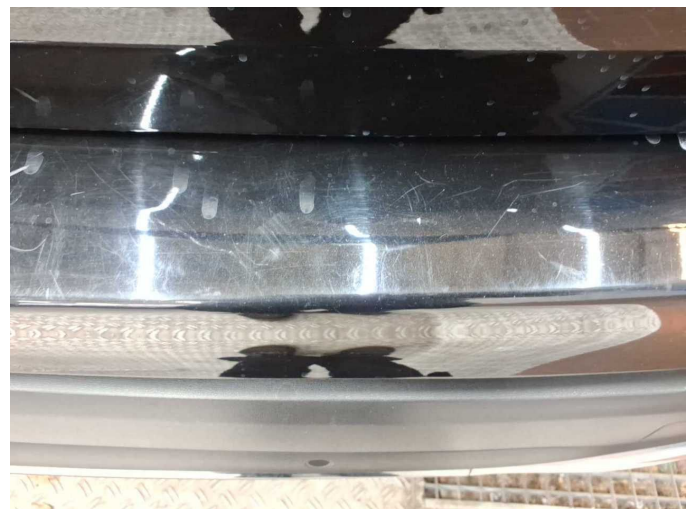
| No. | Component group | Description |
|---|---|---|
| 10 | Rear bumper | Rear bumper - Scratched - Paint |

**Damage 9:** Boot lid / rear door: Boot lid - Scratch(es) - Paint

**Damage 10:** Rear bumper: Rear bumper - Scratched - Paint

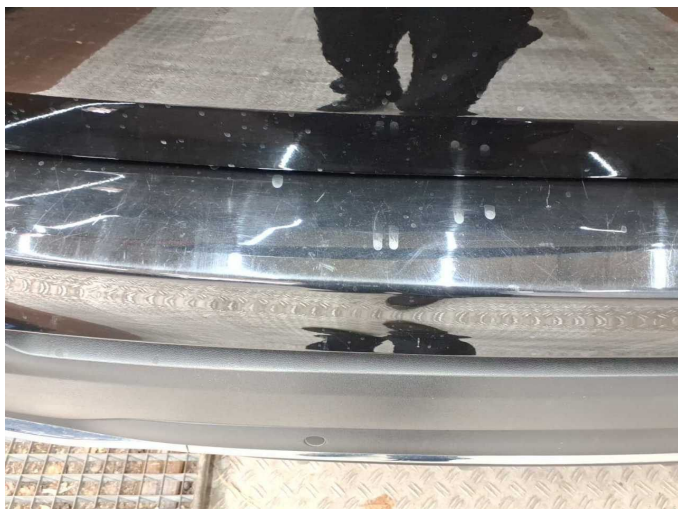
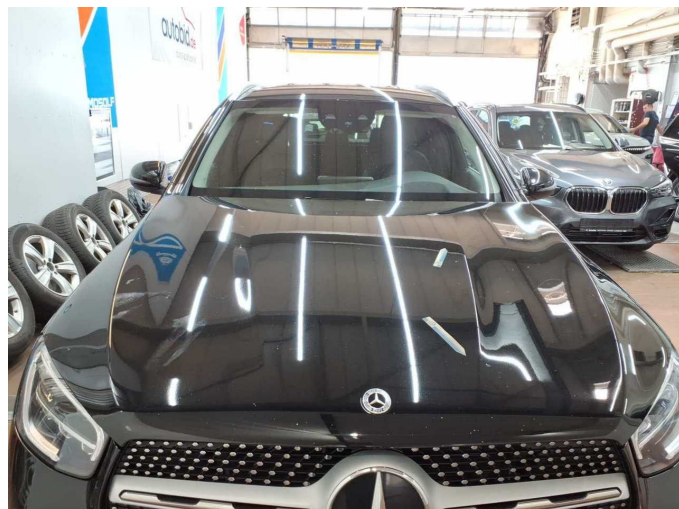
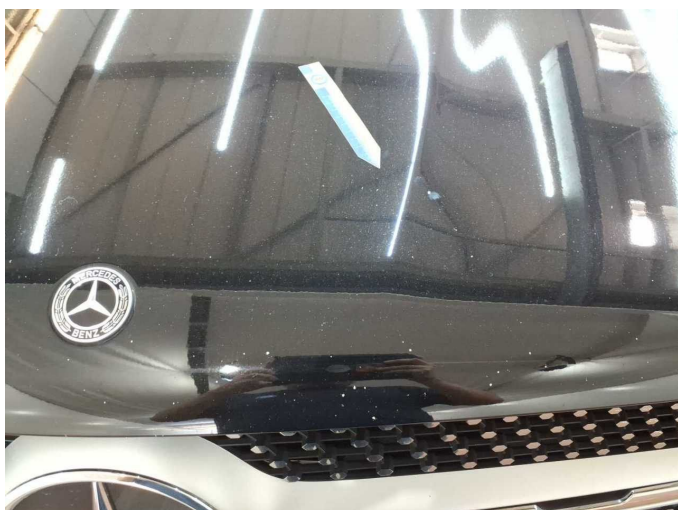
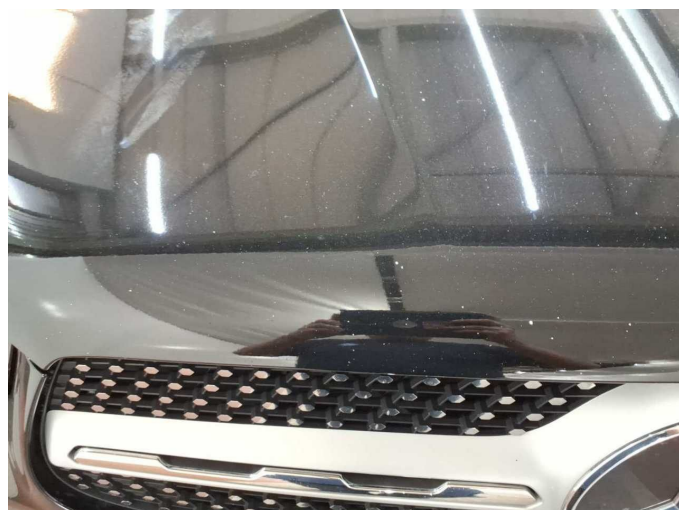
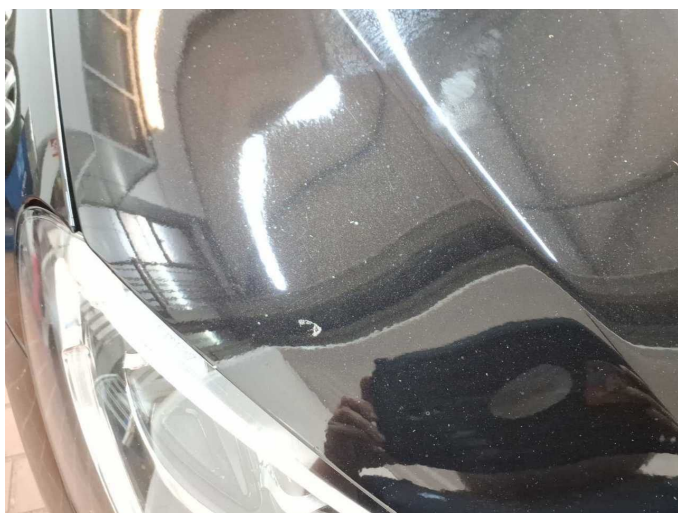
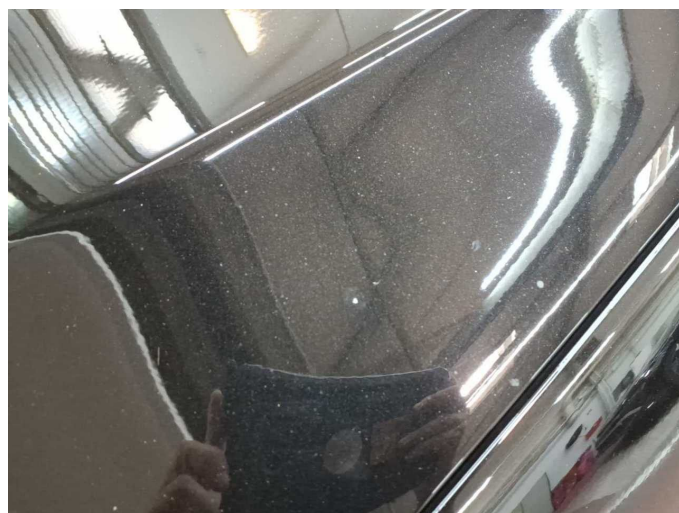
| No. | Component group | Description |
|---|---|---|
| 11 | Bonnet | Bonnet - Dent / paintcoat damage - Repair and paint |

**Damage 10:** Rear bumper: Rear bumper - Scratched - Paint

**Damage 11:** Bonnet: Bonnet - Dent / paintcoat damage - Repair and paint

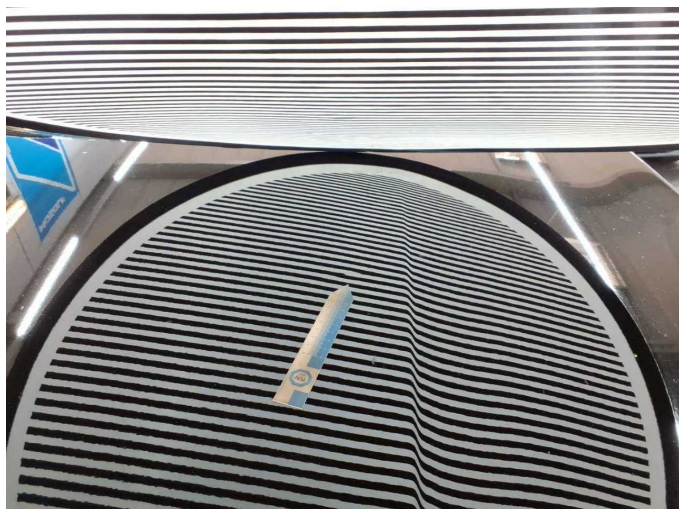
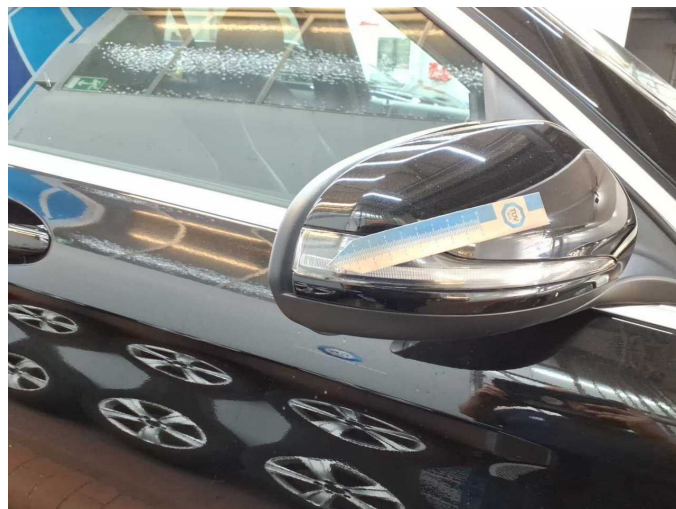
| No. | Component group | Description |
|---|---|---|
| 1 | Indicator - front | Mirror - right side - Scratched - No deduction |

**Damage 11:** Bonnet: Bonnet - Dent / paintcoat damage - Repair and paint

**Wear and tear 1:** Indicator - front: Mirror - right side - Scratched - No deduction

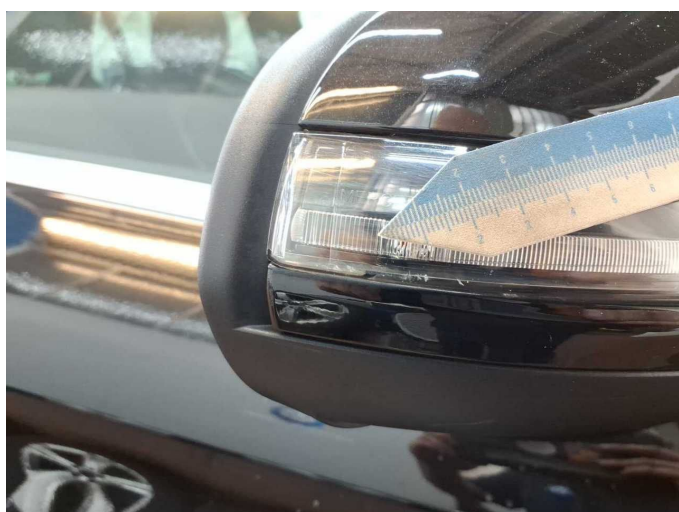
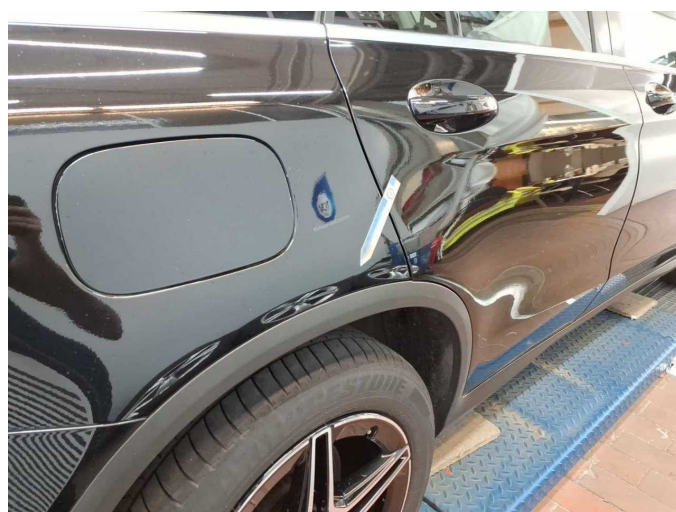
| No. | Component group | Description |
|---|---|---|
| 2 | Side panel - rear right side | Side panel - dent(s) - Smooth repair work |

**Wear and tear 1:** Indicator - front: Mirror - right side - Scratched - No deduction

**Wear and tear 2:** Side panel - rear right side: Side panel - dent(s) - Smooth repair work

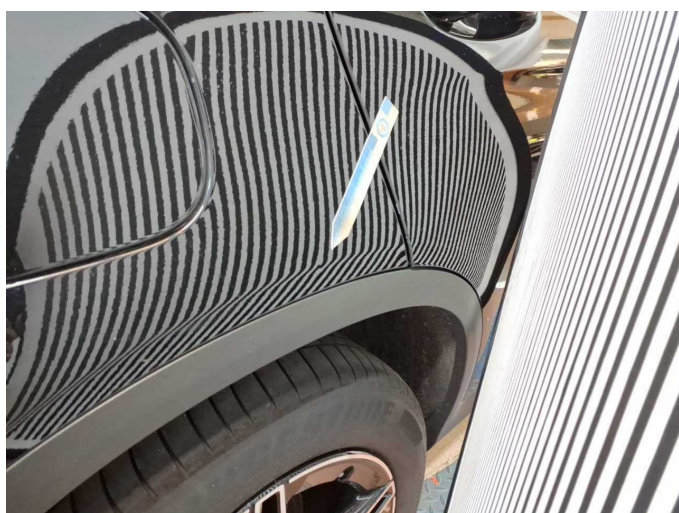
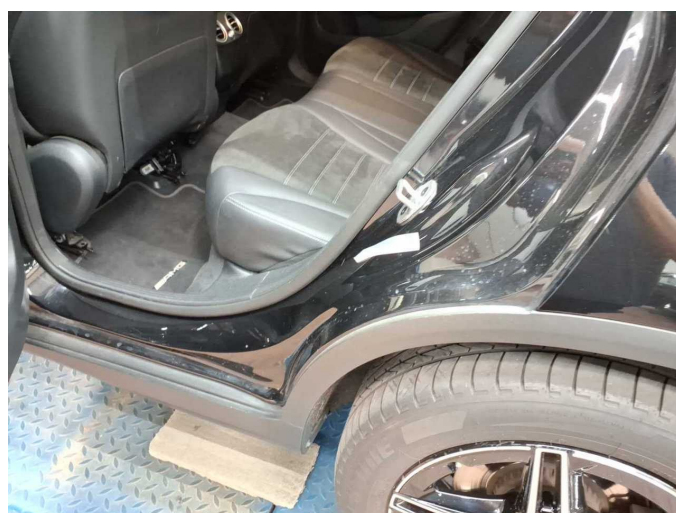
| No. | Component group | Description |
|---|---|---|
| 3 | Side panel - rear left side | Sill - Scratched - Smart repair |

**Wear and tear 2:** Side panel - rear right side: Side panel - dent(s) - Smooth repair work

**Wear and tear 3:** Side panel - rear left side: Sill - Scratched - Smart repair

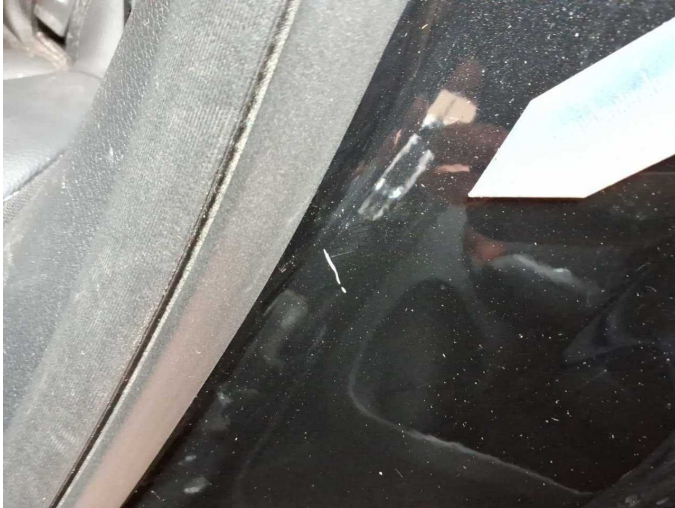
**Wear and tear 3:** Side panel - rear left side: Sill - Scratched - Smart repair

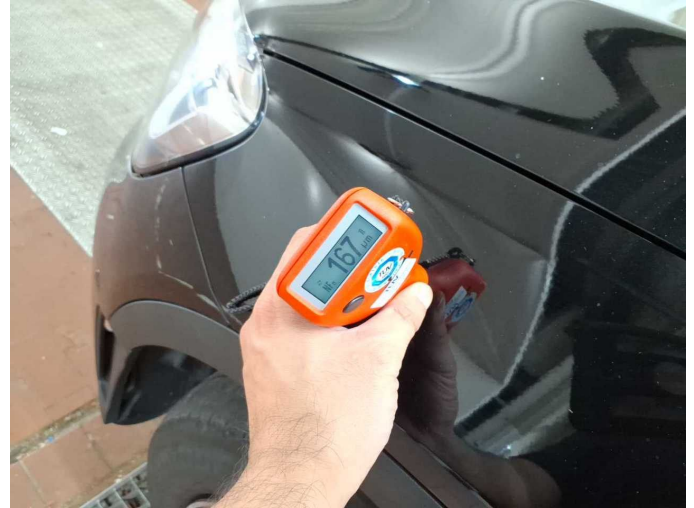
**Mudguard - left side:** 167 µm

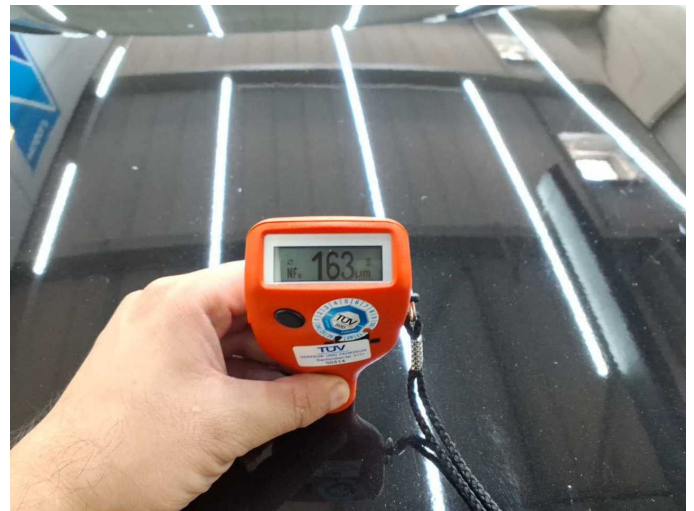
**Mudguard - right side:** 175 µm

**Bonnet:** 163 µm
