Expertise

Protocol number: 46417311  
Order No. / Reference: 26605346  
Inspection date: 9 Jul 2026

Manufacturer: Opel

Model: Grandland 1.5 D Automatik Business Elegance

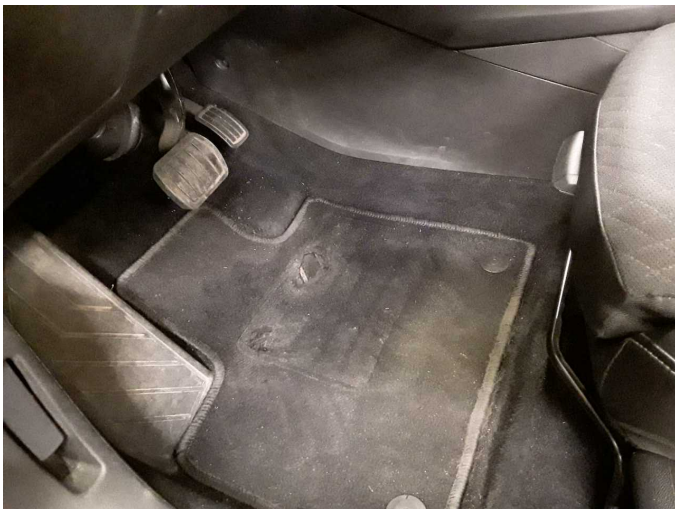
| No. | Component group | Description |
|---|---|---|
| 1 | Trim / covers | Floor mats - Damaged - Replace |

**Damage 1:** Trim / covers: Floor mats - Damaged - Replace

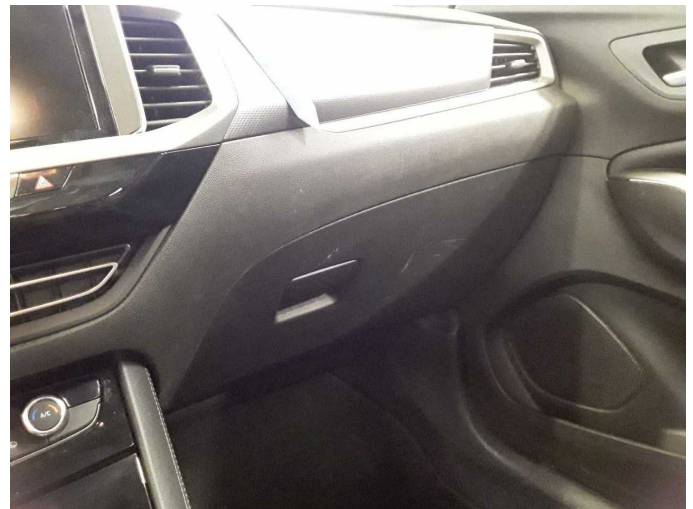
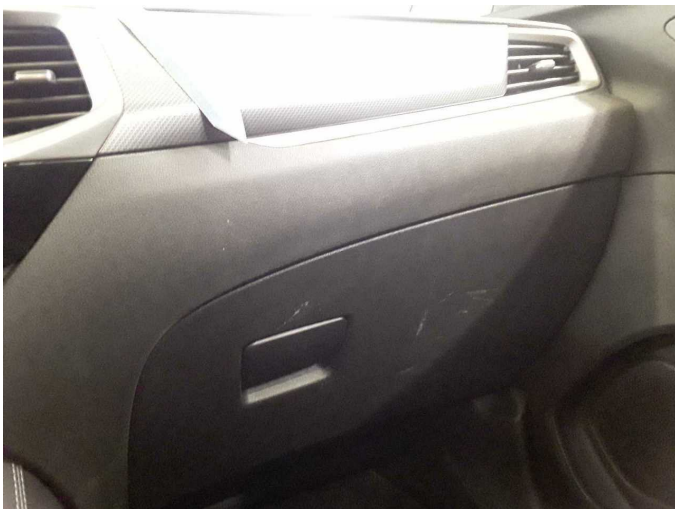
| No. | Component group | Description |
|---|---|---|
| 2 | Instrument panel | Centre console - front - Scratch(es) - Loss in value |

**Damage 2:** Instrument panel: Centre console - front - Scratch(es) - Loss in value

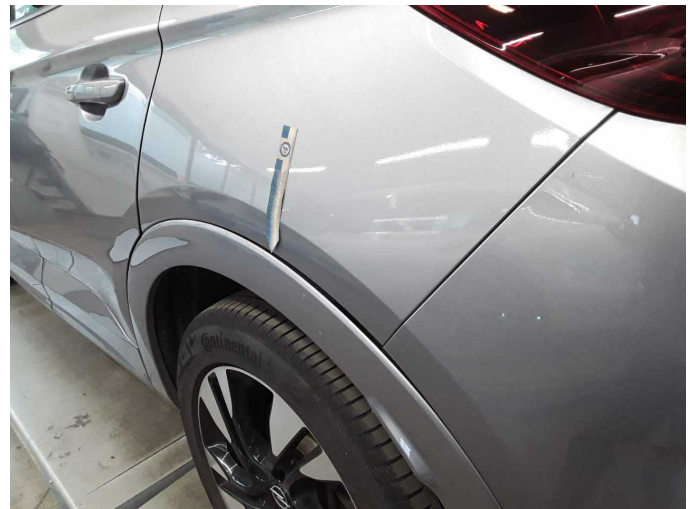
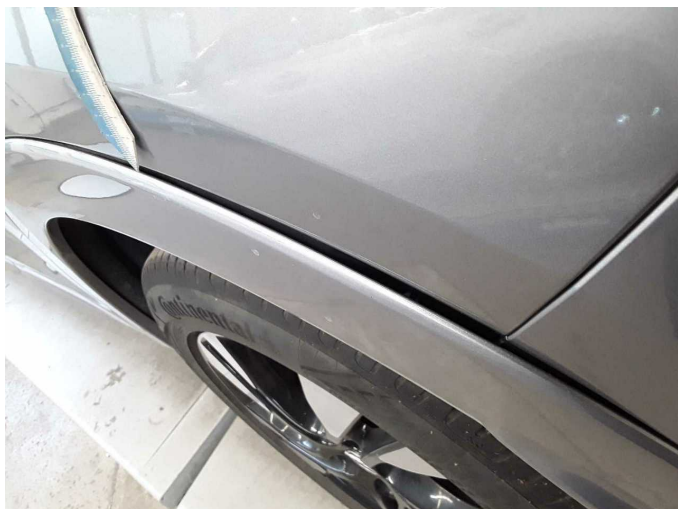
| No. | Component group | Description |
|---|---|---|
| 3 | Side panel - rear left side | Wheel arch - Malposition - Un- / install |

**Damage 3:** Side panel - rear left side: Wheel arch - Malposition - Un- / install

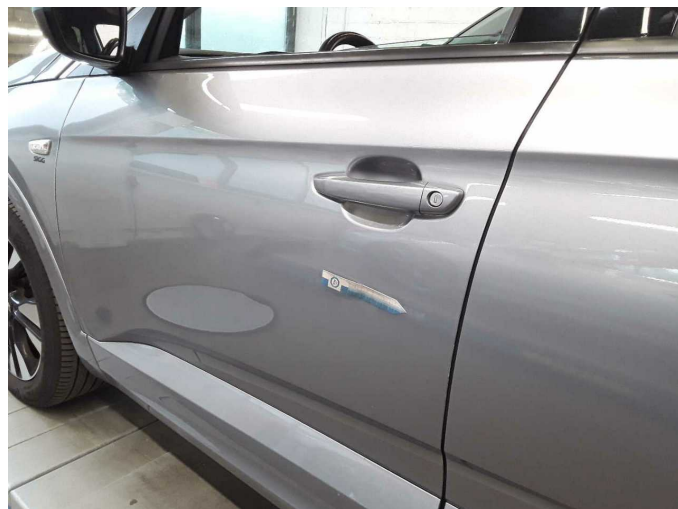
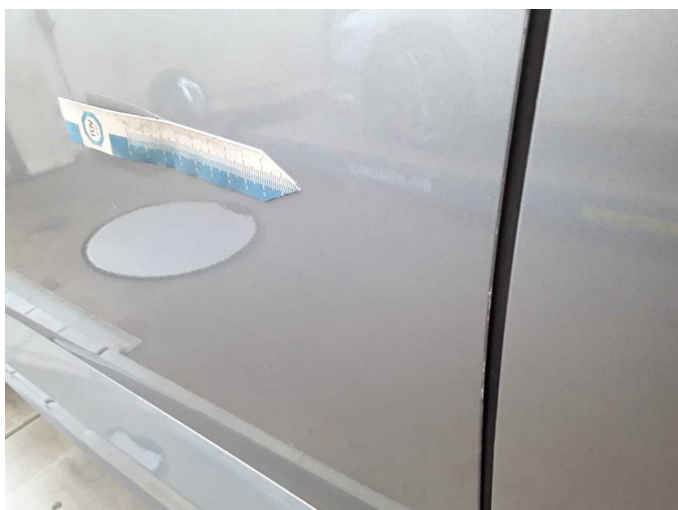
| No. | Component group | Description |
|---|---|---|
| 4 | Door - front left side | Door - Scratch(es) - Smart repair |

**Damage 4:** Door - front left side: Door - Scratch(es) - Smart repair

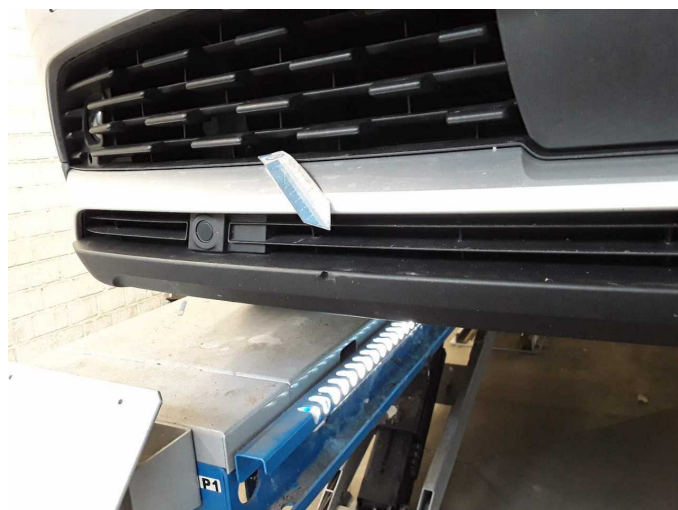
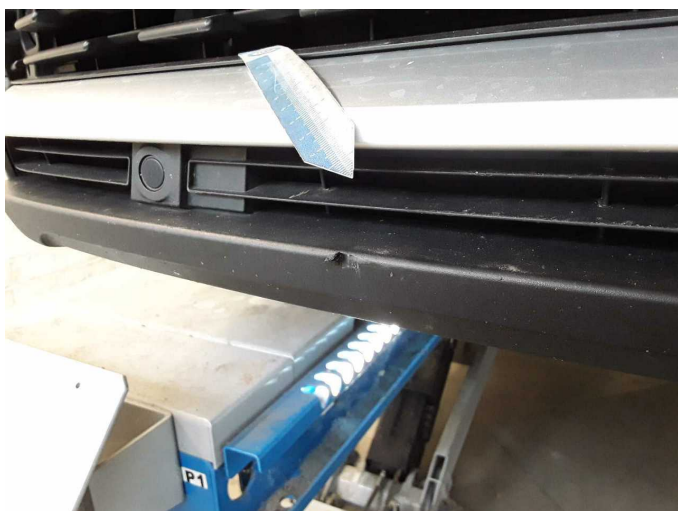
| No. | Component group | Description |
|---|---|---|
| 5 | Front bumper | Spoiler - Scratched - Loss in value |

**Damage 5:** Front bumper: Spoiler - Scratched - Loss in value

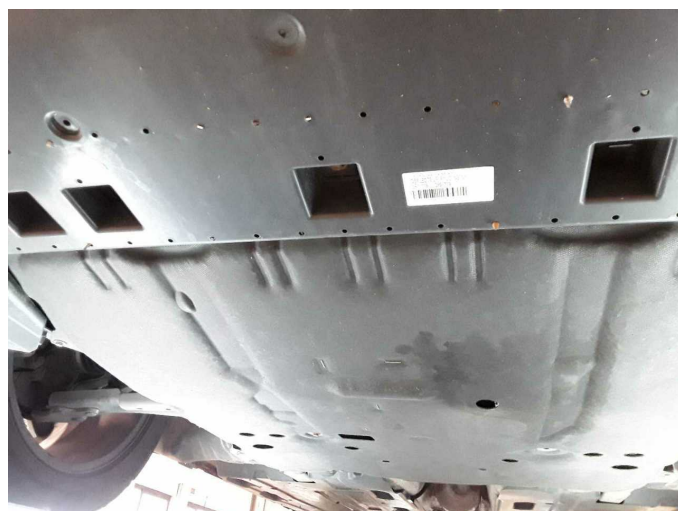
| No. | Component group | Description |
|---|---|---|
| 6 | Engine | Engine - Leaking - Diagnosed and repair if necessary |

**Damage 6:** Engine: Engine - Leaking - Diagnosed and repair if necessary

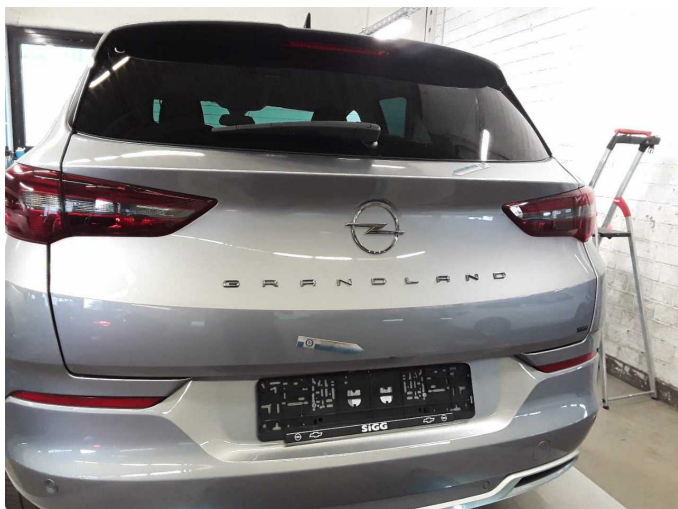
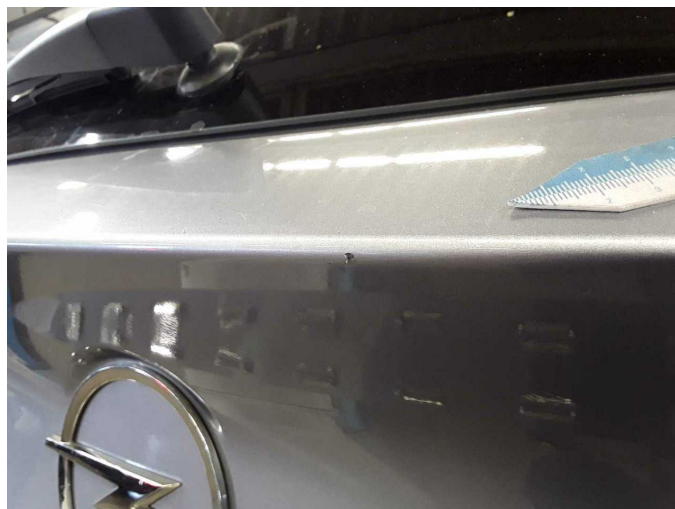
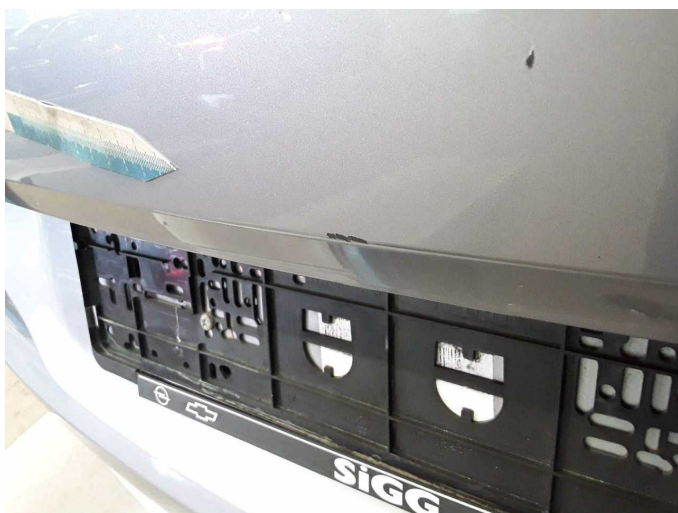
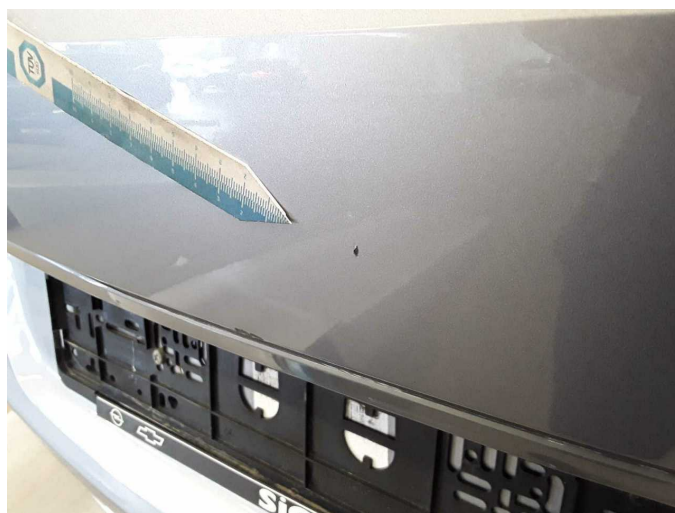
| No. | Component group | Description |
|---|---|---|
| 7 | Boot lid / rear door | Boot lid - Scratch(es) - Paint |

**Damage 7:** Boot lid / rear door: Boot lid - Scratch(es) - Paint
