Expertise

Protocol number: 46605278  
Order No. / Reference: 26692239  
Inspection date: 14 Jul 2026

Manufacturer: Volkswagen

Model: Touran 2.0 TDI SCR DSG Comfortline

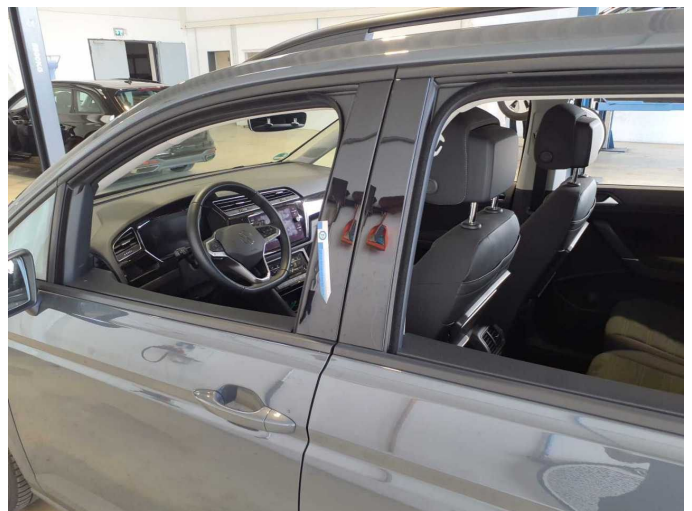
| No. | Component group | Description |
|---|---|---|
| 1 | Door - front left side | Door (Blende oben) - Scratch(es) - Loss in value |

Damage 1: Door - front left side: Door (Blende oben) - Scratch(es) - Loss in value

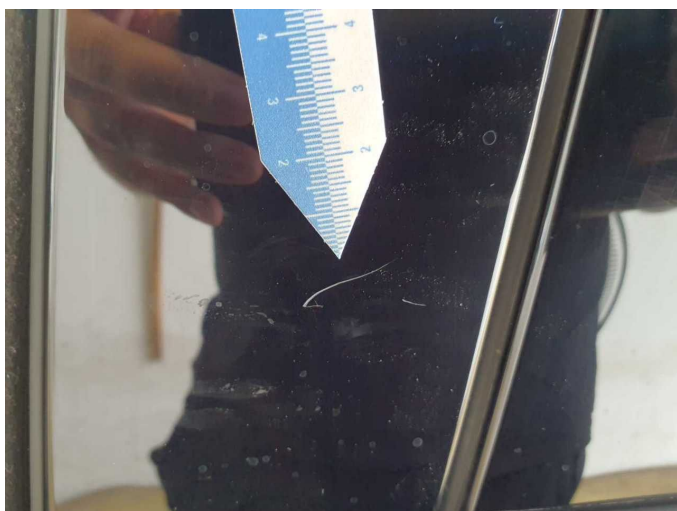
Damage 1: Door - front left side: Door (Blende oben) - Scratch(es) - Loss in value

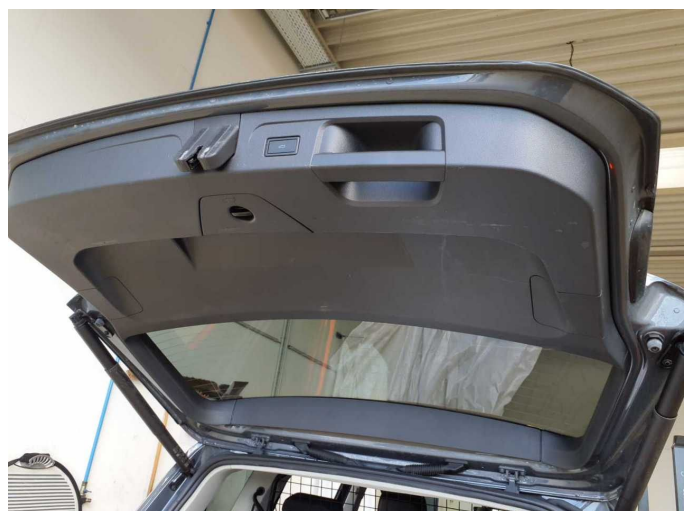
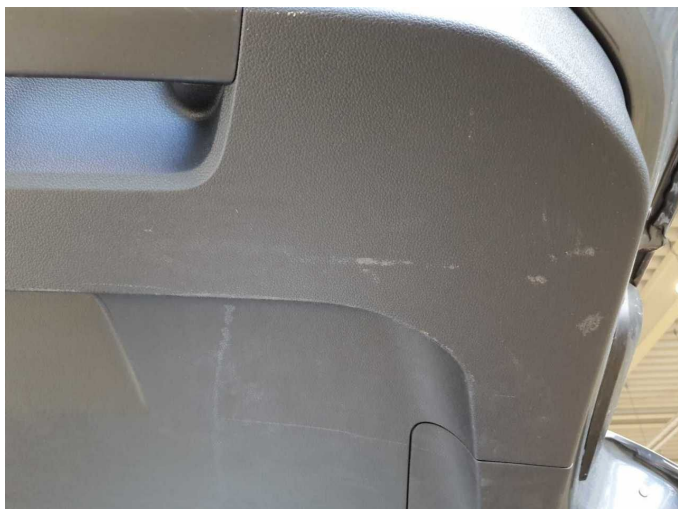
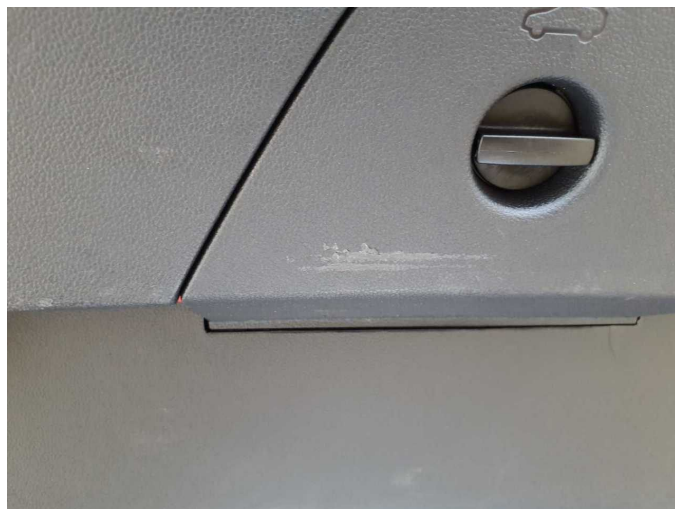
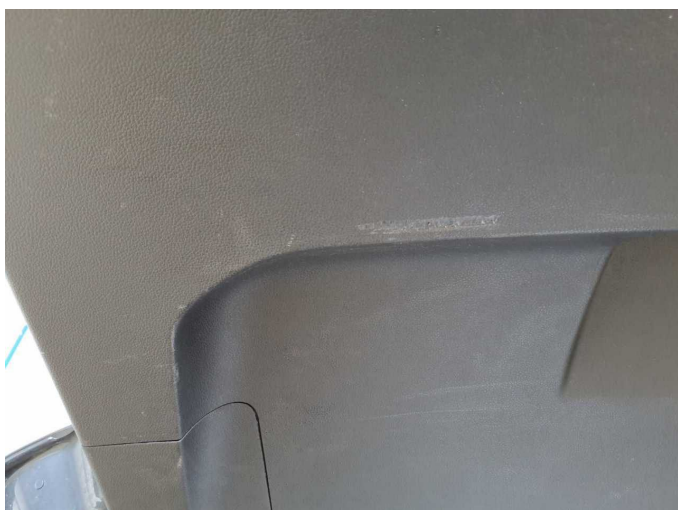
| No. | Component group | Description |
|---|---|---|
| 2 | Trim / covers | Boot lid - interior trim - Scratch(es) - Loss in value |

Damage 2: Trim / covers: Boot lid - interior trim - Scratch(es) - Loss in value

**Damage 2:** Trim / covers: Boot lid - interior trim - Scratch(es) - Loss in value

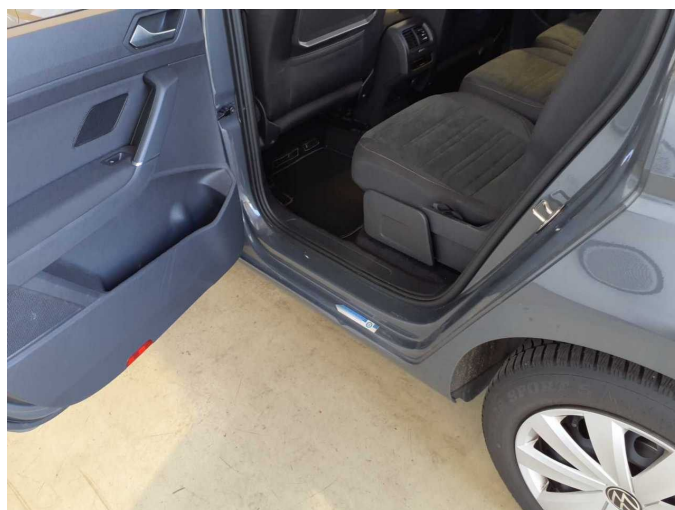
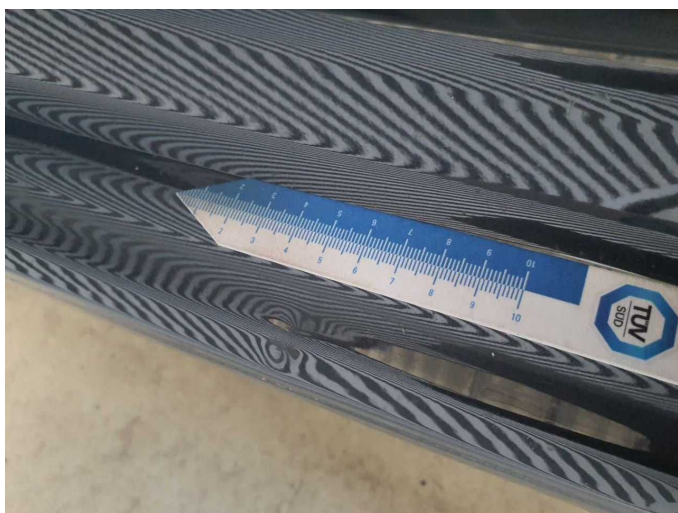
| No. | Component group | Description |
|---|---|---|
| 3 | Sill - left side | Sill - dent(s) - Smart repair |

**Damage 3:** Sill - left side: Sill - dent(s) - Smart repair

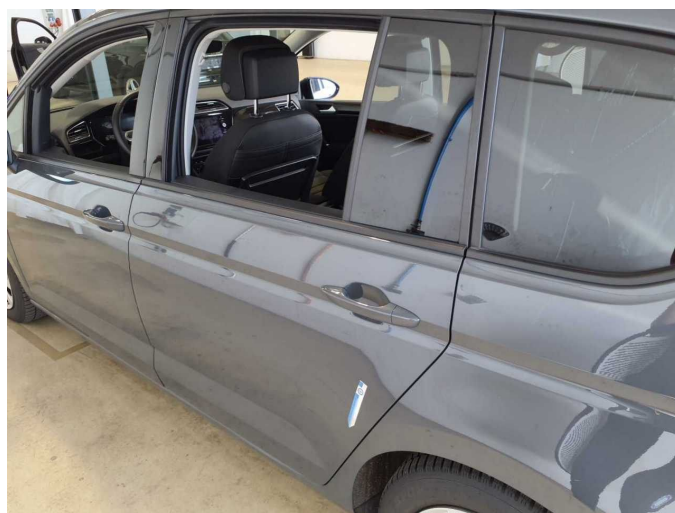
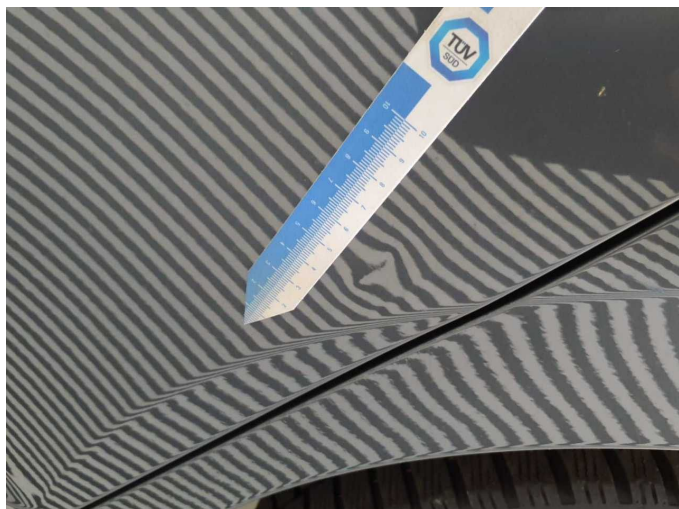
| No. | Component group | Description |
|---|---|---|
| 4 | Door - rear left side | Door - dent(s) - Smart repair |

**Damage 4:** Door - rear left side: Door - dent(s) - Smart repair

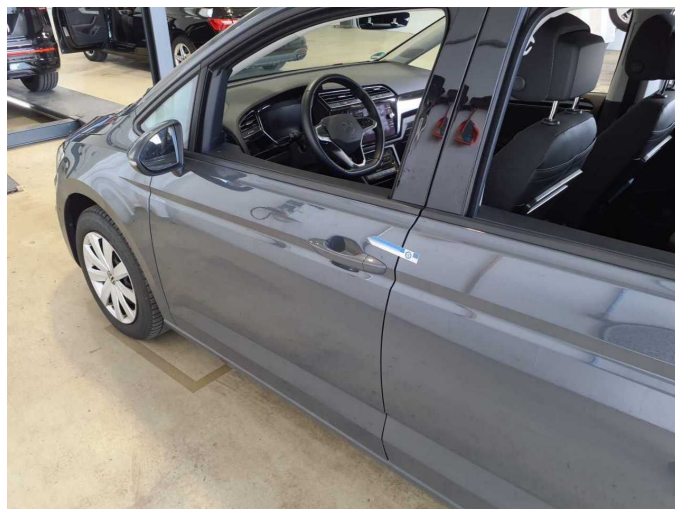
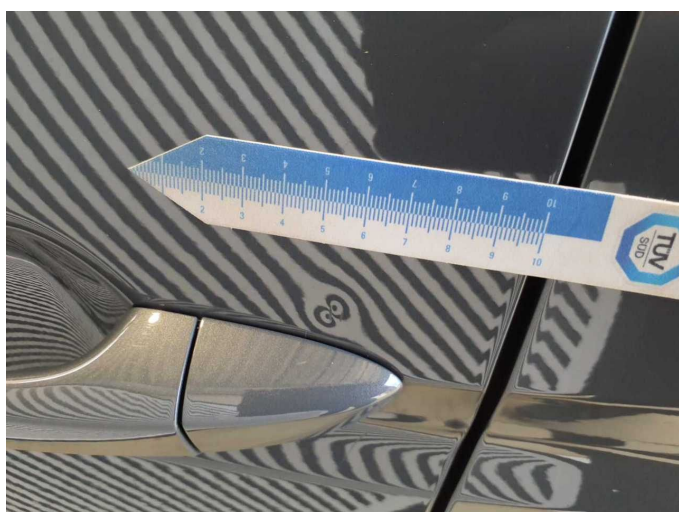
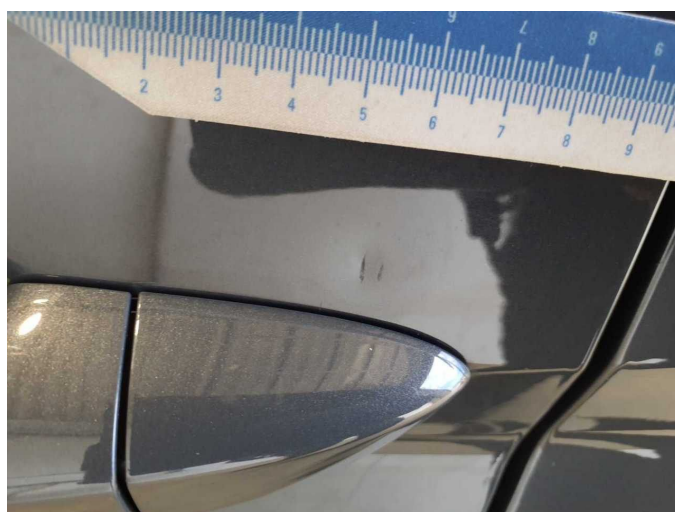
| No. | Component group | Description |
|---|---|---|
| 5 | Door - front left side | Door - Dent / paintcoat damage - Smart repair |

**Damage 5:** Door - front left side: Door - Dent / paintcoat damage - Smart repair

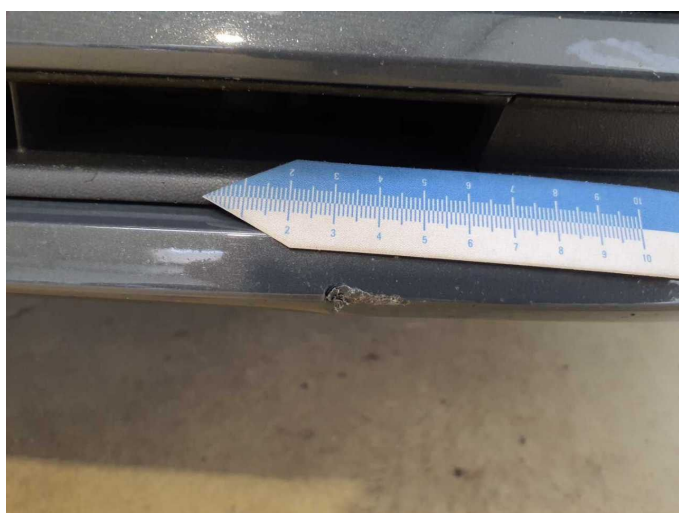
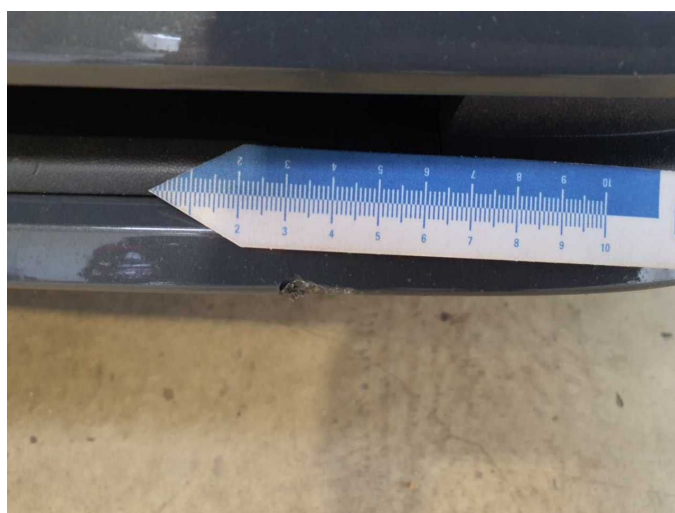
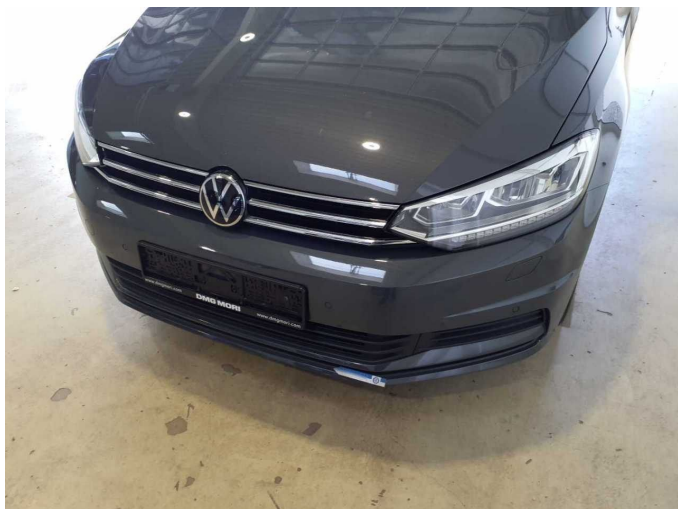
| No. | Component group | Description |
|---|---|---|
| 6 | Front bumper | Front bumper - Dent / paintcoat damage - Smart repair |

**Damage 6:** Front bumper: Front bumper - Dent / paintcoat damage - Smart repair

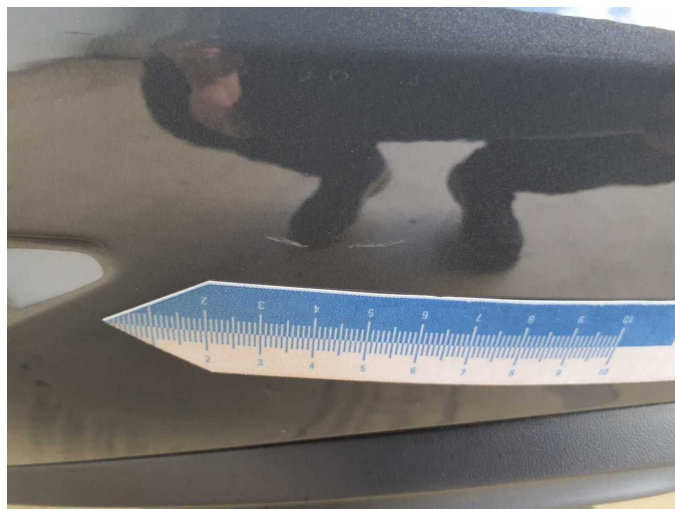
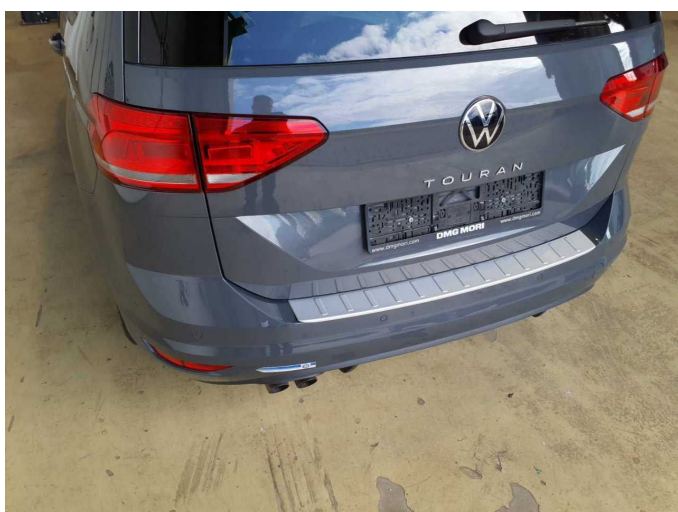
| No. | Component group | Description |
|---|---|---|
| 7 | Rear bumper | Rear bumper - Scratch(es) - Smart repair |

**Damage 7:** Rear bumper: Rear bumper - Scratch(es) - Smart repair

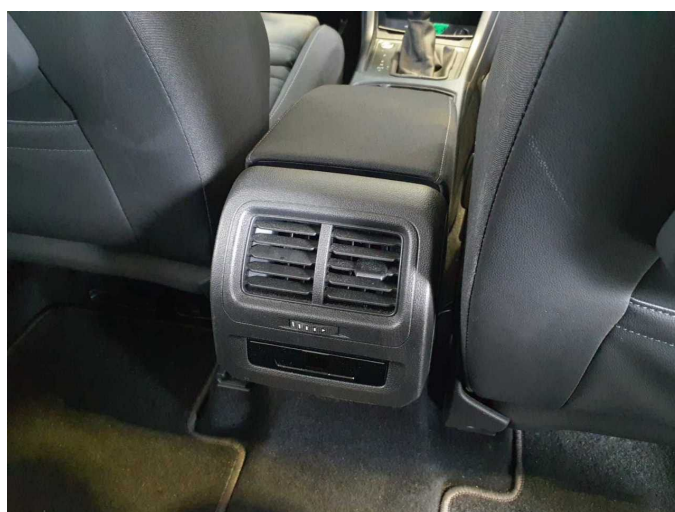
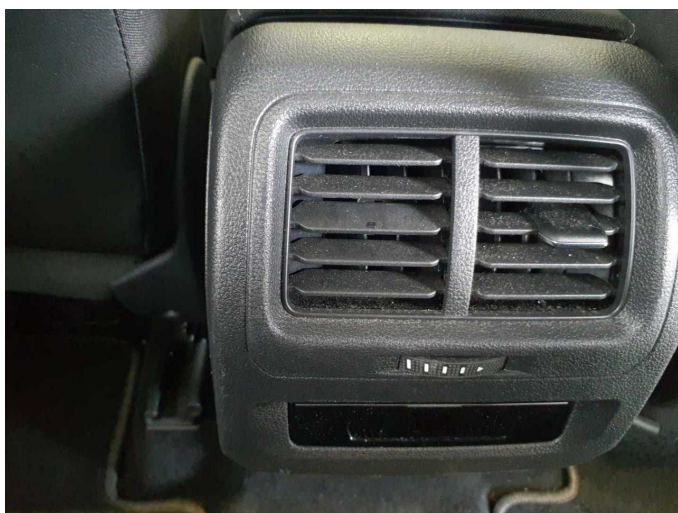
| No. | Component group | Description |
|---|---|---|
| 8 | Instrument panel | Air nozzle - centre (Hinten) - Broken / torn - Replace |

**Damage 8:** Instrument panel: Air nozzle - centre (Hinten) - Broken / torn - Replace

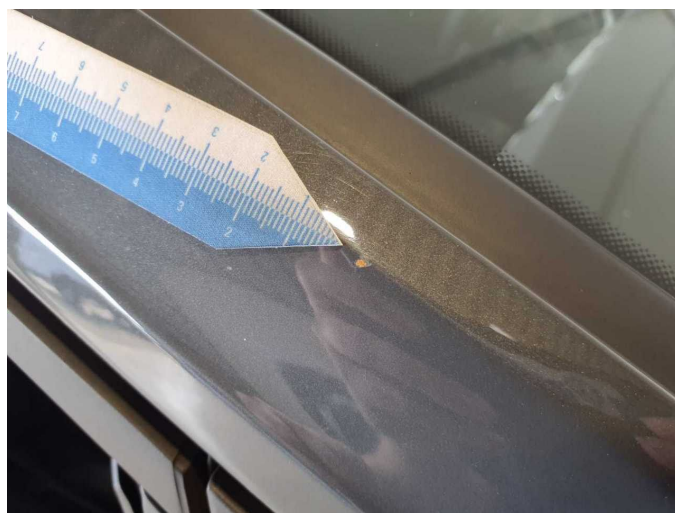
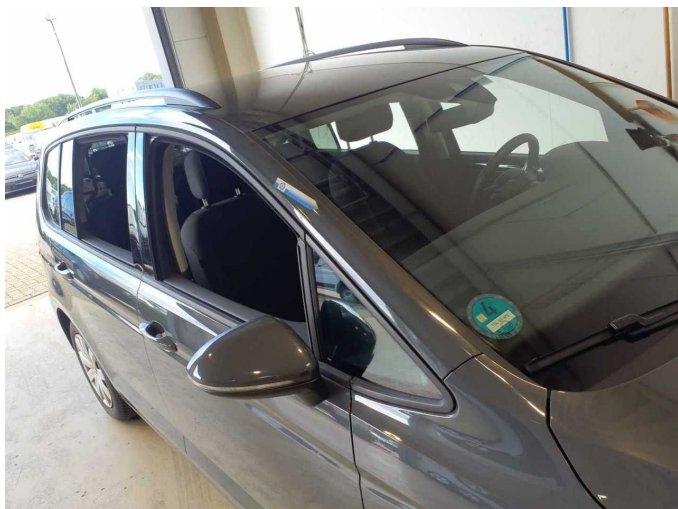
| No. | Component group | Description |
|---|---|---|
| 9 | Body | A-pillar - right side - Corrosion - Repair and paint |

**Damage 9:** Body: A-pillar - right side - Corrosion - Repair and paint

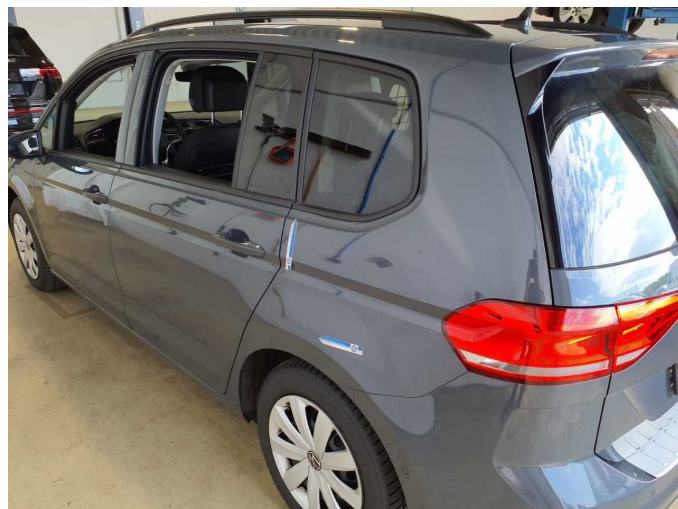
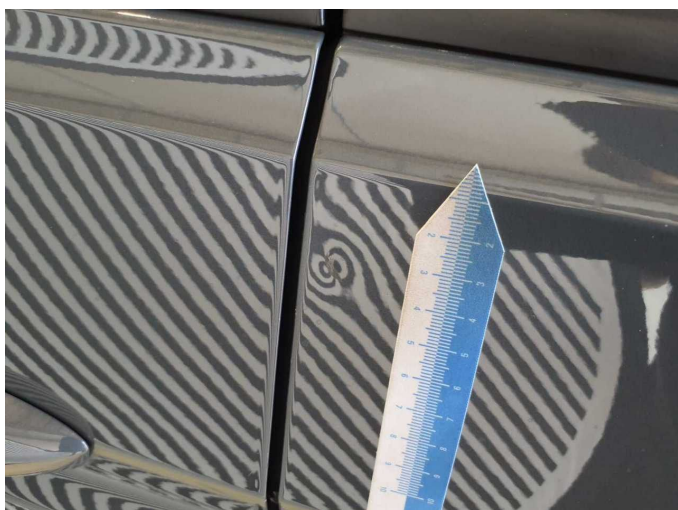
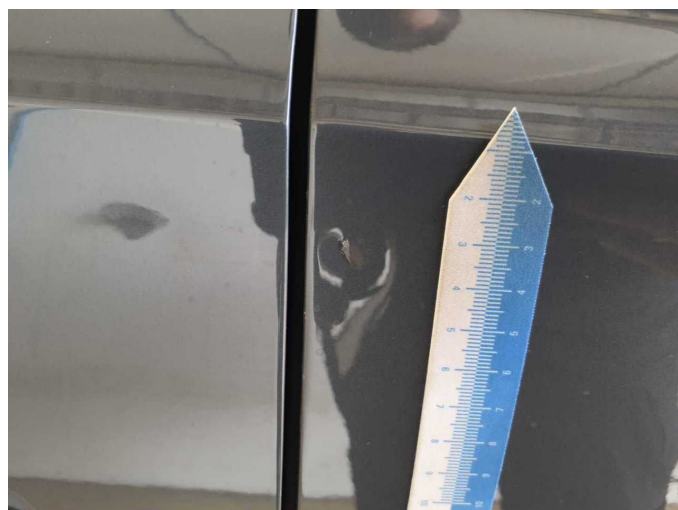
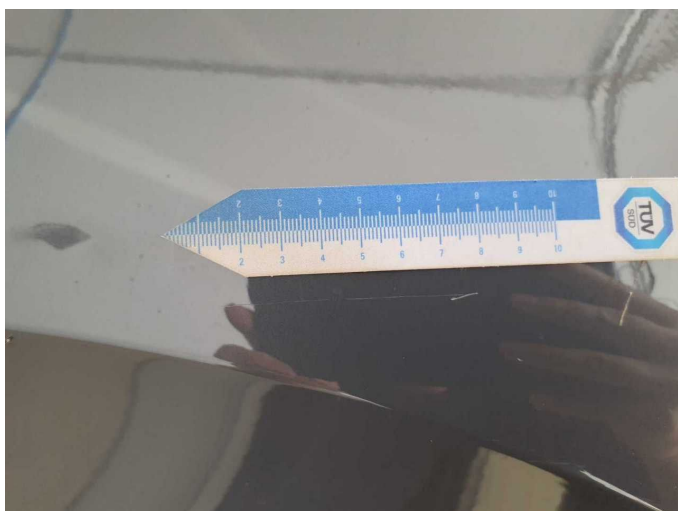
| No. | Component group | Description |
|---|---|---|
| 10 | Side panel - rear left side | Side panel - Dent / paintcoat damage - Repair and paint |

**Damage 10:** Side panel - rear left side: Side panel - Dent / paintcoat damage - Repair and paint

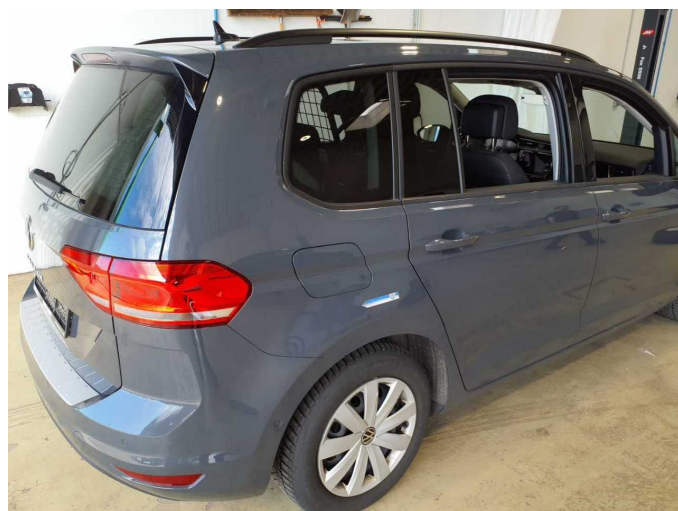
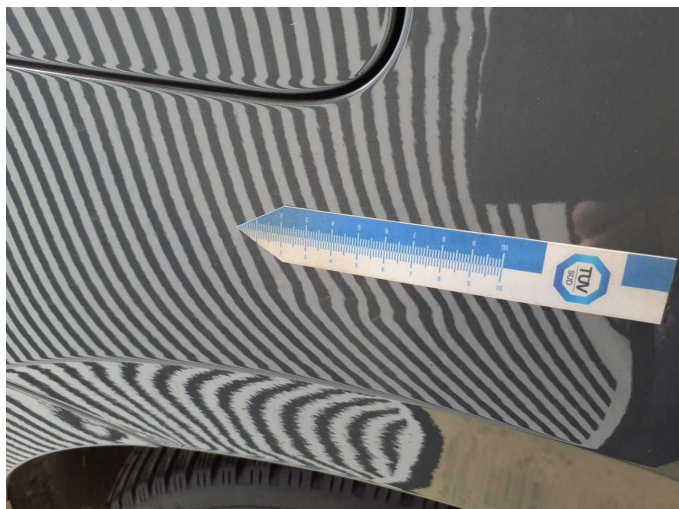
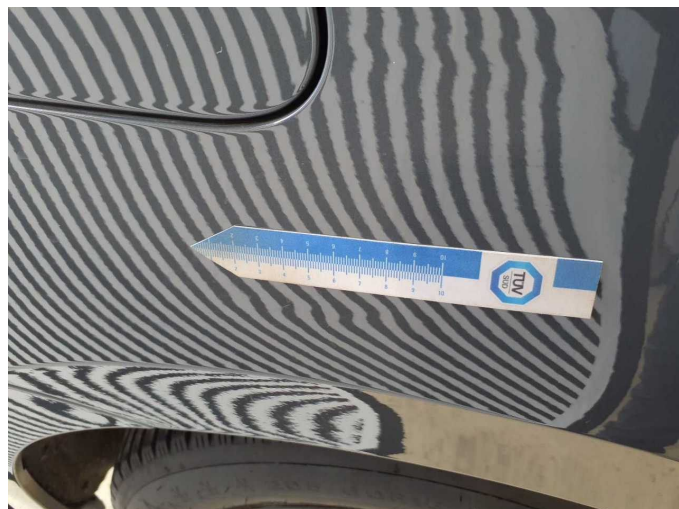
| No. | Component group | Description |
|---|---|---|
| 11 | Side panel - rear right side | Side panel - Deformed - Repair and paint |

**Damage 11:** Side panel - rear right side: Side panel - Deformed - Repair and paint

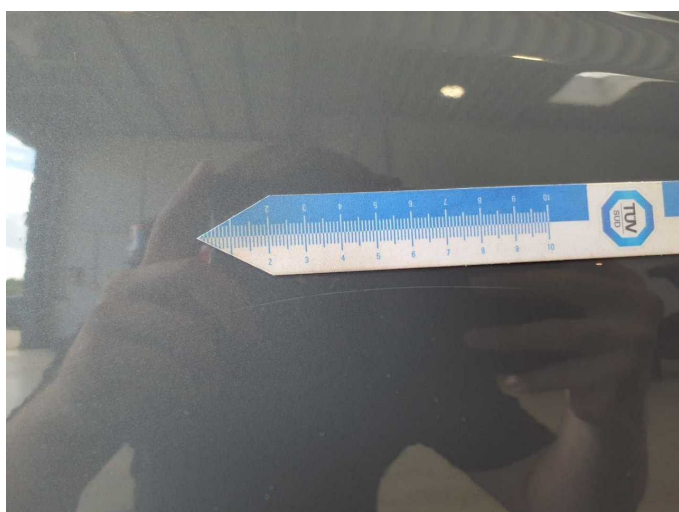
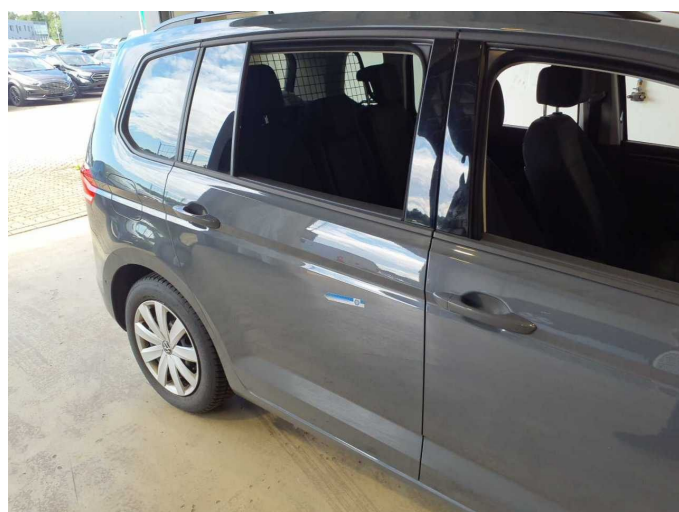
| No. | Component group | Description |
|---|---|---|
| 12 | Door - rear right side | Door - Scratch(es) - Paint |

**Damage 12:** Door - rear right side: Door - Scratch(es) - Paint

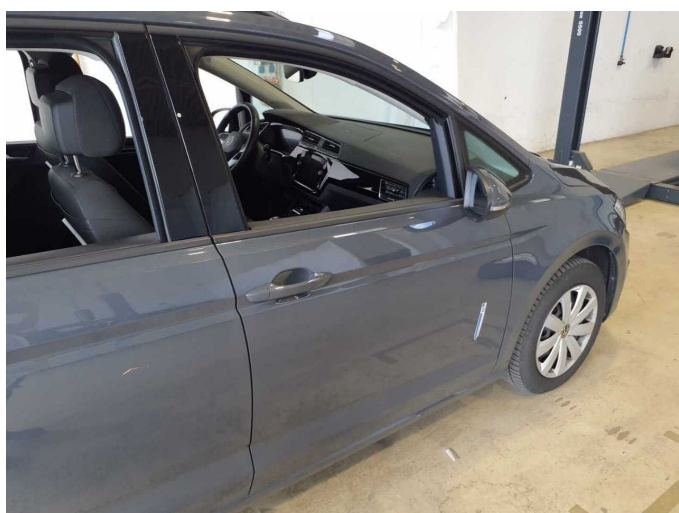
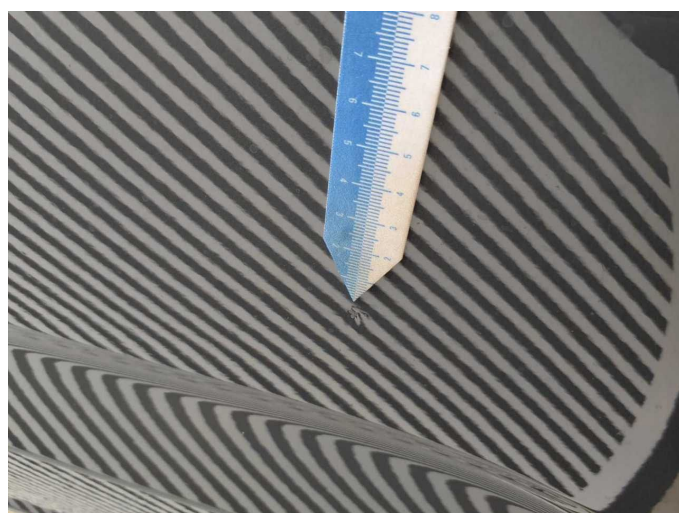
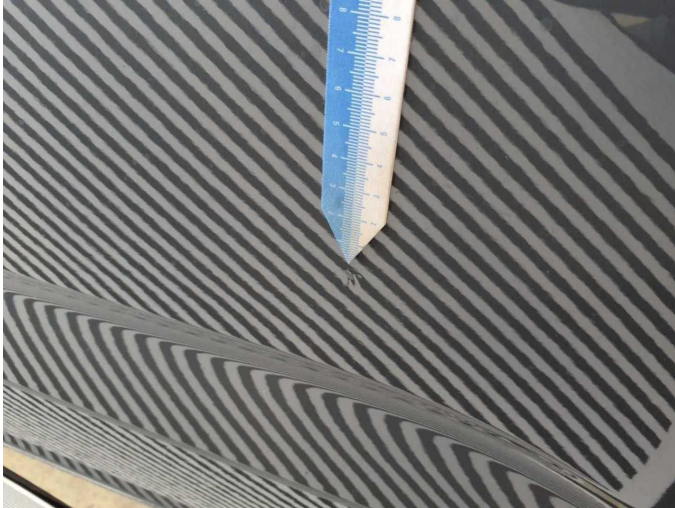
| No. | Component group | Description |
|---|---|---|
| 13 | Door - front right side | Door (Spachtelmasse eingefallen) - Unprofessionally repaired - Repair and paint |

**Damage 13:** Door - front right side: Door (Spachtelmasse eingefallen) - Unprofessionally repaired - Repair and paint

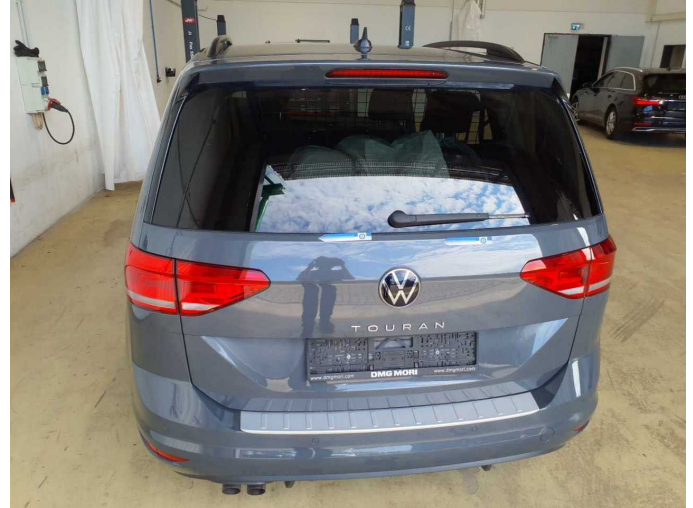
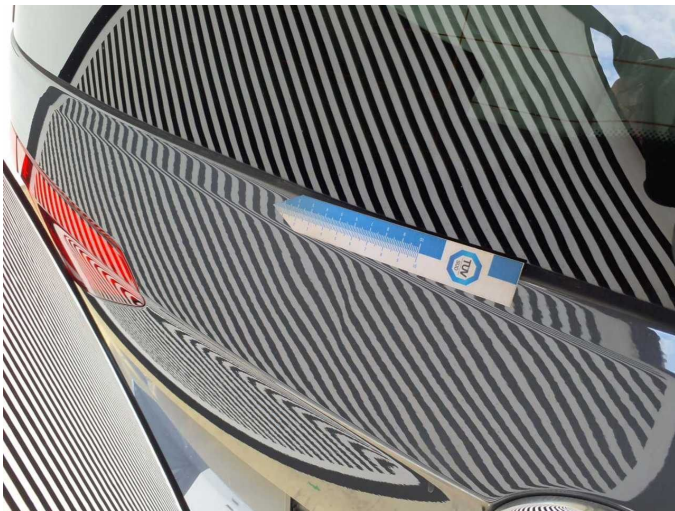
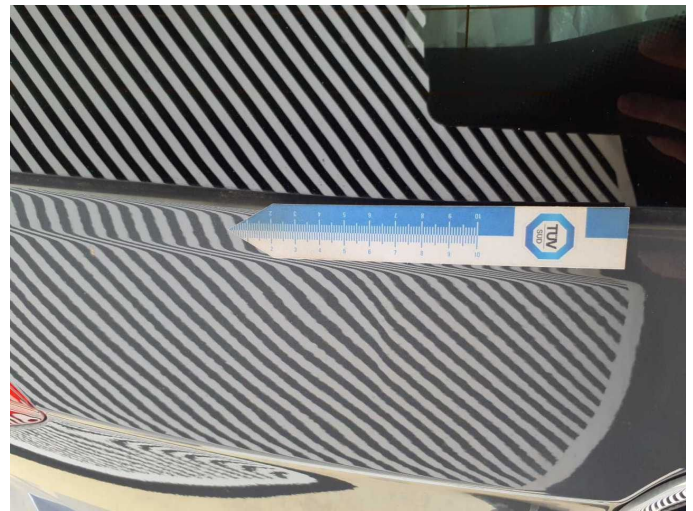
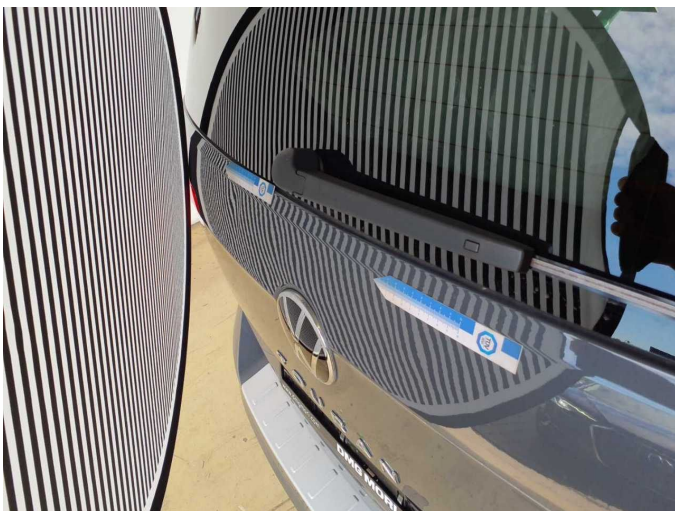
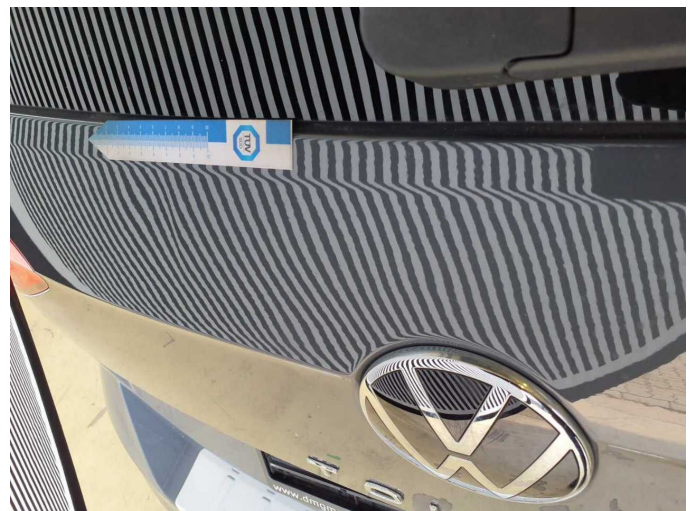
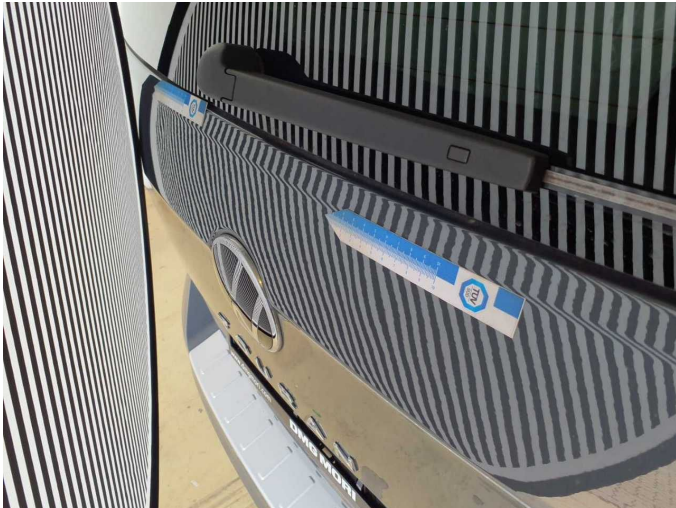
| No. | Component group | Description |
|---|---|---|
| 14 | Boot lid / rear door | Boot lid - Deformed - Repair and paint |

**Damage 14:** Boot lid / rear door: Boot lid - Deformed - Repair and paint

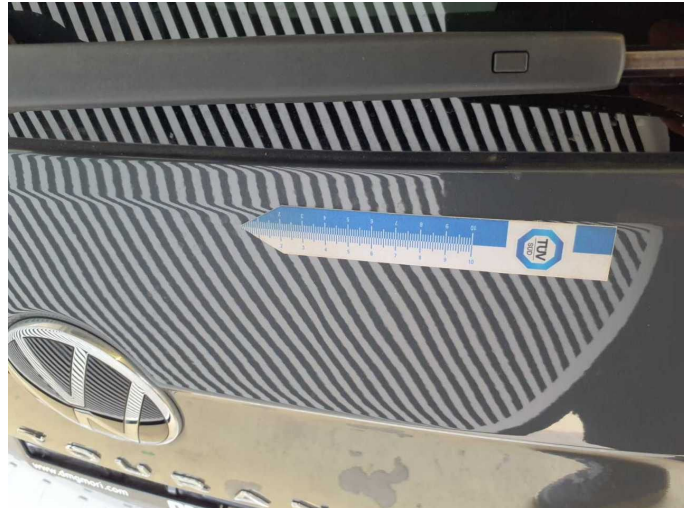
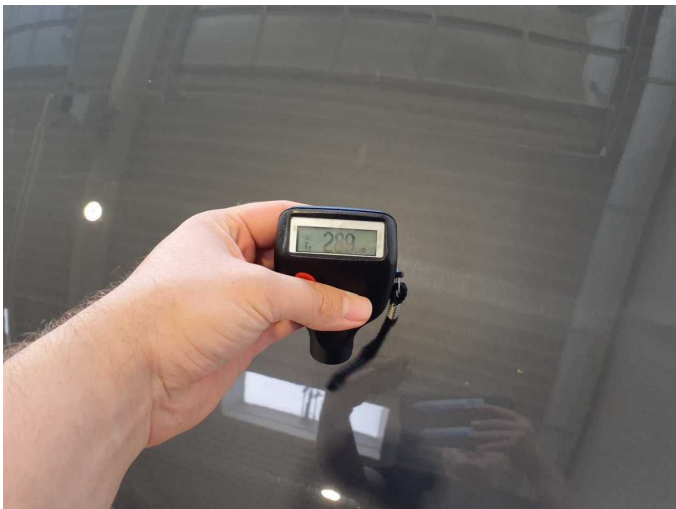
| No. | Repainting |
|---|---|
| 1 | Bonnet, Professionally carried out, Invoice of repair done Non-existent |

| Bonnet | 289 µm | Door - front right side | 171 µm |

**Repainting 1:** Bonnet

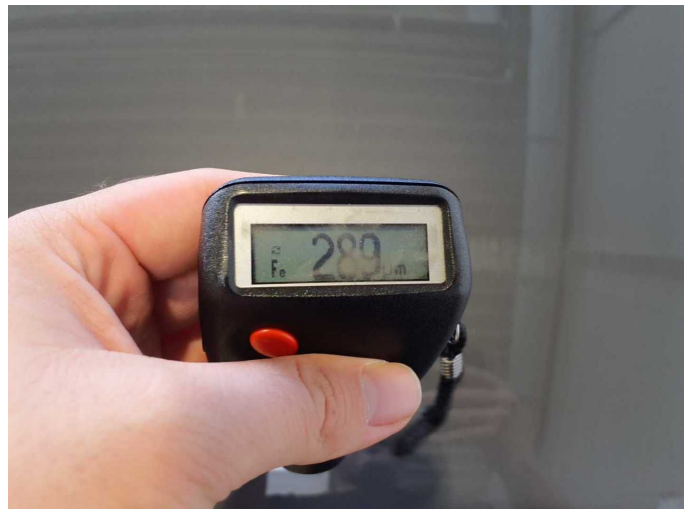
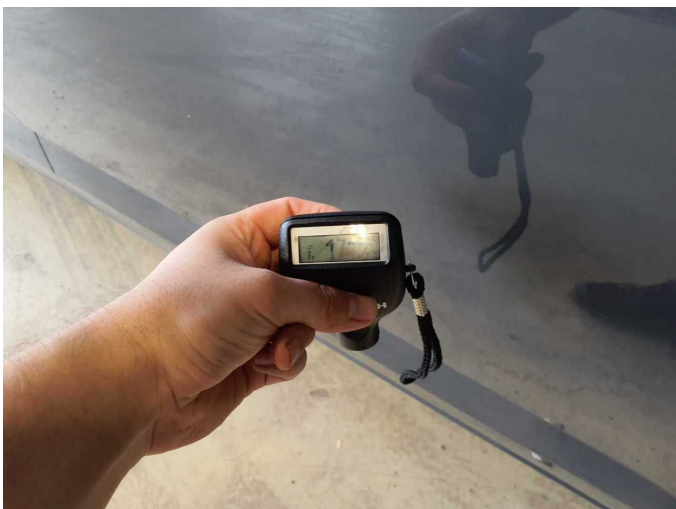
| No. | Repainting |
|---|---|
| 2 | Door - front right side, Unprofessionally carried out, Invoice of repair done Non-existent |

**Repainting 2:** Door - front right side
