Expertise

Protocol number: 46822905  
Order No. / Reference: 26775015  
Inspection date: 29 Jul 2026

Manufacturer: Skoda  
VIN: TMBAH7NP6P7013297

Model: Superb 2.0 TDI DSG Style

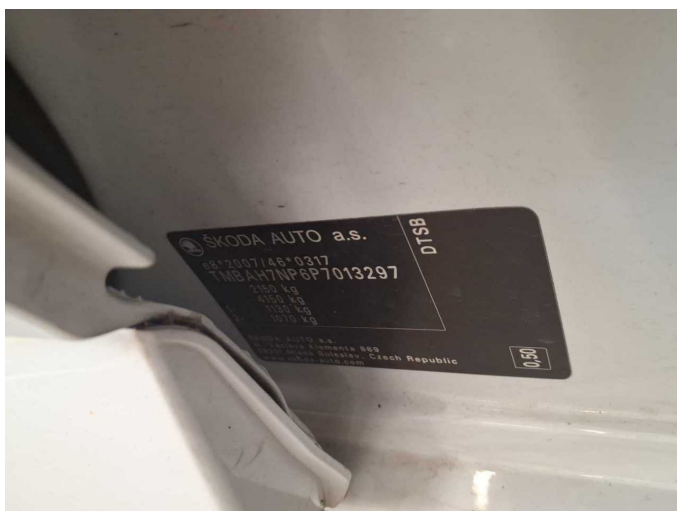
| VIN comparison | The vehicle identification number (VIN) was read from the vehicle and its conformity with the submitted documents was confirmed by the undersigned during the inspection. |

Figure 11: VIN

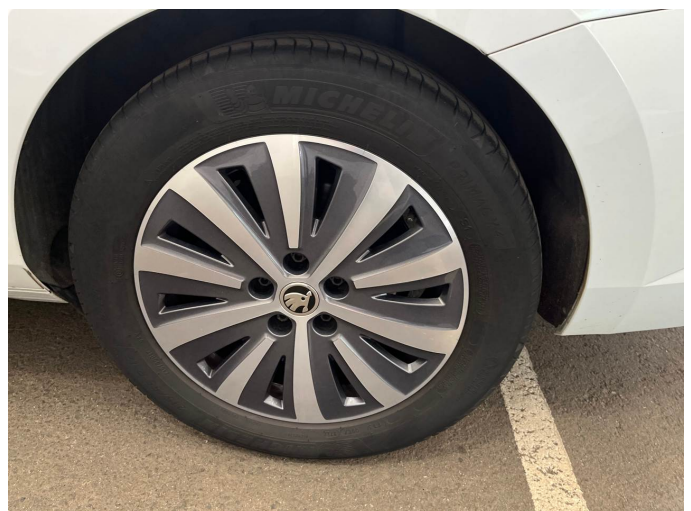
| # | Tyre size | Type of tyre | Manufacturer | Tread depth |
|---|---|---|---|---|
| 1) | 215/55 R17 94V | Summer tyres on Light alloy | Michelin | 5mm / 5mm |
| 2) | 215/55 R17 94V | Summer tyres on Light alloy | Michelin | 6mm / 6mm |

Figure 12: Mounted tyres

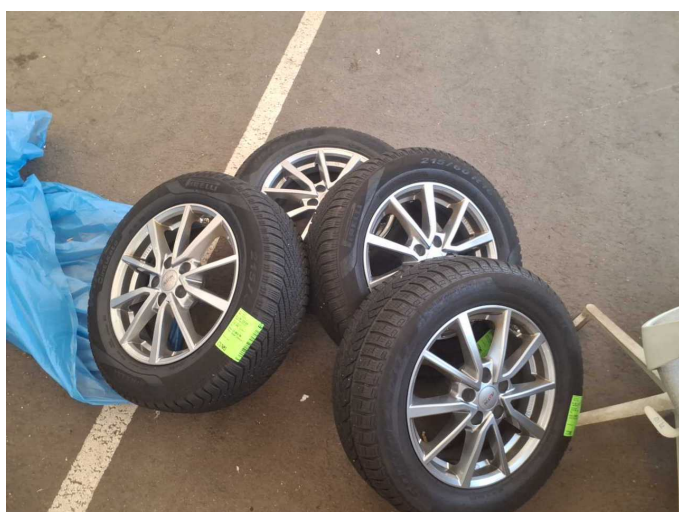
| # | Tyre size | Type of tyre | Manufacturer | Tread depth |
|---|---|---|---|---|
| 1) | 215/60 R16 99H | Winter tyres on Light alloy | Pirelli | 6mm / 6mm |
| 2) | 215/60 R16 99H | Winter tyres on Light alloy | Pirelli | 6mm / 6mm |

Figure 15: Additional tyres

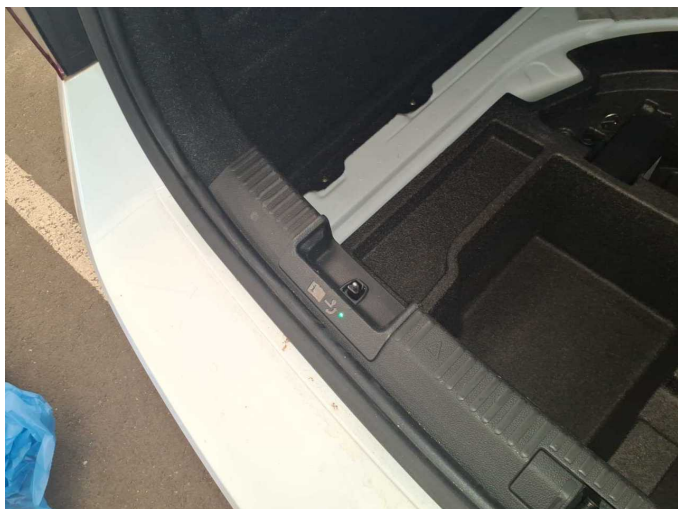
| No. | Component group | Description |
|---|---|---|
| 1 | Trailer hitch | Trailer hitch (Seilzug der AnhängerKopplung) - Damaged - Replace |

**Damage 1:** Trailer hitch: Trailer hitch (Seilzug der AnhängerKopplung) - Damaged - Replace

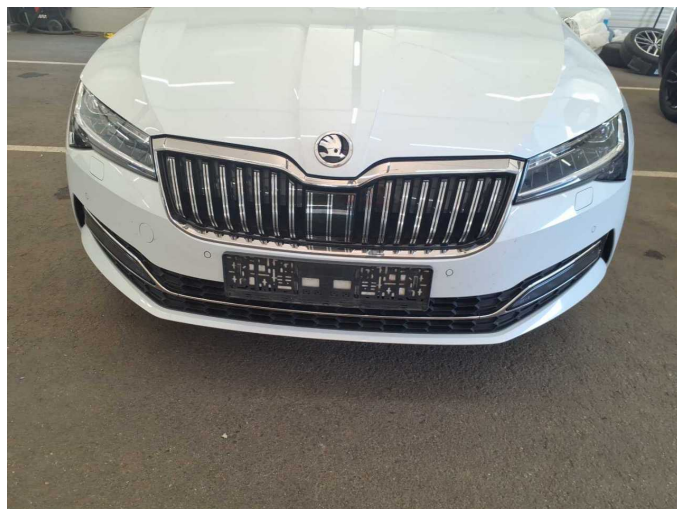
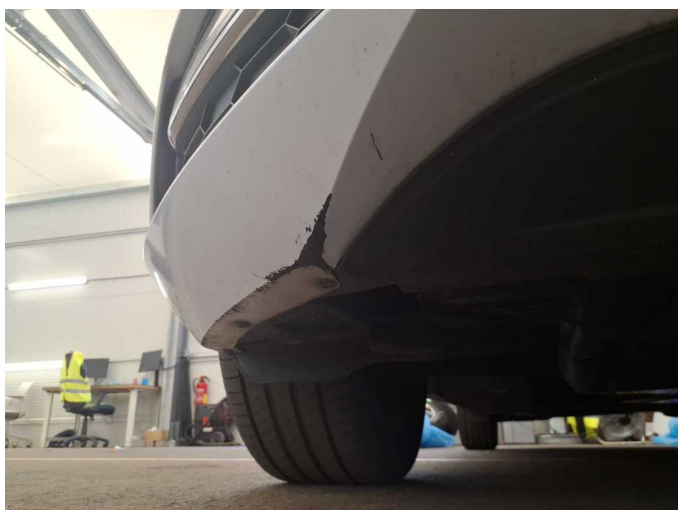
| No. | Component group | Description |
|---|---|---|
| 2 | Front bumper | Front bumper - Scratched - Paint |

**Damage 2:** Front bumper: Front bumper - Scratched - Paint

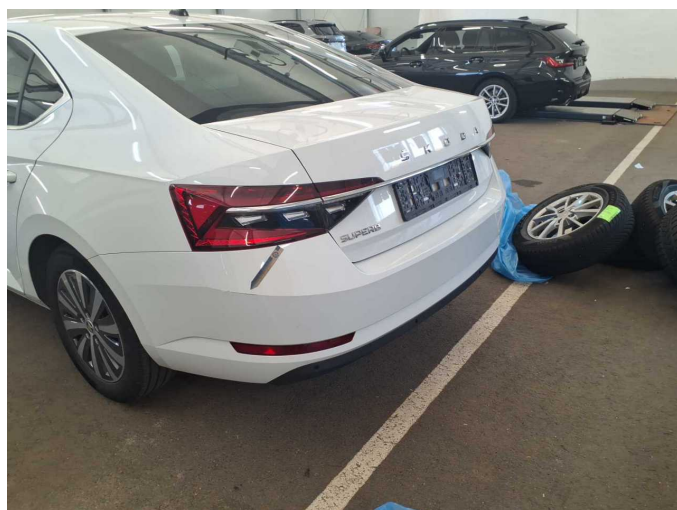
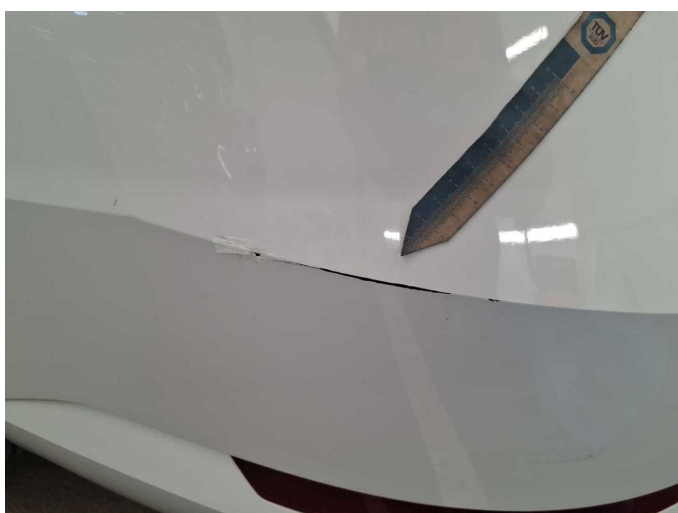
| No. | Component group | Description |
|---|---|---|
| 3 | Rear bumper | Rear bumper - Scratched - Paint |

**Damage 3:** Rear bumper: Rear bumper - Scratched - Paint

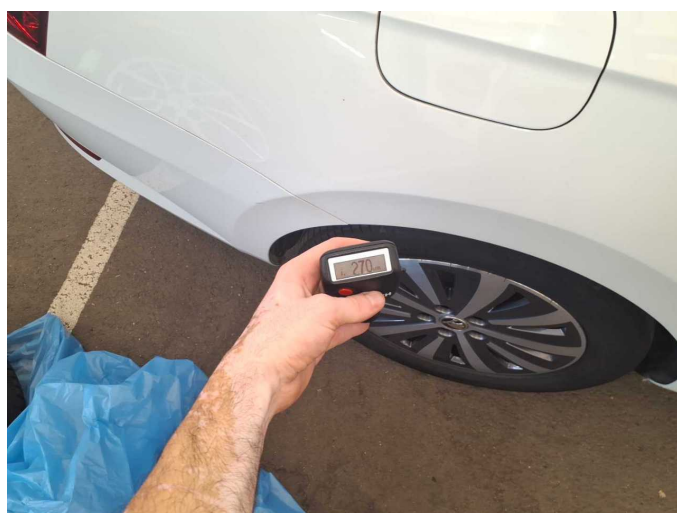
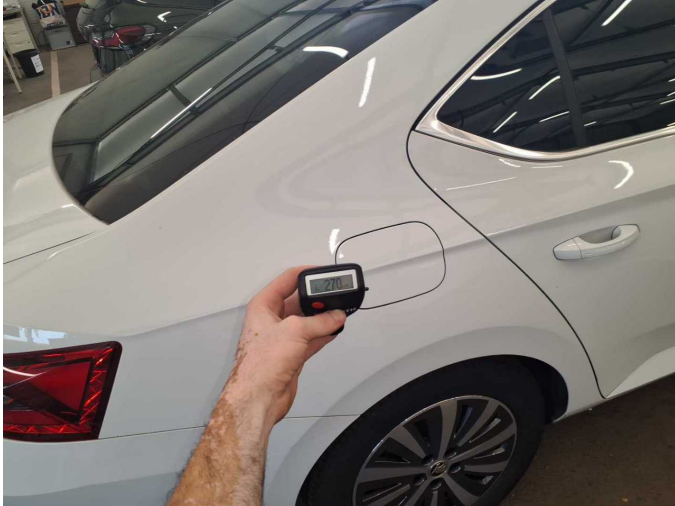
- Side panel - rear right side
- Door - rear right side

**Repainting 1:** Side panel - rear right side

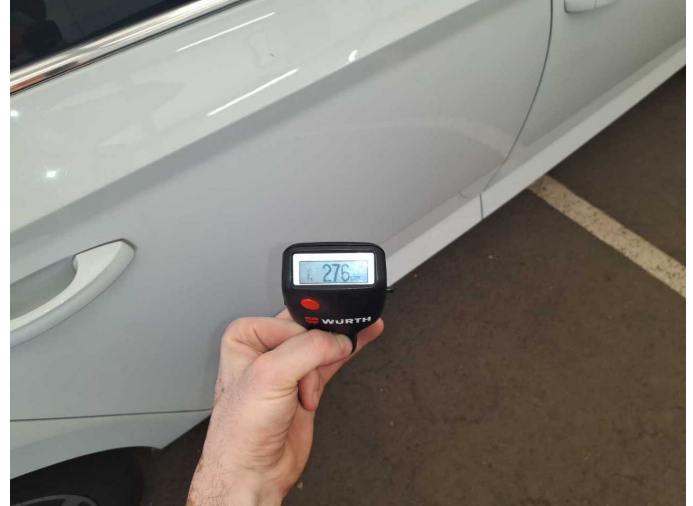
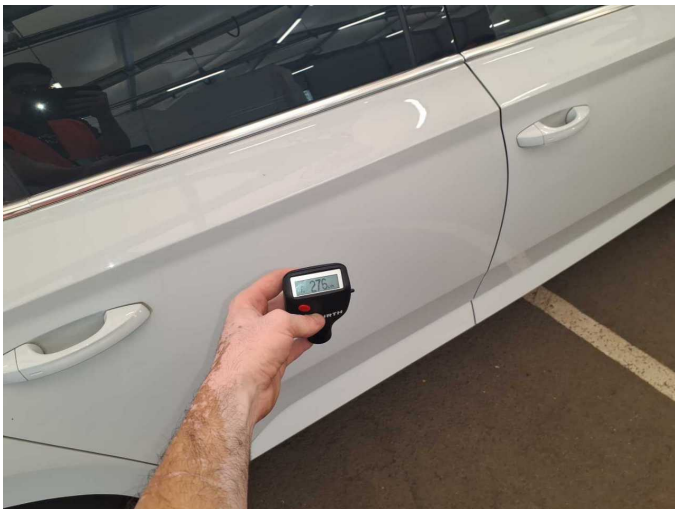
**Repainting 2:** Door - rear right side
