Expertise

Protocol number: 46384060  
Order No. / Reference: 26543789  
Inspection date: 7 Jul 2026

| Manufacturer: Audi | Model: A5 Sportback 40 TDI quattro S tronic S line |

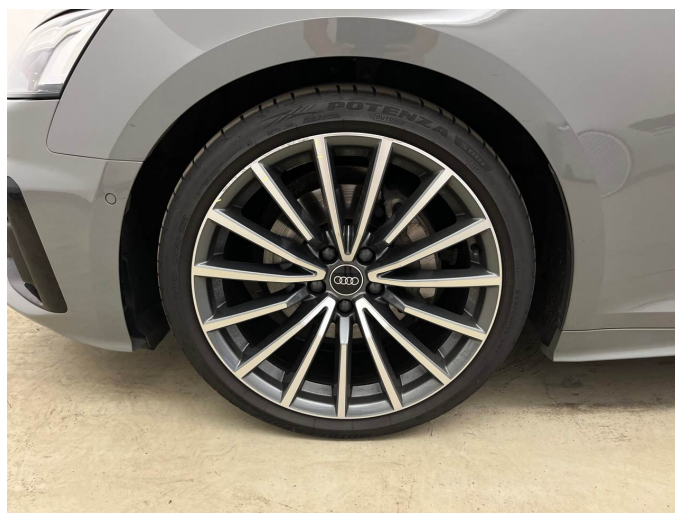
Figure 12: Mounted tyres

| # | Tyre size | Type of tyre | Manufacturer | Tread depth |
|---|---|---|---|---|
| 1) | 255/35 R19 96Y | Summer tyres on Light alloy | Bridgestone | 4mm / 4mm |
| 2) | 255/35 R19 96Y | Summer tyres on Light alloy | Bridgestone | 4mm / 4mm |

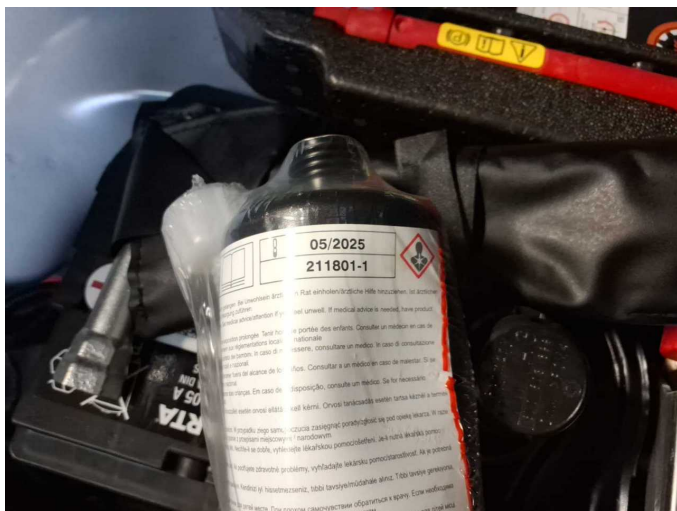
| No. | Component group | Description |
|---|---|---|
| 1 | Equipment | Tirefit filler - Expired - Replace |

Damage 1: Equipment: Tirefit filler - Expired - Replace

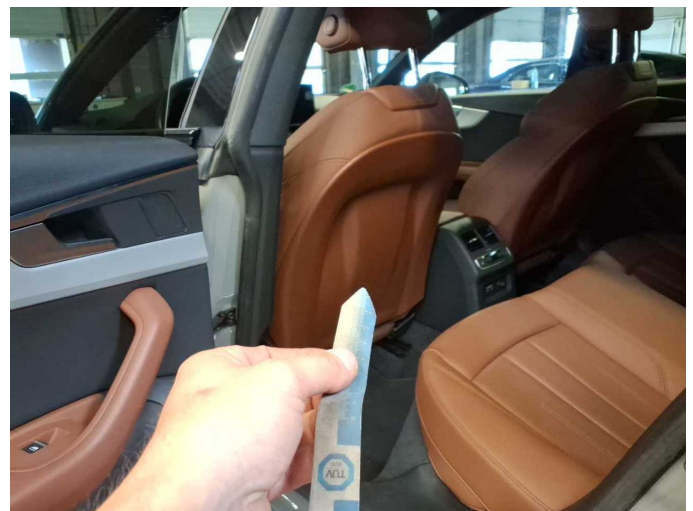
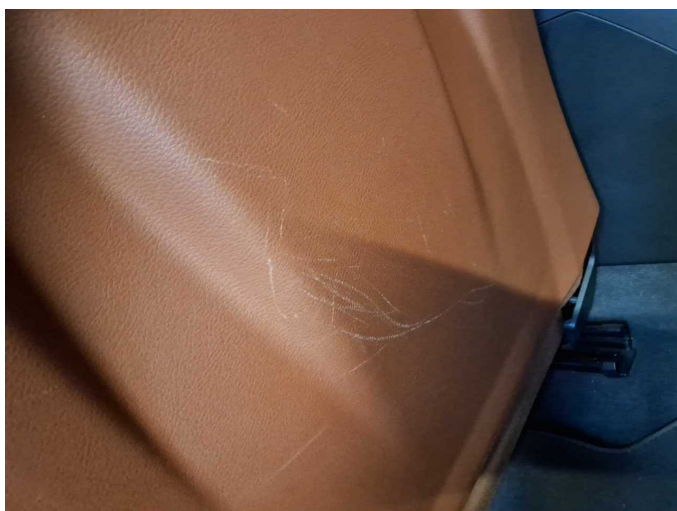
| No. | Component group | Description |
|---|---|---|
| 2 | Seat - front | Seat - left side (Abdeckung hinten) - Scratch(es) - Smart repair |

Damage 2: Seat - front: Seat - left side (Abdeckung hinten) - Scratch(es) - Smart repair

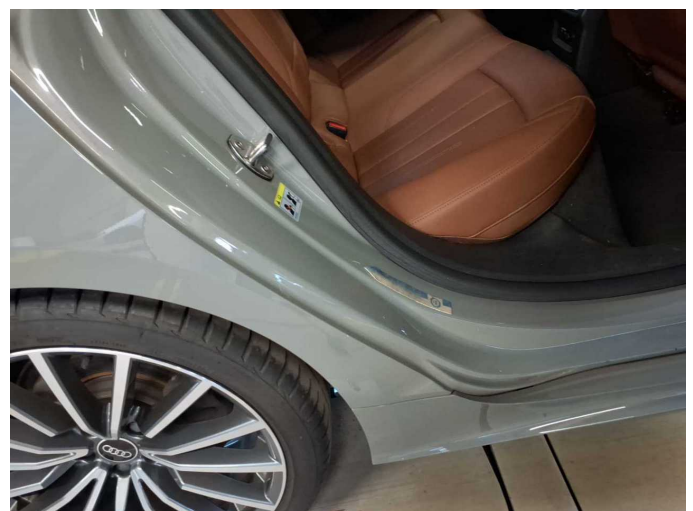
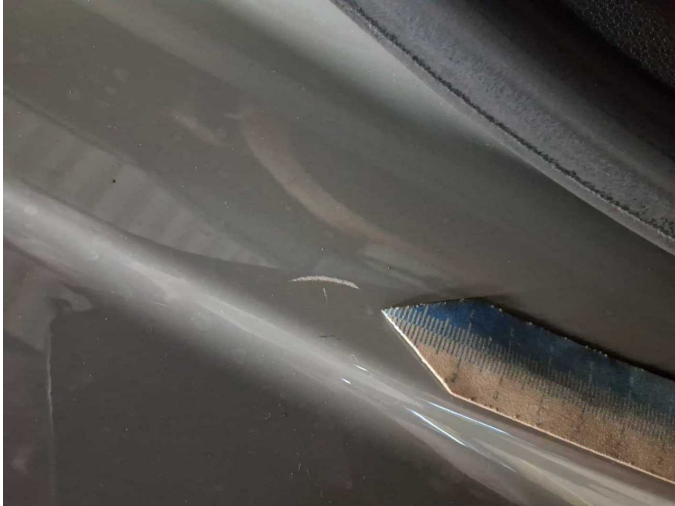
| No. | Component group | Description |
|---|---|---|
| 3 | Side panel - rear right side | Sill - Scratch(es) - Smart repair |

Damage 3: Side panel - rear right side: Sill - Scratch(es) - Smart repair

**Damage 3:** Side panel - rear right side: Sill - Scratch(es) - Smart repair

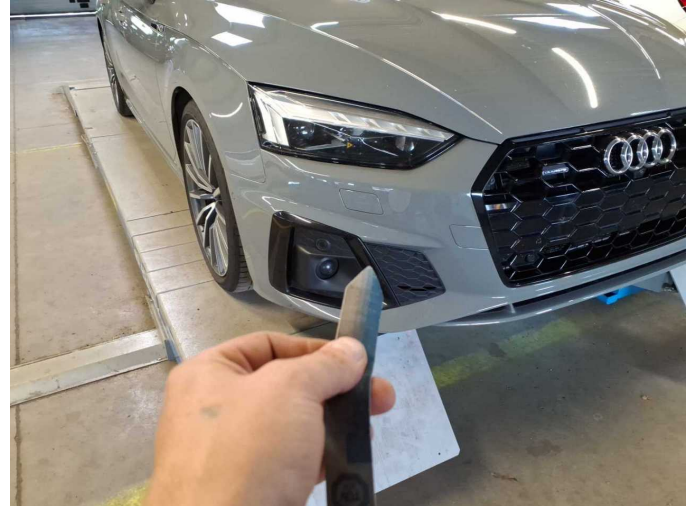
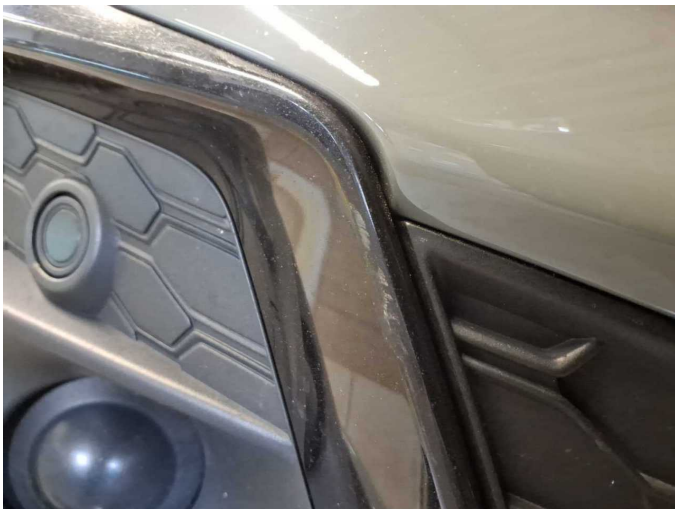
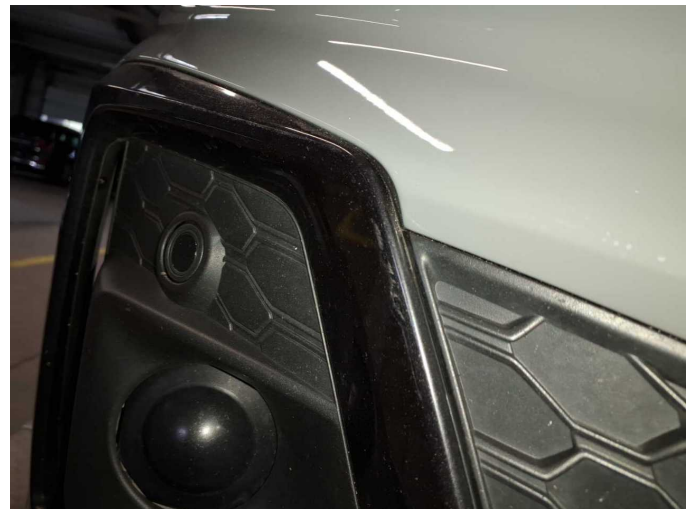
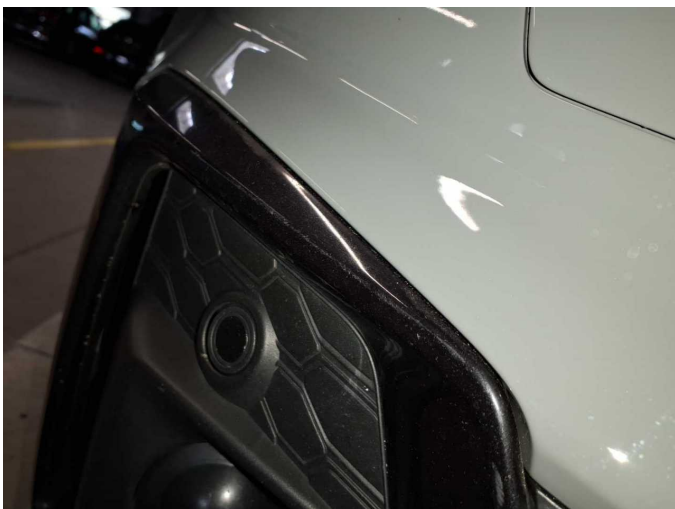
| No. | Component group | Description |
|---|---|---|
| 4 | Front bumper | Air-inlet grille (Rechts, Rahmen) - Scratched - Replace |

**Damage 4:** Front bumper: Air-inlet grille (Rechts, Rahmen) - Scratched - Replace

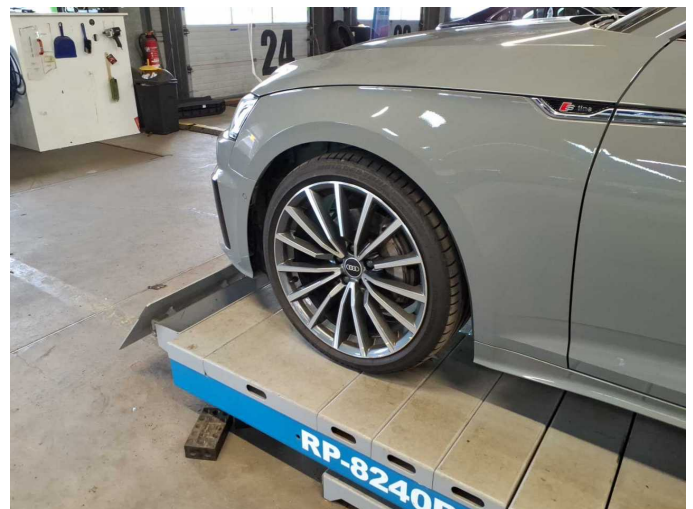
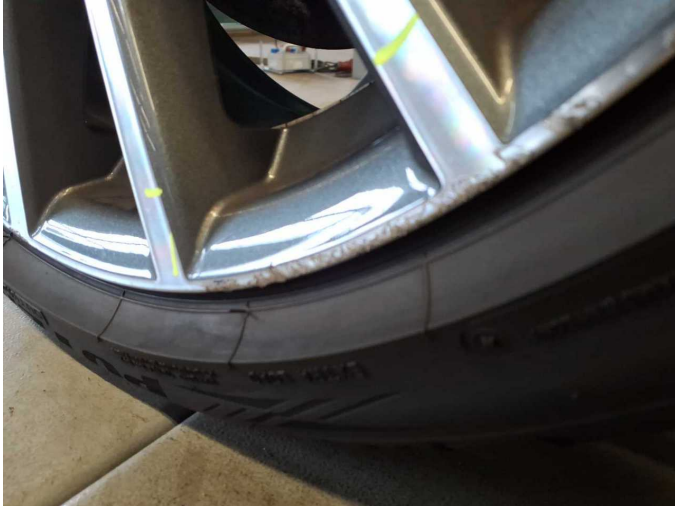
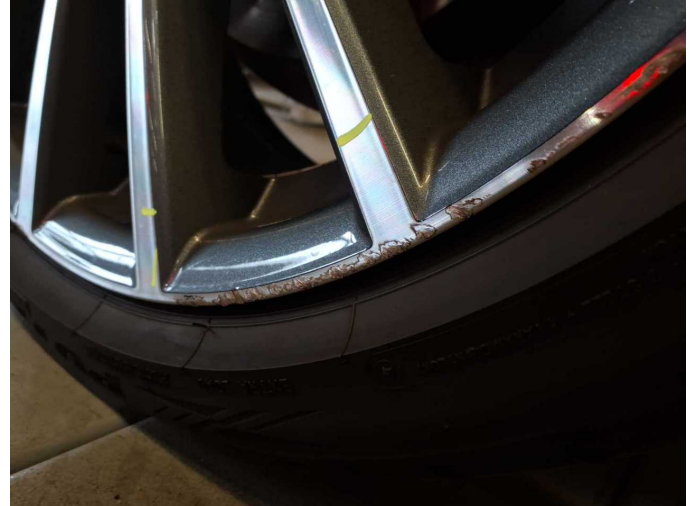
| No. | Component group | Description |
|---|---|---|
| 5 | Wheel / tyres | Alloy rim - front left side - Scratch(es) - Loss in value |

**Damage 5:** Wheel / tyres: Alloy rim - front left side - Scratch(es) - Loss in value

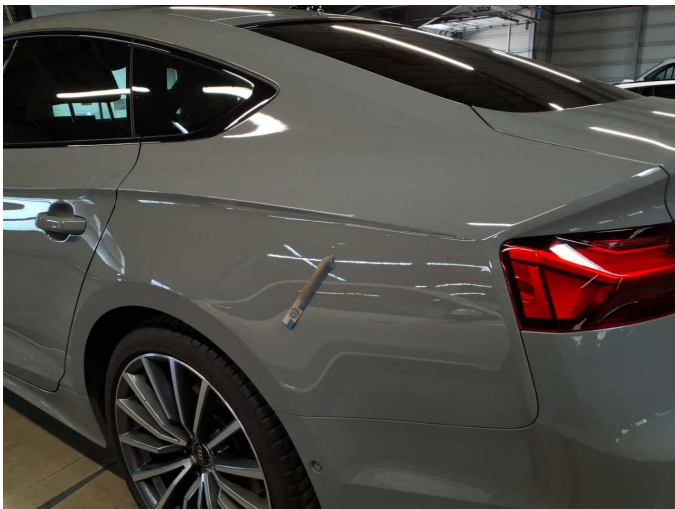
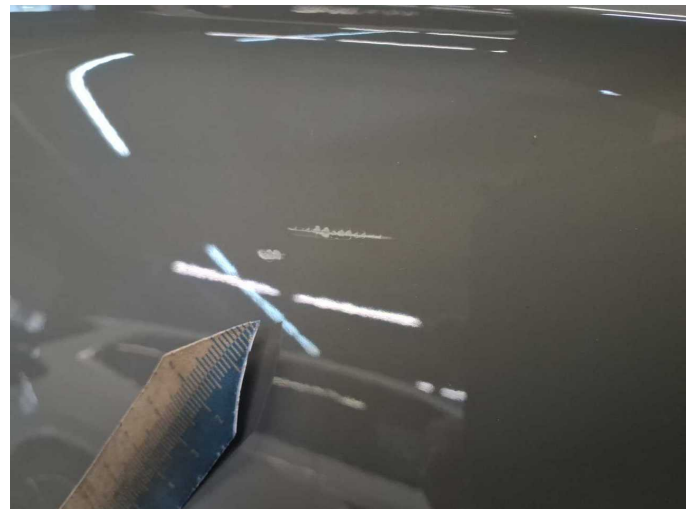
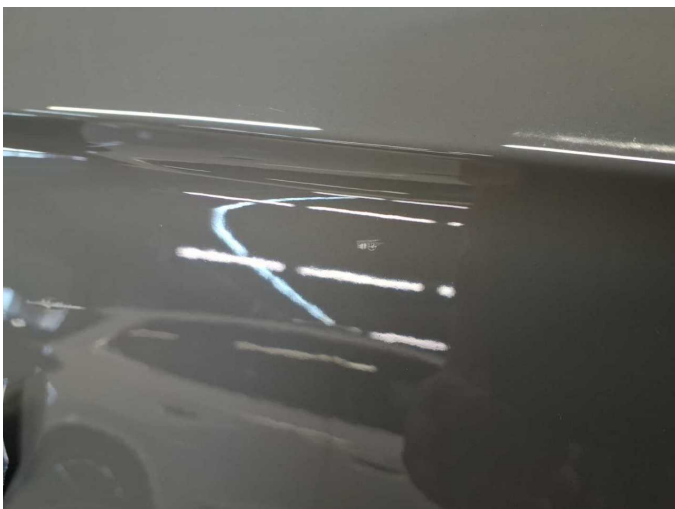
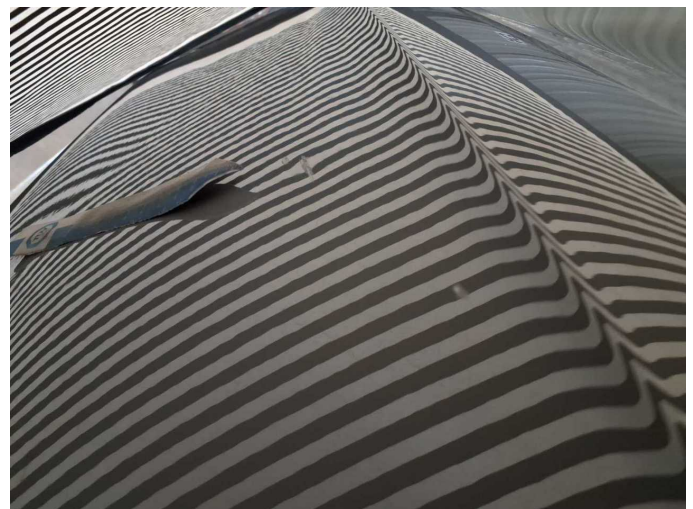
| No. | Component group | Description |
|---|---|---|
| 6 | Side panel - rear left side | Side panel - Dent / paintcoat damage - Repair and paint |

**Damage 6:** Side panel - rear left side: Side panel - Dent / paintcoat damage - Repair and paint

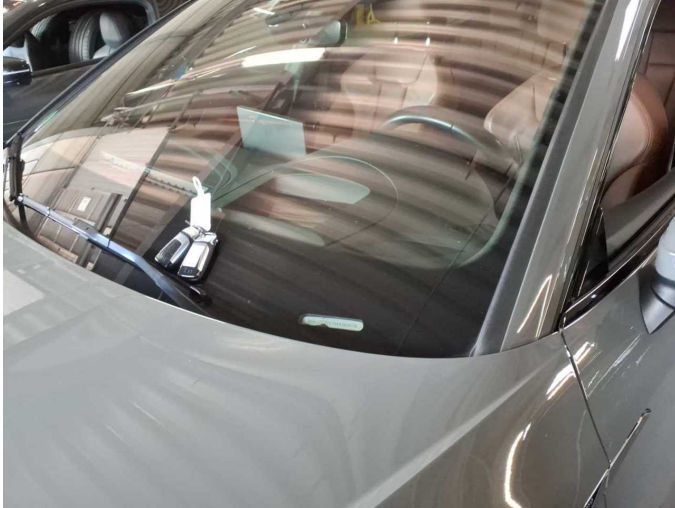
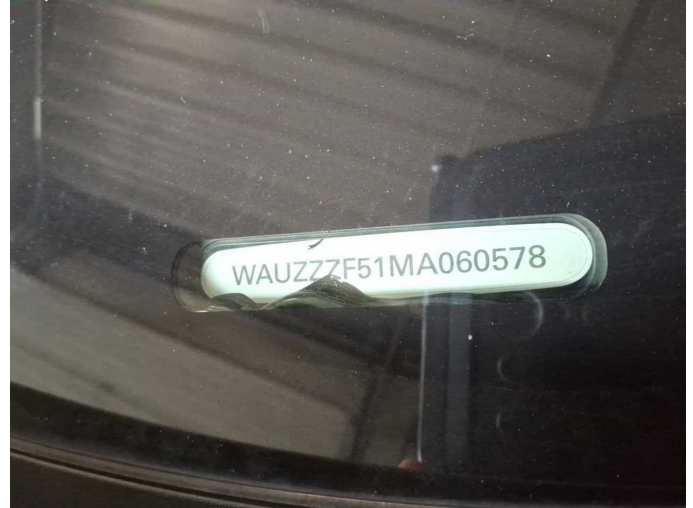
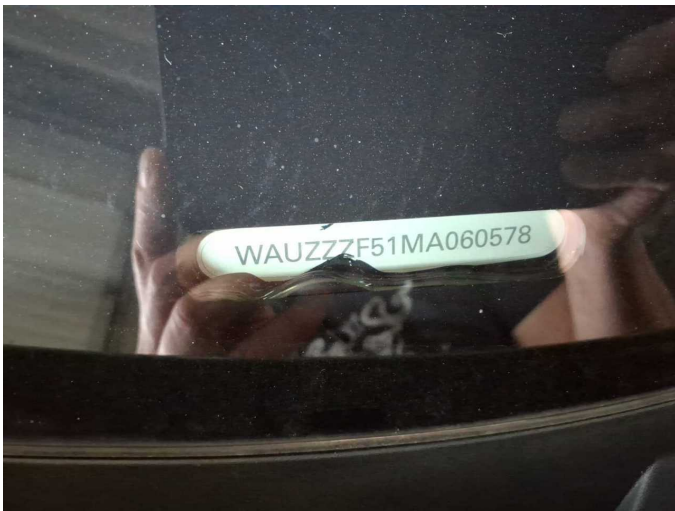
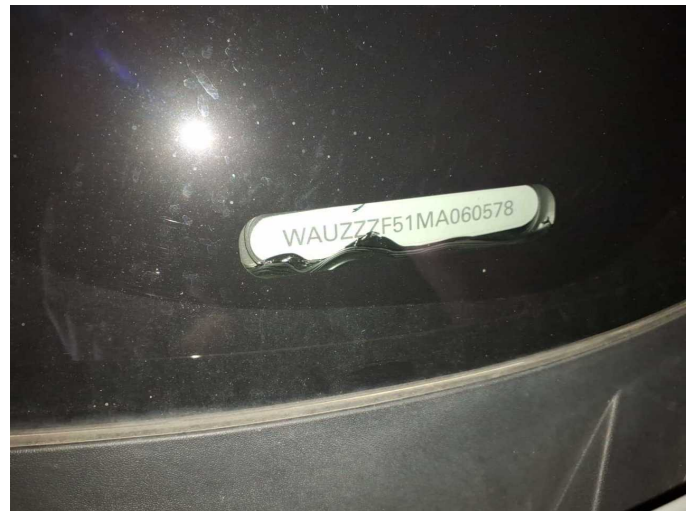
| No. | Component group | Description |
|---|---|---|
| 7 | Vehicle glazing | Windscreen (Kleber zu sehen) - Unprofessionally repaired - Un- / install |

**Damage 7:** Vehicle glazing: Windscreen (Kleber zu sehen) -  
Unprofessionally repaired - Un- / install

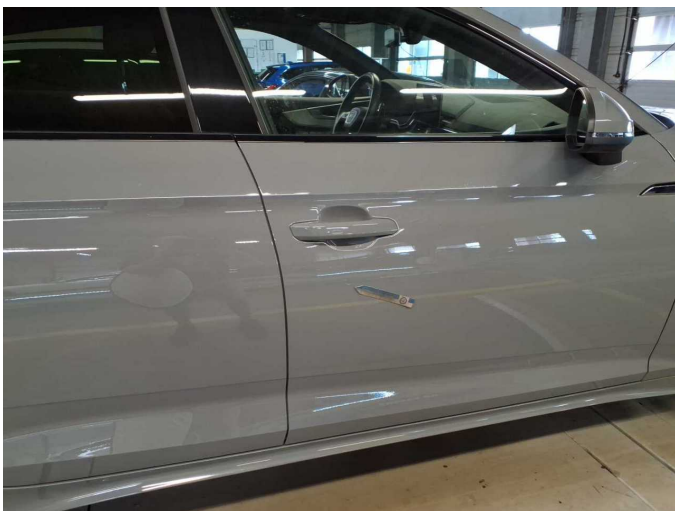
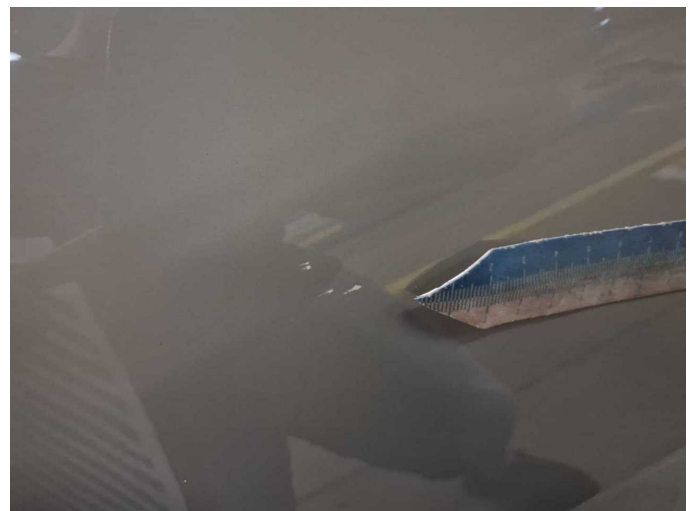
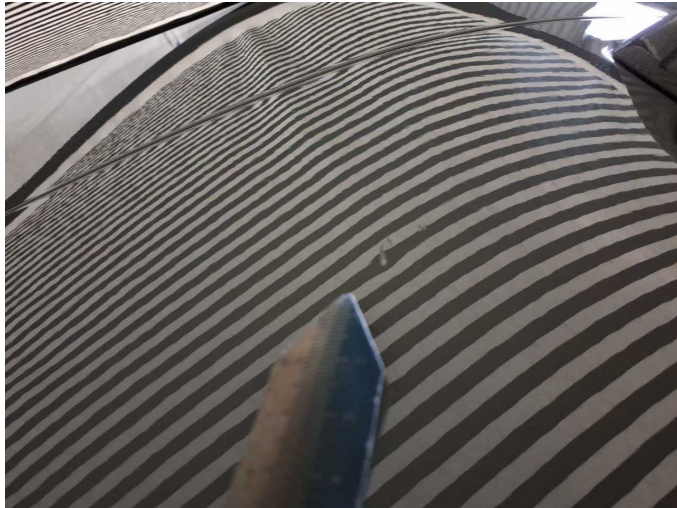
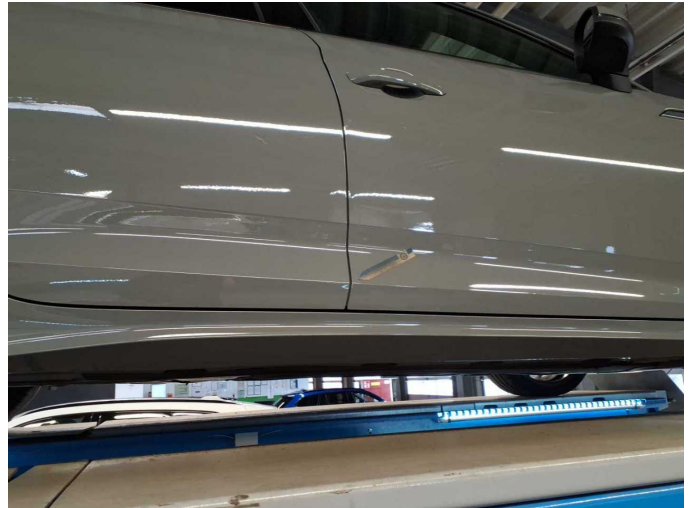
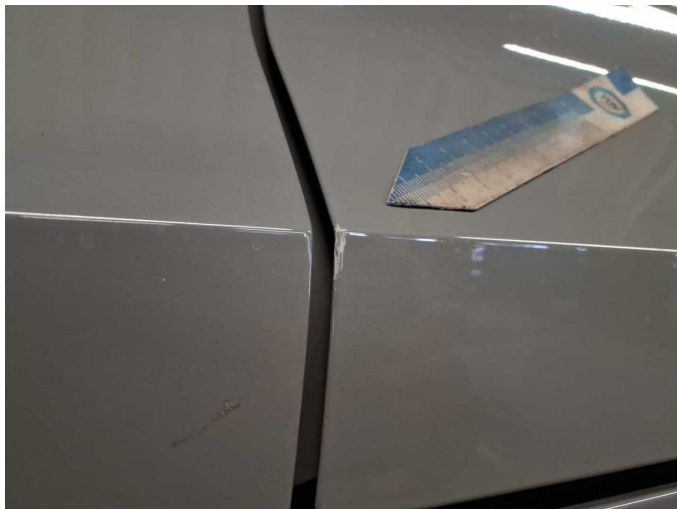
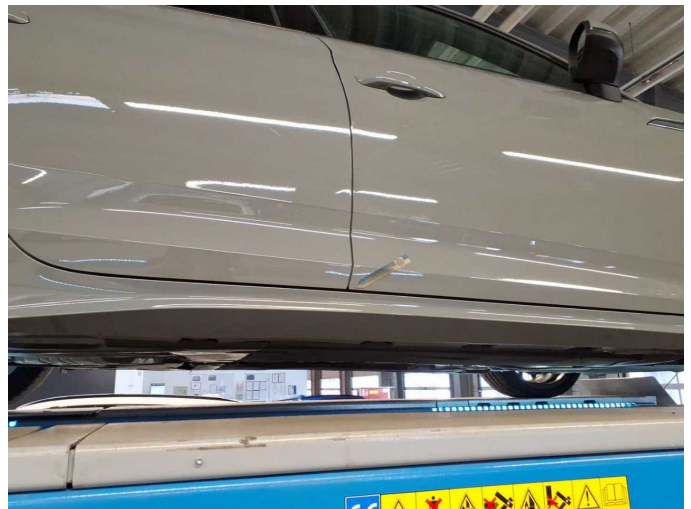
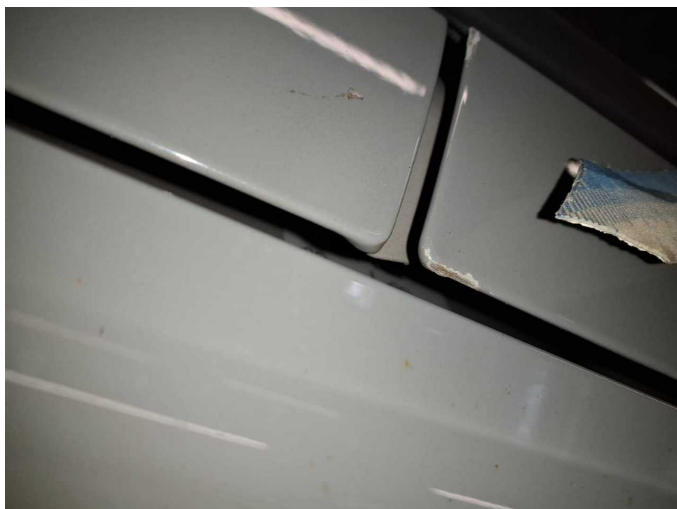
| No. | Component group | Description |
|---|---|---|
| 8 | Door - front right side | Door - Dent / paintcoat damage - Repair and paint |

**Damage 8:** Door - front right side: Door - Dent / paintcoat damage -  
Repair and paint

**Damage 8:** Door - front right side: Door - Dent / paintcoat damage - Repair and paint

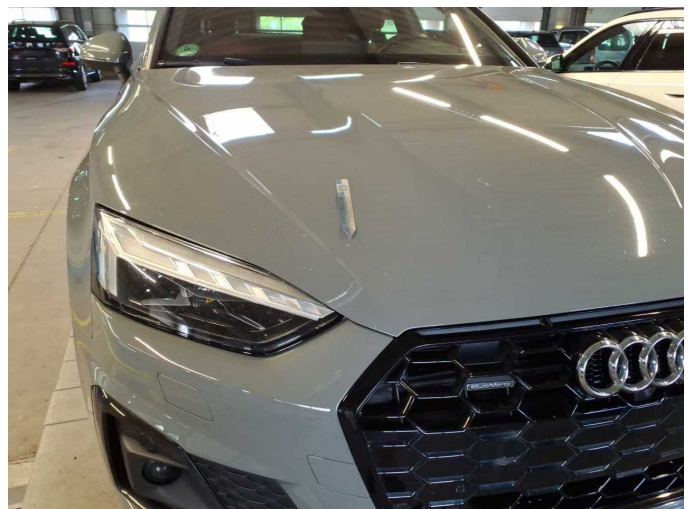
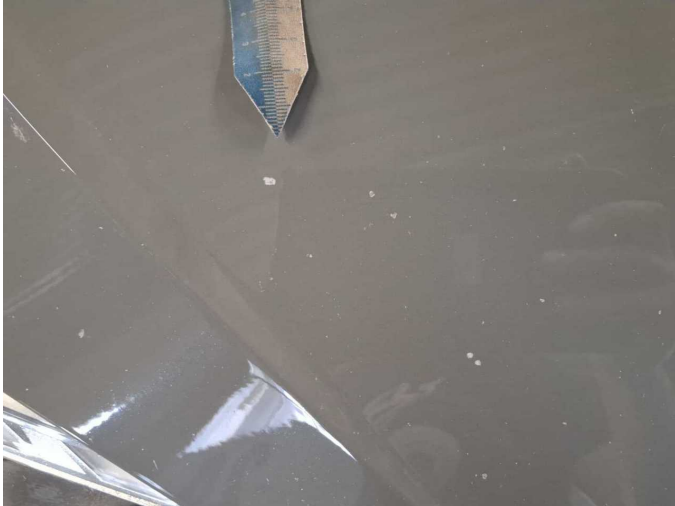
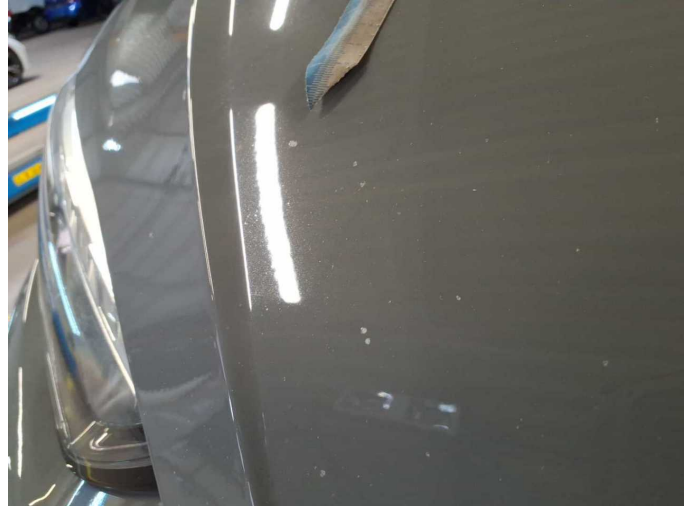
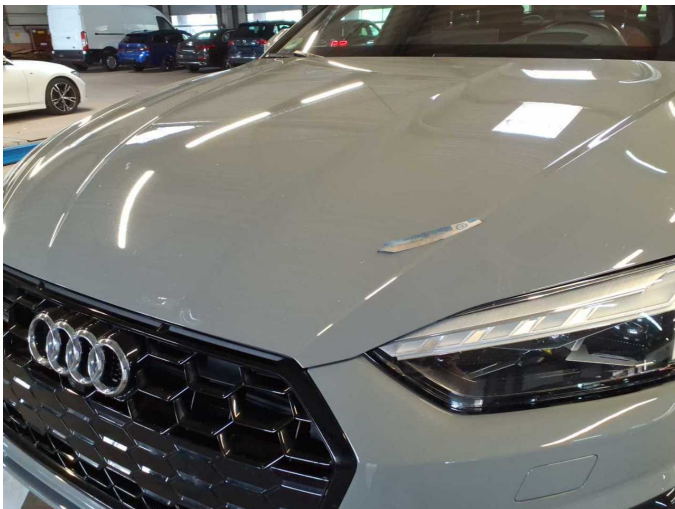
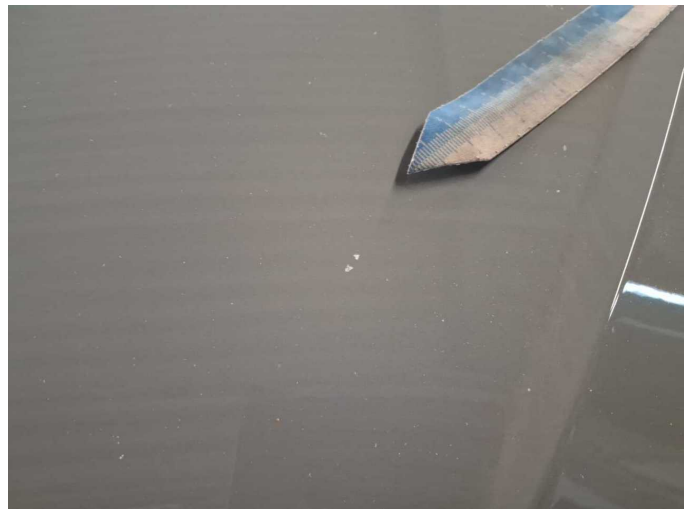
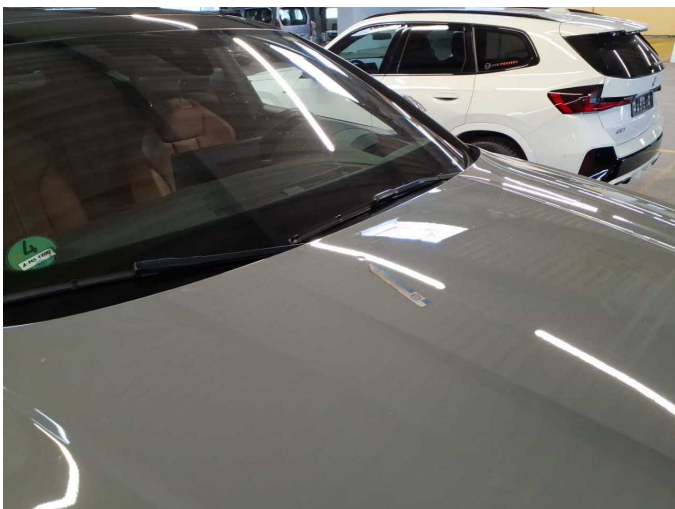
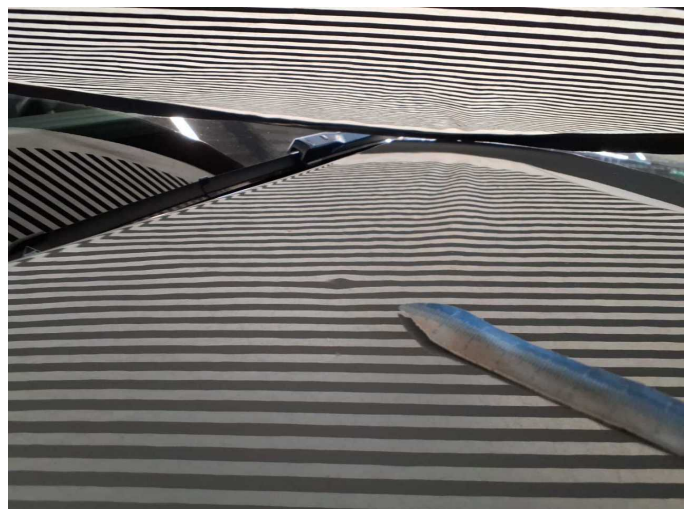
| No. | Component group | Description |
|---|---|---|
| 9 | Bonnet | Bonnet - Dent / paintcoat damage - Repair and paint |

**Damage 9:** Bonnet: Bonnet - Dent / paintcoat damage - Repair and paint

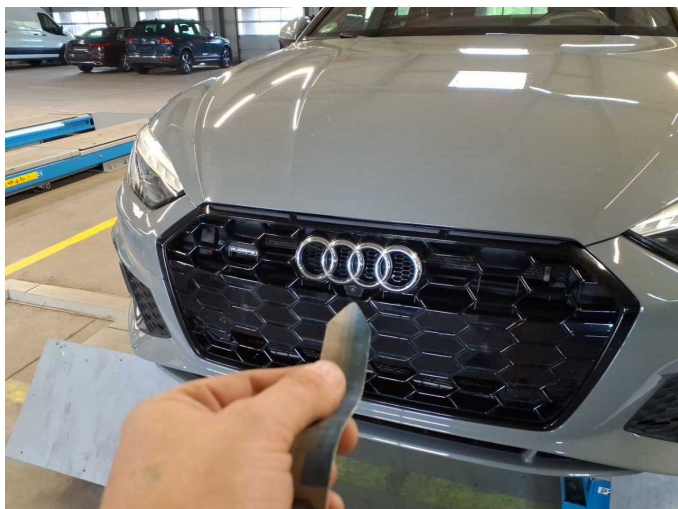
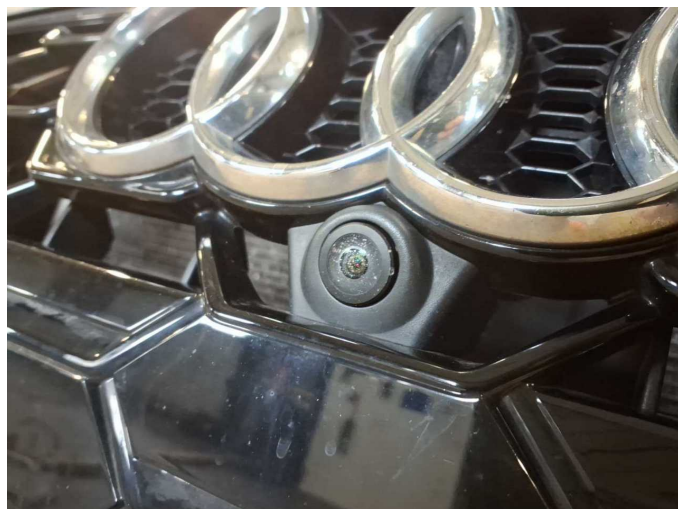
| No. | Component group | Description |
|---|---|---|
| 2 | Electronic systems | Front camera - Stone chips - No deduction |

**Wear and tear 2:** Electronic systems: Front camera - Stone chips - No deduction

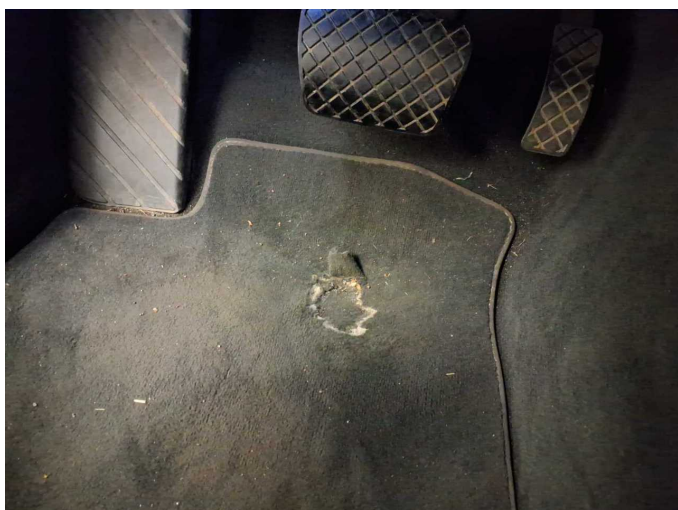
| No. | Component group | Description |
|---|---|---|
| 5 | Trim / covers | Floor mats - Broken / torn - No deduction |

**Wear and tear 5:** Trim / covers: Floor mats - Broken / torn - No deduction
