Expertise

Protocol number: 45791328
Order No. / Reference: 26328270
Inspection date: 22 May 2026

Manufacturer: Opel

Model: Grandland X 1.5 D Start/Stop Business Edition

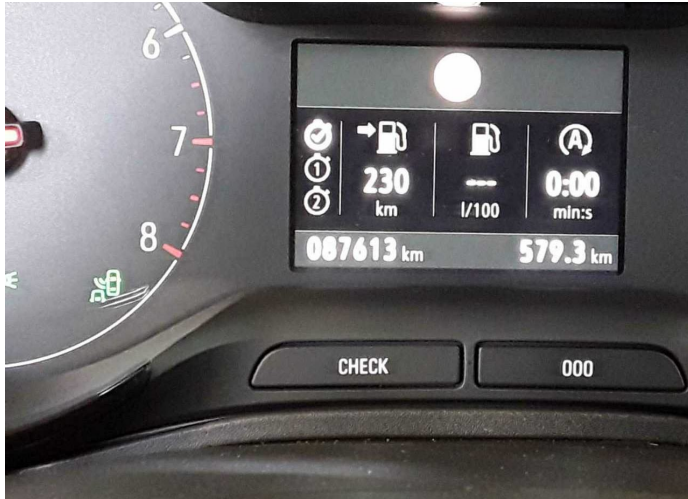
Figure 7: Instrument cluster

Mileage (Read) 87,613 km

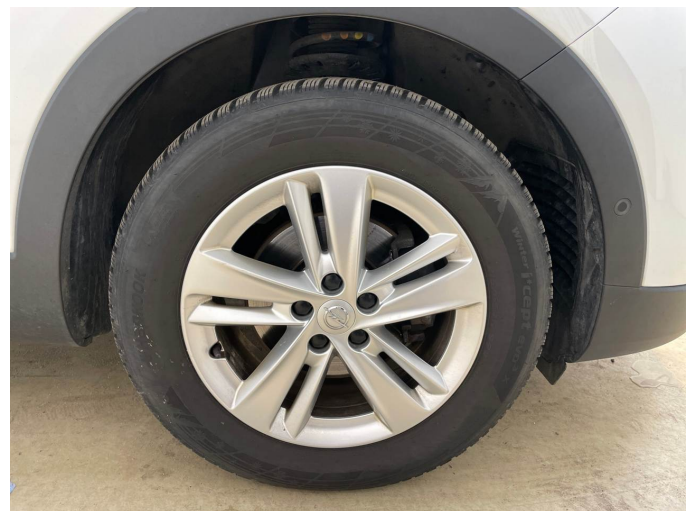
Figure 12: Mounted tyres

#	Tyre size	Type of tyre	Manufacturer	Tread depth
1)	215/65 R17 99V	Winter tyres on Light alloy	Hankook	5mm / 5mm
2)	215/65 R17 99V	Winter tyres on Light alloy	Hankook	6mm / 6mm

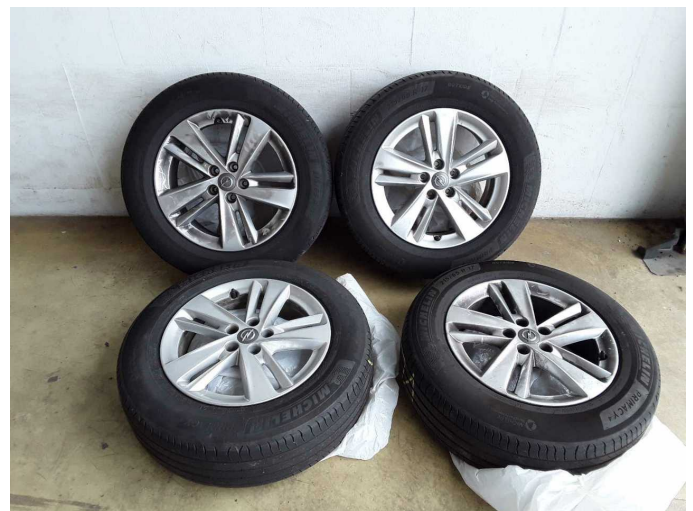
Figure 18: Additional tyres

#	Tyre size	Type of tyre	Manufacturer	Tread depth
1)	215/65 R17 103V	Summer tyres on Light alloy	Michelin	4mm / 4mm
2)	215/65 R17 103V	Summer tyres on Light alloy	Michelin	4mm / 4mm

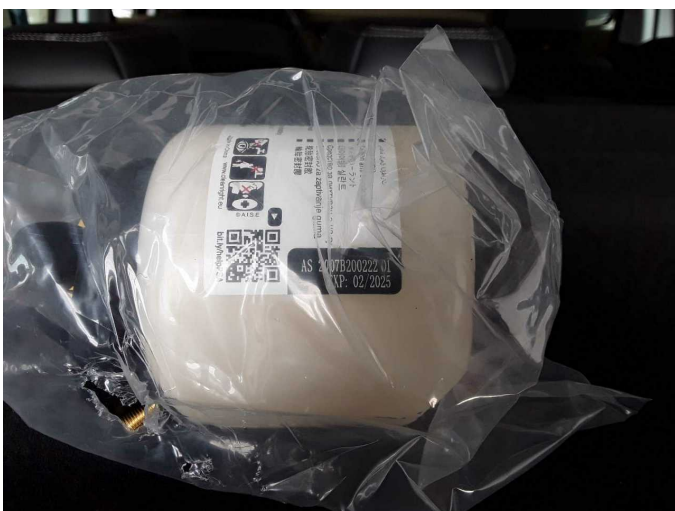
No.	Component group	Description
1	Equipment	Tirefit filler - Expired - Replace

Damage 1: Equipment: Tirefit filler - Expired - Replace

Typ	Tyre size	Type of tyre	Manufacturer	Tread depth
	Tirefit	Expiration date 02/2025
