Expertise

Protocol number: 46456612  
Order No. / Reference: 26553231  
Inspection date: 10 Jul 2026

Manufacturer: Ford

Model: Mondeo Turnier 2.0 EcoBlue Aut. Titanium

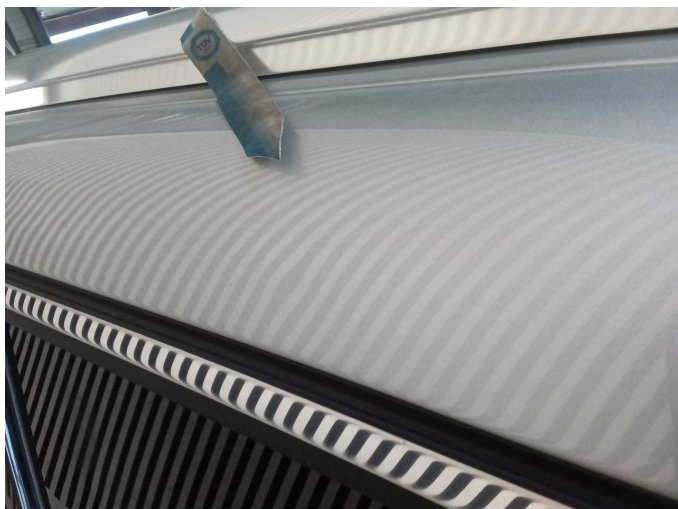
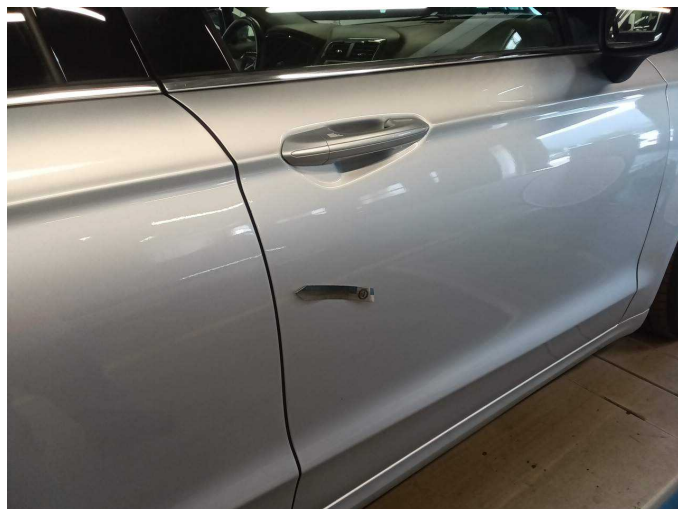
| No. | Component group | Description |
|---|---|---|
| 1 | Roof | Roof rail - left side - dent(s) - Smooth repair work |

**Damage 1:** Roof: Roof rail - left side - dent(s) - Smooth repair work

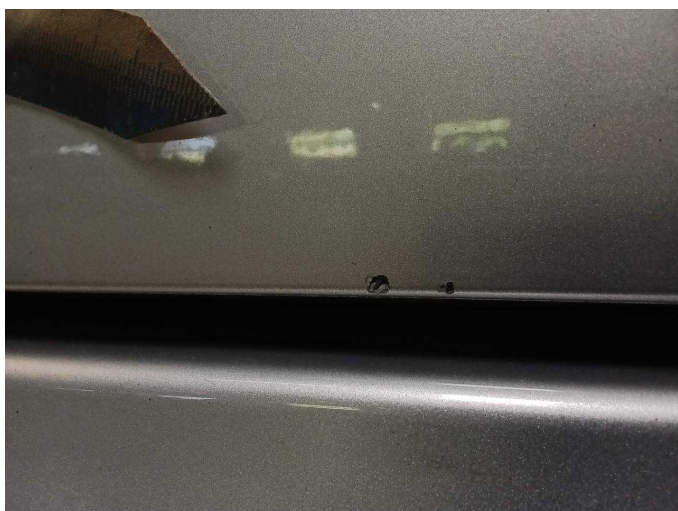
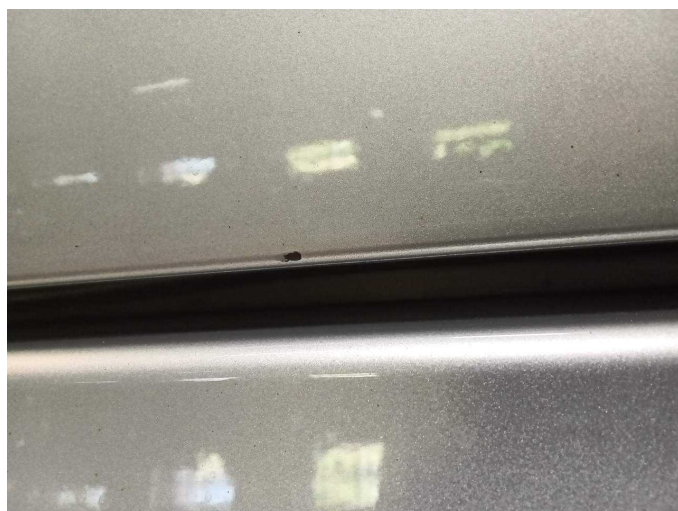
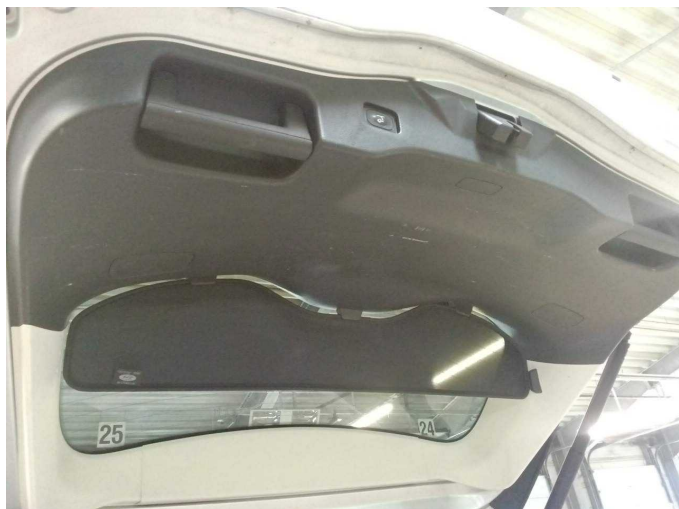
| No. | Component group | Description |
|---|---|---|
| 3 | Boot lid / rear door | Boot lid - Scratch(es) - Smart repair |

**Damage 3:** Boot lid / rear door: Boot lid - Scratch(es) - Smart repair

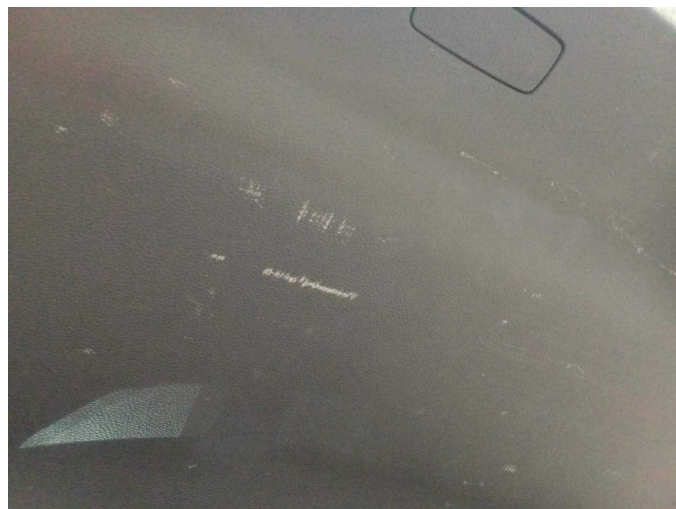
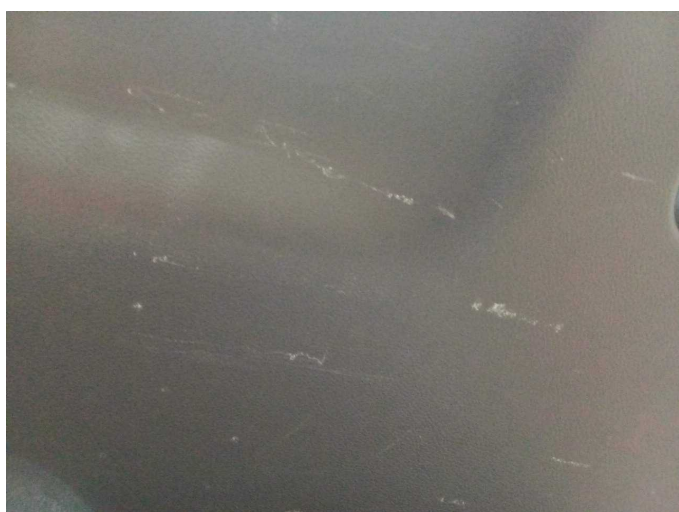
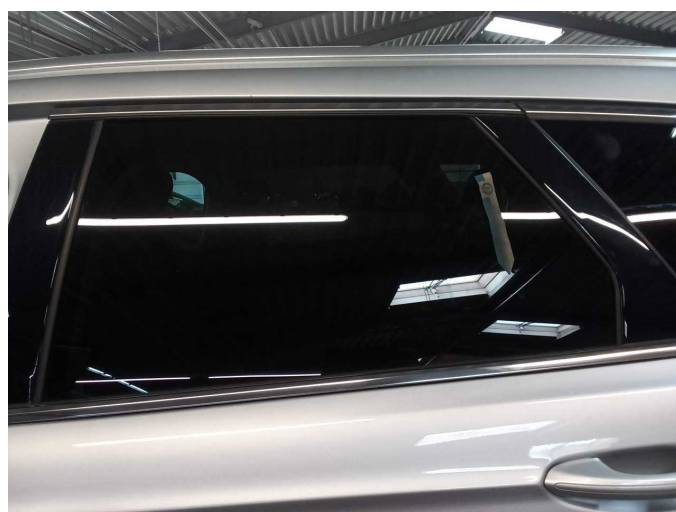
| No. | Component group | Description |
|---|---|---|
| 4 | Trim / covers | Boot lid - interior trim - Scratched - Replace |

**Damage 4:** Trim / covers: Boot lid - interior trim - Scratched - Replace

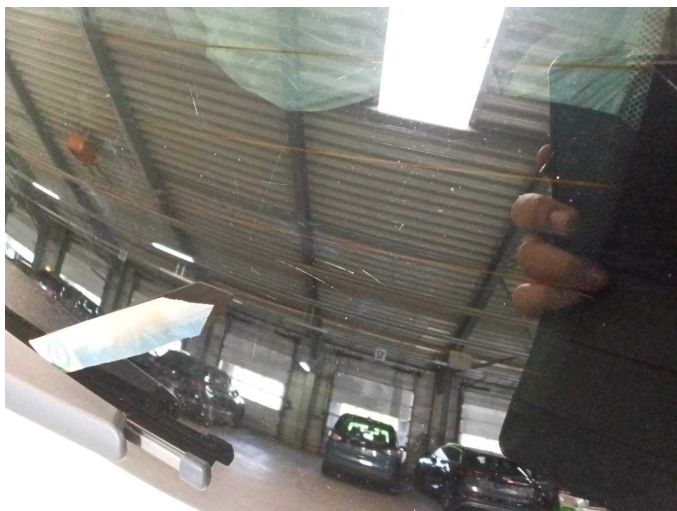
| No. | Component group | Description |
|---|---|---|
| 7 | Vehicle glazing | Rear window - Scratch(es) - Replace |

**Damage 7:** Vehicle glazing: Rear window - Scratch(es) - Replace

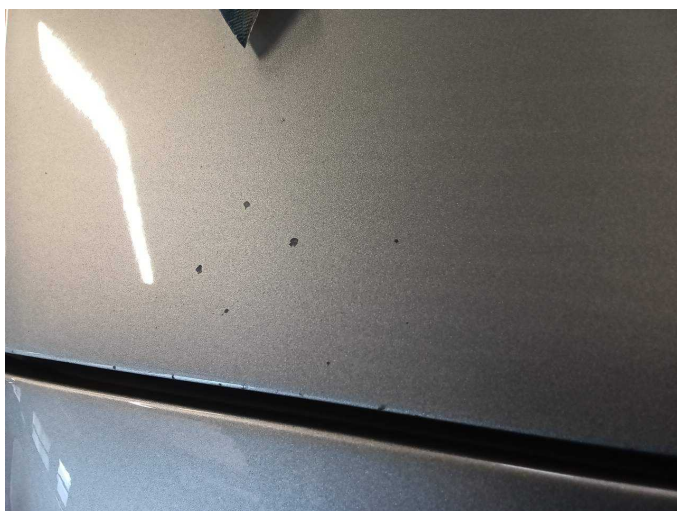
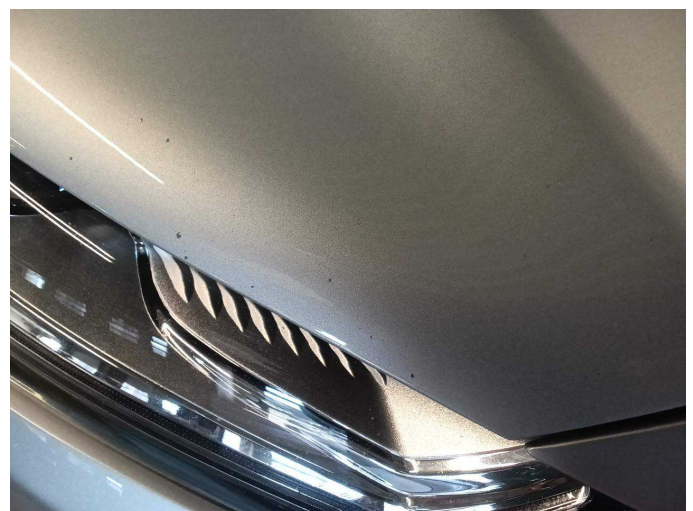
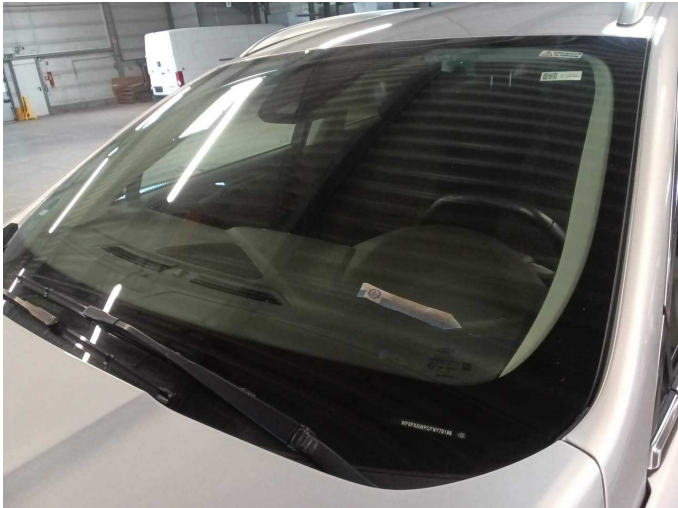
| No. | Component group | Description |
|---|---|---|
| 8 | Bonnet | Bonnet - Stone chips - Paint |

**Damage 8:** Bonnet: Bonnet - Stone chips - Paint

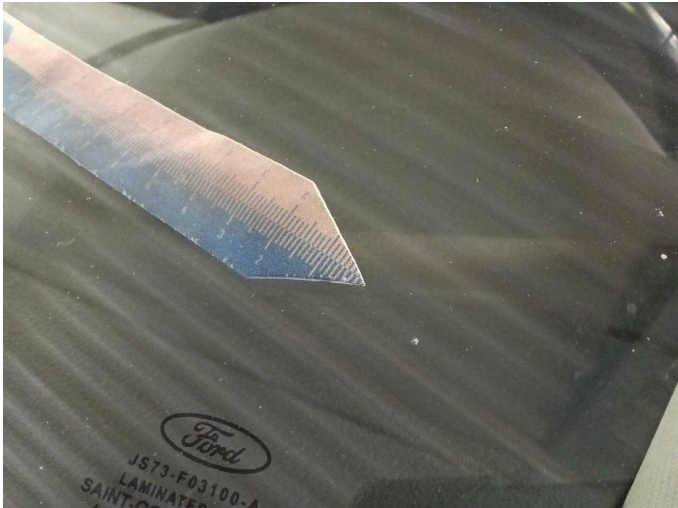
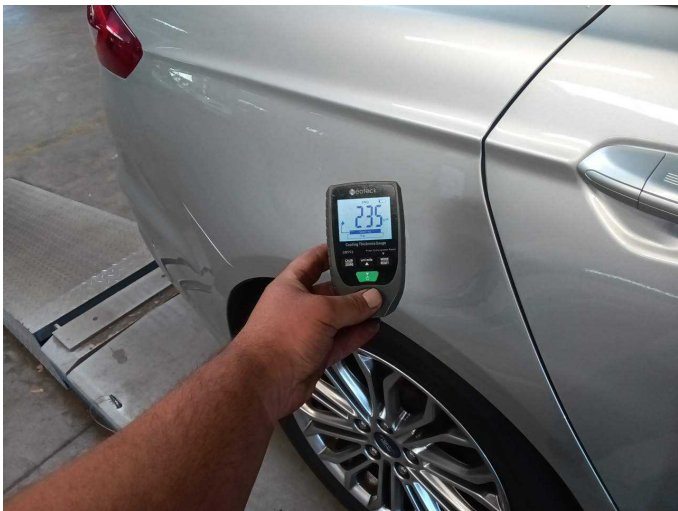
| No. | Component group | Description |
|---|---|---|
| 1 | Vehicle glazing | Windscreen - Stone chips - No deduction |

**Wear and tear 1:** Vehicle glazing: Windscreen - Stone chips - No deduction

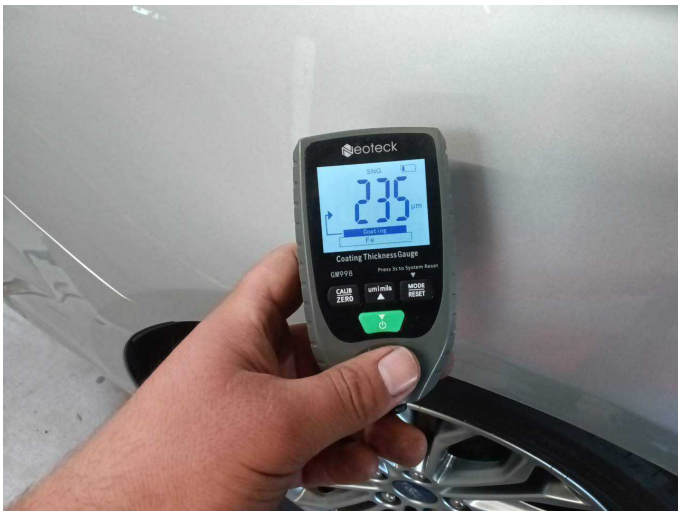
| No. | Repainting |
|---|---|
| 1 | Side panel - rear right side |

| Side panel - rear right side | 235 µm |

**Side panel - rear right side:** 235 µm
