## Expertise

Protocol number: 46288493  
Order No. / Reference: 26487887  
Inspection date: 2 Jul 2026

Model: Golf Variant 2.0 TDI SCR DSG Life

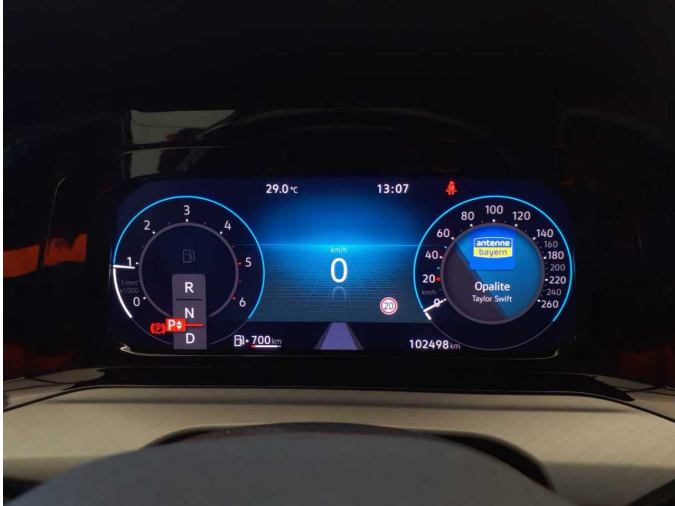
Figure 7: Instrument cluster

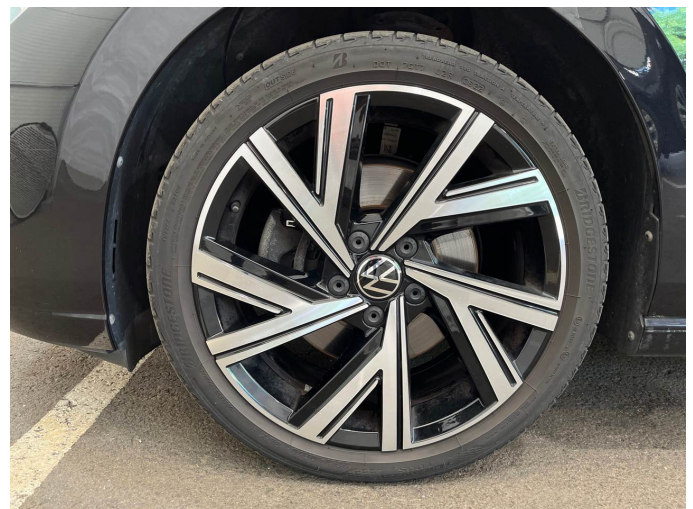
#	Tyre size	Type of tyre	Manufacturer	Tread depth
1)	225/40 R18 92Y	Summer tyres on Light alloy	Bridgestone	4mm / 4mm
2)	225/40 R18 92Y	Summer tyres on Light alloy	Bridgestone	5mm / 5mm

Figure 12: Mounted tyres

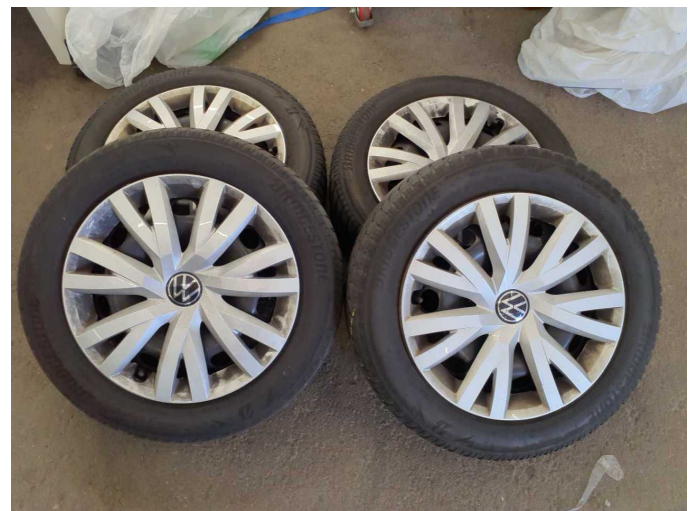
#	Tyre size	Type of tyre	Manufacturer	Tread depth
1)	205/55 R16 91H	Winter tyres on Steel rim with wheel cover	Bridgestone	4mm / 4mm
2)	205/55 R16 91H	Winter tyres on Steel rim with wheel cover	Bridgestone	5mm / 5mm

Figure 16: Additional tyres

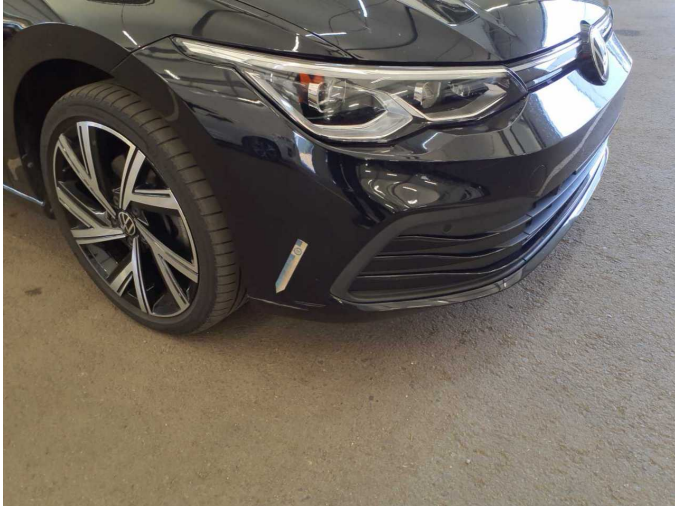
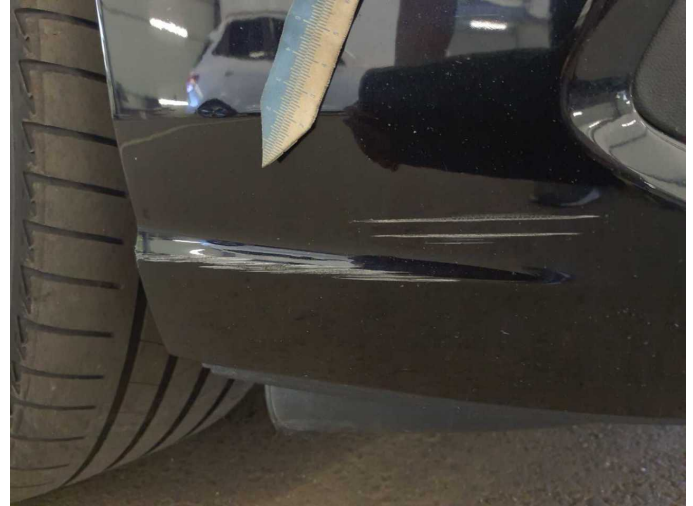
**Damage 1:** Front bumper: Front bumper - Scratch(es) - Paint

No.	Component group	Description
1	Front bumper	Front bumper - Scratch(es) - Paint
2	Vehicle glazing	Windscreen with lane departure assistant - Broken / torn - repair according to calculation

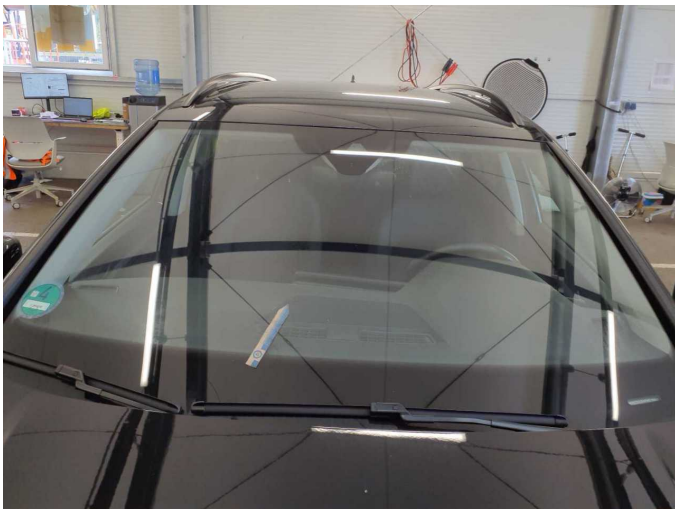
**Damage 2:** Vehicle glazing: Windscreen with lane departure assistant - Broken / torn - repair according to calculation
