Expertise

Protocol number: 45821778  
Order No. / Reference: 26402910  
Inspection date: 5 Jun 2026

Manufacturer: Mercedes-Benz  
VIN: W1N4M1DB9RW339883

Model: GLB 200 d 4Matic 8G-DCT Progressive Advanced

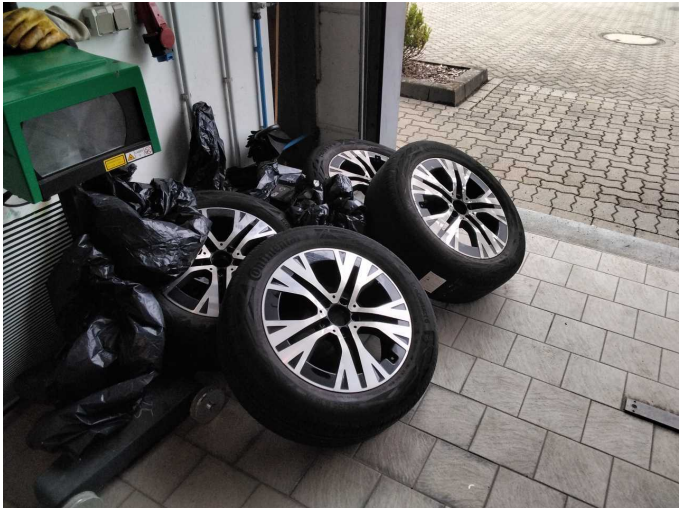
Figure 14: Additional tyres

| No. | Component group | Description |
|---|---|---|
| 7 | 2nd wheel set | 2 tyres - Damaged - Replace |

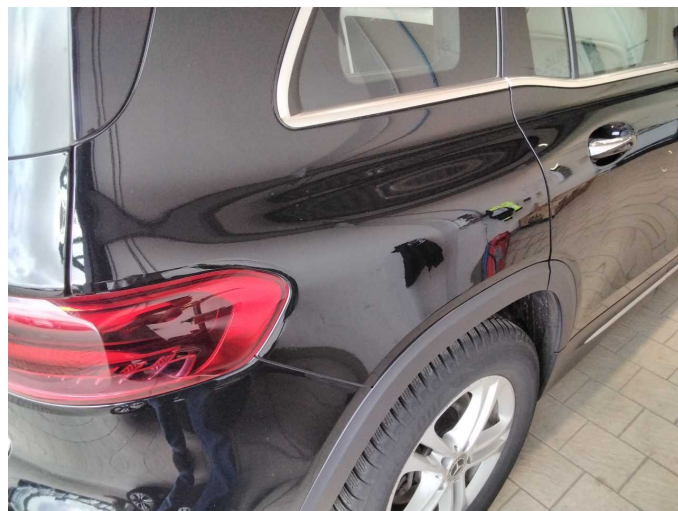
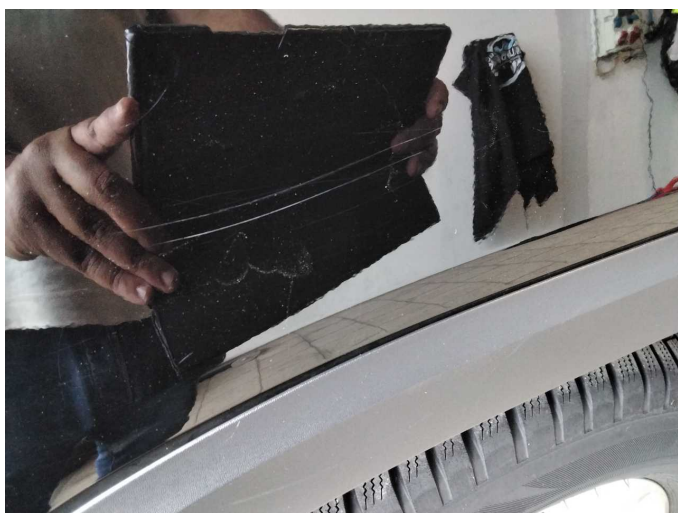
| No. | Component group | Description |
|---|---|---|
| 1 | Side panel - rear right side | Side panel - Scratch(es) - Cover / polish |

**Damage 1:** Side panel - rear right side: Side panel - Scratch(es) - Cover / polish

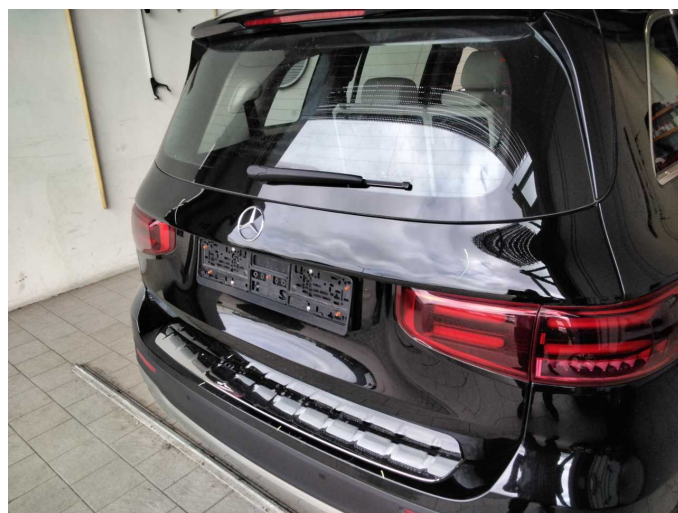
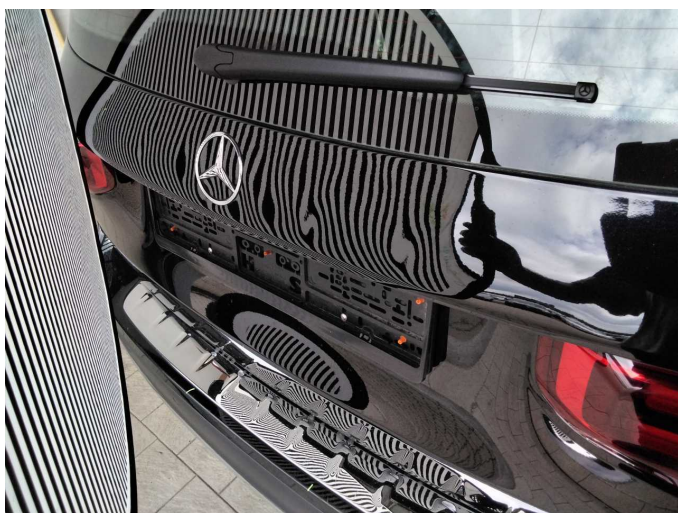
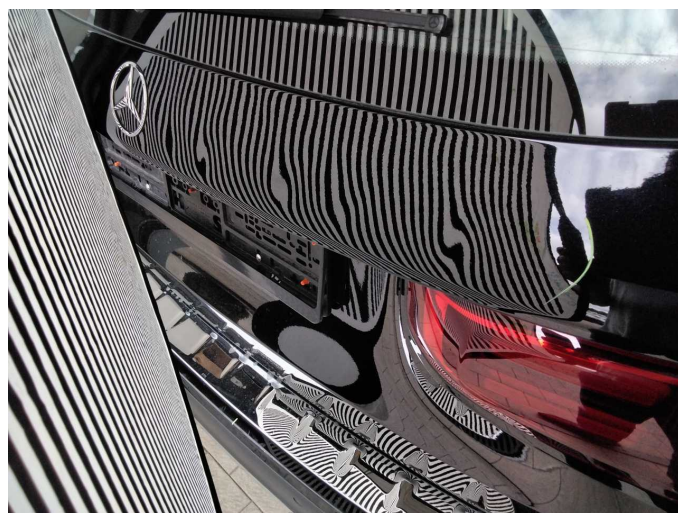
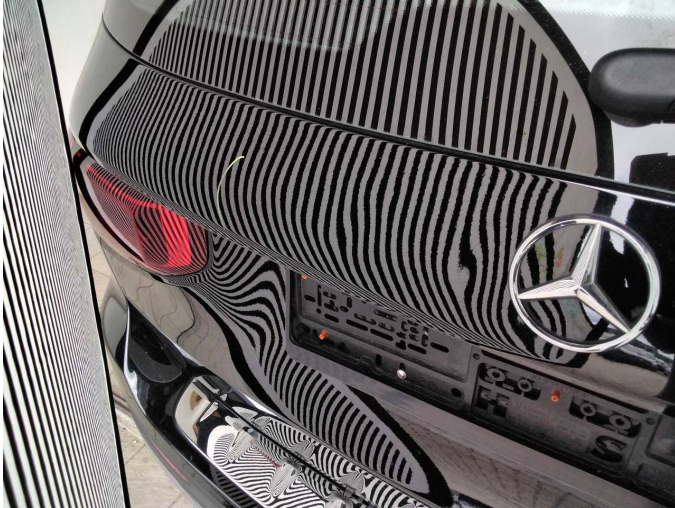
| No. | Component group | Description |
|---|---|---|
| 2 | Boot lid / rear door | Boot lid - dent(s) - Smooth repair work |

**Damage 2:** Boot lid / rear door: Boot lid - dent(s) - Smooth repair work

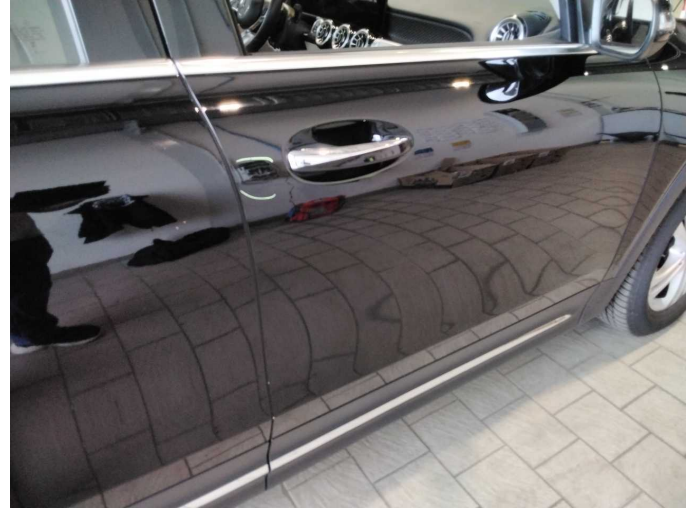
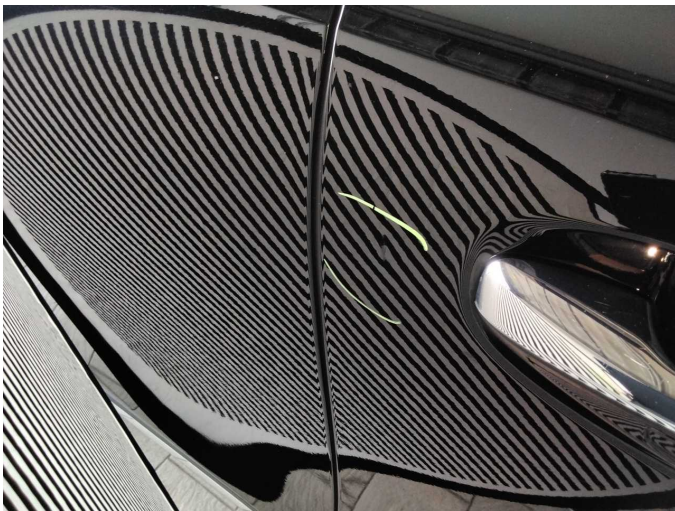
| No. | Component group | Description |
|---|---|---|
| 3 | Door - front right side | Door - Dent / paintcoat damage - Smart repair |

**Damage 3:** Door - front right side: Door - Dent / paintcoat damage - Smart repair

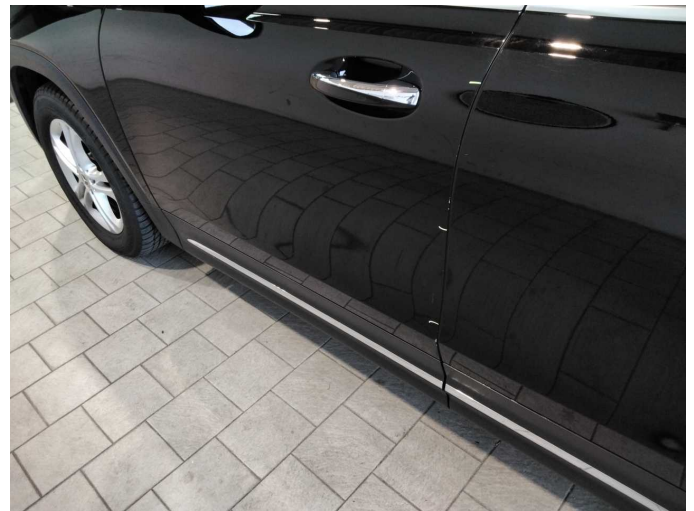
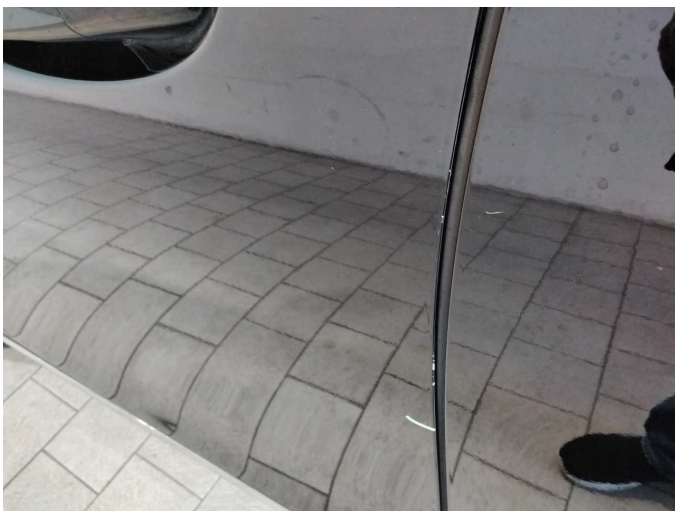
| No. | Component group | Description |
|---|---|---|
| 4 | Door - front left side | Door edge - Scratch(es) - Smart repair |

**Damage 4:** Door - front left side: Door edge - Scratch(es) - Smart repair

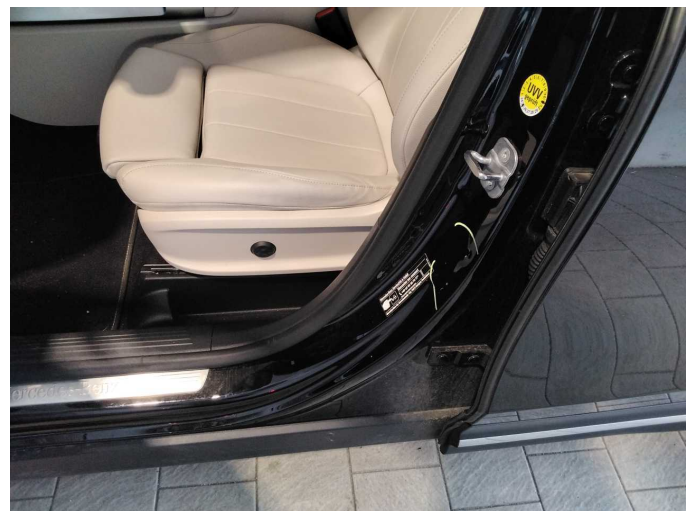
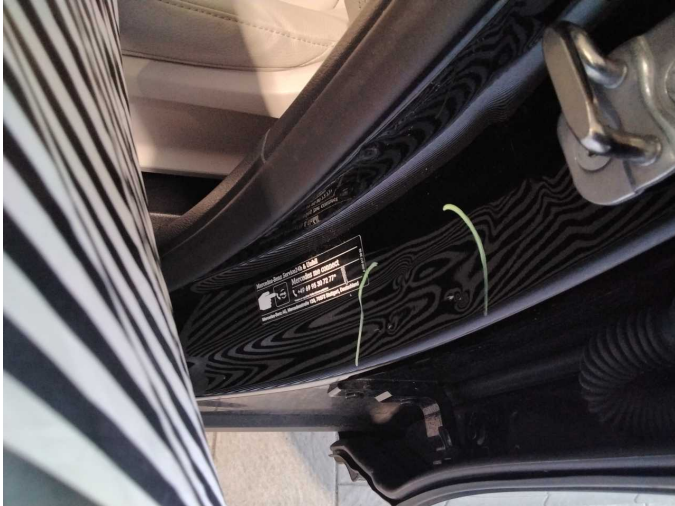
| No. | Component group | Description |
|---|---|---|
| 5 | Body | B-pillar - left side - Dent / paintcoat damage - Smart repair |

**Damage 5:** Body: B-pillar - left side - Dent / paintcoat damage - Smart repair

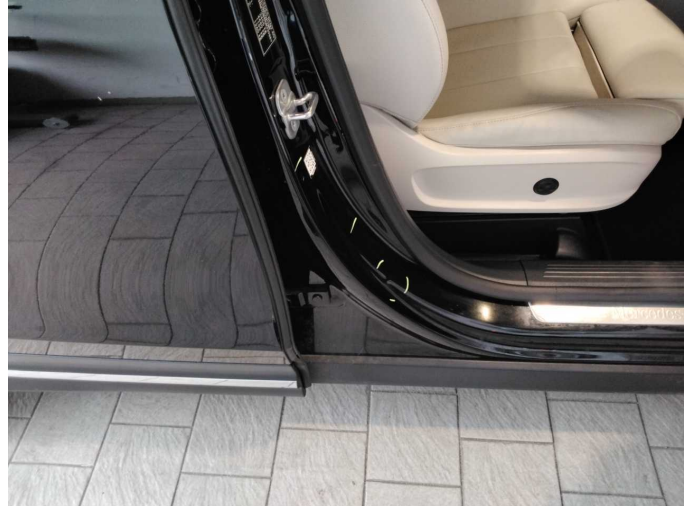
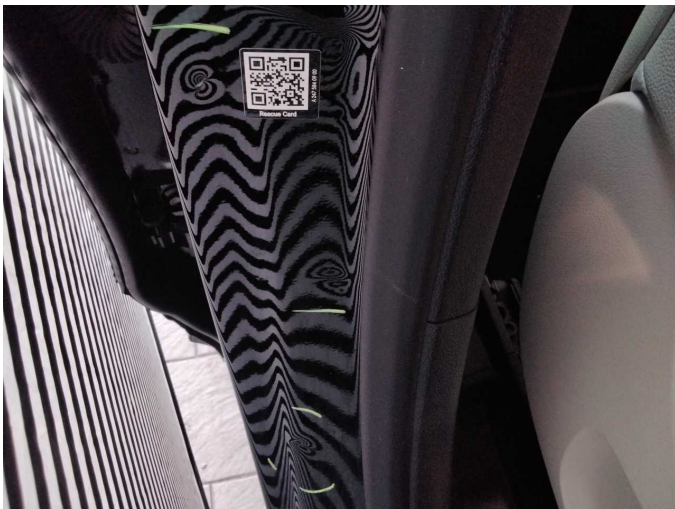
| No. | Component group | Description |
|---|---|---|
| 6 | Body | B-pillar - right side - Dent / paintcoat damage - Smart repair |

**Damage 6:** Body: B-pillar - right side - Dent / paintcoat damage - Smart repair

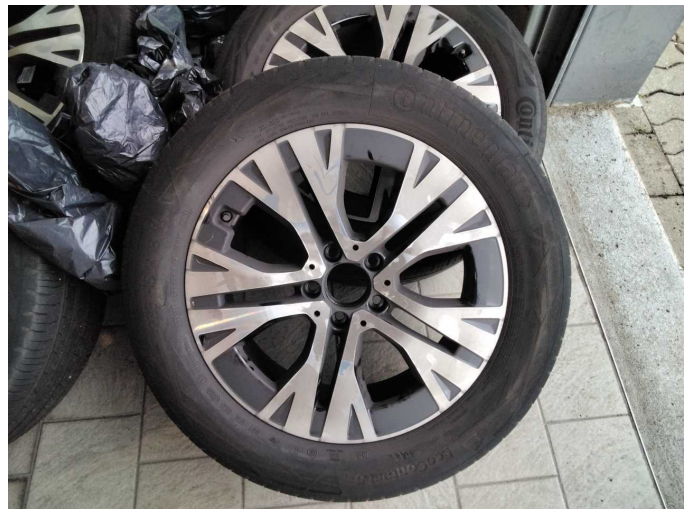
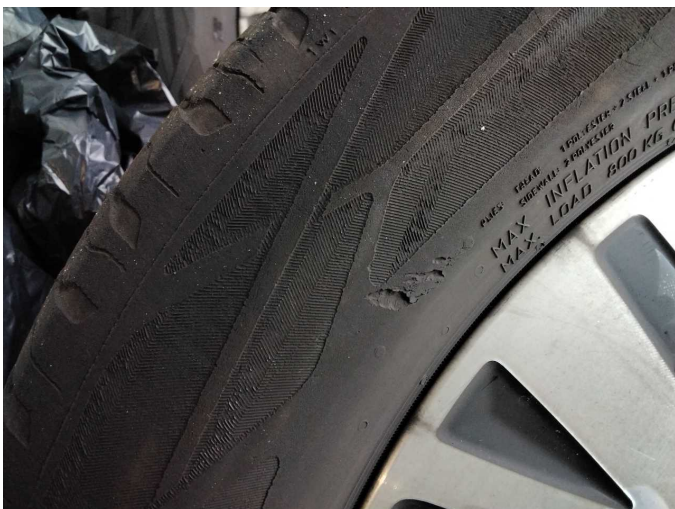
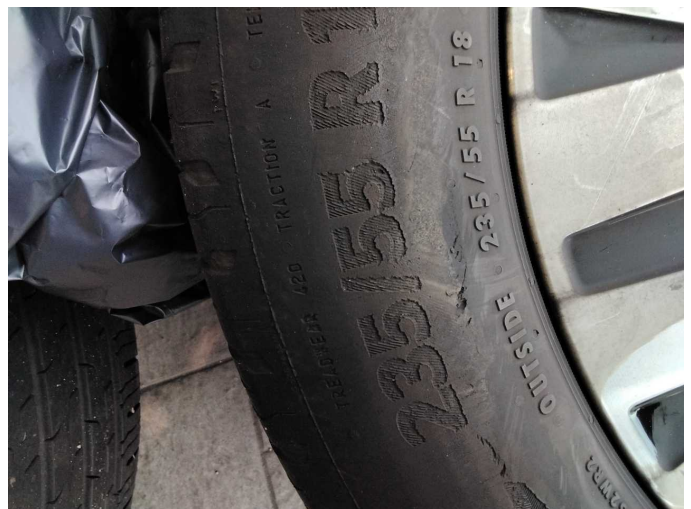
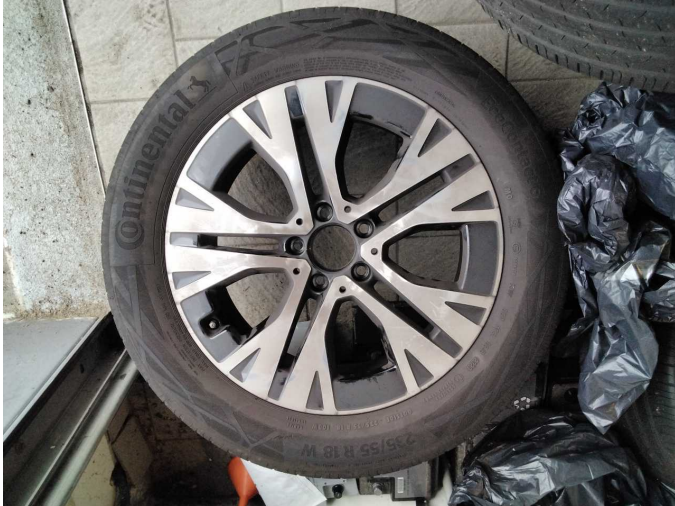
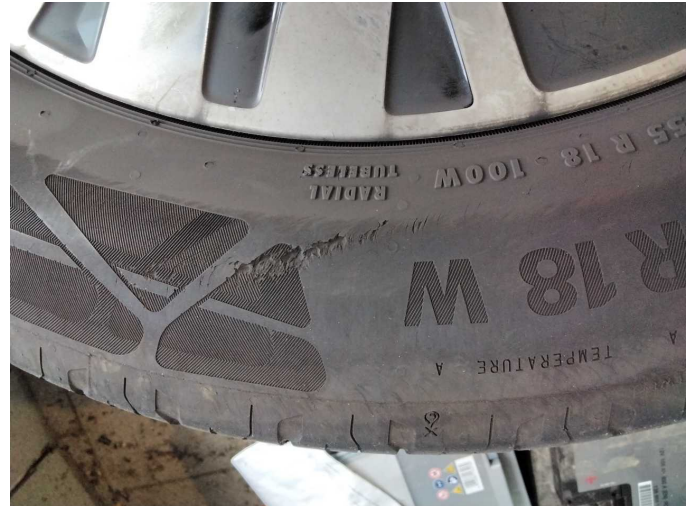
**Damage 7:** 2nd wheel set: 2 tyres - Damaged - Replace

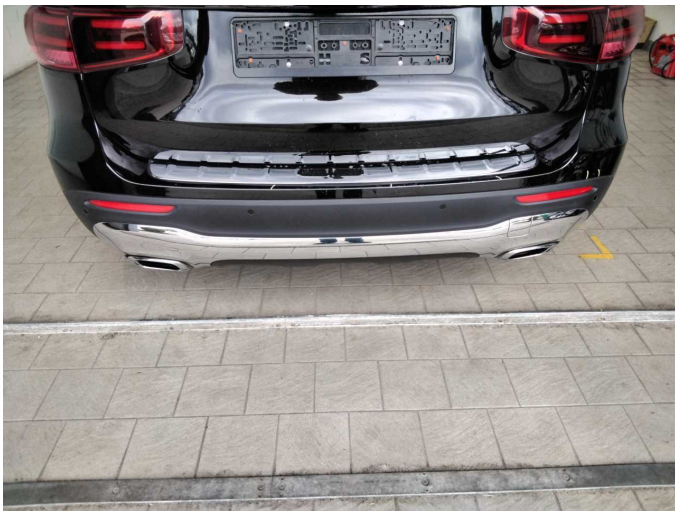
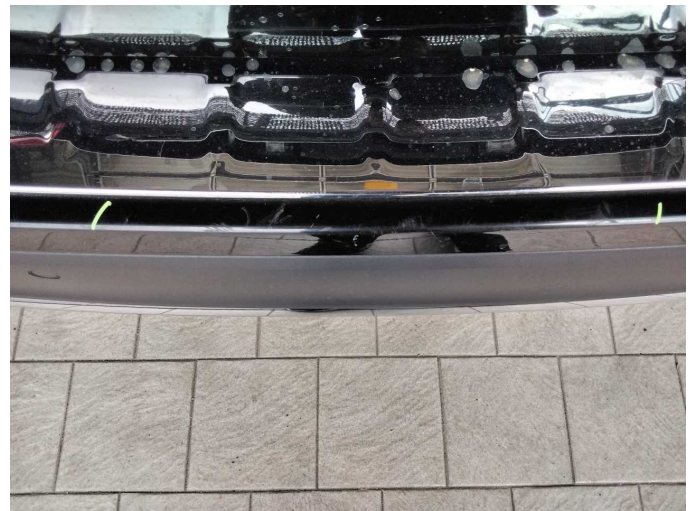
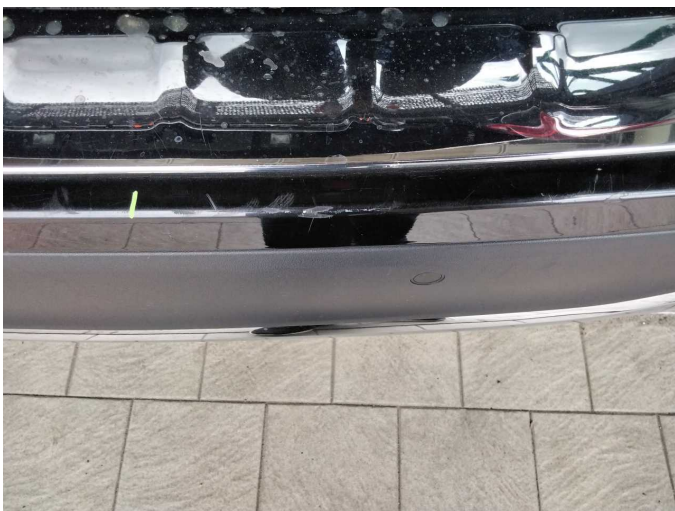
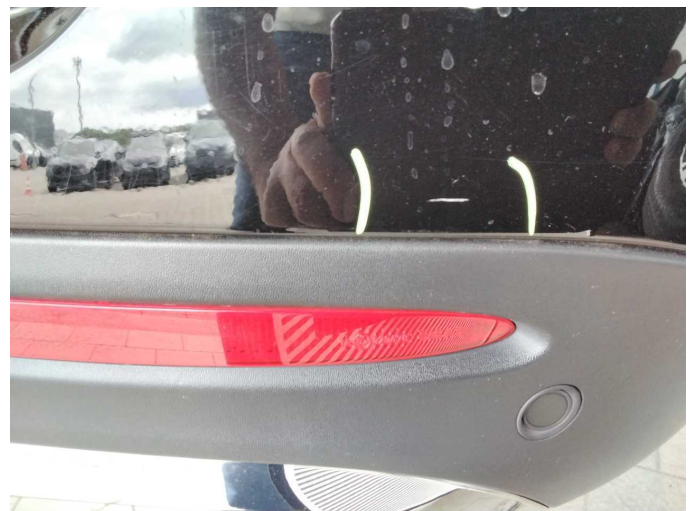
| No. | Component group | Description |
|---|---|---|
| 8 | Rear bumper | Rear bumper - Scratch(es) - Paint |

**Damage 8:** Rear bumper: Rear bumper - Scratch(es) - Paint

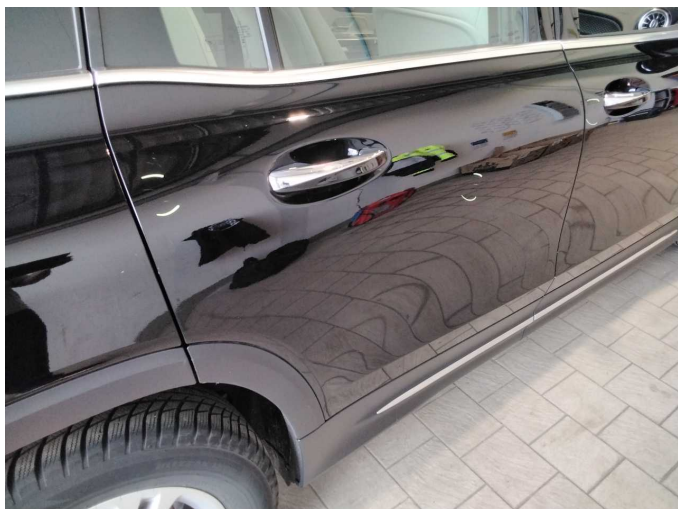
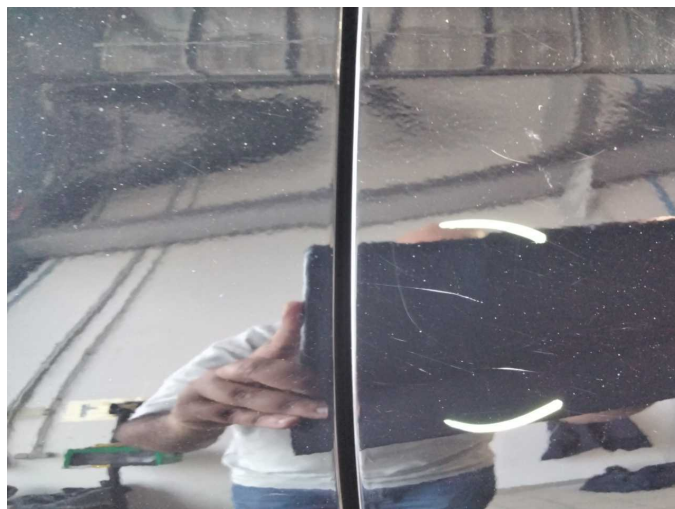
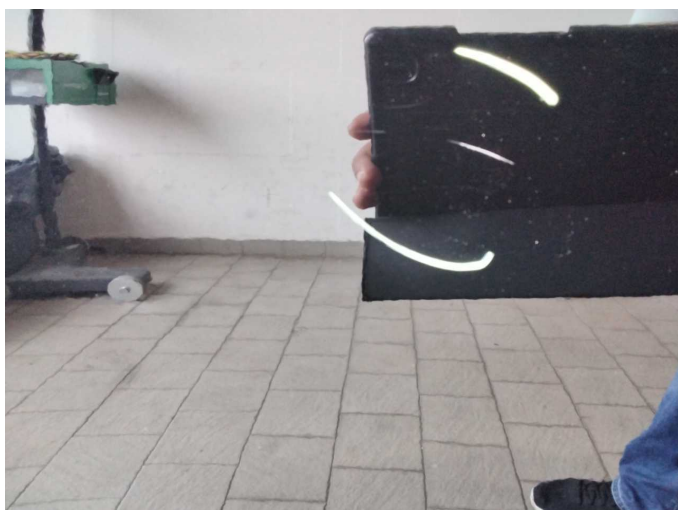
| No. | Component group | Description |
|---|---|---|
| 9 | Door - rear right side | Door - Scratch(es) - Paint |

**Damage 9:** Door - rear right side: Door - Scratch(es) - Paint

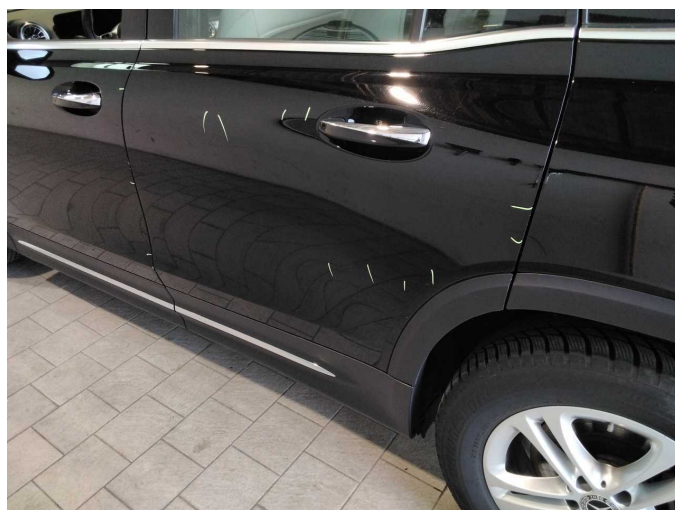
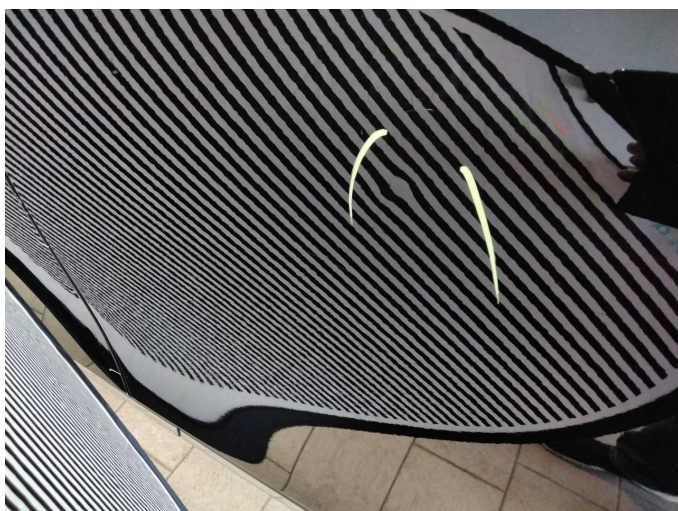
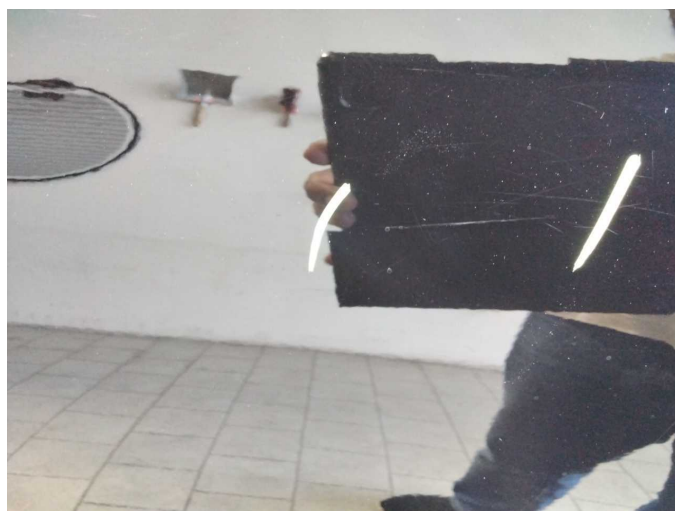
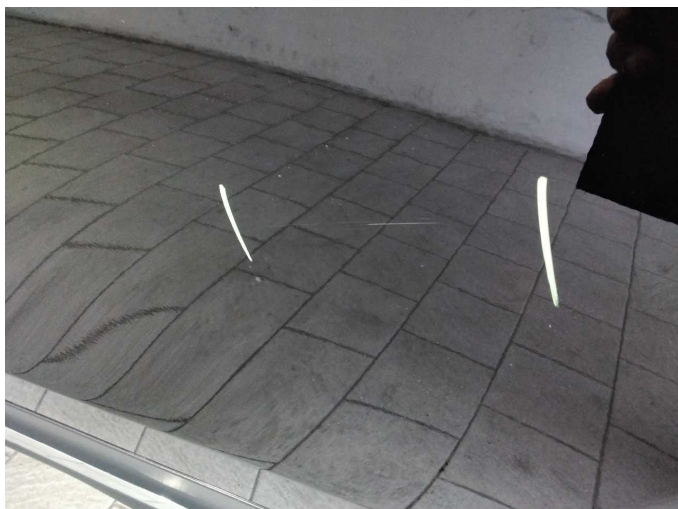
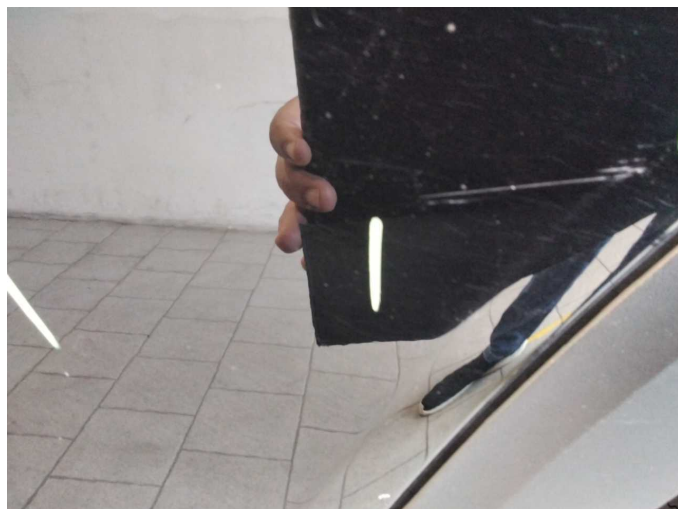
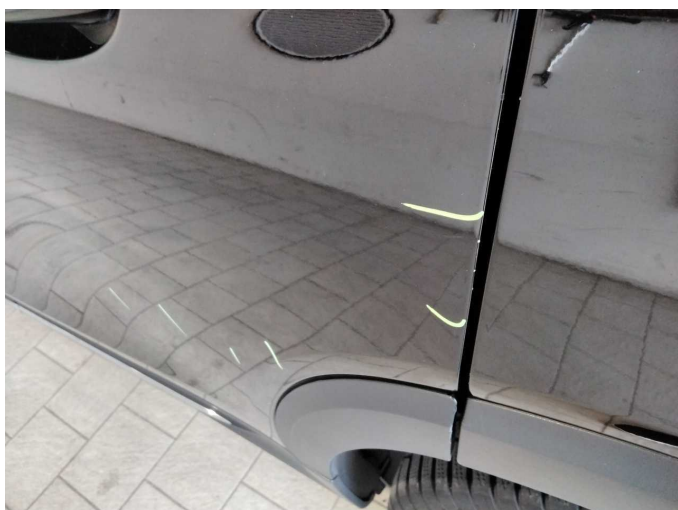
| No. | Component group | Description |
|---|---|---|
| 10 | Door - rear left side | Door - Dent / paintcoat damage - Repair and paint |

**Damage 10:** Door - rear left side: Door - Dent / paintcoat damage - Repair and paint

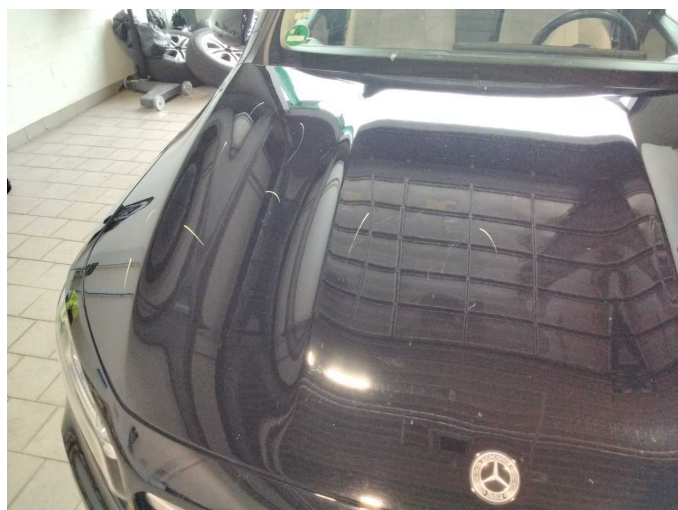
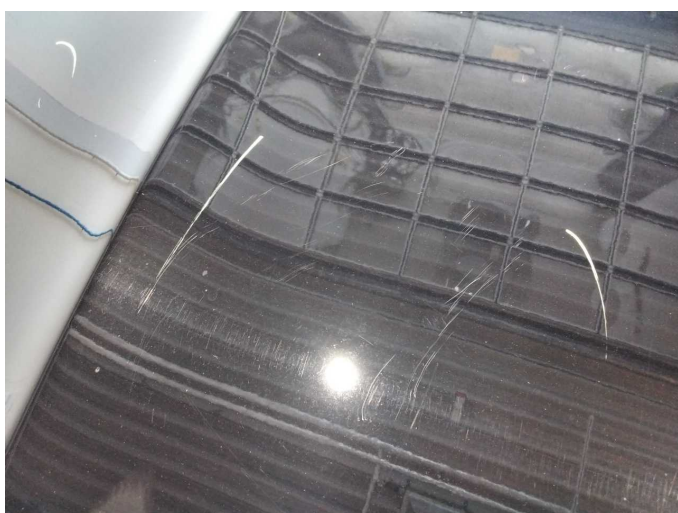
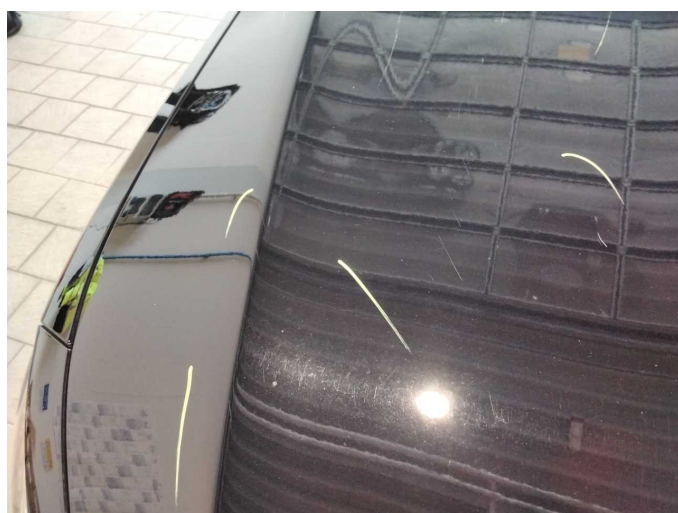
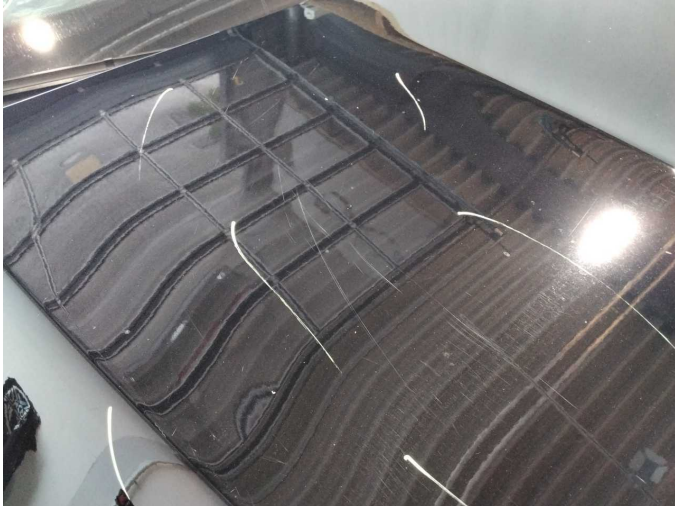
| No. | Component group | Description |
|---|---|---|
| 11 | Bonnet | Bonnet - Scratch(es) - Paint |

**Damage 11:** Bonnet: Bonnet - Scratch(es) - Paint

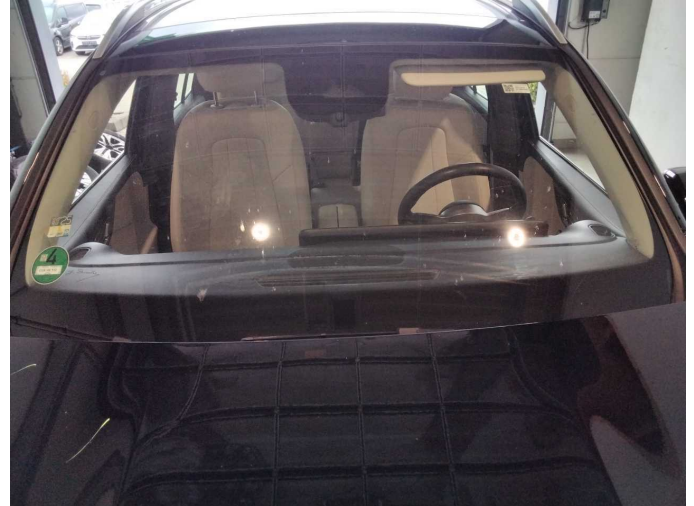
| No. | Component group | Description |
|---|---|---|
| 1 | Vehicle glazing | Windscreen - Stone chips - No deduction |

**Wear and tear 1:** Vehicle glazing: Windscreen - Stone chips - No deduction

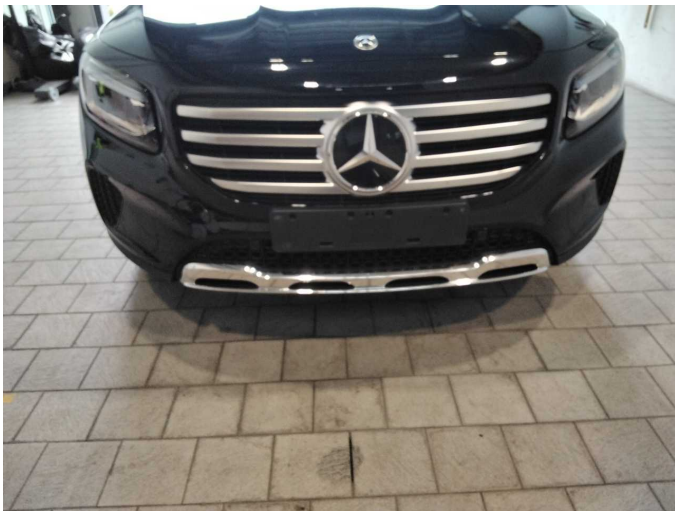
| No. | Component group | Description |
|---|---|---|
| 2 | Front bumper | Front bumper - Stone chips - No deduction |

**Wear and tear 2:** Front bumper: Front bumper - Stone chips - No deduction
