Expertise

Protocol number: 46468278  
Order No. / Reference: 26609262  
Inspection date: 13 Jul 2026

Manufacturer: Ford

Model: Focus Turnier 1.5 EcoBlue Start-Stopp-System  
COOL&CONNECT

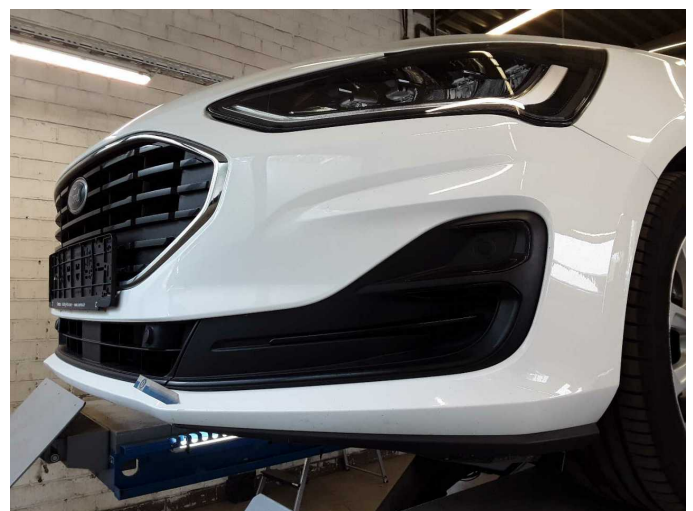
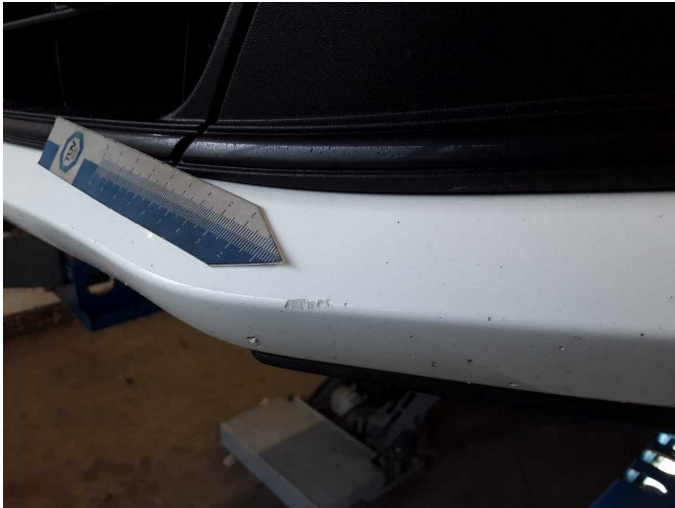
| No. | Component group | Description |
|---|---|---|
| 1 | Front bumper | Front bumper - Scratch(es) - Smart repair |

Damage 1: Front bumper: Front bumper - Scratch(es) - Smart repair

**Damage 1:** Front bumper: Front bumper - Scratch(es) - Smart repair

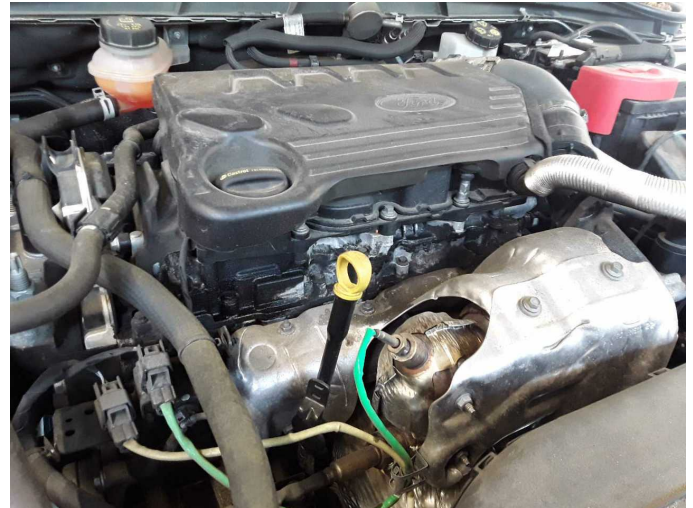
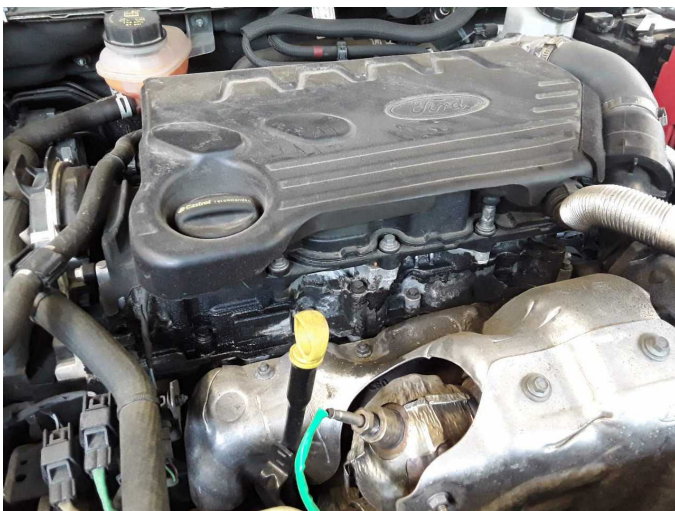
| No. | Component group | Description |
|---|---|---|
| 2 | Engine | Engine - Leaking - Diagnosed and repair if necessary |

**Damage 2:** Engine: Engine - Leaking - Diagnosed and repair if necessary

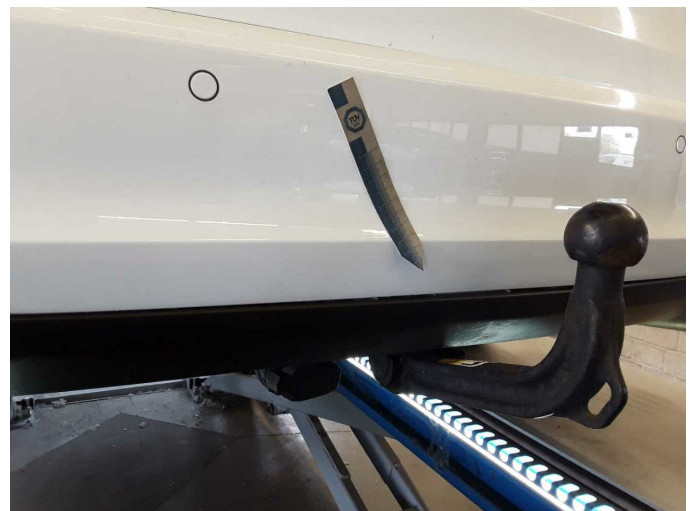
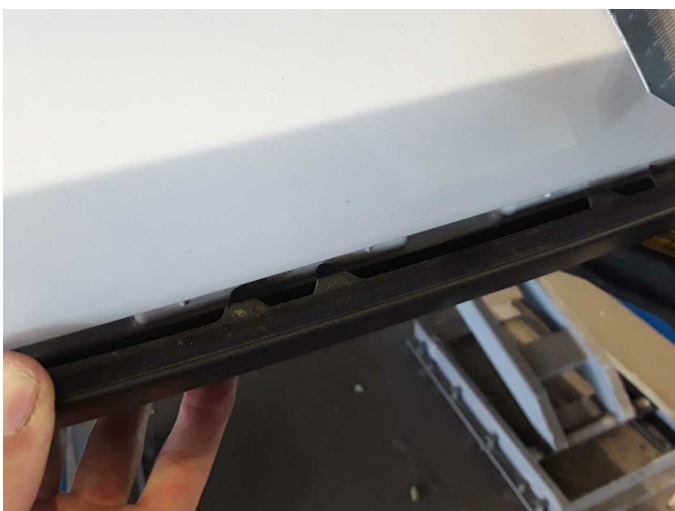
| No. | Component group | Description |
|---|---|---|
| 3 | Rear bumper | Spoiler - Damaged - Replace |

**Damage 3:** Rear bumper: Spoiler - Damaged - Replace

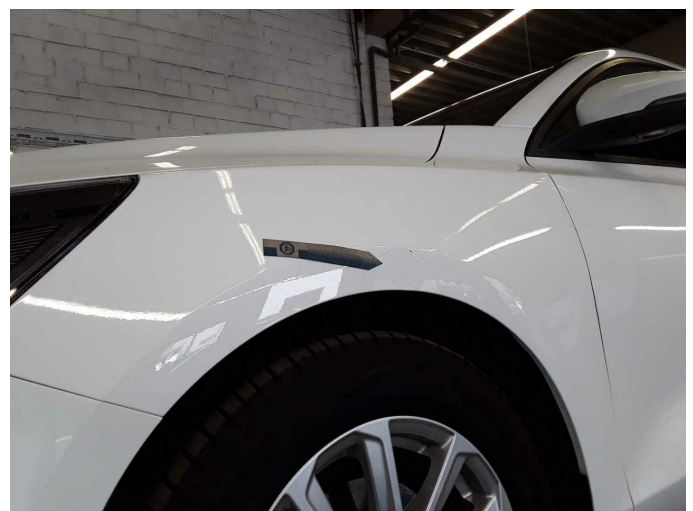
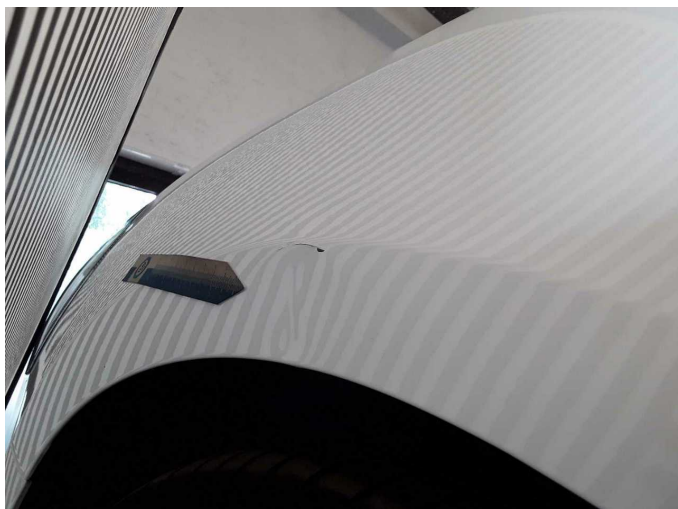
| No. | Component group | Description |
|---|---|---|
| 4 | Mudguard - left side | Mudguard - left side - Dent / paintcoat damage - Repair and paint |

**Damage 4:** Mudguard - left side: Mudguard - left side - Dent / paintcoat damage - Repair and paint

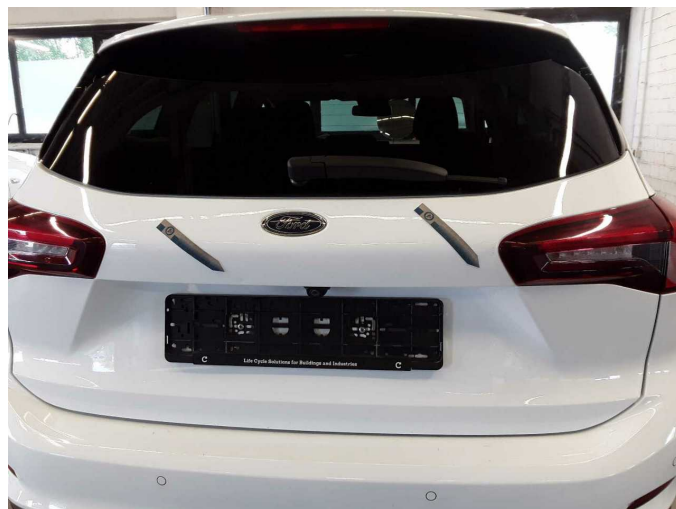
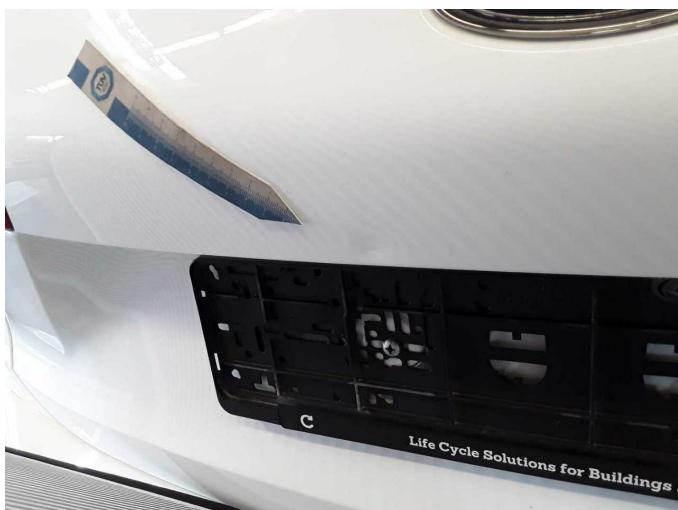
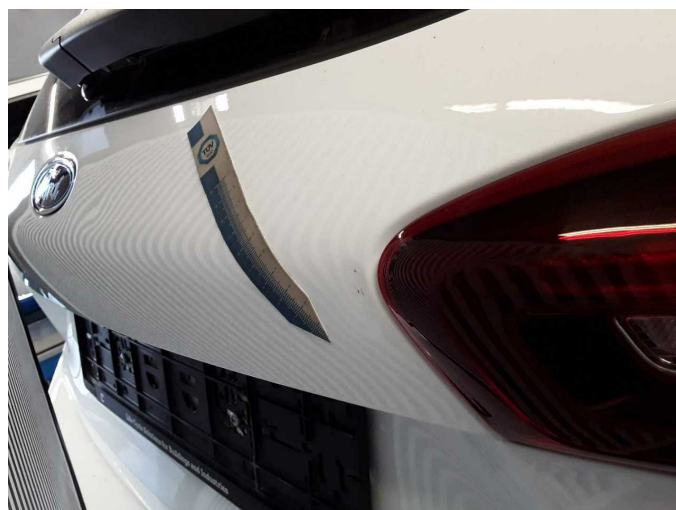
| No. | Component group | Description |
|---|---|---|
| 5 | Boot lid / rear door | Boot lid - Dent / paintcoat damage - Repair and paint |

**Damage 5:** Boot lid / rear door: Boot lid - Dent / paintcoat damage - Repair and paint

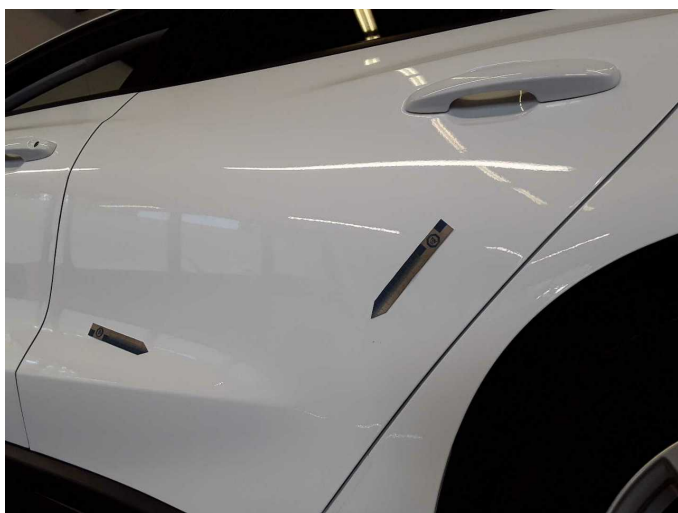
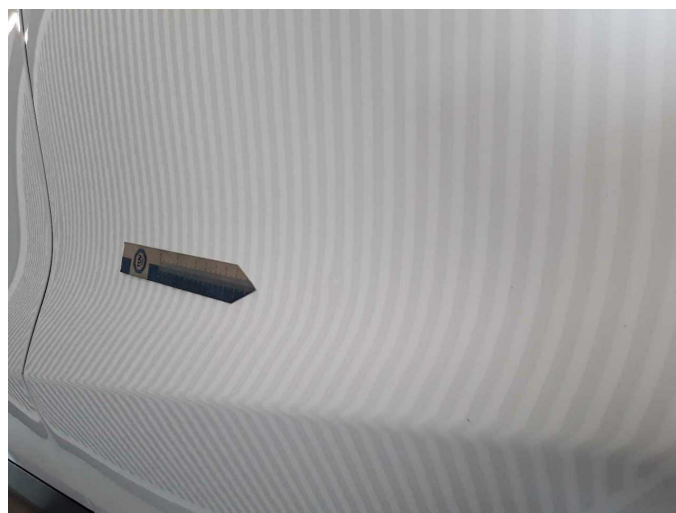
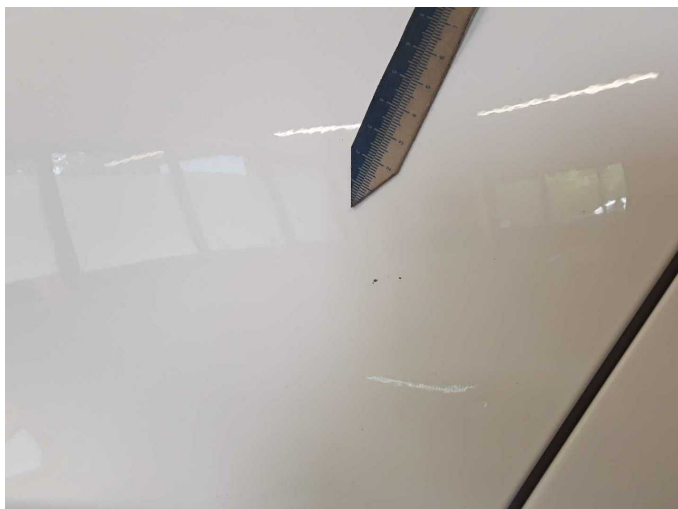
| No. | Component group | Description |
|---|---|---|
| 6 | Door - rear left side | Door - Dent / paintcoat damage - Repair and paint |

**Damage 6:** Door - rear left side: Door - Dent / paintcoat damage - Repair and paint

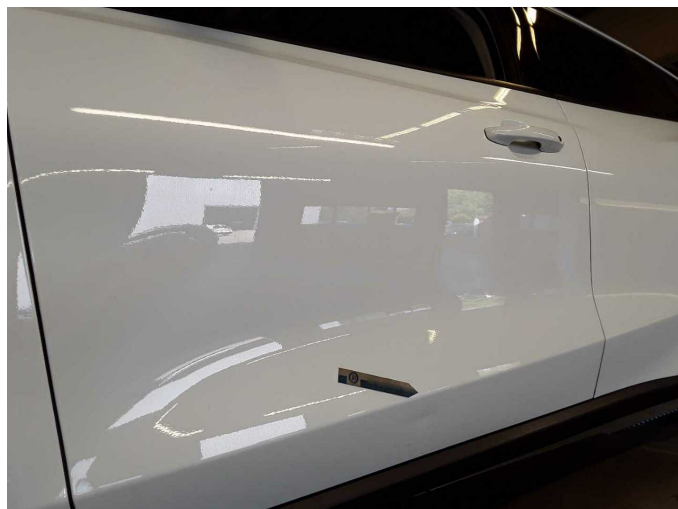
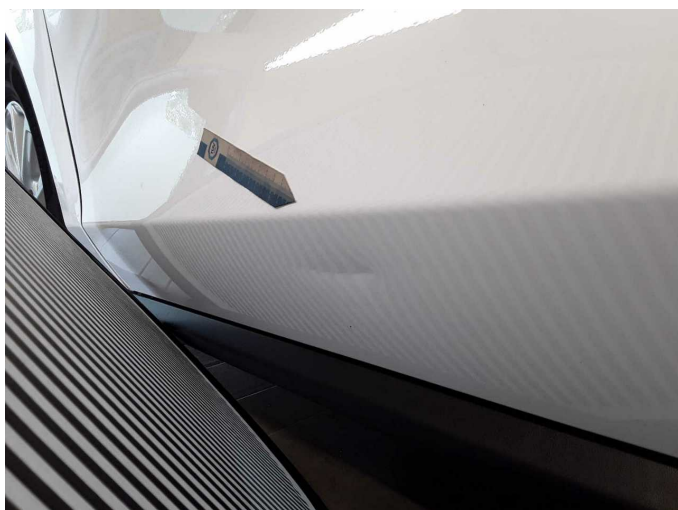
| No. | Component group | Description |
|---|---|---|
| 7 | Door - front left side | Door - Deformed - Repair and paint |

**Damage 7:** Door - front left side: Door - Deformed - Repair and paint

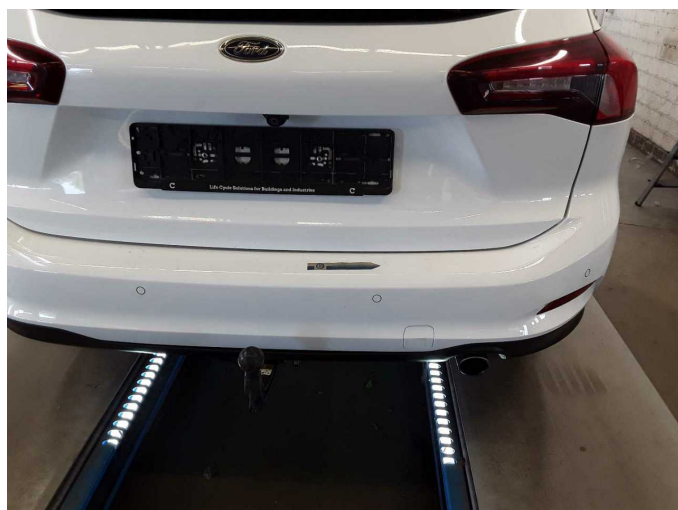
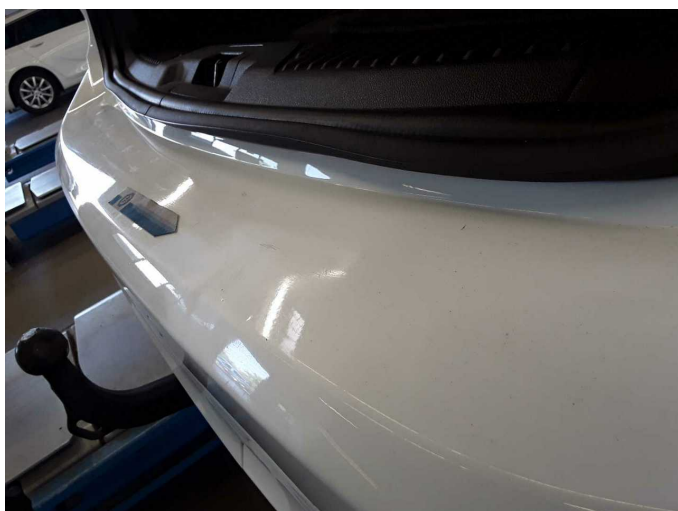
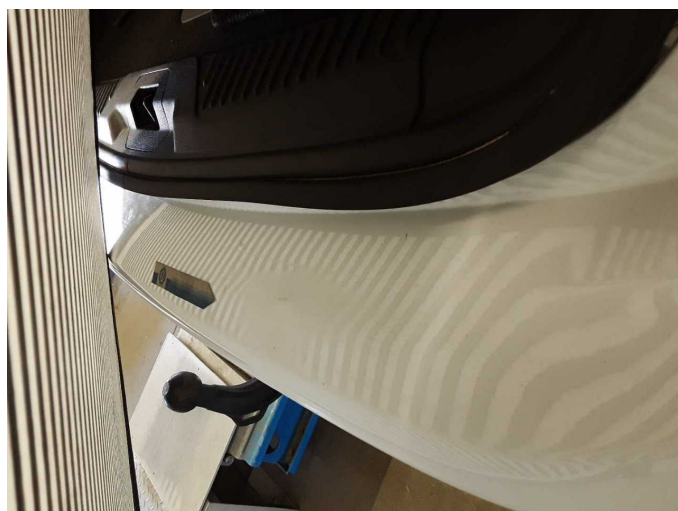
| No. | Component group | Description |
|---|---|---|
| 8 | Rear bumper | Rear bumper - Damaged - Replace |

**Damage 8:** Rear bumper: Rear bumper - Damaged - Replace
