Expertise

Protocol number: 46044509  
Order No. / Reference: 26521030  
Inspection date: 18 Jun 2026

Manufacturer: Volkswagen

Model: Passat Variant 2.0 TDI SCR DSG Business

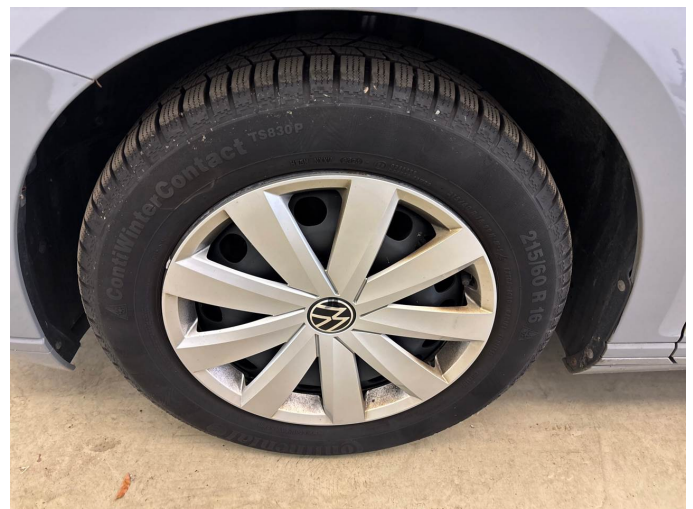
Figure 12: Mounted tyres

| # | Tyre size | Type of tyre | Manufacturer | Tread depth |
|---|---|---|---|---|
| 1) | 215/60 R16 99H | Winter tyres on Steel rim with wheel cover | Continental | 6mm / 6mm |
| 2) | 215/60 R16 99H | Winter tyres on Steel rim with wheel cover | Continental | 6mm / 6mm |

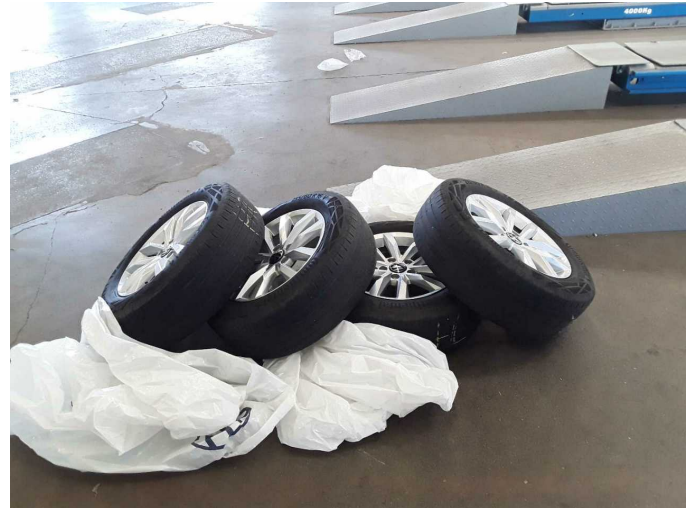
Figure 14: Additional tyres

| # | Tyre size | Type of tyre | Manufacturer | Tread depth |
|---|---|---|---|---|
| 1) | 215/60 R16 95V | Summer tyres on Light alloy | Continental | 3mm / 3mm |
| 2) | 215/60 R16 95V | Summer tyres on Light alloy | Continental | 3mm / 3mm |

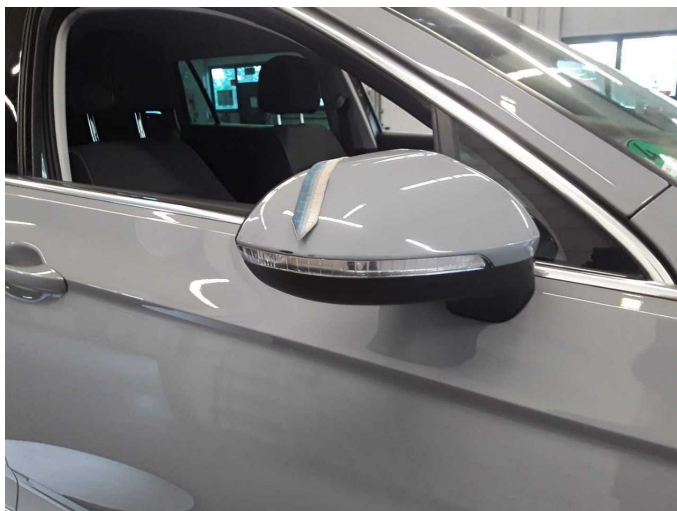
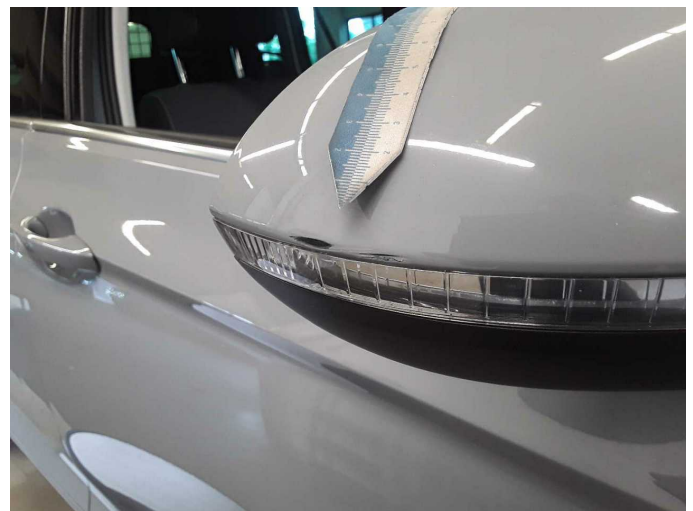
| No. | Component group | Description |
|---|---|---|
| 1 | Wing mirror - right side | Cap - Scratch(es) - Smart repair |

Damage 1: Wing mirror - right side: Cap - Scratch(es) - Smart repair

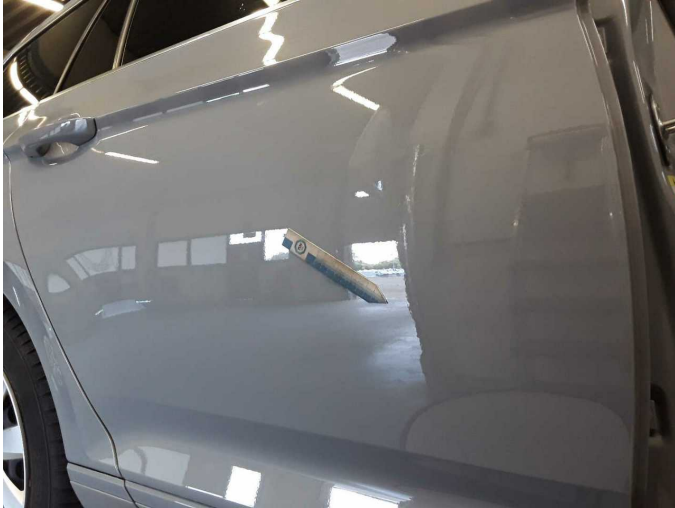
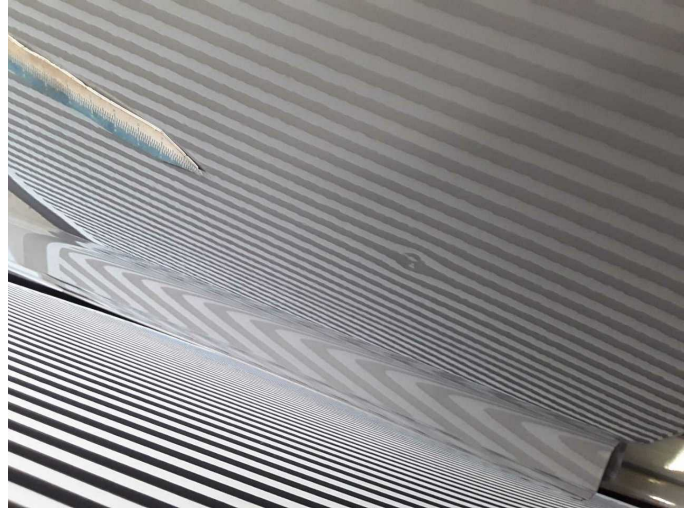
| No. | Component group | Description |
|---|---|---|
| 2 | Door - rear right side | Door - Dent / paintcoat damage - Smart repair |

**Damage 2:** Door - rear right side: Door - Dent / paintcoat damage - Smart repair

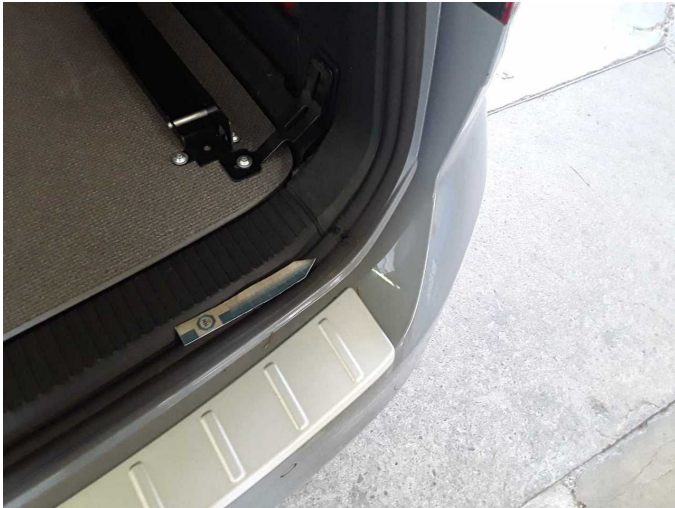
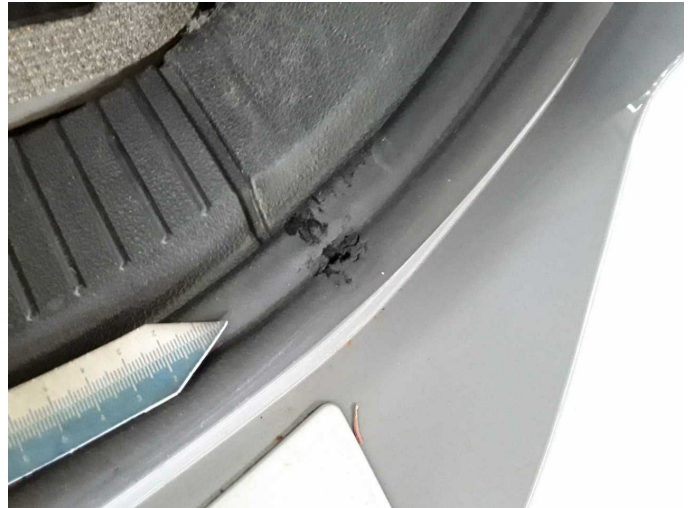
| No. | Component group | Description |
|---|---|---|
| 3 | Cab | Door rubber seal - left side (Heckklappe) - Damaged - Replace |

**Damage 3:** Cab: Door rubber seal - left side (Heckklappe) - Damaged - Replace

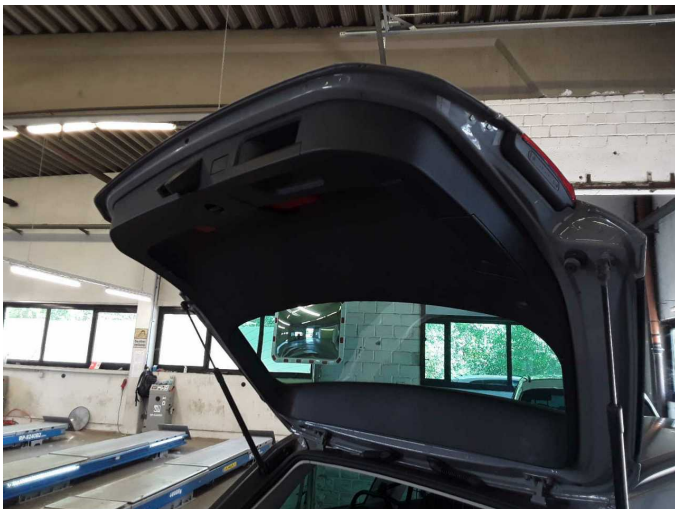
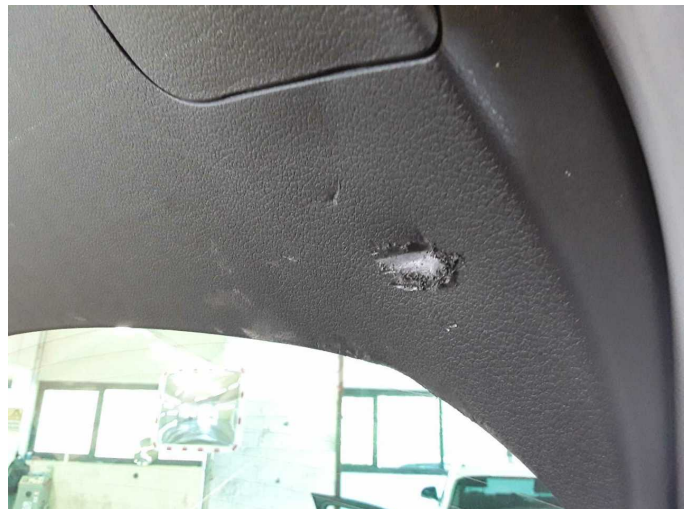
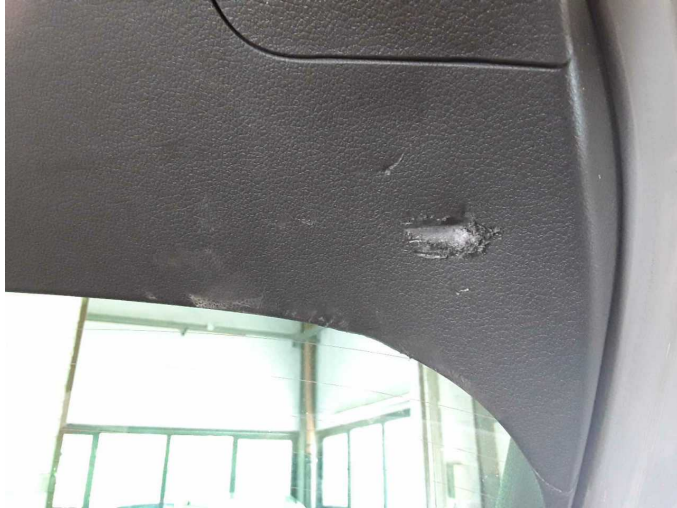
| No. | Component group | Description |
|---|---|---|
| 4 | Trim / covers | Boot lid - interior trim - Damaged - Replace |

**Damage 4:** Trim / covers: Boot lid - interior trim - Damaged - Replace

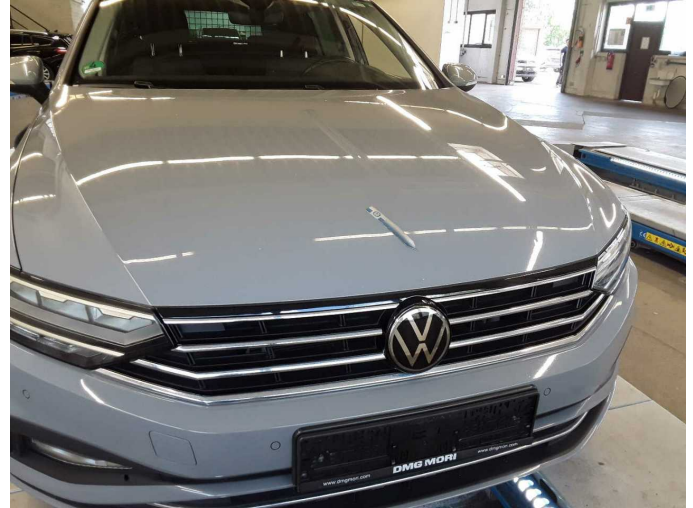
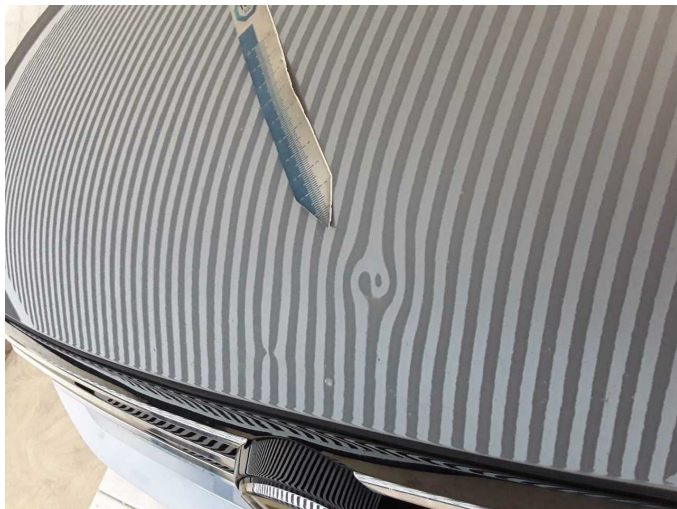
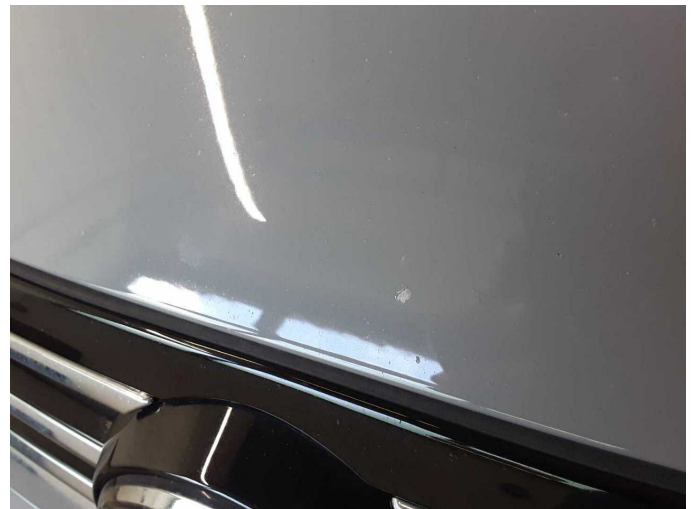
| No. | Component group | Description |
|---|---|---|
| 5 | Bonnet | Bonnet - Dent / paintcoat damage - Paint |

**Damage 5:** Bonnet: Bonnet - Dent / paintcoat damage - Paint

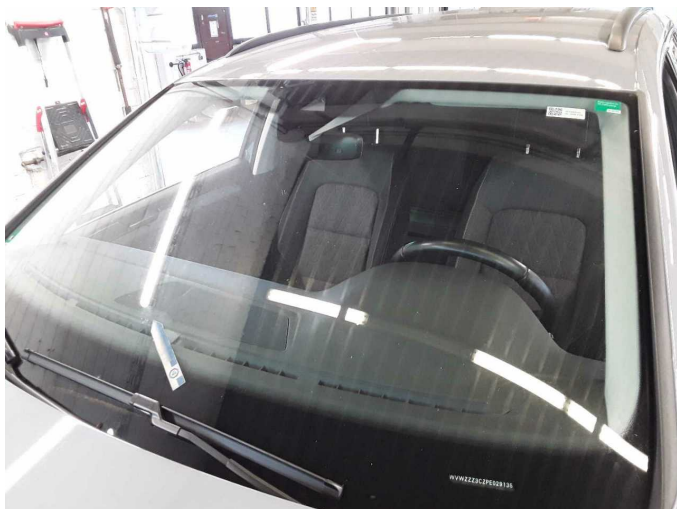
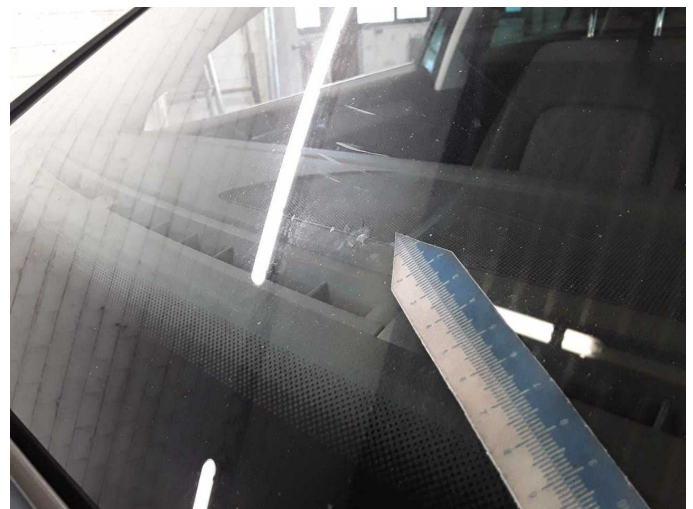
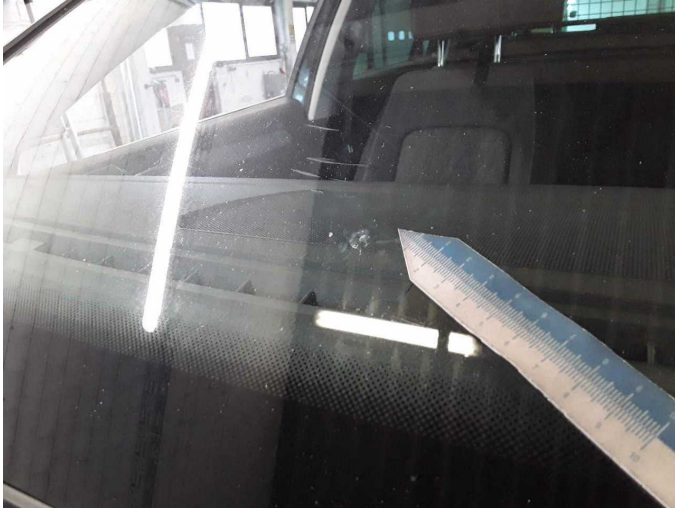
| No. | Component group | Description |
|---|---|---|
| 6 | Vehicle glazing | Windscreen (Rissbildung) - Stone chips - Replace |

**Damage 6:** Vehicle glazing: Windscreen (Rissbildung) - Stone chips - Replace

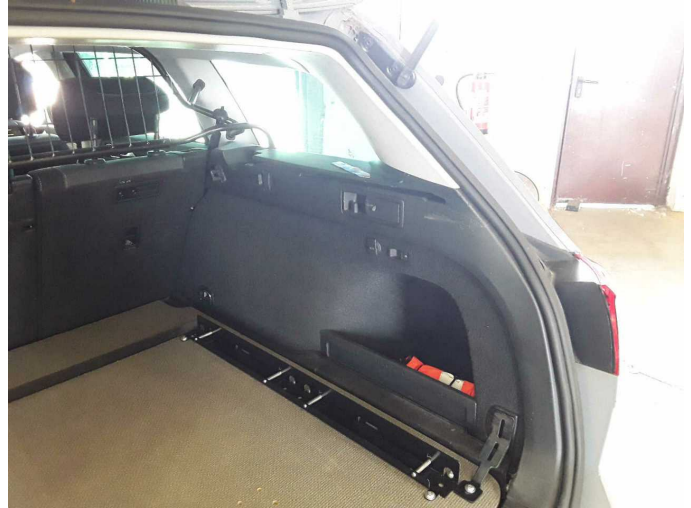
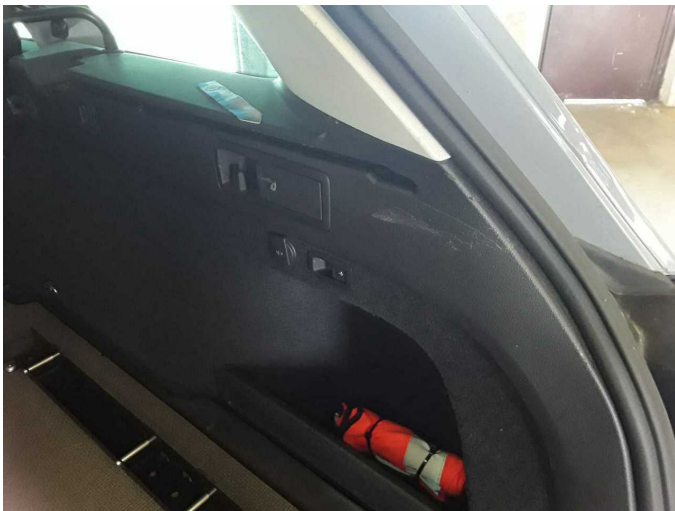
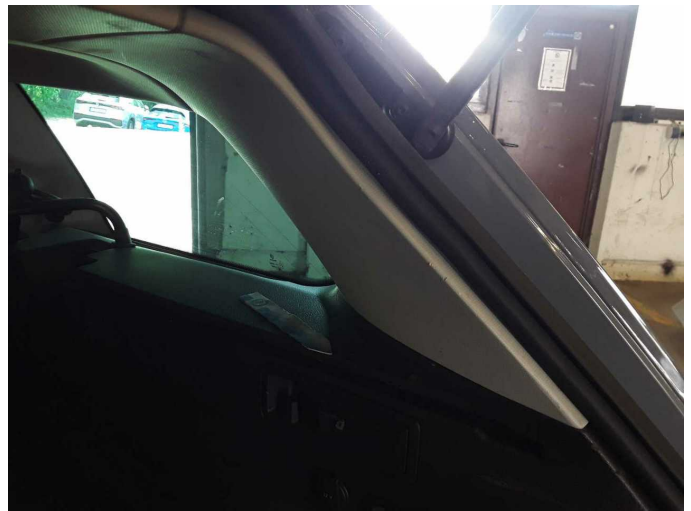
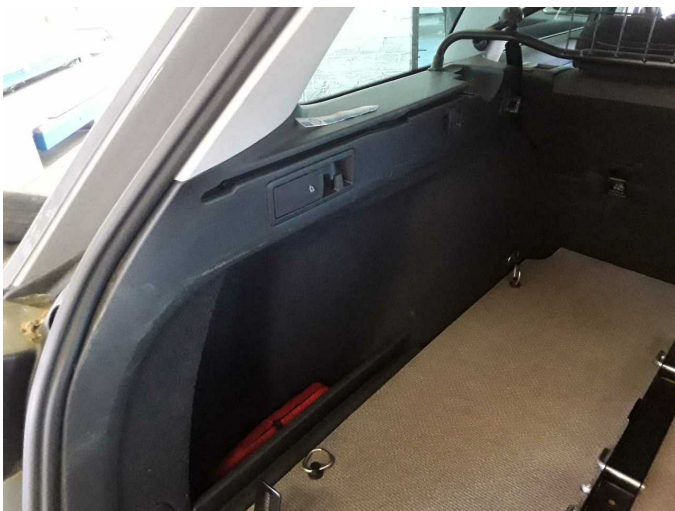
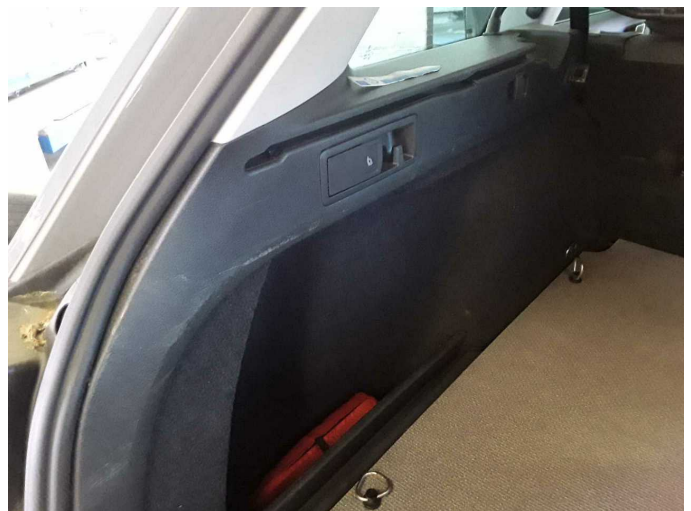
| No. | Component group | Description |
|---|---|---|
| 1 | Interior | Interior - Scratch(es) - No deduction |

**Wear and tear 1:** Interior: Interior - Scratch(es) - No deduction

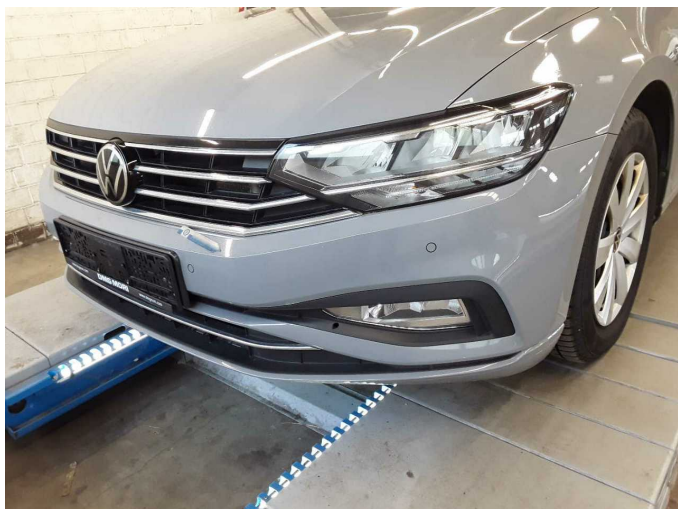
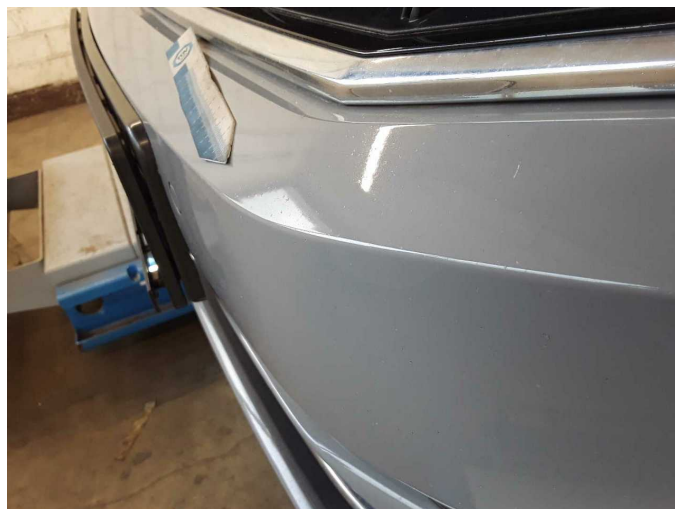
| No. | Component group | Description |
|---|---|---|
| 2 | Front bumper | Front bumper - Stone chips - No deduction |

**Wear and tear 2:** Front bumper: Front bumper - Stone chips - No deduction

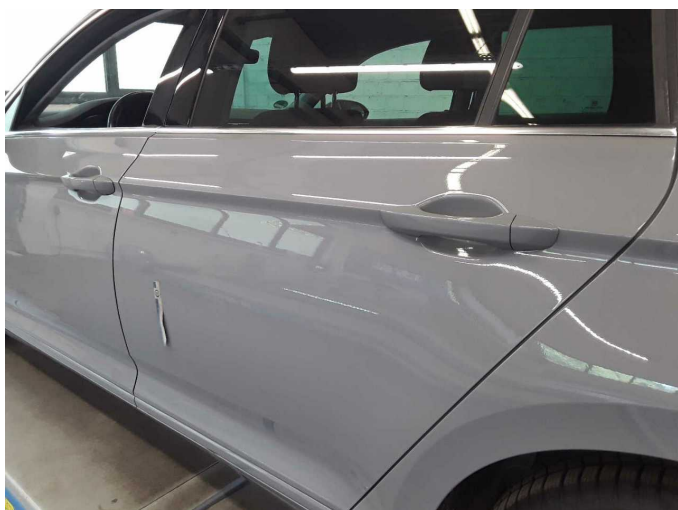
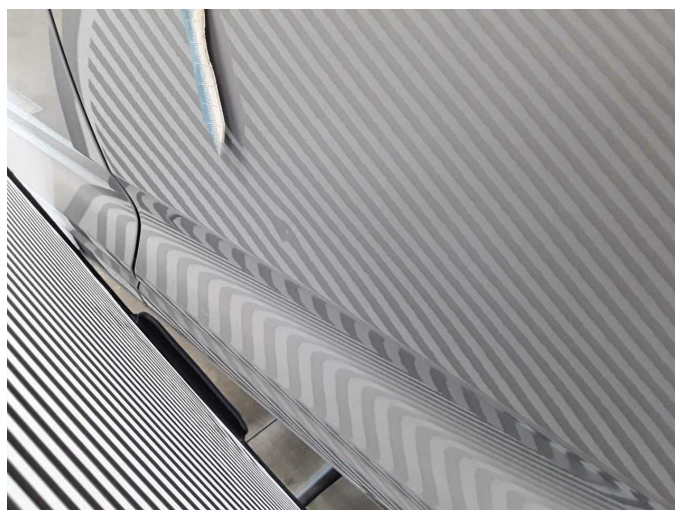
| No. | Component group | Description |
|---|---|---|
| 3 | Door - rear left side | Door - dent(s) - No deduction |

**Wear and tear 3:** Door - rear left side: Door - dent(s) - No deduction
