## Expertise

Protocol number: 46010859  
Order No. / Reference: 26456217  
Inspection date: 18 Jun 2026

Model: GLC-Coupe 220 d 4Matic 9G-TRONIC

VIN: W1N0J1FB0PG158716

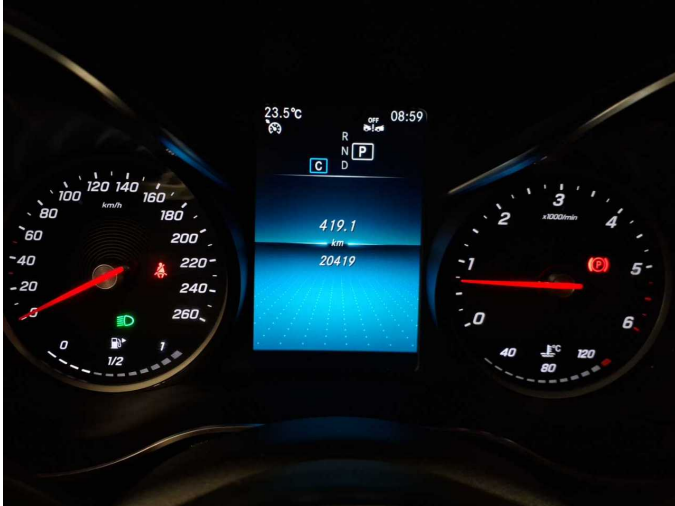
Figure 7: Instrument cluster

<b>Vehicle Identification number</b>	W1N0J1FB0PG158716
<b>Mileage (Read)</b>	20,419 km
<b>First registration</b>	31 Mar 2023
<b>Number of holders</b>	1
<b>Next periodical technical inspection</b> (Report on hand)	05/2028

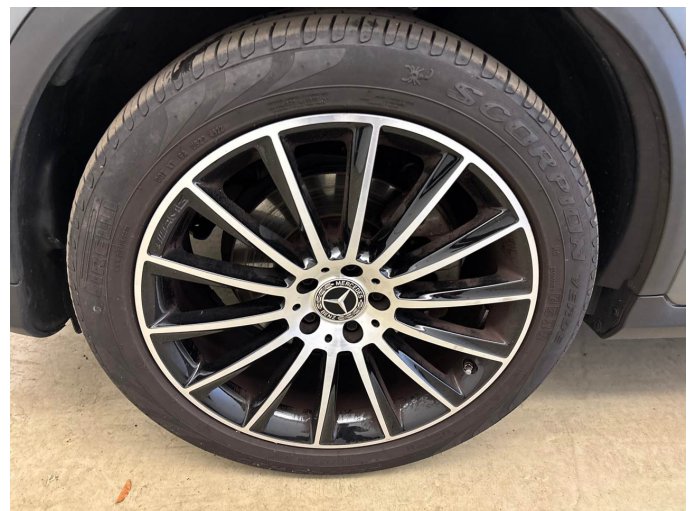
#	Tyre size	Type of tyre	Manufacturer	Tread depth
1)	255/45 R20 101W	Summer tyres on Light alloy	Pirelli	6mm / 6mm
2)	255/45 R20 101W	Summer tyres on Light alloy	Pirelli	6mm / 6mm

Figure 12: Mounted tyres

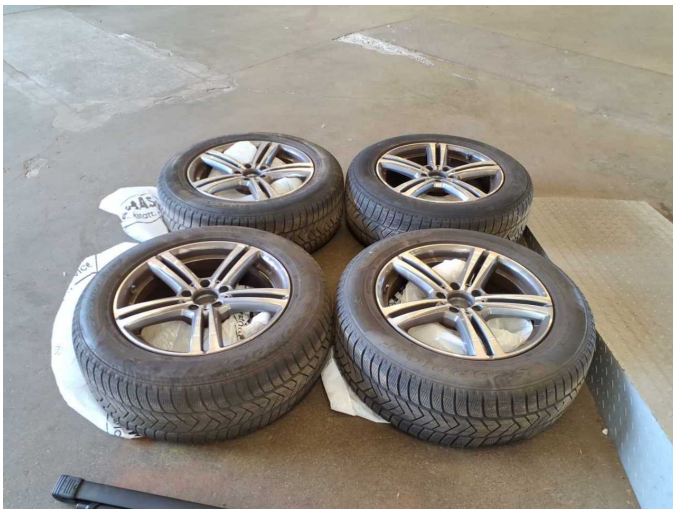
#	Tyre size	Type of tyre	Manufacturer	Tread depth
1)	235/60 R18 103H	Winter tyres on Light alloy	Pirelli	5mm / 5mm
2)	235/60 R18 103H	Winter tyres on Light alloy	Pirelli	5mm / 5mm

Figure 15: Additional tyres

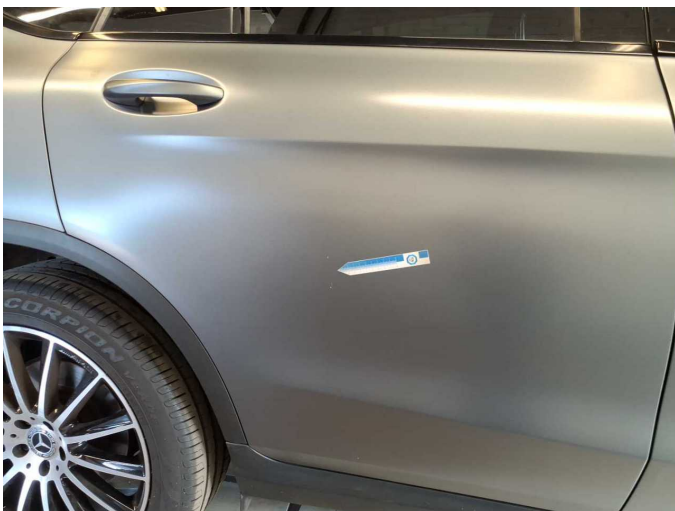
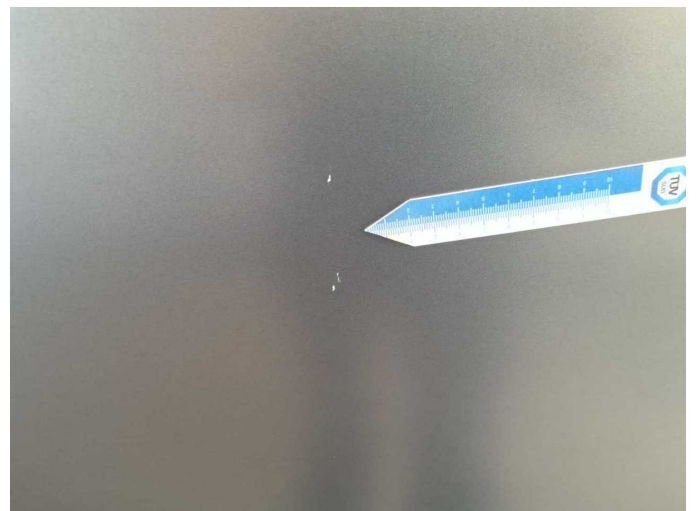
No.	Component group	Description
1	Door - rear right side	Door - Scratch(es) - Paint
2	Door - rear left side	Door - Scratch(es) - Paint
3	Rear bumper	Rear bumper - Scratch(es) - Paint
4	Door - front right side	Door - Scratch(es) - Paint

Damage 1: Door - rear right side: Door - Scratch(es) - Paint

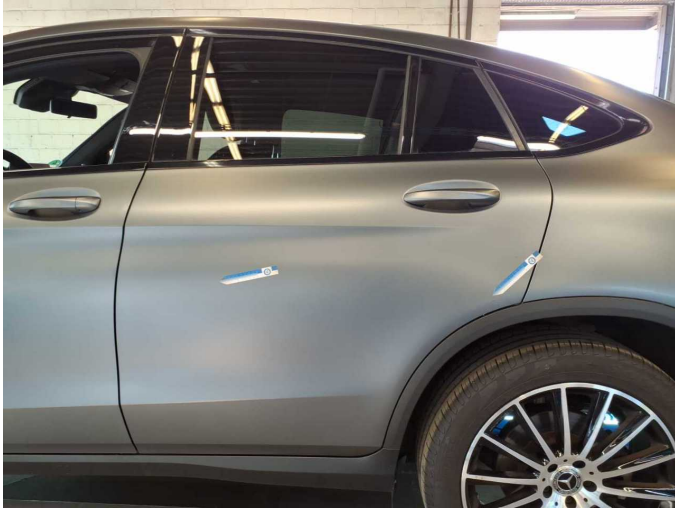
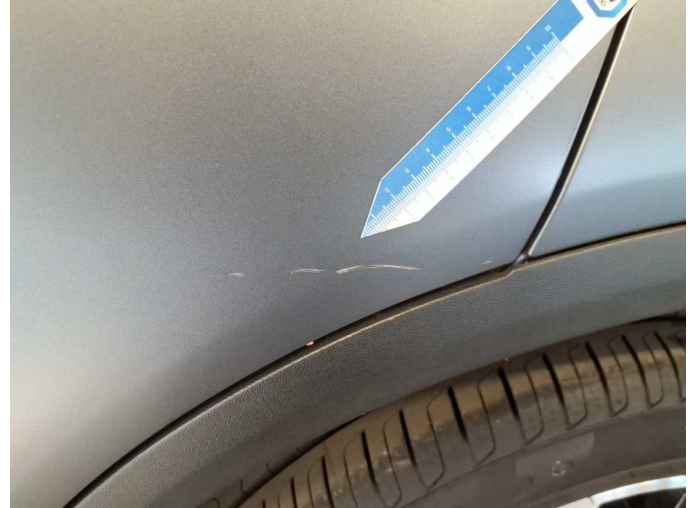
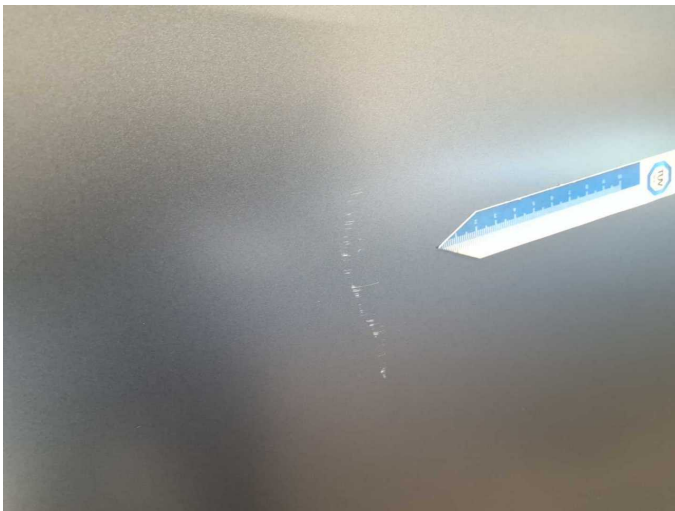
**Damage 2:** Door - rear left side: Door - Scratch(es) - Paint

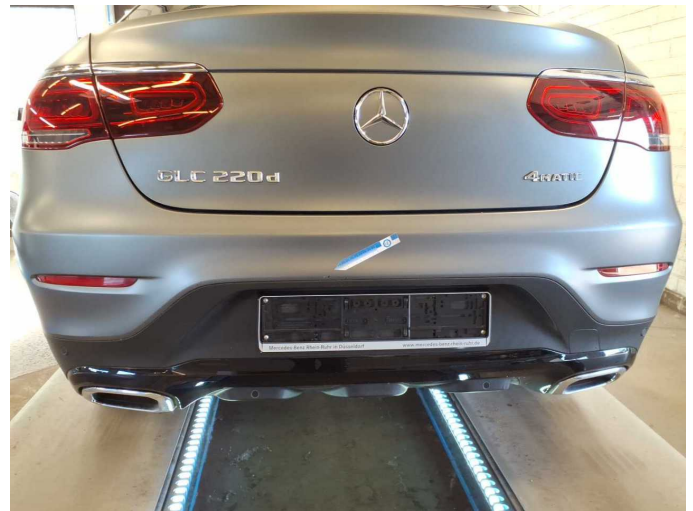
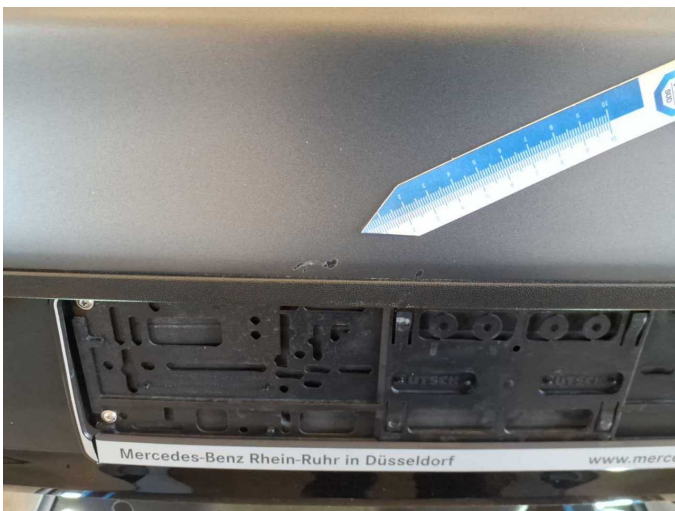
**Damage 3:** Rear bumper: Rear bumper - Scratch(es) - Paint

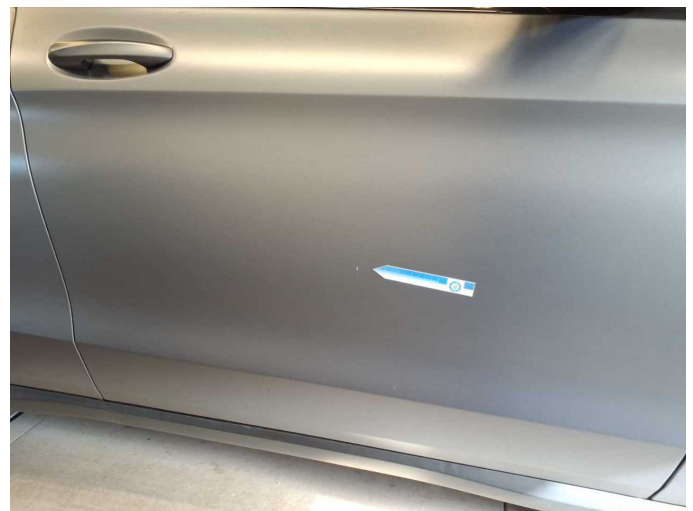
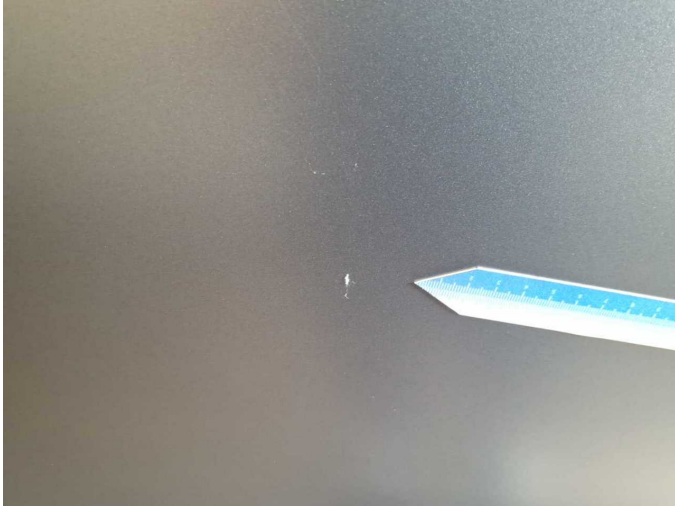
**Damage 4:** Door - front right side: Door - Scratch(es) - Paint

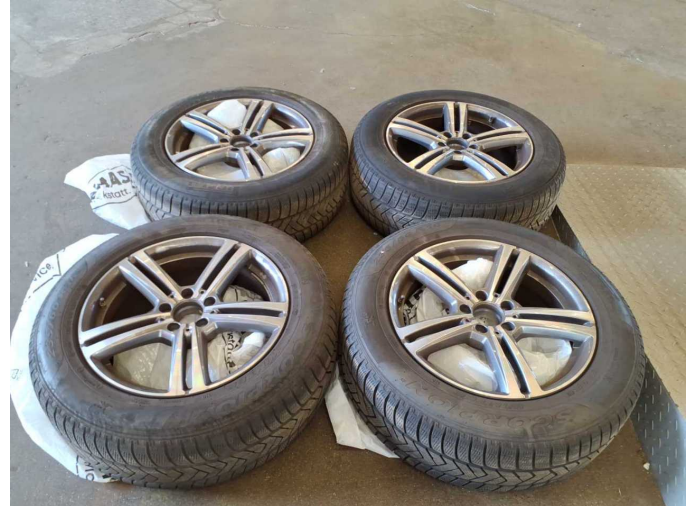
Documents - Log book  
2nd wheel set - Wheel cover set - complete (Nabendeckel)

**Missing part 2:** 2nd wheel set: Wheel cover set - complete (Nabendeckel) - Missing - Replace

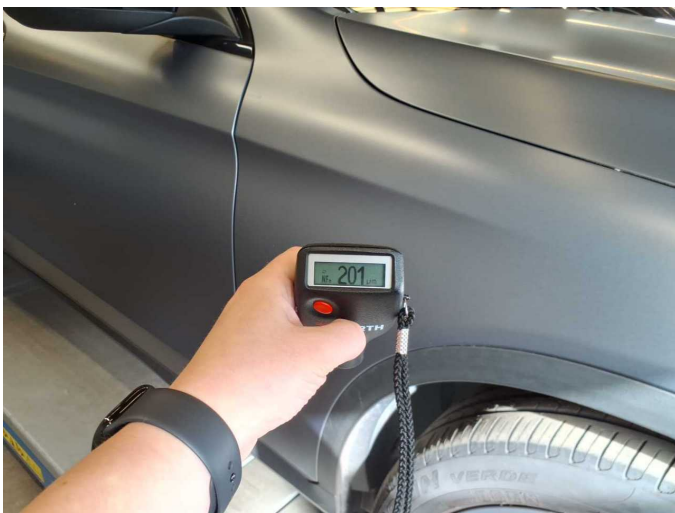
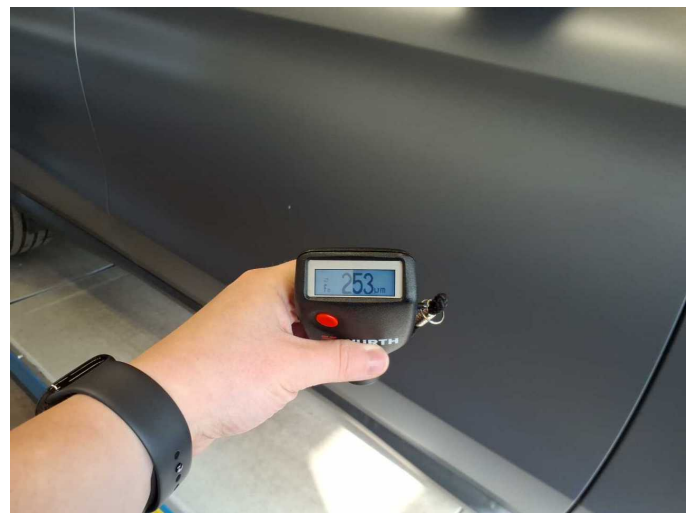
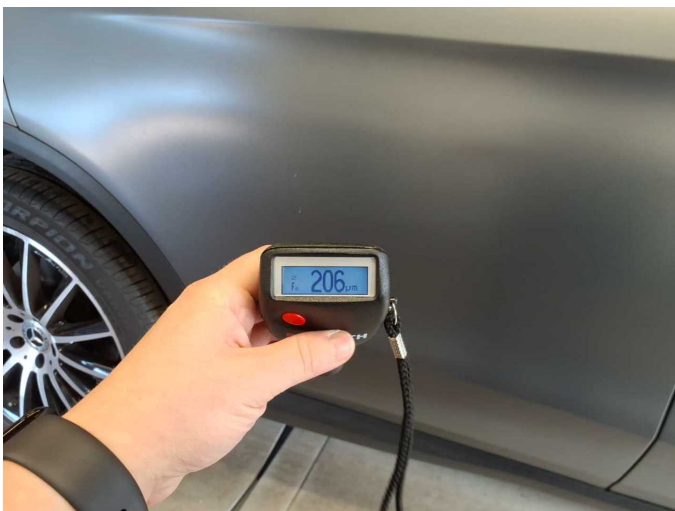
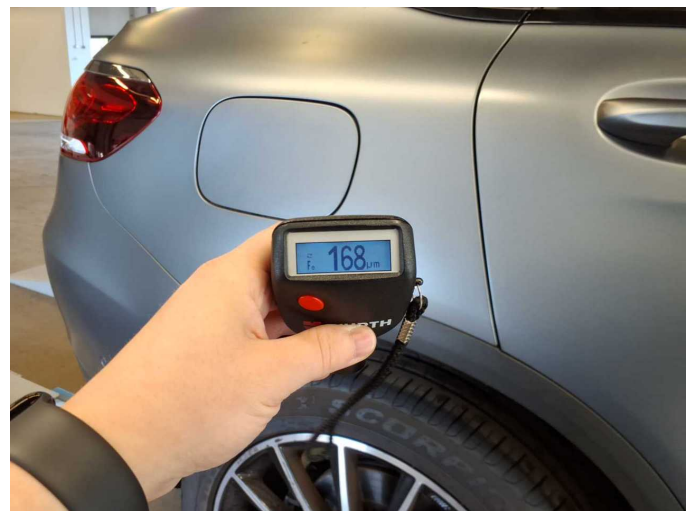
1	Mudguard - right side, Side panel - rear right side, Door - rear right side, Door - front right side, Professionally carried out, Invoice of repair done Non-existent
---	--

Mudguard - right side	201 µm	Side panel - rear right side	168 µm
Door - rear right side	206 µm	Door - front right side	253 µm

According to available information previous damages were repaired at the vehicle. Traces of repairs, which allow conclusions about the area of repair, were not recognizable during the inspection.

**Repainting 1:** Mudguard - right side, Side panel - rear right side, Door - rear right side, Door - front right side
