Expertise

Protocol number: 46667291  
Order No. / Reference: 26701614  
Inspection date: 23 Jul 2026

Manufacturer: Volkswagen

Model: Passat Variant 1.4 TSI Plug-In-Hybrid DSG GTE

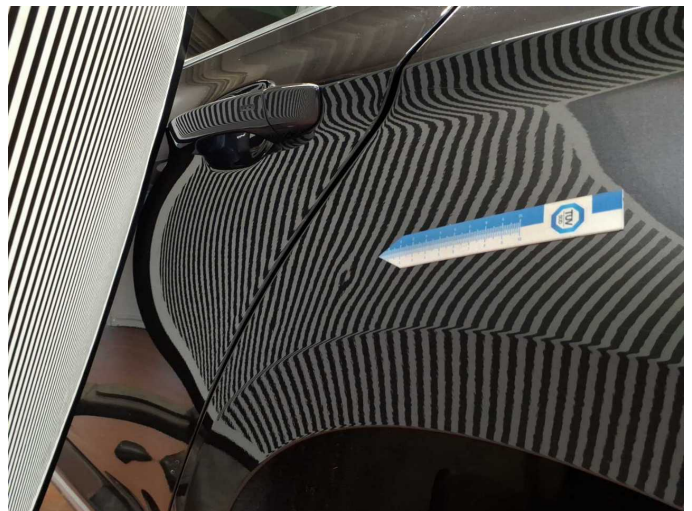
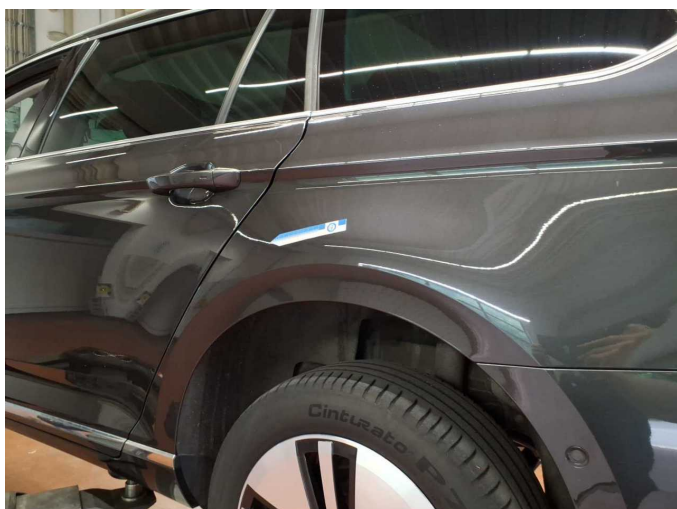
| No. | Component group | Description |
|---|---|---|
| 1 | Side panel - rear left side | Side panel - dent(s) - Smooth repair work |

Damage 1: Side panel - rear left side: Side panel - dent(s) - Smooth repair work

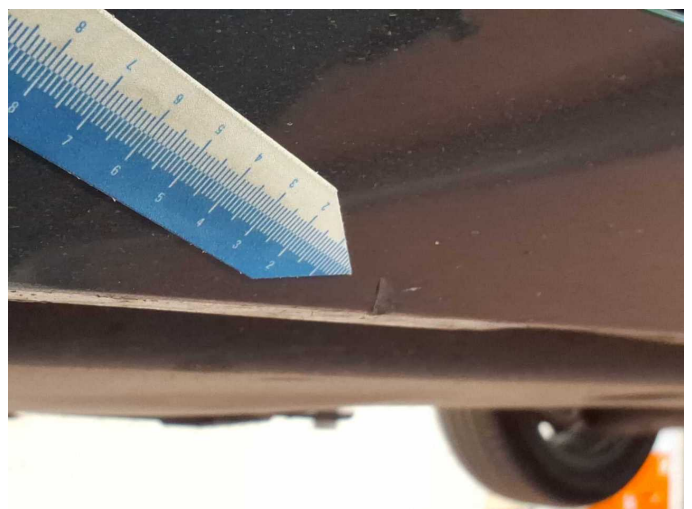
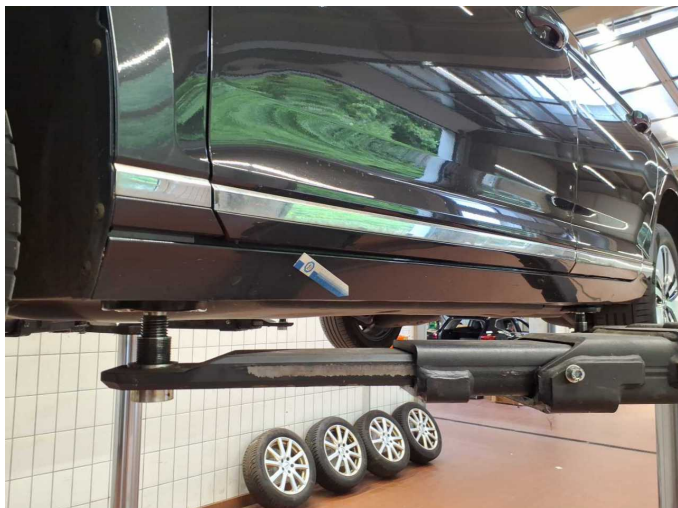
| No. | Component group | Description |
|---|---|---|
| 2 | Sill - left side | Trim - Scratched - Smart repair |

Damage 2: Sill - left side: Trim - Scratched - Smart repair

**Damage 2:** Sill - left side: Trim - Scratched - Smart repair

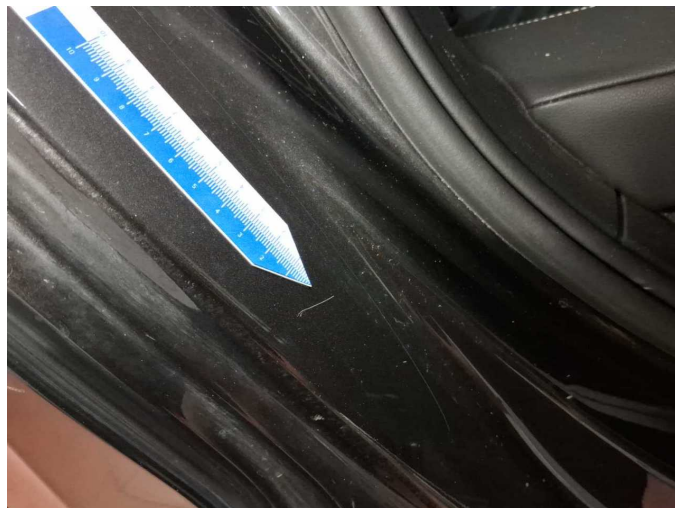
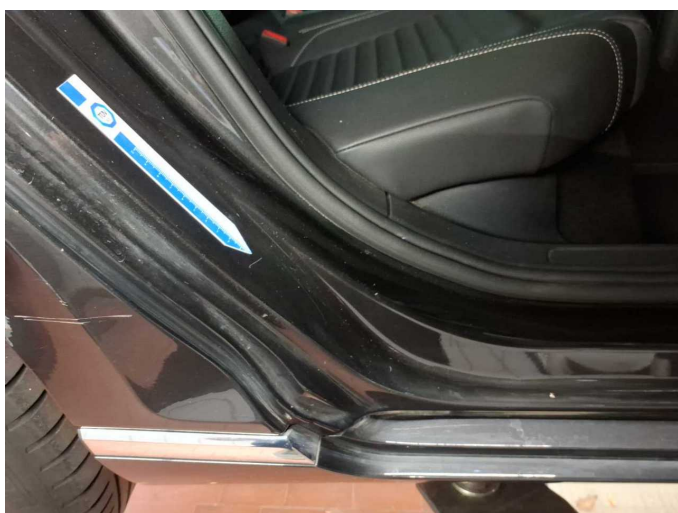
| No. | Component group | Description |
|---|---|---|
| 3 | Side panel - rear right side | Sill - Scratch(es) - Smart repair |

**Damage 3:** Side panel - rear right side: Sill - Scratch(es) - Smart repair

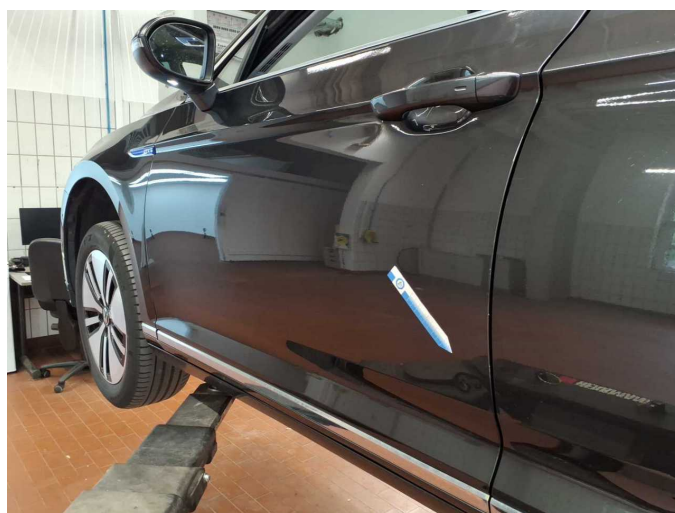
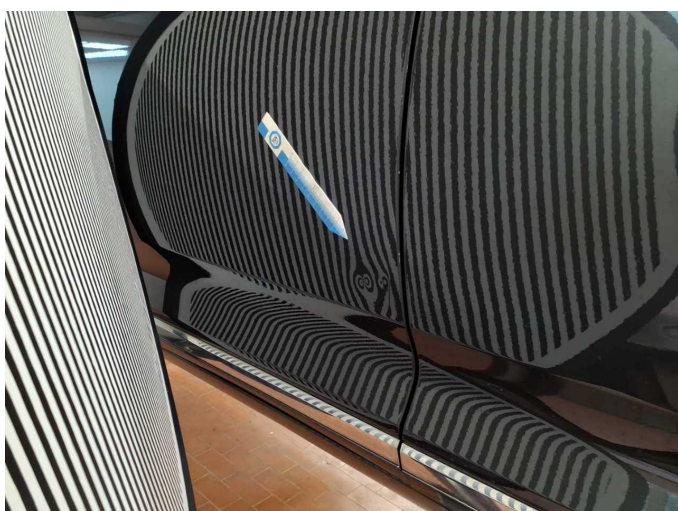
| No. | Component group | Description |
|---|---|---|
| 4 | Door - front left side | Door - dent(s) - Smooth repair work |

**Damage 4:** Door - front left side: Door - dent(s) - Smooth repair work

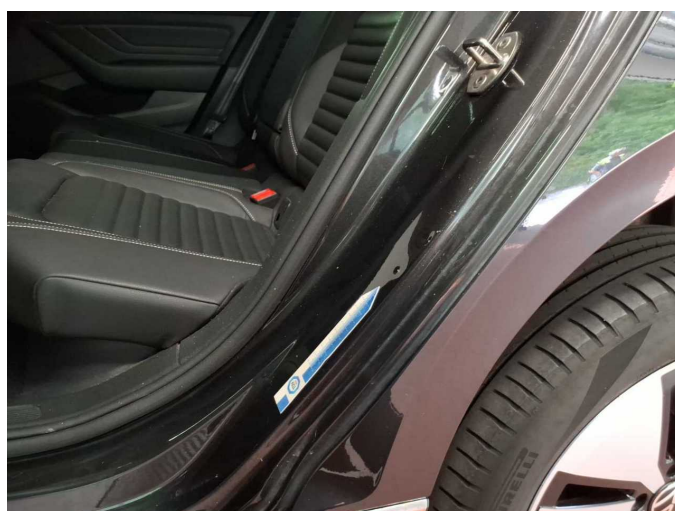
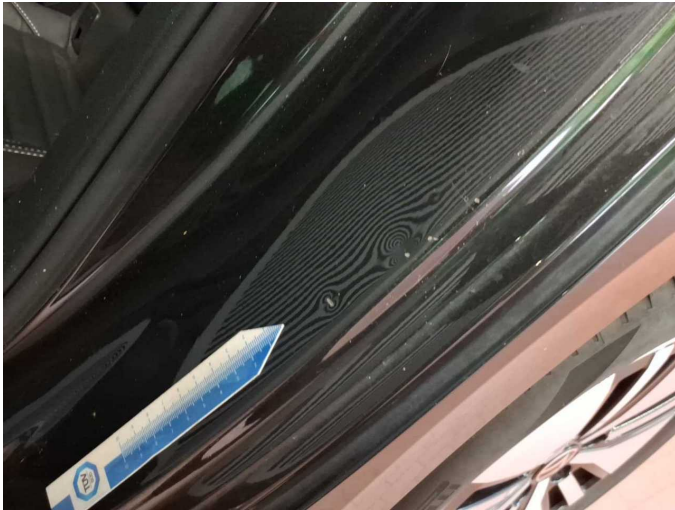
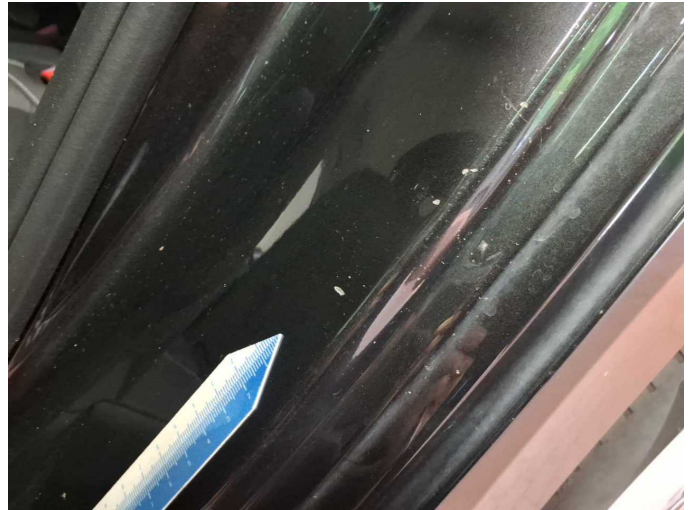
| No. | Component group | Description |
|---|---|---|
| 5 | Side panel - rear left side | Sill - Dent / paintcoat damage - Smart repair |

**Damage 5:** Side panel - rear left side: Sill - Dent / paintcoat damage - Smart repair

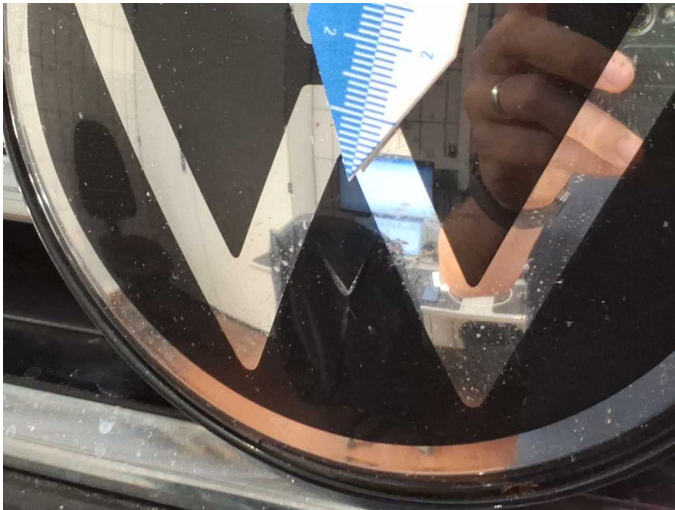
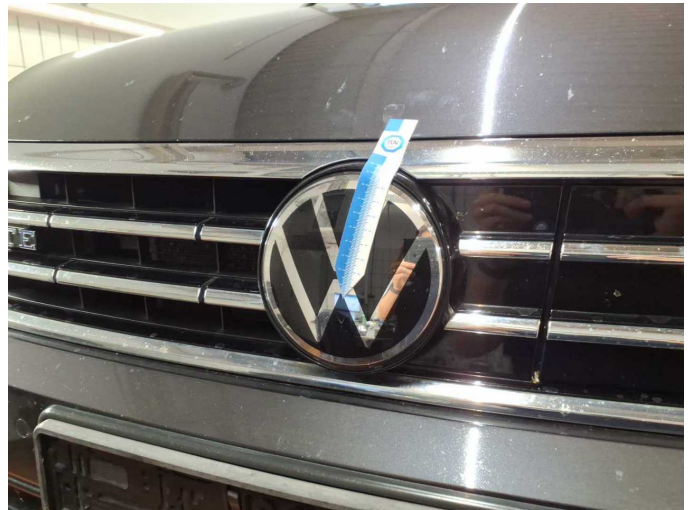
| No. | Component group | Description |
|---|---|---|
| 6 | Front structure | Emblem - Broken / torn - Replace |

**Damage 6:** Front structure: Emblem - Broken / torn - Replace

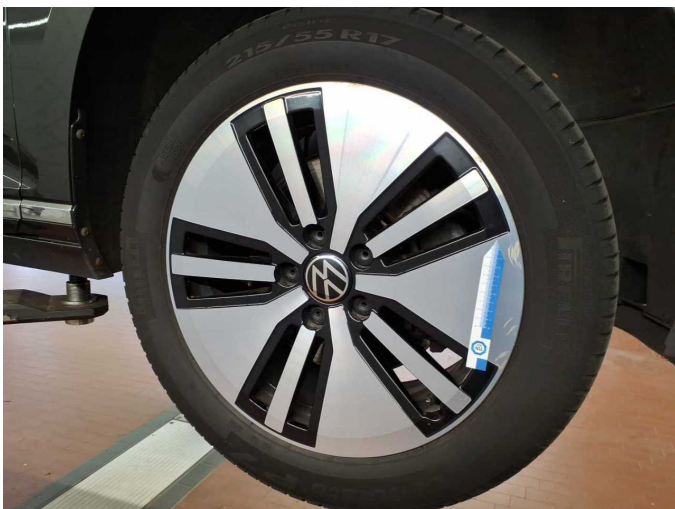
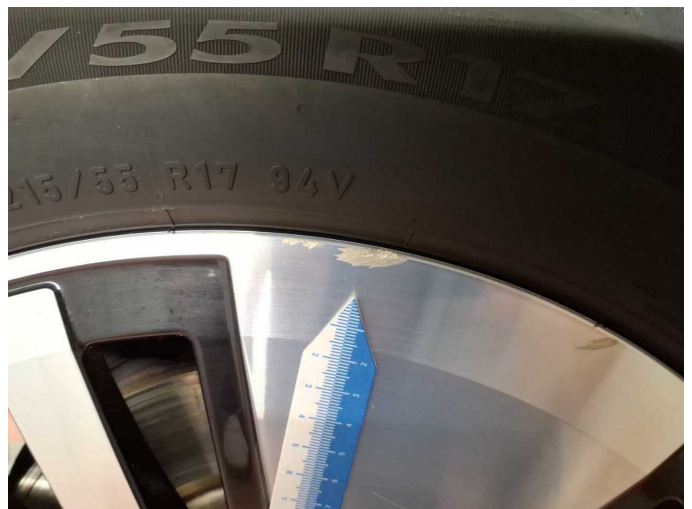
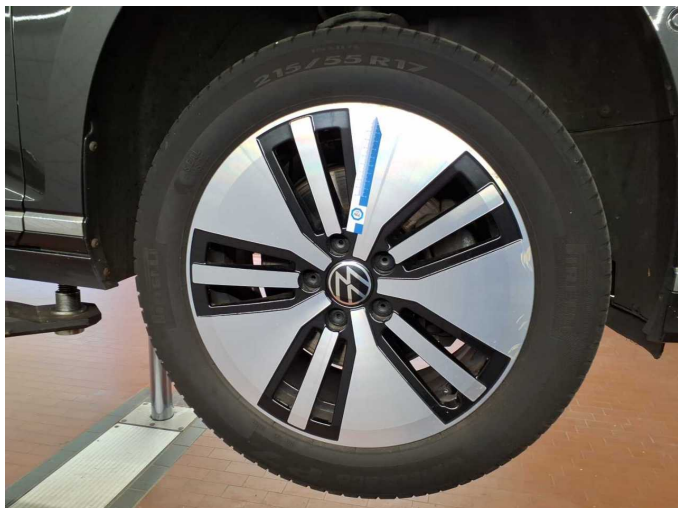
| No. | Component group | Description |
|---|---|---|
| 7 | Wheel / tyres | Alloy rim - front right side - Scratched - Loss in value |

**Damage 7:** Wheel / tyres: Alloy rim - front right side - Scratched - Loss in value

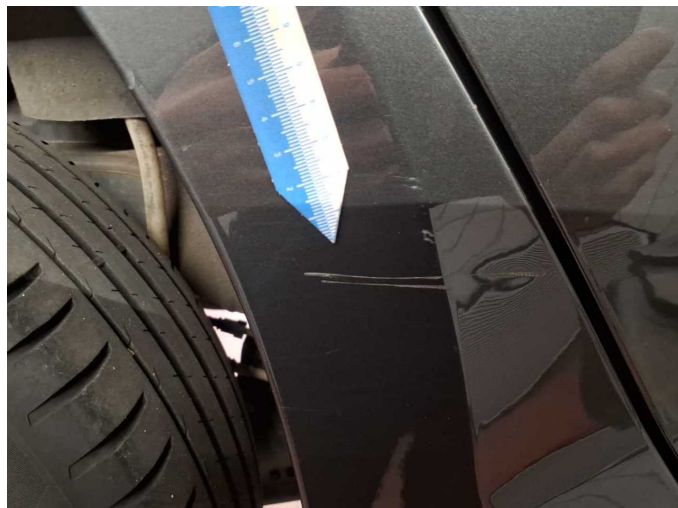
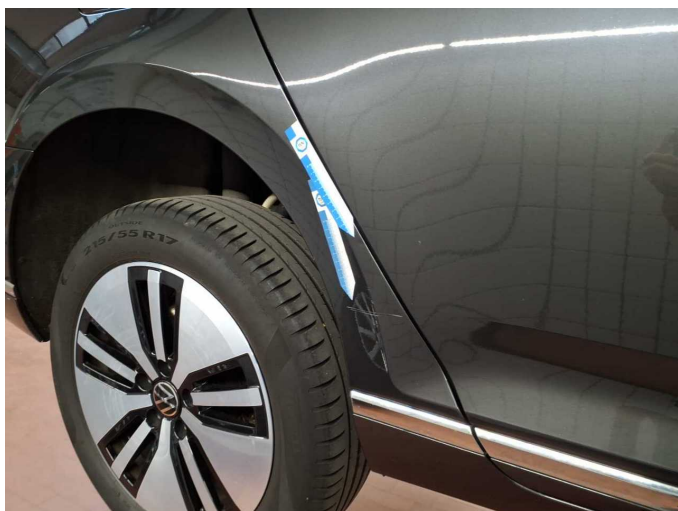
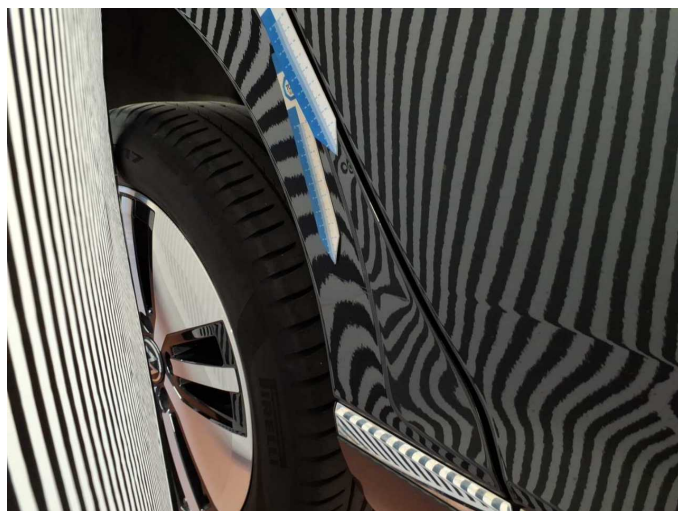
| No. | Component group | Description |
|---|---|---|
| 8 | Side panel - rear right side | Elbow - Dent / paintcoat damage - Repair and paint |

**Damage 8:** Side panel - rear right side: Elbow - Dent / paintcoat damage - Repair and paint

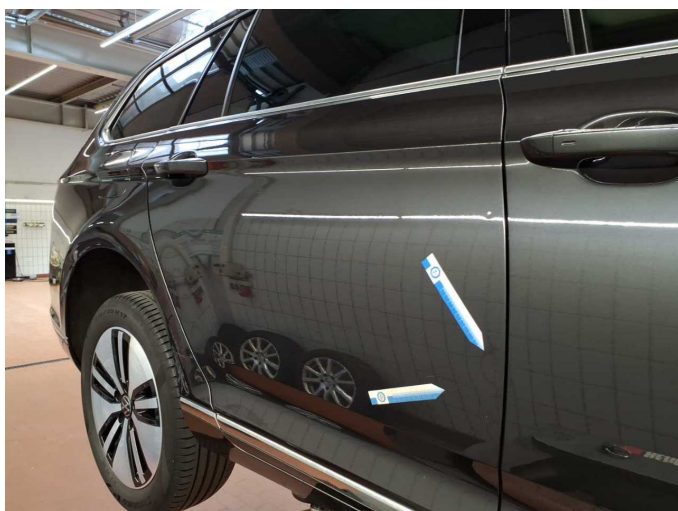
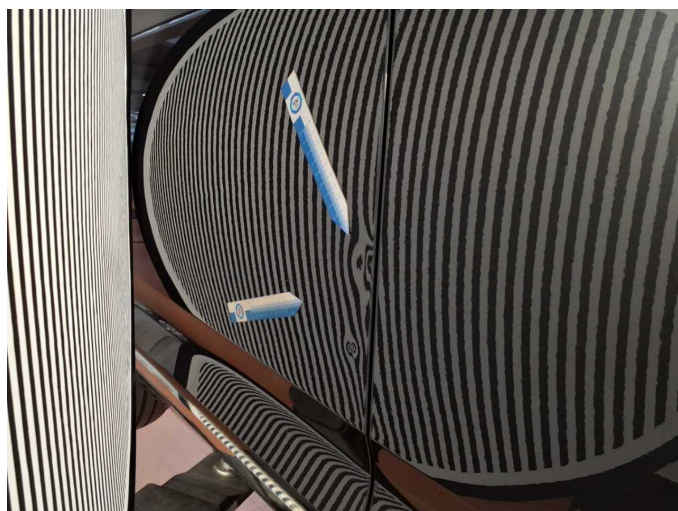
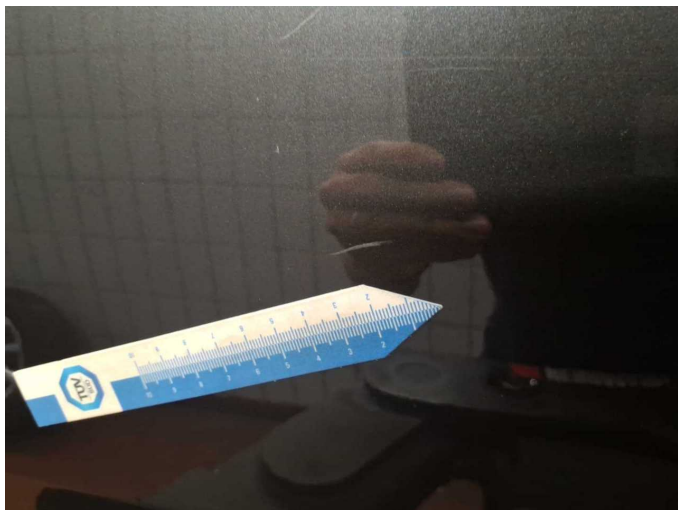
| No. | Component group | Description |
|---|---|---|
| 9 | Door - rear right side | Door - Dent / paintcoat damage - Repair and paint |

**Damage 9:** Door - rear right side: Door - Dent / paintcoat damage - Repair and paint

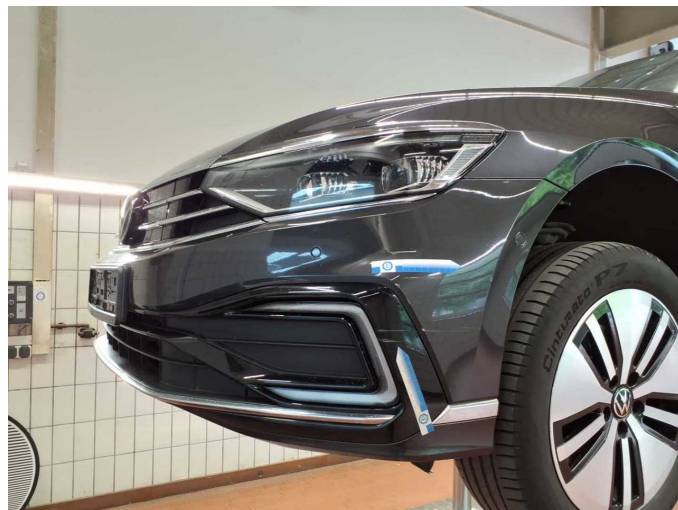
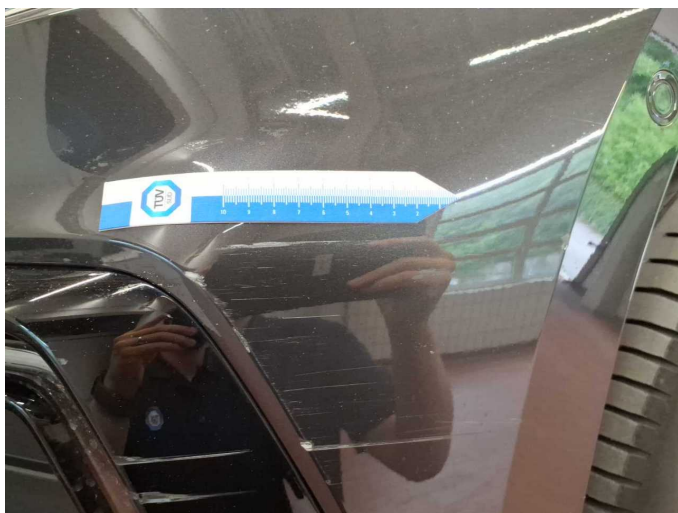
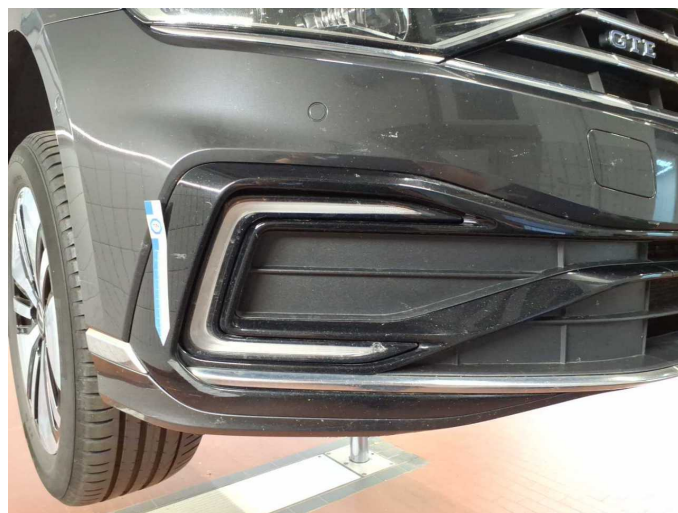
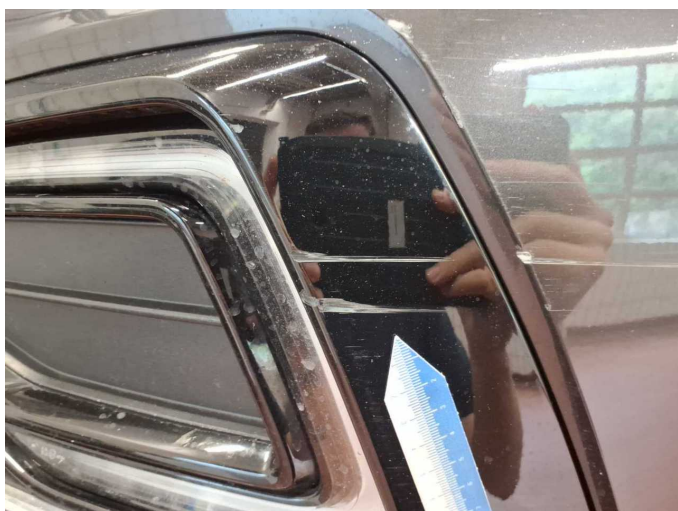
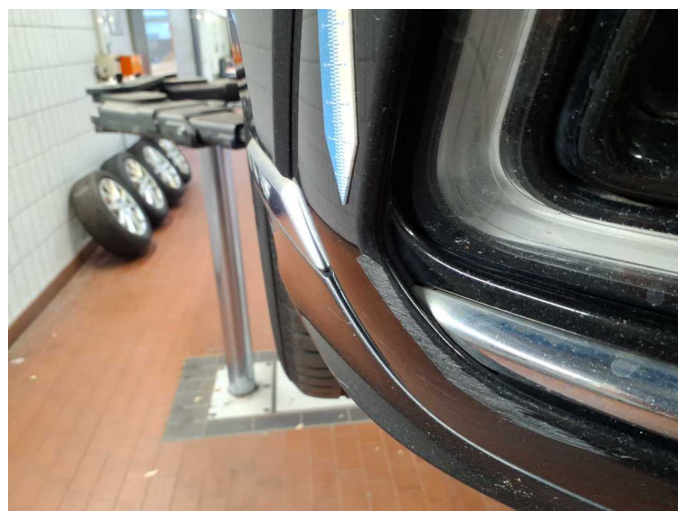
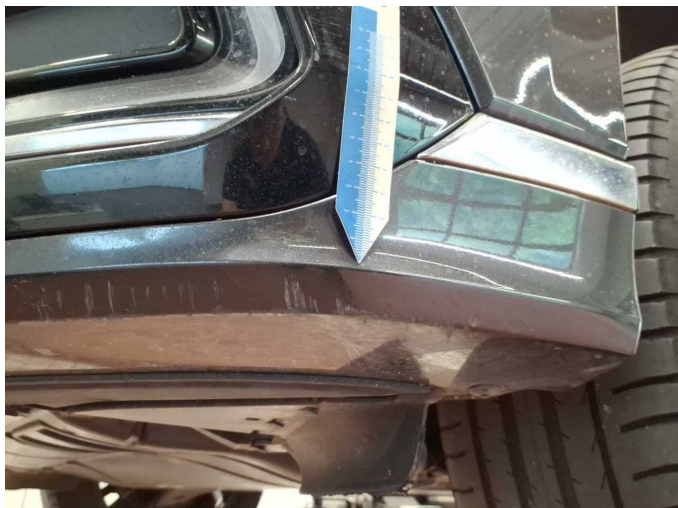
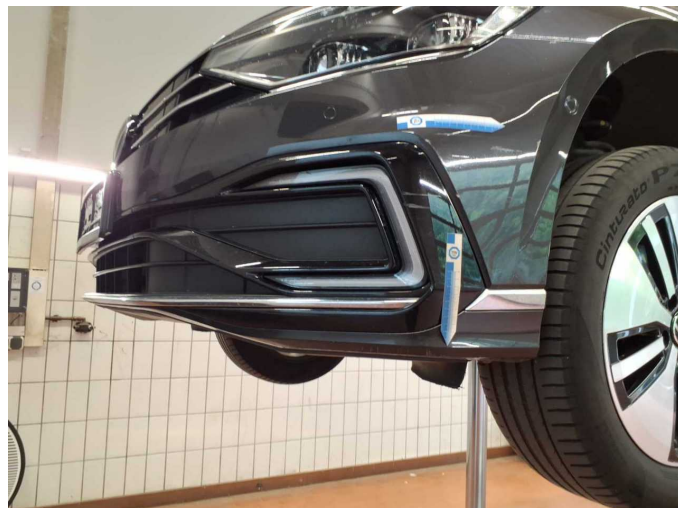
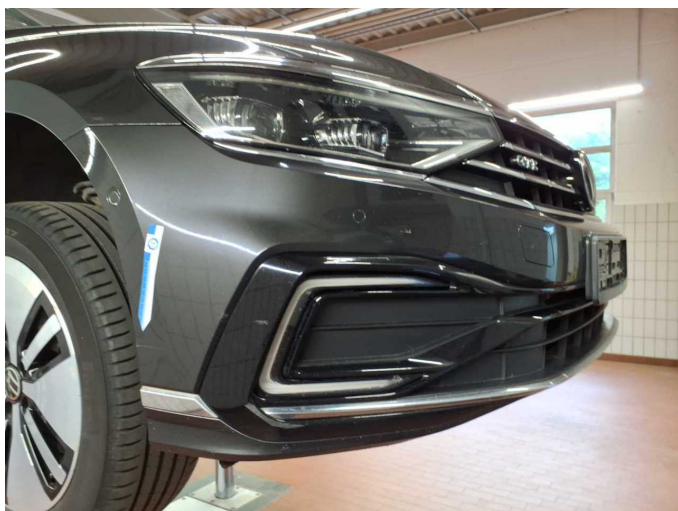
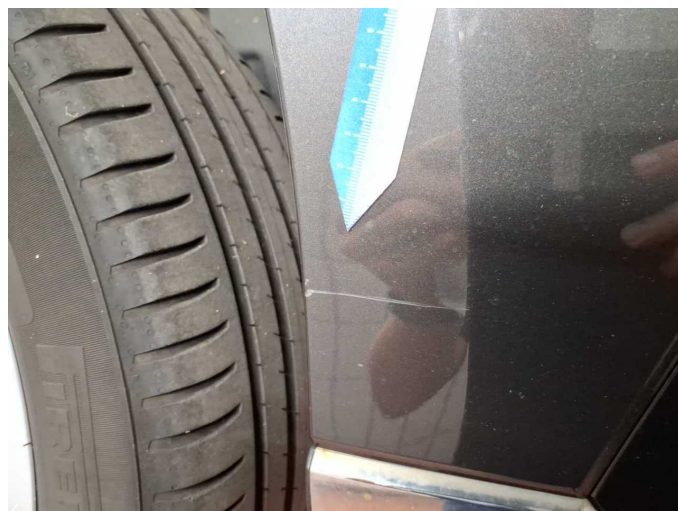
| No. | Component group | Description |
|---|---|---|
| 10 | Front bumper | Front bumper (+ Blende Rechts+links) - Scratched - Paint |

**Damage 10:** Front bumper: Front bumper (+ Blende Rechts+links) - Scratched - Paint

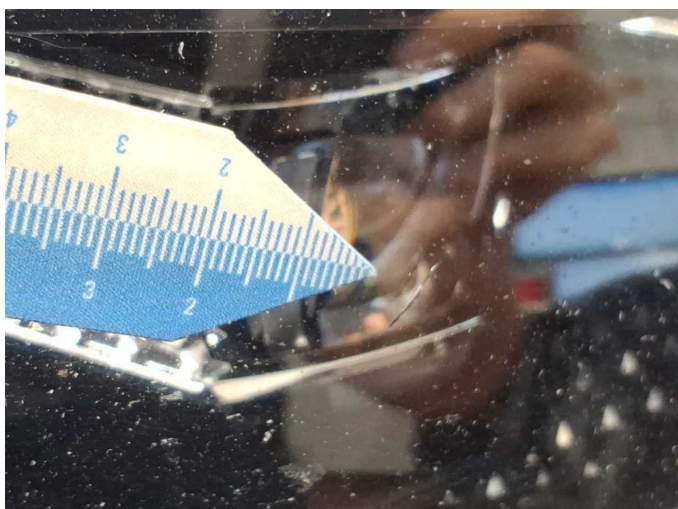
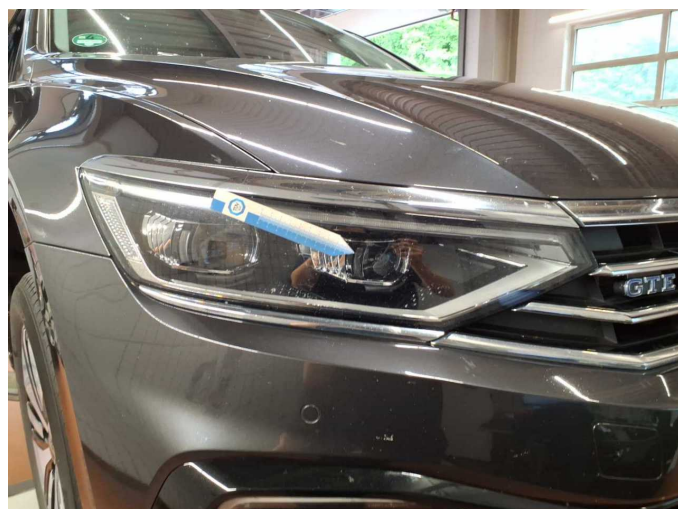
| No. | Component group | Description |
|---|---|---|
| 11 | Headlight | Headlight - right side - Broken / torn - repair according to calculation |

**Damage 11:** Headlight: Headlight - right side - Broken / torn - repair according to calculation

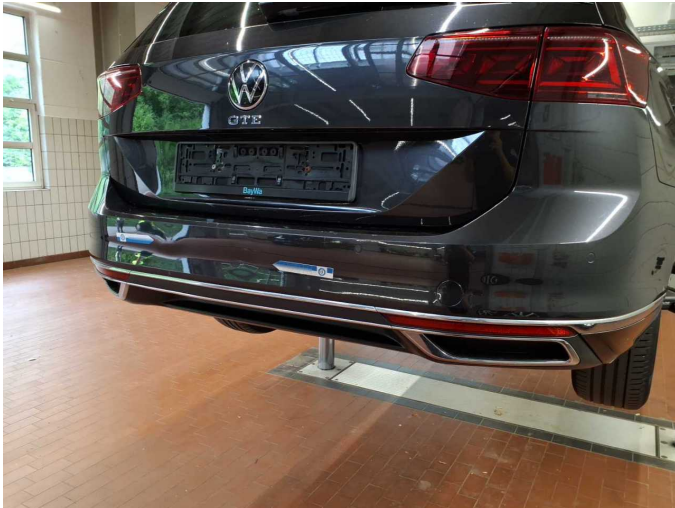
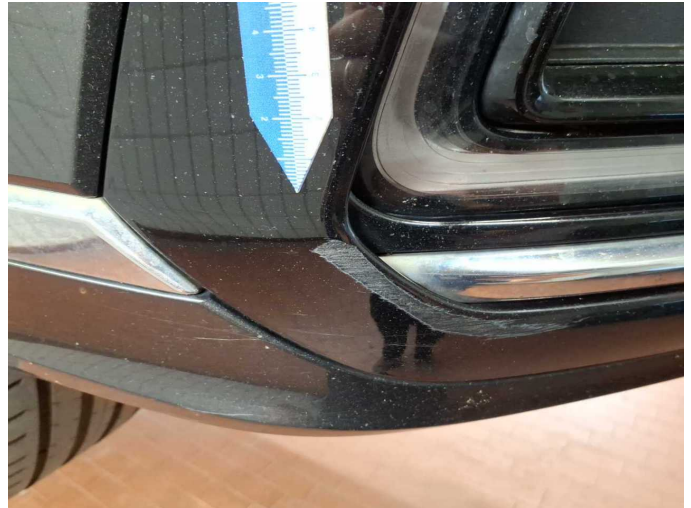
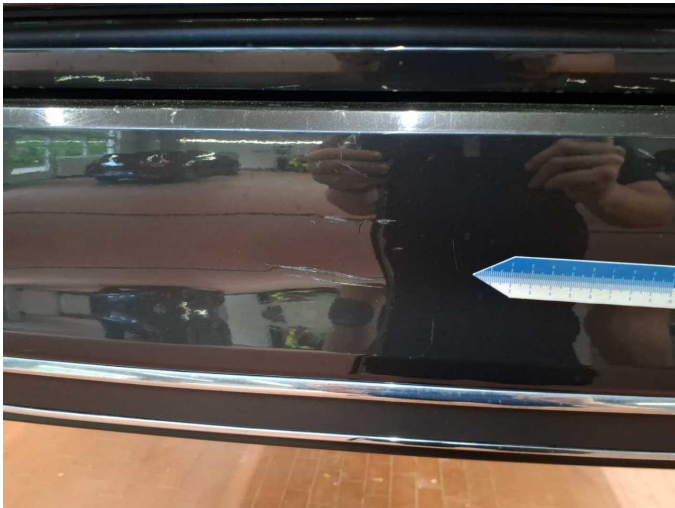
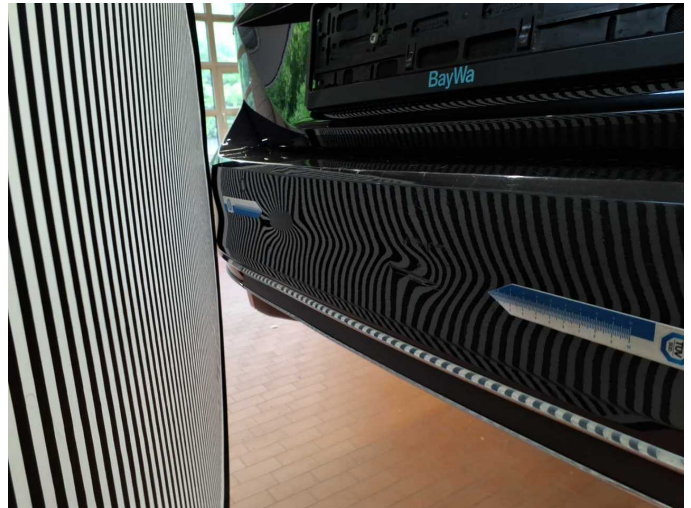
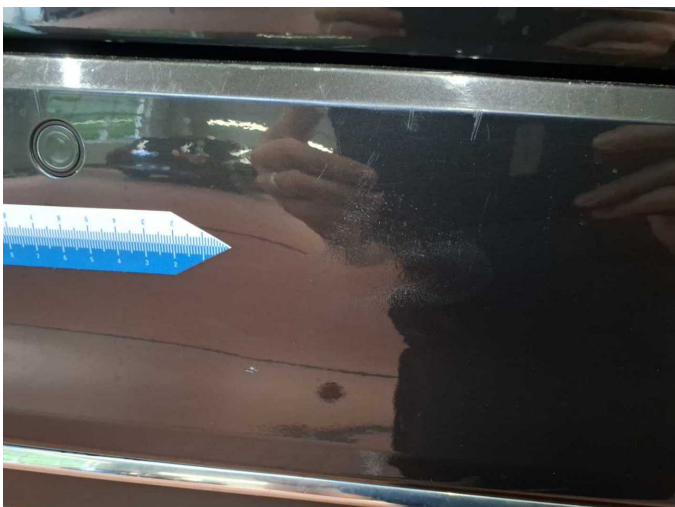
| No. | Component group | Description |
|---|---|---|
| 12 | Rear bumper | Rear bumper - Dent / paintcoat damage - Replace |

**Damage 12:** Rear bumper: Rear bumper - Dent / paintcoat damage - Replace

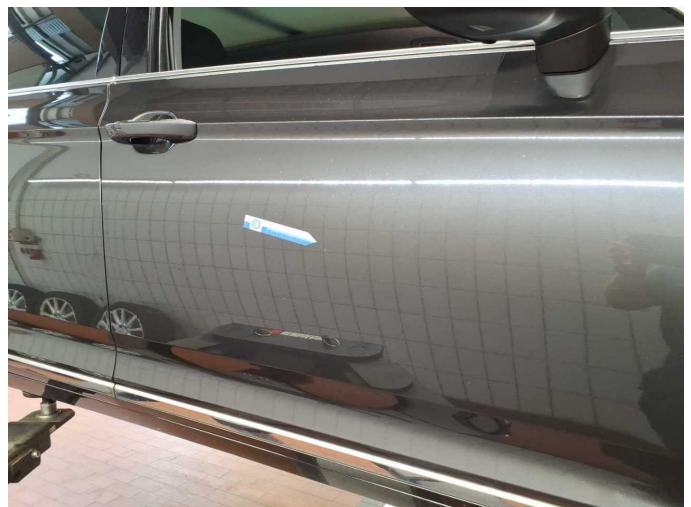
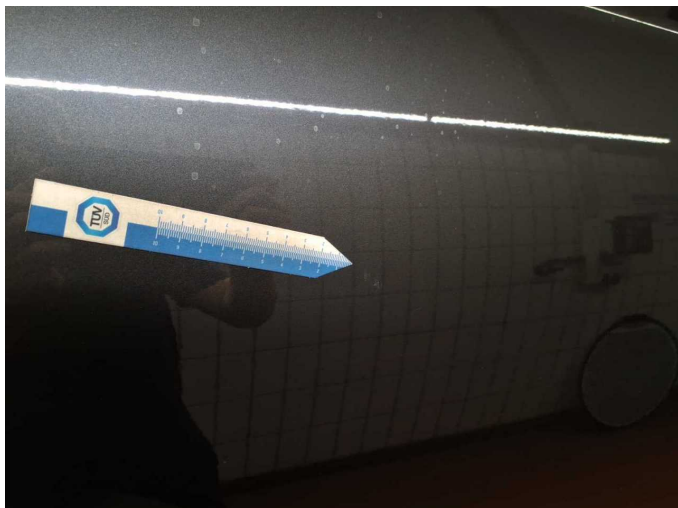
| No. | Component group | Description |
|---|---|---|
| 1 | Door - front right side | Door - Scratch(es) - No deduction |

**Wear and tear 1:** Door - front right side: Door - Scratch(es) - No deduction

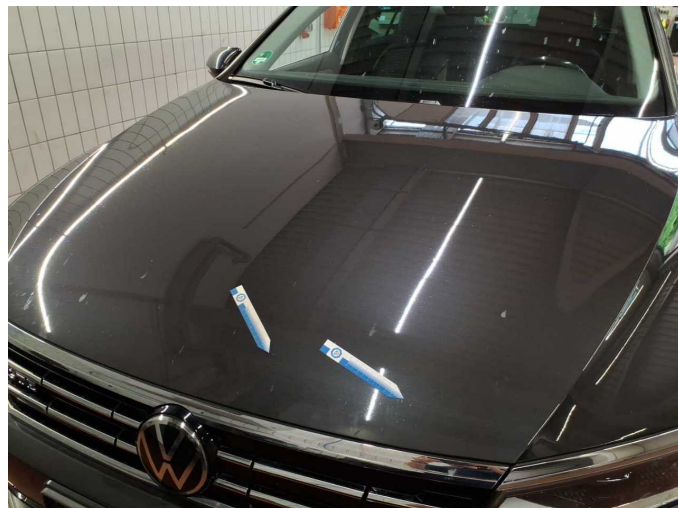
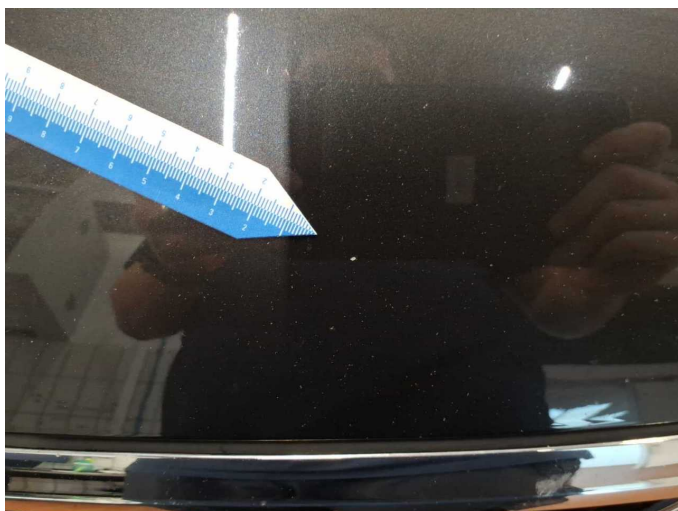
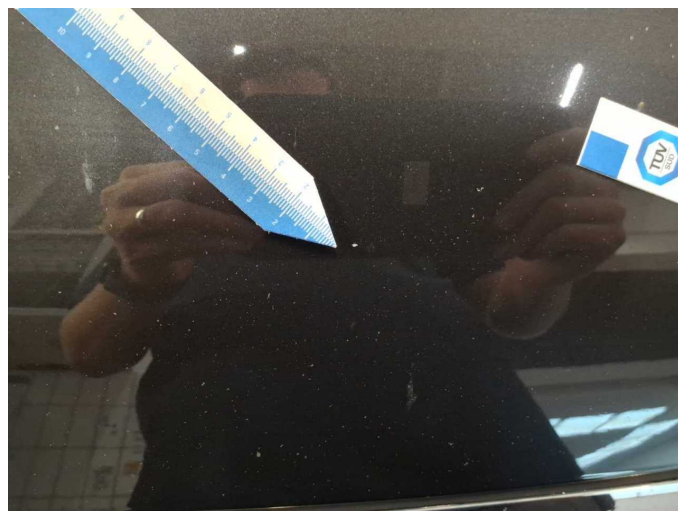
| No. | Component group | Description |
|---|---|---|
| 3 | Bonnet | Bonnet - Stone chips - No deduction |

**Wear and tear 3:** Bonnet: Bonnet - Stone chips - No deduction
