Expertise

Protocol number: 46357385  
Order No. / Reference: 26610950  
Inspection date: 3 Jul 2026

Manufacturer: Skoda  
VIN: TMBJR7NP5N7039528

Model: Superb Combi 2.0 TDI DSG Style

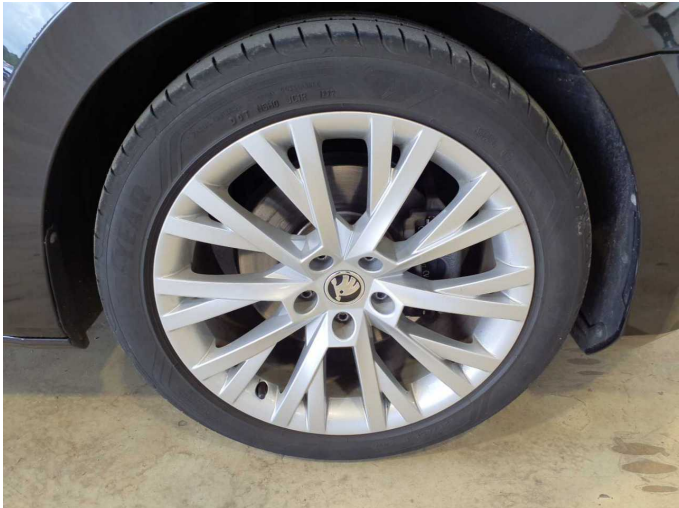
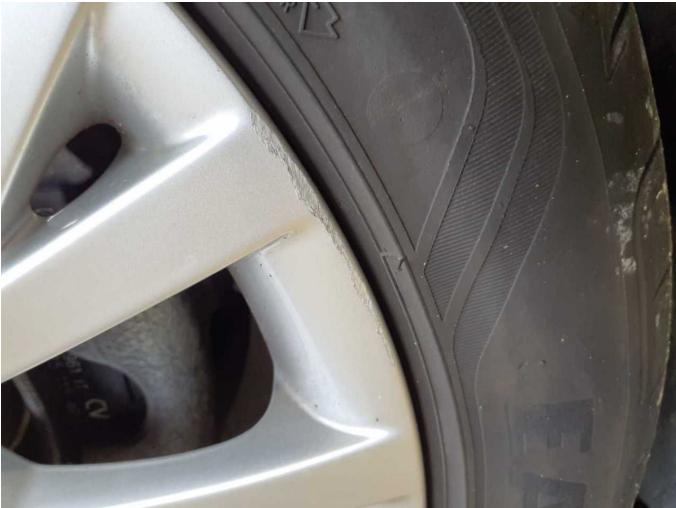
| No. | Component group | Description |
|---|---|---|
| 2 | Wheel / tyres | Alloy rim - front right side - Scratch(es) - Loss in value |

Damage 2: Wheel / tyres: Alloy rim - front right side - Scratch(es) - Loss in value

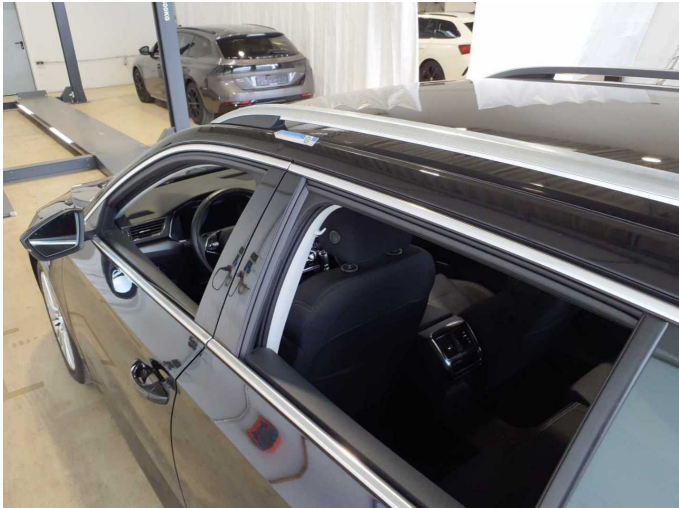
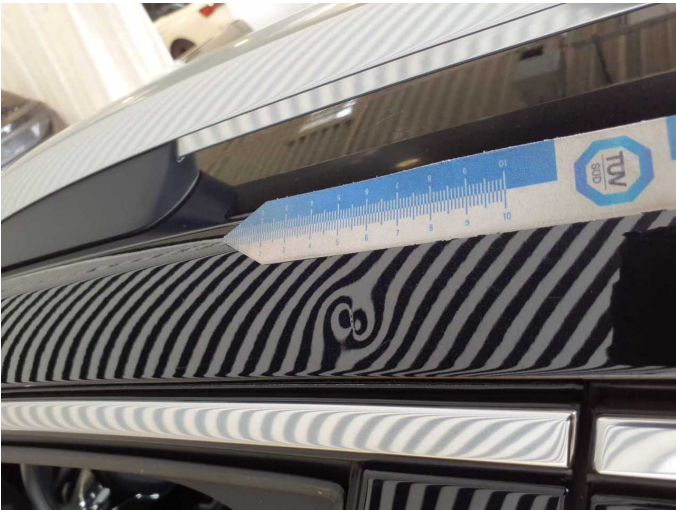
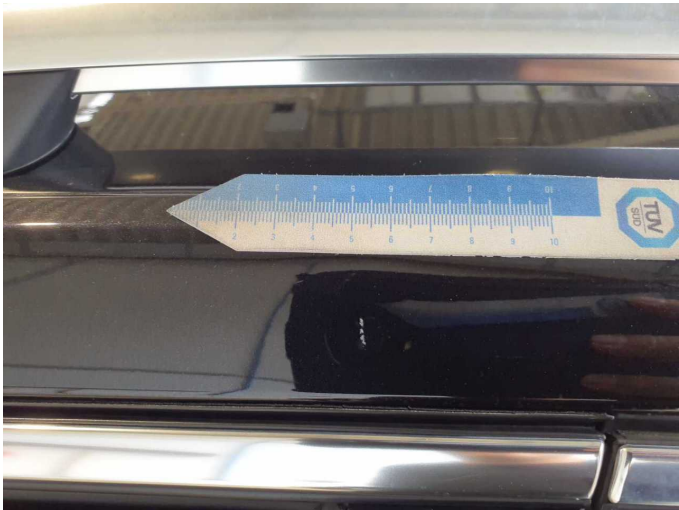
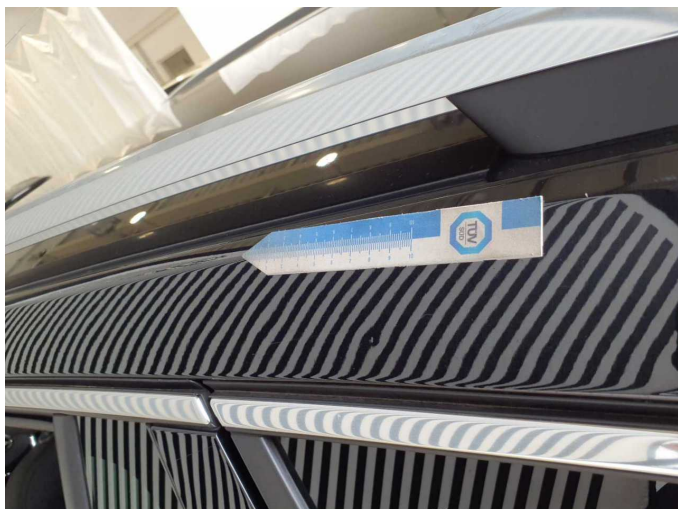
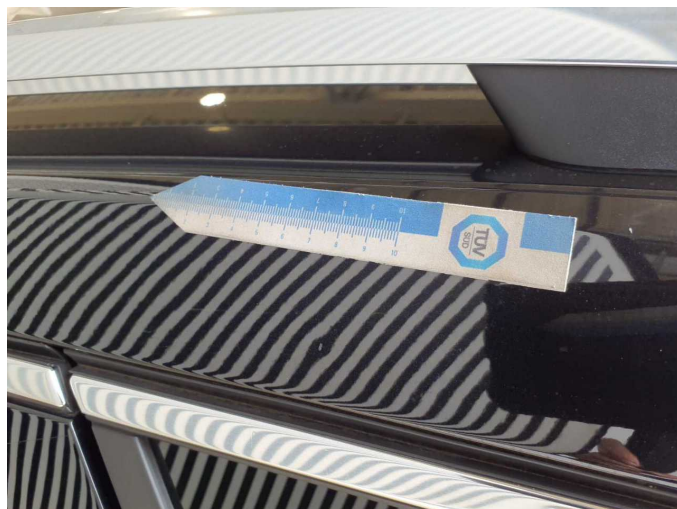
| No. | Component group | Description |
|---|---|---|
| 3 | Roof | Roof rail - left side - Dent / paintcoat damage - Smart repair |

Damage 3: Roof: Roof rail - left side - Dent / paintcoat damage - Smart repair

**Damage 3:** Roof: Roof rail - left side - Dent / paintcoat damage - Smart repair

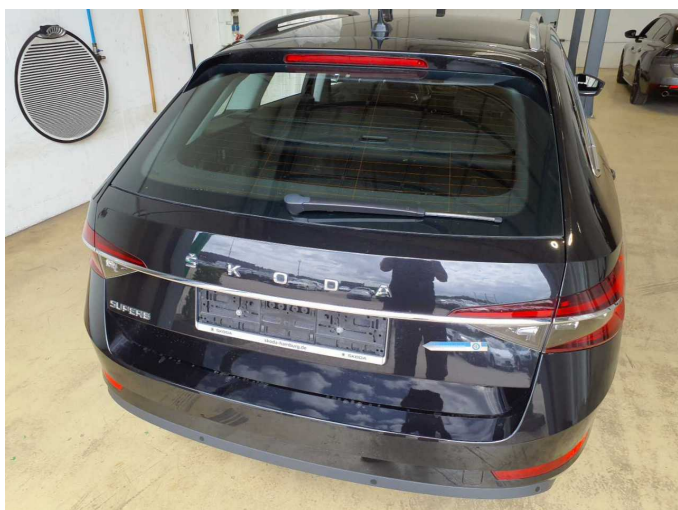
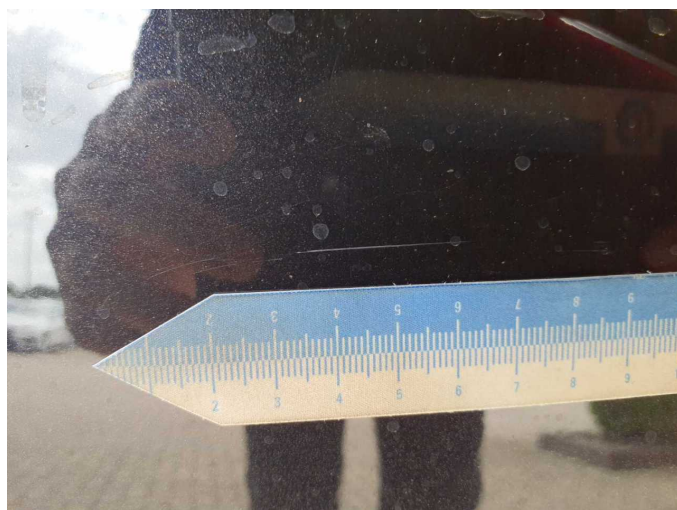
| No. | Component group | Description |
|---|---|---|
| 4 | Boot lid / rear door | Boot lid - Scratch(es) - Smart repair |

**Damage 4:** Boot lid / rear door: Boot lid - Scratch(es) - Smart repair

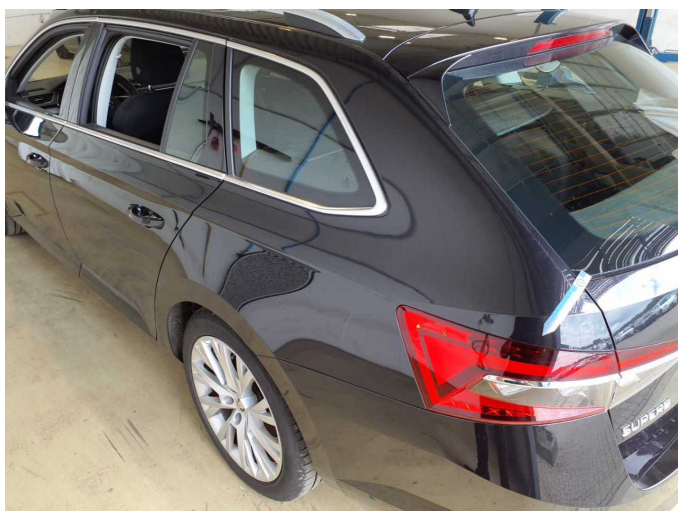
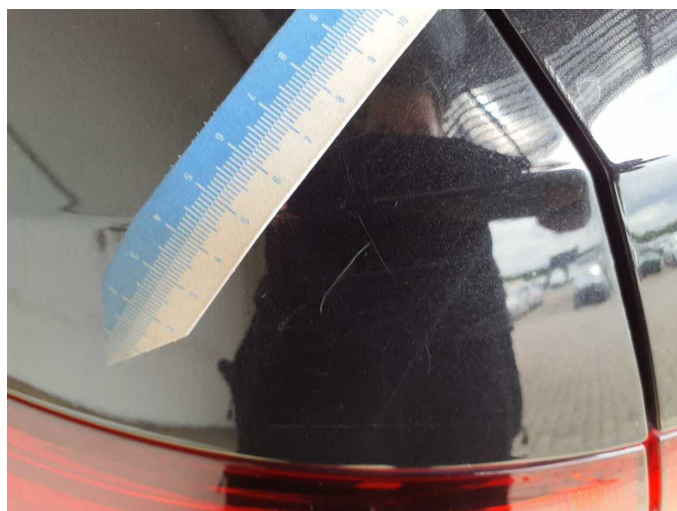
| No. | Component group | Description |
|---|---|---|
| 5 | Side panel - rear left side | Side panel - Scratch(es) - Smart repair |

**Damage 5:** Side panel - rear left side: Side panel - Scratch(es) - Smart repair

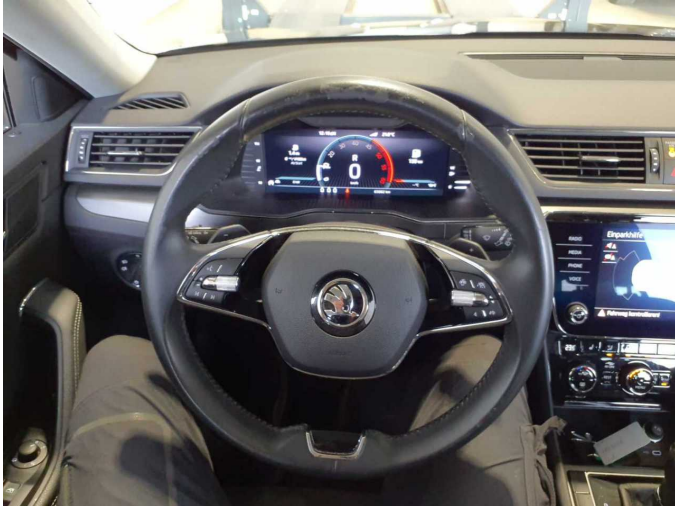
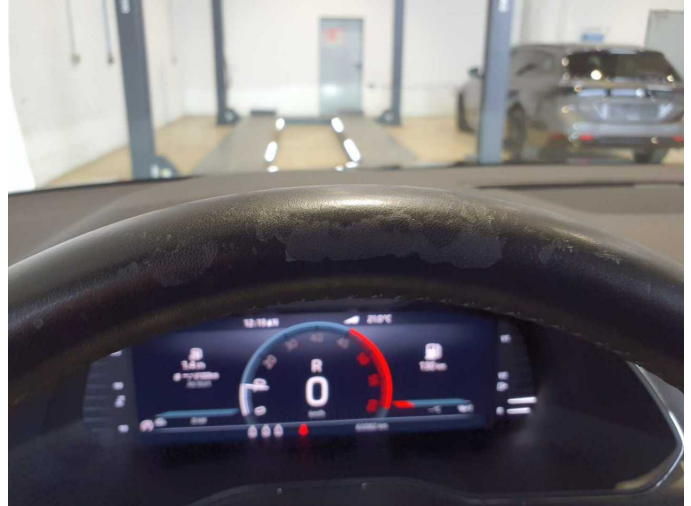
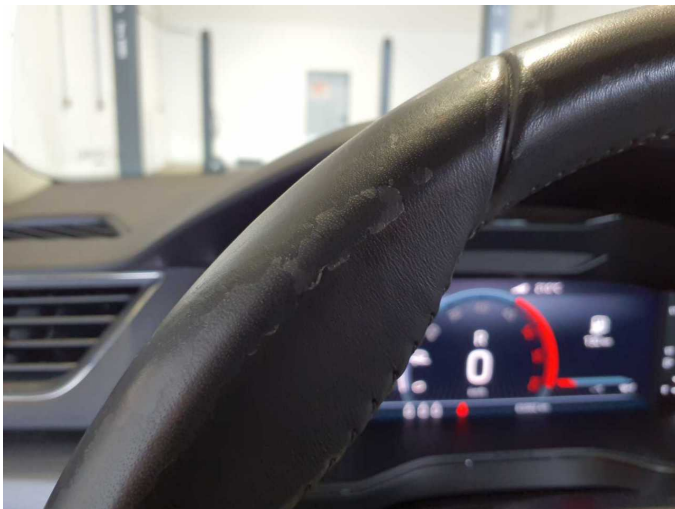
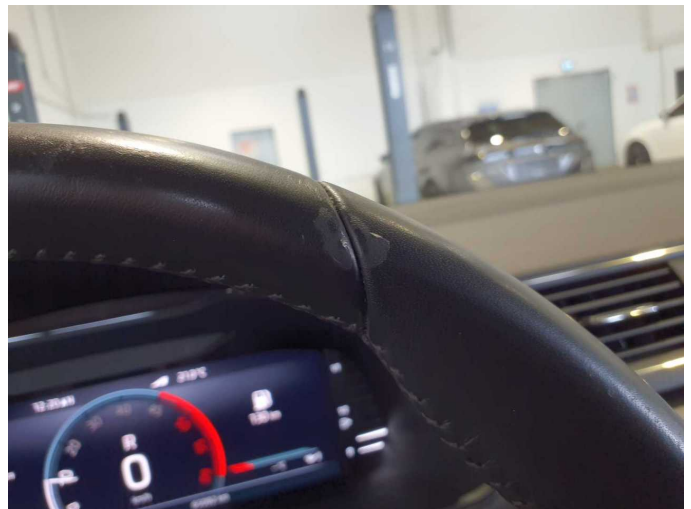
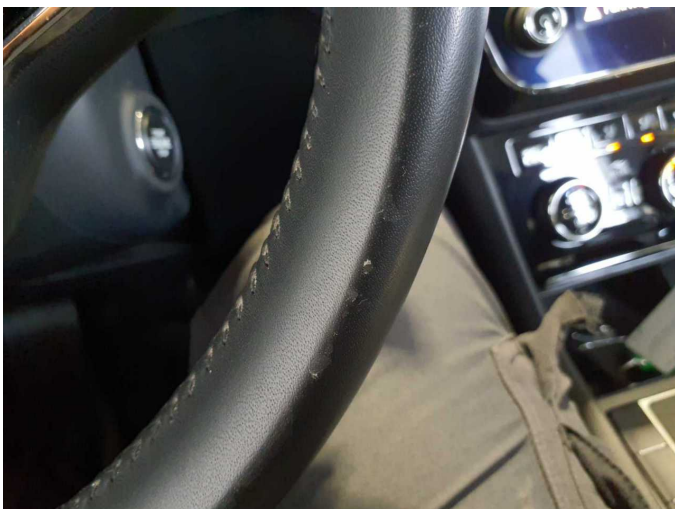
| No. | Component group | Description |
|---|---|---|
| 7 | Steering system | Steering wheel sheath - Scratch(es) - Smart repair |

**Damage 7:** Steering system: Steering wheel sheath - Scratch(es) - Smart repair

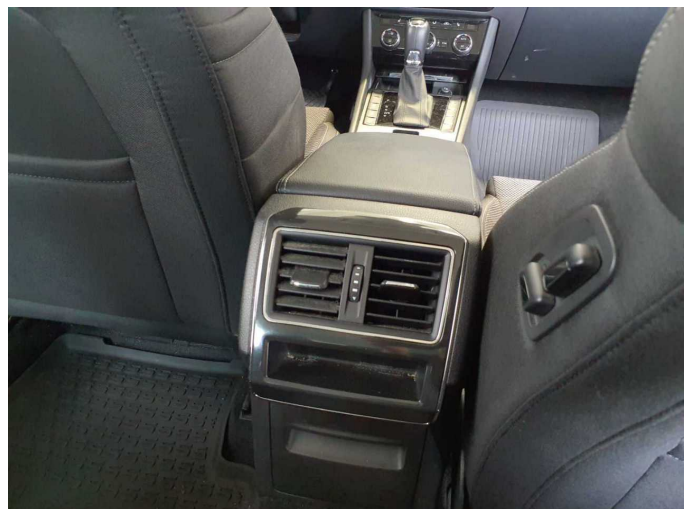
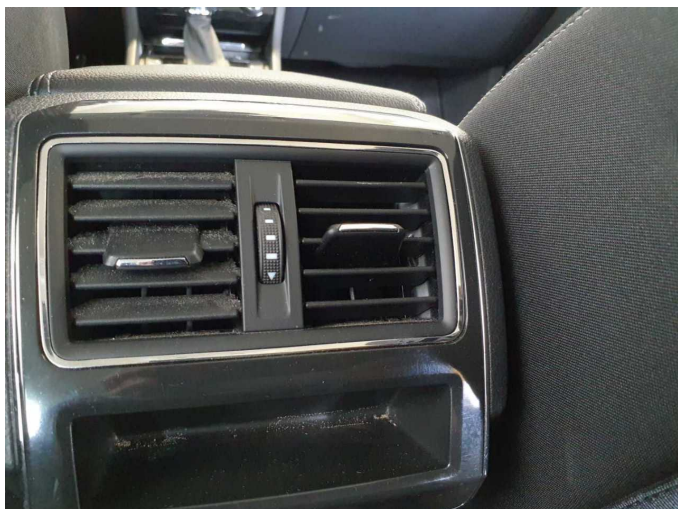
| No. | Component group | Description |
|---|---|---|
| 8 | Instrument panel | Air nozzle - centre (Hinten) - Broken / torn - Replace |

**Damage 8:** Instrument panel: Air nozzle - centre (Hinten) - Broken / torn - Replace

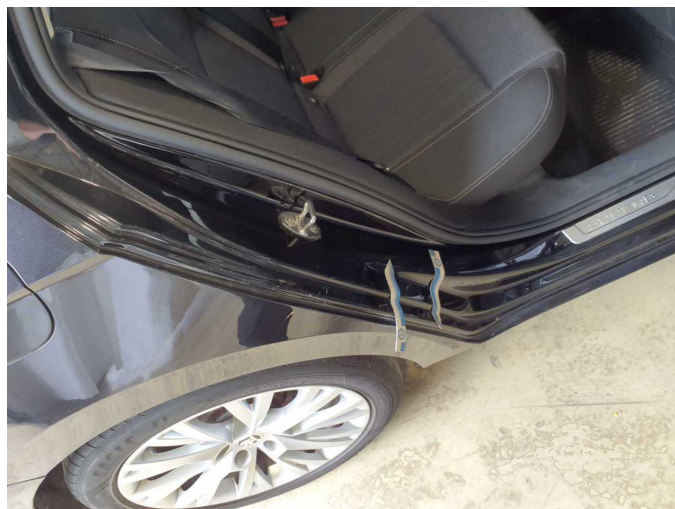
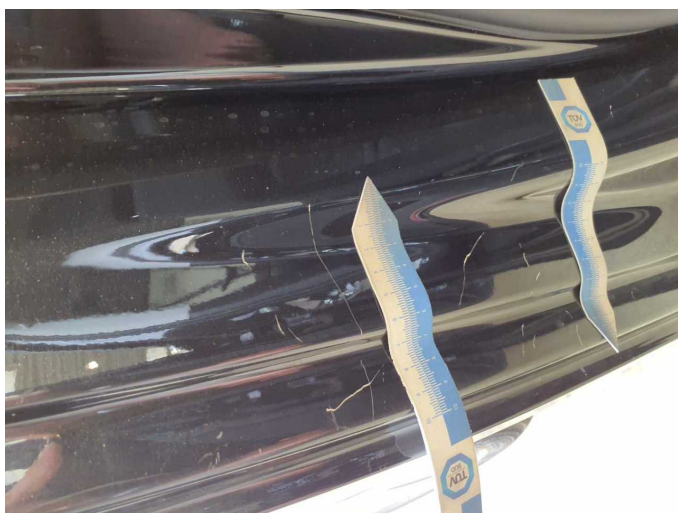
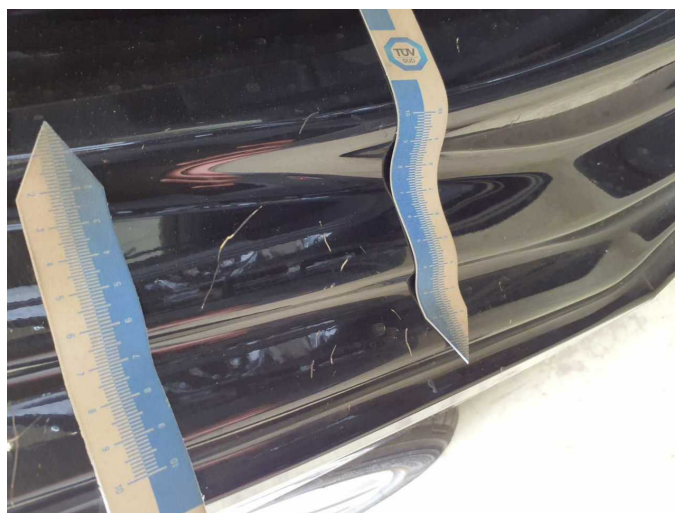
| No. | Component group | Description |
|---|---|---|
| 9 | Side panel - rear right side | Sill - Scratch(es) - Paint |

**Damage 9:** Side panel - rear right side: Sill - Scratch(es) - Paint

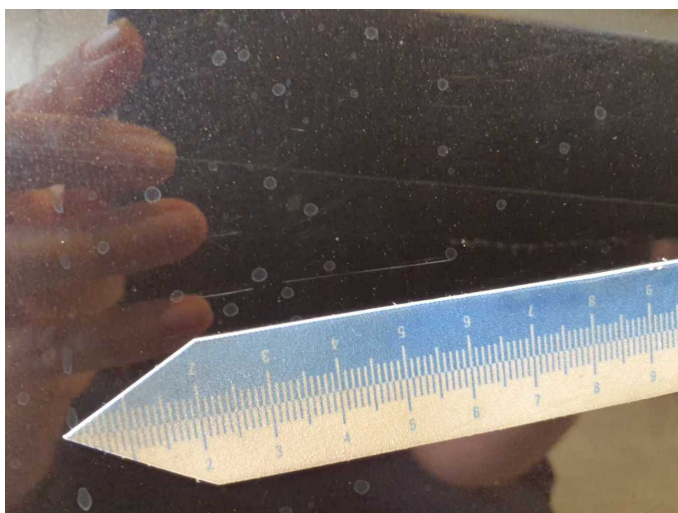
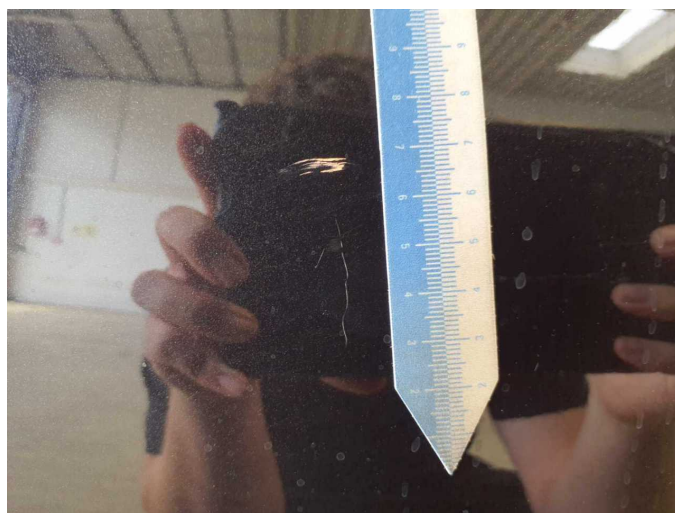
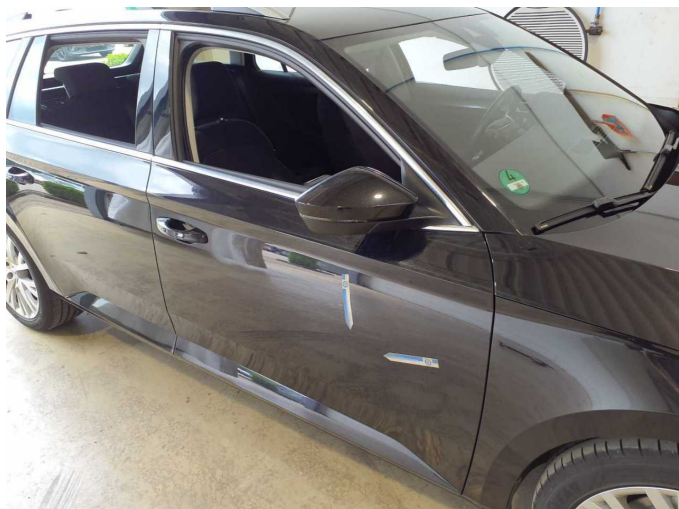
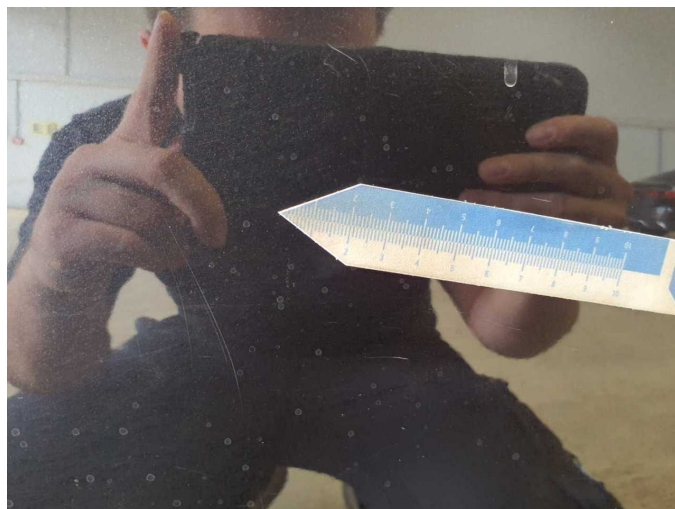
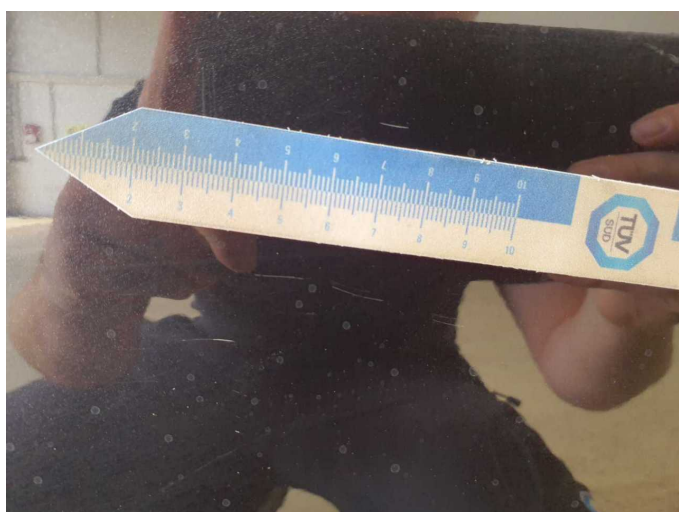
| No. | Component group | Description |
|---|---|---|
| 10 | Door - front right side | Door - Scratch(es) - Paint |

**Damage 10:** Door - front right side: Door - Scratch(es) - Paint

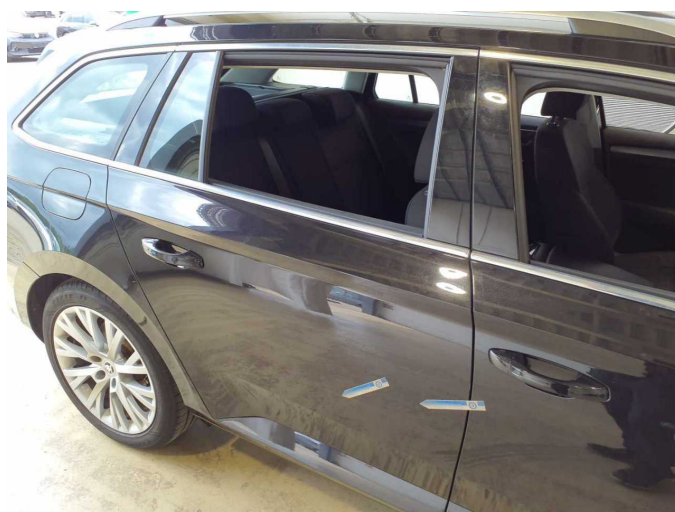
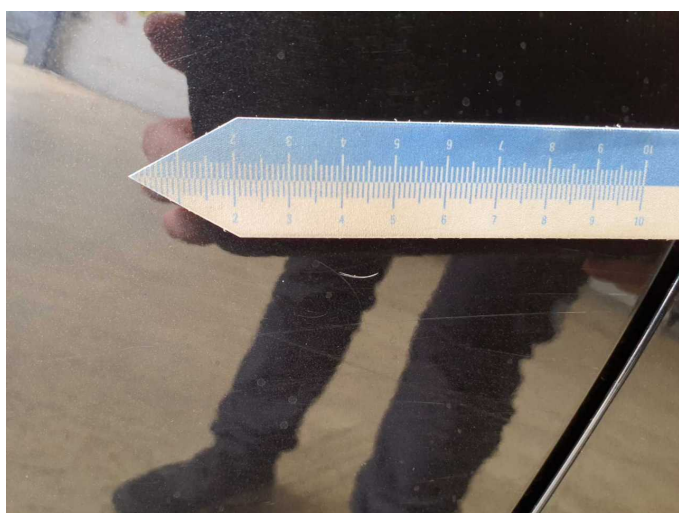
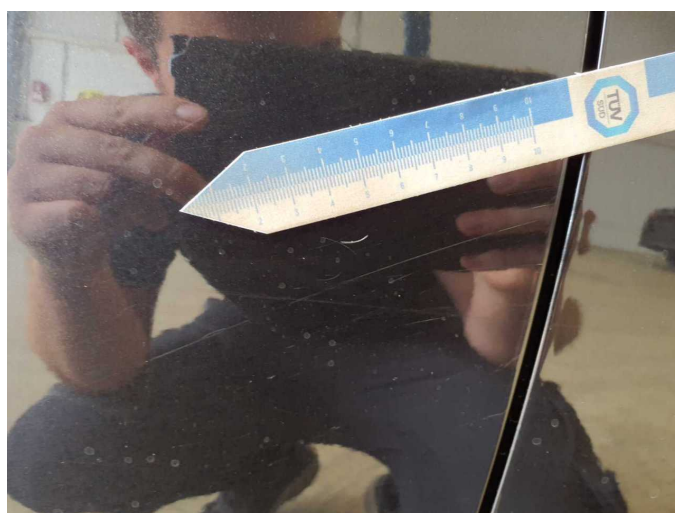
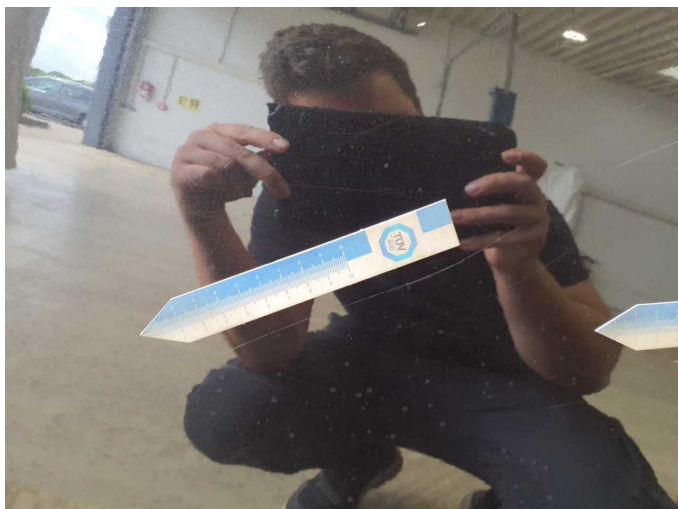
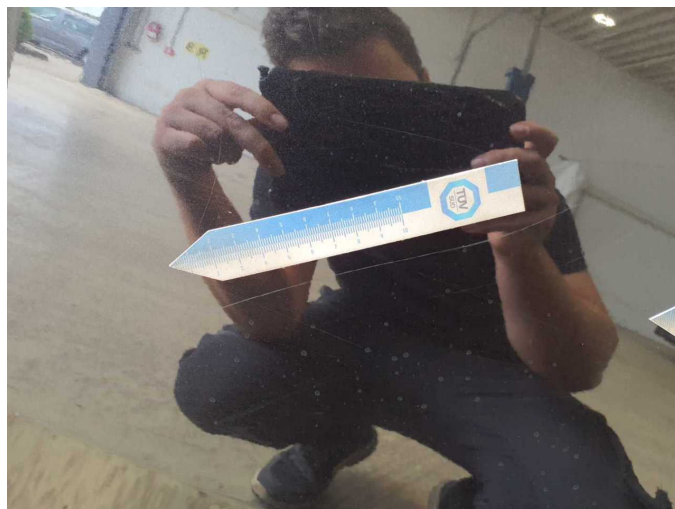
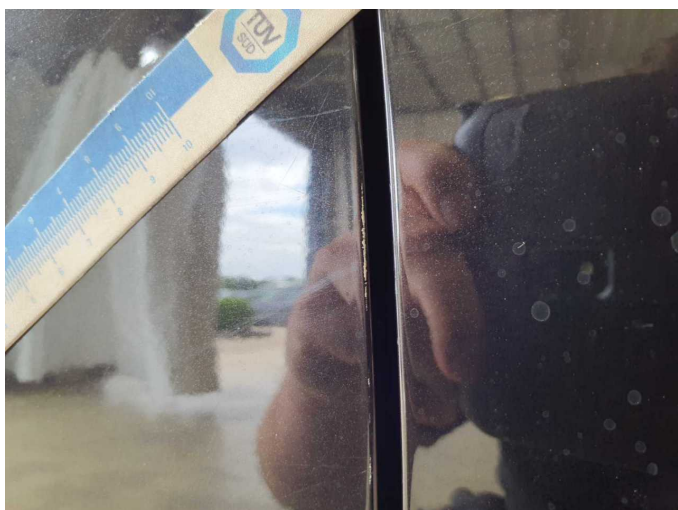
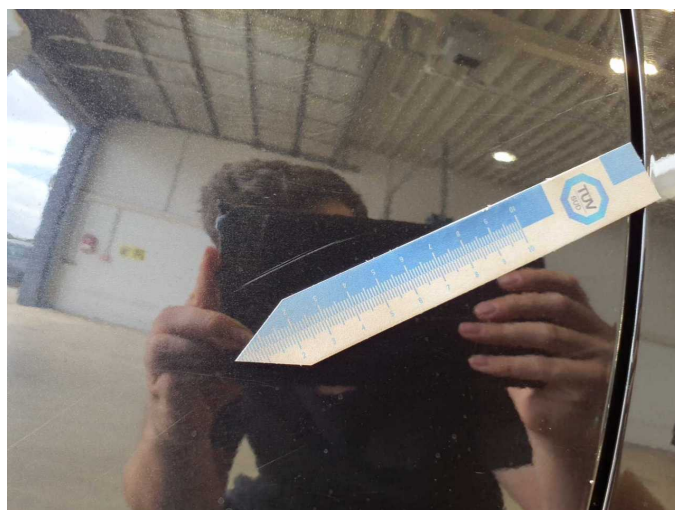
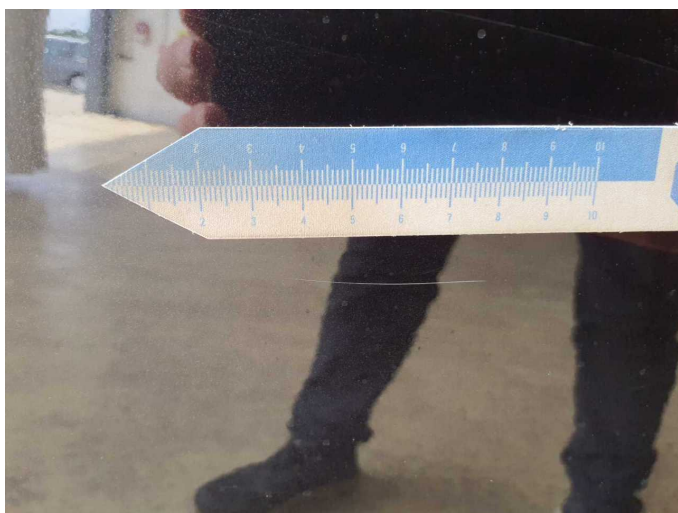
| No. | Component group | Description |
|---|---|---|
| 11 | Door - rear right side | Door - Scratch(es) - Paint |

**Damage 11:** Door - rear right side: Door - Scratch(es) - Paint

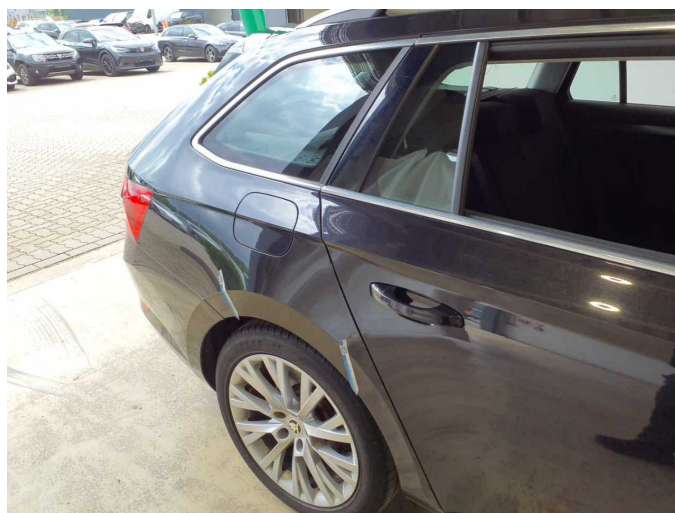
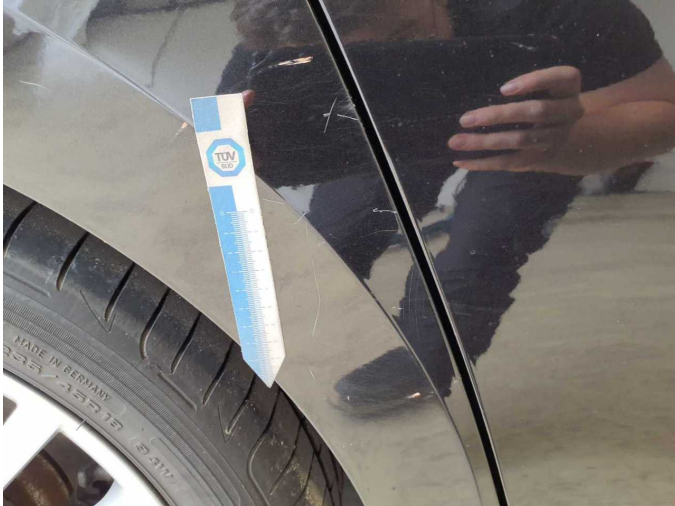
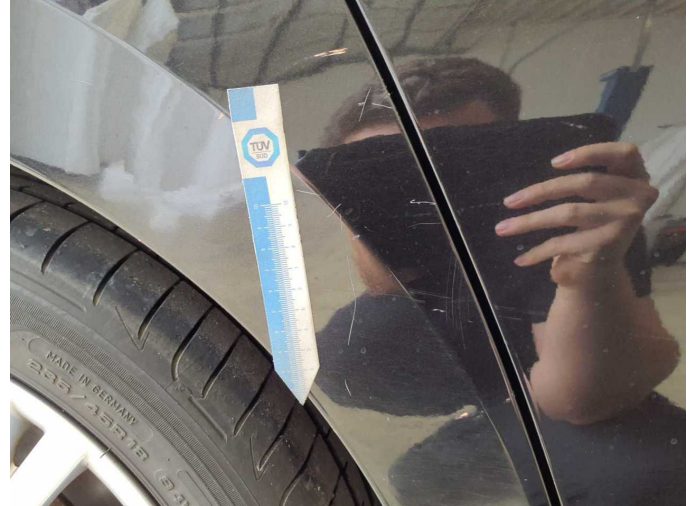
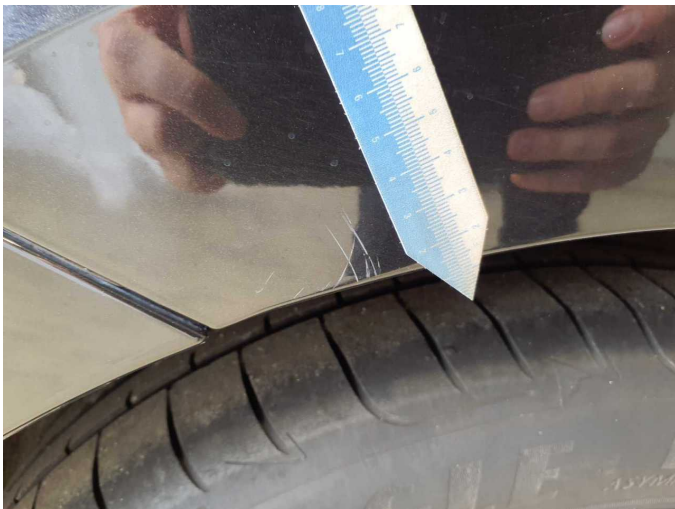
| No. | Component group | Description |
|---|---|---|
| 12 | Side panel - rear right side | Side panel - Scratch(es) - Paint |

**Damage 12:** Side panel - rear right side: Side panel - Scratch(es) - Paint

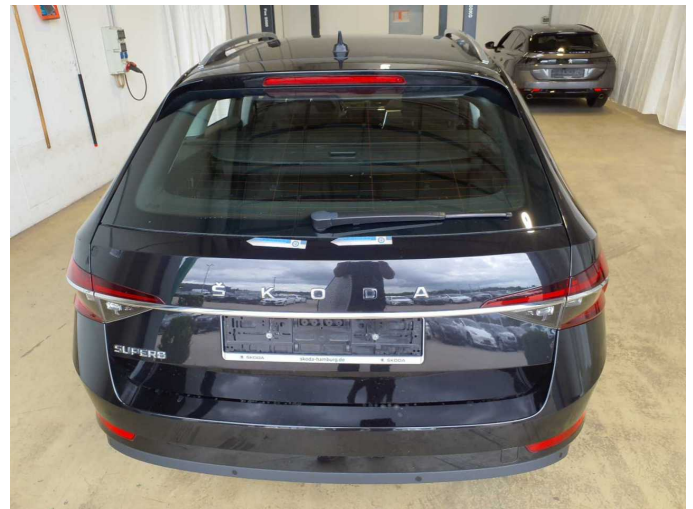
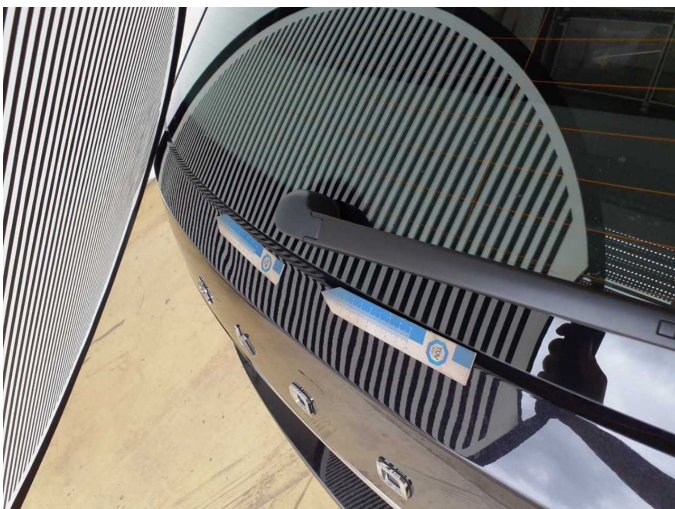
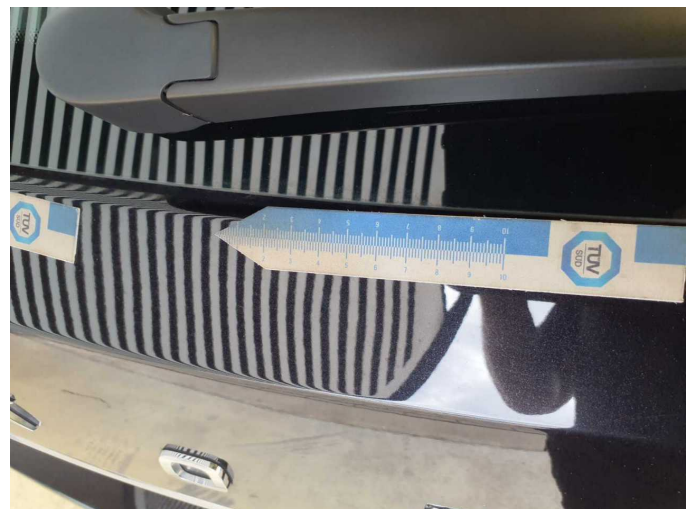
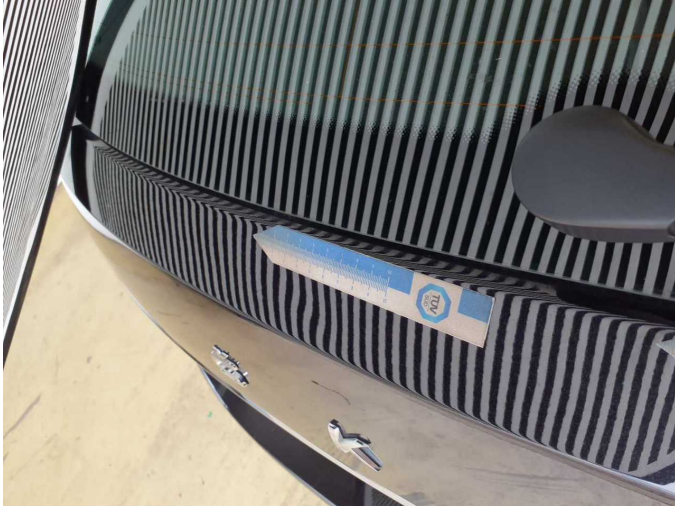
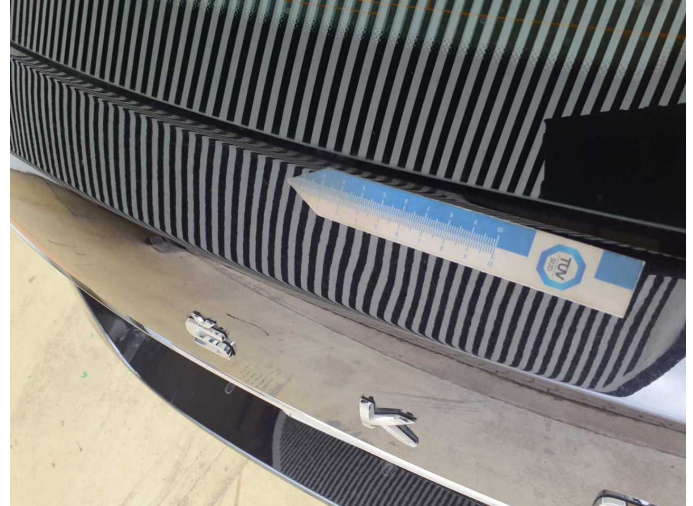
| No. | Component group | Description |
|---|---|---|
| 7 | Boot lid / rear door | Boot lid - dent(s) - Smooth repair work |

**Wear and tear 7:** Boot lid / rear door: Boot lid - dent(s) - Smooth repair work

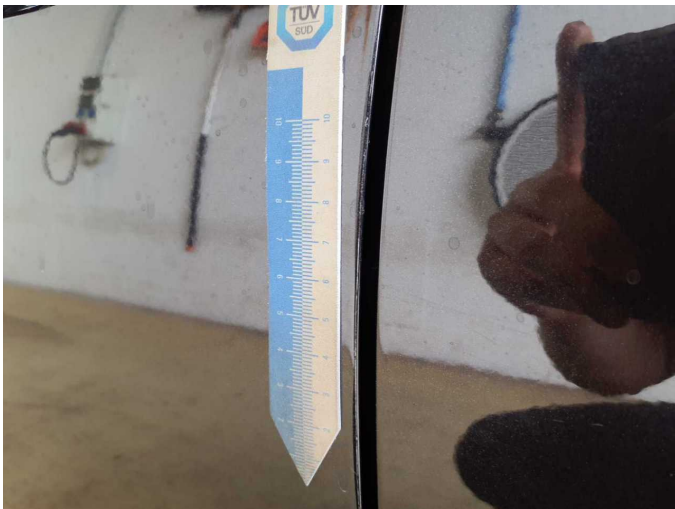
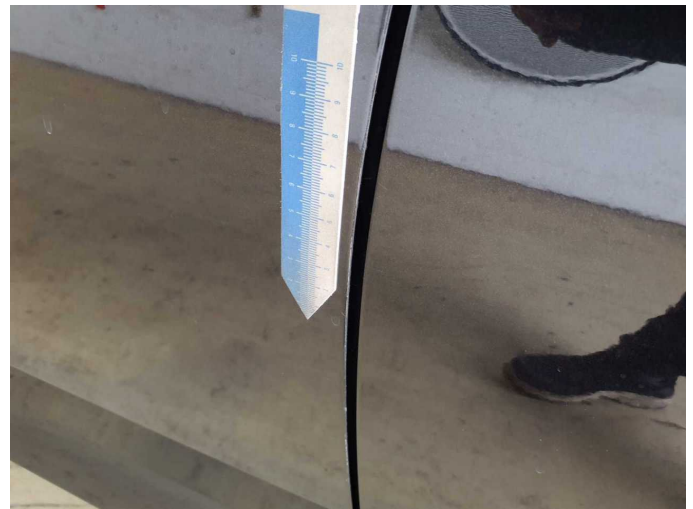
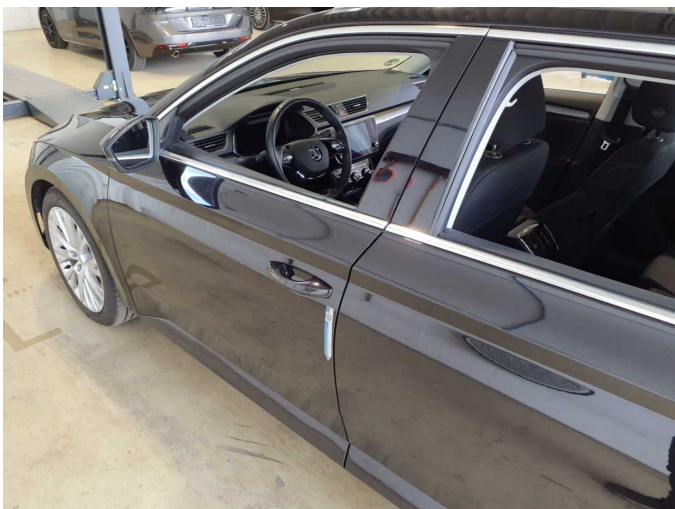
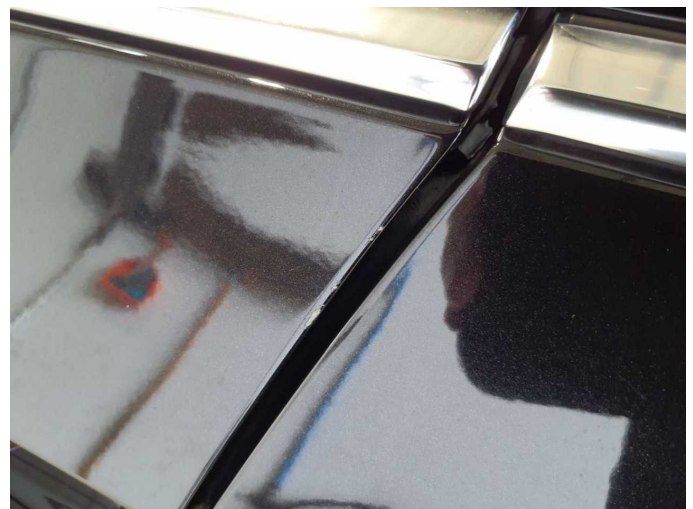
| No. | Component group | Description |
|---|---|---|
| 8 | Door - front left side | Door edge - Scratch(es) - Smart repair |

**Wear and tear 8:** Door - front left side: Door edge - Scratch(es) - Smart repair
