Expertise

Protocol number: 46179573
Order No. / Reference: 26508648
Inspection date: 24 Jun 2026

Model: Focus Turnier 1.0 EcoBoost Start-Stop-System Aut. ACTIVE X

VIN: WF0PXXGCHPMG57692

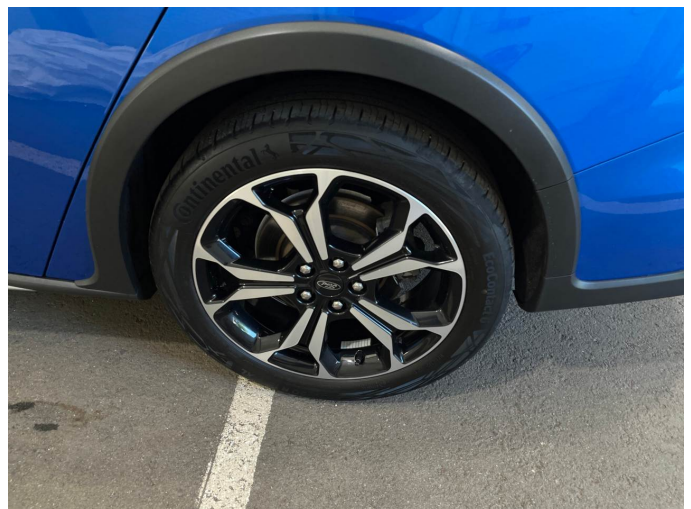
Figure 12: Mounted tyres

| # | Tyre size | Type of tyre | Manufacturer | Tread depth |
|---|---|---|---|---|
| 1) | 215/55 R17 98V | Winter tyres on Light alloy | Bridgestone | 6mm / 6mm |
| 2) | 215/55 R17 98V | Winter tyres on Light alloy | Bridgestone | 7mm / 7mm |

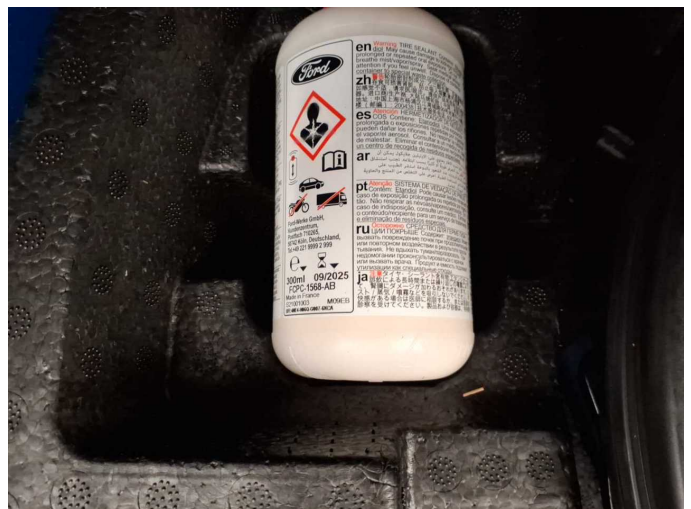
| No. | Component group | Description |
|---|---|--|
| 1 | Equipment | Tirefit filler - Expired - Replace |

Damage 1: Equipment: Tirefit filler - Expired - Replace

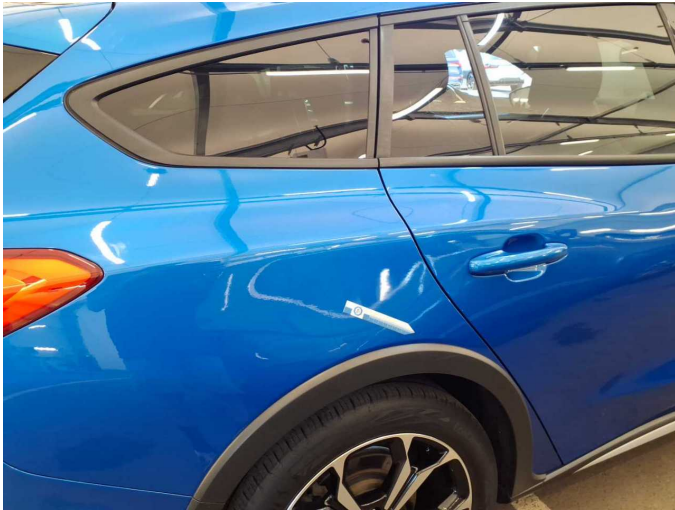
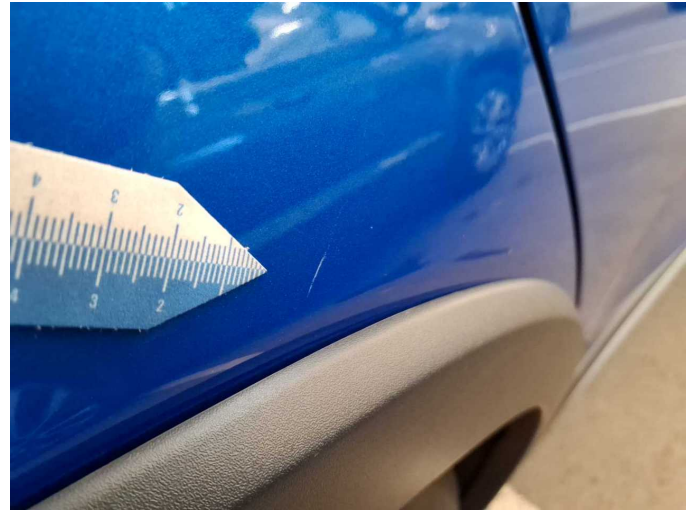
| No. | Component group | Description |
|---|---|--|
| 2 | Side panel - rear right side | Side panel - Scratch(es) - Smart repair |

Damage 2: Side panel - rear right side: Side panel - Scratch(es) - Smart repair
