Expertise

Protocol number: 46716509  
Order No. / Reference: 26772539  
Inspection date: 27 Jul 2026

Manufacturer: Mercedes-Benz

Model: E 400e 4Matic 9G-TRONIC

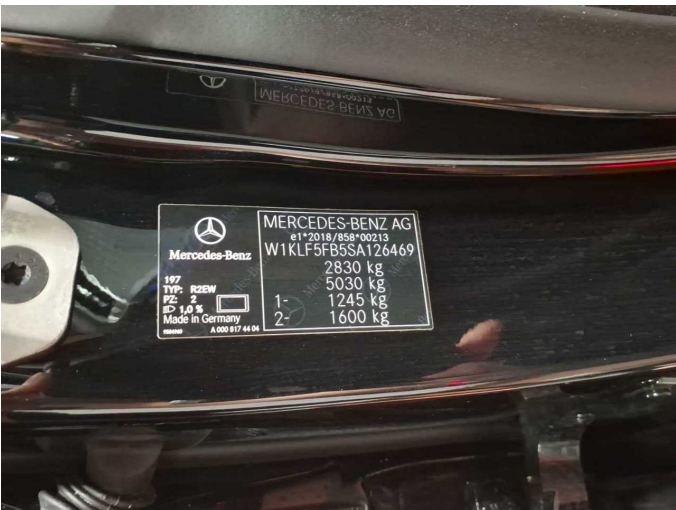
Figure 11: VIN

| VIN comparison | The vehicle identification number (VIN) was read from the vehicle and its conformity with the submitted documents was confirmed by the undersigned during the inspection. |

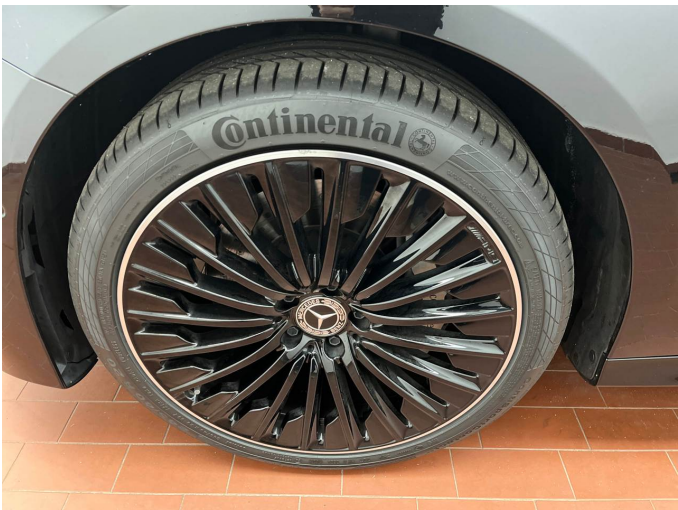
Figure 12: Mounted tyres

| Mounted tyres | | | | |
|---|---|---|---|---|
| 1) | 245/40 R20 99Y | Summer tyres on Light alloy | Michelin | 5mm / 5mm |
| 2) | 275/35 R20 102Y | Summer tyres on Light alloy | Michelin | 5mm / 5mm |

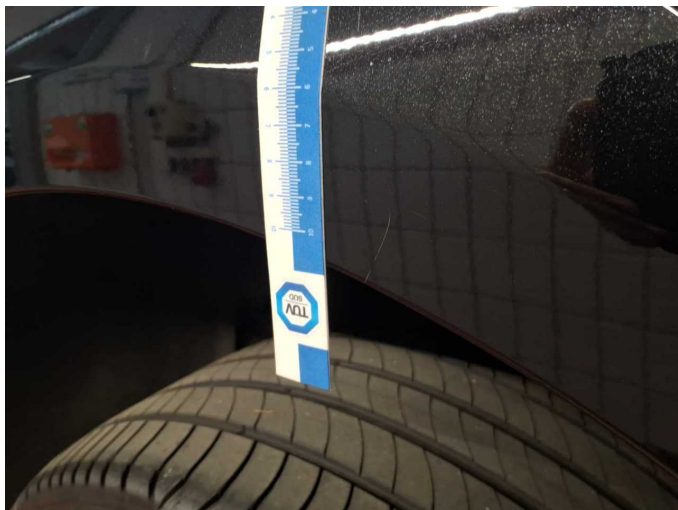
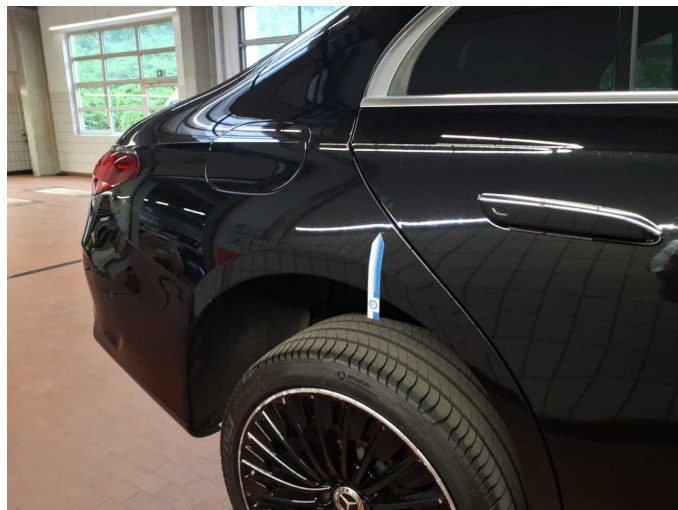
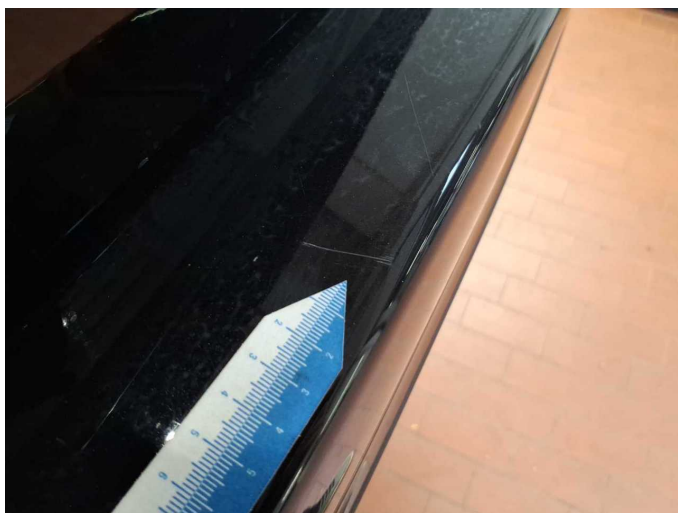
| No. | Component group | Description |
|---|---|---|
| 1 | Side panel - rear right side | Side panel - Scratch(es) - Smart repair |

**Damage 1:** Side panel - rear right side: Side panel - Scratch(es) - Smart repair

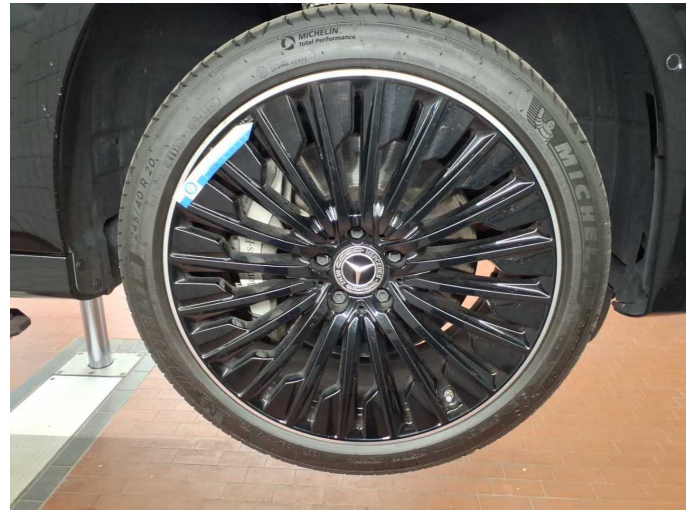
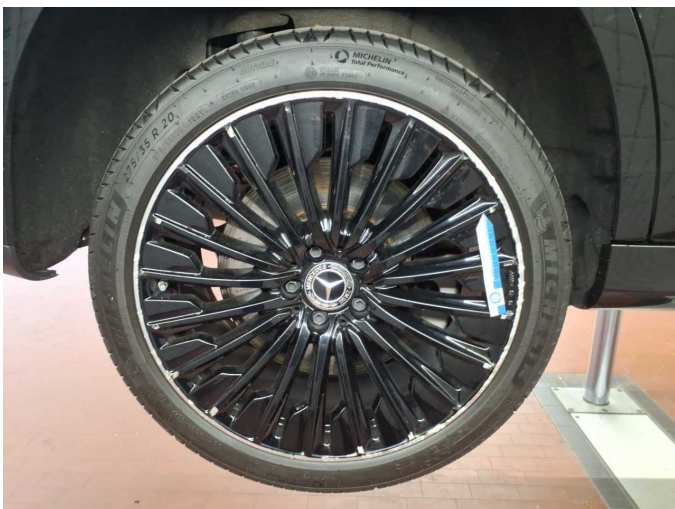
| No. | Component group | Description |
|---|---|---|
| 5 | Wheel / tyres | Alloy rim - front right side - Scratched - Replace |

**Damage 5:** Wheel / tyres: Alloy rim - front right side - Scratched - Replace

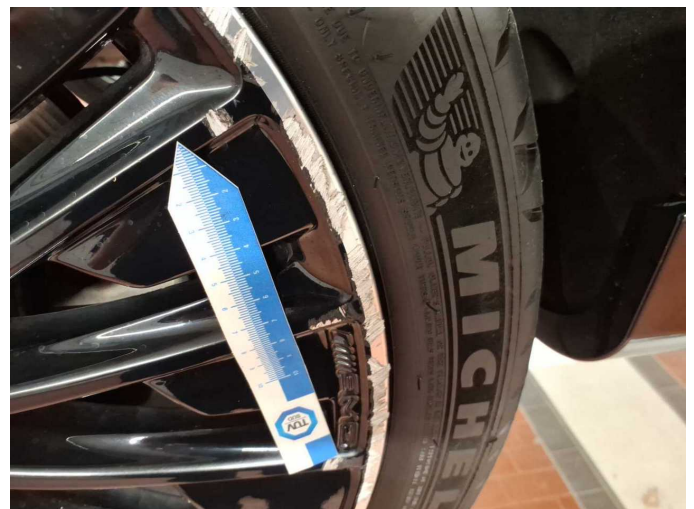
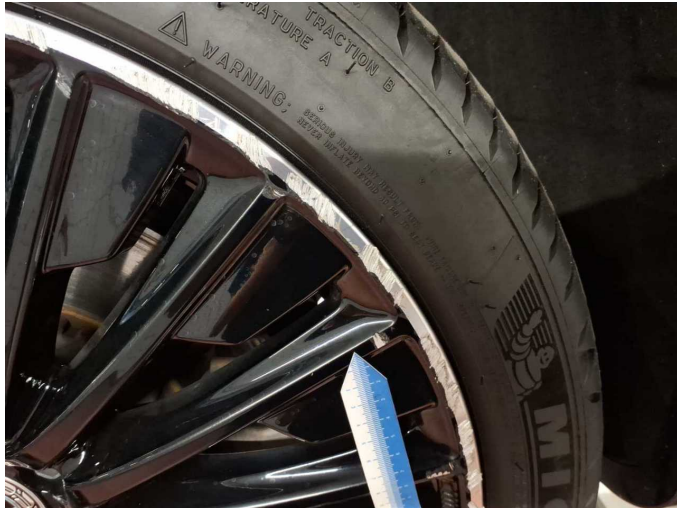
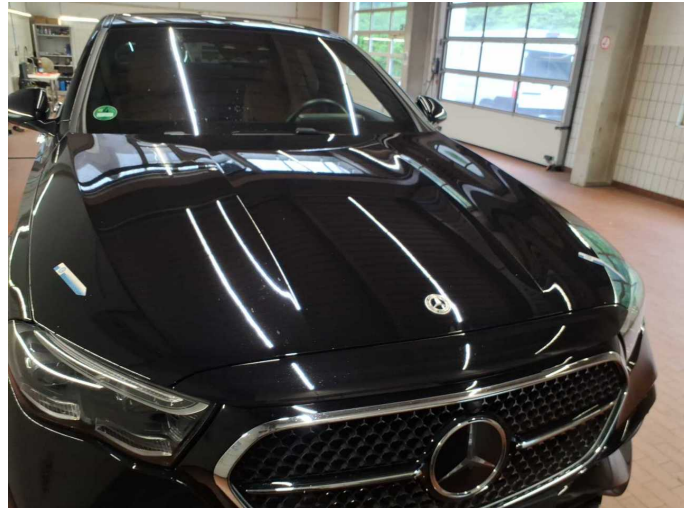
| No. | Component group | Description |
|---|---|---|
| 6 | Wheel / tyres | Alloy rim - rear right side - Scratched - Replace |

**Damage 6:** Wheel / tyres: Alloy rim - rear right side - Scratched - Replace

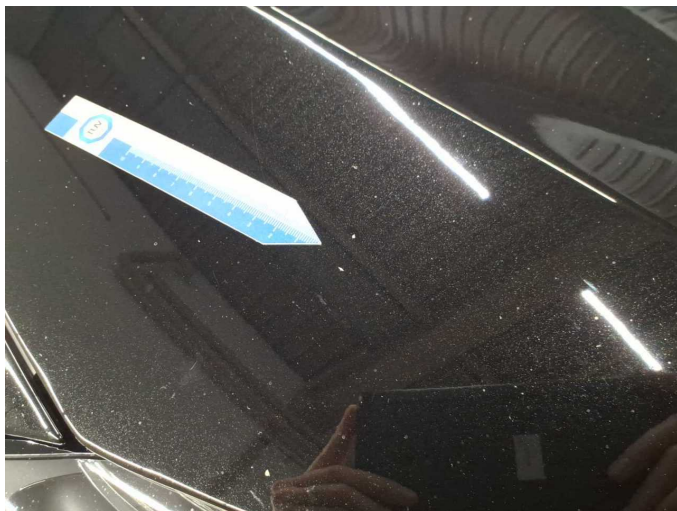
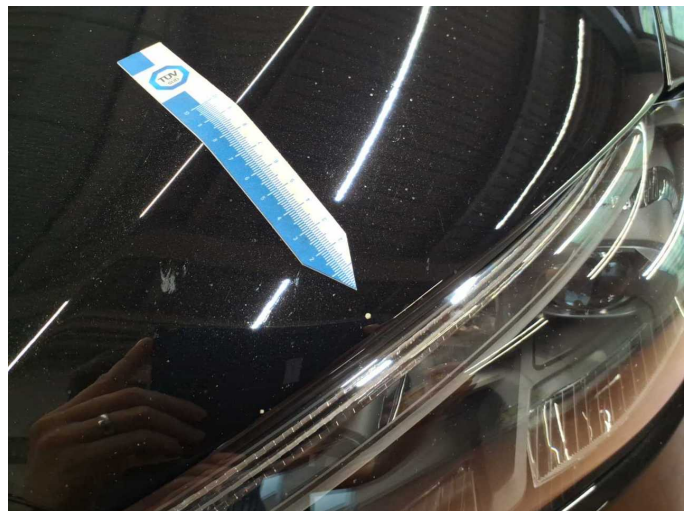
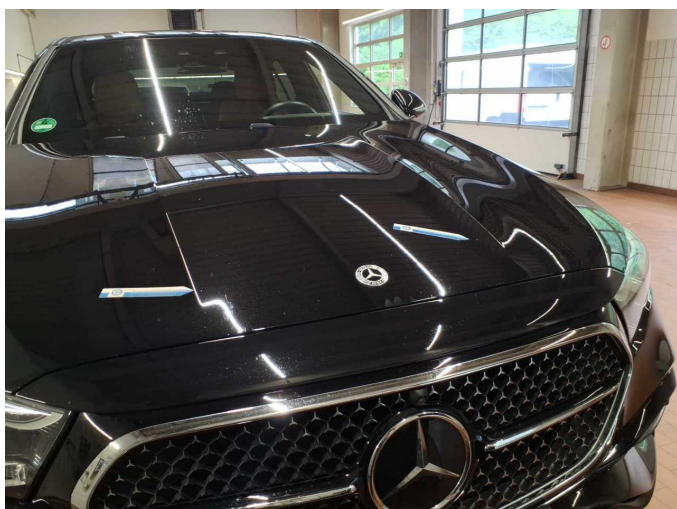
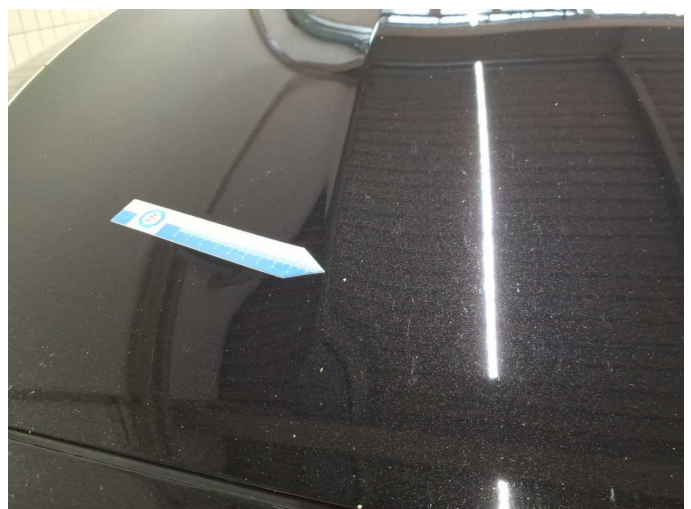
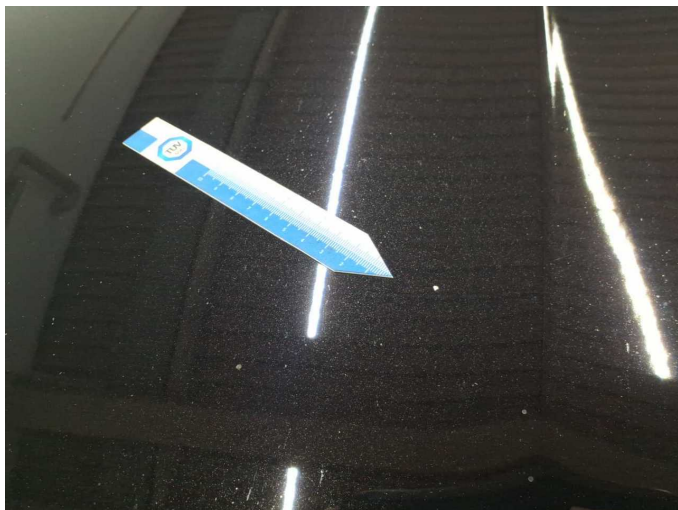
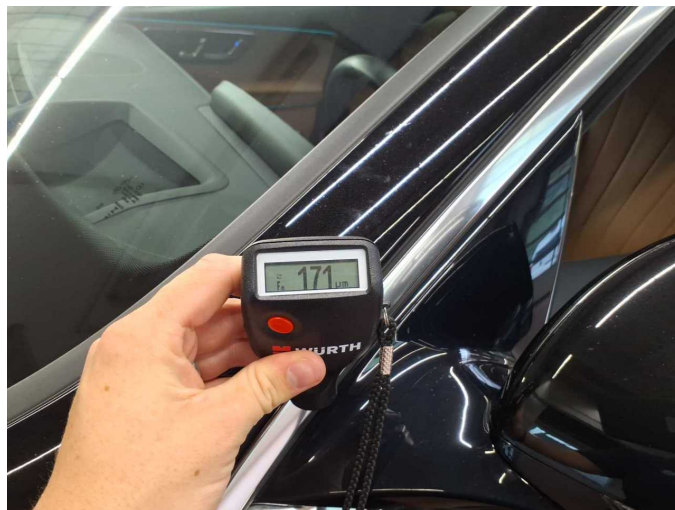
| No. | Component group | Description |
|---|---|---|
| 2 | Bonnet | Bonnet - Stone chips - No deduction |

**Wear and tear 2:** Bonnet: Bonnet - Stone chips - No deduction
