Expertise

Protocol number: 46572926  
Order No. / Reference: 26664035  
Inspection date: 17 Jul 2026

Model: Transit Custom 320 L2H1 VA Trend

VIN: WF01XXTTG1MK26671

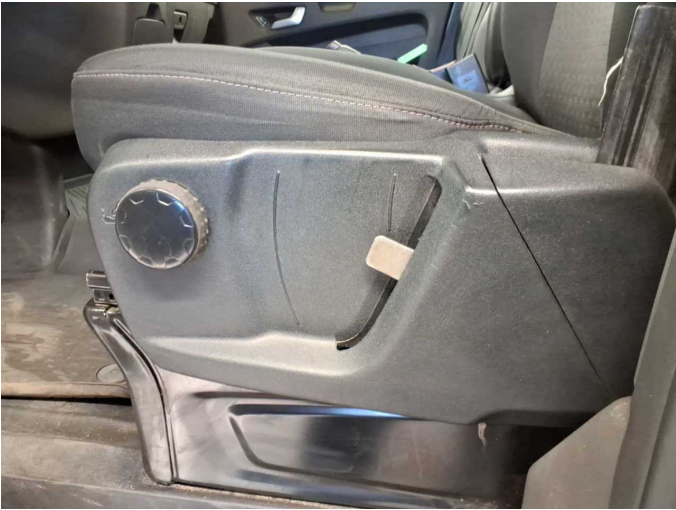
Damage 1: Seat - front: Lever seat adjustment - Missing - Replace

| No. | Component group | Description |
|---|---|---|
| 1 | Seat - front | Lever seat adjustment - Missing - Replace |

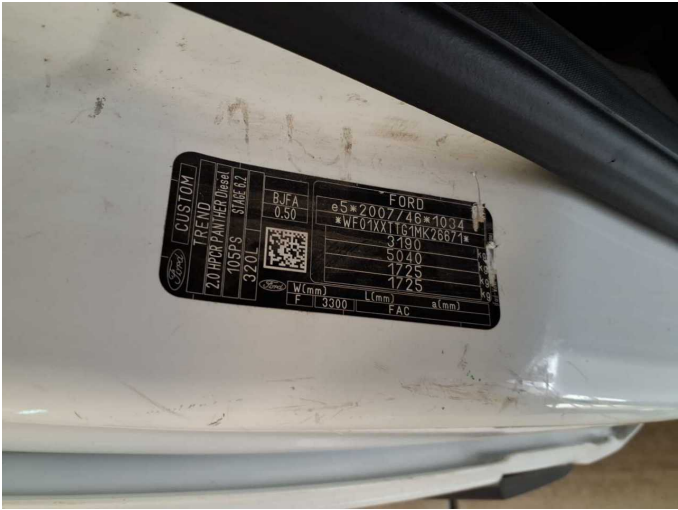
Damage 2: Body: Identification plate - Scratch(es) - Replace

| No. | Component group | Description |
|---|---|---|
| 2 | Body | Identification plate - Scratch(es) - Replace |

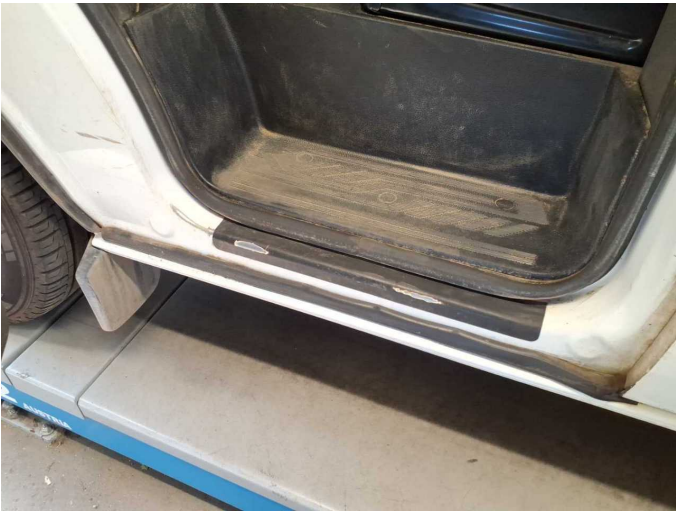
Damage 3: Sill - left side: Sill - Scratch(es) - Smart repair

| No. | Component group | Description |
|---|---|---|
| 3 | Sill - left side | Sill - Scratch(es) - Smart repair |

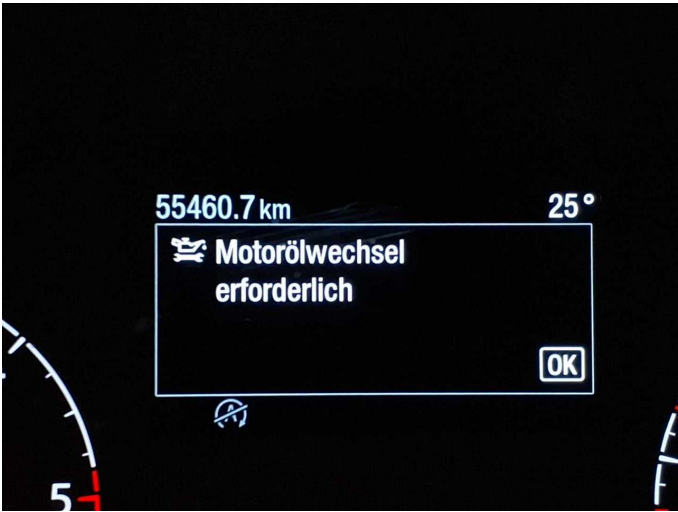
Damage 4: Misc.: Inspection / maintenance - Due - Perform

| No. | Component group | Description |
|---|---|---|
| 4 | Misc. | Inspection / maintenance - Due - Perform |

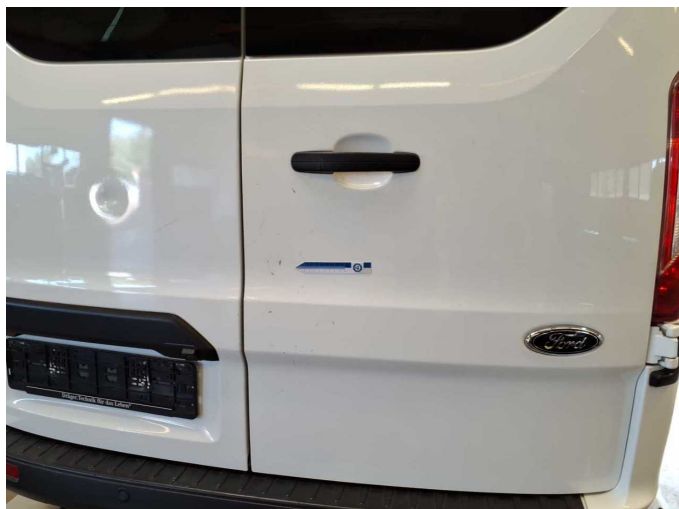
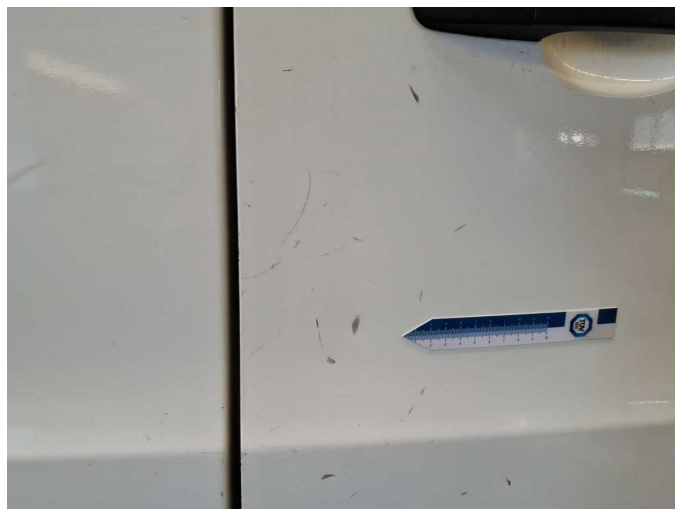
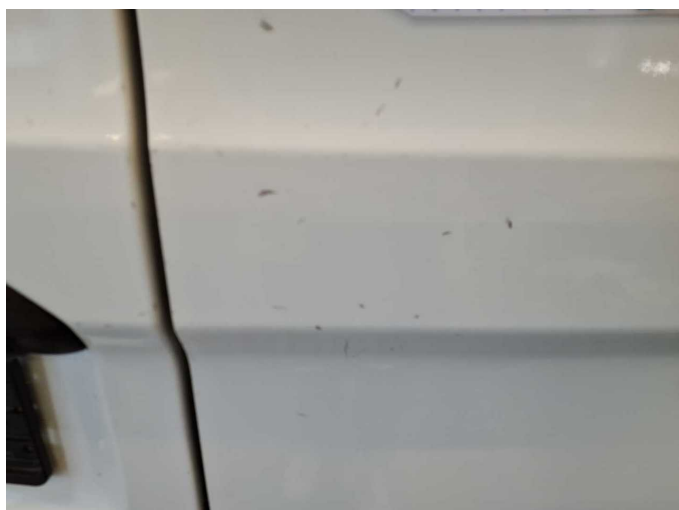
**Damage 5:** Boot lid / rear door: Rear door - right side - Scratch(es) - Paint

| No. | Component group | Description |
|---|---|---|
| 5 | Boot lid / rear door | Rear door - right side - Scratch(es) - Paint |

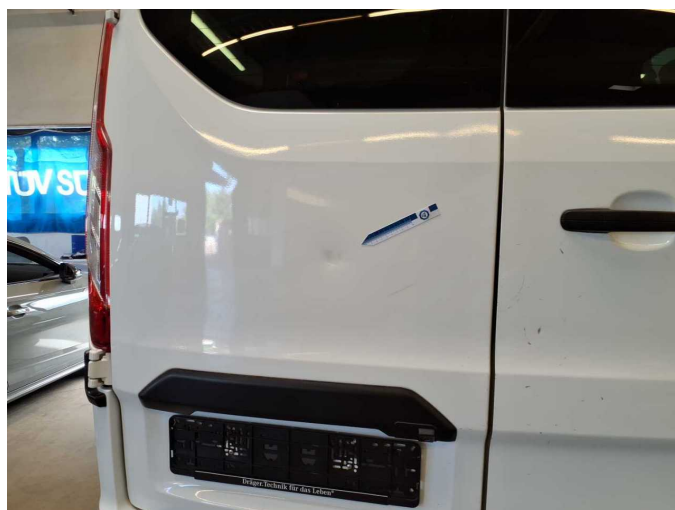
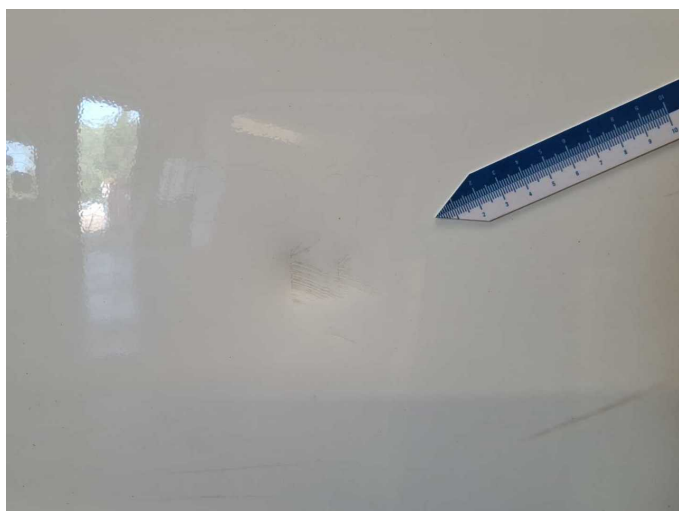
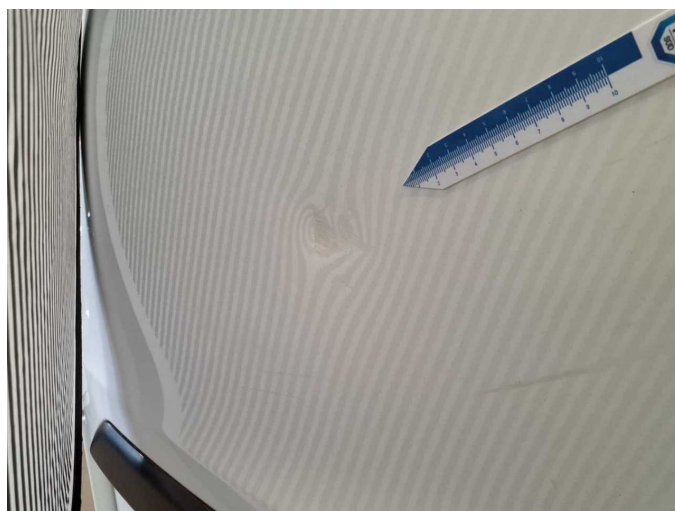
**Damage 6:** Boot lid / rear door: Rear door - left side - Dent / paintcoat damage - Repair and paint

| No. | Component group | Description |
|---|---|---|
| 6 | Boot lid / rear door | Rear door - left side - Dent / paintcoat damage - Repair and paint |

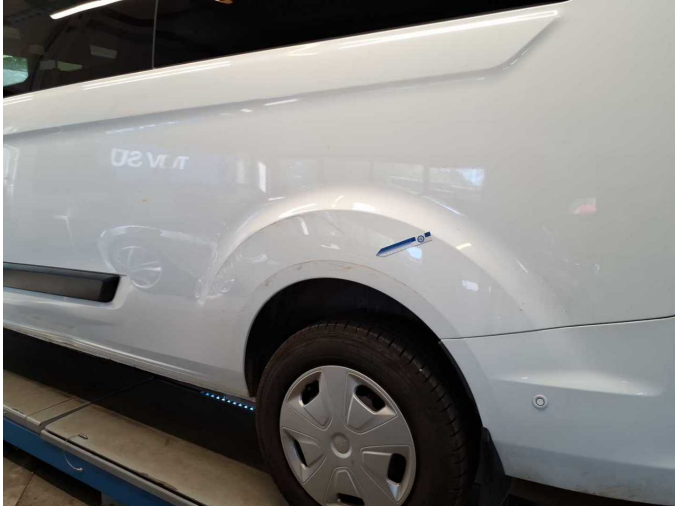
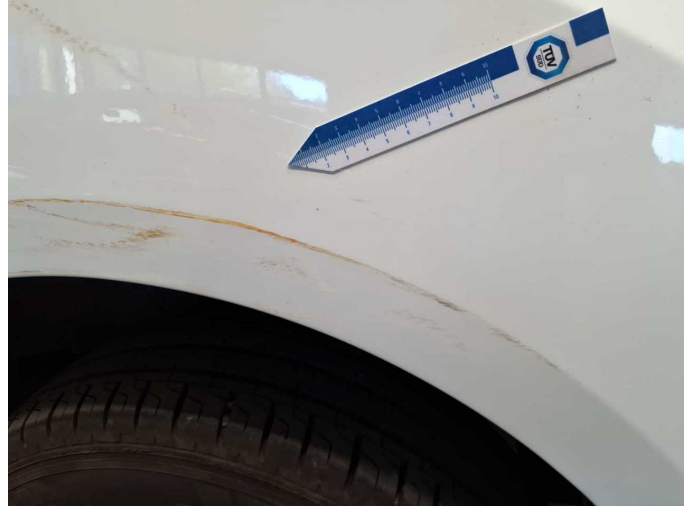
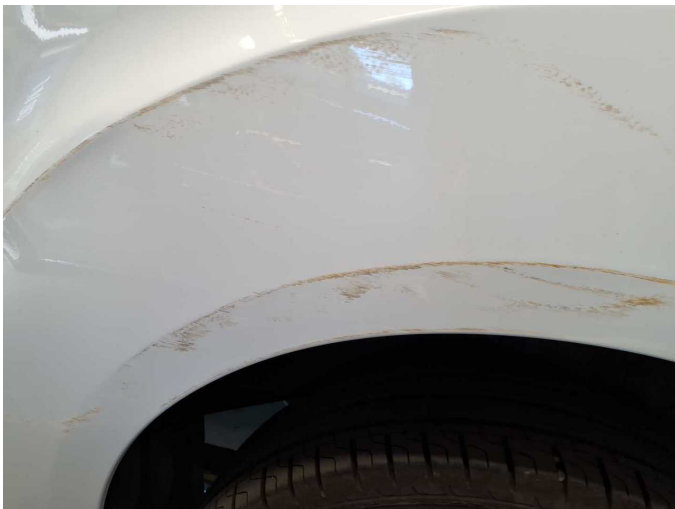
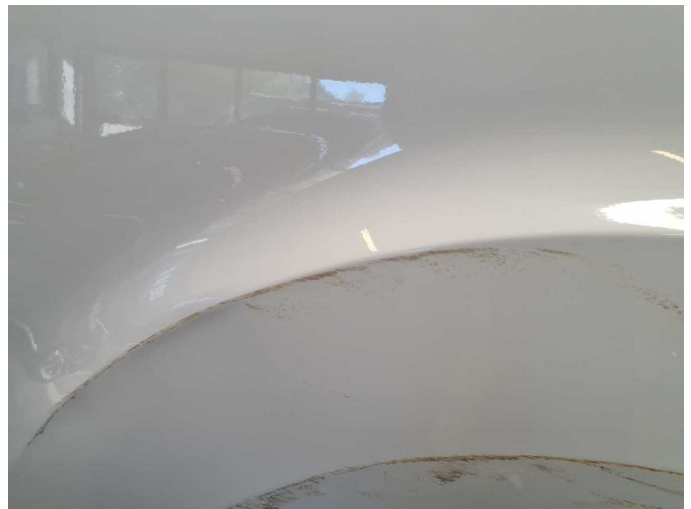
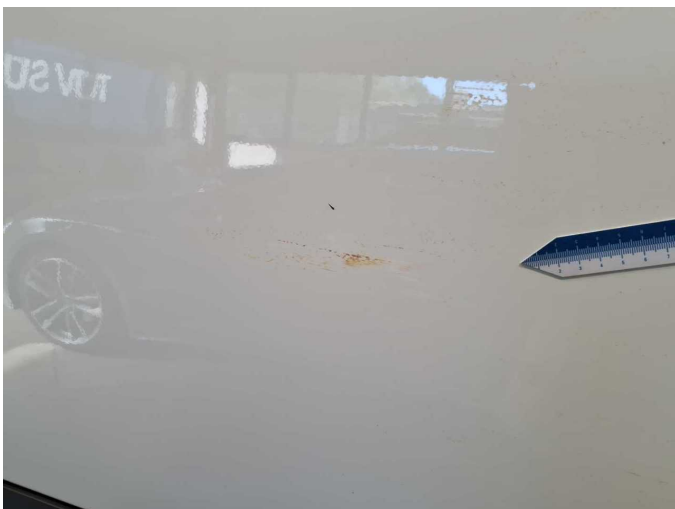
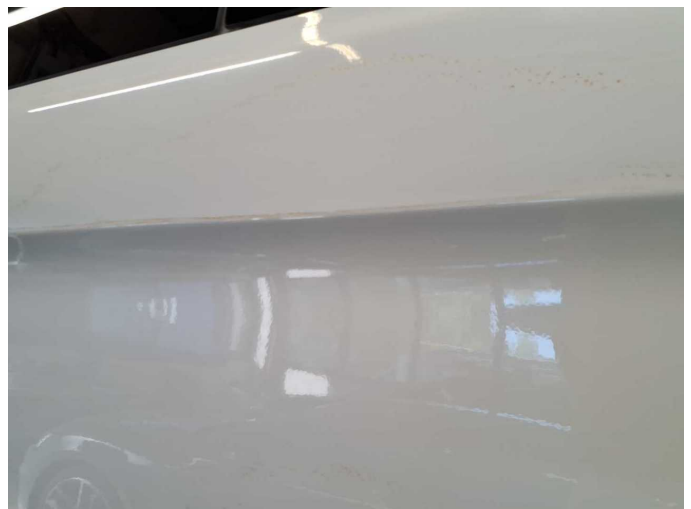
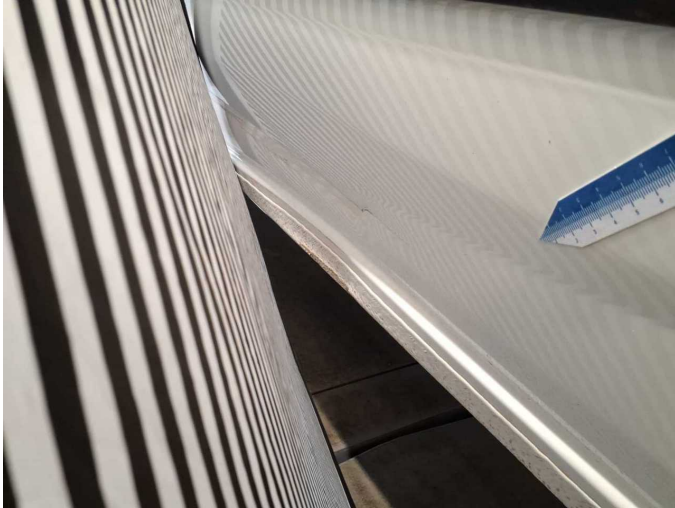
**Damage 7:** Side panel - rear left side: Side panel - Dent / paintcoat damage - Repair and paint

| No. | Component group | Description |
|---|---|---|
| 7 | Side panel - rear left side | Side panel - Dent / paintcoat damage - Repair and paint |

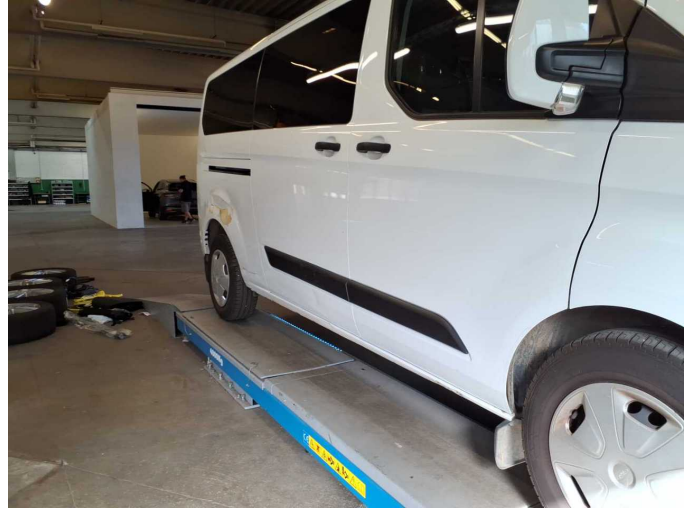
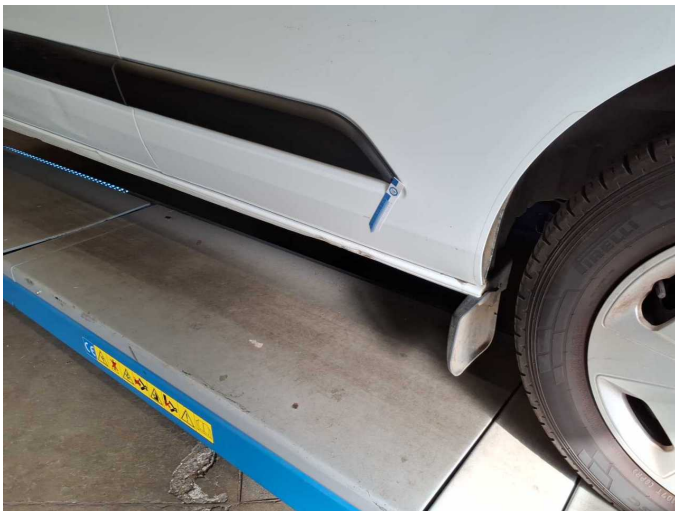
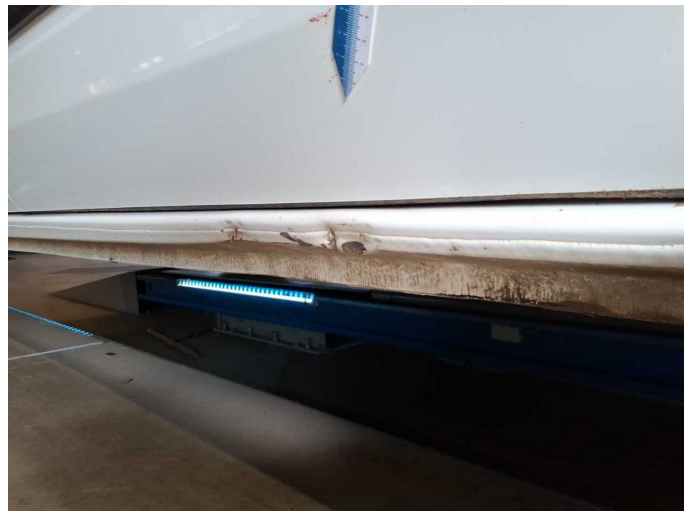
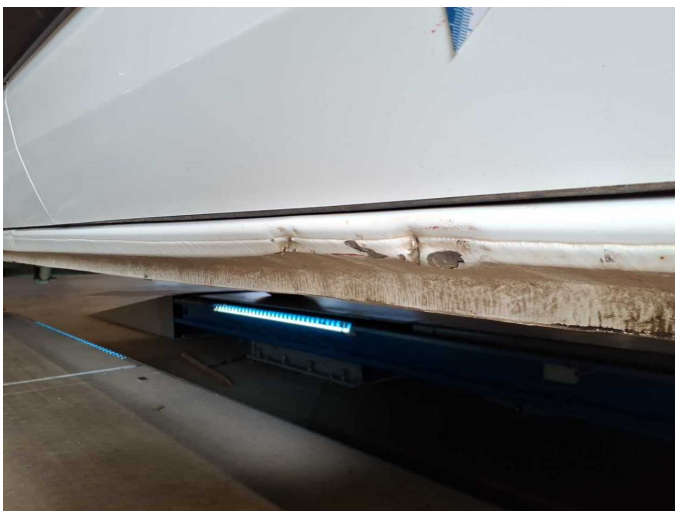
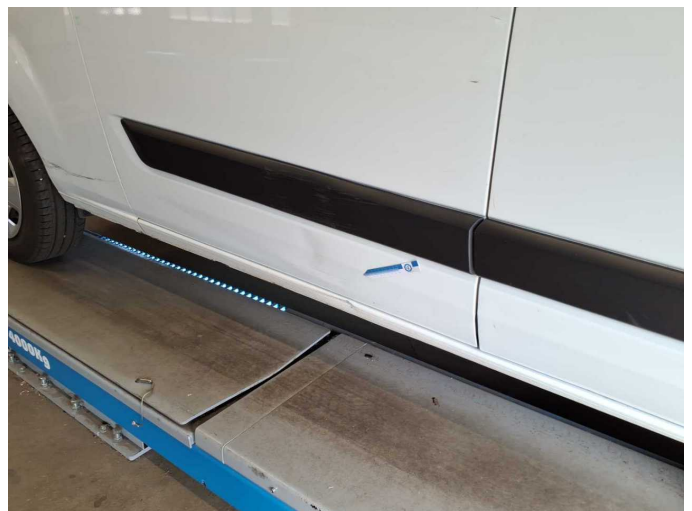
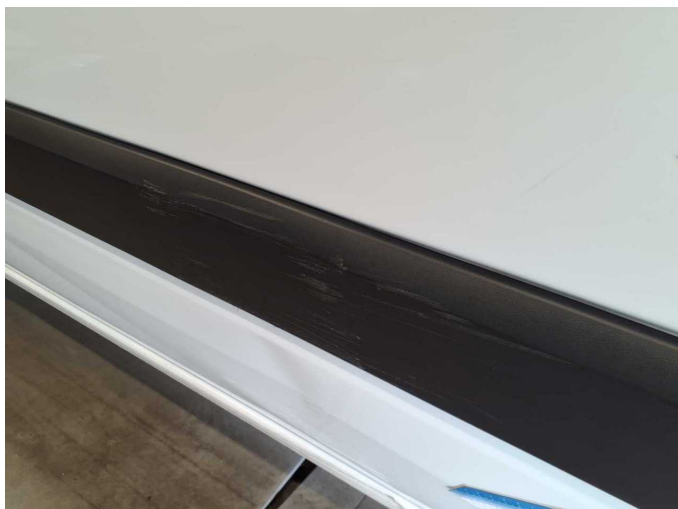
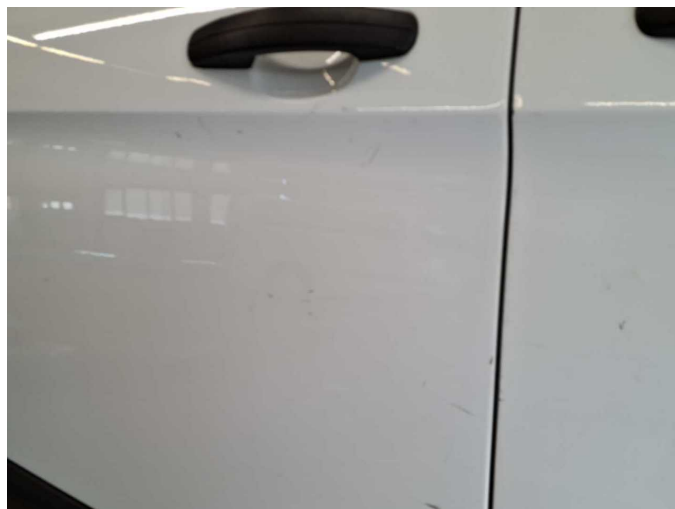
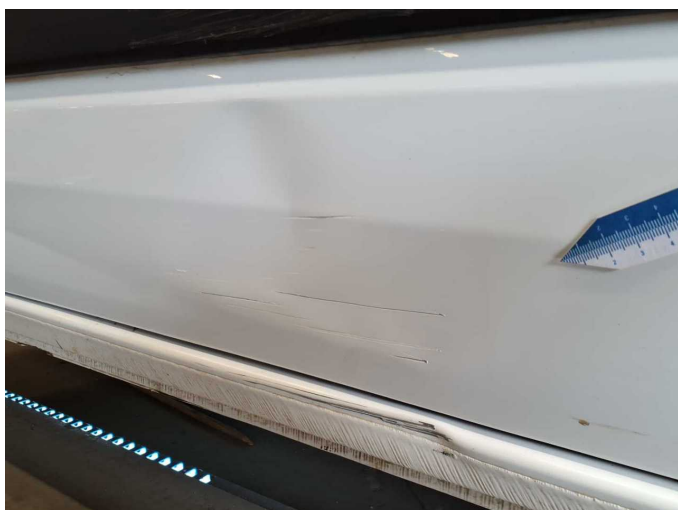
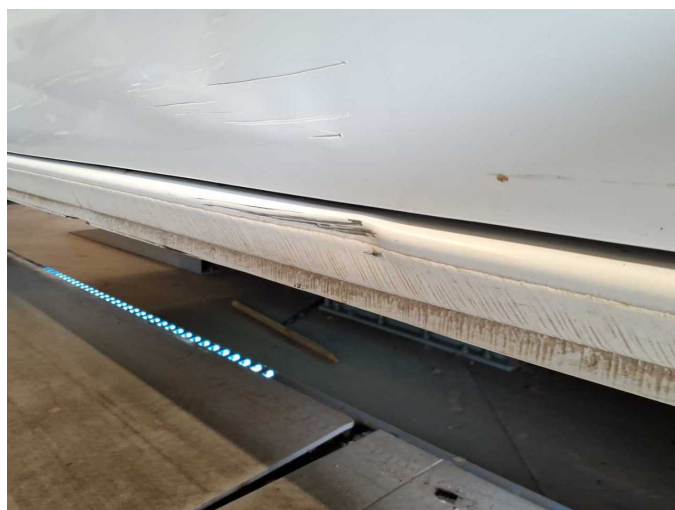
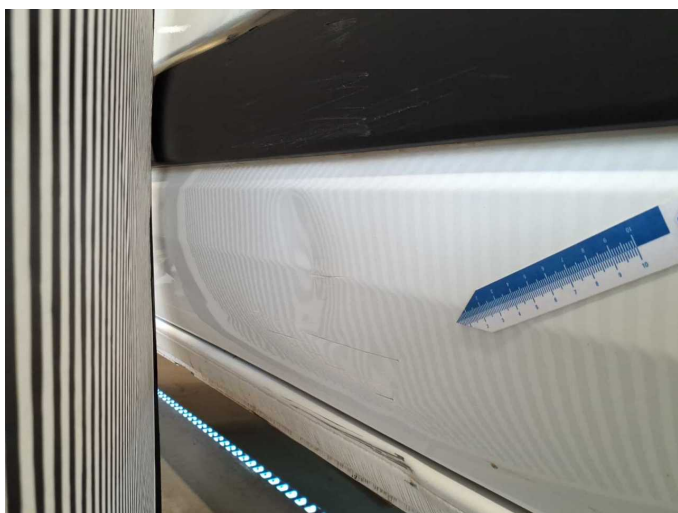
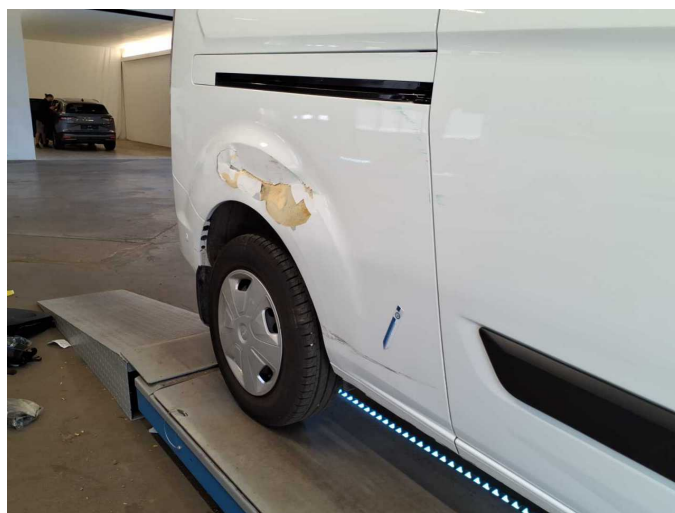
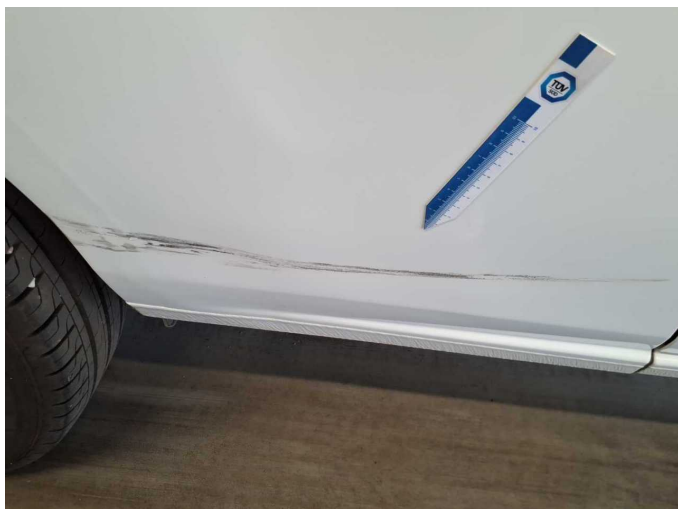
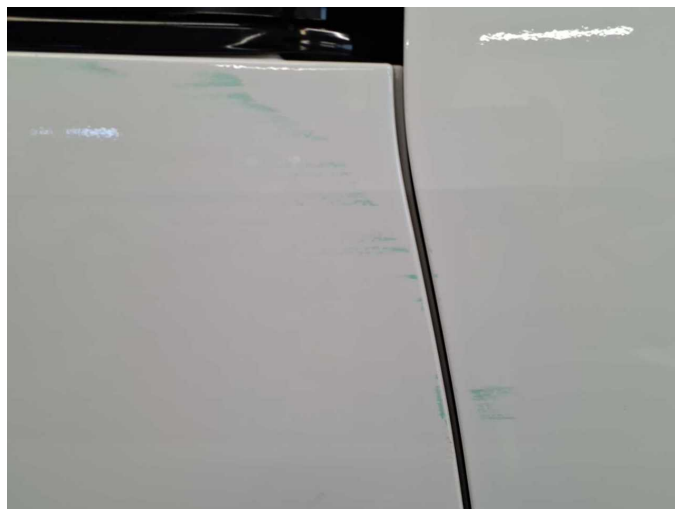
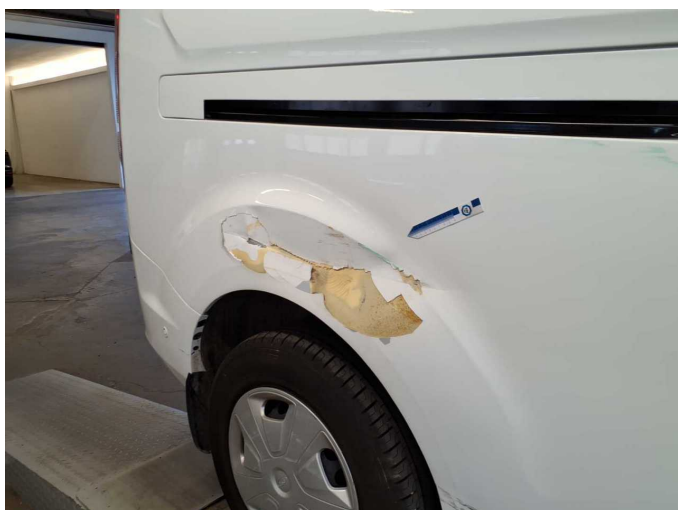
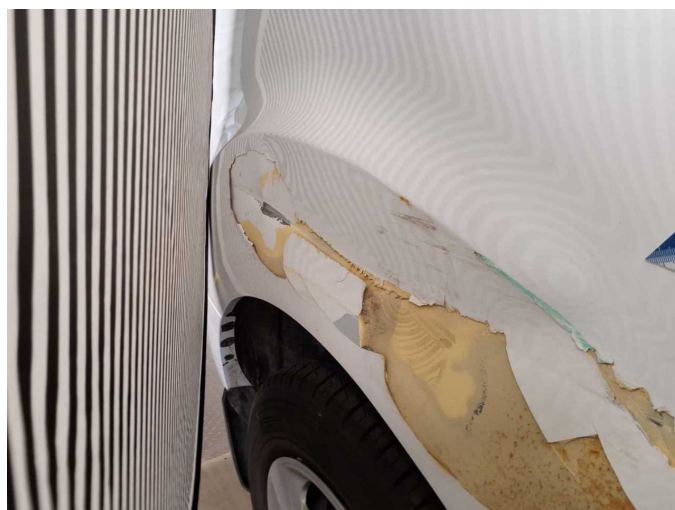
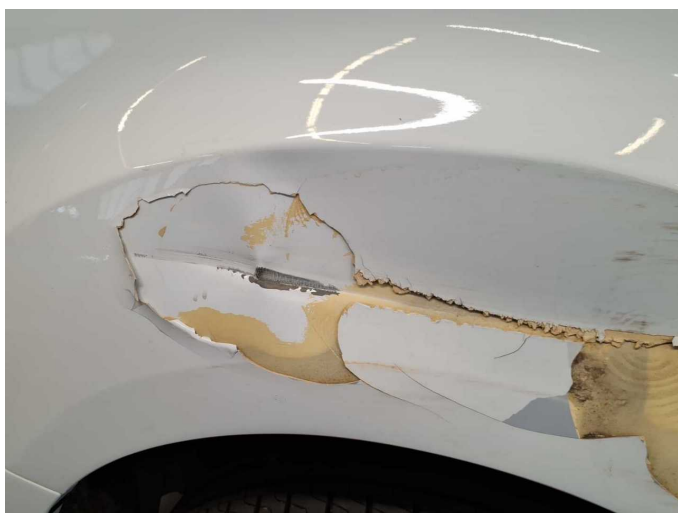
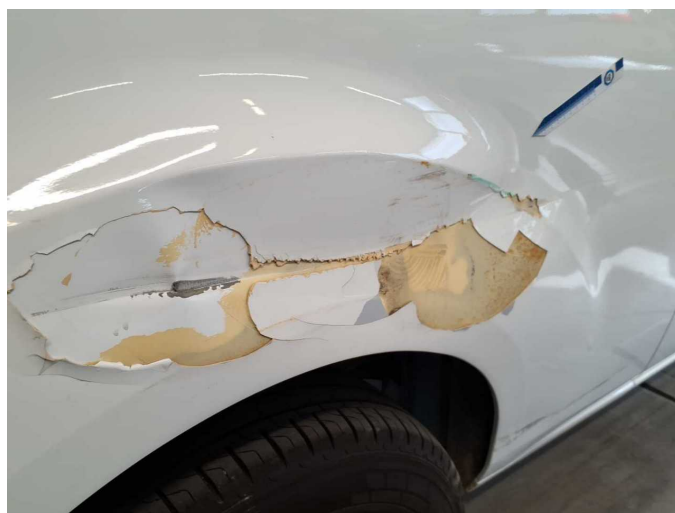
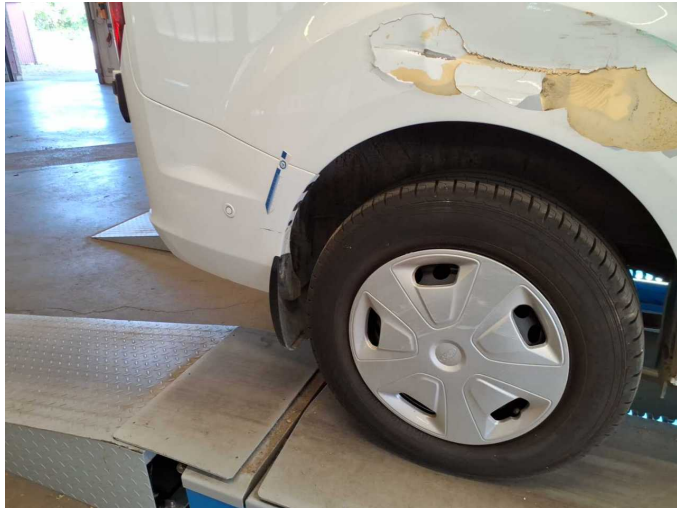
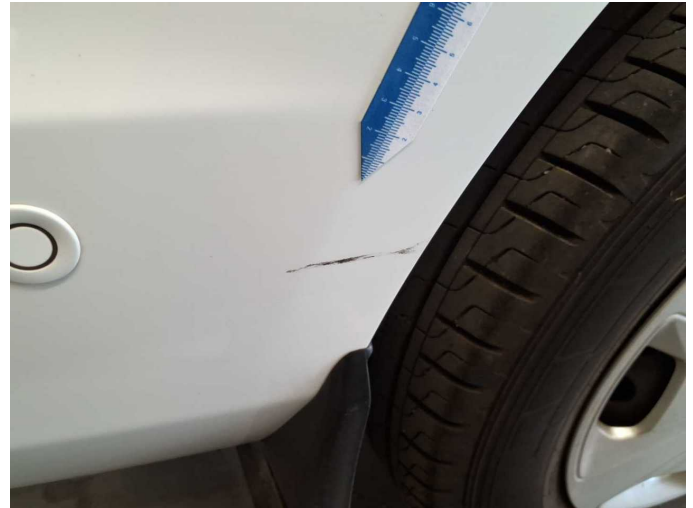
| No. | Previous damage | Extent of damage (Net) |
|---|---|---|
| 2 | Rear, Side right, Provided by user / customer, from 14 Oct 2024 | 8.082,84 € |

1 Rear, Side right

**Accident 1:** Rear, Side right

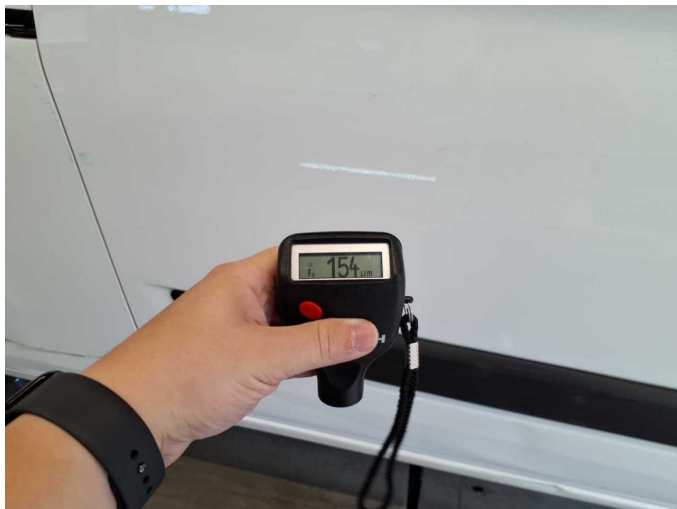
1 Door - rear right side, Professionally carried out  
2 Side panel - rear right side, Unprofessionally carried out, Invoice of repair done Non-existent

| Side panel - rear right side | 1,520<br>µm | Door - rear right side | 154 µm |

**Repainting 1:** Door - rear right side

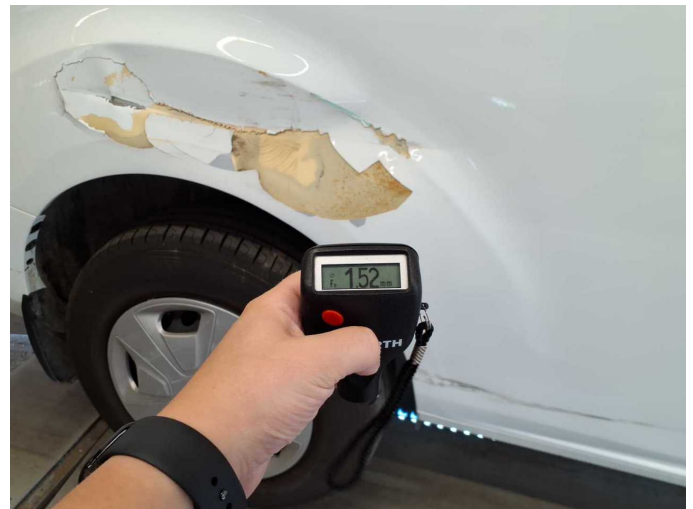
**Repainting 2:** Side panel - rear right side
