Expertise

Protocol number: 46179517  
Order No. / Reference: 26461654  
Inspection date: 23 Jun 2026

Manufacturer: Mercedes-Benz

Model: GLC 300 de 4Matic 9G-TRONIC

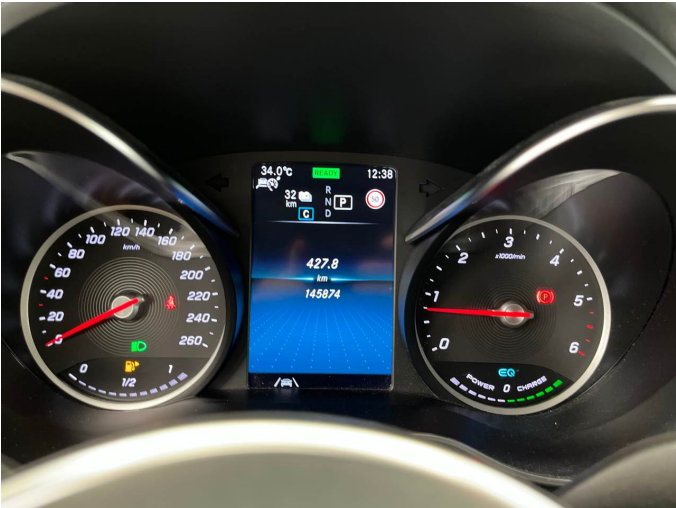
Figure 7: Instrument cluster

| Vehicle details | |
|---|---|
| Mileage (Read) | 145,874 km |

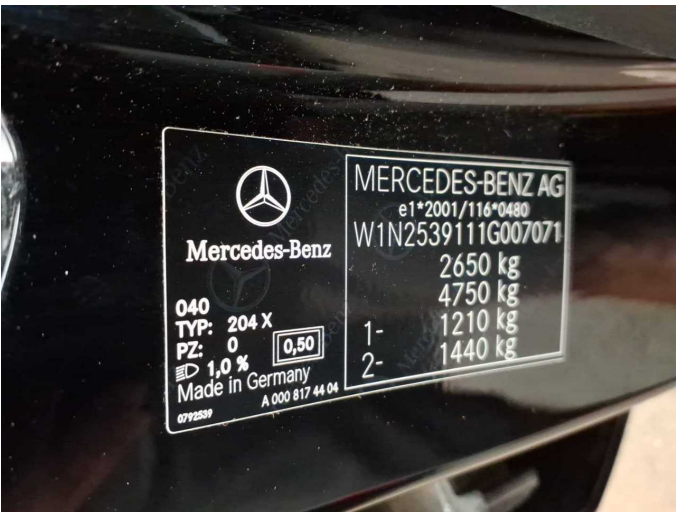
Figure 11: VIN

| VIN comparison | The vehicle identification number (VIN) was read from the vehicle and its conformity with the submitted documents was confirmed by the undersigned during the inspection. |

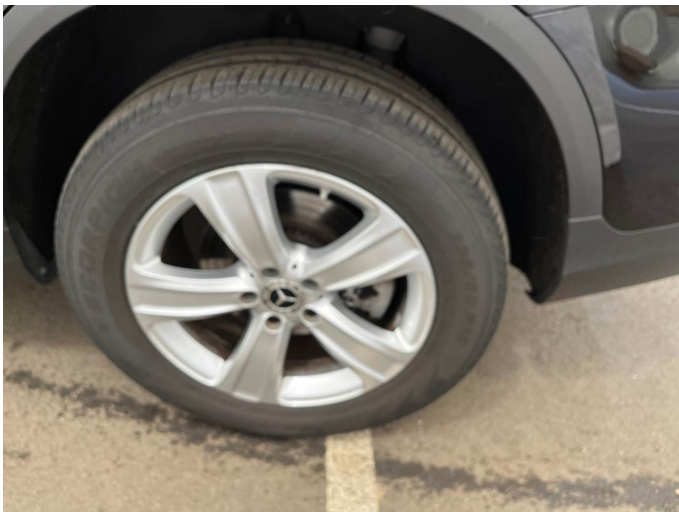
Figure 12: Mounted tyres

| # | Tyre size | Type of tyre | Manufacturer | Tread depth |
|---|---|---|---|---|
| 1) | 235/60 R18 103V | Summer tyres on Light alloy | Pirelli | 5mm / 5mm |
| 2) | 235/60 R18 103V | Summer tyres on Light alloy | Pirelli | 5mm / 5mm |

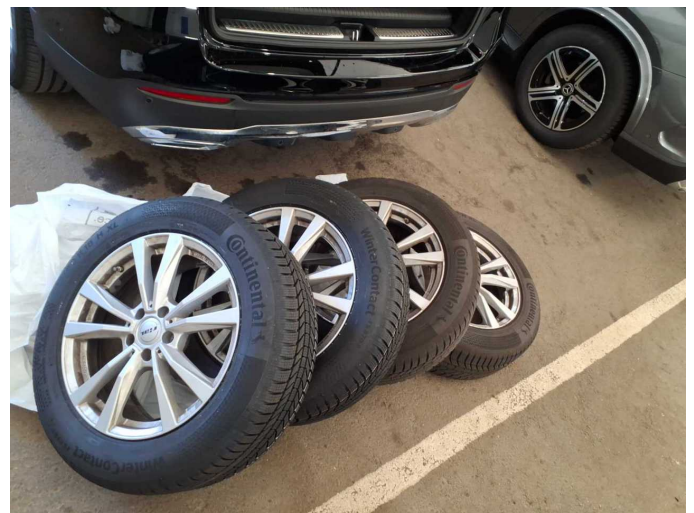
Figure 16: Additional tyres

| # | Tyre size | Type of tyre | Manufacturer | Tread depth |
|---|---|---|---|---|
| 1) | 235/60 R18 107H | Winter tyres on Light alloy | Continental | 7mm / 7mm |
| 2) | 235/60 R18 107H | Winter tyres on Light alloy | Continental | 7mm / 7mm |

- Die Unterbodenbesichtigung war nur ebenerdig & eingeschränkt möglich. Mehrkosten möglich.
- Der angegebene Winterradsatz ist kein Bestandteil des Auslieferungsumfangs.
- Ein Nachweis über die Zulässigkeit des beiliegenden Radsatzes wurde nicht erbracht.

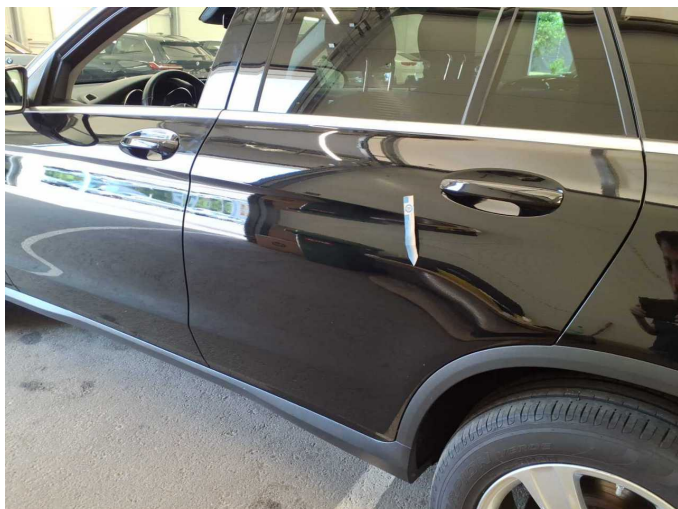
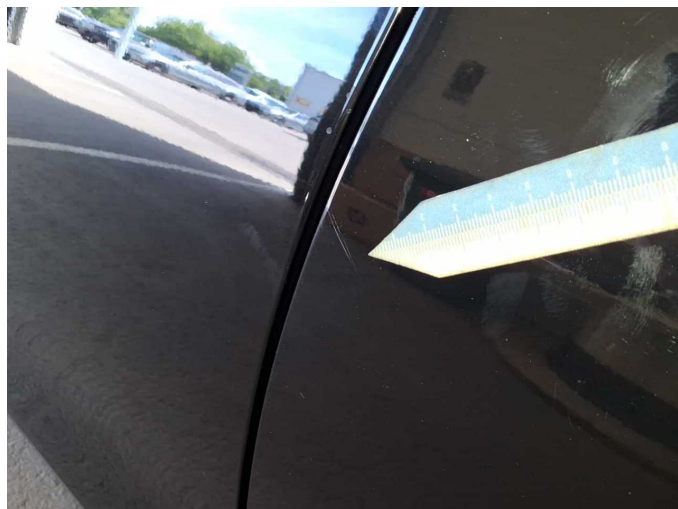
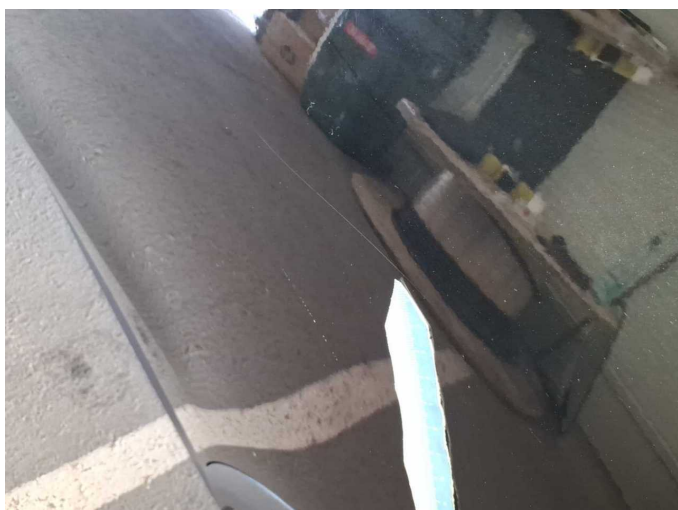
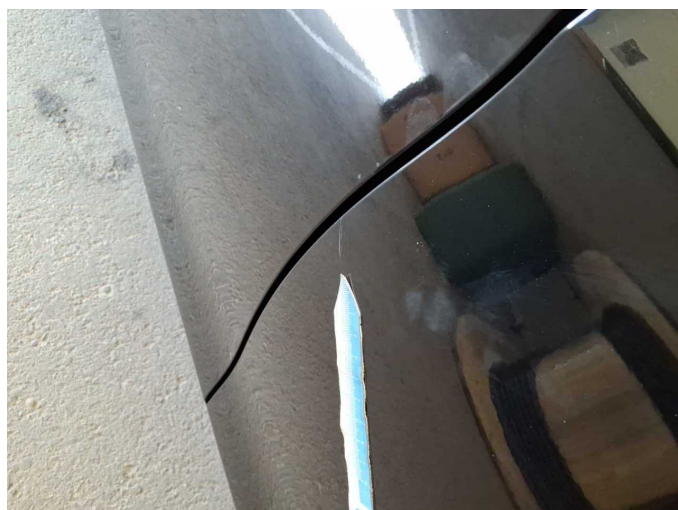
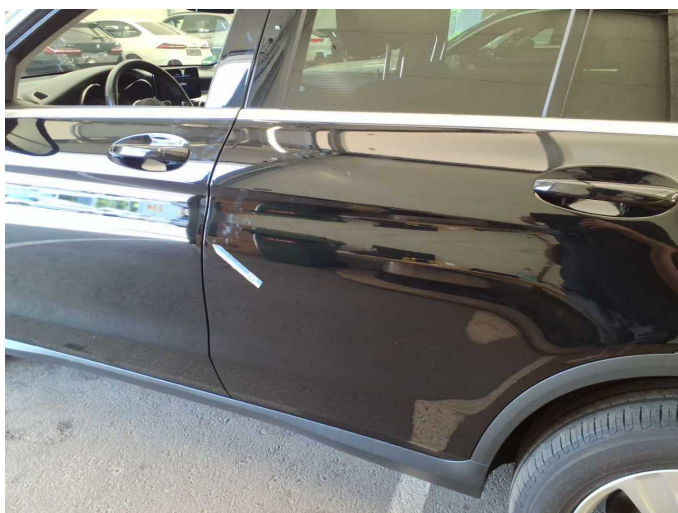
| No. | Component group | Description |
|---|---|---|
| 1 | Door - rear left side | Door - Scratch(es) - Paint |

**Damage 1:** Door - rear left side: Door - Scratch(es) - Paint
