Expertise

Protocol number: 46481289  
Order No. / Reference: 26657771  
Inspection date: 13 Jul 2026

Manufacturer: Audi

Model: A6 Avant 40 TDI S tronic design

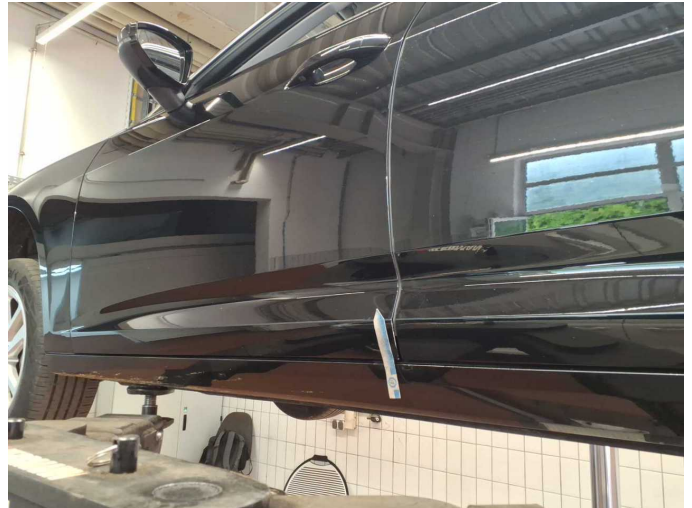
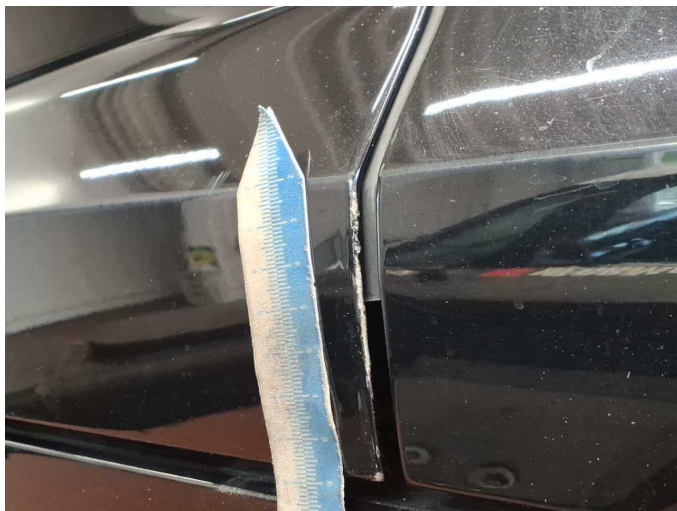
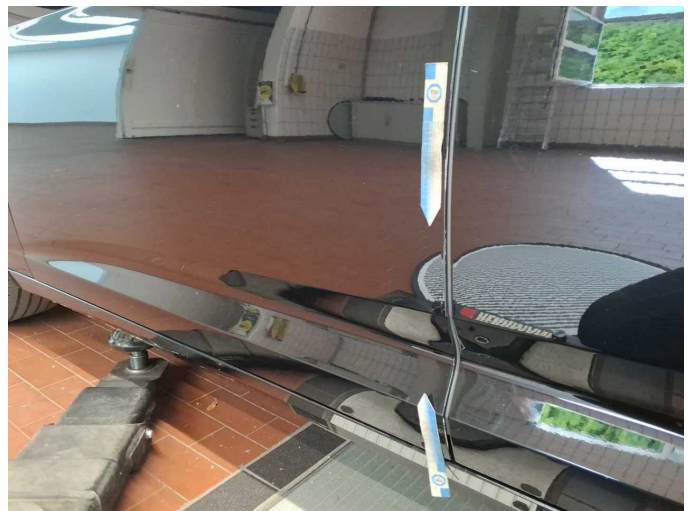
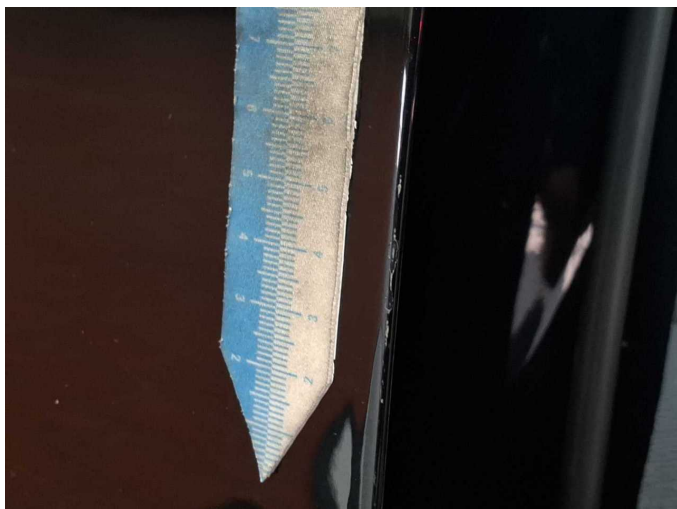
| No. | Component group | Description |
|---|---|---|
| 1 | Door - front left side | Door edge - Scratch(es) - Smart repair |

**Damage 1:** Door - front left side: Door edge - Scratch(es) - Smart repair

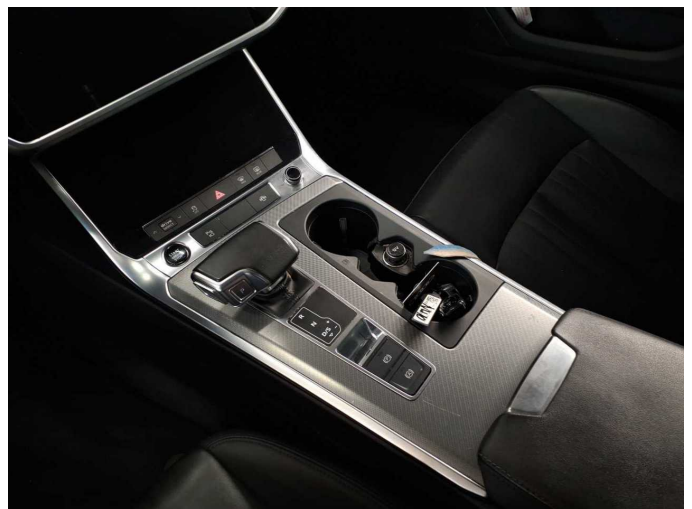
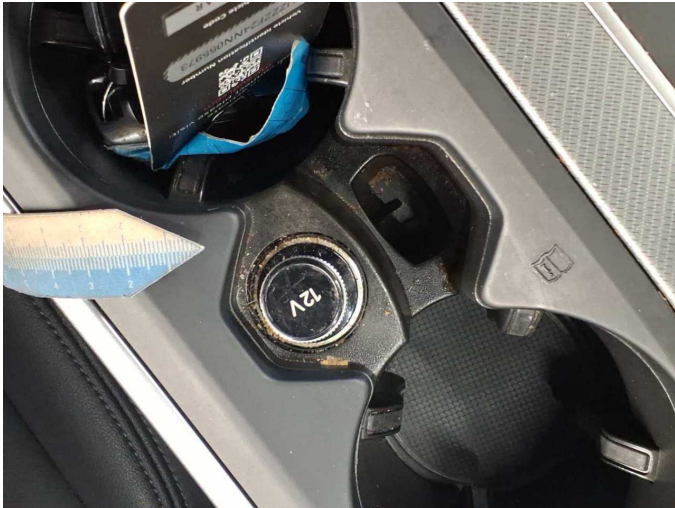
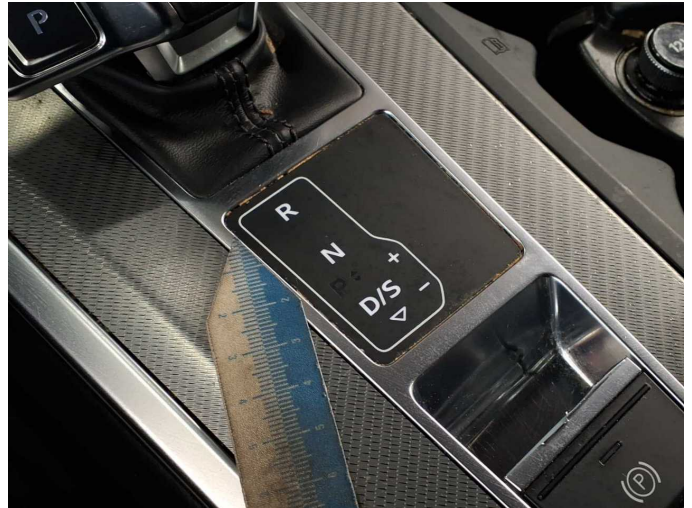
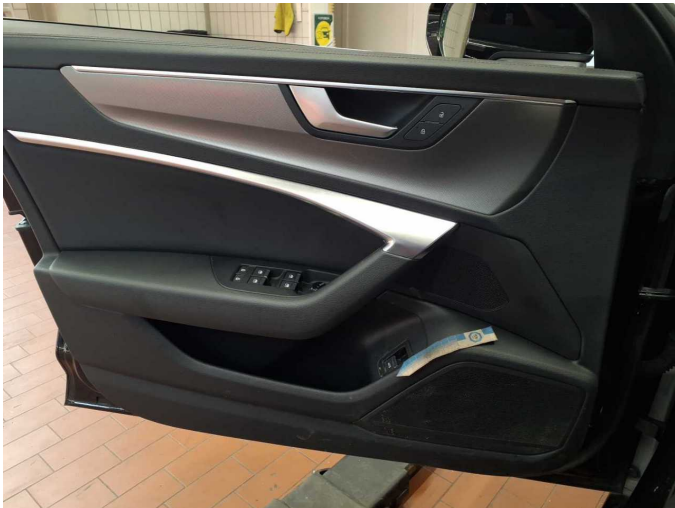
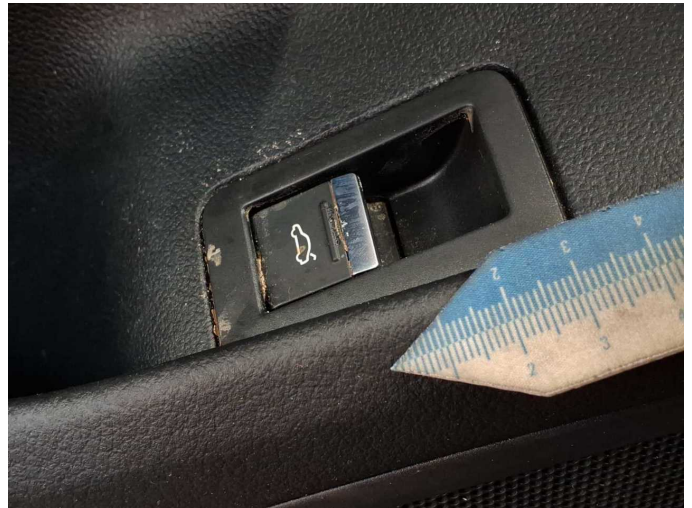
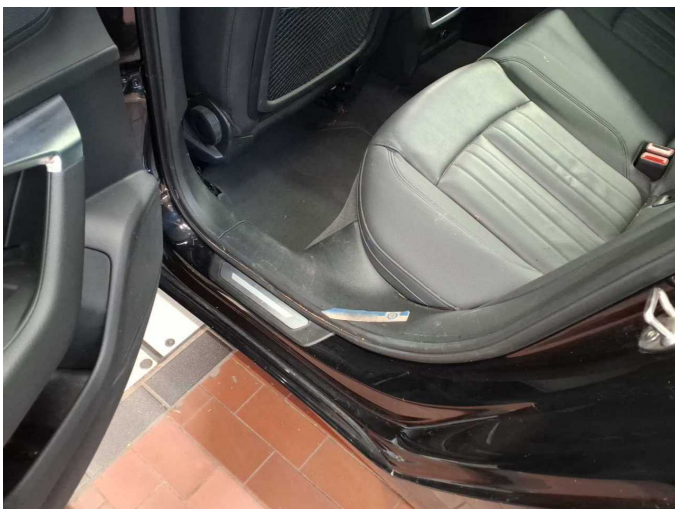
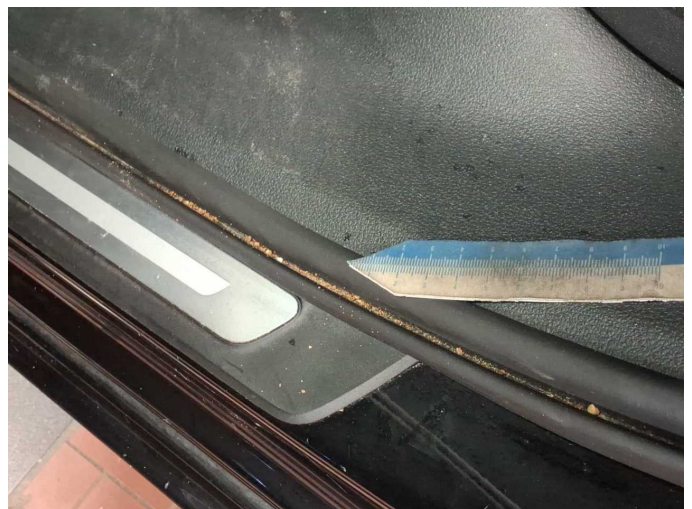
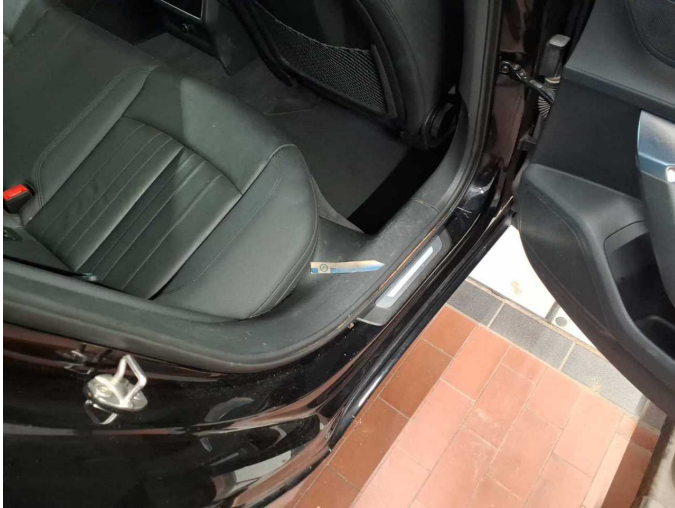
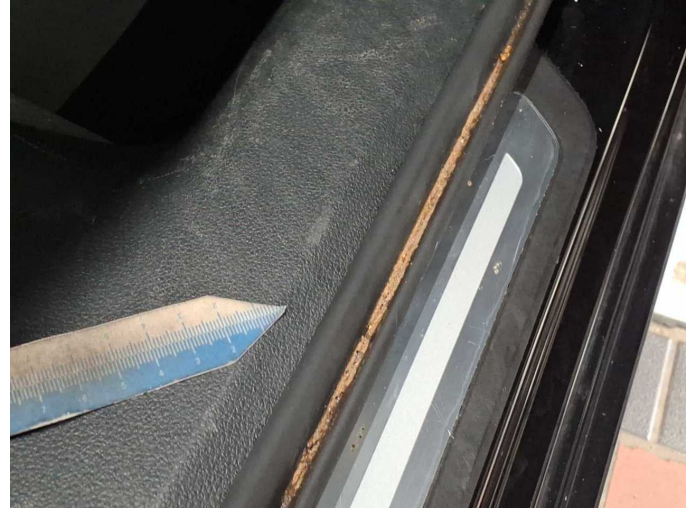
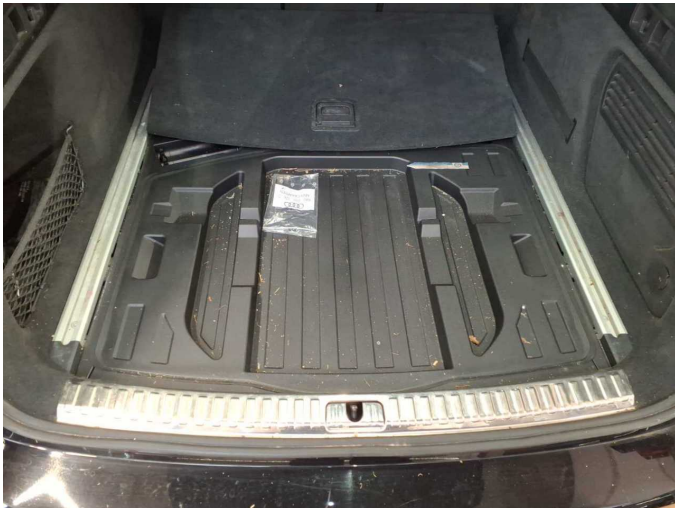
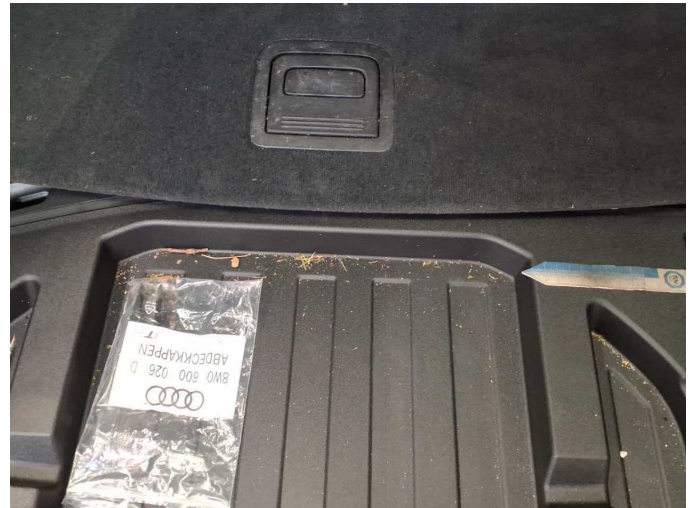
**Damage 2:** Interior: Interior - Soiled - Clean

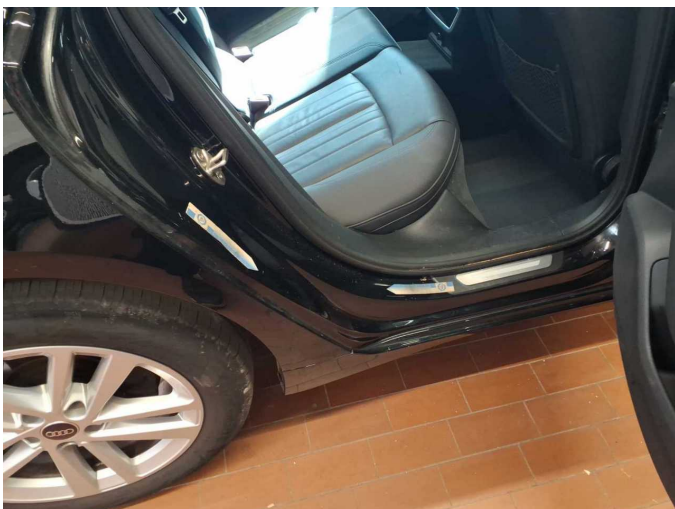
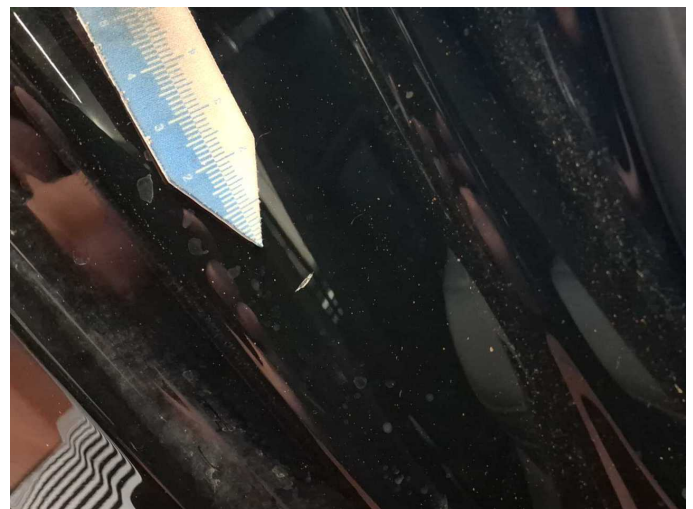
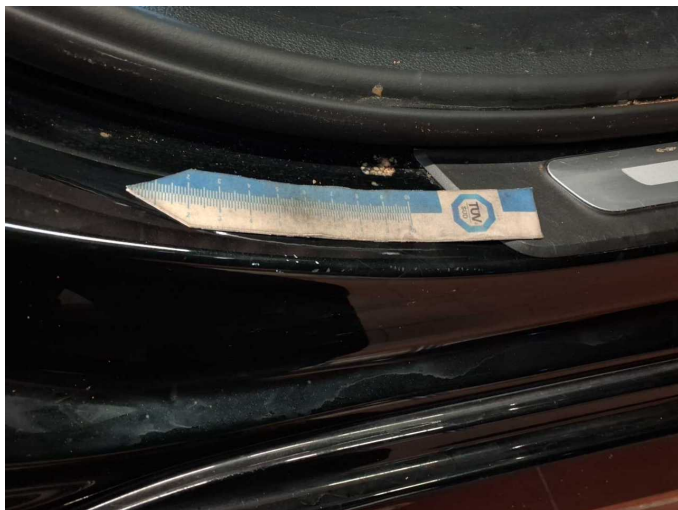
| No. | Component group | Description |
|---|---|---|
| 3 | Side panel - rear right side | Sill - Scratch(es) - Smart repair |

**Damage 3:** Side panel - rear right side: Sill - Scratch(es) - Smart repair

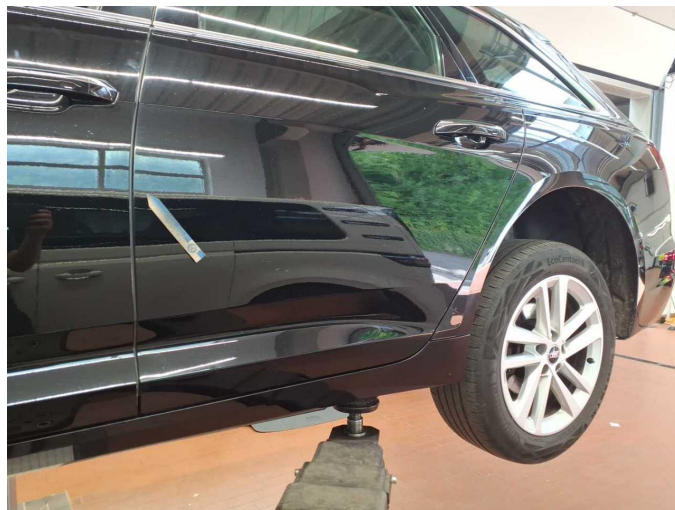
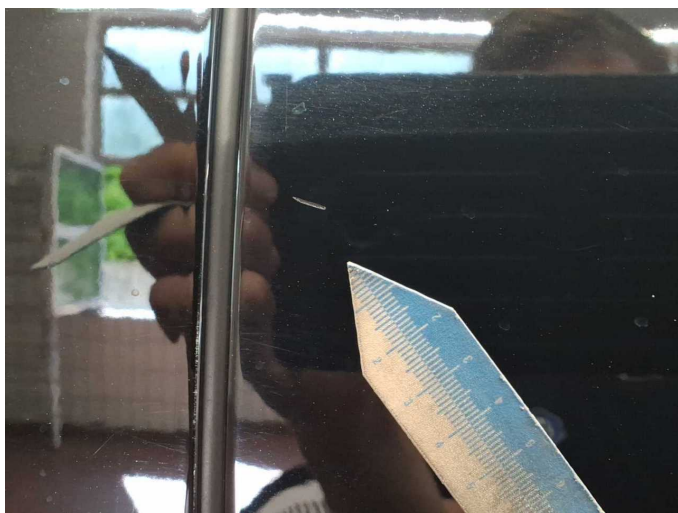
| No. | Component group | Description |
|---|---|---|
| 4 | Door - rear left side | Door - Scratch(es) - Smart repair |

**Damage 4:** Door - rear left side: Door - Scratch(es) - Smart repair

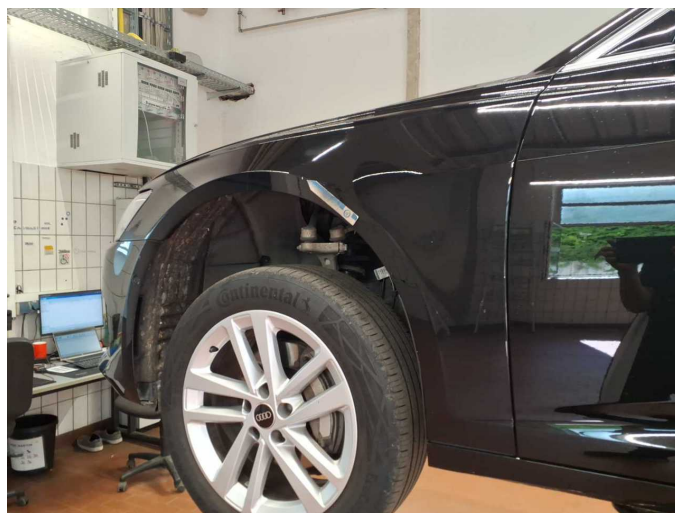
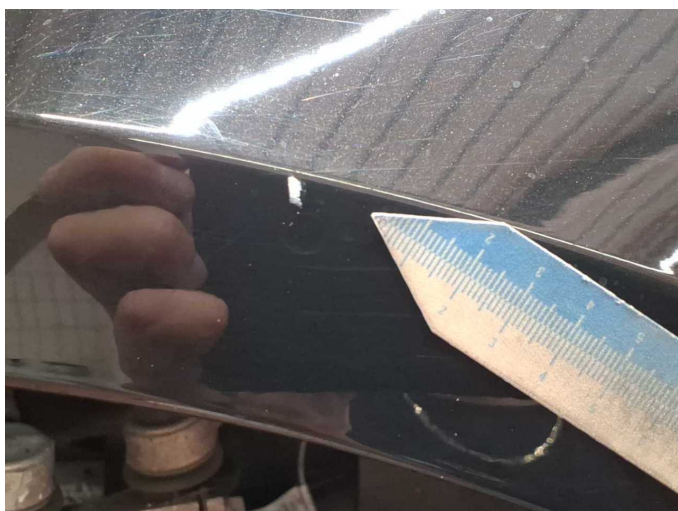
| No. | Component group | Description |
|---|---|---|
| 5 | Mudguard - left side | Mudguard - left side - Scratch(es) - Smart repair |

**Damage 5:** Mudguard - left side: Mudguard - left side - Scratch(es) - Smart repair

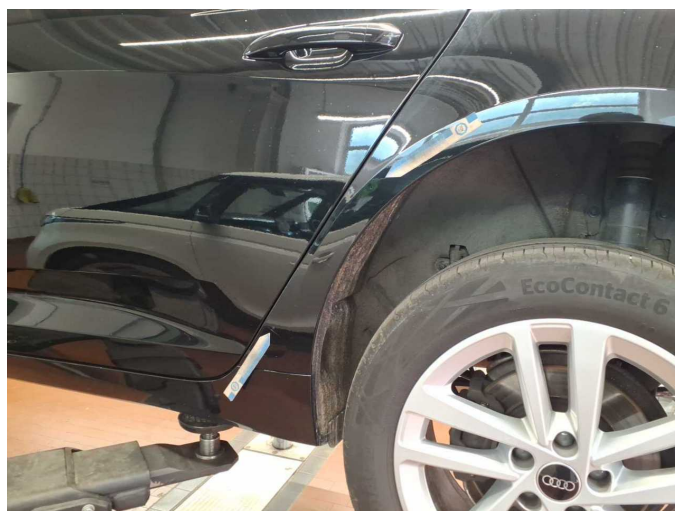
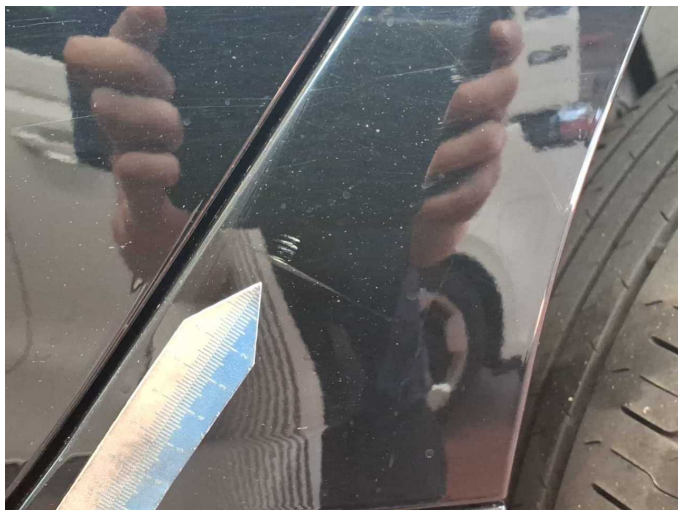
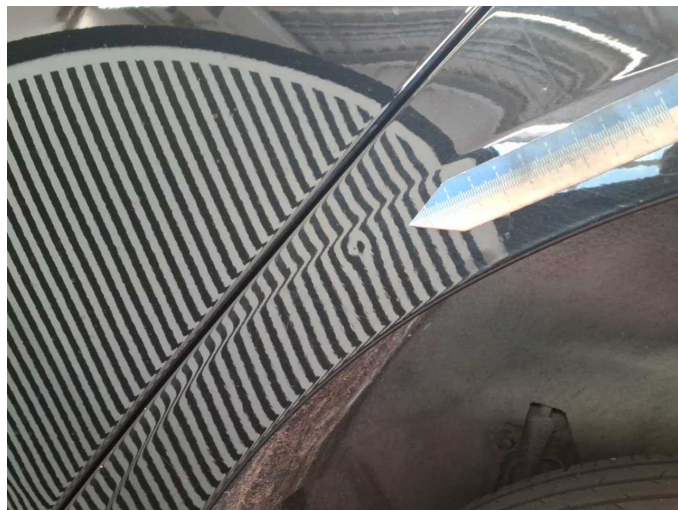
| No. | Component group | Description |
|---|---|---|
| 6 | Side panel - rear left side | Elbow (+ Delle Gebrauchspur) - Scratch(es) - Smart repair |

**Damage 6:** Side panel - rear left side: Elbow (+ Delle Gebrauchspur) - Scratch(es) - Smart repair

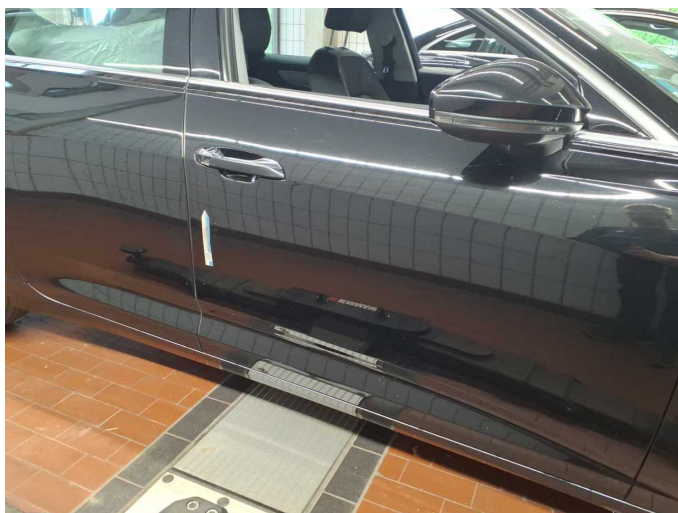
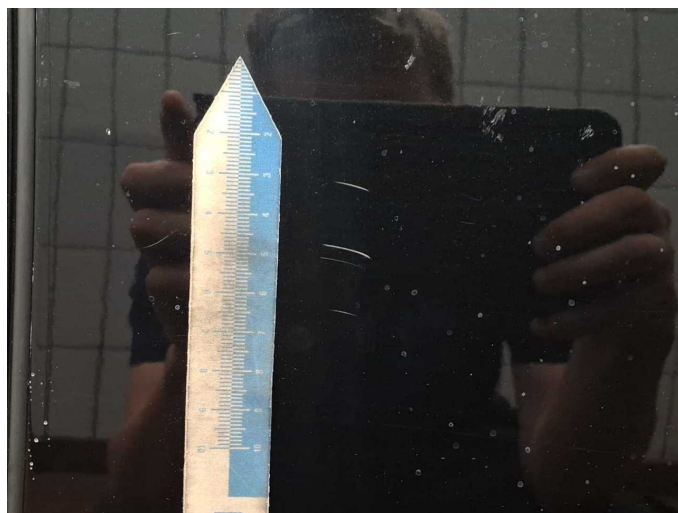
| No. | Component group | Description |
|---|---|---|
| 7 | Door - front right side | Door - Scratch(es) - Smart repair |

**Damage 7:** Door - front right side: Door - Scratch(es) - Smart repair

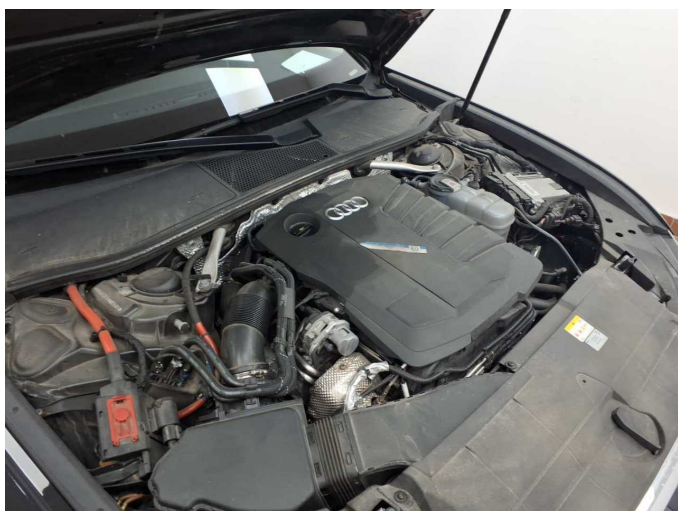
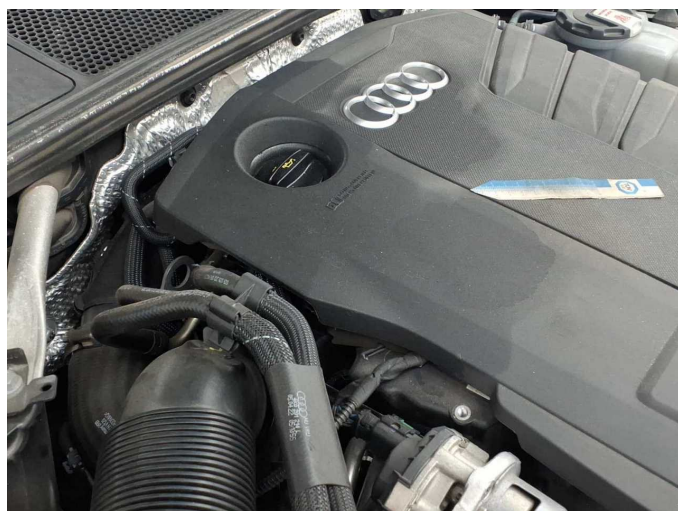
| No. | Component group | Description |
|---|---|---|
| 8 | Engine | Engine - Leaking - Perform diagnosis |

**Damage 8:** Engine: Engine - Leaking - Perform diagnosis

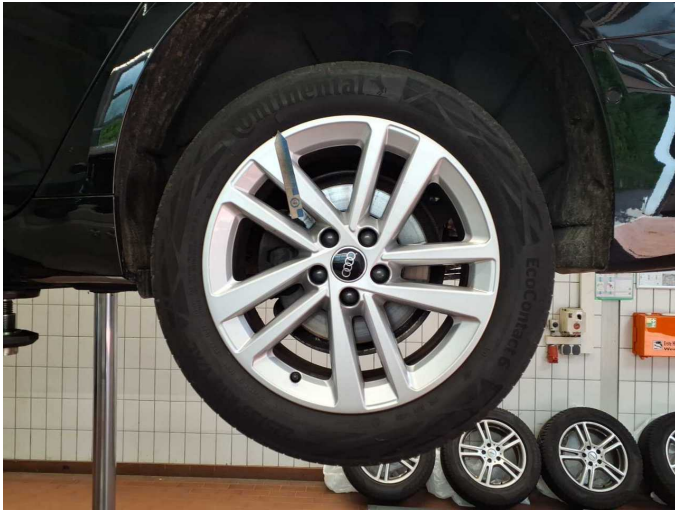
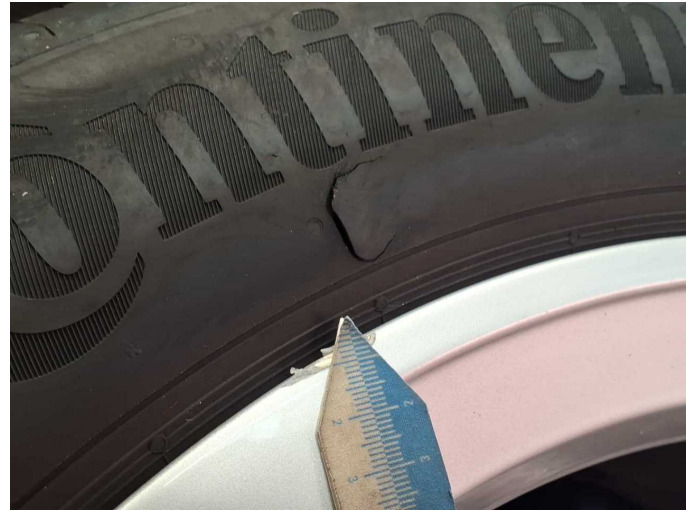
| No. | Component group | Description |
|---|---|---|
| 9 | Wheel / tyres | Tyre - rear left side (nicht fahrbereit) - Broken / torn - Replace |

**Damage 9:** Wheel / tyres: Tyre - rear left side (nicht fahrbereit) - Broken / torn - Replace

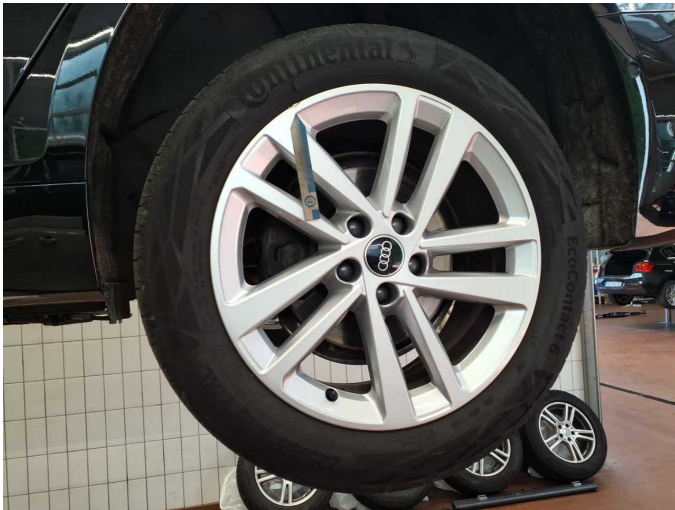
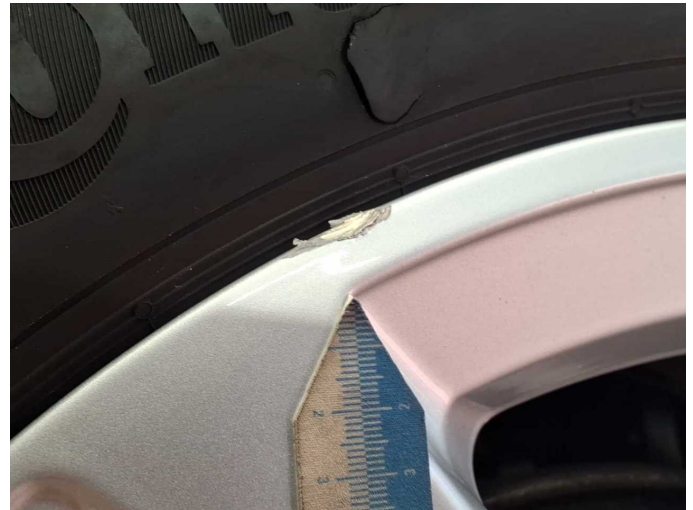
**Damage 10:** Wheel / tyres: Alloy rim - rear left side - Scratched - Loss in value

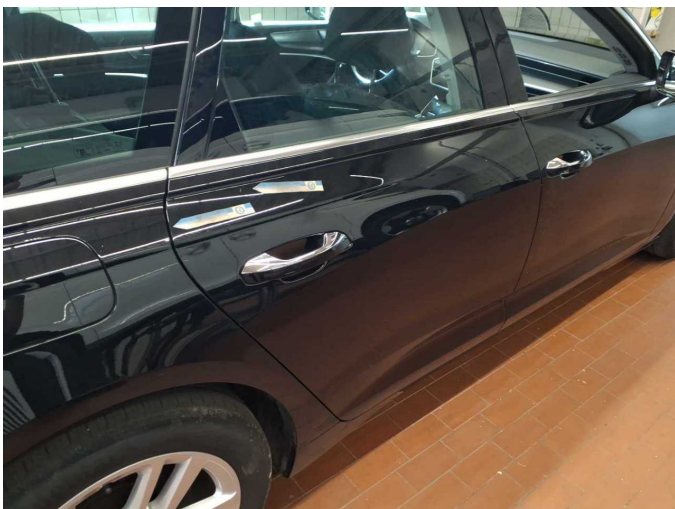
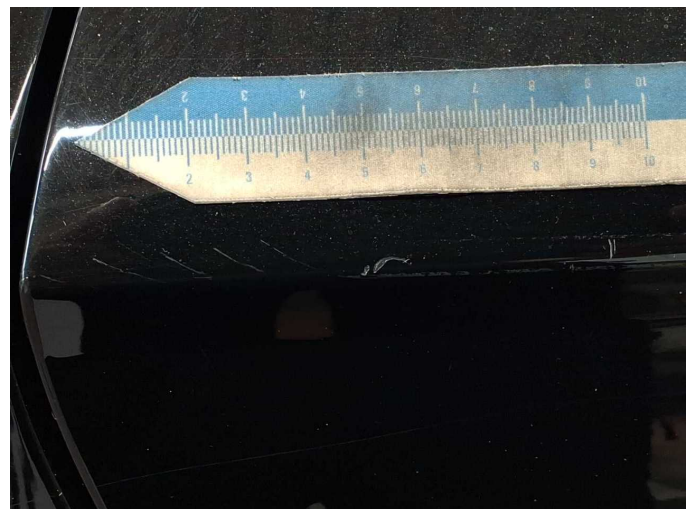
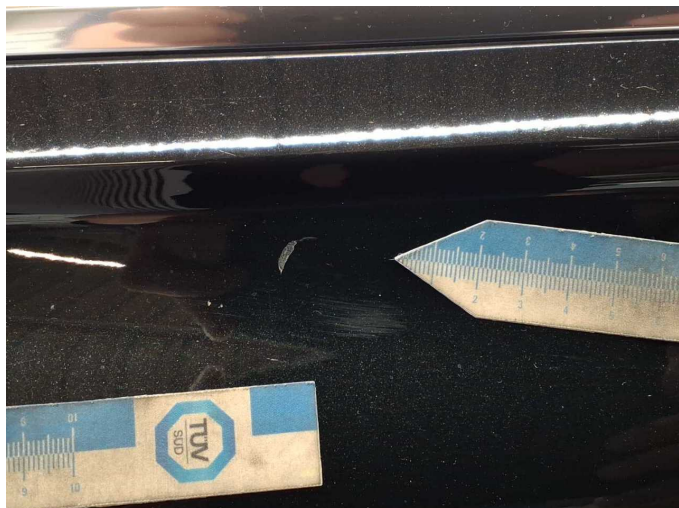
| No. | Component group | Description |
|---|---|---|
| 11 | Door - rear right side | Door - Scratch(es) - Smart repair |

**Damage 11:** Door - rear right side: Door - Scratch(es) - Smart repair

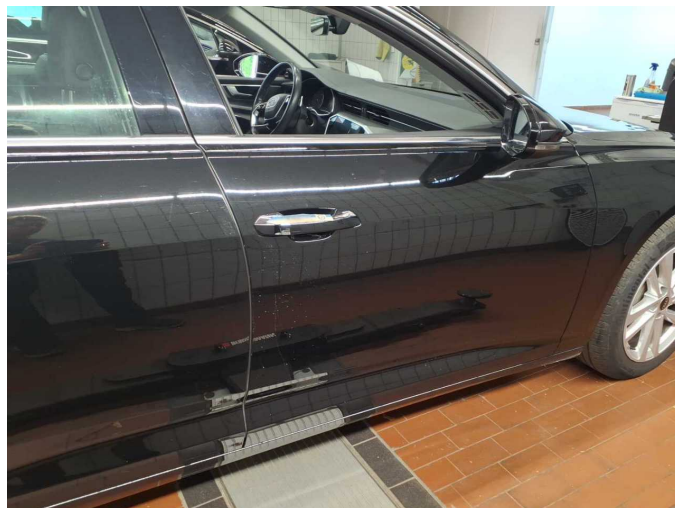
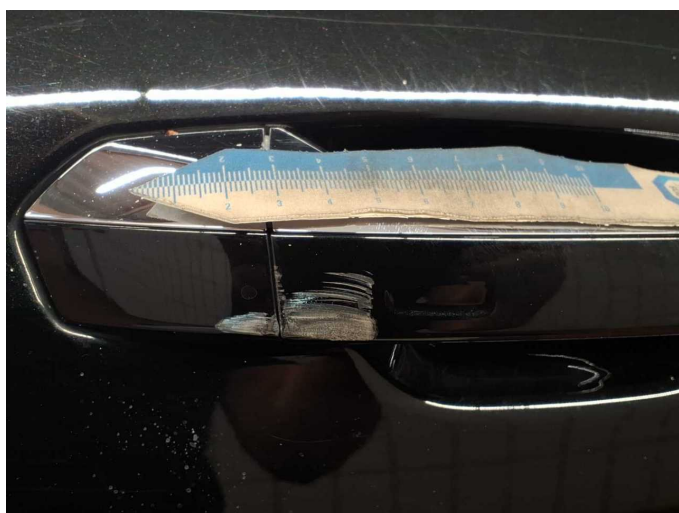
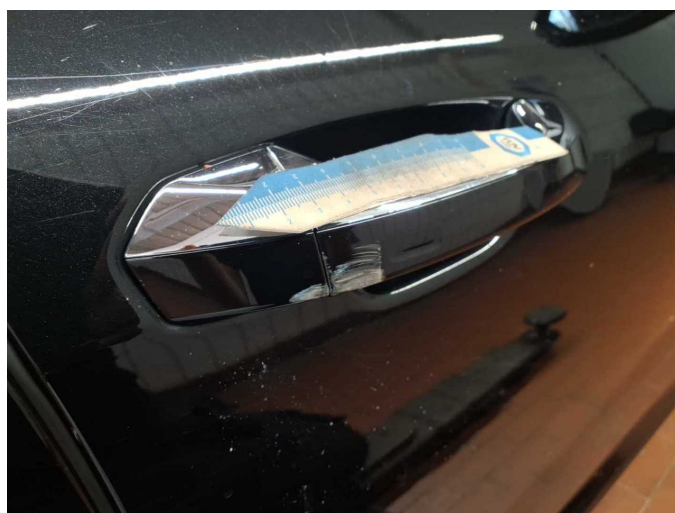
**Damage 12:** Door - front right side: Door handle - outside - Scratched - Paint

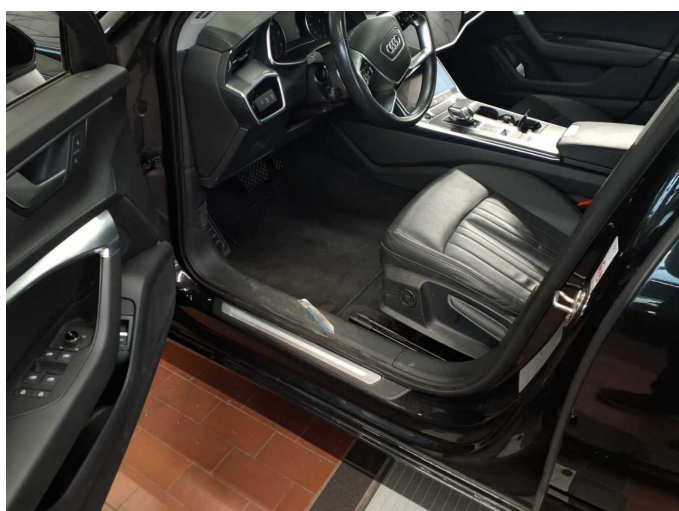
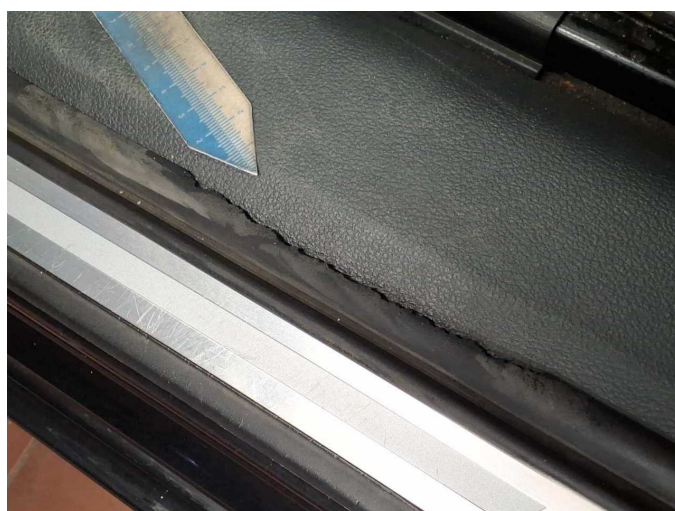
| No. | Component group | Description |
|---|---|---|
| 13 | Cab | Door rubber seal - left side (Tür vorn links) - Broken / torn - Replace |

**Damage 13:** Cab: Door rubber seal - left side (Tür vorn links) - Broken / torn - Replace

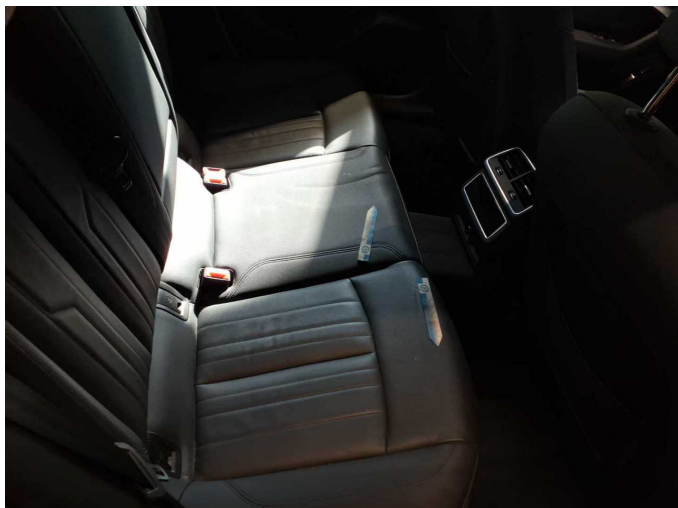
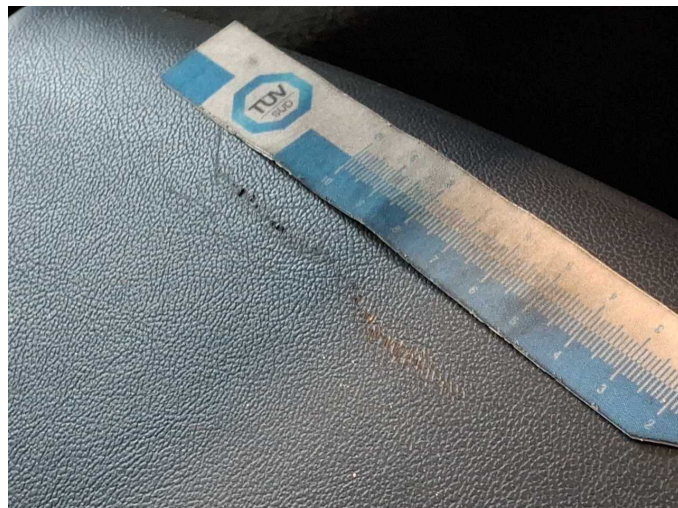
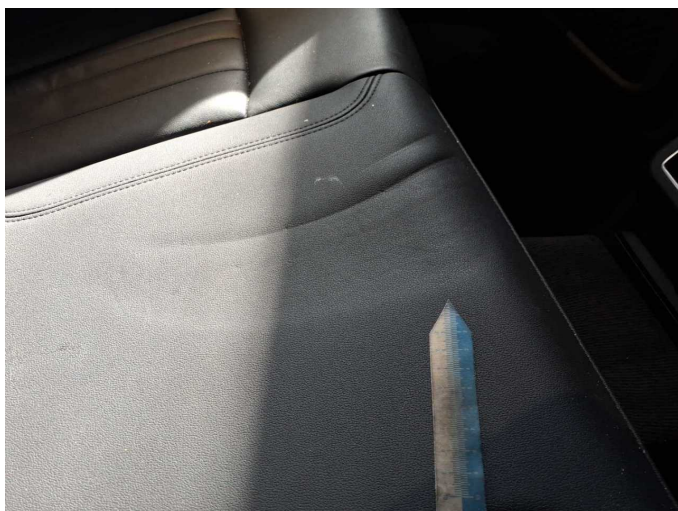
| No. | Component group | Description |
|---|---|---|
| 14 | Seat - rear | Seat cover - 3 seater bench (+ Druckstelle Reifen) - Scratch(es) - Replace |

**Damage 14:** Seat - rear: Seat cover - 3 seater bench (+ Druckstelle Reifen) - Scratch(es) - Replace

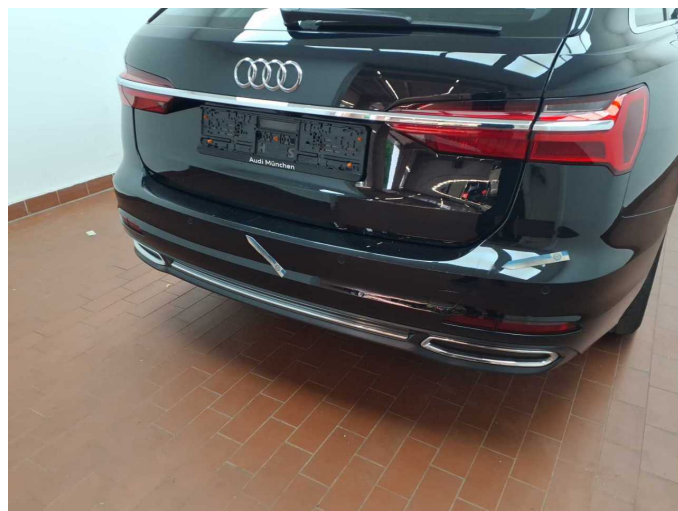
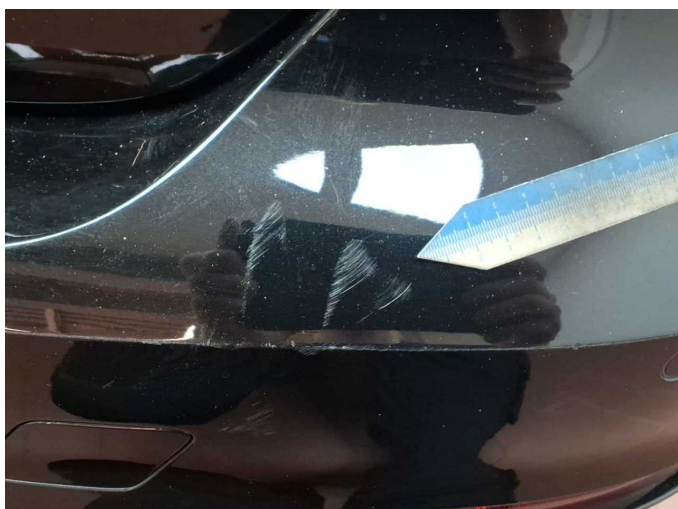
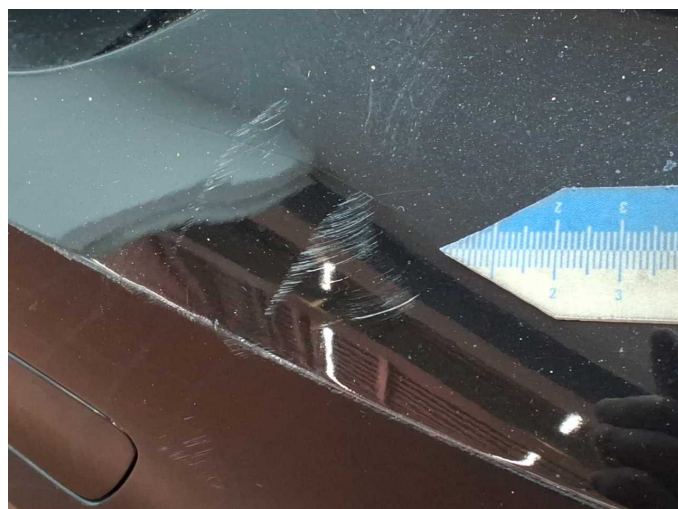
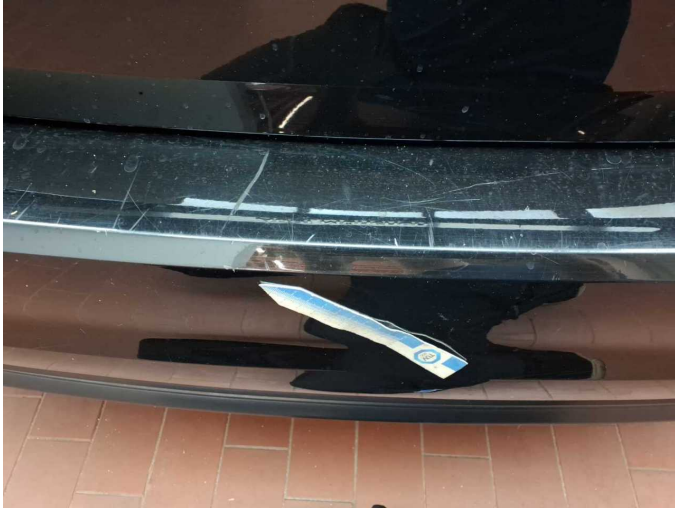
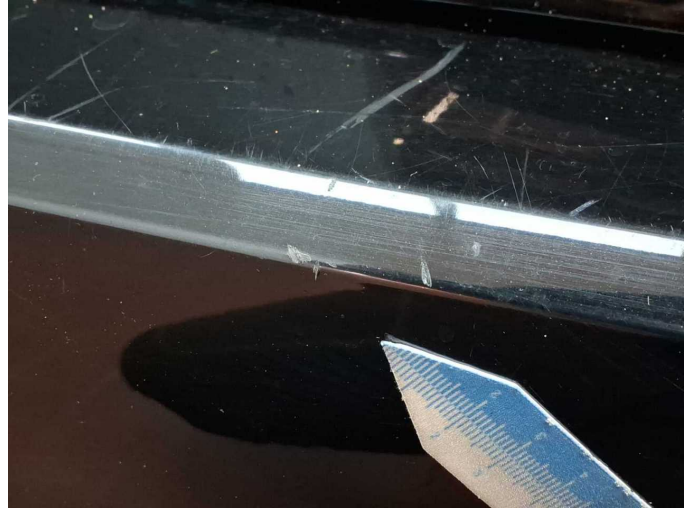
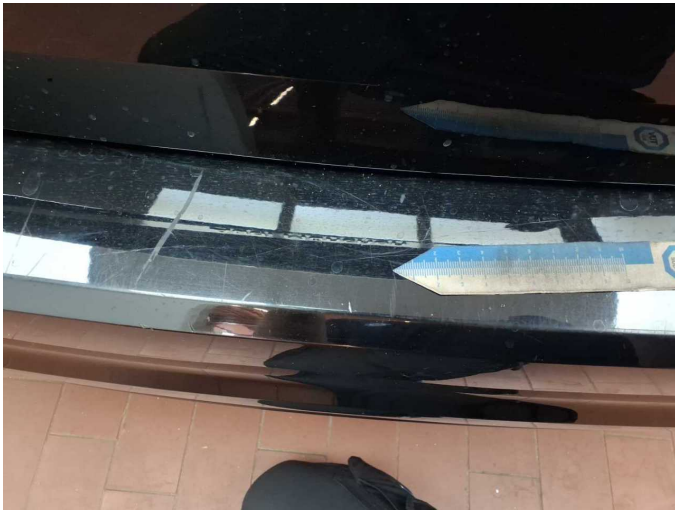
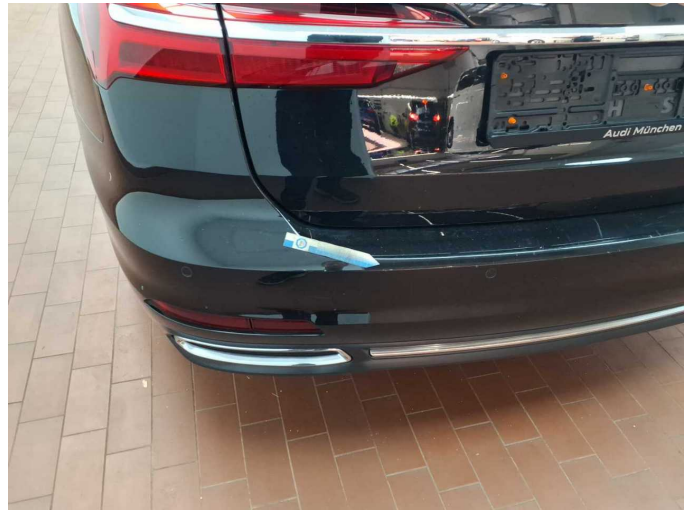
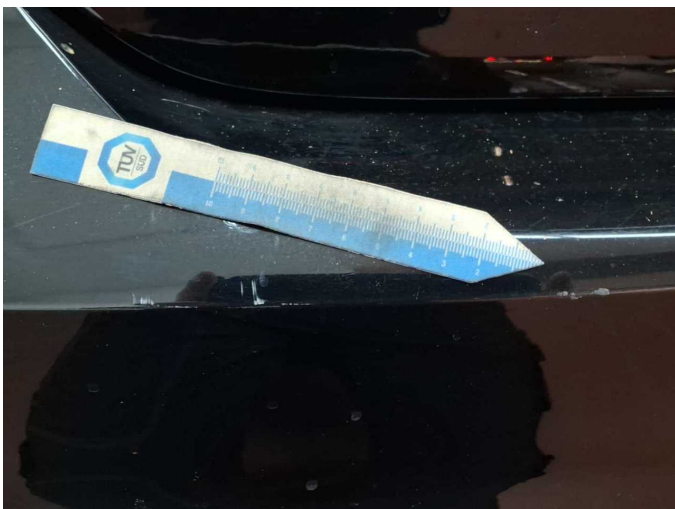
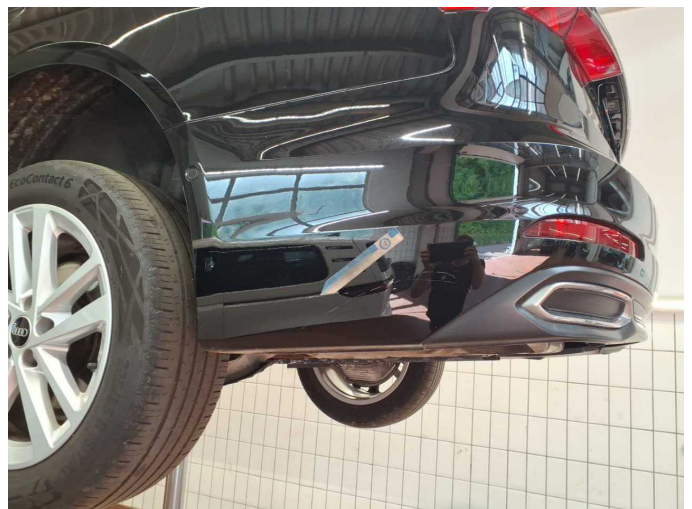
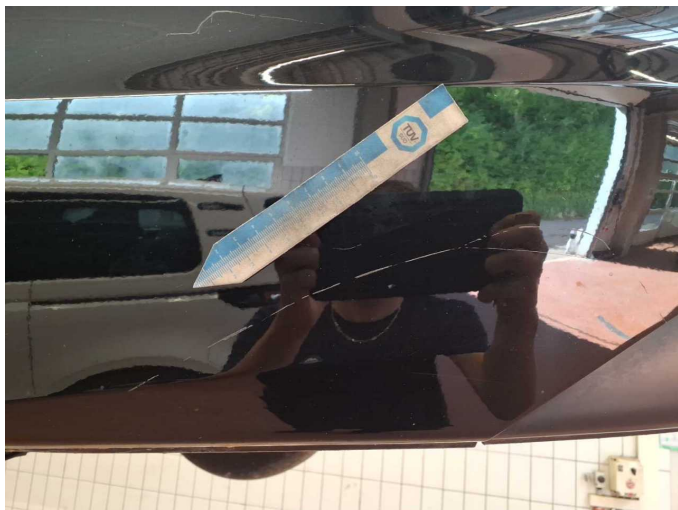
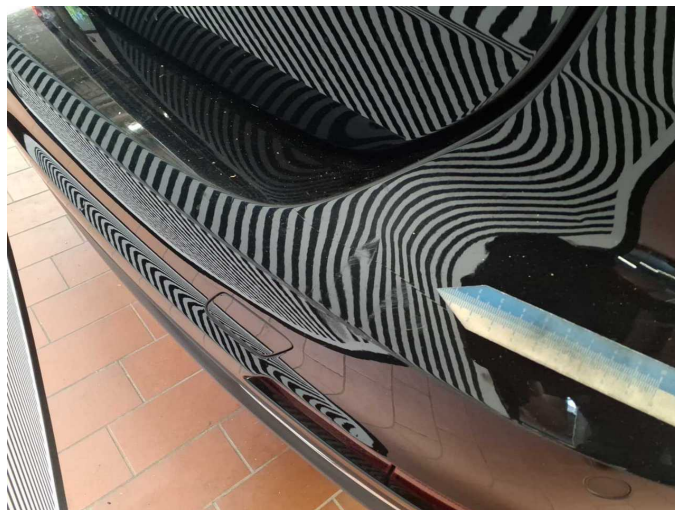
| No. | Component group | Description |
|---|---|---|
| 15 | Rear bumper | Rear bumper - Dent / paintcoat damage - Repair and paint |

**Damage 15:** Rear bumper: Rear bumper - Dent / paintcoat damage - Repair and paint

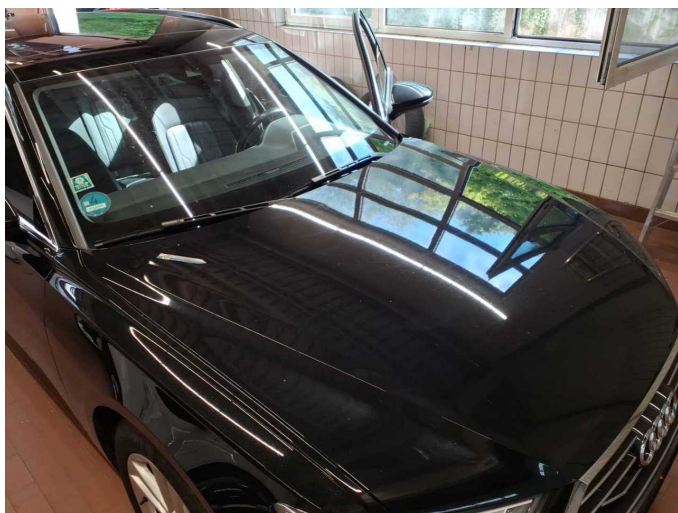
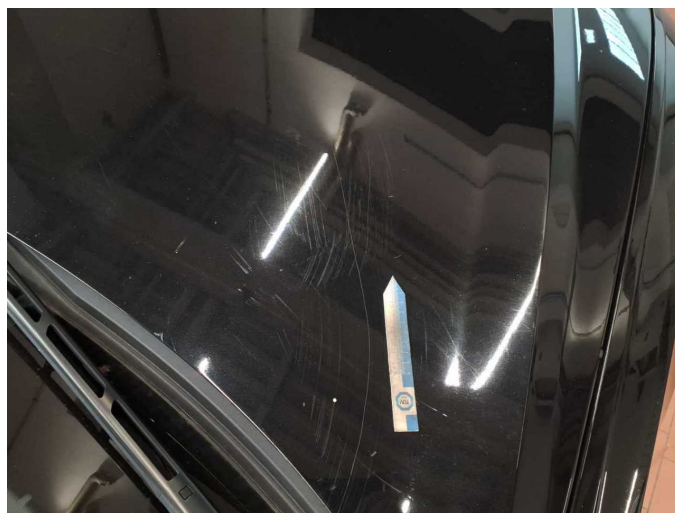
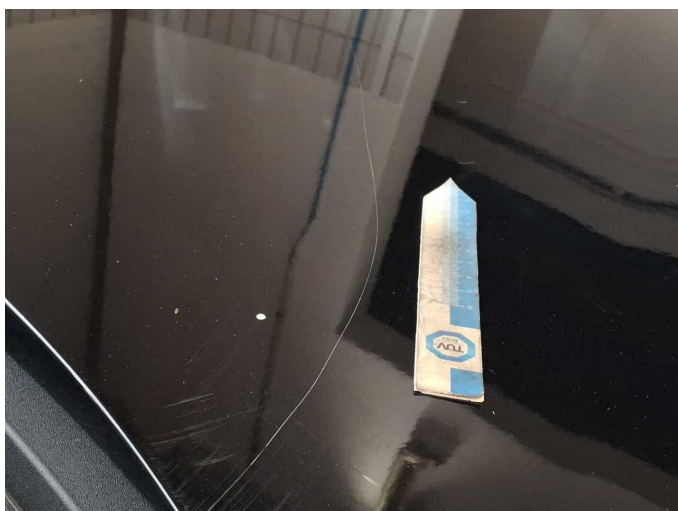
**Damage 16:** Bonnet: Bonnet - Scratch(es) - Paint

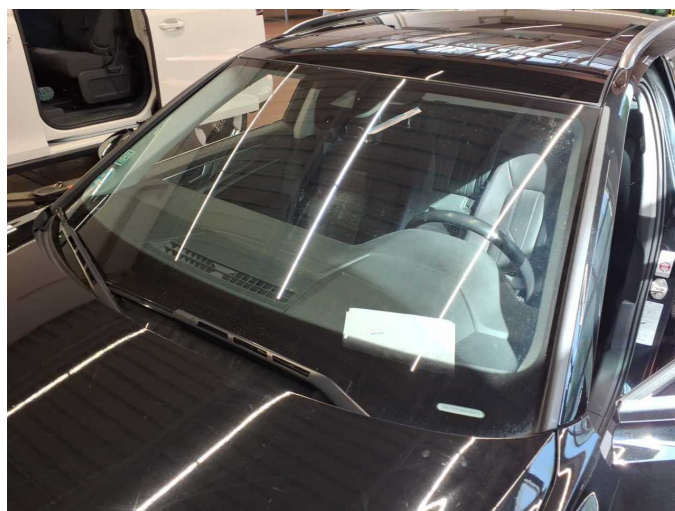
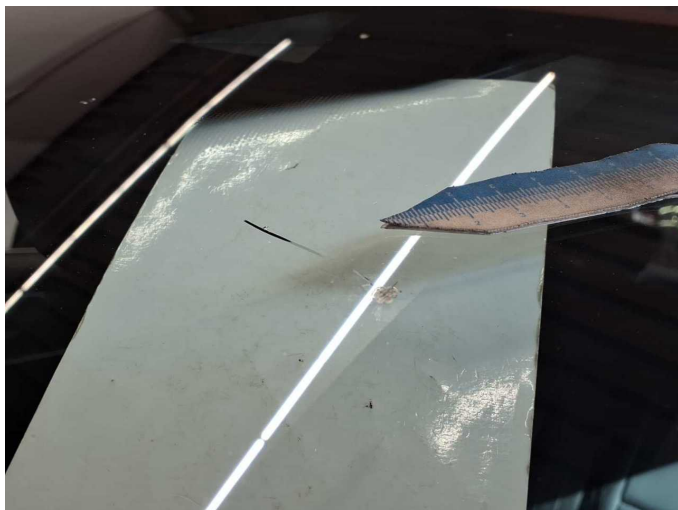
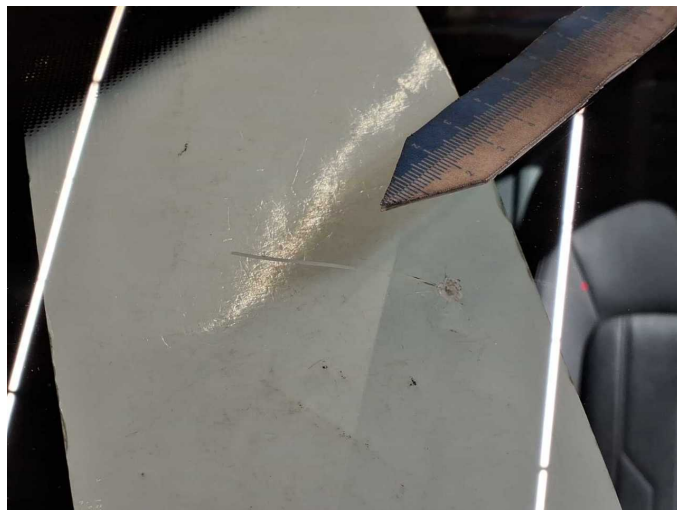
| No. | Component group | Description |
|---|---|---|
| 17 | Vehicle glazing | Windscreen - Broken / torn - repair according to calculation |

**Damage 17:** Vehicle glazing: Windscreen - Broken / torn - repair according to calculation

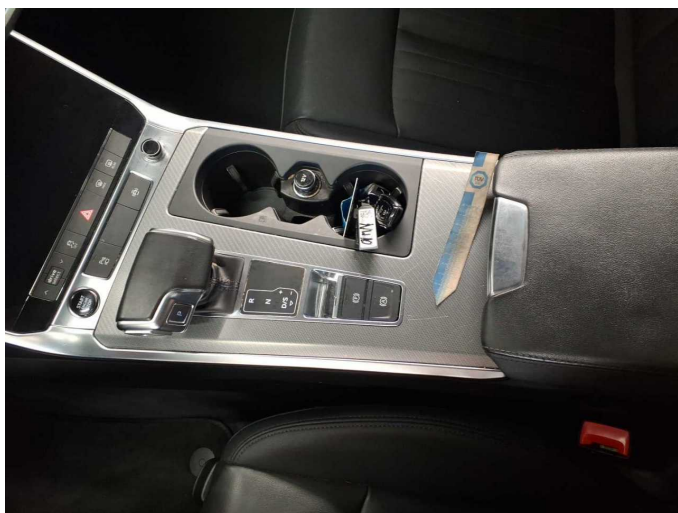
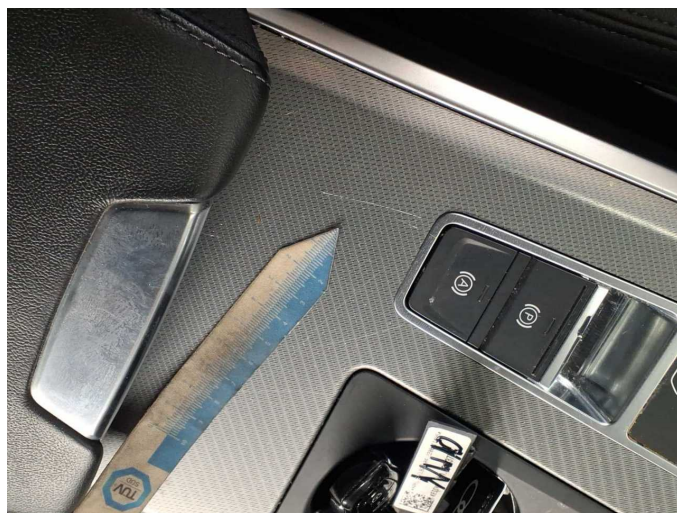
**Wear and tear 6:** Instrument panel: Centre console - front - Scratch(es) - No deduction
