Expertise

Protocol number: 46481289  
Order No. / Reference: 26657771  
Inspection date: 13 Jul 2026

Manufacturer: Audi

Model: A6 Avant 40 TDI S tronic design

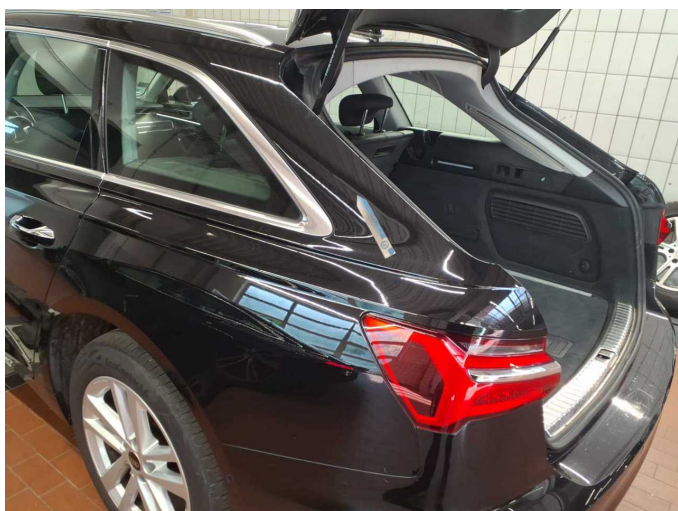
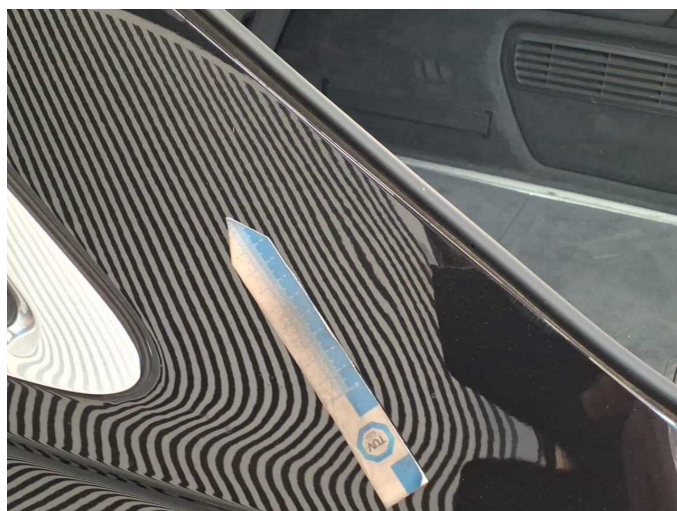
| No. | Component group | Description |
|---|---|---|
| 7 | Side panel - rear left side | Side panel - dent(s) - Smooth repair work |

**Wear and tear 7:** Side panel - rear left side: Side panel - dent(s) - Smooth repair work
