Expertise

Protocol number: 46619112  
Order No. / Reference: 26760033  
Inspection date: 16 Jul 2026

Manufacturer: Volkswagen

Model: Passat Variant 2.0 TDI SCR DSG Business

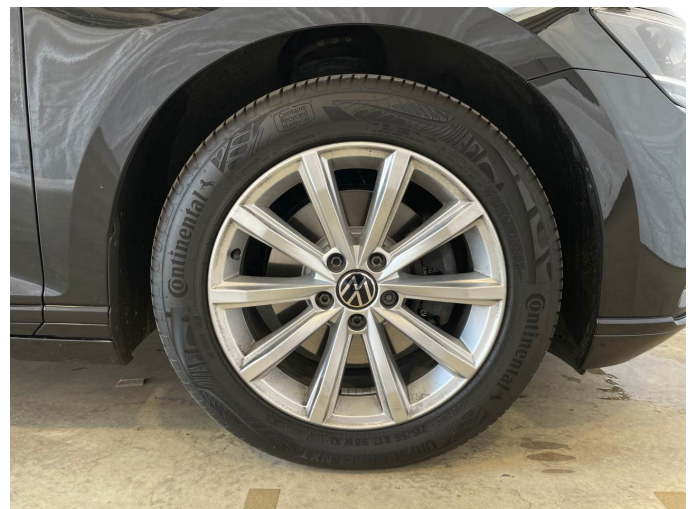
Figure 12: Mounted tyres

| # | Tyre size | Type of tyre | Manufacturer | Tread depth |
|---|---|---|---|---|
| 1) | 215/55 R17 98W | Summer tyres on Light alloy | Continental | 6mm / 6mm |
| 2) | 215/55 R17 98W | Summer tyres on Light alloy | Continental | 5mm / 5mm |

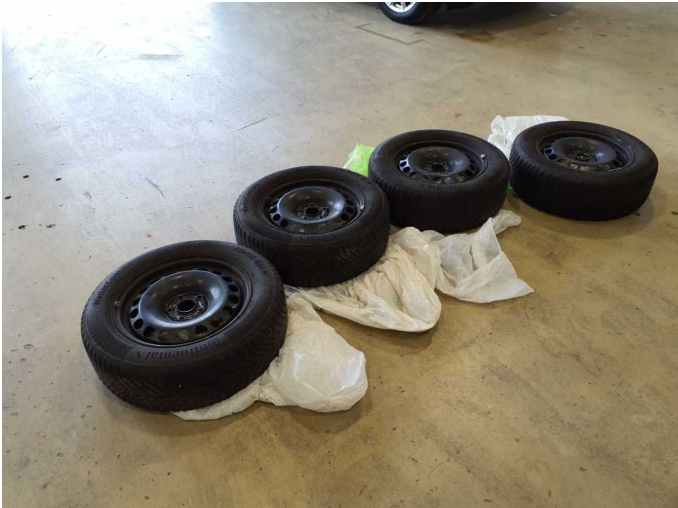
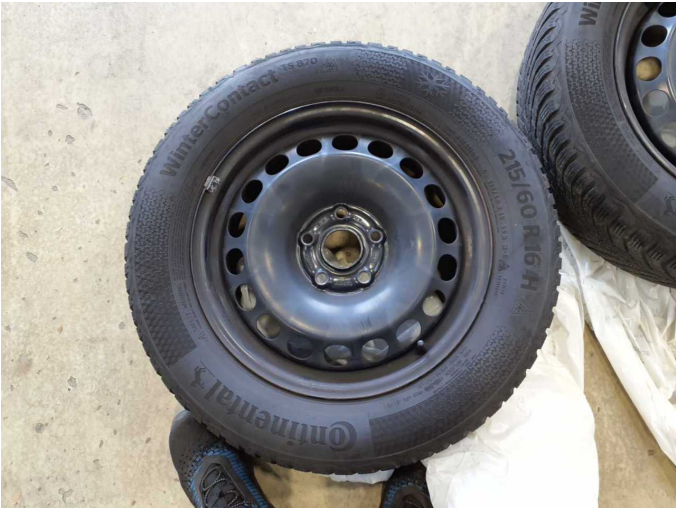
Figure 14: Additional tyres

| # | Tyre size | Type of tyre | Manufacturer | Tread depth |
|---|---|---|---|---|
| 1) | 215/60 R16 95H | Winter tires (with run-flat tires) on Steel | Continental | 4mm / 4mm |
| 2) | 215/60 R16 95H | Winter tires (with run-flat tires) on Steel | Continental | 4mm / 4mm |

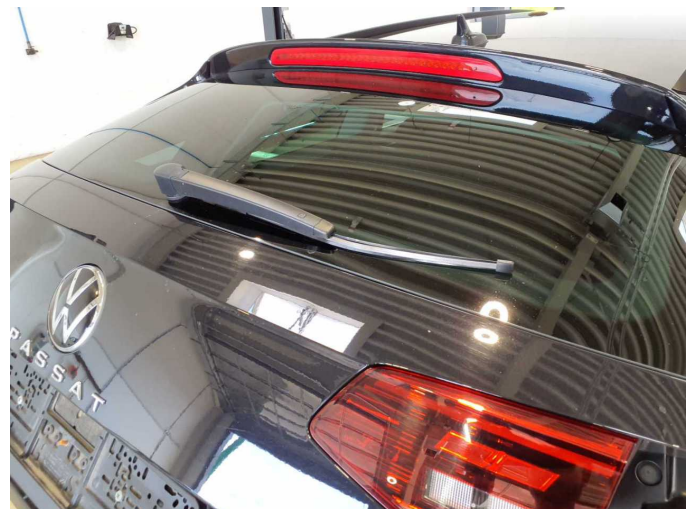
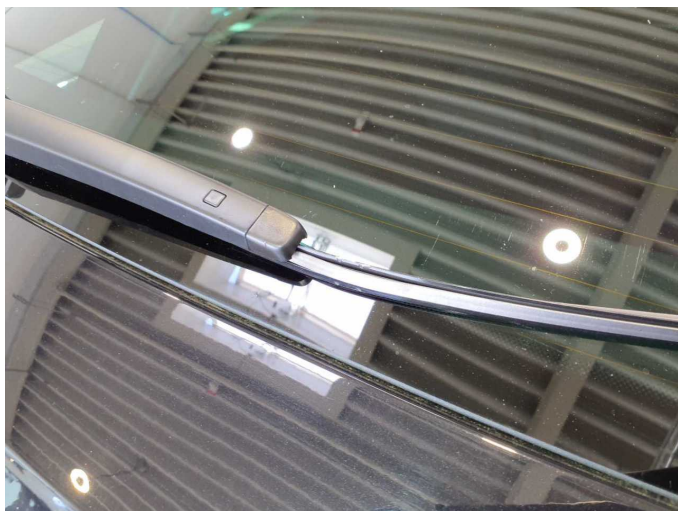
| No. | Component group | Description |
|---|---|---|
| 1 | Screen cleaning | Wiper blades - rear - Broken / torn - Replace |

**Damage 1:** Screen cleaning: Wiper blades - rear - Broken / torn - Replace

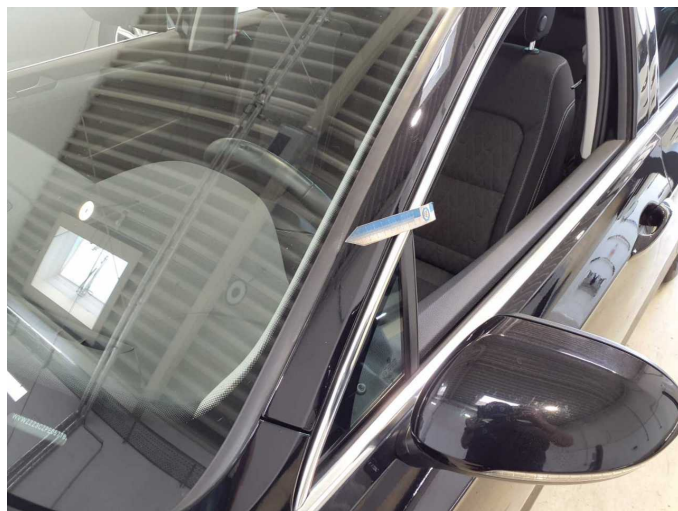
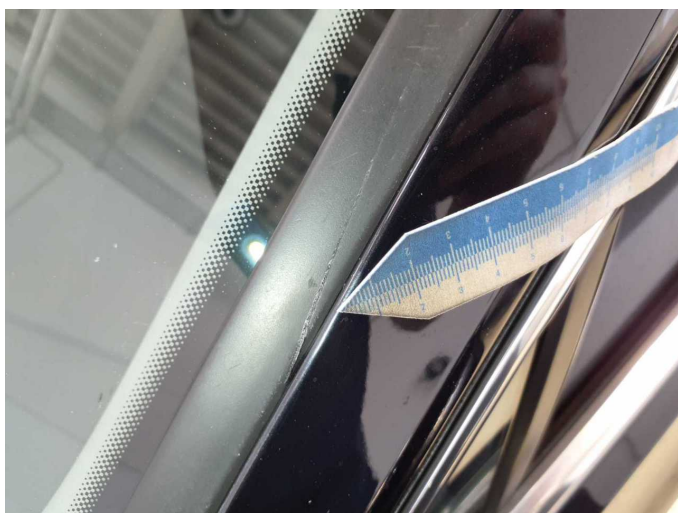
| No. | Component group | Description |
|---|---|---|
| 2 | Roof | Cowl - left side - Scratch(es) - Replace |

**Damage 2:** Roof: Cowl - left side - Scratch(es) - Replace

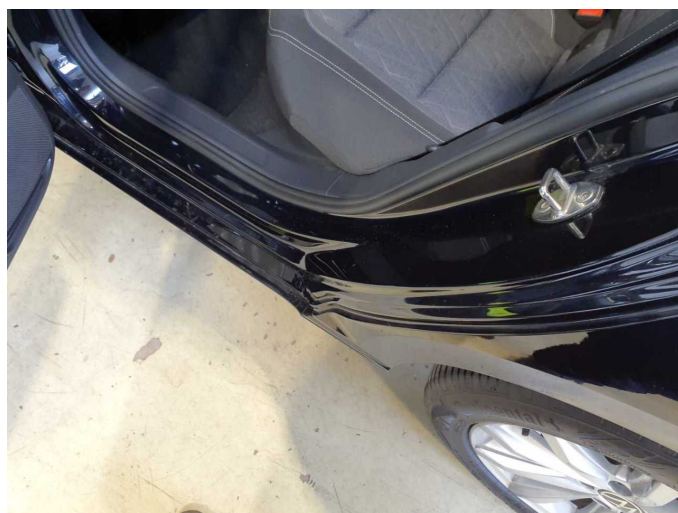
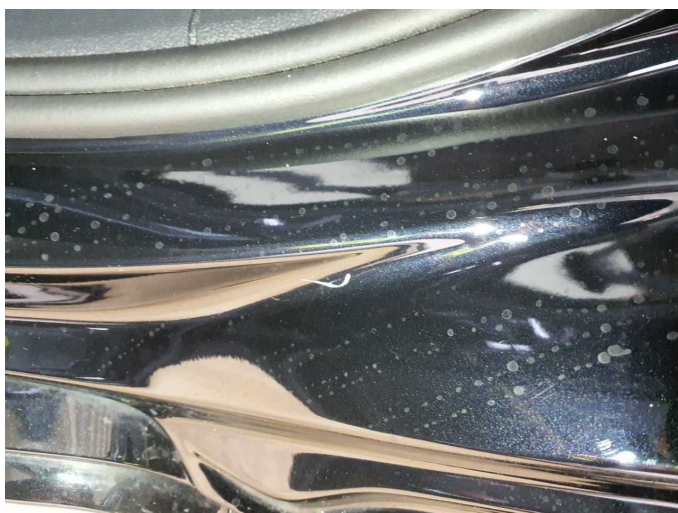
| No. | Component group | Description |
|---|---|---|
| 3 | Side panel - rear left side | Sill - Scratch(es) - Smart repair |

**Damage 3:** Side panel - rear left side: Sill - Scratch(es) - Smart repair

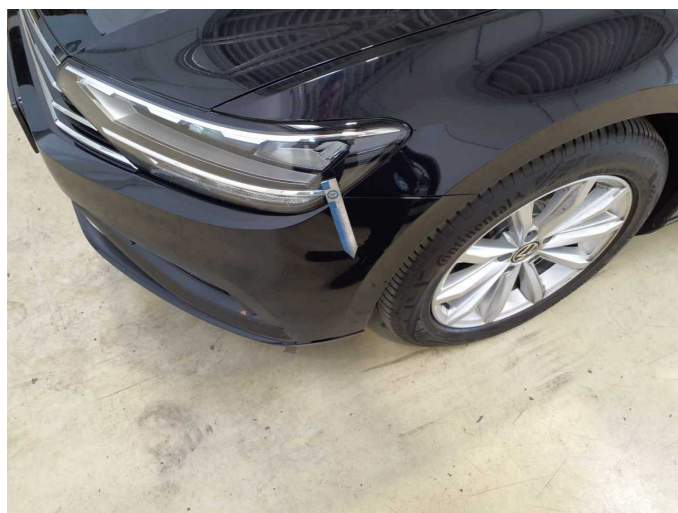
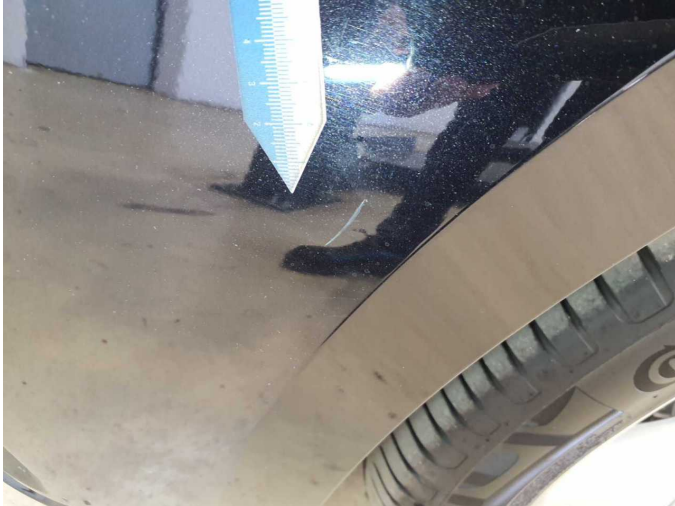
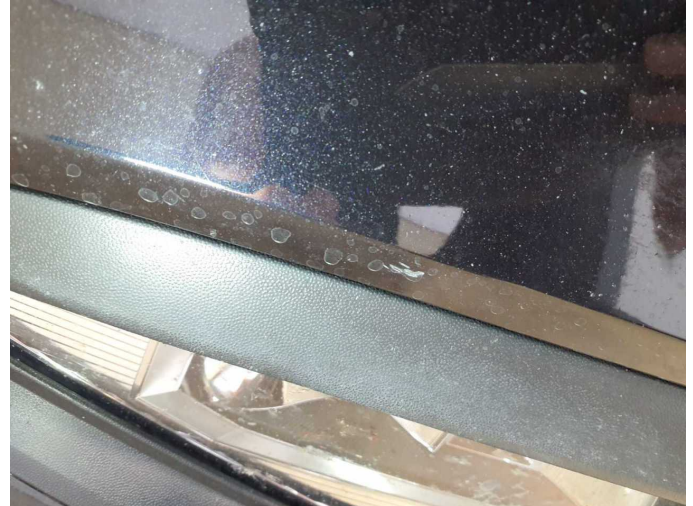
| No. | Component group | Description |
|---|---|---|
| 4 | Front bumper | Front bumper - Scratch(es) - Smart repair |

**Damage 4:** Front bumper: Front bumper - Scratch(es) - Smart repair

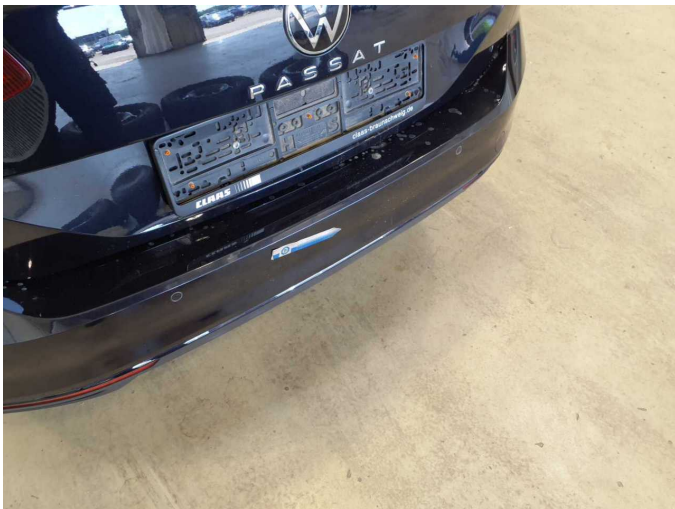
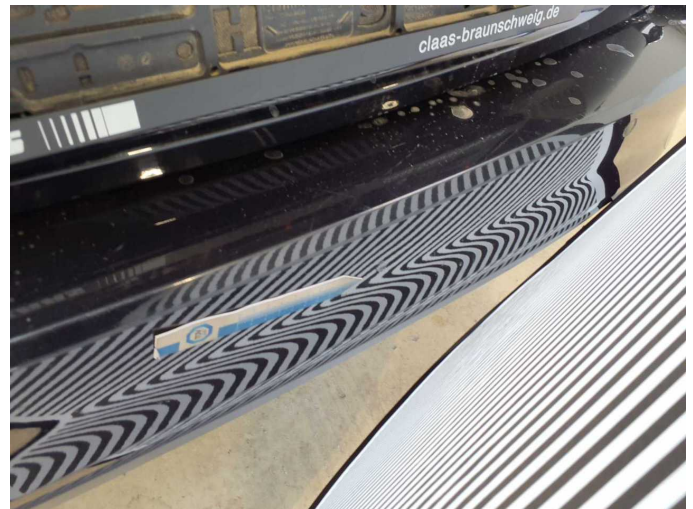
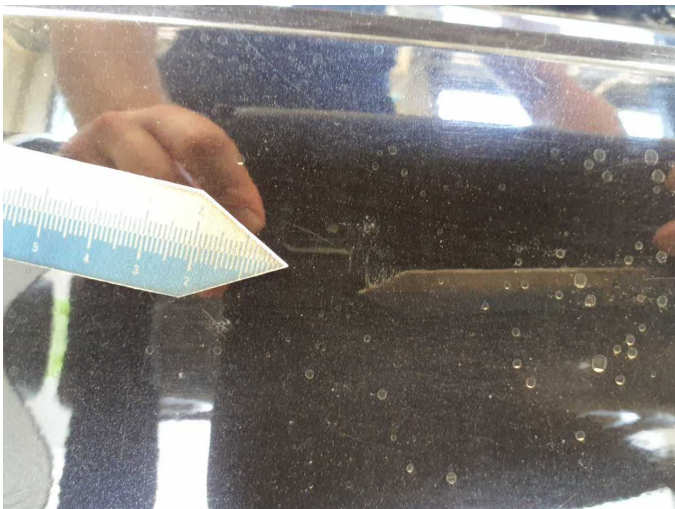
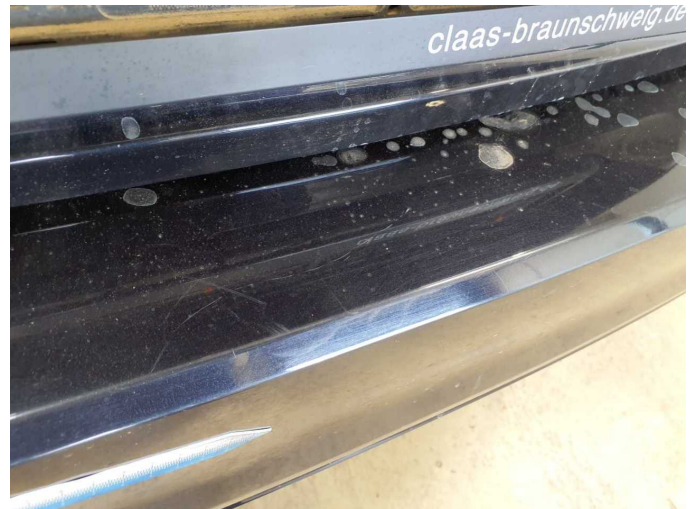
| No. | Component group | Description |
|---|---|---|
| 5 | Rear bumper | Rear bumper - Dent / paintcoat damage - Paint |

**Damage 5:** Rear bumper: Rear bumper - Dent / paintcoat damage - Paint

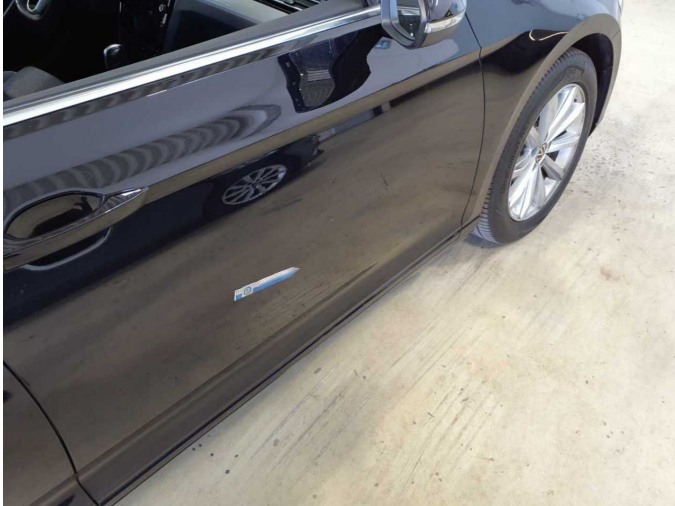
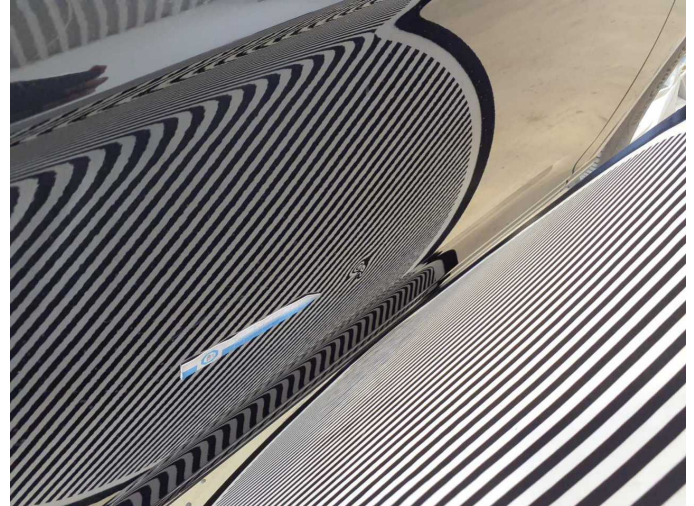
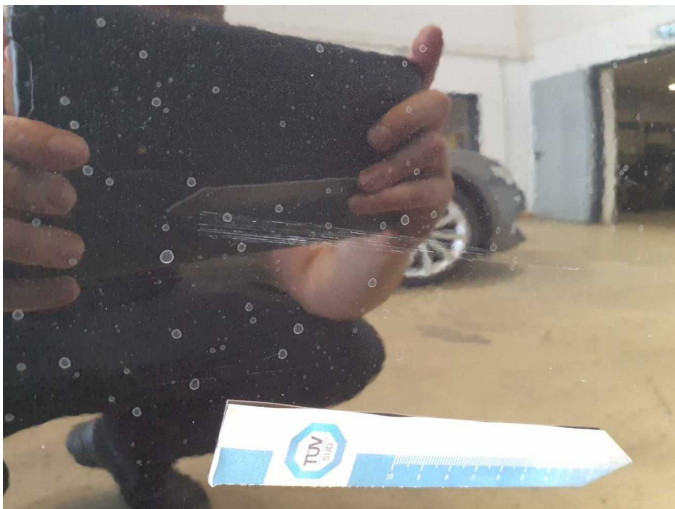
| No. | Component group | Description |
|---|---|---|
| 6 | Door - front right side | Door - Dent / paintcoat damage - Repair and paint |

**Damage 6:** Door - front right side: Door - Dent / paintcoat damage - Repair and paint

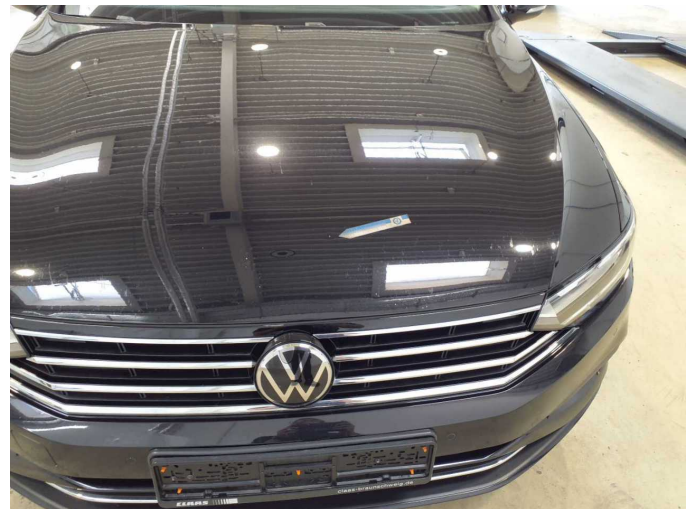
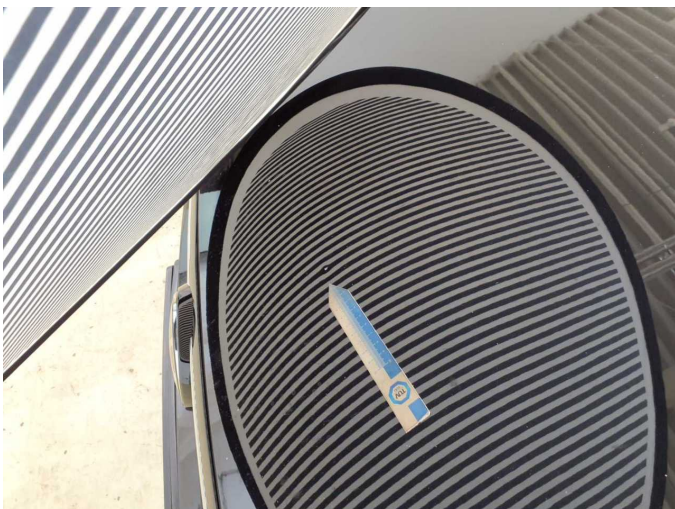
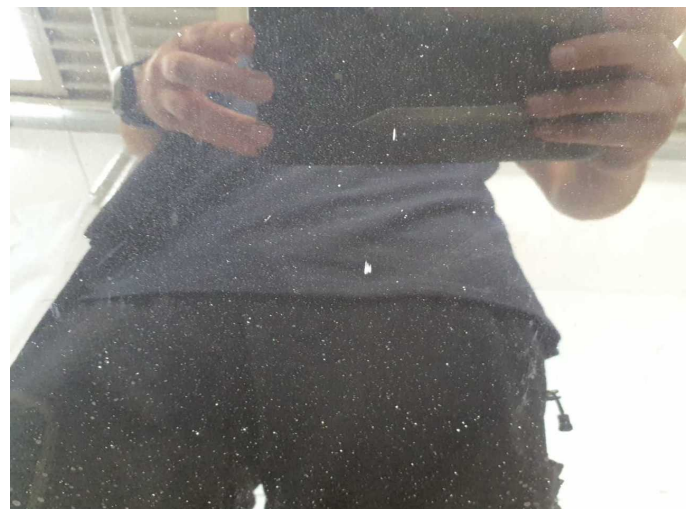
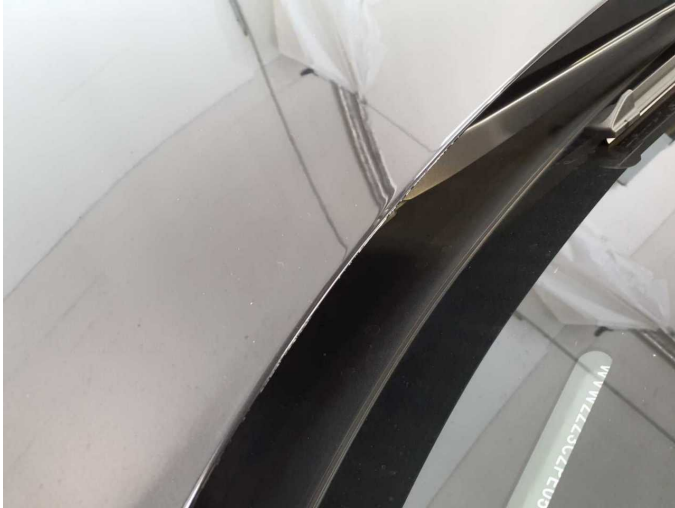
| No. | Component group | Description |
|---|---|---|
| 7 | Bonnet | Bonnet - Dent / paintcoat damage - Repair and paint |

**Damage 7:** Bonnet: Bonnet - Dent / paintcoat damage - Repair and paint
