Expertise

Protocol number: 45920654
Order No. / Reference: 26354178
Inspection date: 12 Jun 2026

Model: Focus Turnier 1.5 EcoBlue Start-Stopp-System Aut. TITANIUM

VIN: WF0PXXGCHPNU71503

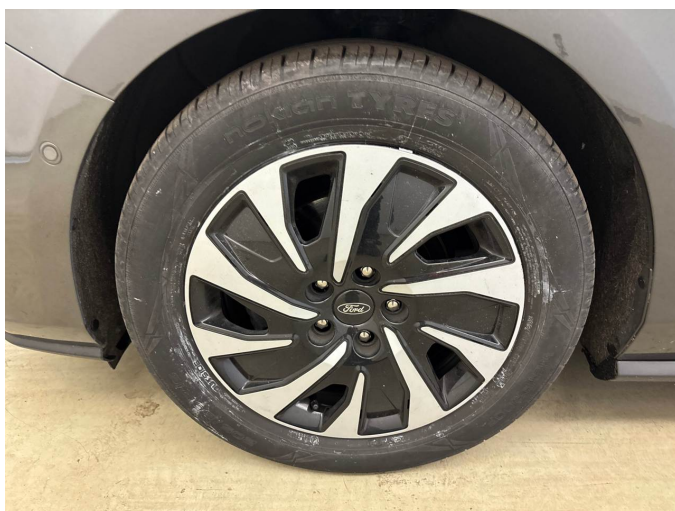
Figure 11: Mounted tyres

Mounted tyres				
#	Tyre size	Type of tyre	Manufacturer	Tread depth
1)	205/60 R16 96V	Summer tyres on Steel rim with wheel cover	Nokian	6mm / 6mm
2)	205/60 R16 92V	Summer tyres on Steel rim with wheel cover	Goodyear	5mm / 5mm

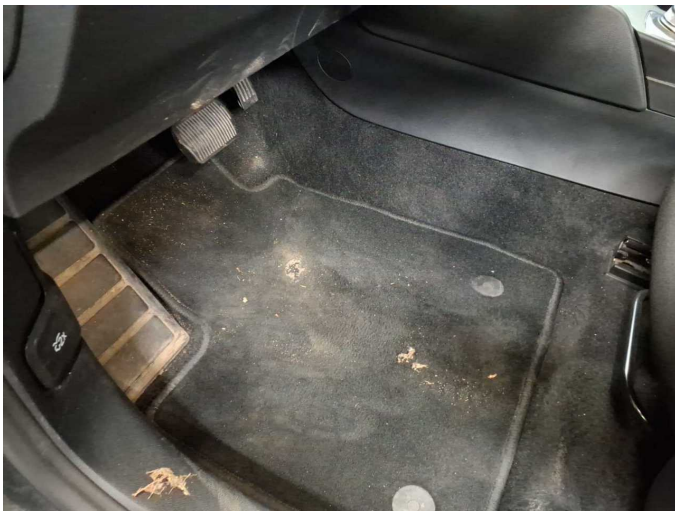
Damage 1: Trim / covers: Floor mats (VL) - Holes - Replace

No.	Component group	Description
1	Trim / covers	Floor mats (VL) - Holes - Replace
2	Front bumper	Grille - Broken / torn - Replace
3	Bonnet	Insulation lining - Damage caused by marten / rodent - Replace

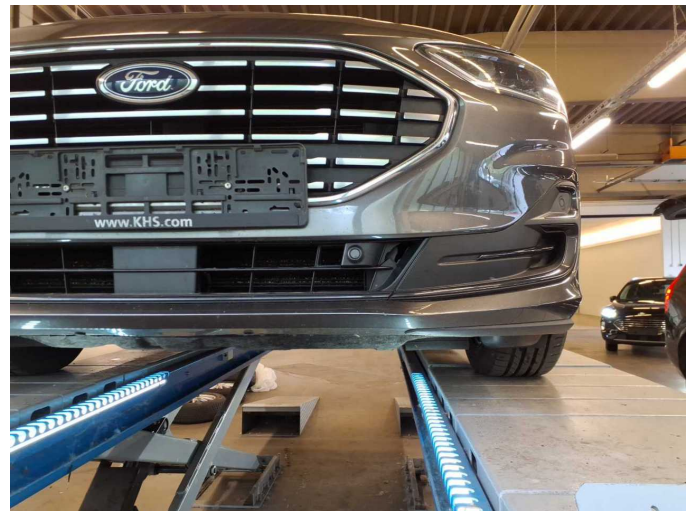
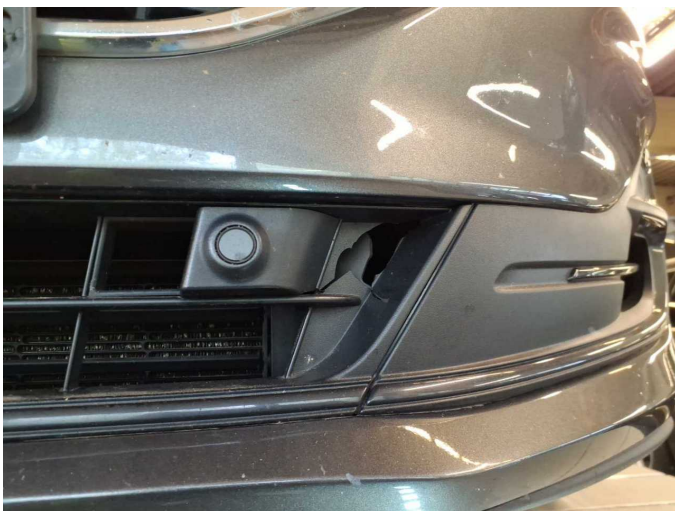
Damage 2: Front bumper: Grille - Broken / torn - Replace

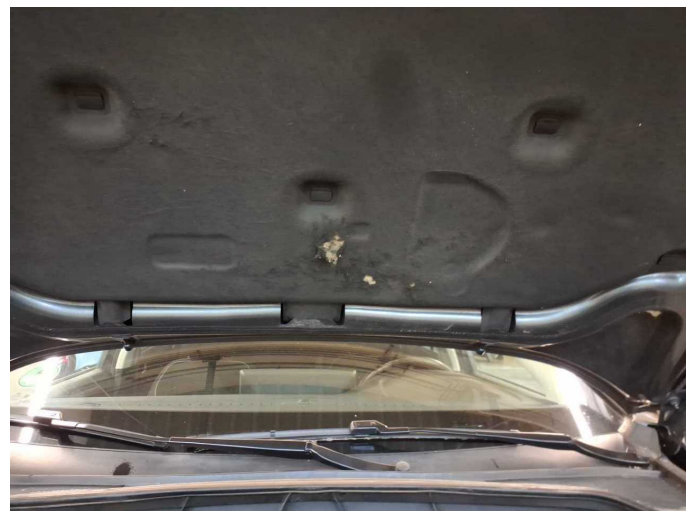
Damage 3: Bonnet: Insulation lining - Damage caused by marten / rodent - Replace
