Expertise

Protocol number: 46905287  
Order No. / Reference: 26759908  
Inspection date: 5 Aug 2026

| Manufacturer: Mercedes-Benz | Model: EQA 250+ |
| VIN: W1N9N0CB8TJ182785 | |

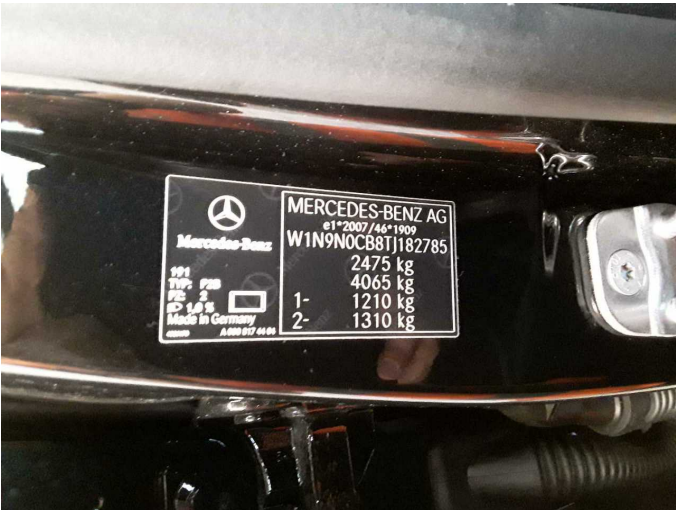
Figure 11: VIN

| VIN comparison | The vehicle identification number (VIN) was read from the vehicle and its conformity with the submitted documents was confirmed by the undersigned during the inspection. |

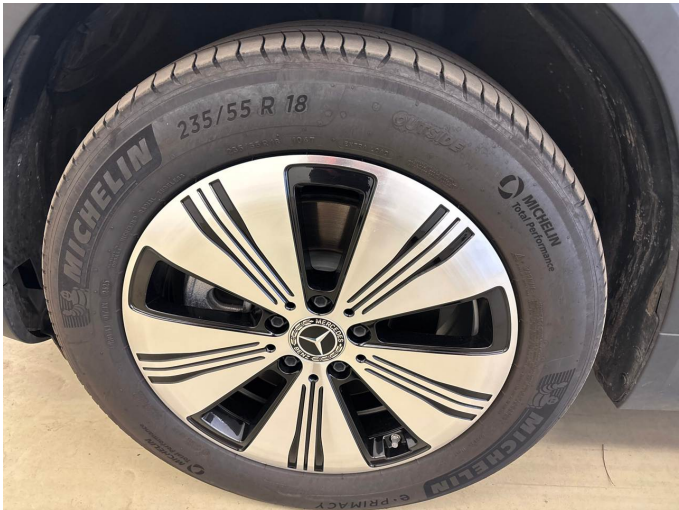
| # | Tyre size | Type of tyre | Manufacturer | Tread depth |
|---|---|---|---|---|
| 1) | 235/55 R18 104T | Summer tyres on Light alloy | Michelin | 6mm / 6mm |
| 2) | 235/55 R18 104T | Summer tyres on Light alloy | Michelin | 6mm / 6mm |

Figure 12: Mounted tyres

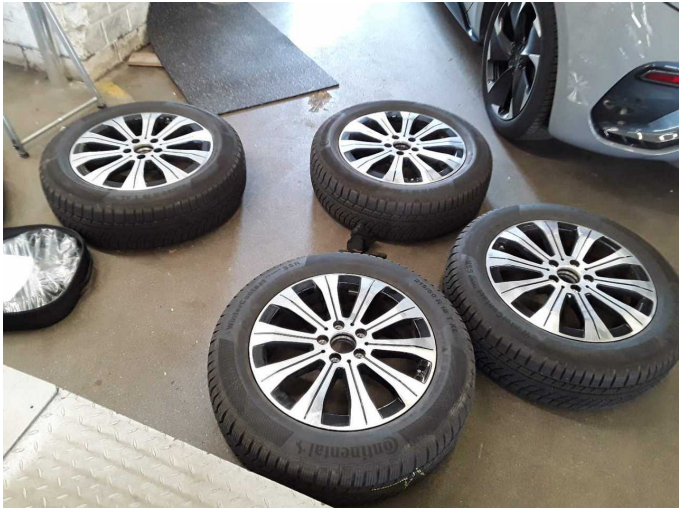
| # | Tyre size | Type of tyre | Manufacturer | Tread depth |
|---|---|---|---|---|
| 1) | 215/60 R18 102T | Winter tyres on Light alloy | Continental | 6mm / 6mm |
| 2) | 215/60 R18 102T | Winter tyres on Light alloy | Continental | 7mm / 7mm |

Figure 16: Additional tyres

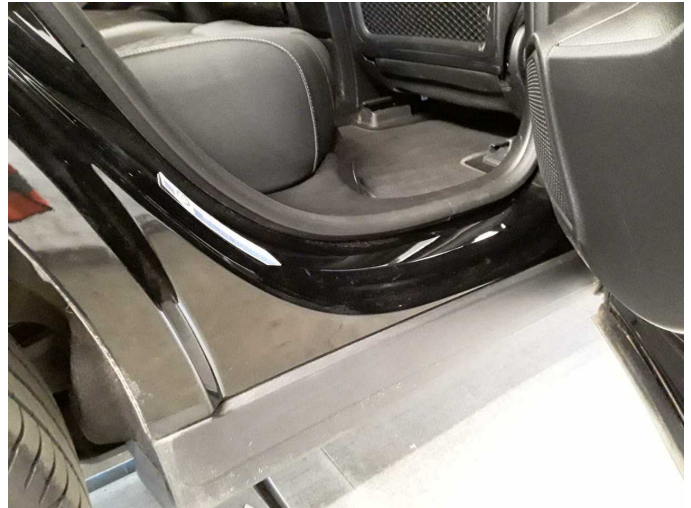
| No. | Component group | Description |
|---|---|---|
| 1 | Side panel - rear right side | Sill - Scratch(es) - Smart repair |

**Damage 1:** Side panel - rear right side: Sill - Scratch(es) - Smart repair

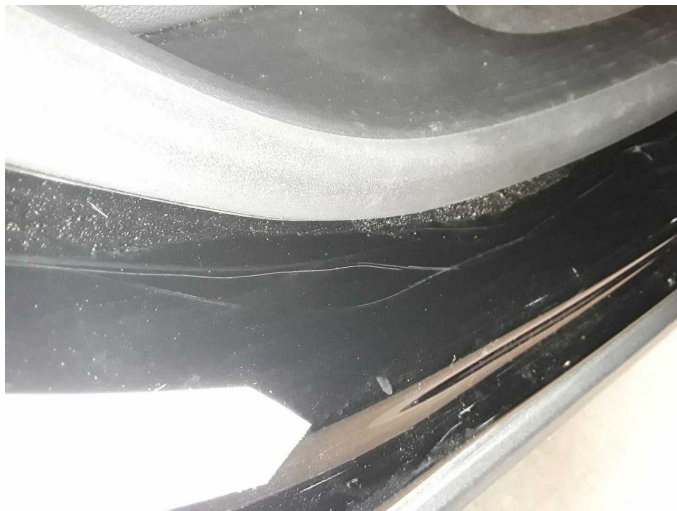
**Damage 1:** Side panel - rear right side: Sill - Scratch(es) - Smart repair

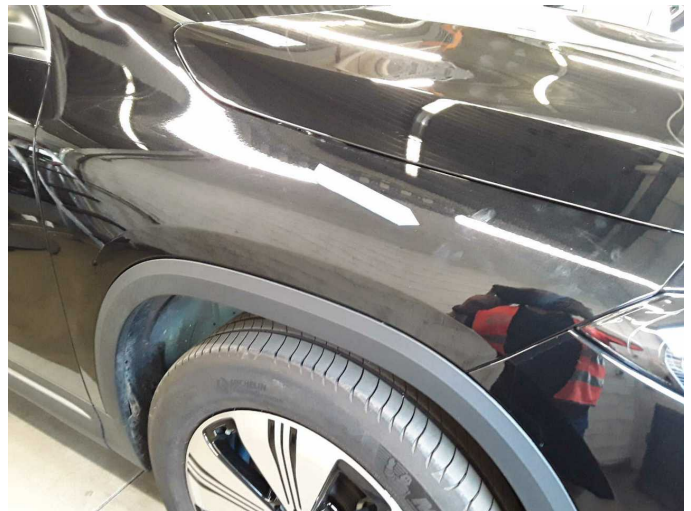
| No. | Component group | Description |
|---|---|---|
| 1 | Mudguard - right side | Mudguard - right side - Soiled - No deduction |

**Wear and tear 1:** Mudguard - right side: Mudguard - right side - Soiled - No deduction

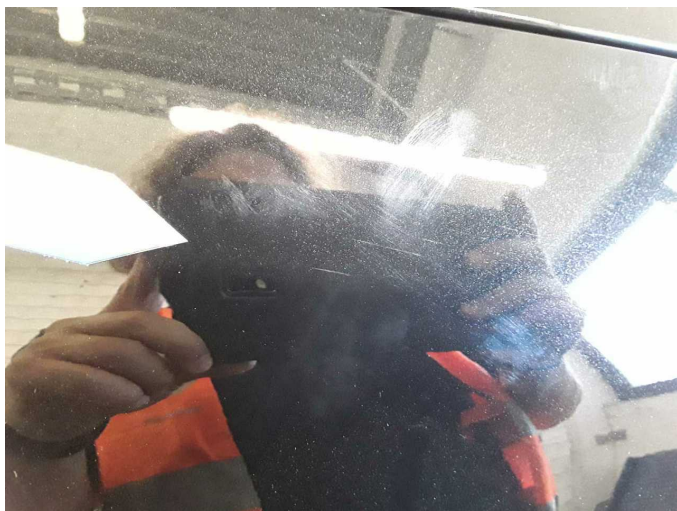
**Wear and tear 1:** Mudguard - right side: Mudguard - right side - Soiled - No deduction

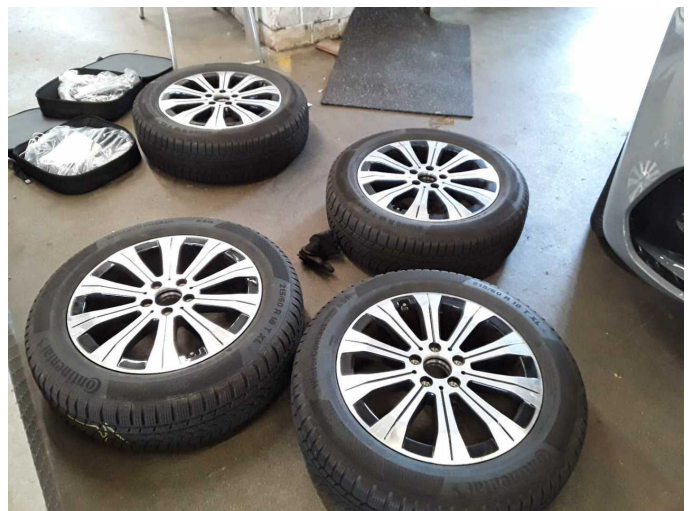
2nd wheel set - Wheel cover set - complete

**Missing part 1:** 2nd wheel set: Wheel cover set - complete - Missing - Replace

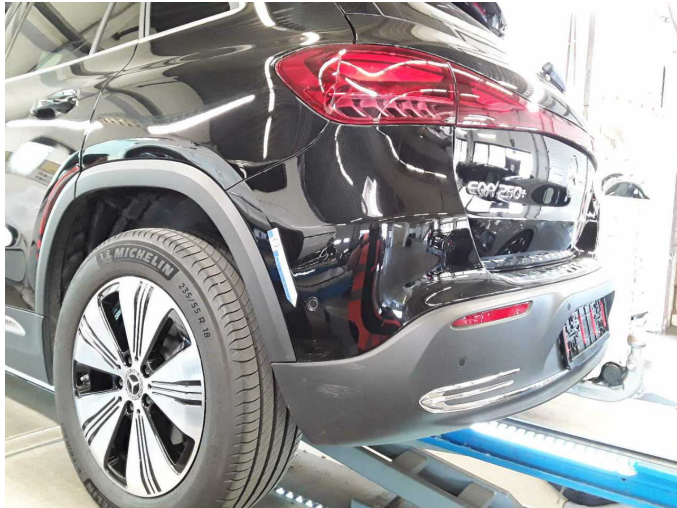
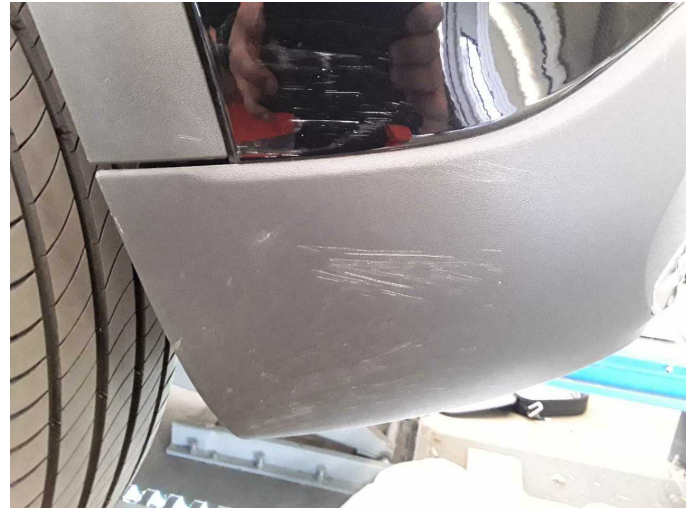
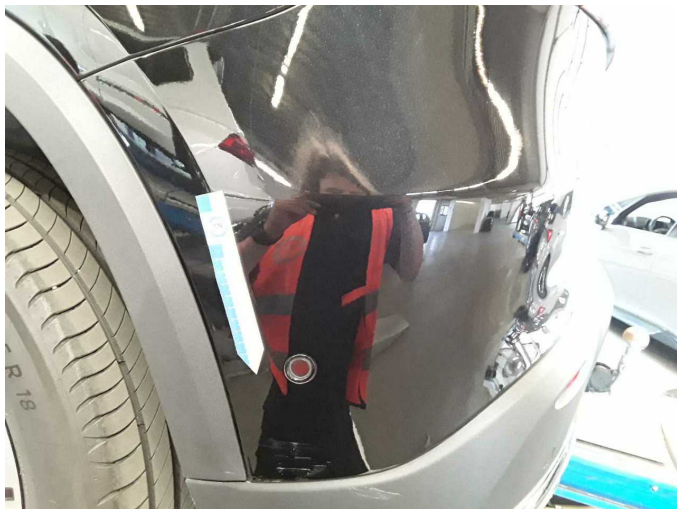
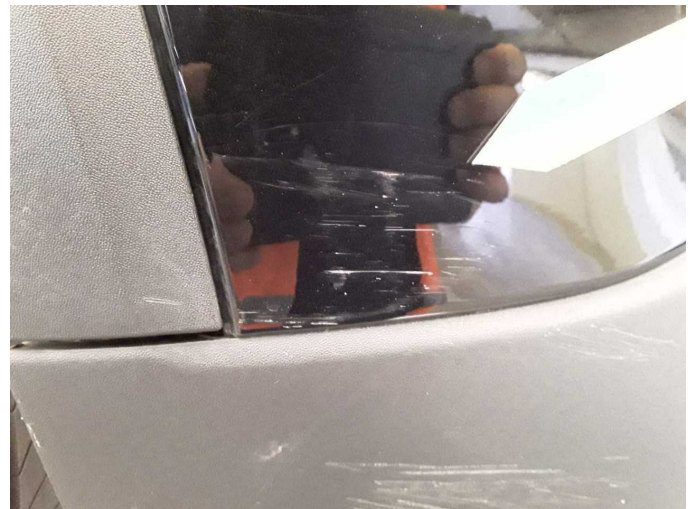
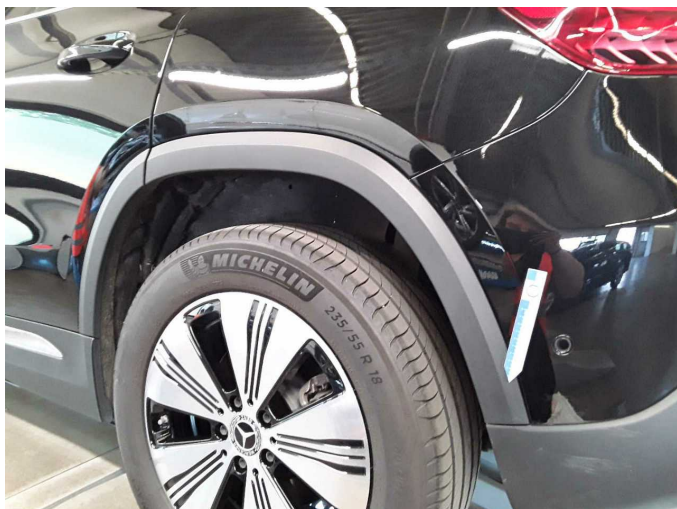
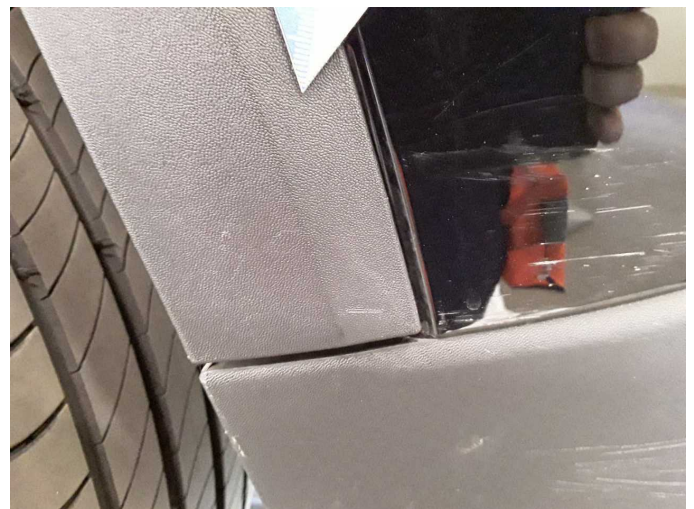
1 Rear, Side - left

Non-repaired previous damages were found at the vehicle. The necessary repair costs are listed in the expert report or if necessary, are listed in detail in a separately enclosed repair cost calculation.

**Accident 1: Rear, Side - left**
