Expertise

Protocol number: 46823979  
Order No. / Reference: 26782937  
Inspection date: 29 Jul 2026

Model: A6 45 TDI quattro tiptronic sport

VIN: WAUZZZF23MN021991

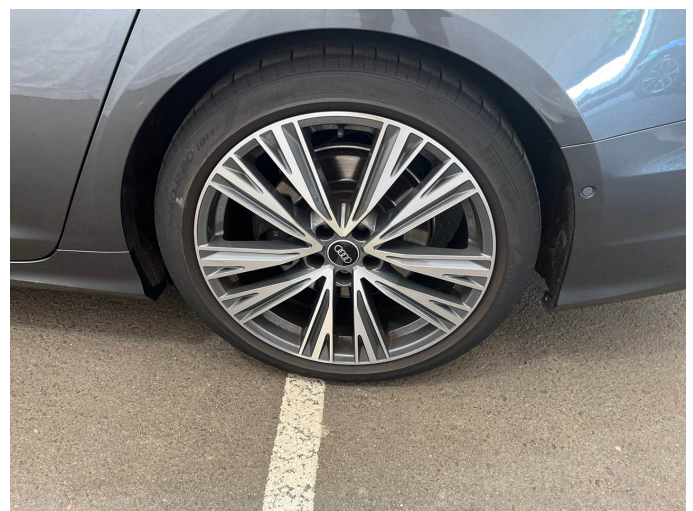
| # | Tyre size | Type of tyre | Manufacturer | Tread depth |
|---|---|---|---|---|
| 1) | 255/40 R20 101Y | Summer tyres on Light alloy | Pirelli | 4mm / 4mm |
| 2) | 255/40 R20 101Y | Summer tyres on Light alloy | Pirelli | 4mm / 4mm |

Figure 12: Mounted tyres

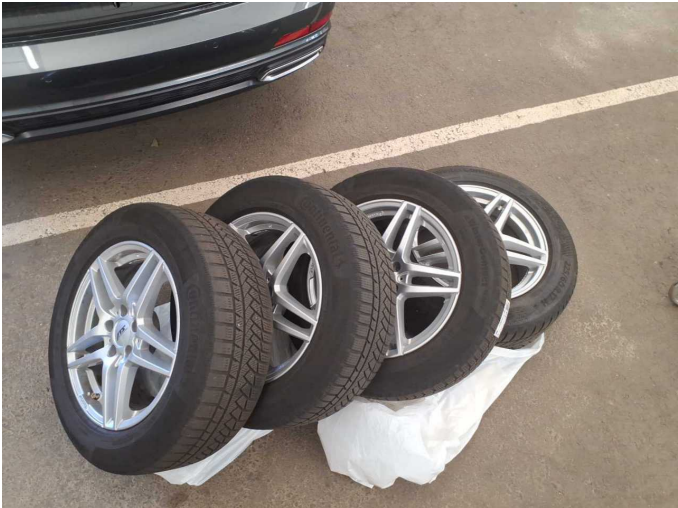
| # | Tyre size | Type of tyre | Manufacturer | Tread depth |
|---|---|---|---|---|
| 1) | 225/60 R17 99H | Winter tyres on Light alloy | Continental | 5mm / 5mm |
| 2) | 225/60 R17 99H | Winter tyres on Light alloy | Continental | 6mm / 6mm |

Figure 16: Additional tyres

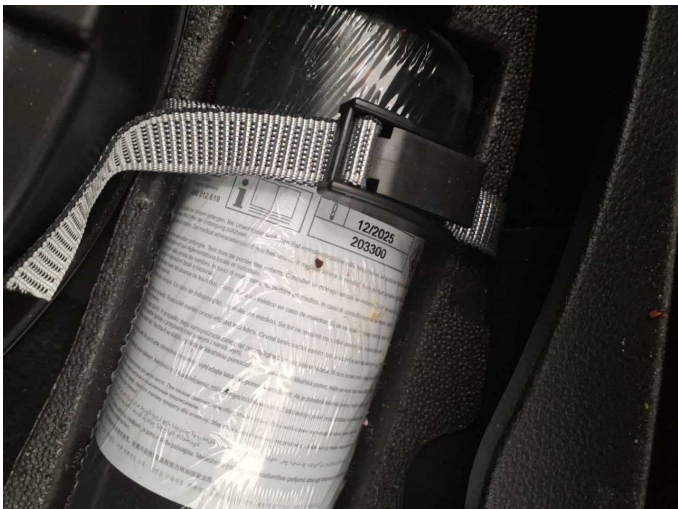
Damage 1: Equipment: Tirefit filler - Expired - Replace

| No. | Component group | Description |
|---|---|---|
| 1 | Equipment | Tirefit filler - Expired - Replace |

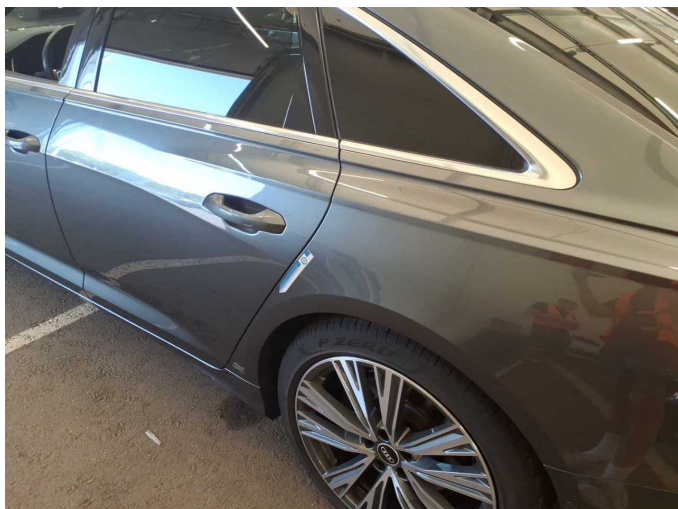
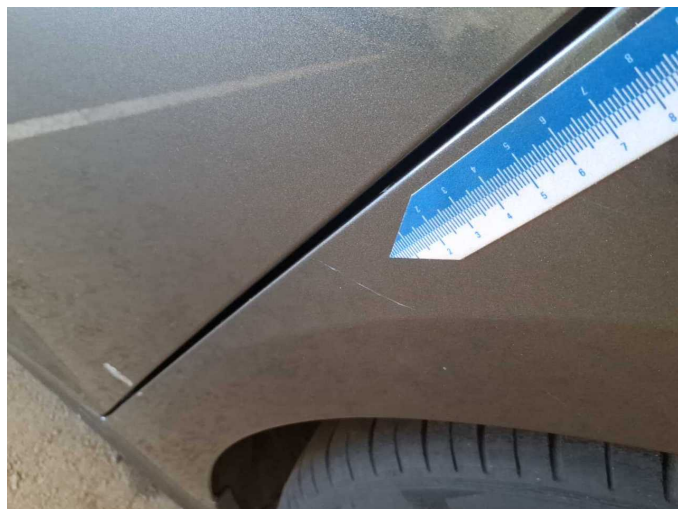
**Damage 2:** Side panel - rear left side: Side panel - Scratch(es) - Smart repair

| No. | Component group | Description |
|---|---|---|
| 2 | Side panel - rear left side | Side panel - Scratch(es) - Smart repair |

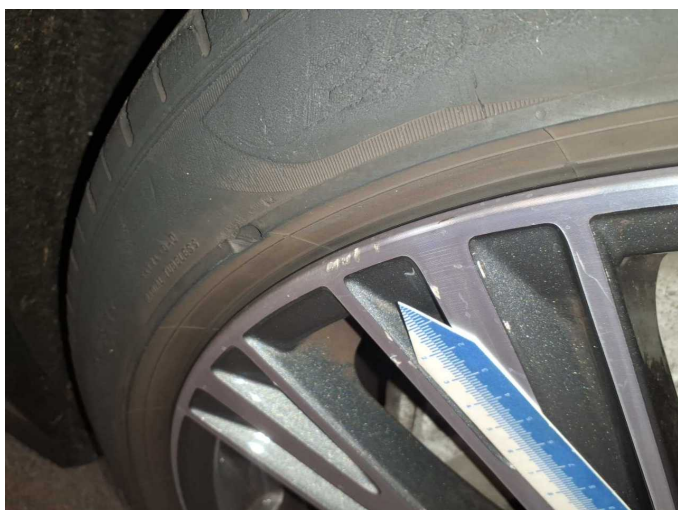
**Damage 3:** Wheel / tyres: Tyre - front right side - Damaged - Replace

| No. | Component group | Description |
|---|---|---|
| 3 | Wheel / tyres | Tyre - front right side - Damaged - Replace |

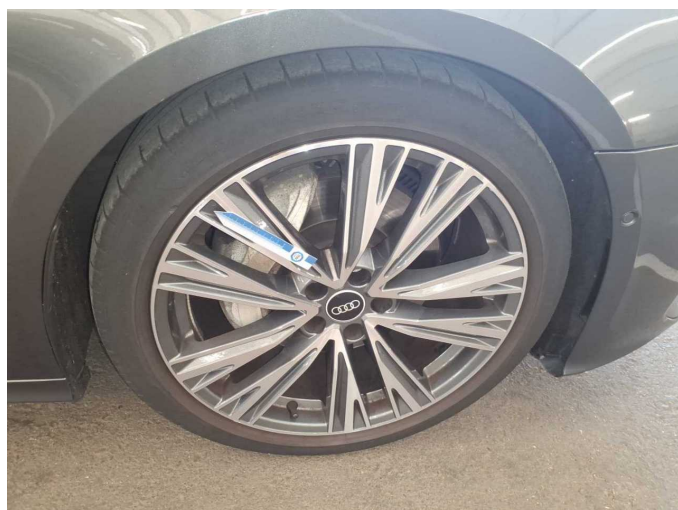
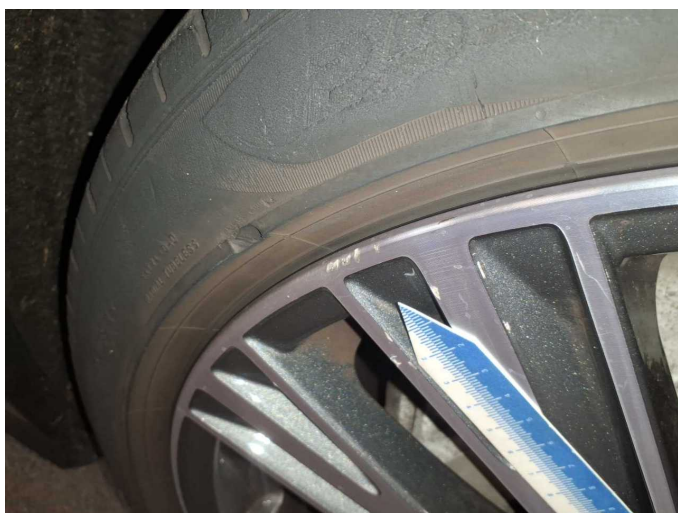
**Damage 4:** Wheel / tyres: Alloy rim - front right side - Scratch(es) - Loss in value

| No. | Component group | Description |
|---|---|---|
| 4 | Wheel / tyres | Alloy rim - front right side - Scratch(es) - Loss in value |

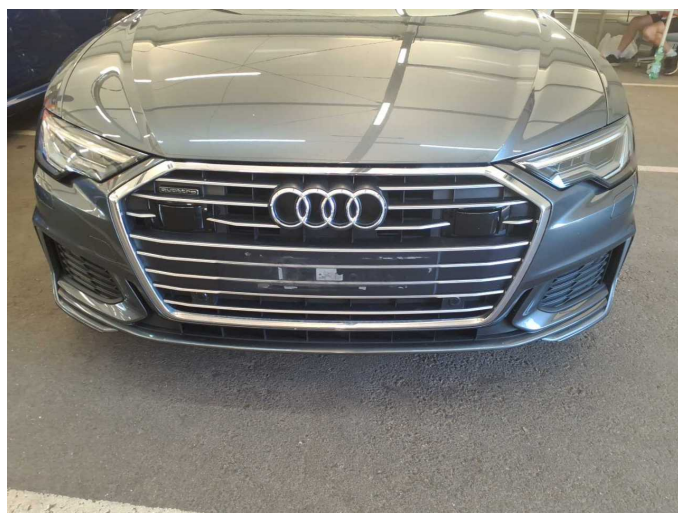
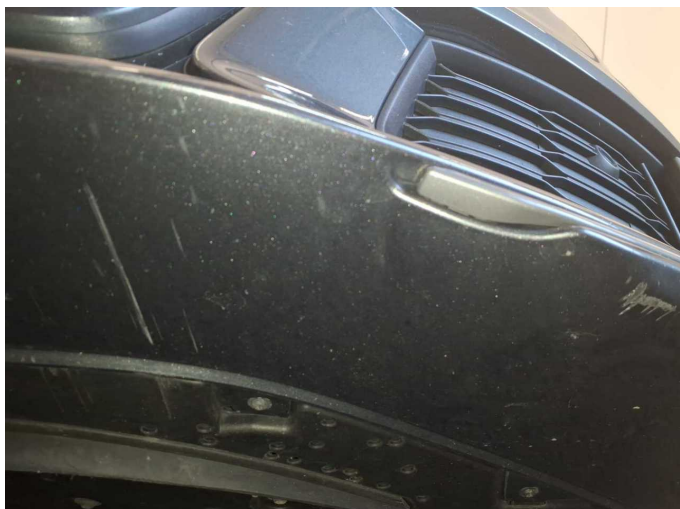
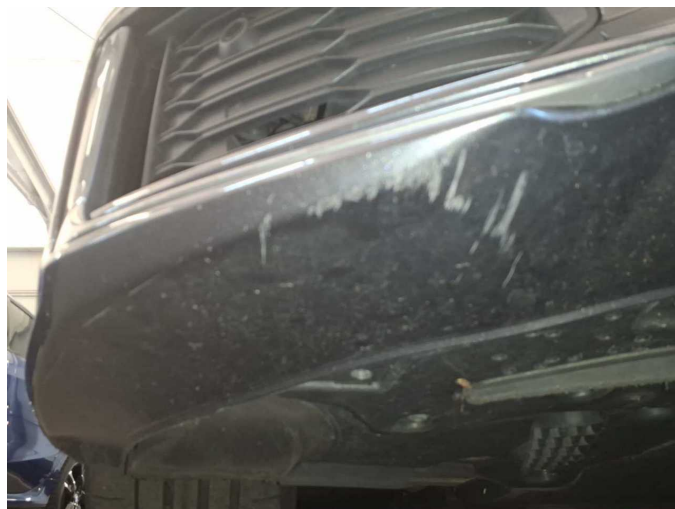
**Damage 5:** Front bumper: Front bumper - Scratched - Paint

| No. | Component group | Description |
|---|---|---|
| 5 | Front bumper | Front bumper - Scratched - Paint |

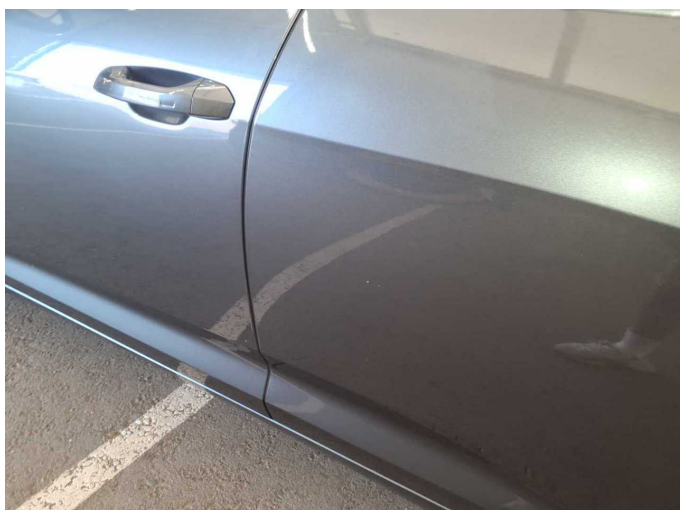
**Wear and tear 3:** Door - rear left side: Door - Stone chips - No deduction

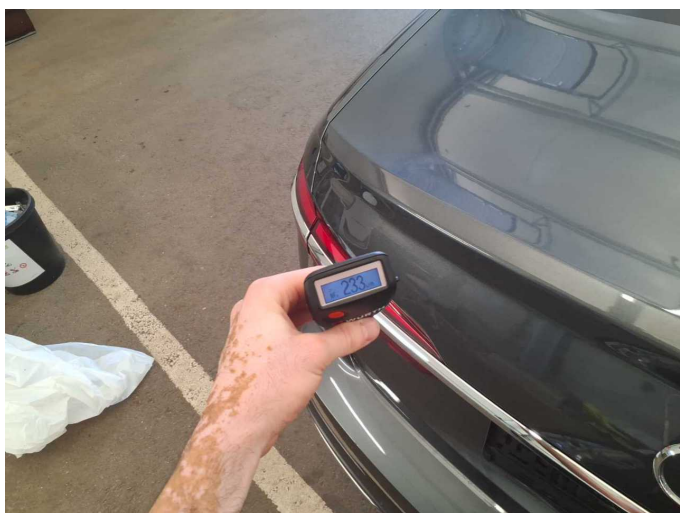
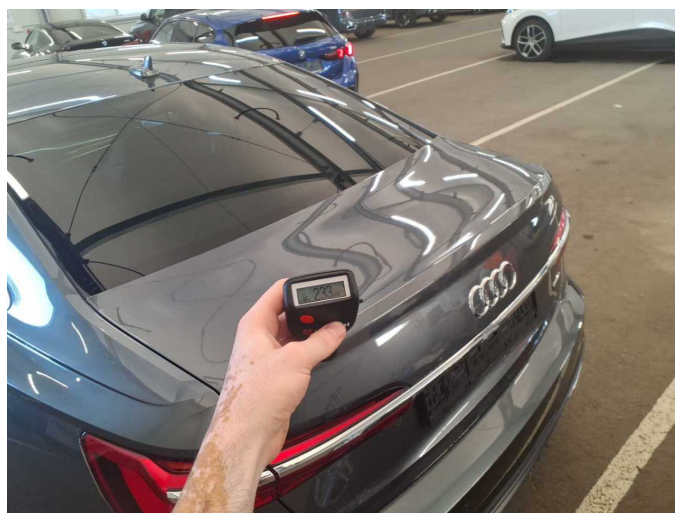
**Repainting 1:** Boot lid / rear door
