Expertise

Protocol number: 46043935  
Order No. / Reference: 26373308-1  
Inspection date: 8 Jun 2026

Manufacturer: Ford

Model: Kuga 2.5 Duratec FHEV ST-LINE X

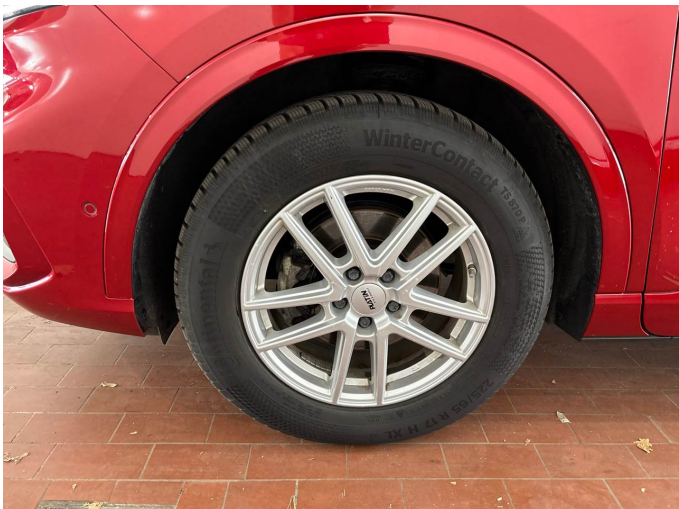
Figure 12: Mounted tyres

| # | Tyre size | Type of tyre | Manufacturer | Tread depth |
|---|---|---|---|---|
| 1) | 225/65 R17 106H | Winter tyres on Light alloy | Continental | 7mm / 7mm |
| 2) | 225/65 R17 106H | Winter tyres on Light alloy | Continental | 8mm / 8mm |

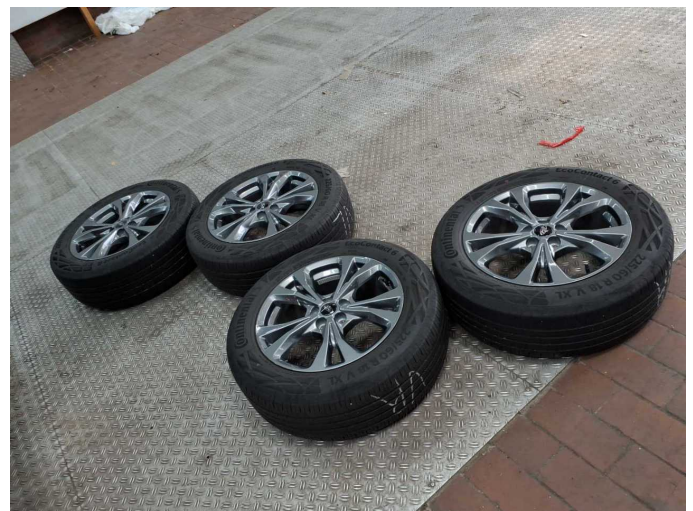
Figure 16: Additional tyres

| # | Tyre size | Type of tyre | Manufacturer | Tread depth |
|---|---|---|---|---|
| 1) | 225/60 R18 104V | Summer tyres on Light alloy | Continental | 4mm / 4mm |
| 2) | 225/60 R18 104V | Summer tyres on Light alloy | Continental | 4mm / 4mm |

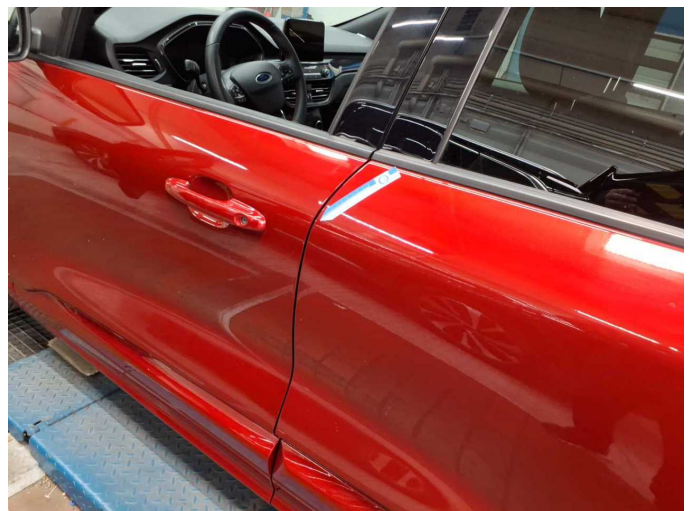
| No. | Component group | Description |
|---|---|---|
| 1 | Door - rear left side | Door - Scratch(es) - Smart repair |

Damage 1: Door - rear left side: Door - Scratch(es) - Smart repair

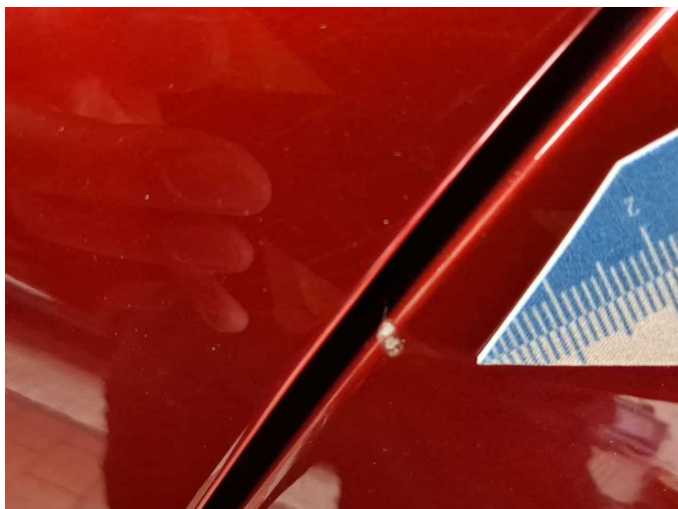
**Damage 1:** Door - rear left side: Door - Scratch(es) - Smart repair

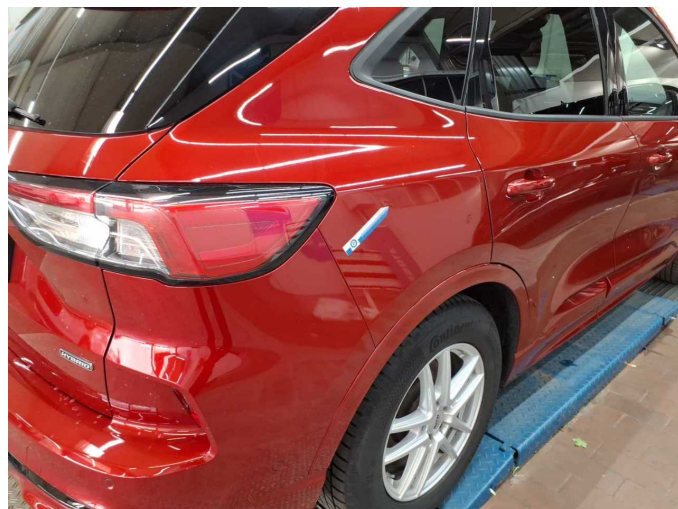
| No. | Component group | Description |
|---|---|---|
| 2 | Side panel - rear right side | Side panel - dent(s) - Smooth repair work |

**Damage 2:** Side panel - rear right side: Side panel - dent(s) - Smooth repair work

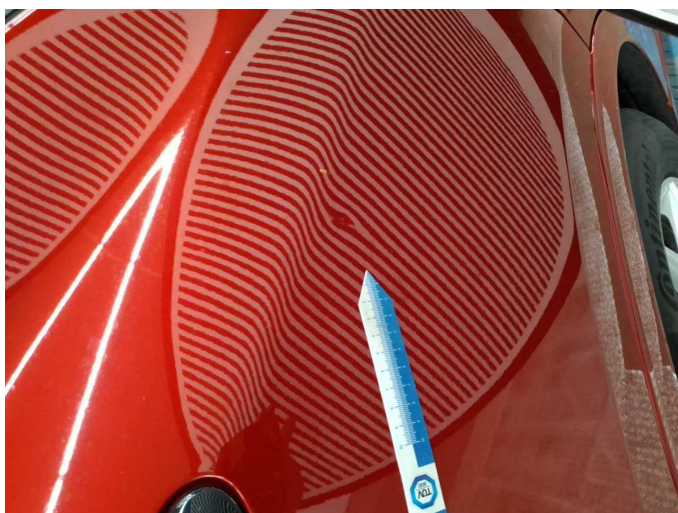
**Damage 2:** Side panel - rear right side: Side panel - dent(s) - Smooth repair work

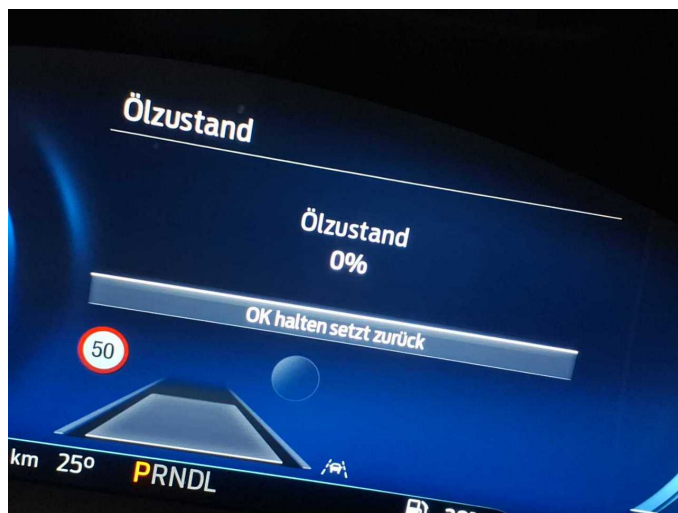
| No. | Component group | Description |
|---|---|---|
| 3 | Misc. | Inspection / maintenance - Due - Perform |

**Damage 3:** Misc.: Inspection / maintenance - Due - Perform

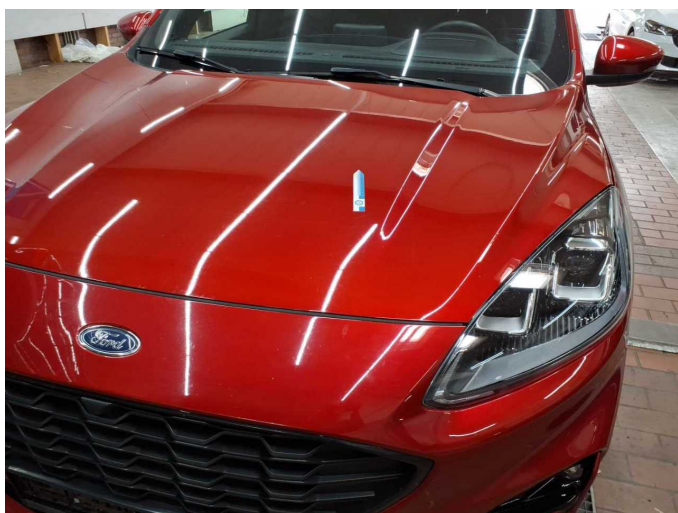
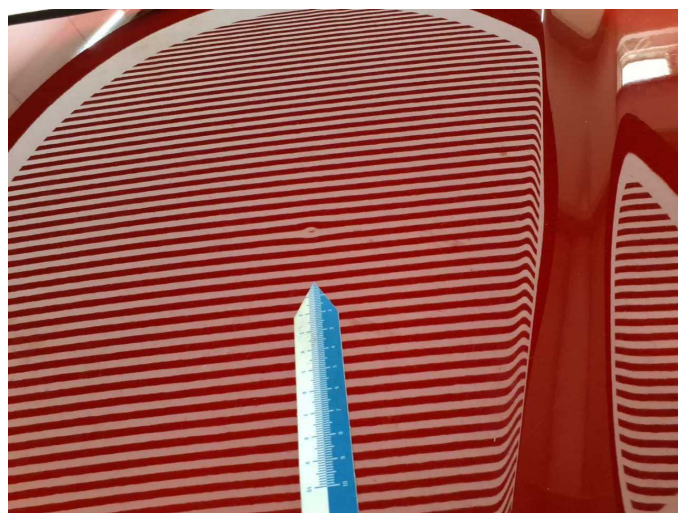
| No. | Component group | Description |
|---|---|---|
| 2 | Bonnet | Bonnet - dent(s) - No deduction |

**Wear and tear 2:** Bonnet: Bonnet - dent(s) - No deduction

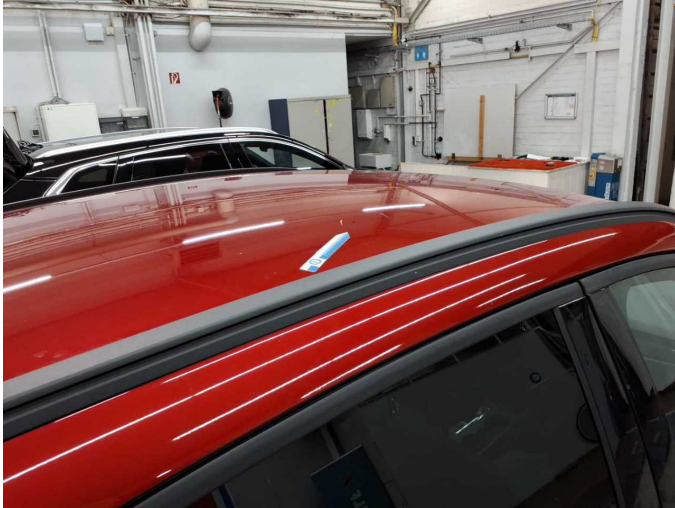
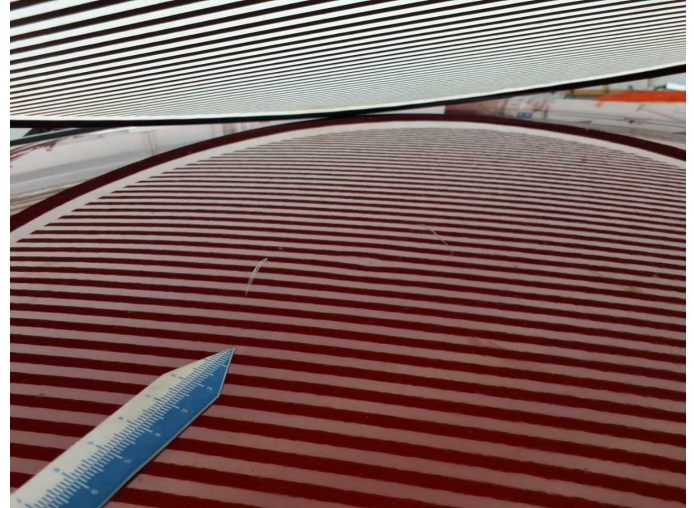
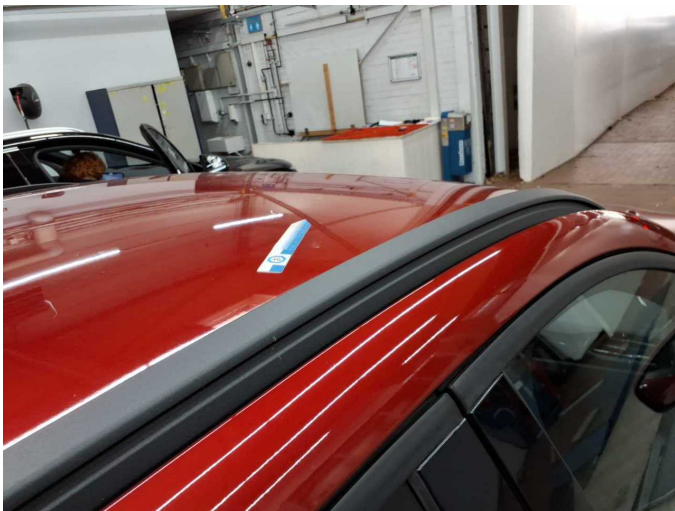
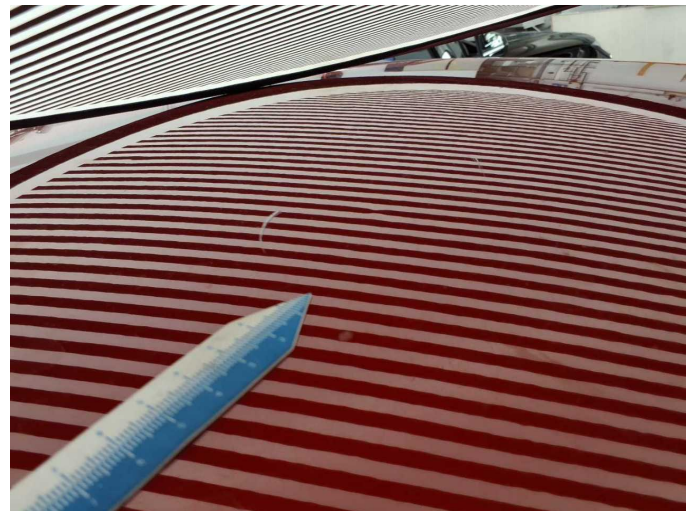
| No. | Component group | Description |
|---|---|---|
| 3 | Roof | Roof - dent(s) - No deduction |

**Wear and tear 3:** Roof: Roof - dent(s) - No deduction

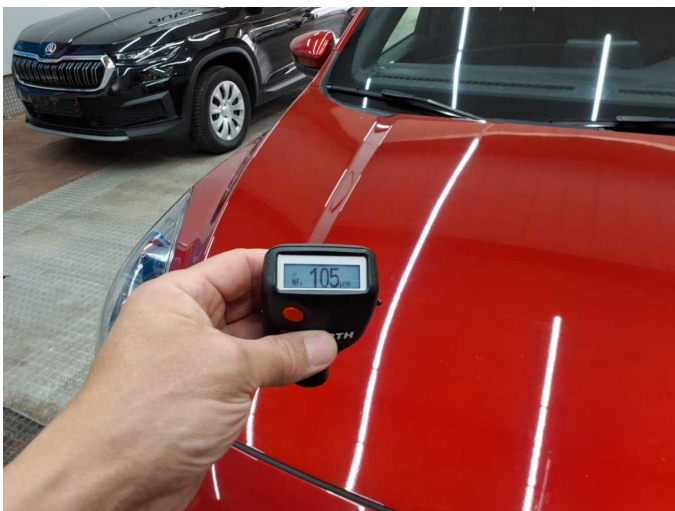
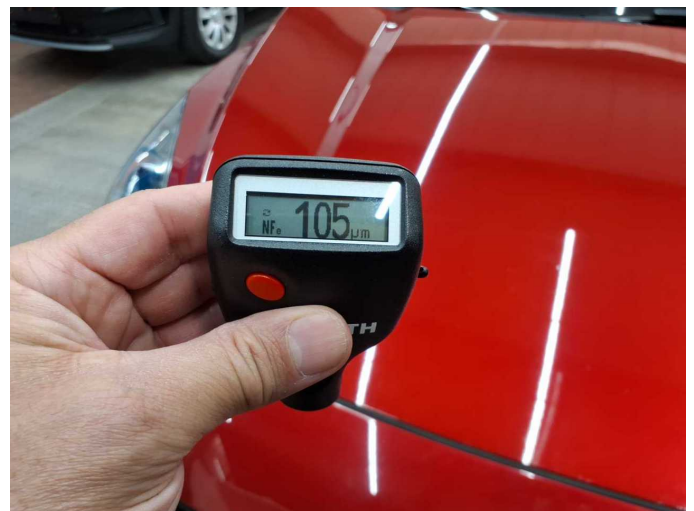
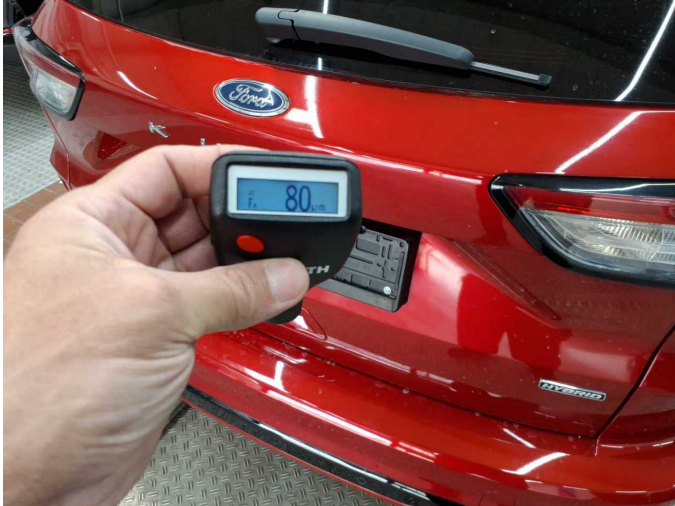
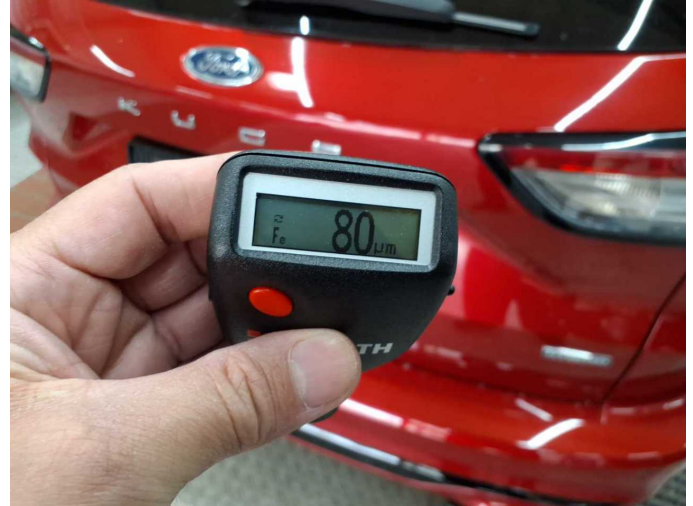
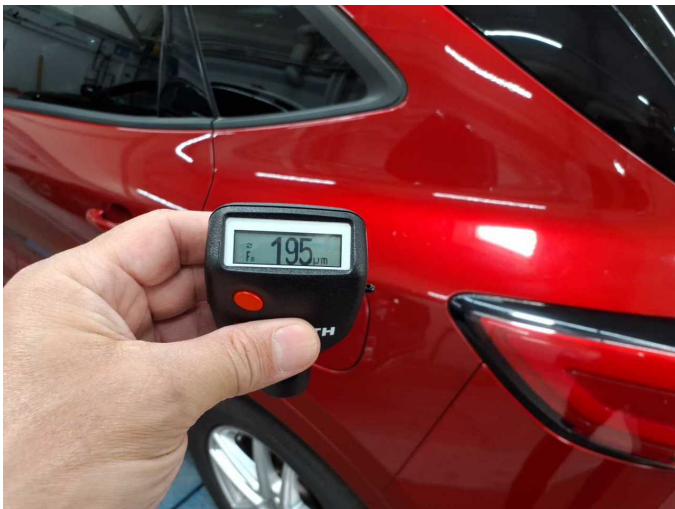
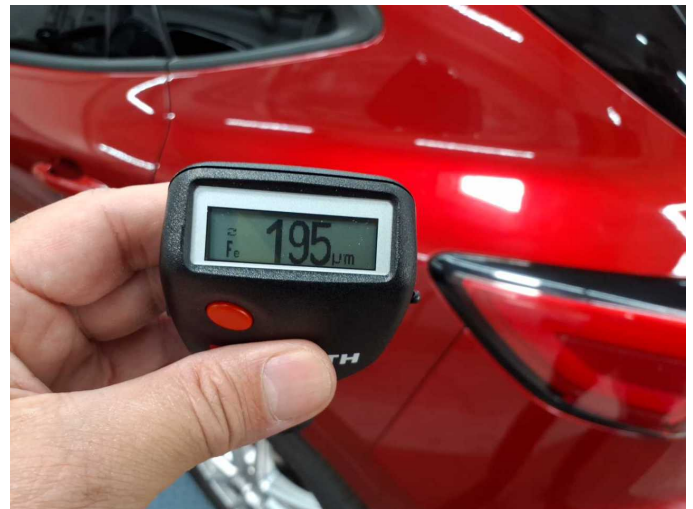
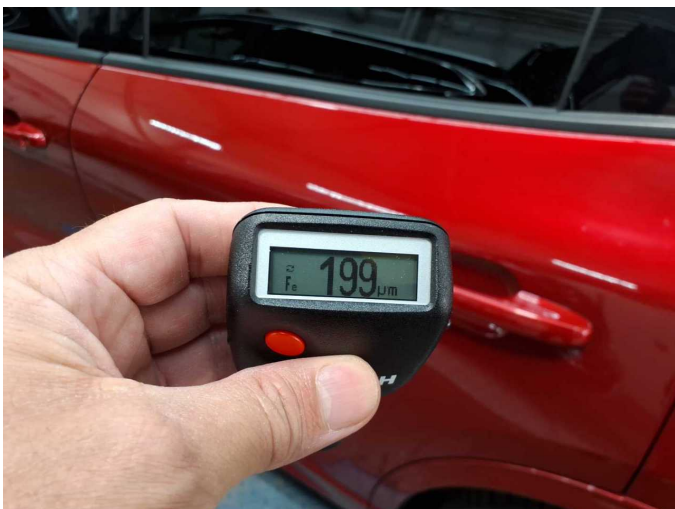
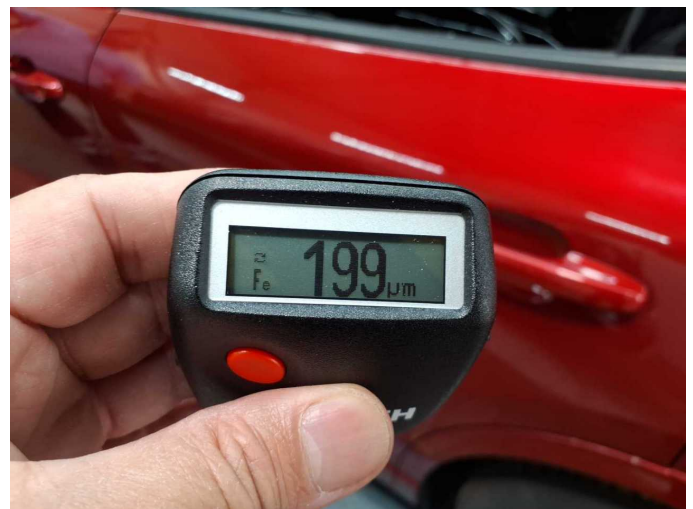
1 Boot lid / rear door, Bonnet, Side panel - rear left side, Door - rear left side, Professionally carried out

**Repainting 1:** Boot lid / rear door, Bonnet, Side panel - rear left side, Door - rear left side

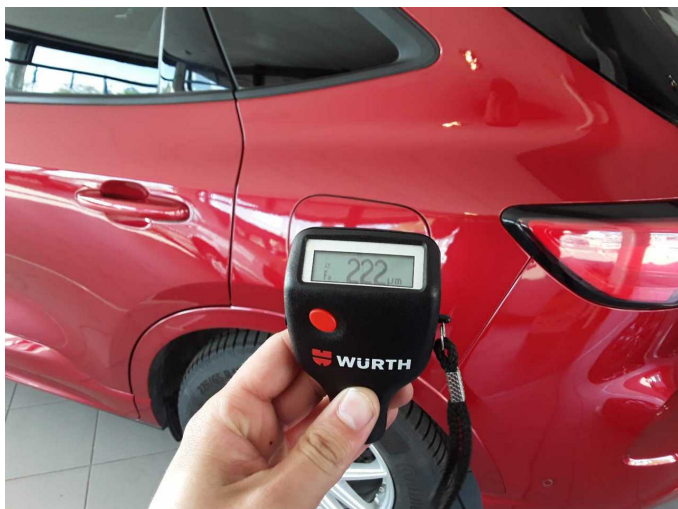
| Side panel - rear left side | 195 µm | Door - rear left side | 199 µm |

**Side panel - rear left side:** 195 µm

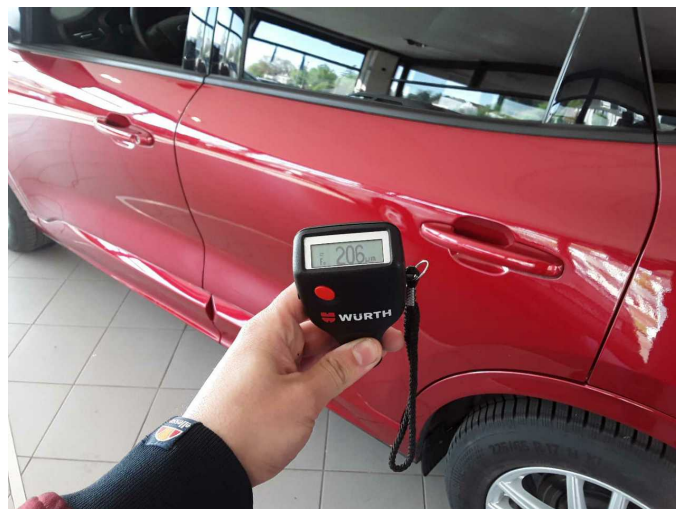
**Door - rear left side:** 199 µm
