Expertise

Protocol number: 46408429  
Order No. / Reference: 26670898  
Inspection date: 8 Jul 2026

| Manufacturer: Ford | Model: Focus Turnier 1.5 EcoBlue Start-Stopp-System Aut. TITANIUM X |

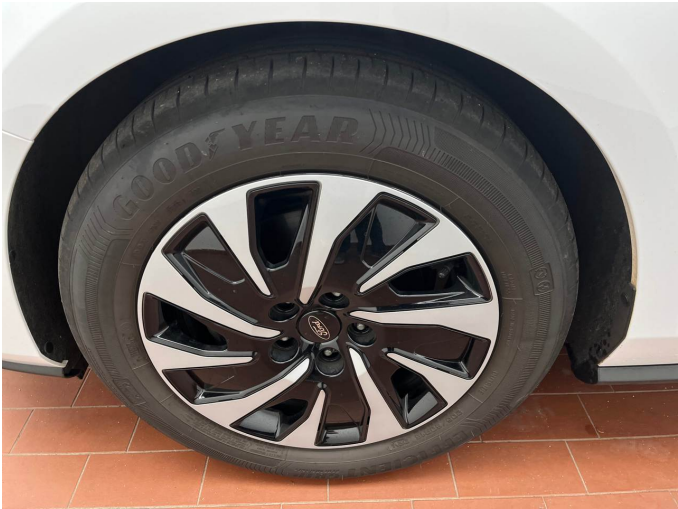
| # | Tyre size | Type of tyre | Manufacturer | Tread depth |
|---|---|---|---|---|
| 1) | 205/60 R16 92V | Summer tyres on Steel rim with wheel cover | Goodyear | 4mm / 4mm |
| 2) | 205/60 R16 92V | Summer tyres on Steel rim with wheel cover | Goodyear | 5mm / 5mm |

Figure 12: Mounted tyres

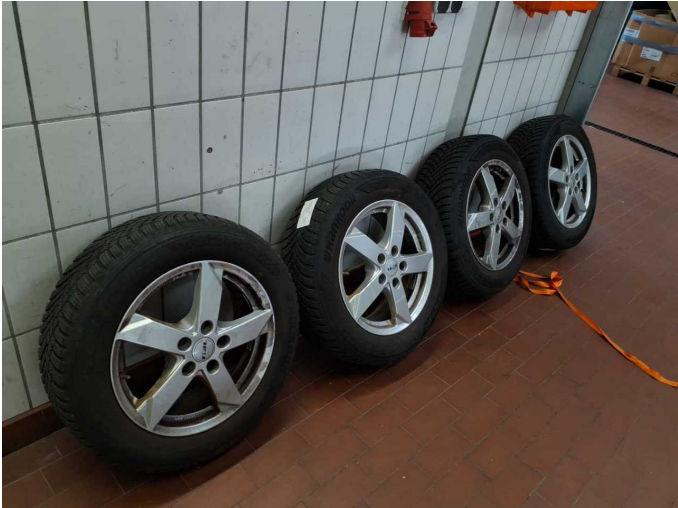
| # | Tyre size | Type of tyre | Manufacturer | Tread depth |
|---|---|---|---|---|
| 1) | 205/60 R16 96H | Winter tyres on Light alloy | Hankook | 4mm / 4mm |
| 2) | 205/60 R16 96H | Winter tyres on Light alloy | Hankook | 6mm / 6mm |

Figure 16: Additional tyres

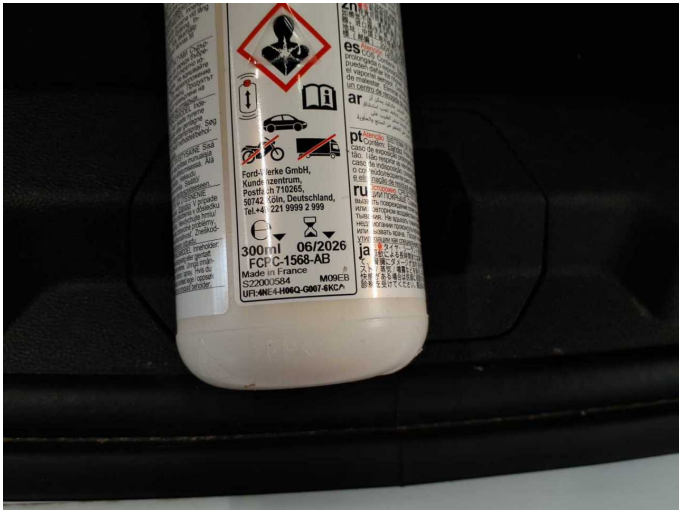
| No. | Component group | Description |
|---|---|---|
| 1 | Equipment | Tirefit filler - Due - Replace |

Damage 1: Equipment: Tirefit filler - Due - Replace

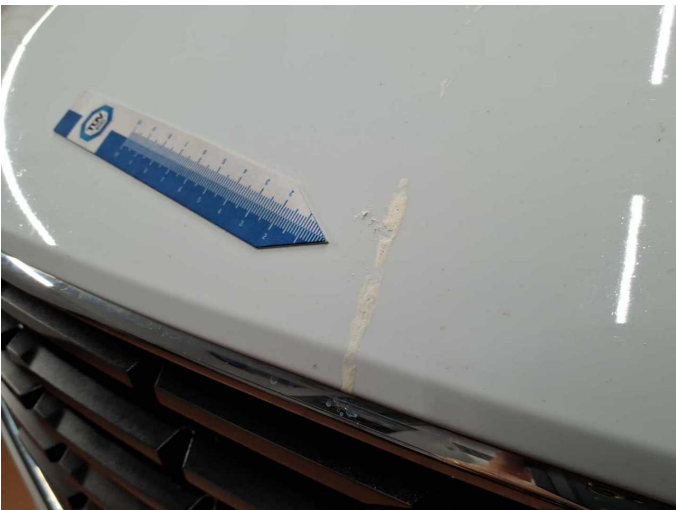
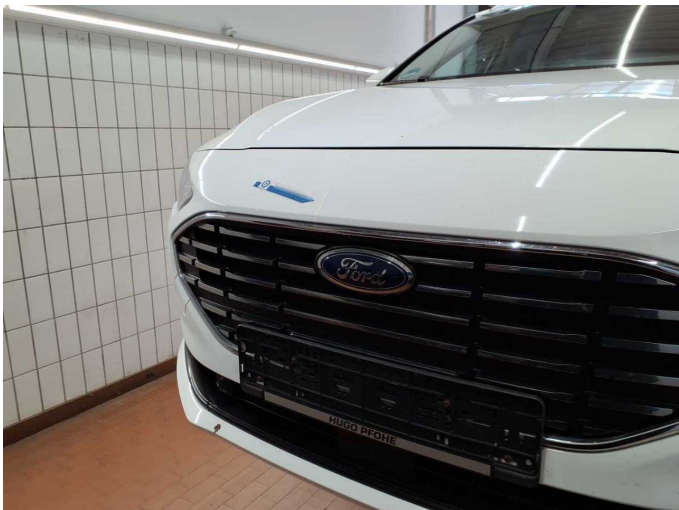
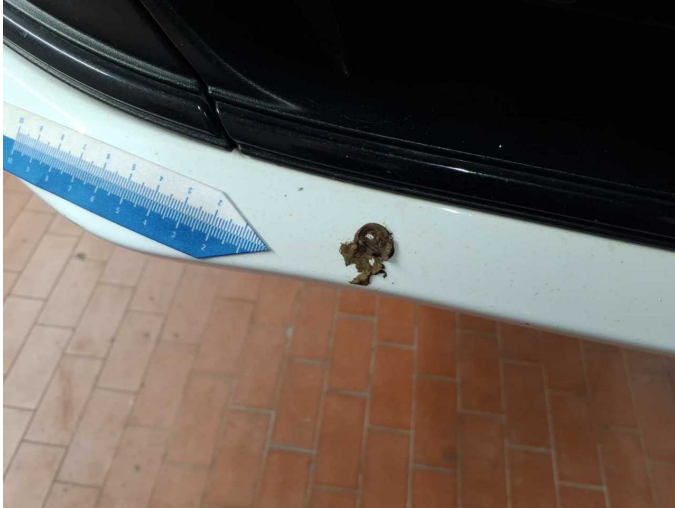
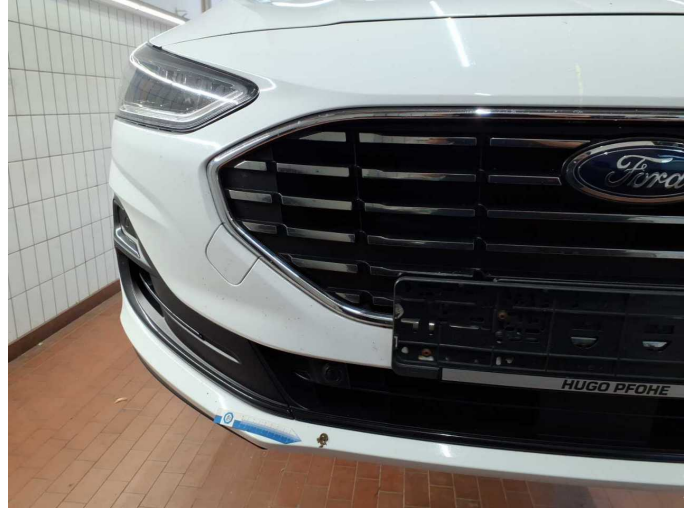
| No. | Component group | Description |
|---|---|---|
| 2 | Front bumper | Front bumper - Soiled - Conditioning |

Damage 2: Front bumper: Front bumper - Soiled - Conditioning

**Damage 2:** Front bumper: Front bumper - Soiled - Conditioning

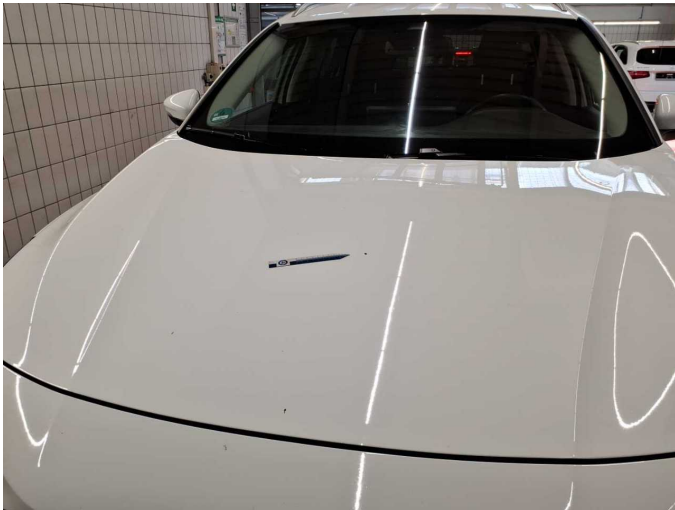
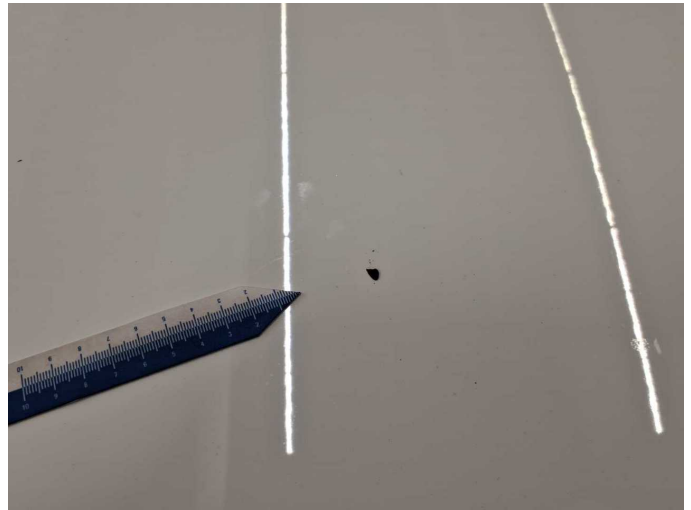
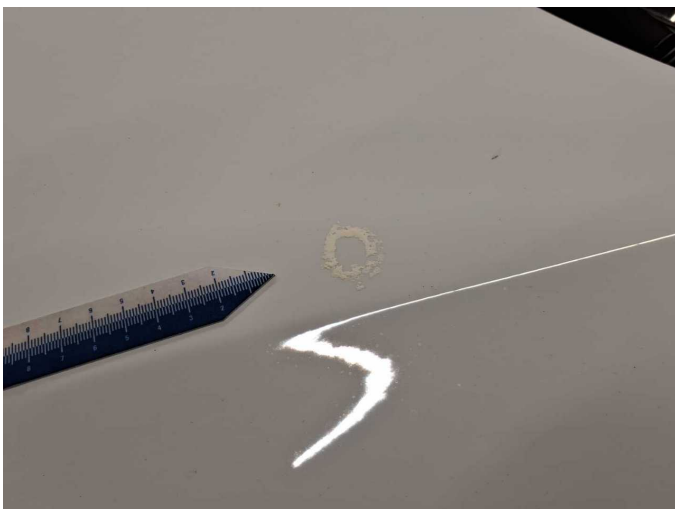
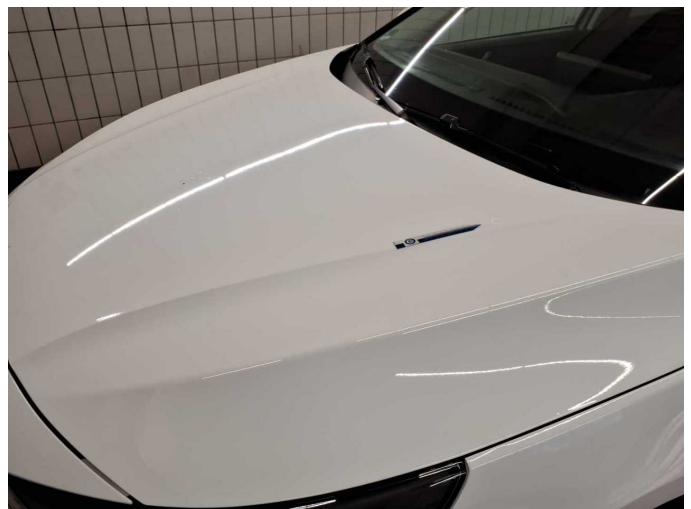
| No. | Component group | Description |
|---|---|---|
| 3 | Bonnet | Bonnet - Soiled - Conditioning |

**Damage 3:** Bonnet: Bonnet - Soiled - Conditioning

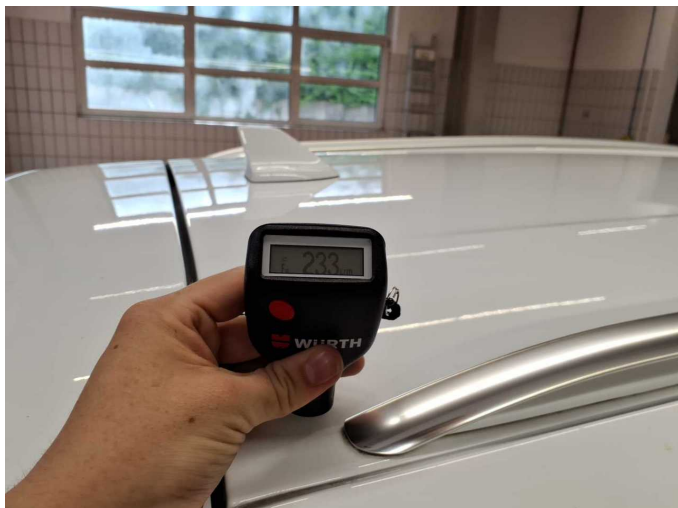
| No. | Previous damage | Extent of damage (Net) |
|---|---|---|
| 1 | Roof, Rear, Provided by user / customer, from 6 Aug 2025 | 3.629,17 € |

- 1 Roof, Professionally carried out, Invoice of repair done Non-existent
- 2 Boot lid / rear door, Professionally carried out, Invoice of repair done Non-existent

| Roof | 233 µm | Boot lid / rear door | 183 µm |

**Repainting 1: Roof**

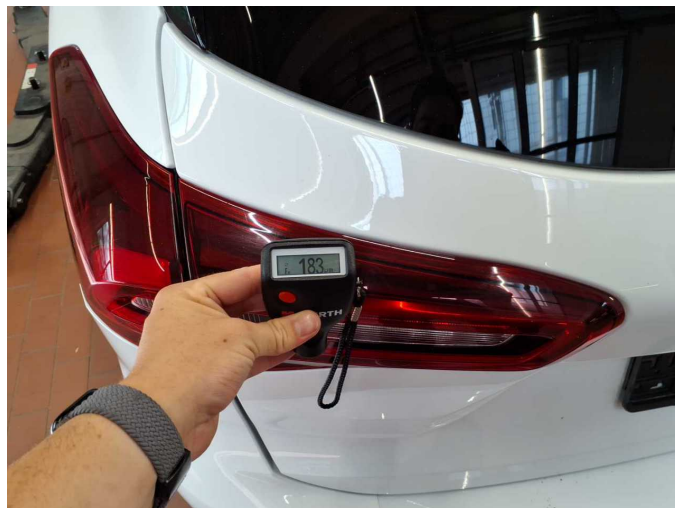
**Repainting 2: Boot lid / rear door**
