Expertise

Protocol number: 46044467  
Order No. / Reference: 26539797  
Inspection date: 18 Jun 2026

Manufacturer: Mercedes-Benz  
VIN: W1NKM0FBXPF012730

Model: GLC 220 d 4Matic 9G-TRONIC Avantgarde Advanced

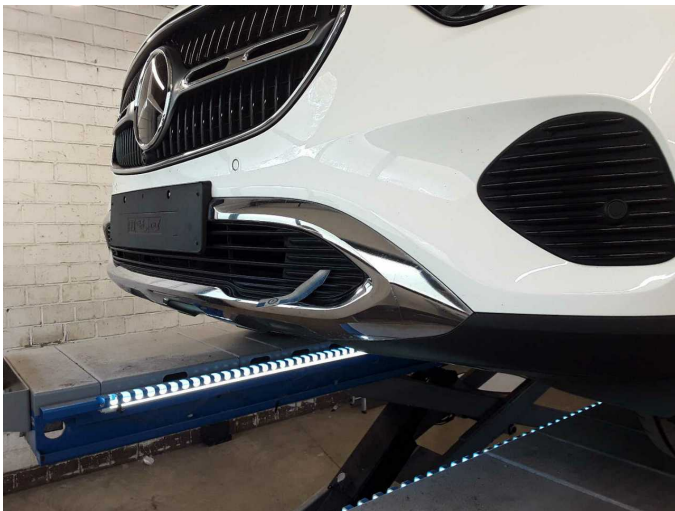
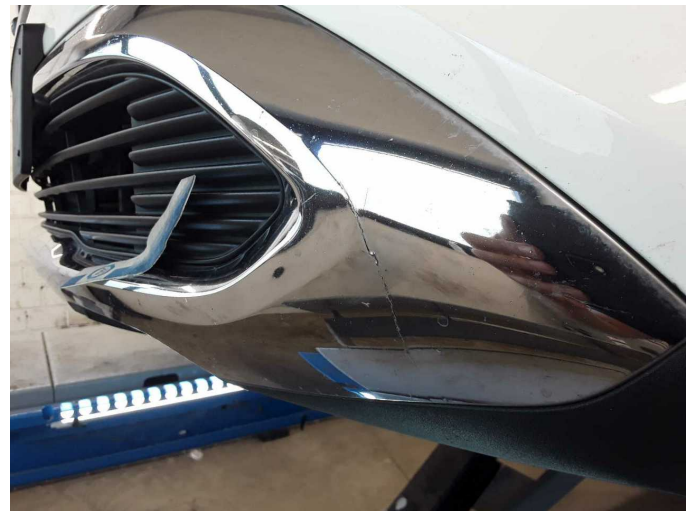
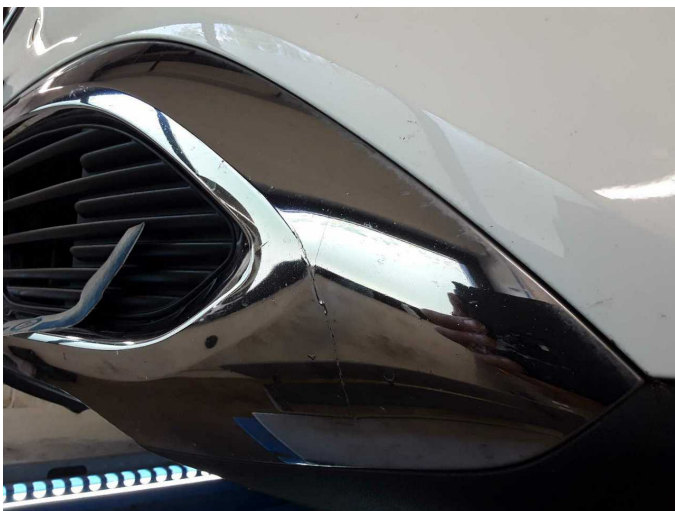
**Damage 1:** Front bumper: Spoiler - Broken / torn - Replace

| No. | Component group | Description |
|---|---|---|
| 1 | Front bumper | Spoiler - Broken / torn - Replace |

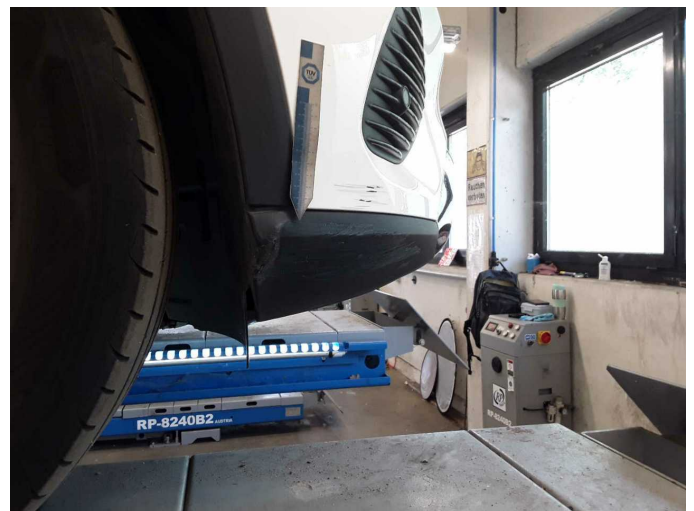
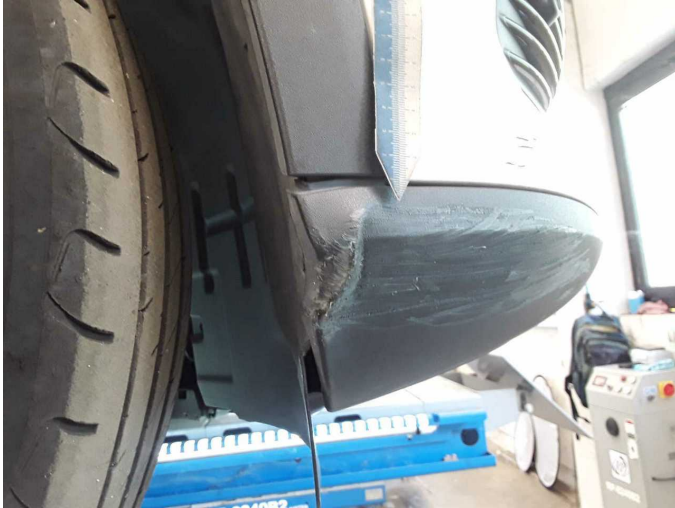
**Damage 2:** Front bumper: Protection strip - right side - Damaged - Replace

| No. | Component group | Description |
|---|---|---|
| 2 | Front bumper | Protection strip - right side - Damaged - Replace |

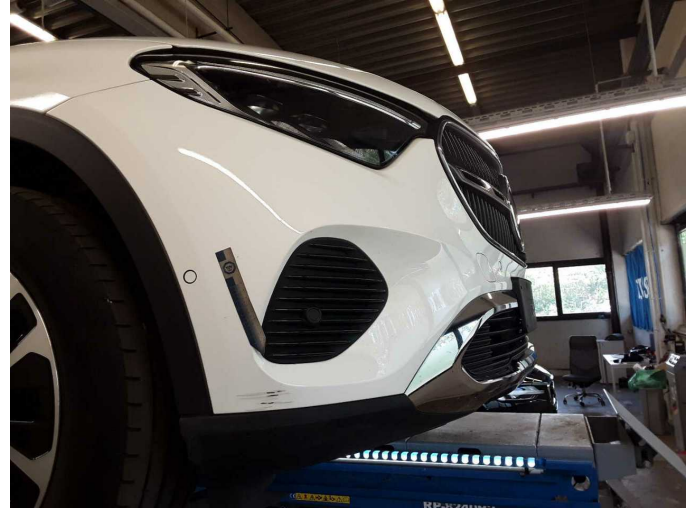
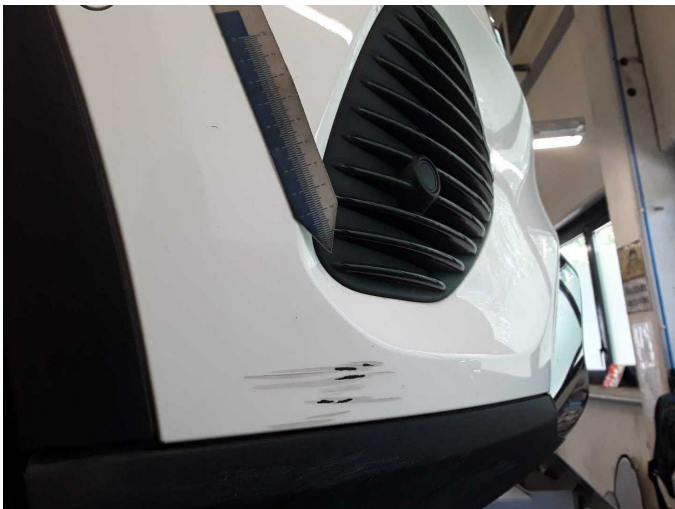
**Damage 3:** Front bumper: Front bumper - Scratched - Paint

| No. | Component group | Description |
|---|---|---|
| 3 | Front bumper | Front bumper - Scratched - Paint |

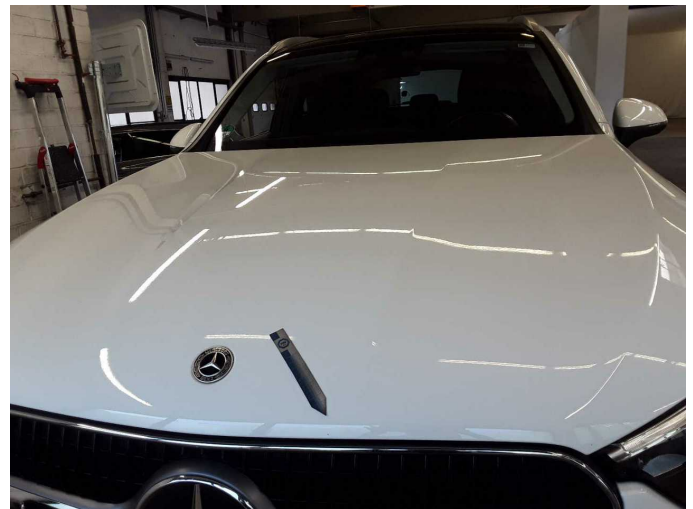
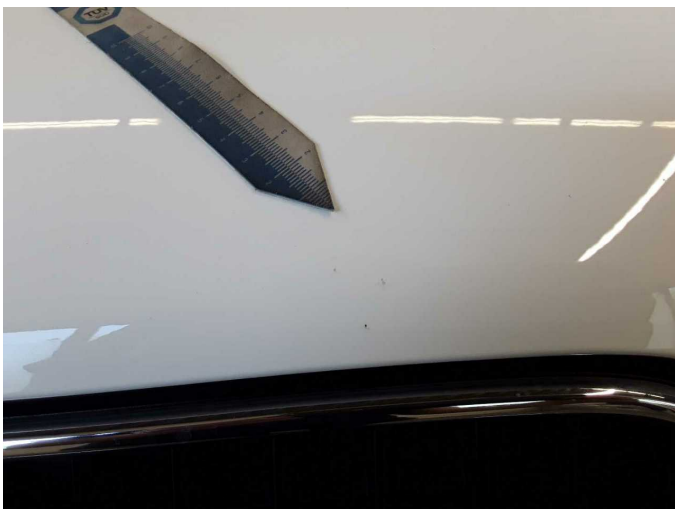
**Wear and tear 1:** Bonnet: Bonnet - Stone chips - No deduction

| No. | Component group | Description |
|---|---|---|
| 1 | Bonnet | Bonnet - Stone chips - No deduction |

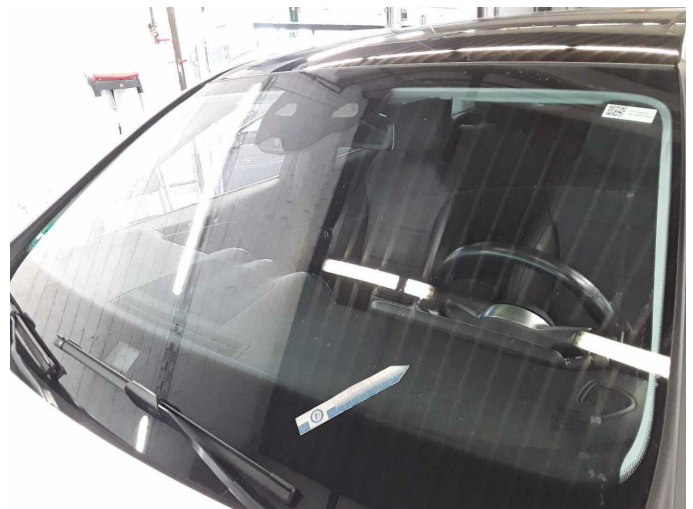
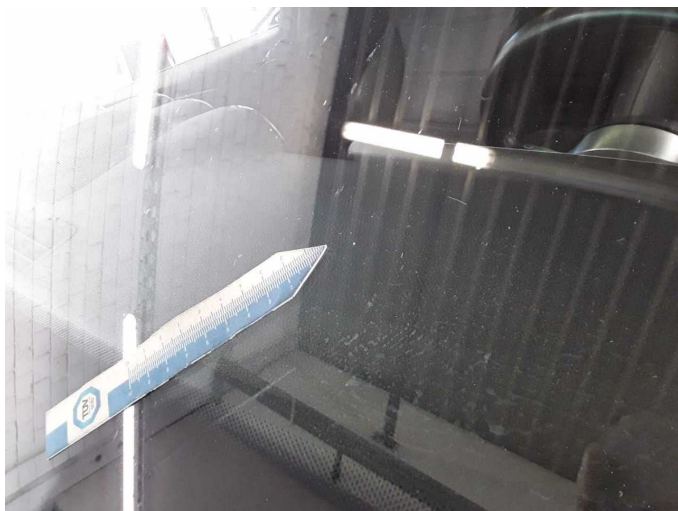
**Wear and tear 2:** Vehicle glazing: Windscreen - Stone chips - No deduction

| No. | Component group | Description |
|---|---|---|
| 2 | Vehicle glazing | Windscreen - Stone chips - No deduction |
