Expertise

Protocol number: 46365890  
Order No. / Reference: 26617106  
Inspection date: 3 Jul 2026

Manufacturer: Mercedes-Benz  
VIN: W1KAF0DB0PR119886

Model: C 200 d 9G-TRONIC

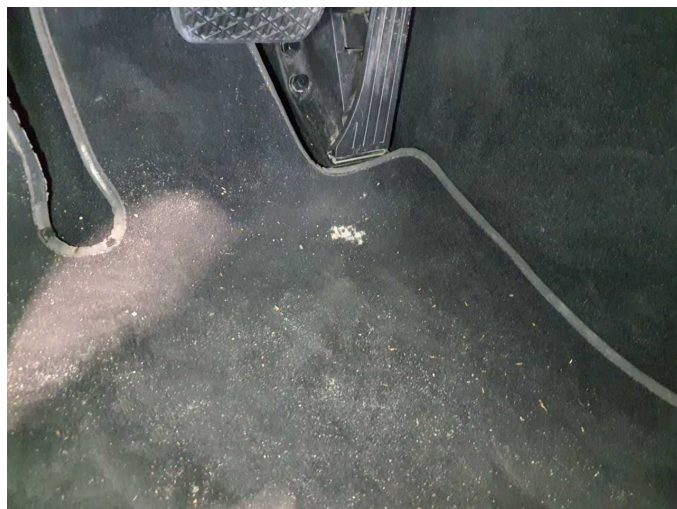
| No. | Component group | Description |
|---|---|---|
| 2 | Trim / covers | Floor mats - Broken / torn - Replace |

**Damage 2:** Trim / covers: Floor mats - Broken / torn - Replace

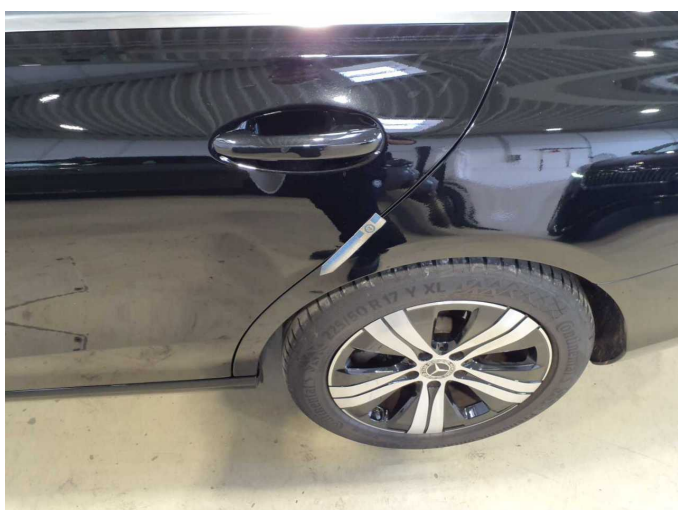
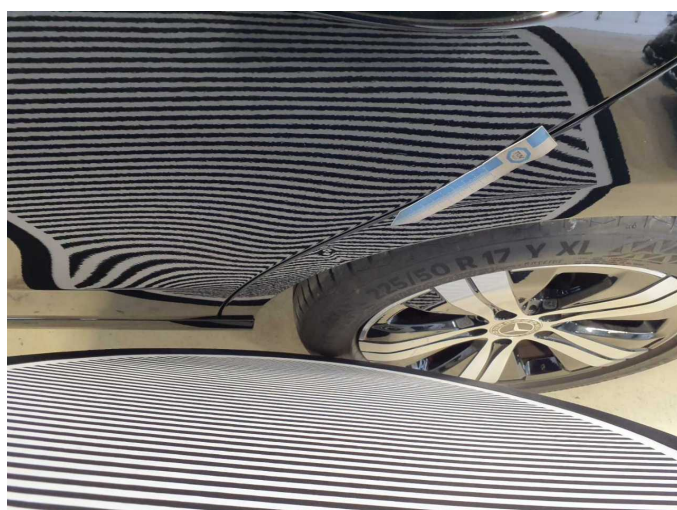
| No. | Component group | Description |
|---|---|---|
| 3 | Side panel - rear left side | Side panel - dent(s) - Smooth repair work |

**Damage 3:** Side panel - rear left side: Side panel - dent(s) - Smooth repair work

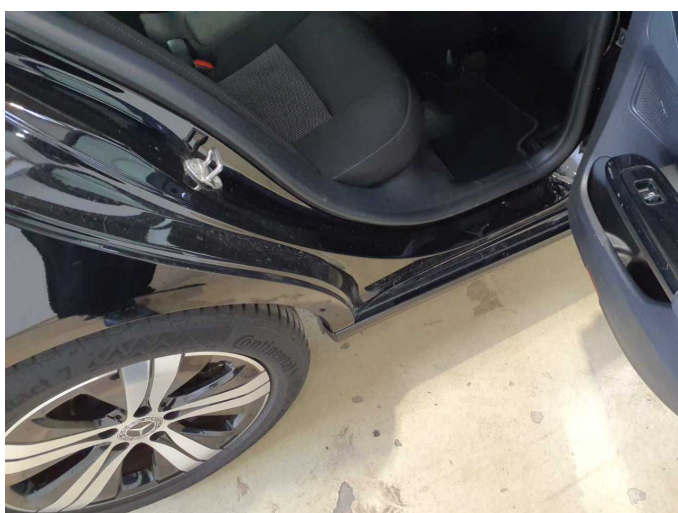
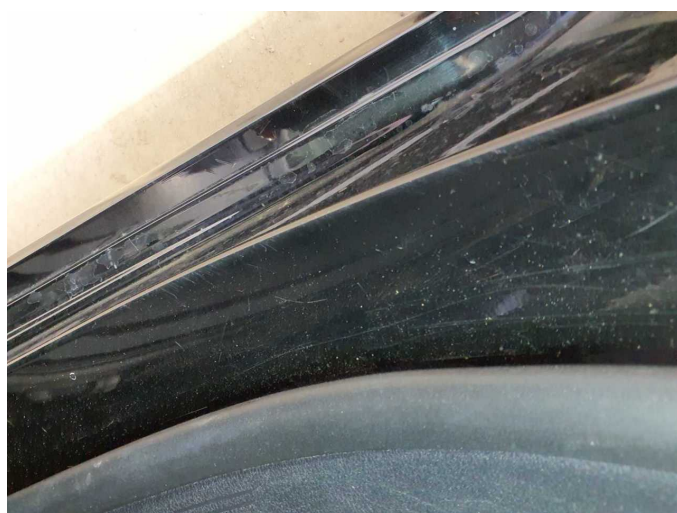
| No. | Component group | Description |
|---|---|---|
| 4 | Side panel - rear right side | Sill - Scratch(es) - Smart repair |

**Damage 4:** Side panel - rear right side: Sill - Scratch(es) - Smart repair

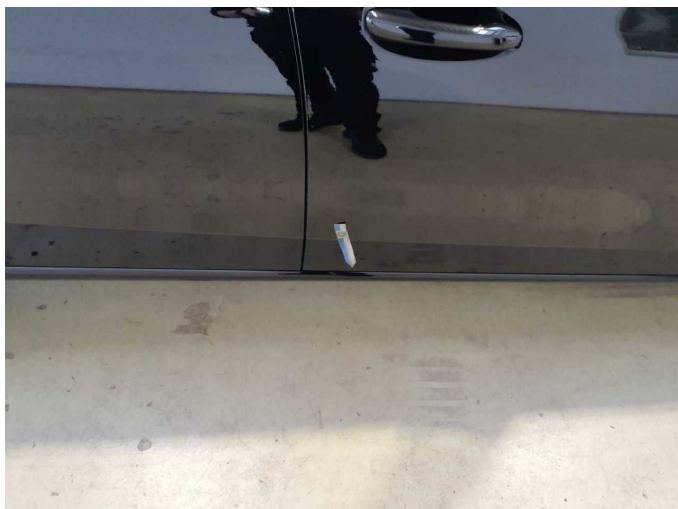
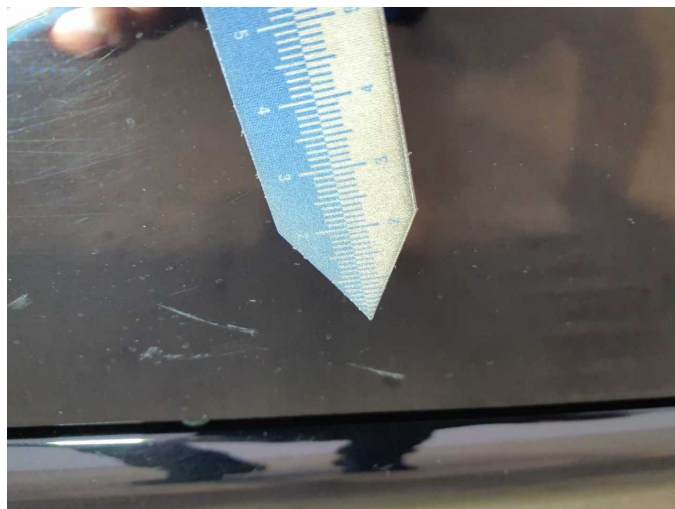
| No. | Component group | Description |
|---|---|---|
| 5 | Door - front right side | Door - Scratch(es) - Smart repair |

**Damage 5:** Door - front right side: Door - Scratch(es) - Smart repair

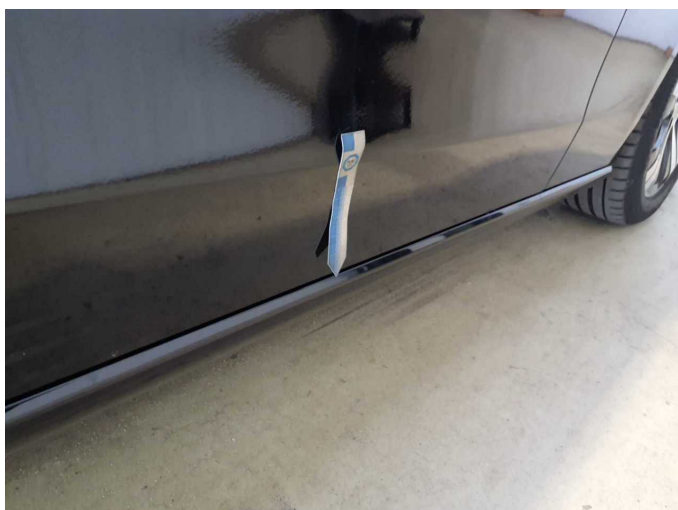
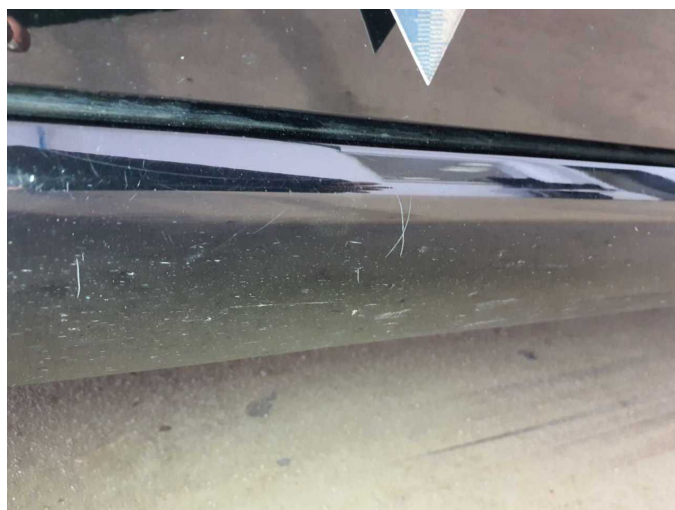
| No. | Component group | Description |
|---|---|---|
| 6 | Sill - right side | Trim - Scratch(es) - Smart repair |

**Damage 6:** Sill - right side: Trim - Scratch(es) - Smart repair

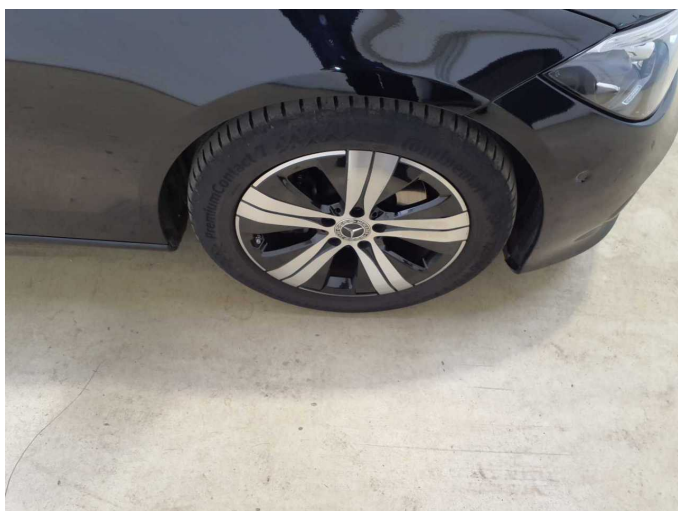
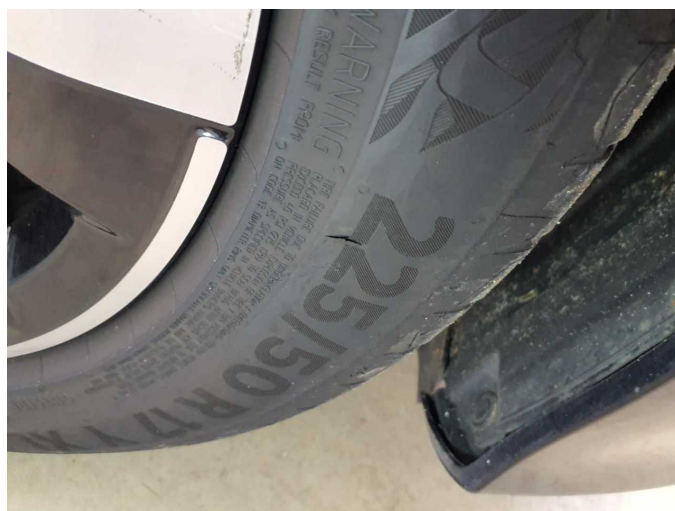
| No. | Component group | Description |
|---|---|---|
| 7 | Wheel / tyres | Tyre - front right side (nicht fahrbereit) - Broken / torn - Replace |

**Damage 7:** Wheel / tyres: Tyre - front right side (nicht fahrbereit) - Broken / torn - Replace

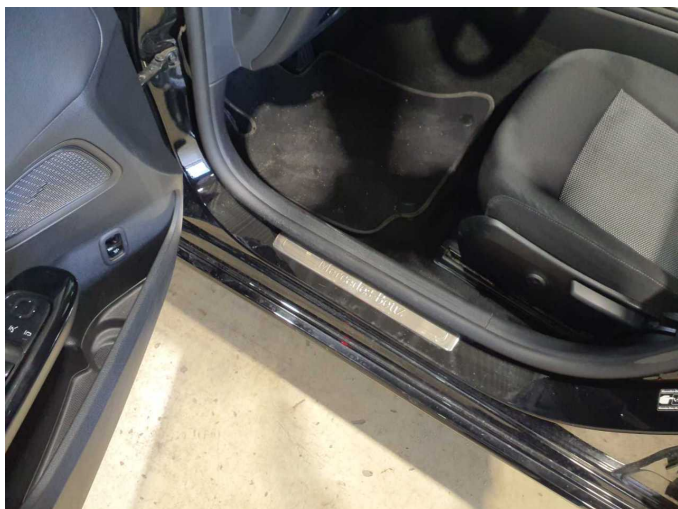
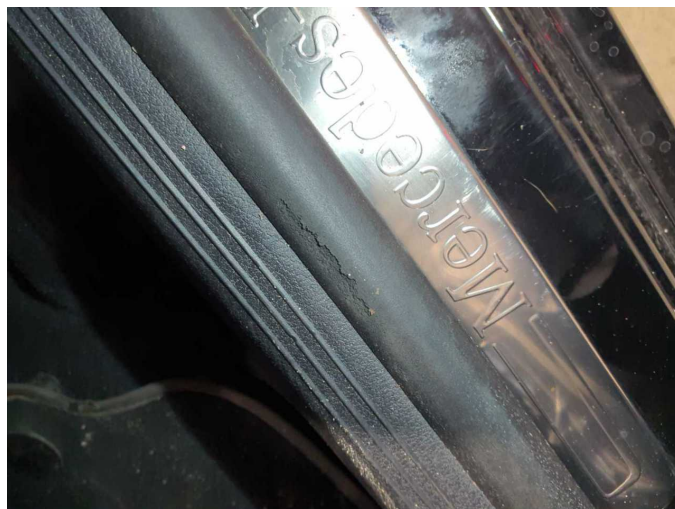
| No. | Component group | Description |
|---|---|---|
| 8 | Door - front left side | Door seal - Broken / torn - Replace |

**Damage 8:** Door - front left side: Door seal - Broken / torn - Replace

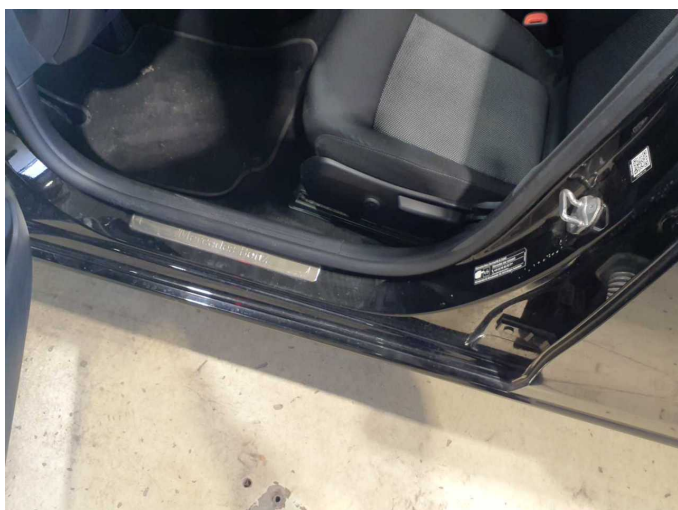
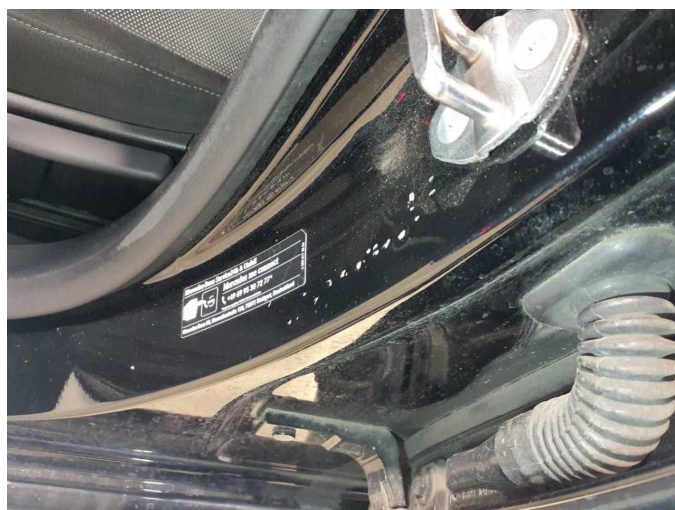
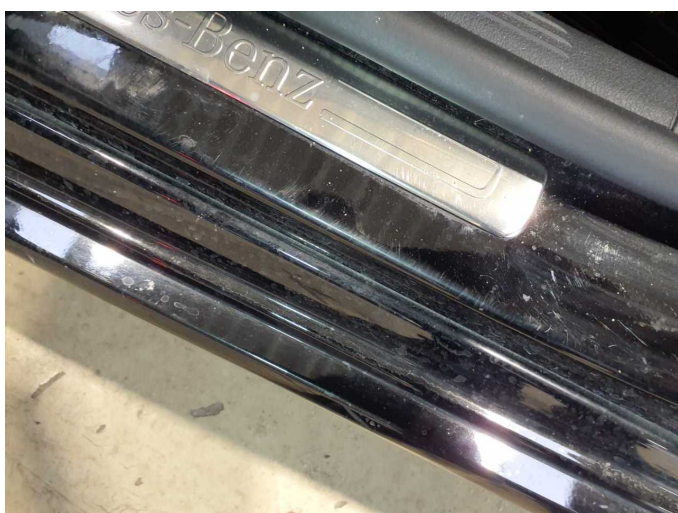
| No. | Component group | Description |
|---|---|---|
| 9 | Sill - left side | Sill - Dent / paintcoat damage - Smart repair |

**Damage 9:** Sill - left side: Sill - Dent / paintcoat damage - Smart repair

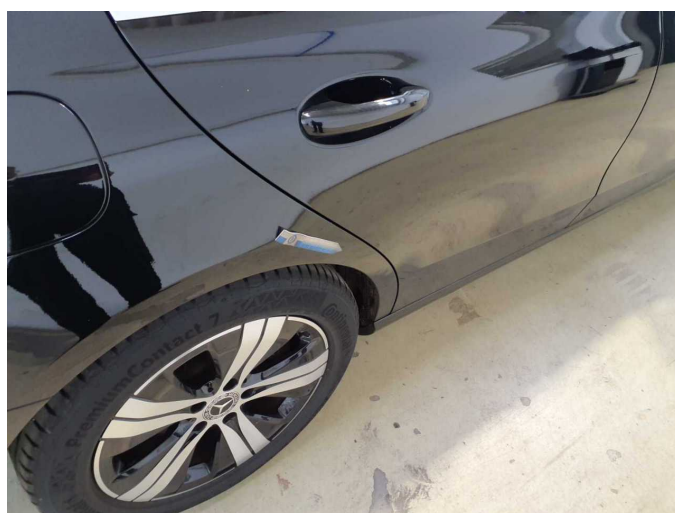
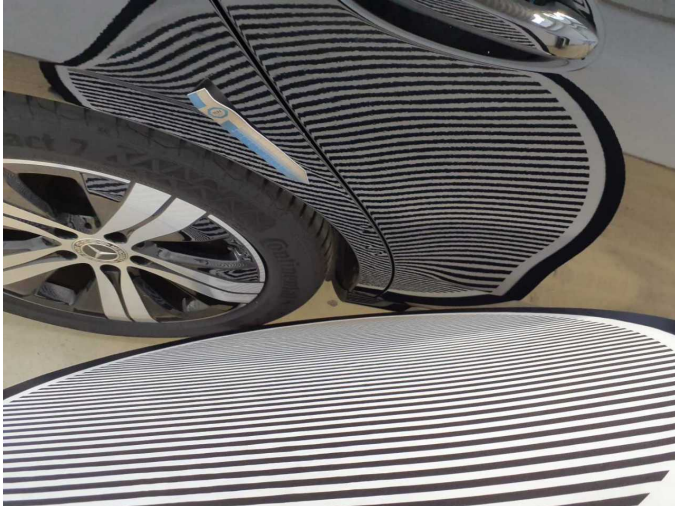
| No. | Component group | Description |
|---|---|---|
| 10 | Side panel - rear right side | Side panel - Dent / paintcoat damage - Smart repair |

**Damage 10:** Side panel - rear right side: Side panel - Dent / paintcoat damage - Smart repair

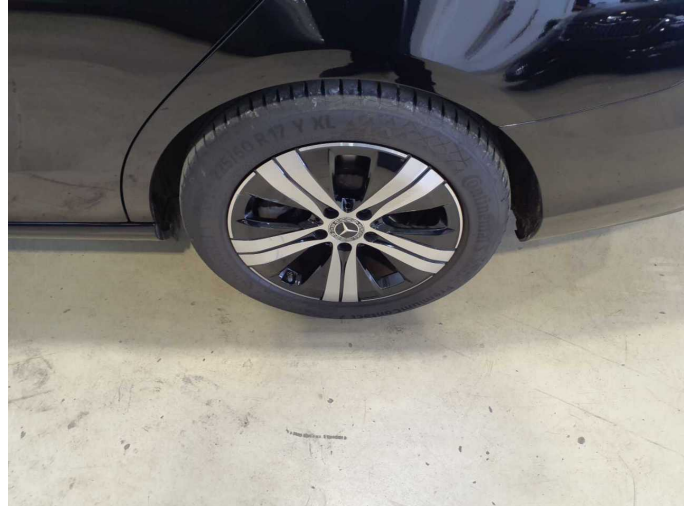
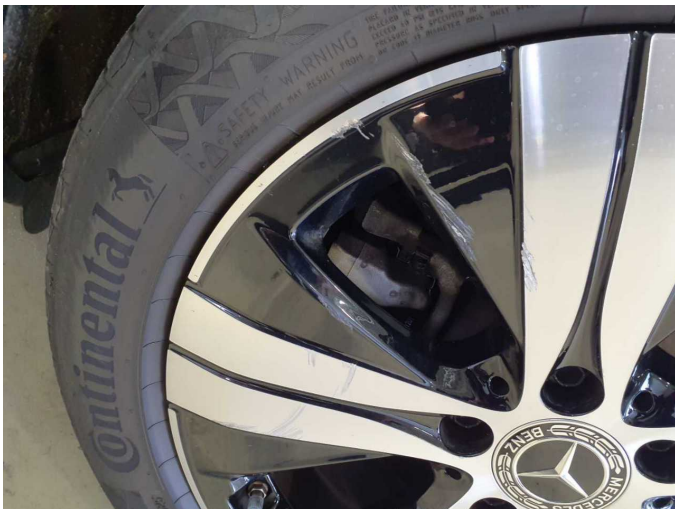
| No. | Component group | Description |
|---|---|---|
| 11 | Wheel / tyres | Alloy rim - rear left side - Scratch(es) - Loss in value |

**Damage 11:** Wheel / tyres: Alloy rim - rear left side - Scratch(es) - Loss in value

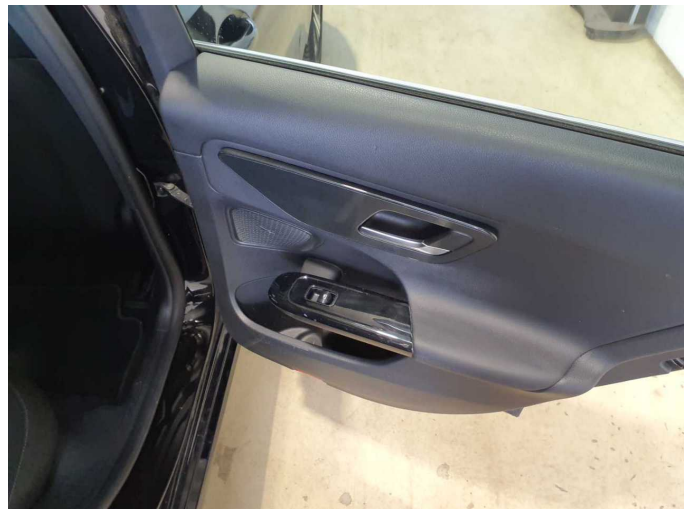
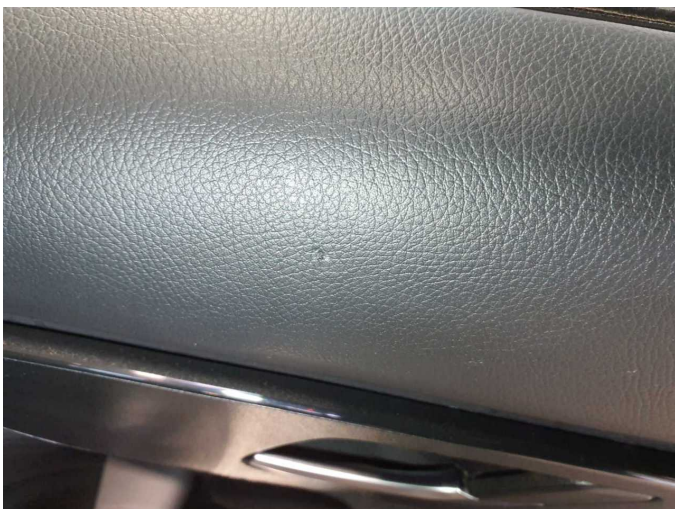
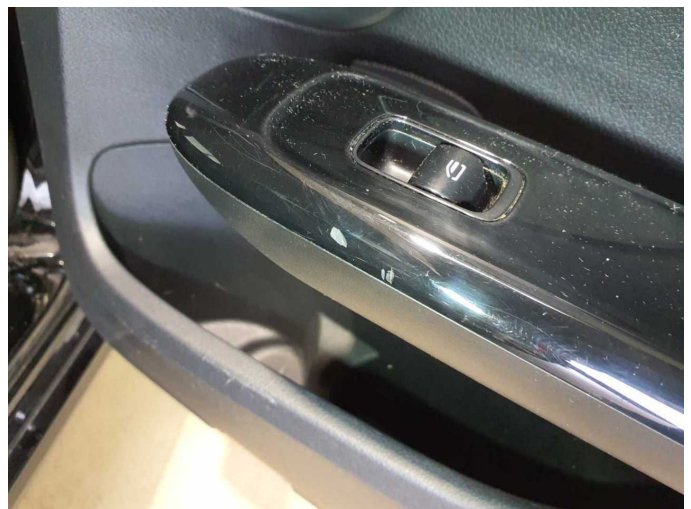
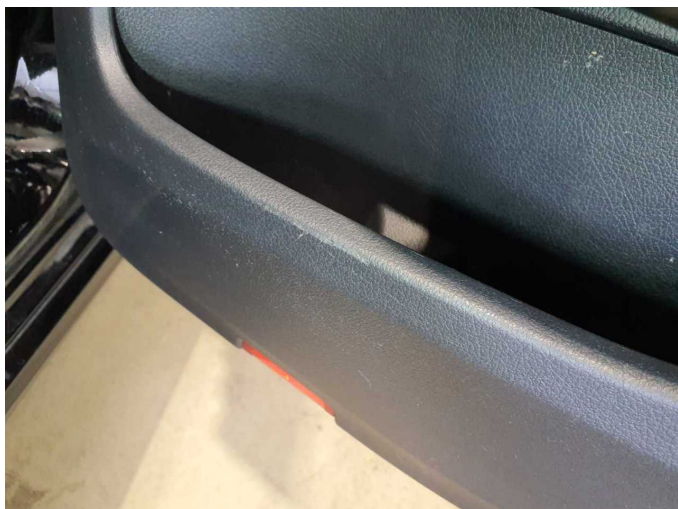
| No. | Component group | Description |
|---|---|---|
| 12 | Trim / covers | Door trim - rear right side - Scratch(es) - Replace |

**Damage 12:** Trim / covers: Door trim - rear right side - Scratch(es) - Replace

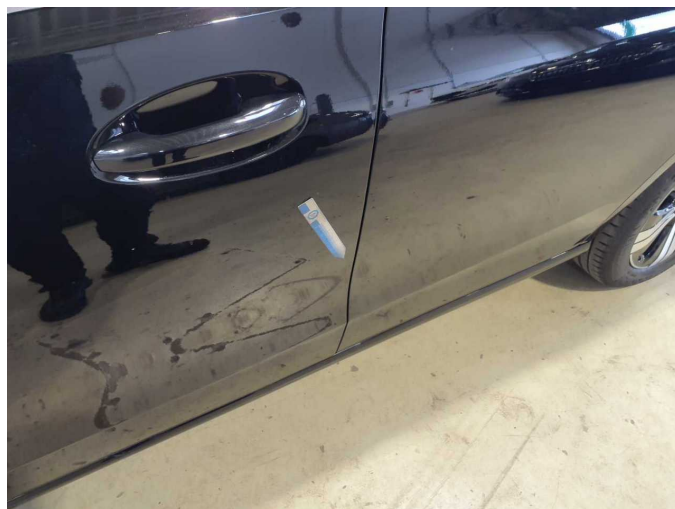
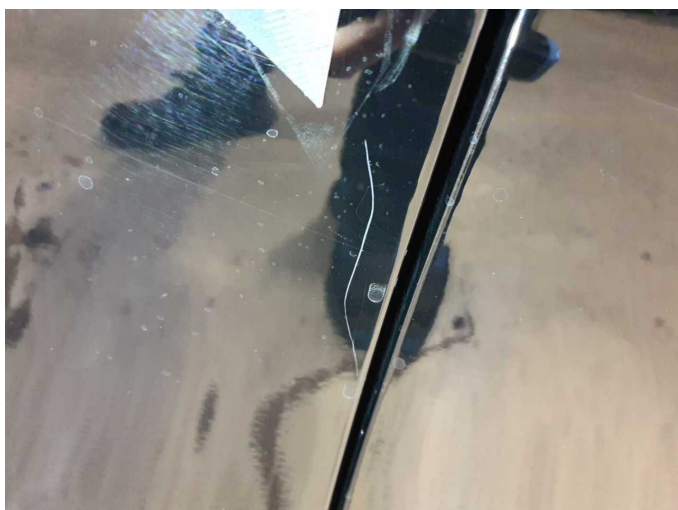
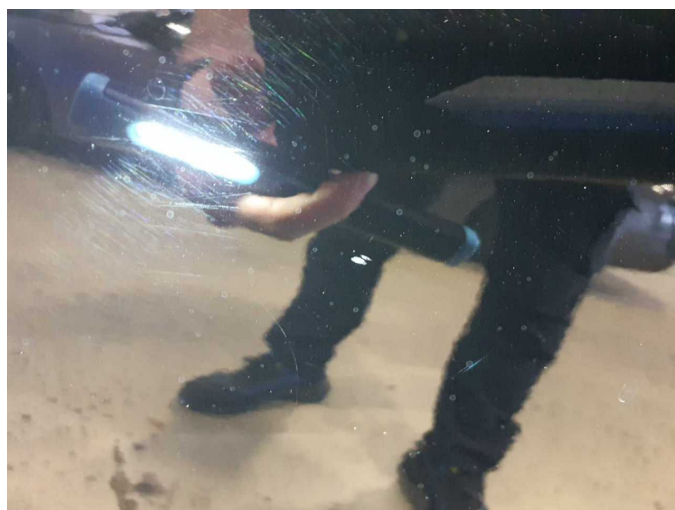
| No. | Component group | Description |
|---|---|---|
| 13 | Door - front left side | Door - Scratch(es) - Paint |

**Damage 13:** Door - front left side: Door - Scratch(es) - Paint

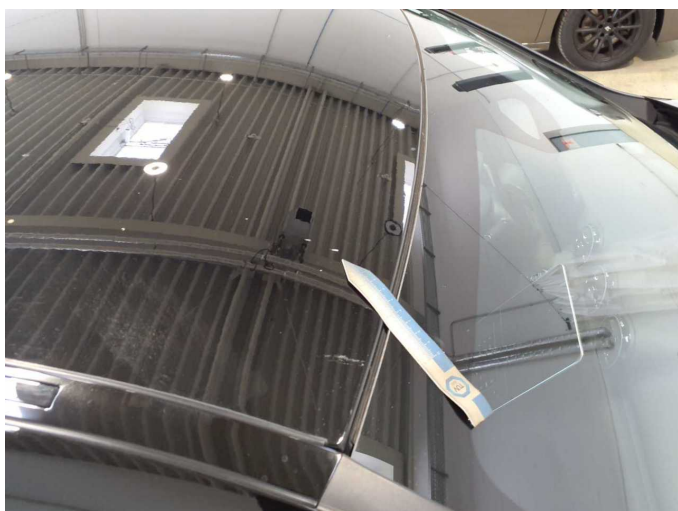
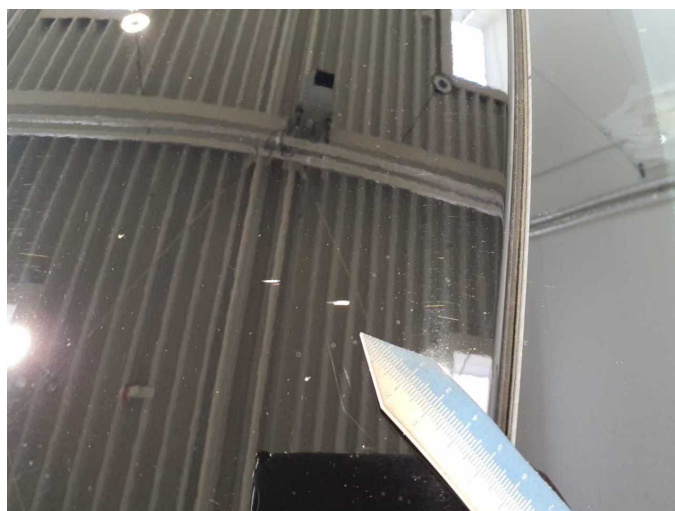
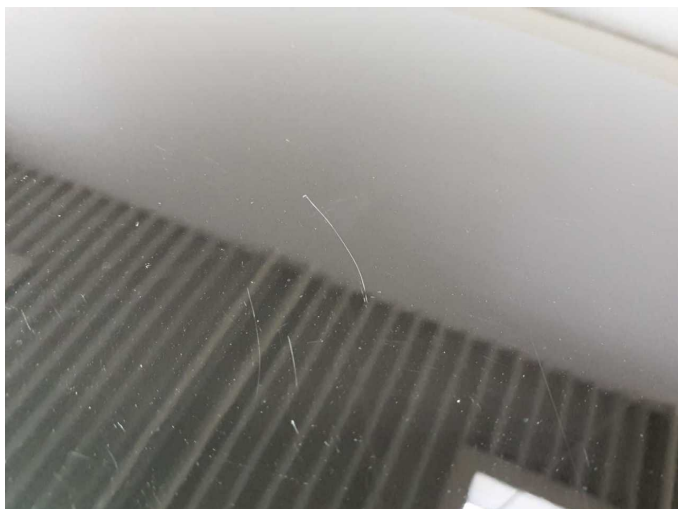
| No. | Component group | Description |
|---|---|---|
| 14 | Roof | Roof - Scratch(es) - Paint |

**Damage 14:** Roof: Roof - Scratch(es) - Paint

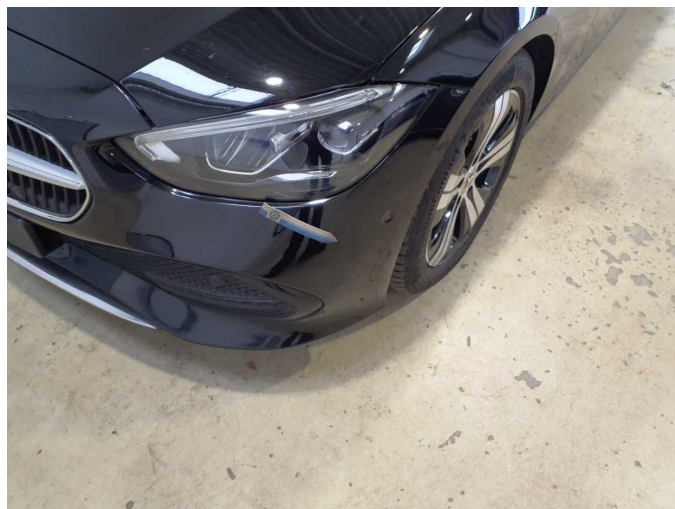
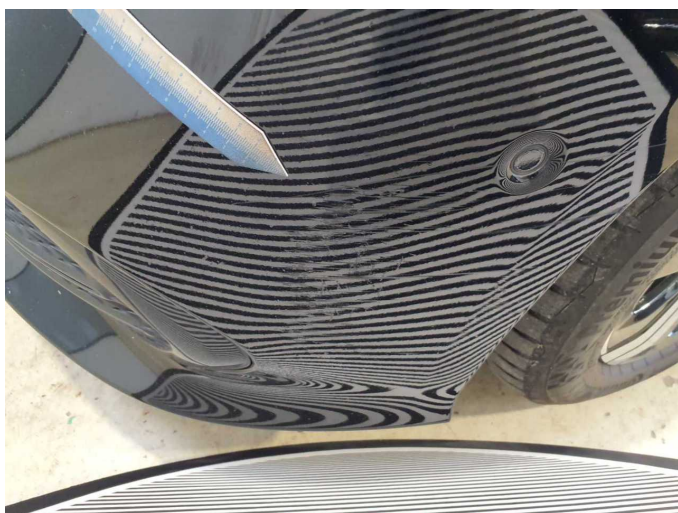
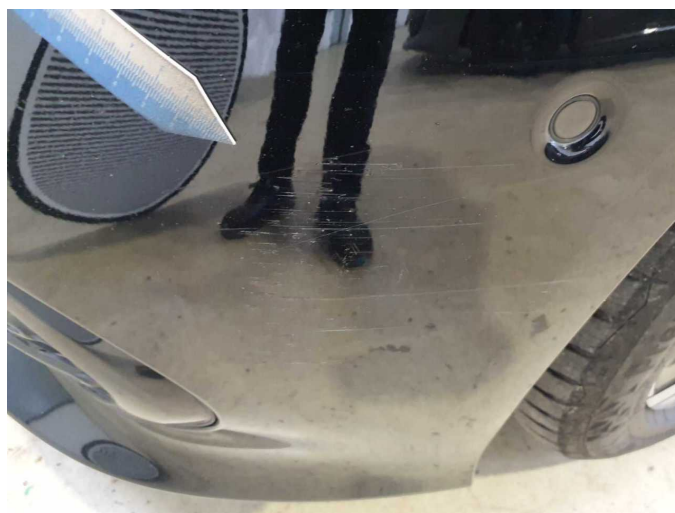
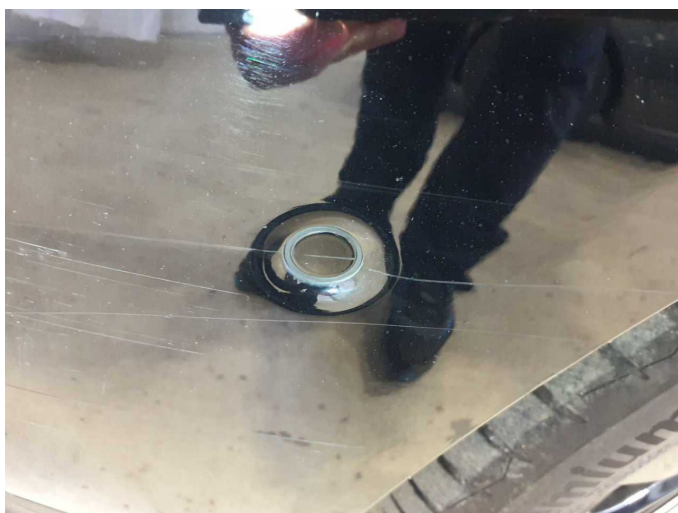
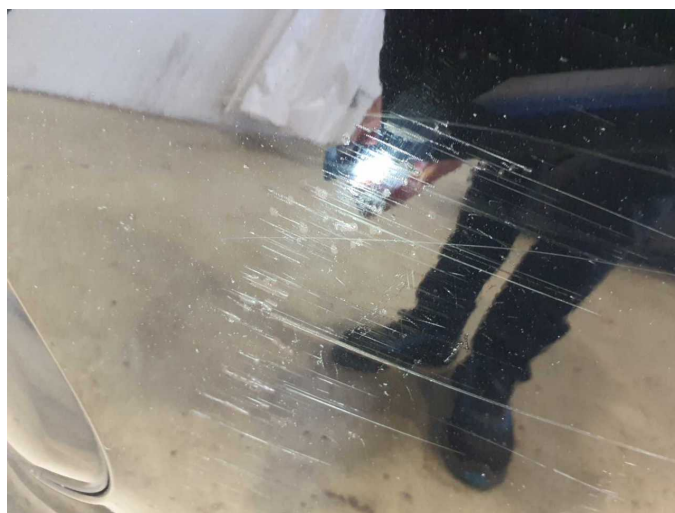
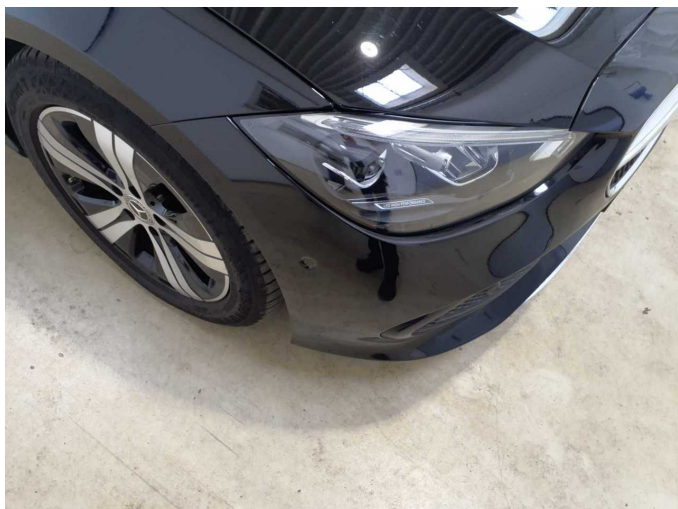
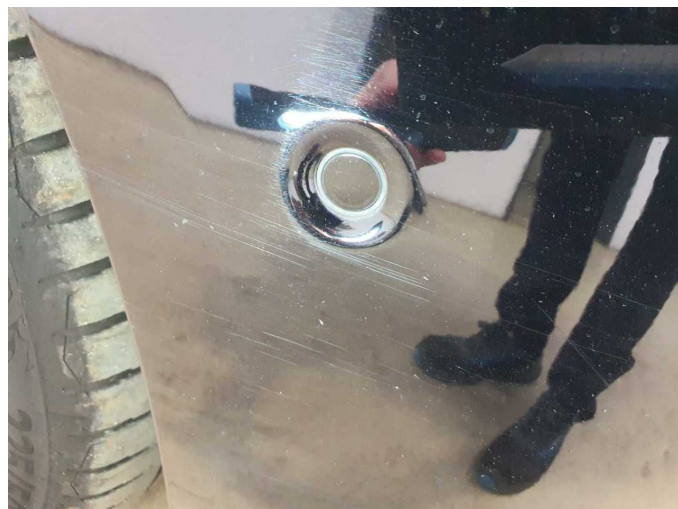
| No. | Component group | Description |
|---|---|---|
| 15 | Front bumper | Front bumper (Inklusive anbauteile) - Scratched - Paint |

**Damage 15:** Front bumper: Front bumper (Inklusive anbauteile) - Scratched - Paint

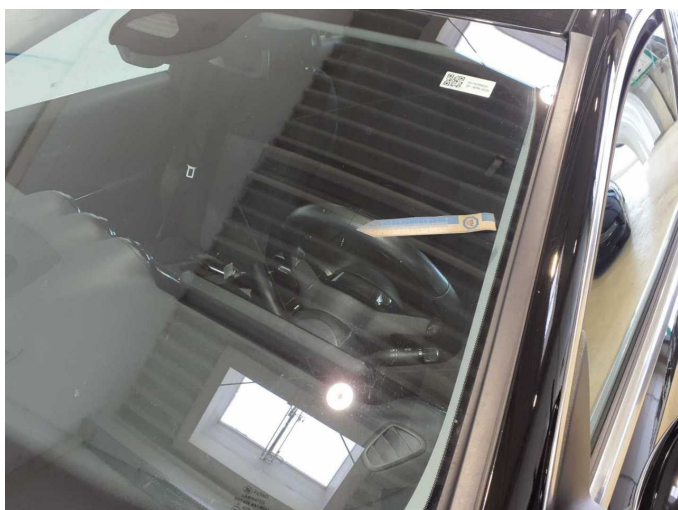
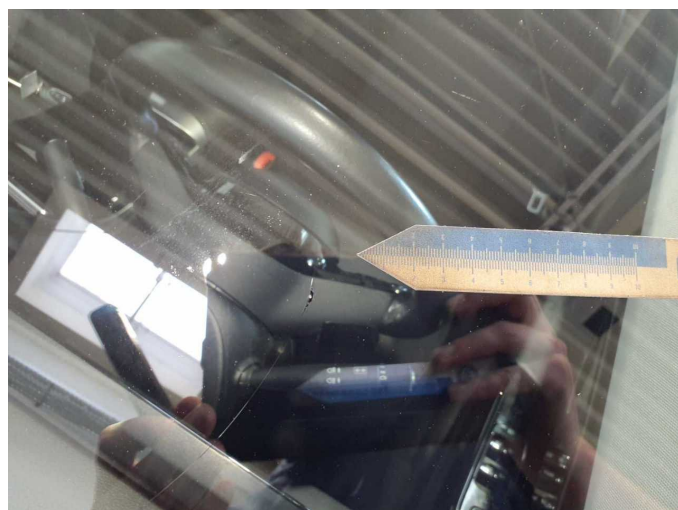
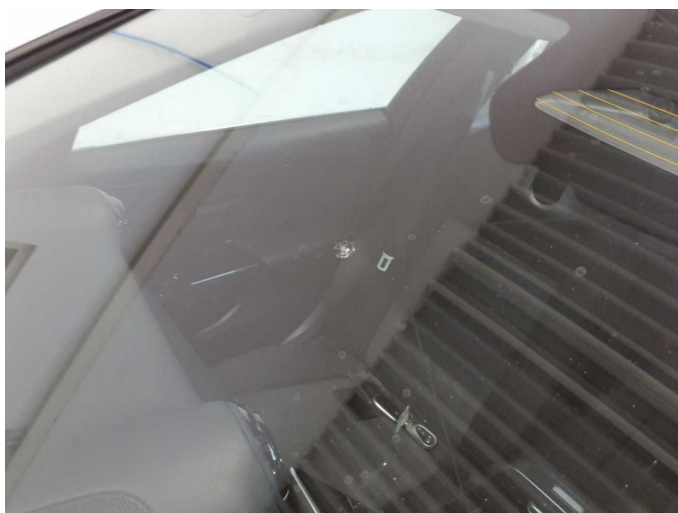
| No. | Component group | Description |
|---|---|---|
| 16 | Vehicle glazing | Windscreen - Broken / torn - repair according to calculation |

**Damage 16:** Vehicle glazing: Windscreen - Broken / torn - repair according to calculation
