## Expertise

Protocol number: 45837960  
Order No. / Reference: 26394431  
Inspection date: 3 Jun 2026

Manufacturer: Opel

Model: Astra Sports Tourer 1.5 D Automatik Elegance

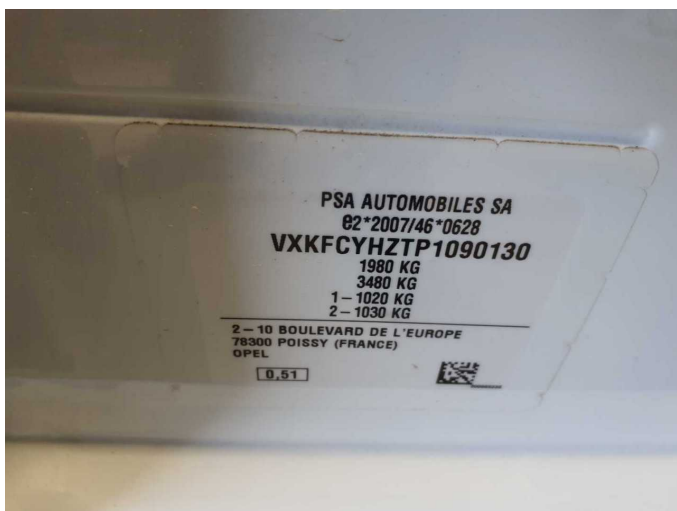
Figure 11: VIN

Documents submitted	At the time of the inspection, the vehicle registration certificate Part 2 (title) was available, but the vehicle registration certificate Part 1 (document) was not. (Copy)
VIN comparison	The vehicle identification number (VIN) was read from the vehicle and its conformity with the submitted documents was confirmed by the undersigned during the inspection.
Inspection	The inspection conditions were sufficient for the assessment of the vehicle. No lifting equipment or pit was available for inspecting the vehicle. Therefore, inspection of the vehicle's underside was only possible to a limited extent.
Test drive	No test drive/shunting maneuver was carried out during the inspection of the vehicle.
Engine function test	An engine test run was performed.

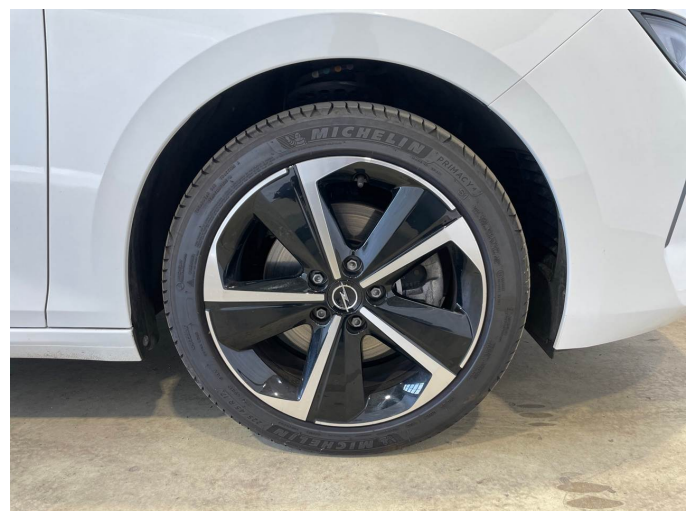
#	Tyre size	Type of tyre	Manufacturer	Tread depth
1)	225/45 R17 94V	Summer tyres on Light alloy	Michelin	5mm / 5mm
2)	225/45 R17 94V	Summer tyres on Light alloy	Michelin	6mm / 6mm

Figure 12: Mounted tyres

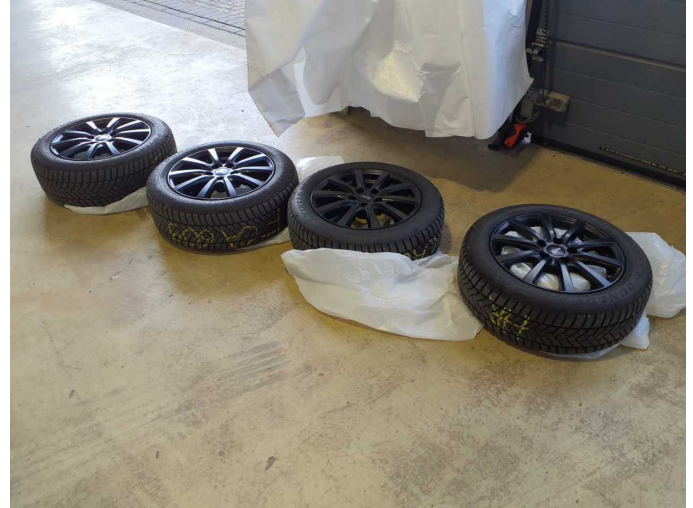
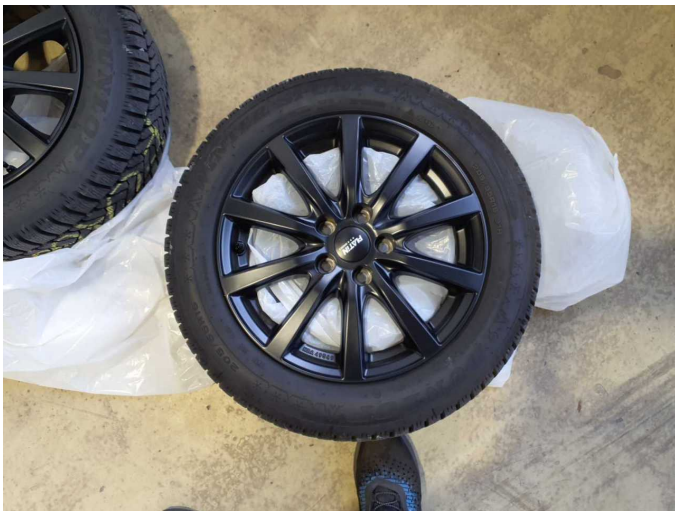
#	Tyre size	Type of tyre	Manufacturer	Tread depth
1)	205/55 R16 91H	Winter tyres on Light alloy	Dunlop	7mm / 7mm
2)	205/55 R16 91H	Winter tyres on Light alloy	Dunlop	7mm / 7mm

Der beiliegende Winterradsatz ist kein Bestandteil des Auslieferungsumfangs.

Figure 14: Additional tyres

Figure 15: Additional tyres

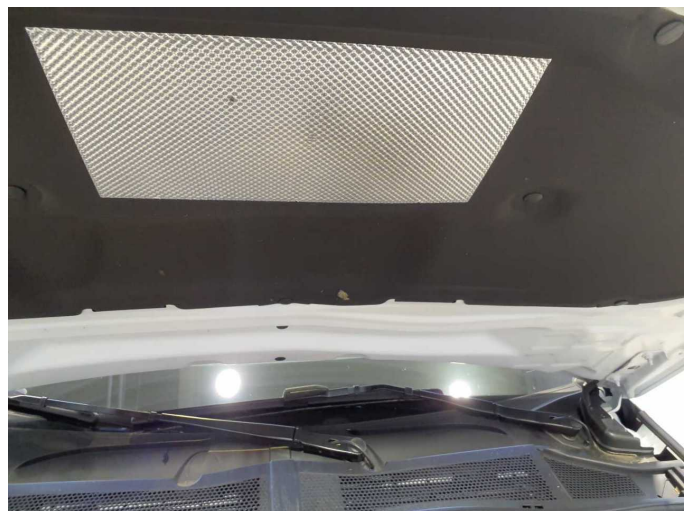
Damage 1: Bonnet: Insulation lining - Broken / torn - Replace

No.	Component group	Description
1	Bonnet	Insulation lining - Broken / torn - Replace
2	Misc.	Inspection / maintenance - Due - Perform

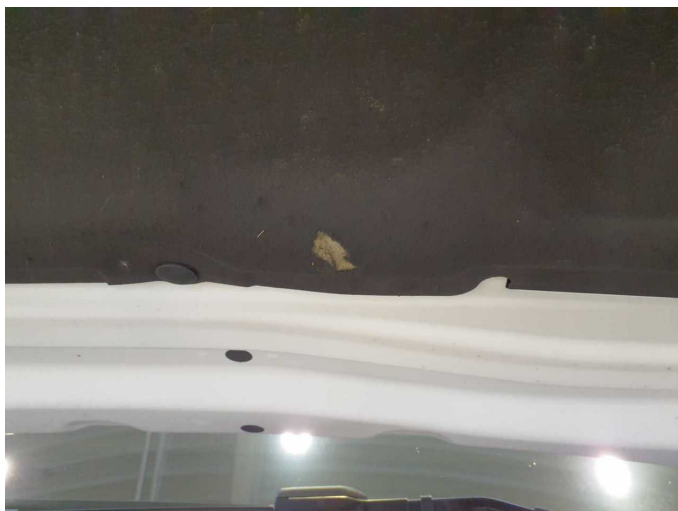
**Damage 1:** Bonnet: Insulation lining - Broken / torn - Replace

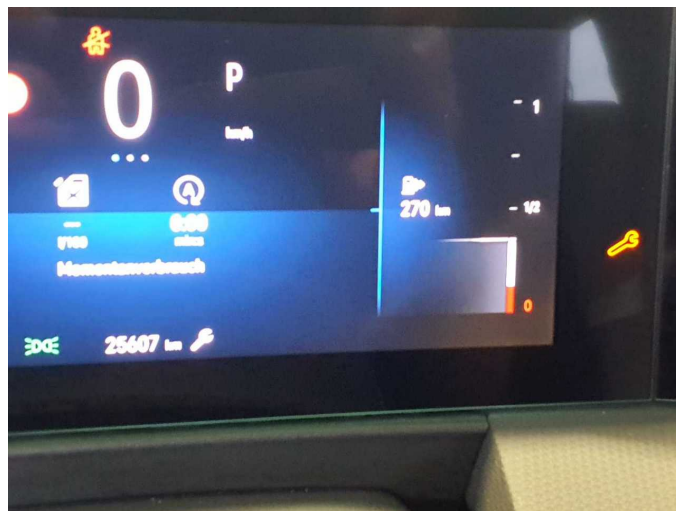
**Damage 2:** Misc.: Inspection / maintenance - Due - Perform

<b>Maintenance booklet / proof</b>	digital proof / complete	<b>Next maintenance in</b>	0 km
<b>Last service on / at</b>	12/2024 at 21,000 km		
<b>Key is / should be</b>	2 / 2	<b>FZG documents</b>	ZB#2 (B) was available (copy), ZB#1 (S) was not available.
		<b>Letter No.</b>	HB397617
<b>Previous damage / Accident</b>	None detectable	<b>Repainting</b>	None detectable
<b>Inspection conditions</b>	sufficient	<b>Lifting equipment / pit</b>	No
<b>Test drive</b>	Not performed	<b>Engine function test</b>	Performed
<b>Manufacturer key number/ type code number</b>	1889 / AEY 00087		
<b>Emission standard</b>	EURO6;WLTP;AP;PI/CI; M, N1 I	<b>fine dust sticker</b>	
<b>Permitted total weight</b>	1,980 kg	<b>Empty weight</b>
