Expertise

Protocol number: 46108966
Order No. / Reference: 26558671
Inspection date: 23 Jun 2026

Manufacturer: Renault

Model: Twingo Electric ZEN

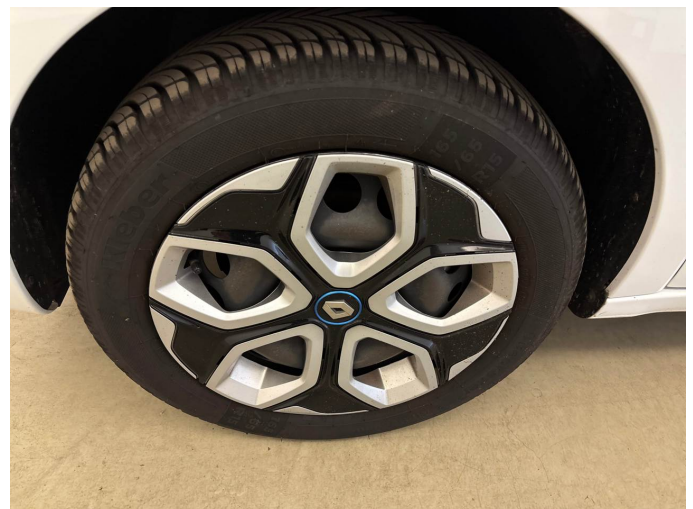
Figure 12: Mounted tyres

#	Tyre size	Type of tyre	Manufacturer	Tread depth
1)	165/65 R15 81T	All-season tyres on Steel rim with wheel cover	Kleber	5mm / 5mm
2)	185/60 R15 84T	All-season tyres on Steel rim with wheel cover	Kleber	5mm / 5mm

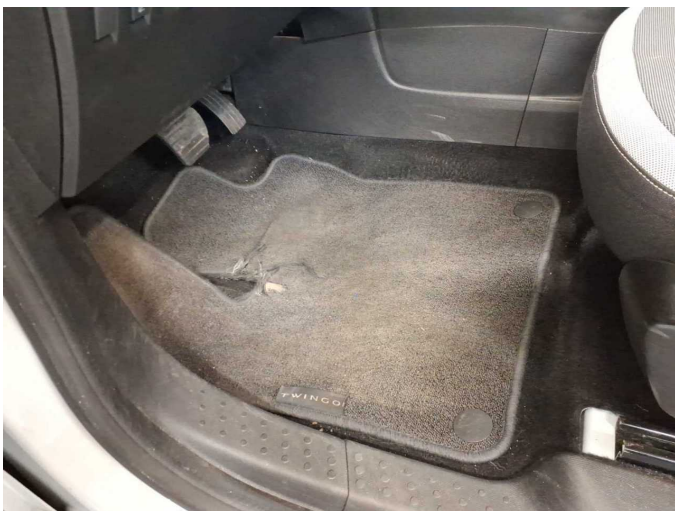
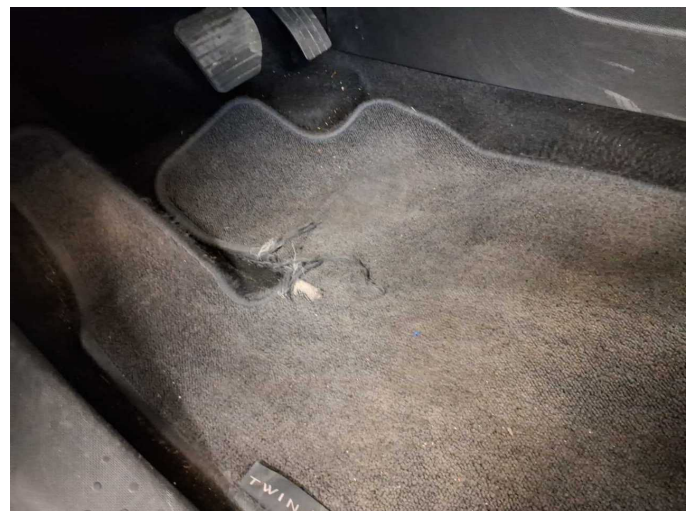
Damage 1: Trim / covers: Floor mats - Damaged - Replace

No.	Component group	Description
1	Trim / covers	Floor mats - Damaged - Replace
2	Rear bumper	Rear bumper - Scratch(es) - Smart repair
3	Body	Body - Glued / labelled - De-glue / neutralise
4	Misc.	Inspection / maintenance - Due - Perform

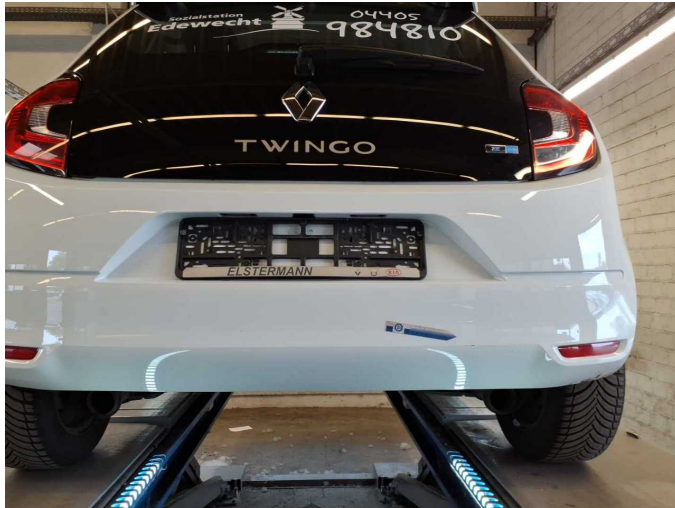
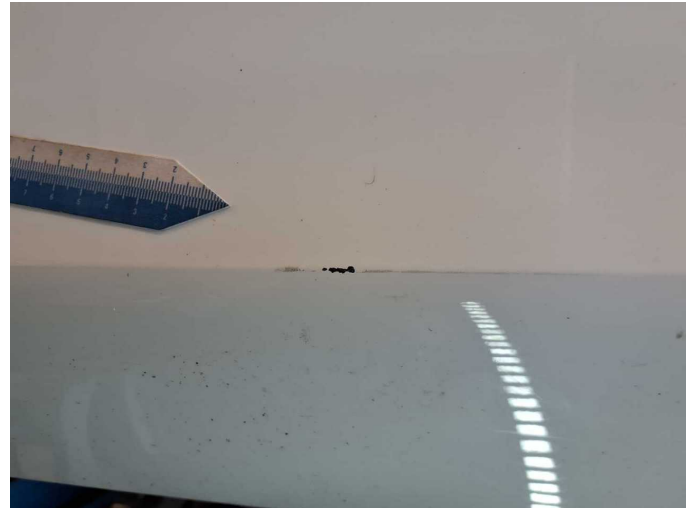
Damage 2: Rear bumper: Rear bumper - Scratch(es) - Smart repair

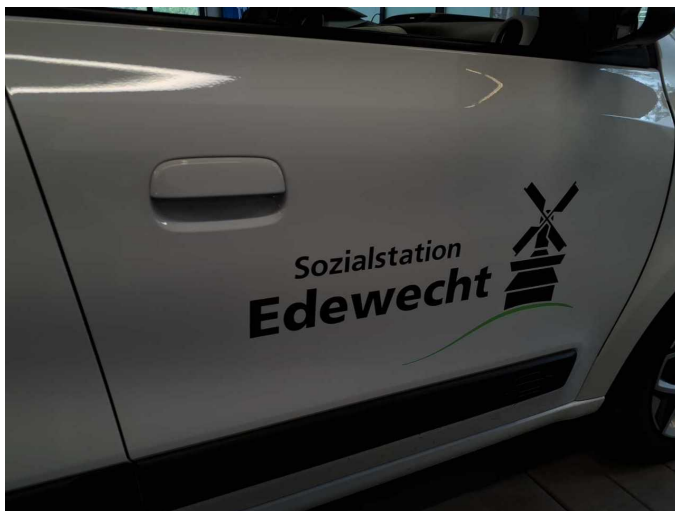
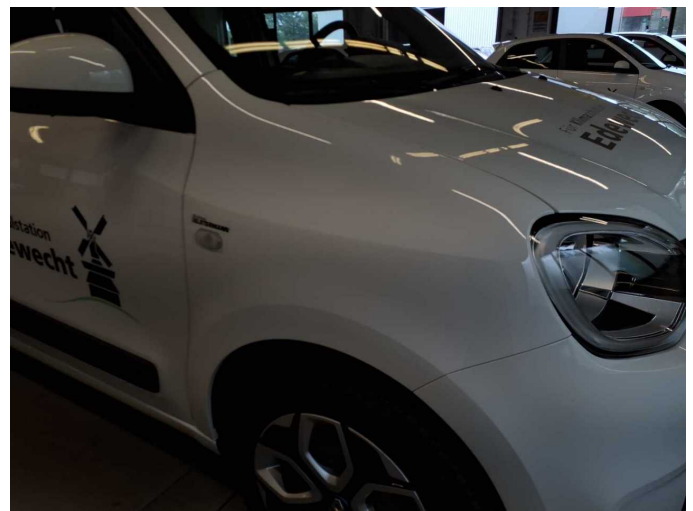
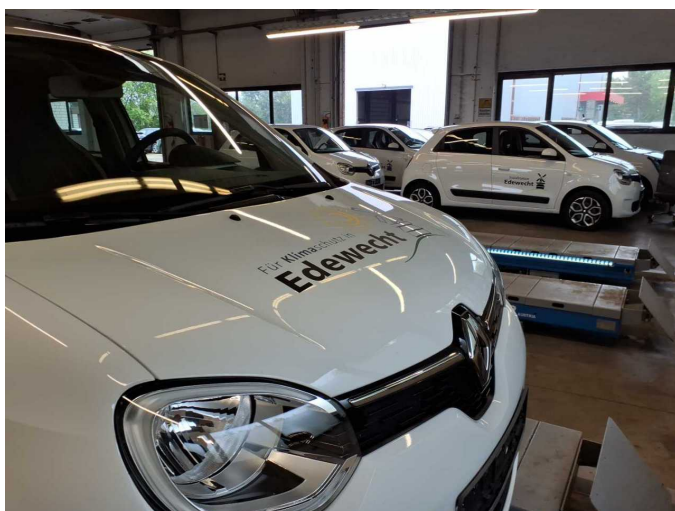
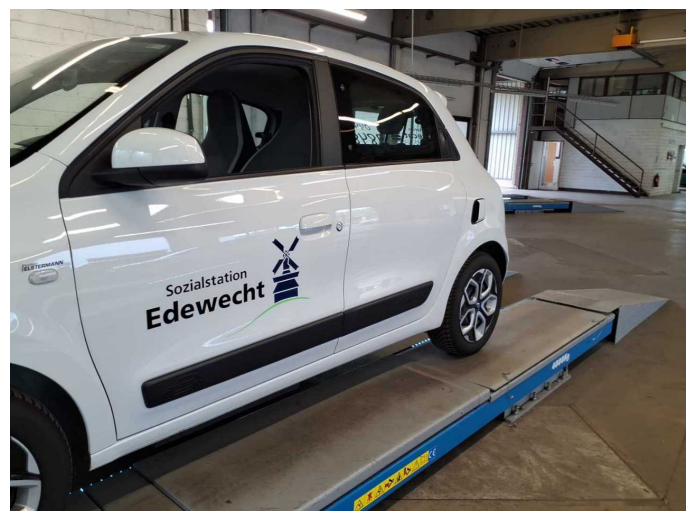
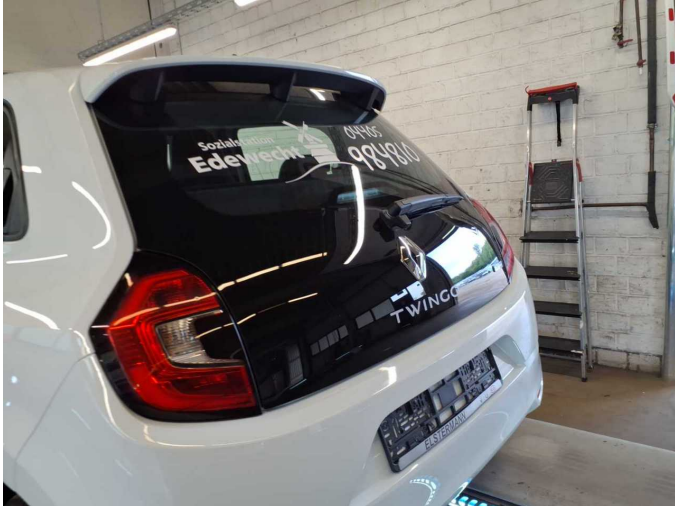
Damage 3: Body: Body - Glued / labelled - De-glug / neutralise

Damage 3: Body: Body - Glued / labelled - De-glue / neutralise

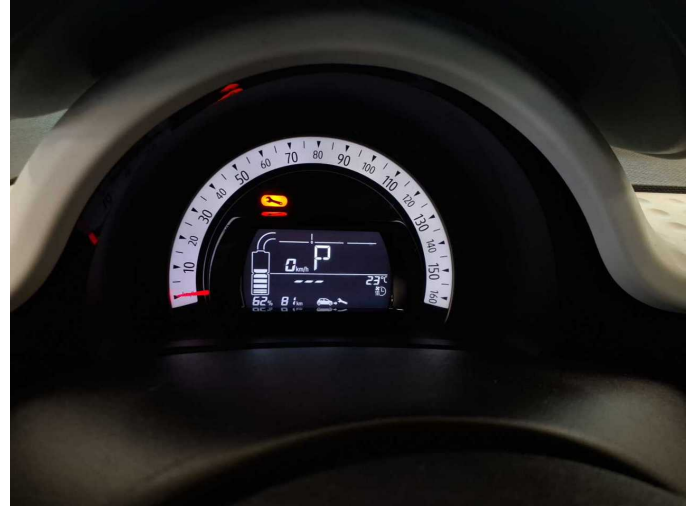
Damage 4: Misc.: Inspection / maintenance - Due - Perform

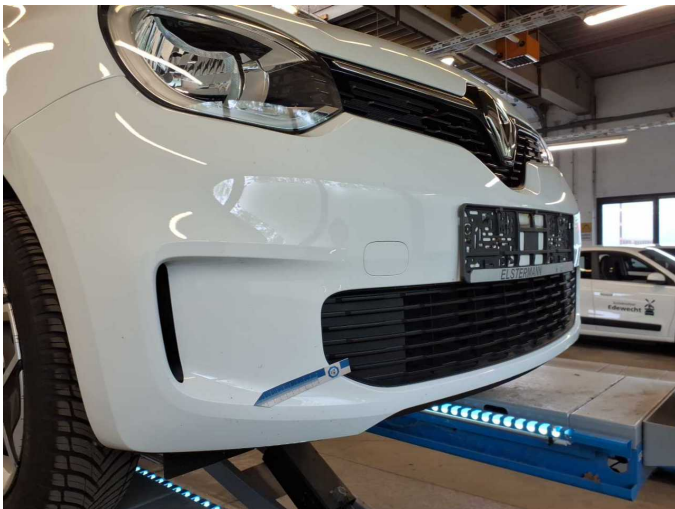
Wear and tear 1: Front bumper: Front bumper - Stone chips - No deduction

No.	Component group	Description
1	Front bumper	Front bumper - Stone chips - No deduction
