Expertise

Protocol number: 46762585  
Order No. / Reference: 25867418  
Inspection date: 23 Jul 2026

Manufacturer: Land Rover  
VIN: SALCA2BN4NH908810

Model: Discovery Sport D200 R-Dynamic S

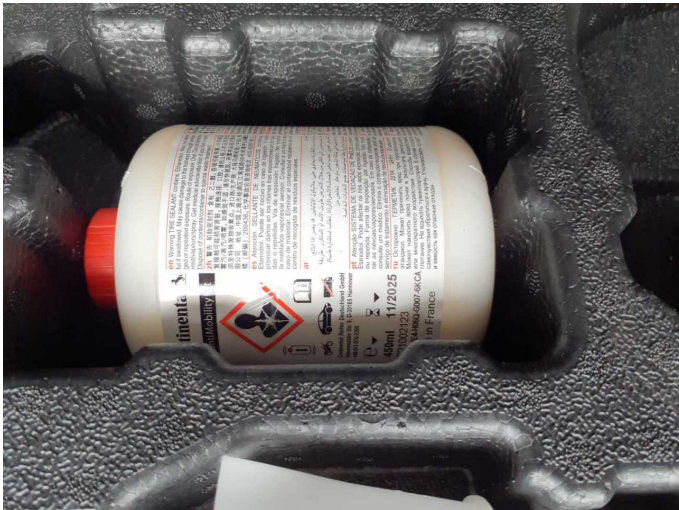
Damage 1: Equipment: Tirefit filler - Expired - Replace

| No. | Component group | Description |
|---|---|---|
| 1 | Equipment | Tirefit filler - Expired - Replace |

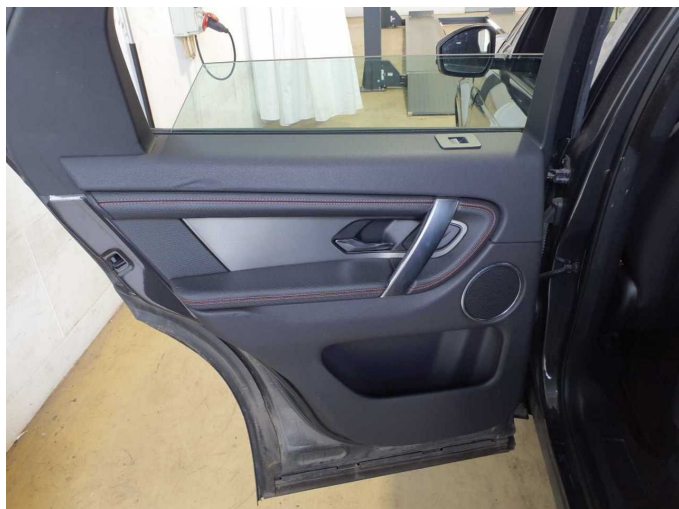
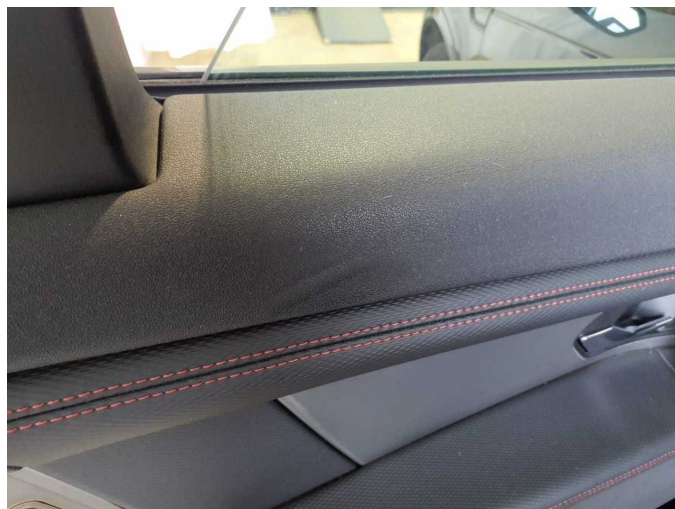
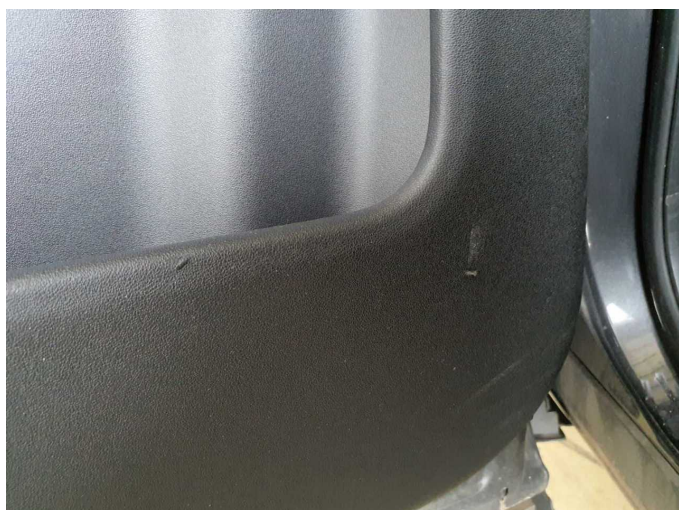
**Damage 2:** Trim / covers: Door trim - rear left side - Scratch(es) - Loss in value

| No. | Component group | Description |
|---|---|---|
| 2 | Trim / covers | Door trim - rear left side - Scratch(es) - Loss in value |

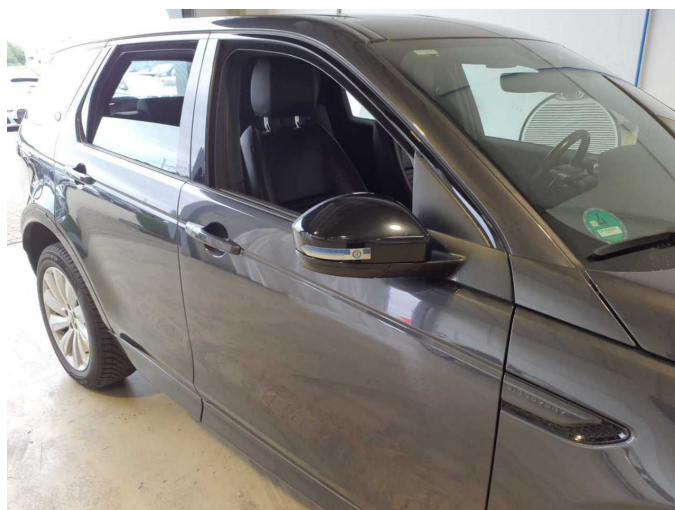
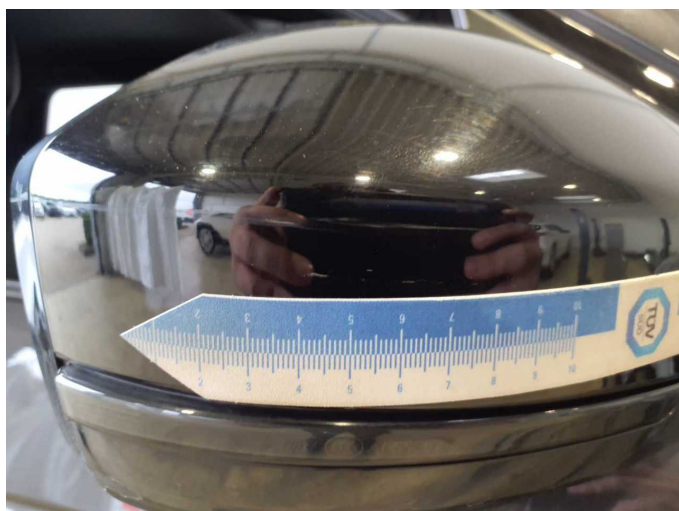
**Damage 3:** Wing mirror - right side: Cap - Scratch(es) - Smart repair

| No. | Component group | Description |
|---|---|---|
| 3 | Wing mirror - right side | Cap - Scratch(es) - Smart repair |

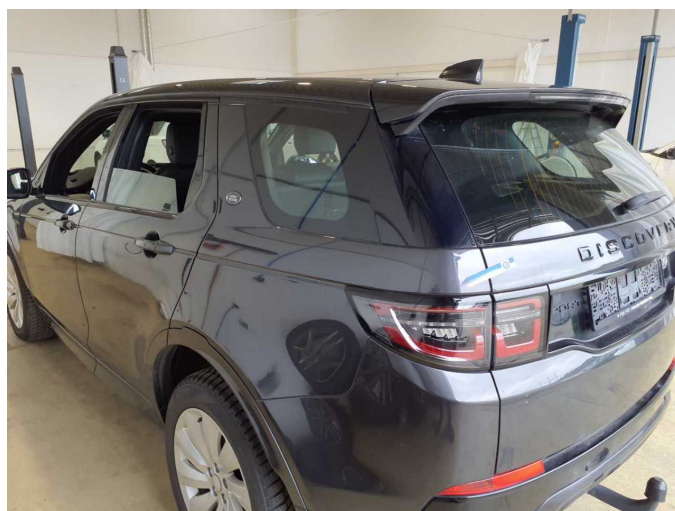
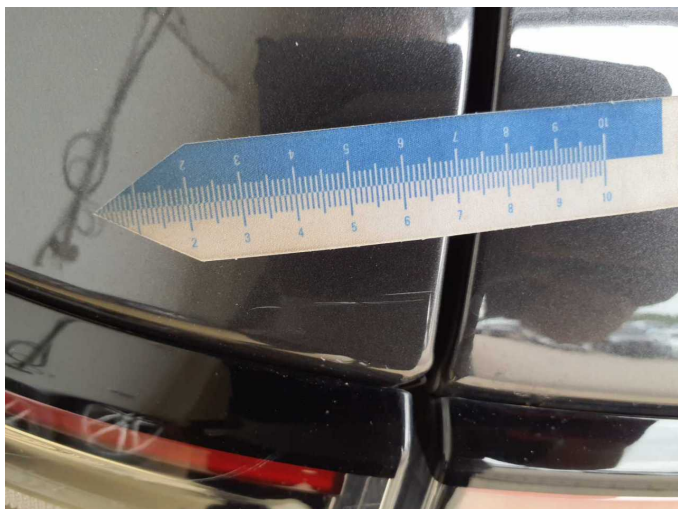
**Damage 4:** Side panel - rear left side: Side panel - Scratch(es) - Smart repair

| No. | Component group | Description |
|---|---|---|
| 4 | Side panel - rear left side | Side panel - Scratch(es) - Smart repair |

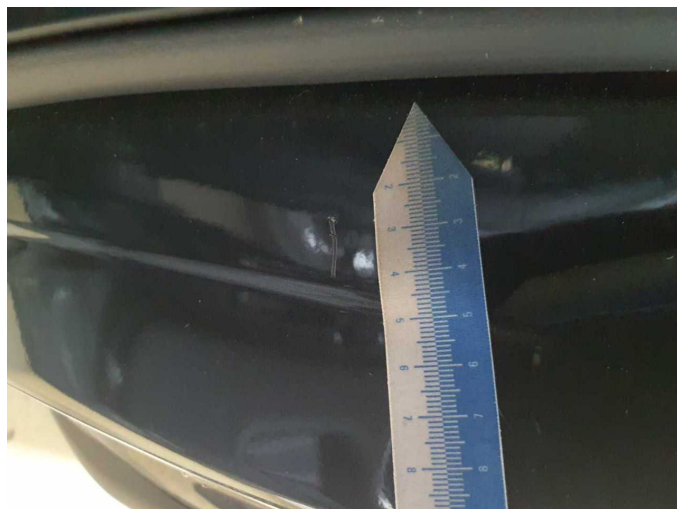
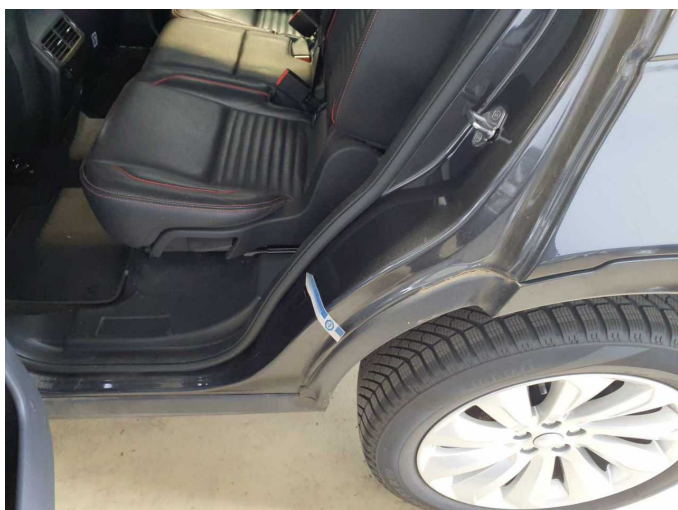
**Damage 5:** Side panel - rear left side: Sill - Scratch(es) - Smart repair

| No. | Component group | Description |
|---|---|---|
| 5 | Side panel - rear left side | Sill - Scratch(es) - Smart repair |

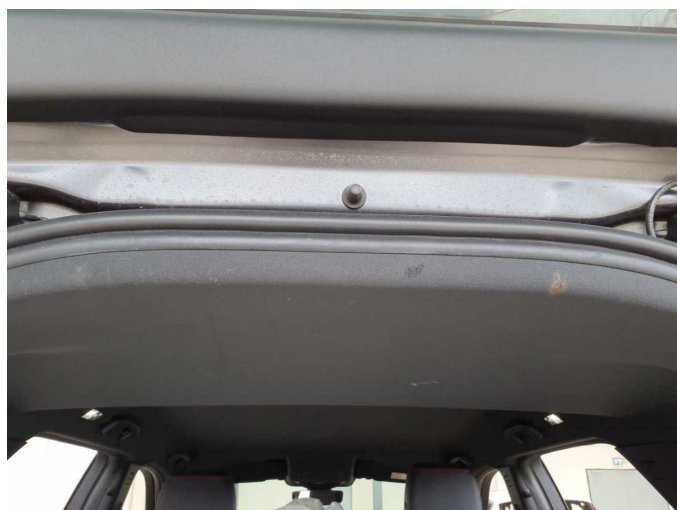
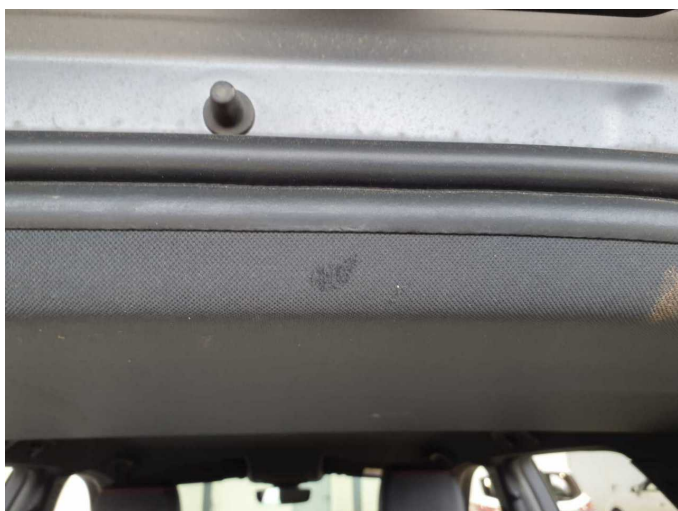
**Damage 6:** Trim / covers: Roof lining - Scratch(es) - Smart repair

| No. | Component group | Description |
|---|---|---|
| 6 | Trim / covers | Roof lining - Scratch(es) - Smart repair |

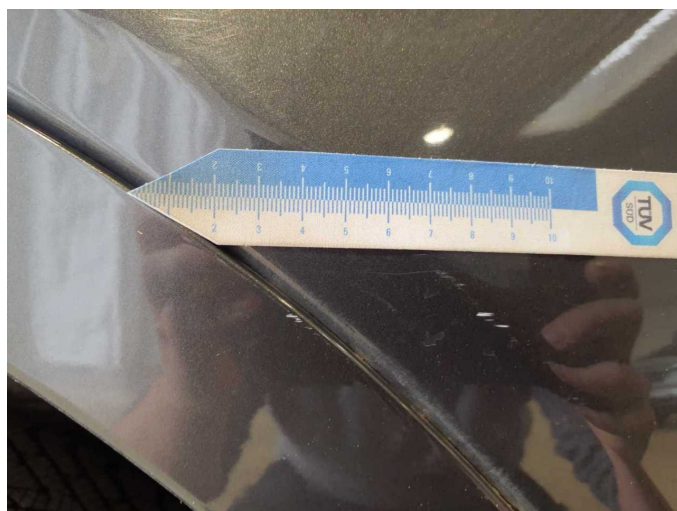
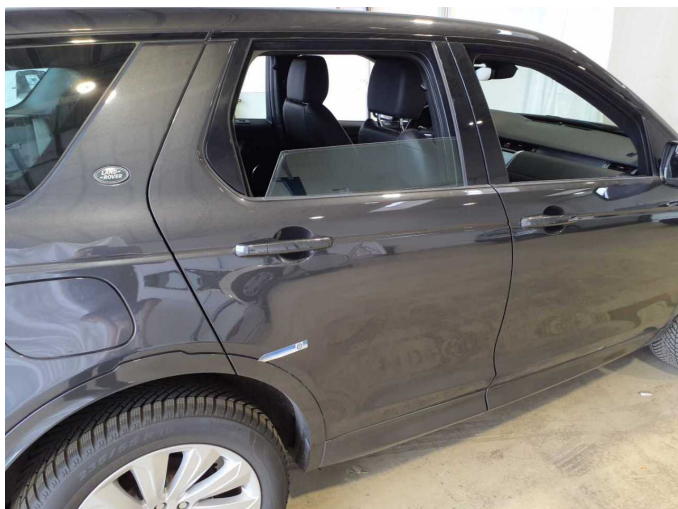
**Damage 7:** Door - rear right side: Door - Scratch(es) - Smart repair

| No. | Component group | Description |
|---|---|---|
| 7 | Door - rear right side | Door - Scratch(es) - Smart repair |

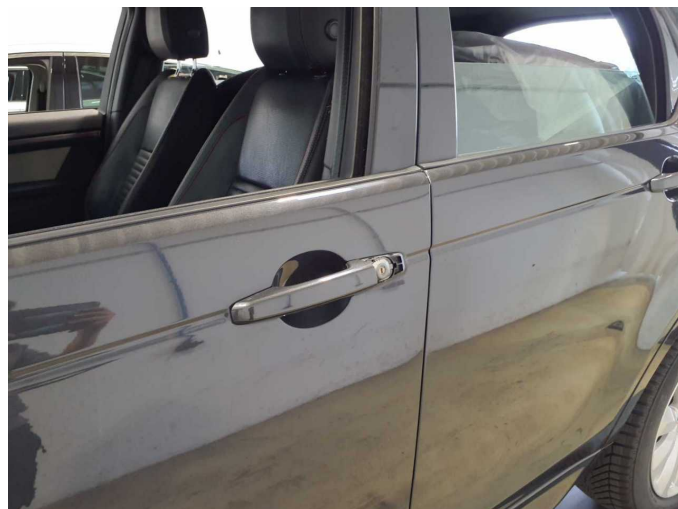
**Damage 8:** Door - front left side: Door handle - outside (Kappe) - Missing - Replace

| No. | Component group | Description |
|---|---|---|
| 8 | Door - front left side | Door handle - outside (Kappe) - Missing - Replace |

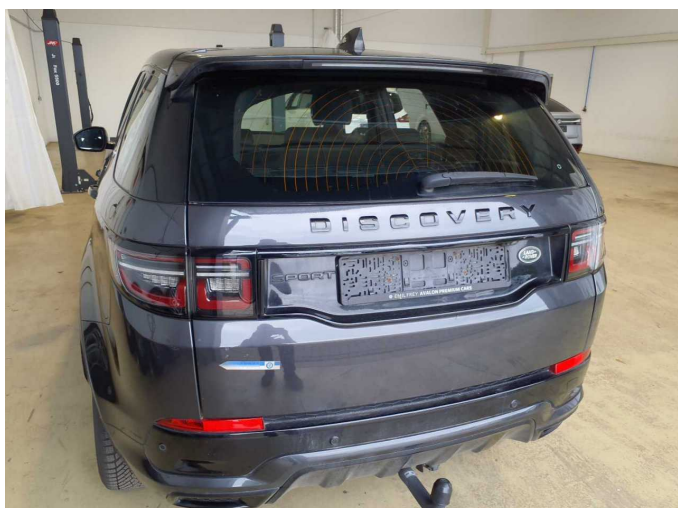
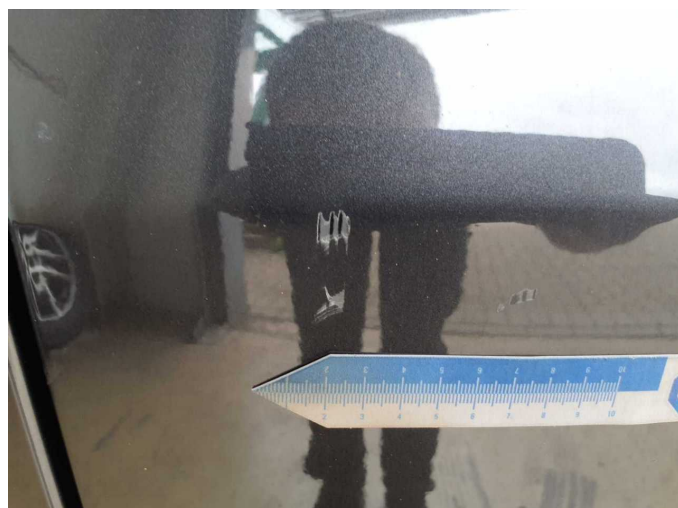
**Damage 9:** Boot lid / rear door: Boot lid (unterer Teil) - Scratch(es) - Paint

| No. | Component group | Description |
|---|---|---|
| 9 | Boot lid / rear door | Boot lid (unterer Teil) - Scratch(es) - Paint |

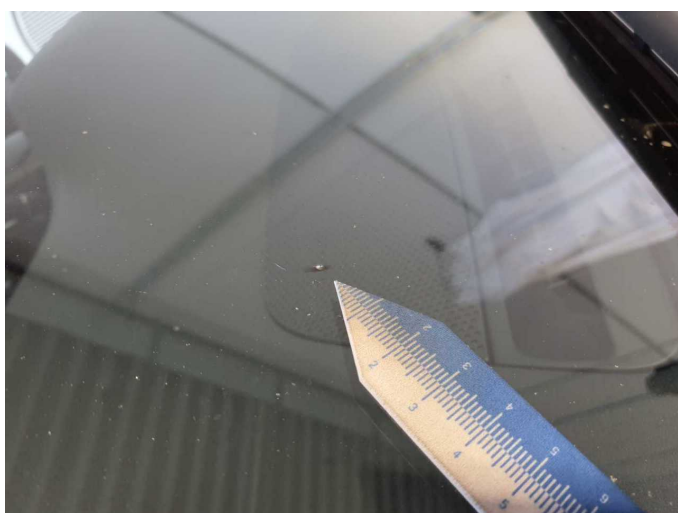
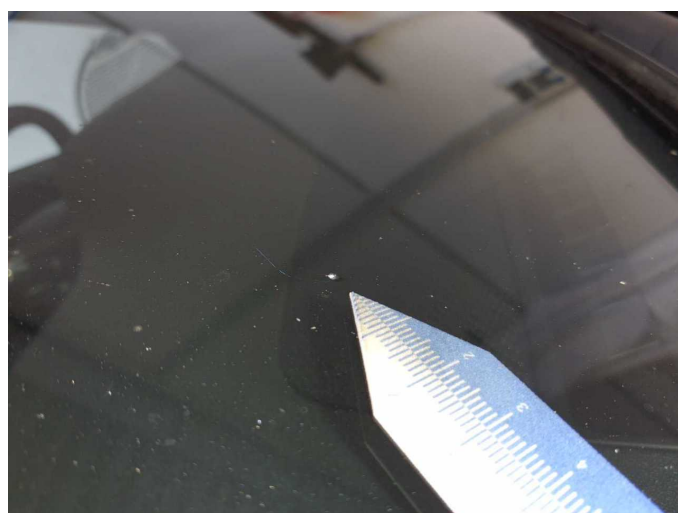
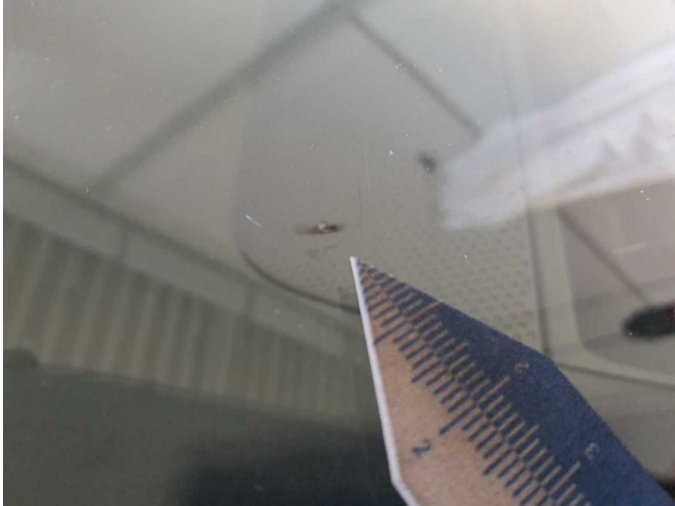
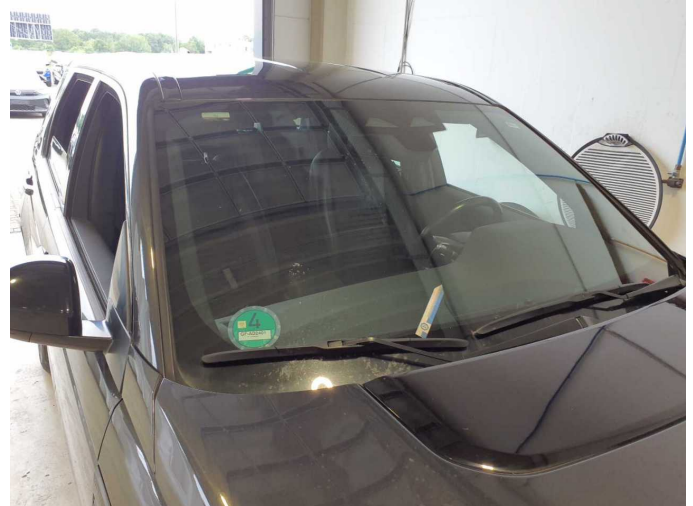
**Damage 10:** Vehicle glazing: Windscreen - Broken / torn - Replace

| No. | Component group | Description |
|---|---|---|
| 10 | Vehicle glazing | Windscreen - Broken / torn - Replace |

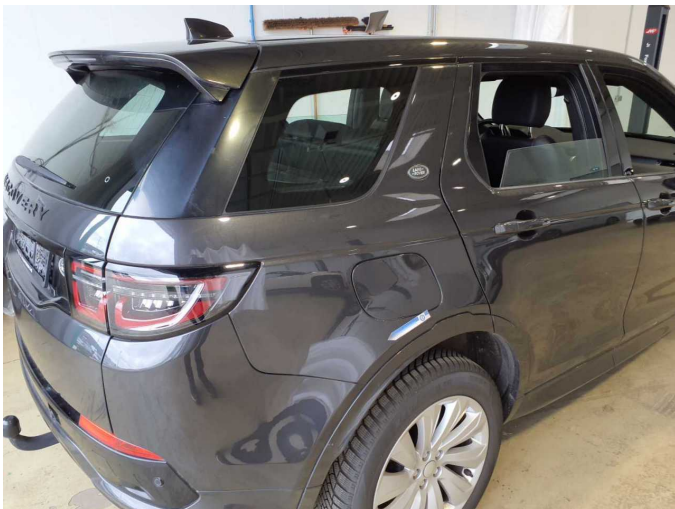
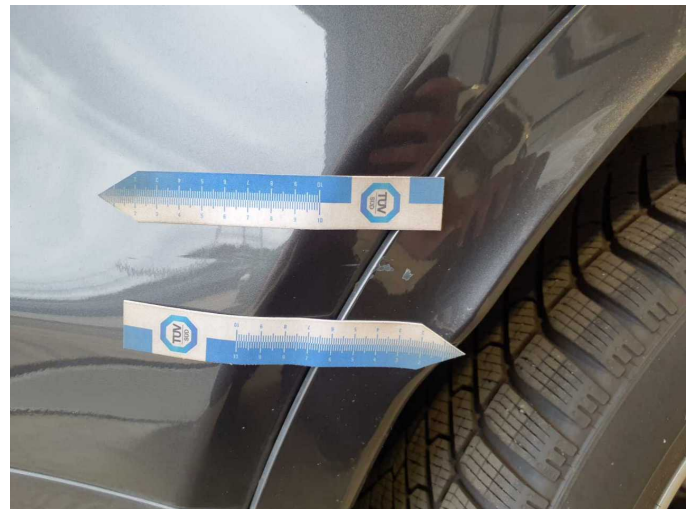
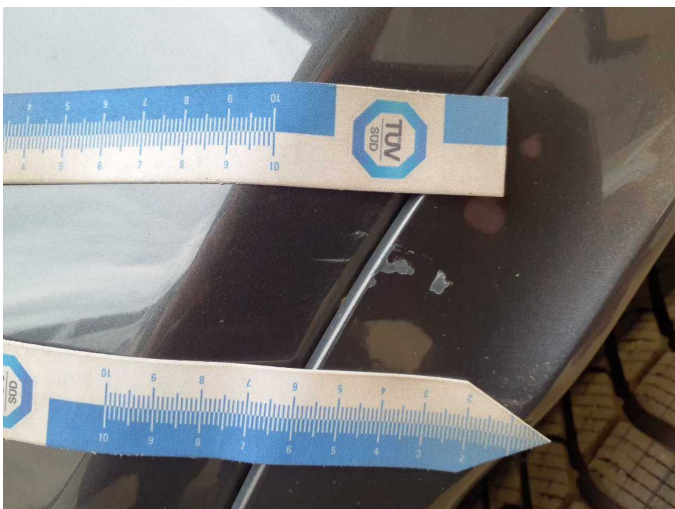
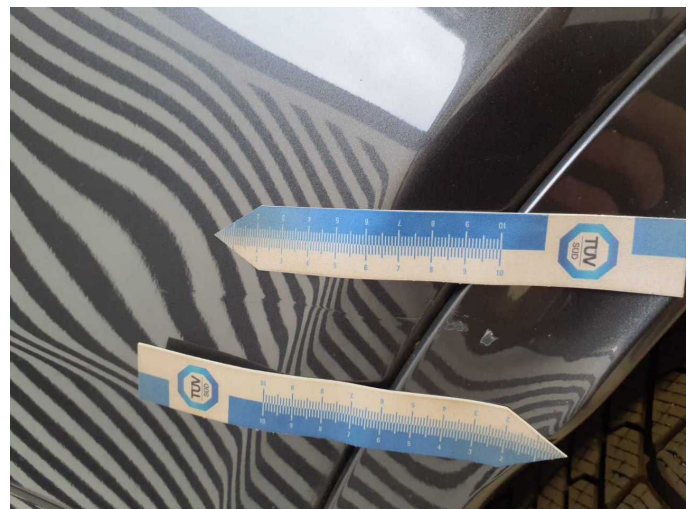
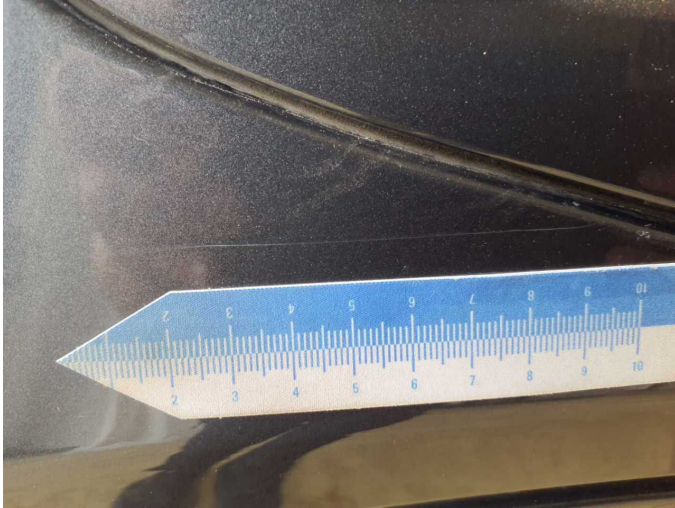
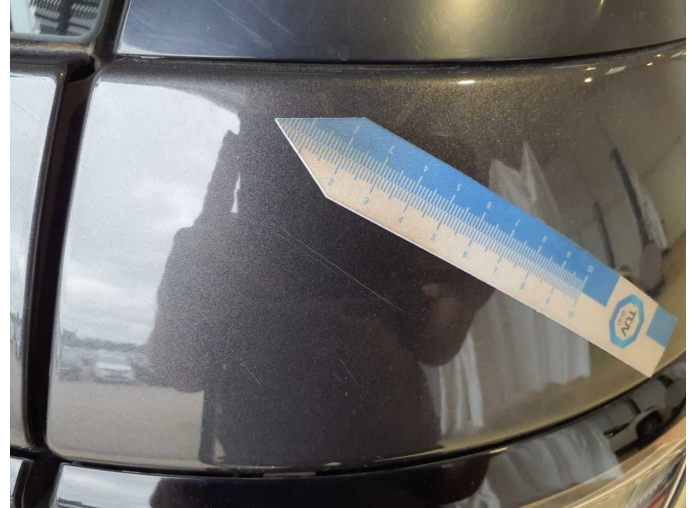
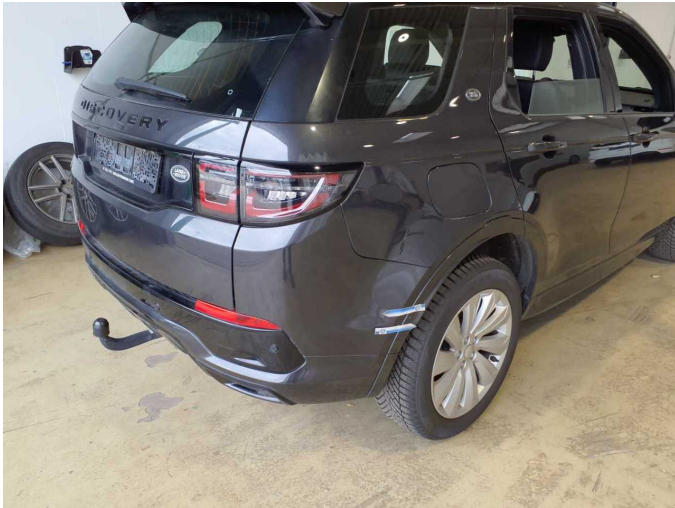
**Damage 11:** Side panel - rear right side: Side panel (+ Radhausverbreiterung lackieren) - Dent / paintcoat damage - Paint

| No. | Component group | Description |
|---|---|---|
| 11 | Side panel - rear right side | Side panel (+ Radhausverbreiterung lackieren) - Dent / paintcoat damage - Paint |

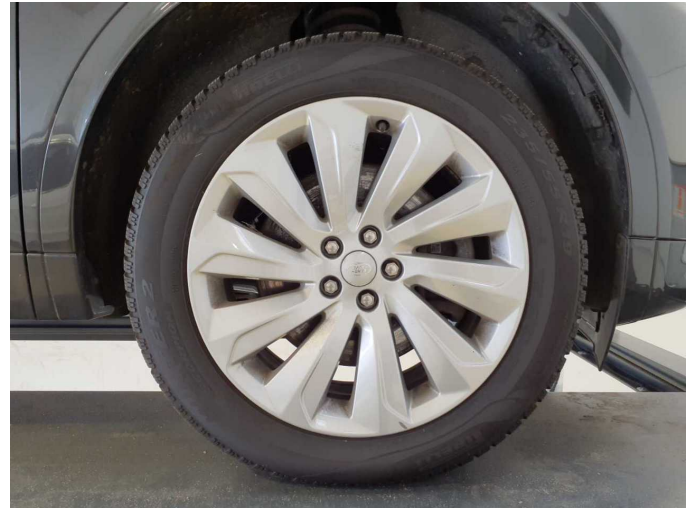
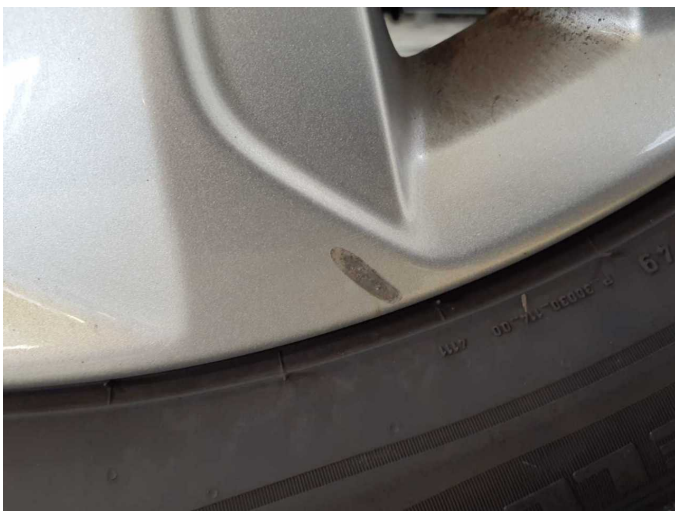
**Wear and tear 5:** Wheel / tyres: Alloy rim - front right side (Kein Teil der Ausstattung) - Scratch(es) - No deduction

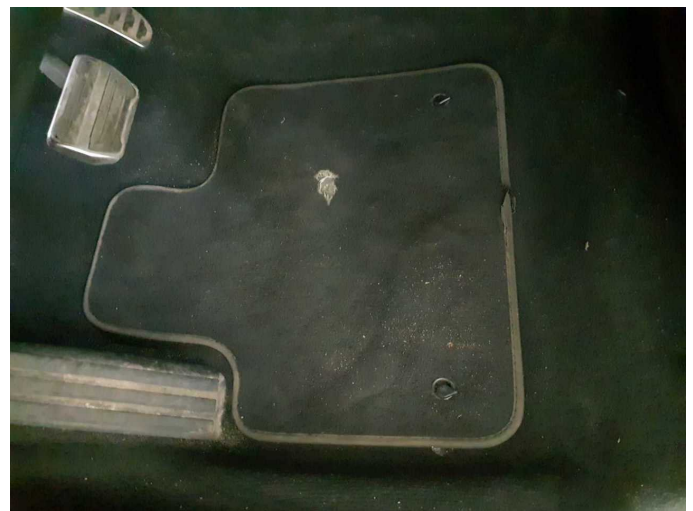
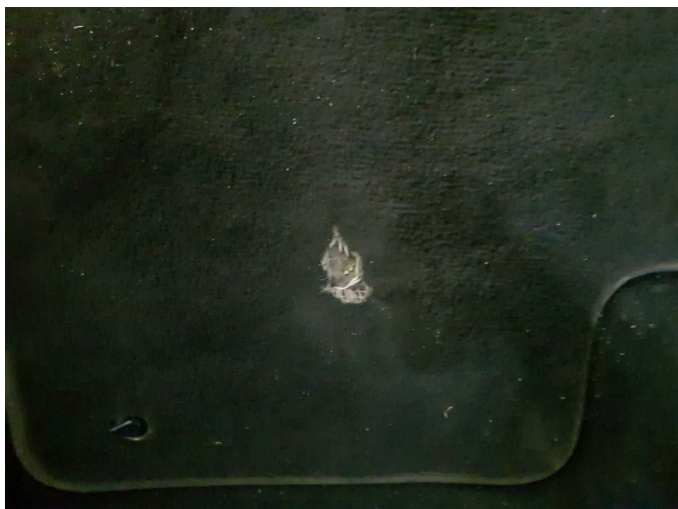
**Wear and tear 6:** Trim / covers: Floor mats (VL) - Holes - No deduction
