Protocol number: 45484776
Order No. / Reference: 26044159
Inspection date: 15 May 2026

Manufacturer: Audi

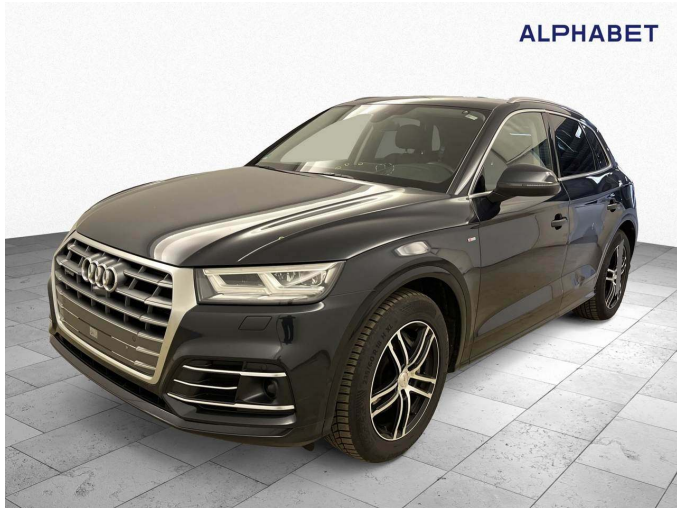
Figure 1: Diagonal front (left)

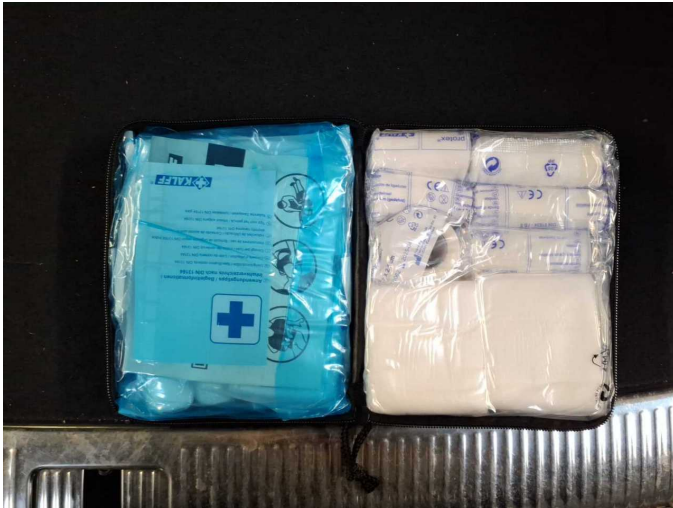
Damage 1: Equipment: First aid kit - Expired - Replace

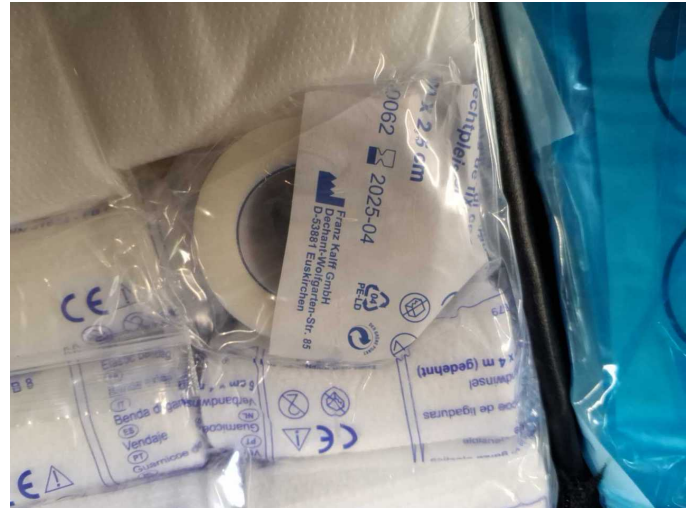
Damage 1: Equipment: First aid kit - Expired - Replace

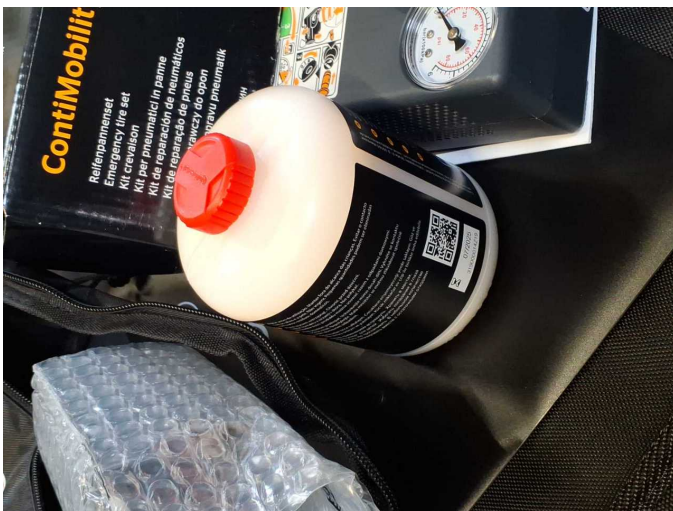
Damage 2: Equipment: Tirefit filler - Expired - Replace

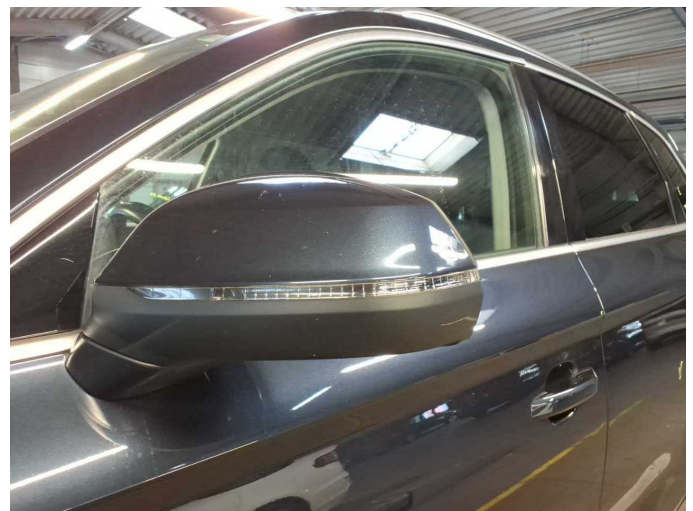
Damage 3: Wing mirror - left side: Cap (Schwarze abdeckung / Aufnahme) - Scratch(es) - Smart repair

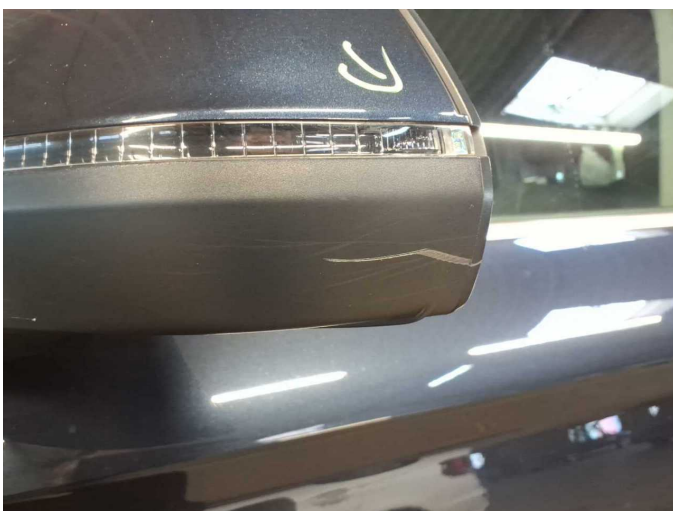
Damage 3: Wing mirror - left side: Cap (Schwarze abdeckung / Aufnahme) - Scratch(es) - Smart repair

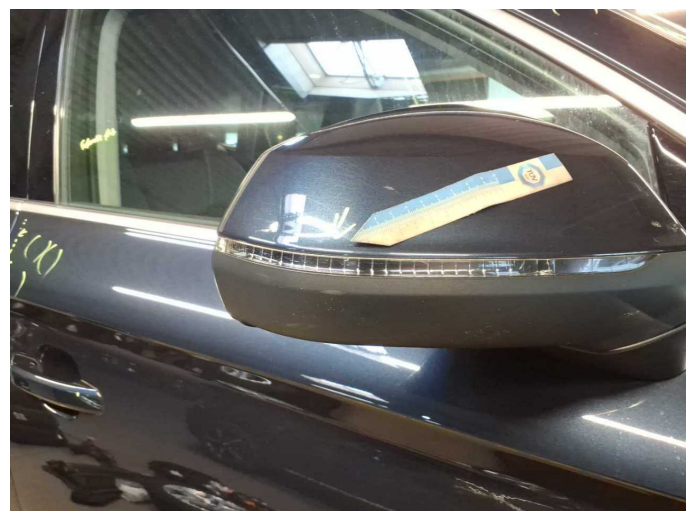
Damage 4: Wing mirror - right side: Cap (Schwarze aufnahme / abdeckung) - Scratch(es) - Smooth repair work

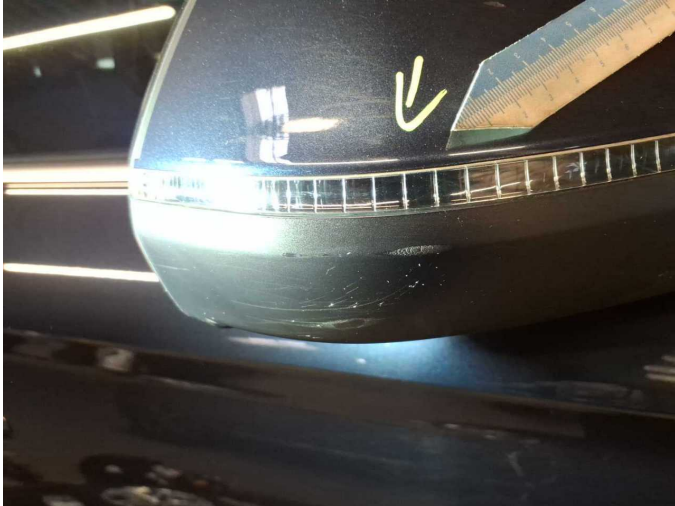
Damage 4: Wing mirror - right side: Cap (Schwarze aufnahme / abdeckung) - Scratch(es) - Smooth repair work

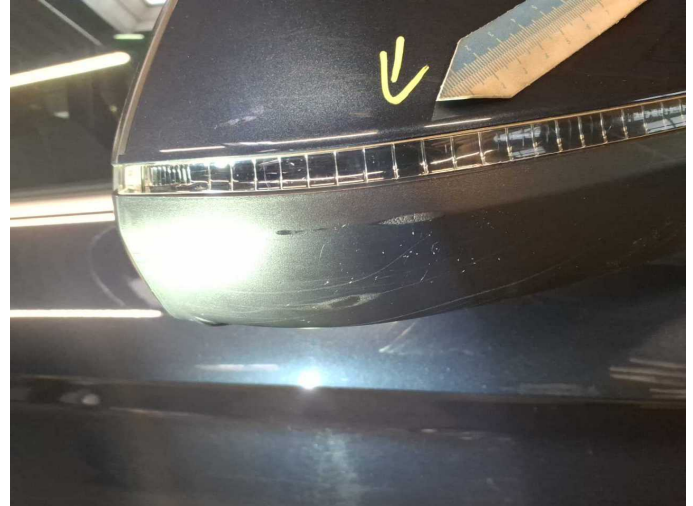
Damage 4: Wing mirror - right side: Cap (Schwarze aufnahme / abdeckung) - Scratch(es) - Smooth repair work

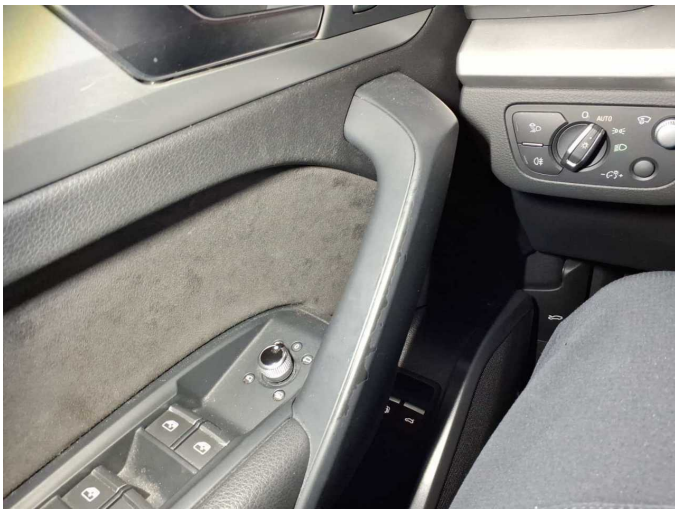
Damage 5: Trim / covers: Door trim - front left side (Türgriff VL) - Scratch(es) - Smart repair

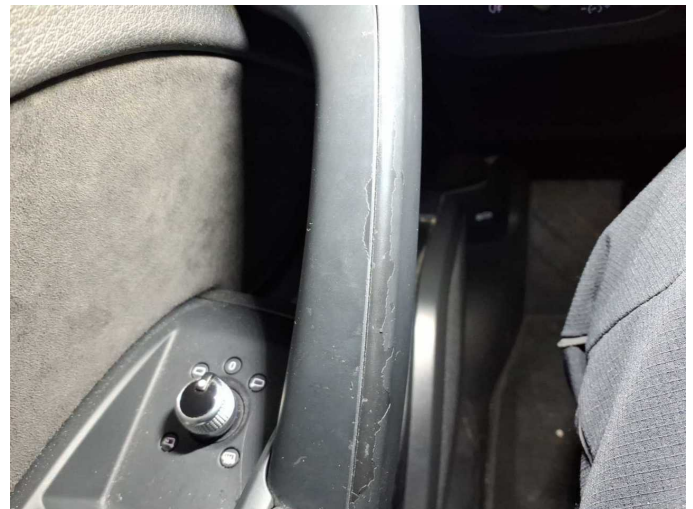
Damage 5: Trim / covers: Door trim - front left side (Türgriff VL) - Scratch(es) - Smart repair

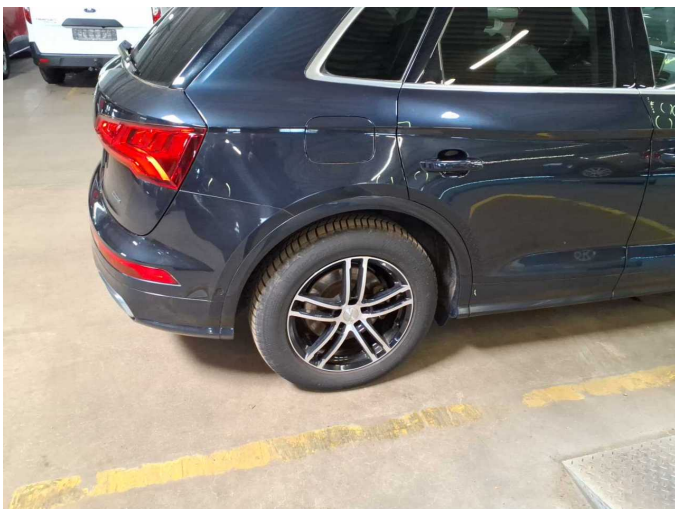
Damage 7: Braking system: Brake discs and pads - rear (Tragbild mangelhaft auf der linken seite) - Corrosion - Perform diagnosis

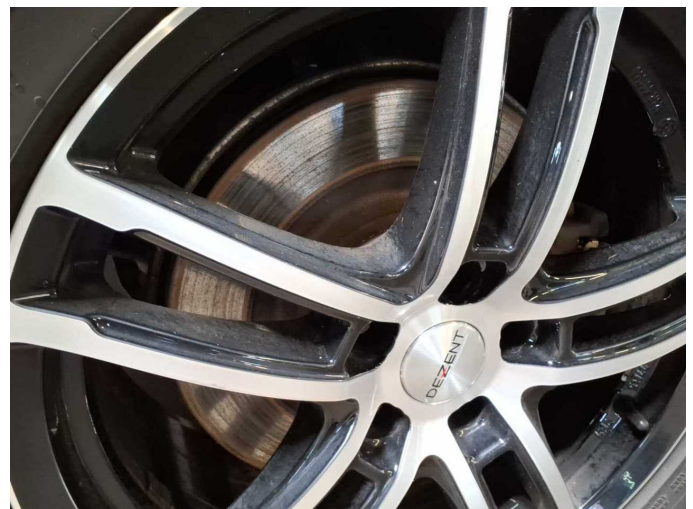
Damage 7: Braking system: Brake discs and pads - rear (Tragbild mangelhaft auf der linken seite) - Corrosion - Perform diagnosis

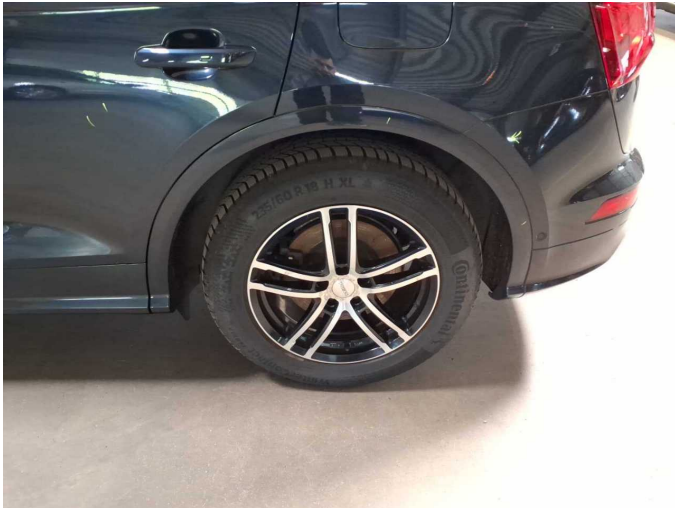
Damage 7: Braking system: Brake discs and pads - rear (Tragbild mangelhaft auf der linken Seite) - Corrosion - Perform diagnosis

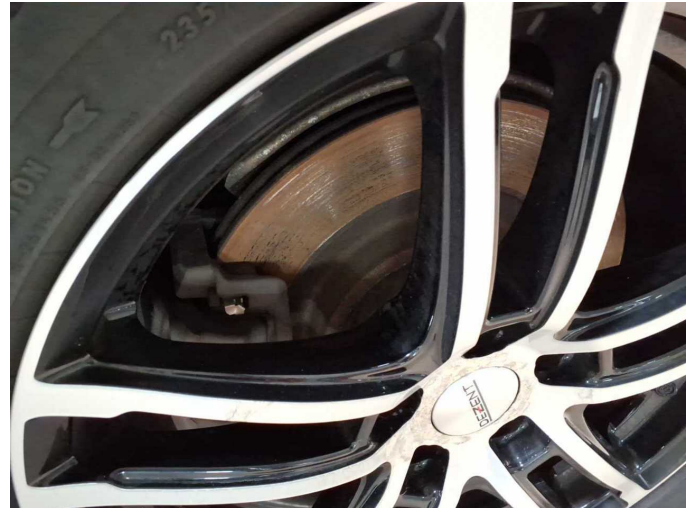
Damage 7: Braking system: Brake discs and pads - rear (Tragbild mangelhaft auf der linken Seite) - Corrosion - Perform diagnosis

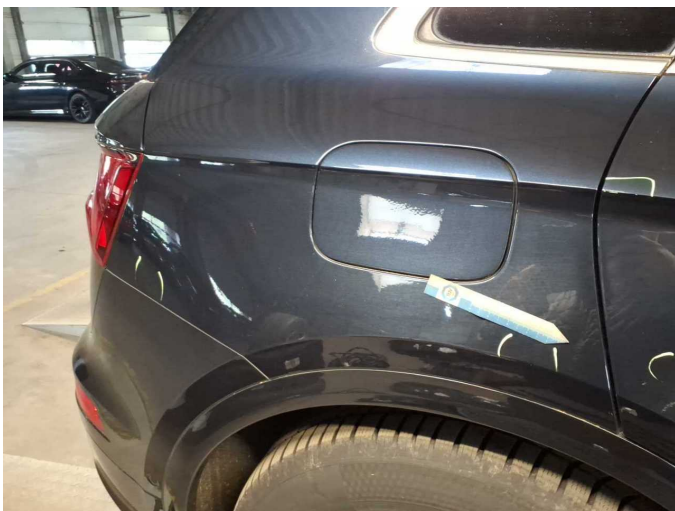
Damage 8: Side panel - rear right side: Side panel - dent(s) - Smooth repair work

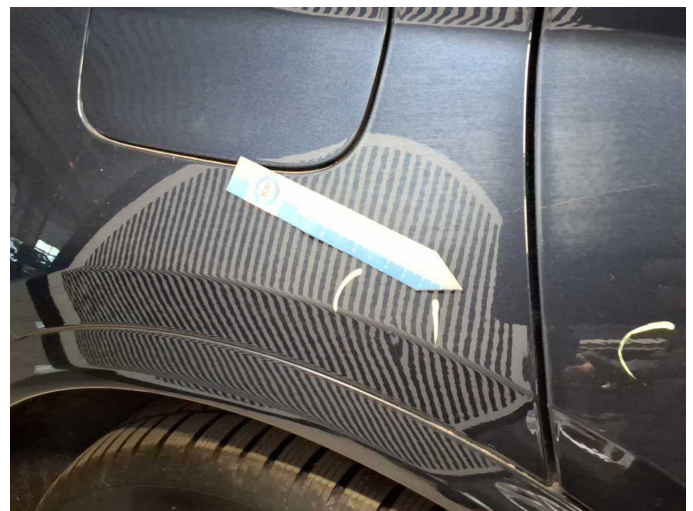
Damage 8: Side panel - rear right side: Side panel - dent(s) - Smooth repair work

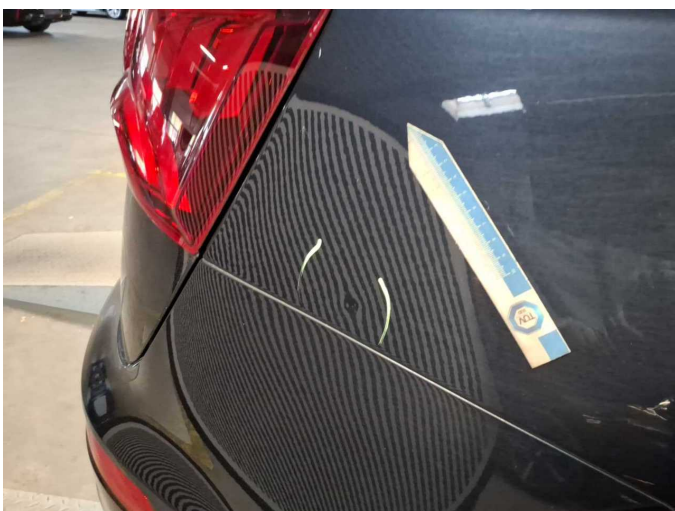
Damage 8: Side panel - rear right side: Side panel - dent(s) - Smooth repair work

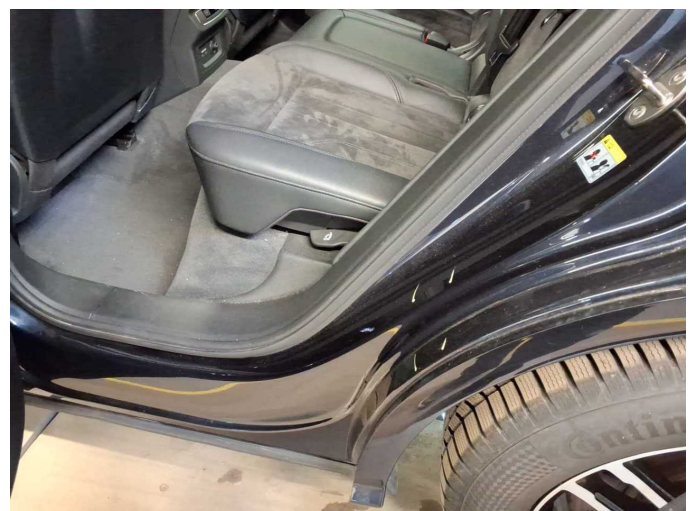
Damage 9: Sill - left side: Sill - dent(s) - Smooth repair work

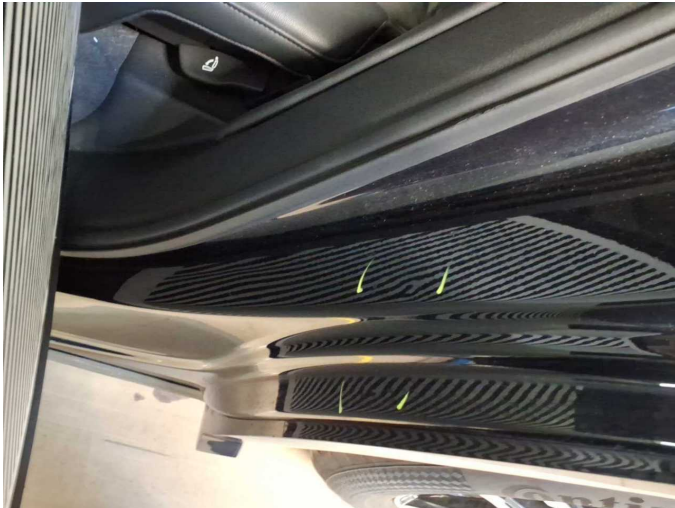
Damage 9: Sill - left side: Sill - dent(s) - Smooth repair work

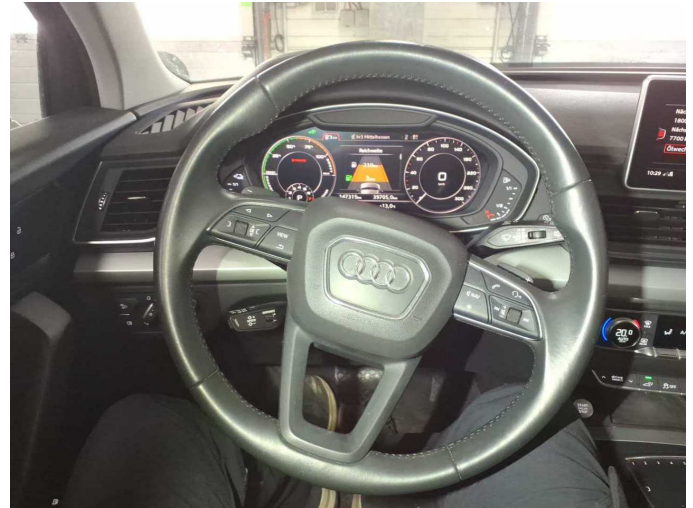
Damage 10: Steering system: Steering wheel - Scratch(es) - Smart repair

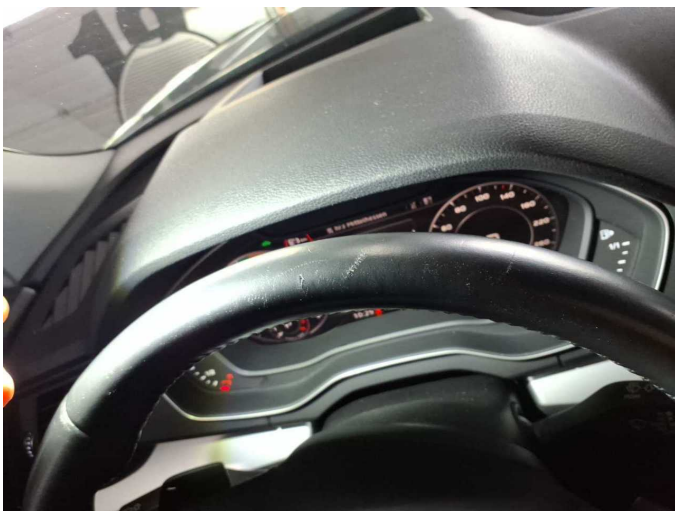
Damage 10: Steering system: Steering wheel - Scratch(es) - Smart repair

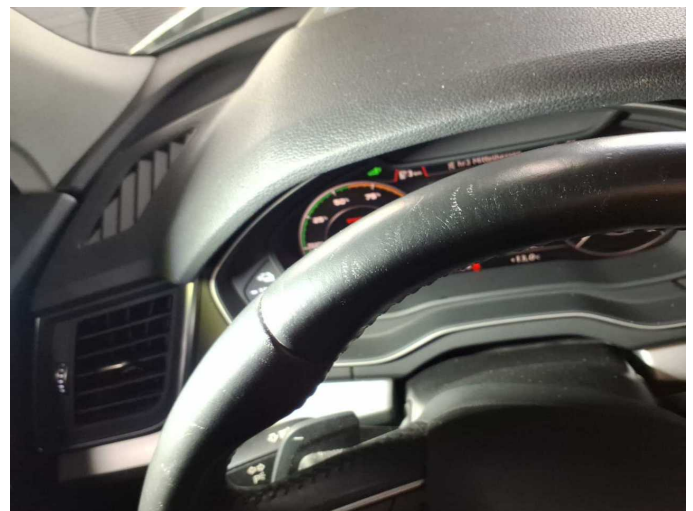
Damage 10: Steering system: Steering wheel - Scratch(es) - Smart repair

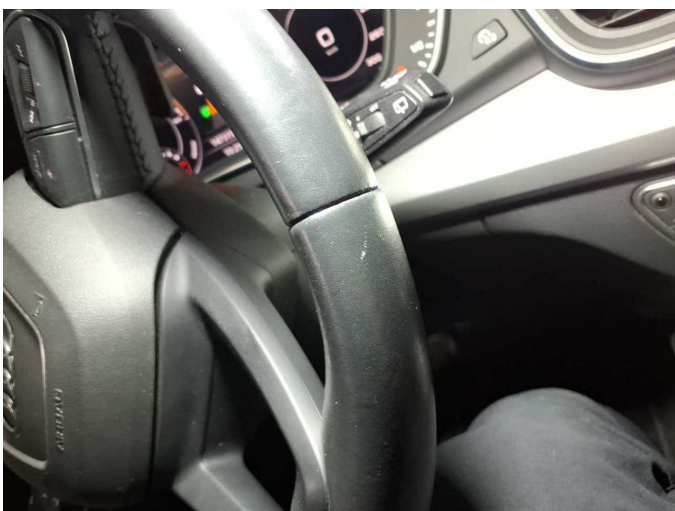
Damage 10: Steering system: Steering wheel - Scratch(es) - Smart repair

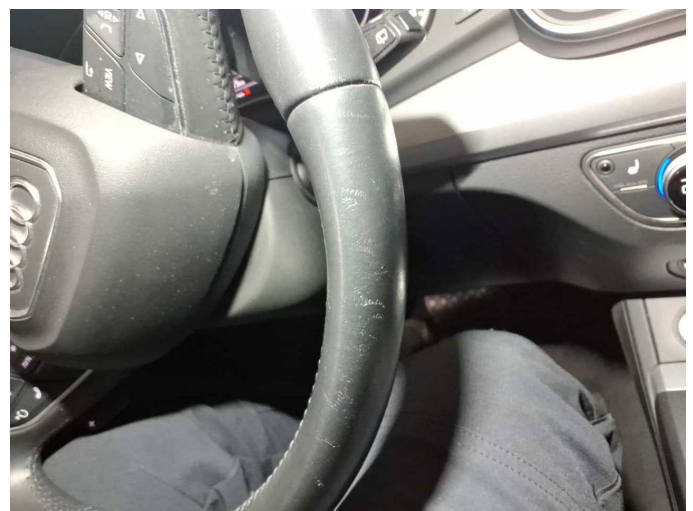
Damage 10: Steering system: Steering wheel - Scratch(es) - Smart repair

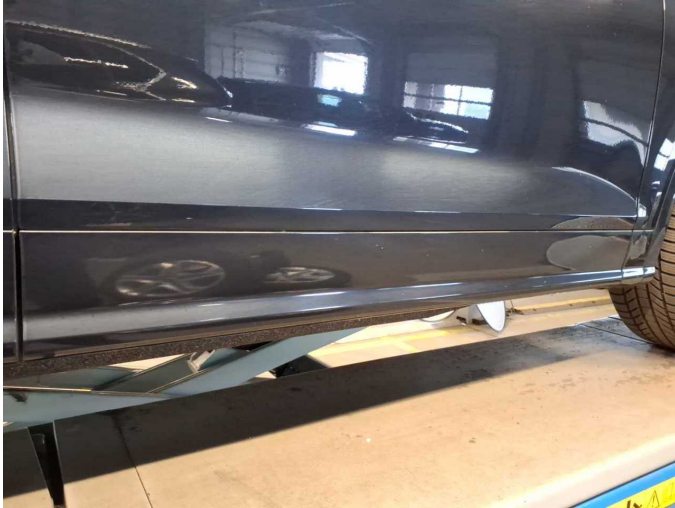
Damage 11: Door - front right side: Brightware - lower - Scratch(es) - Smart repair

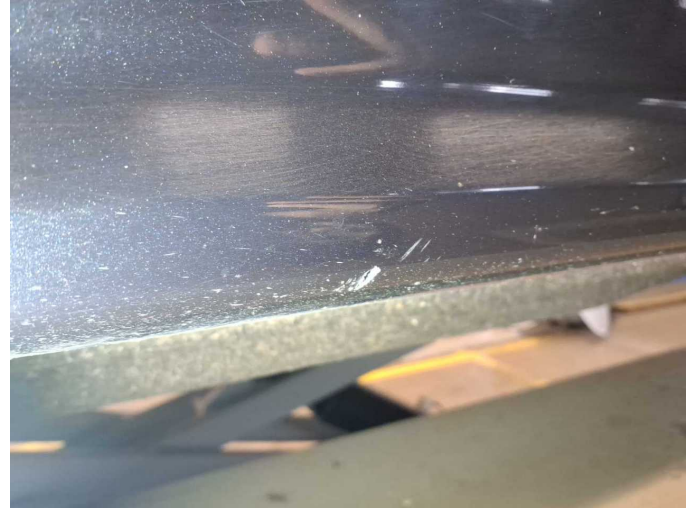
Damage 11: Door - front right side: Brightware - lower - Scratch(es) - Smart repair

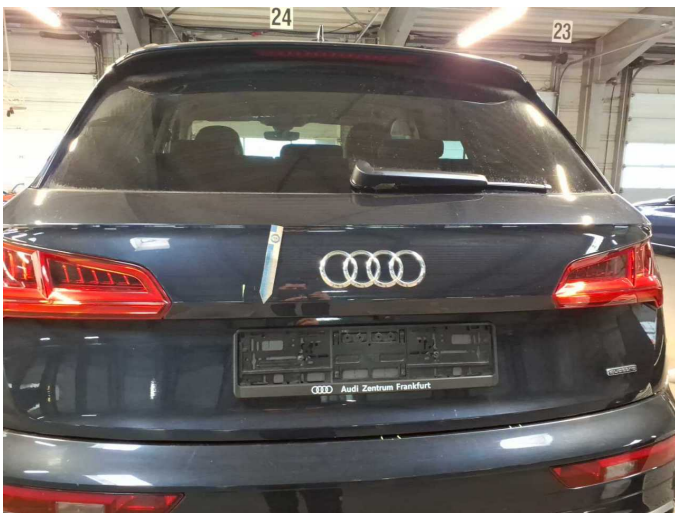
Damage 12: Boot lid / rear door: Boot lid - Scratch(es) - Smart repair

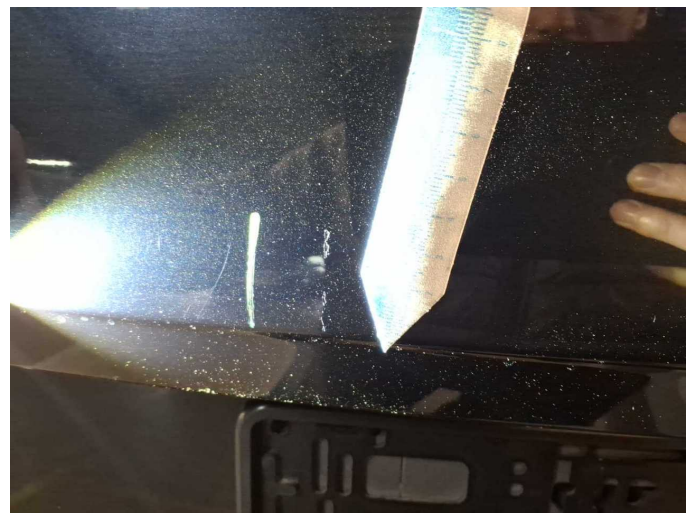
Damage 12: Boot lid / rear door: Boot lid - Scratch(es) - Smart repair

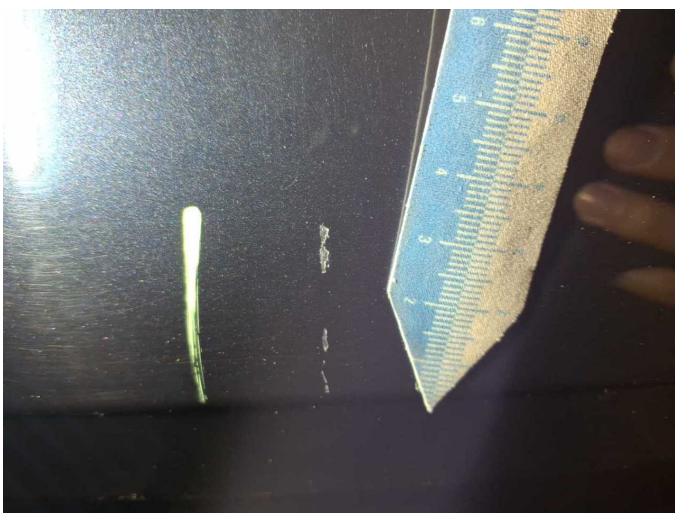
Damage 12: Boot lid / rear door: Boot lid - Scratch(es) - Smart repair

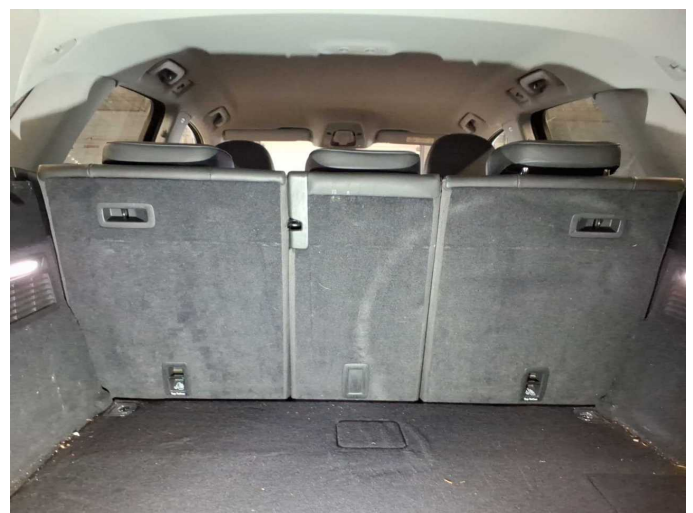
Damage 13: Seat - rear: Upholstery - Scratched - Smart repair

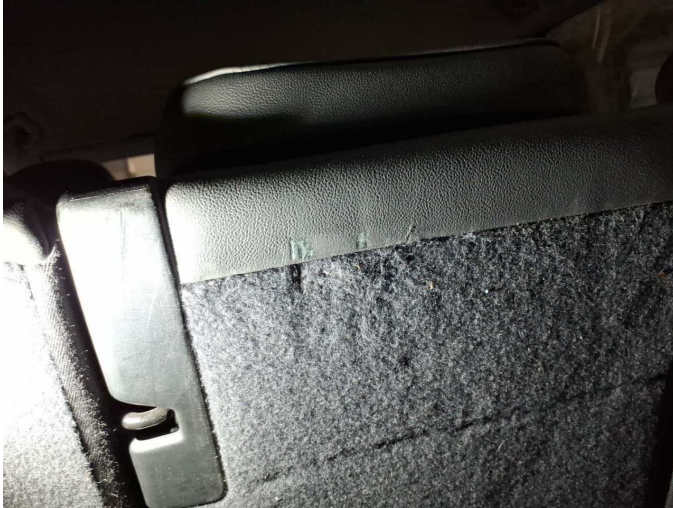
Damage 13: Seat - rear: Upholstery - Scratched - Smart repair

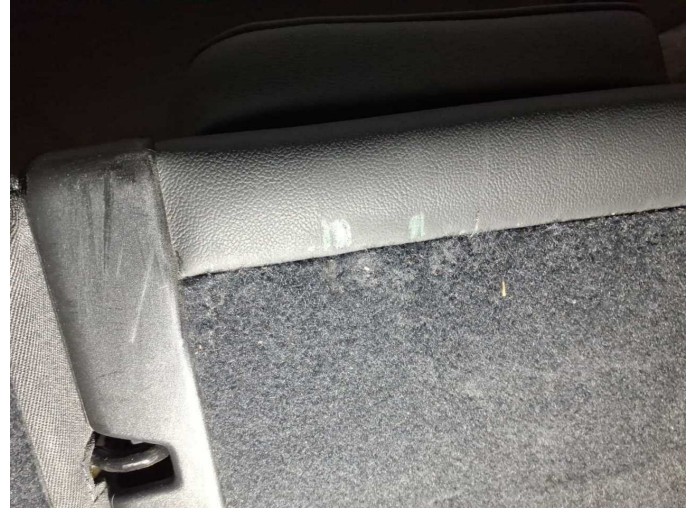
Damage 13: Seat - rear: Upholstery - Scratched - Smart repair

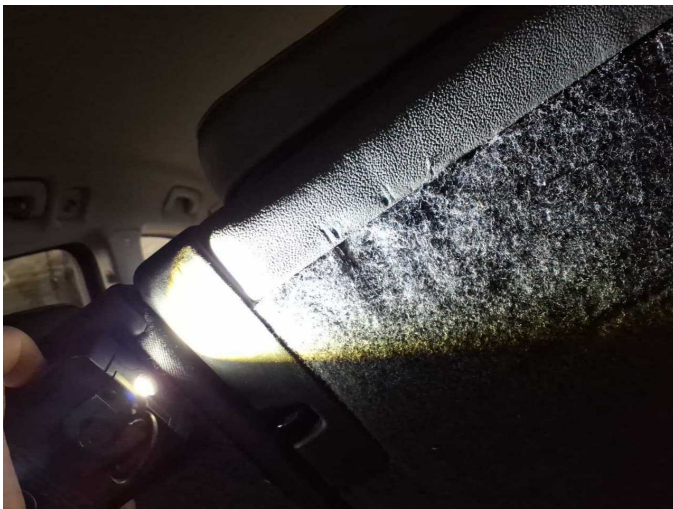
Damage 13: Seat - rear: Upholstery - Scratched - Smart repair

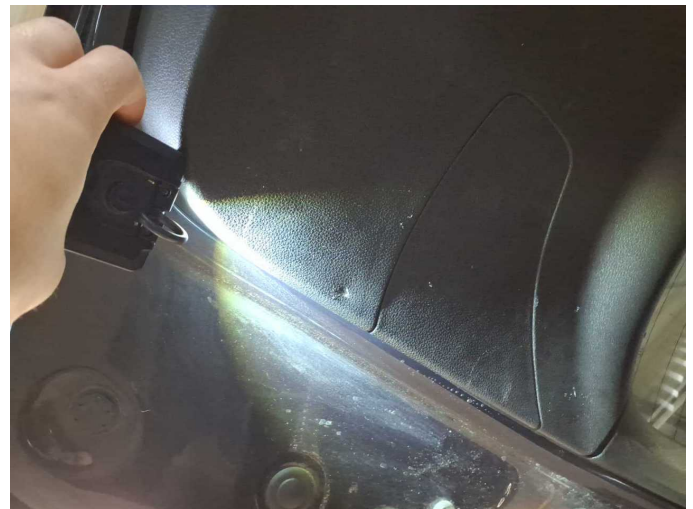
Damage 14: Trim / covers: Boot lid - interior trim - Deformed - Replace

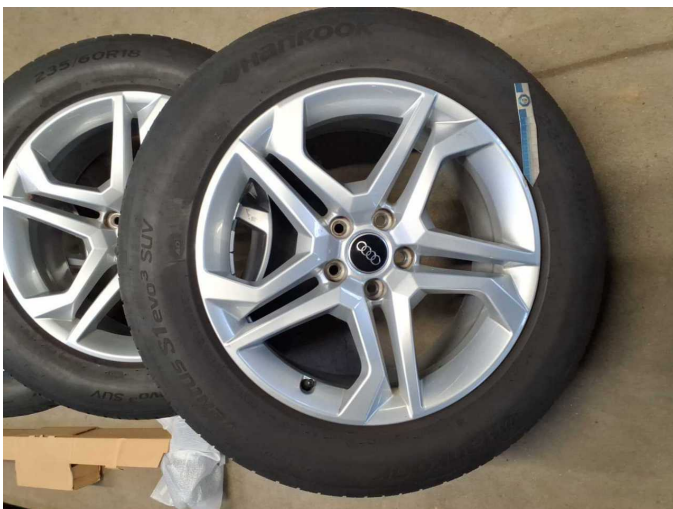
Damage 15: Wheel / tyres: Alloy rim - front left side - Scratch(es) - Loss in value

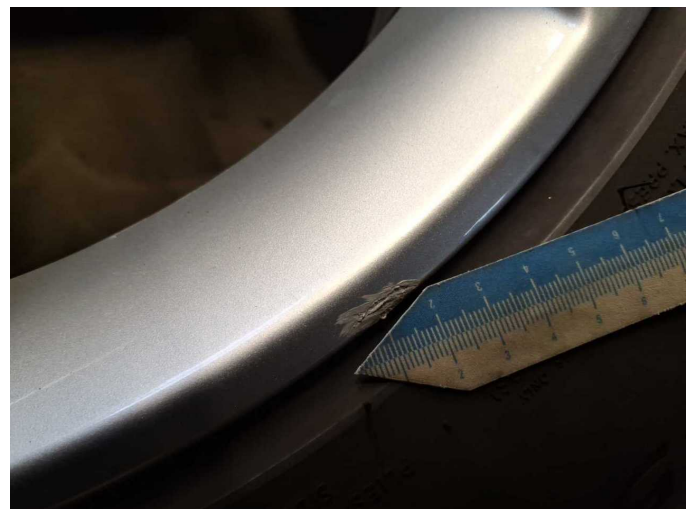
Damage 15: Wheel / tyres: Alloy rim - front left side - Scratch(es) - Loss in value

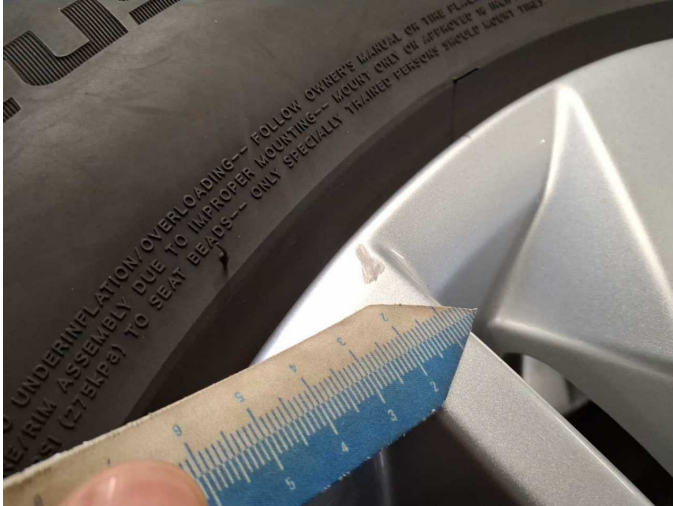
Damage 15: Wheel / tyres: Alloy rim - front left side - Scratch(es) - Loss in value

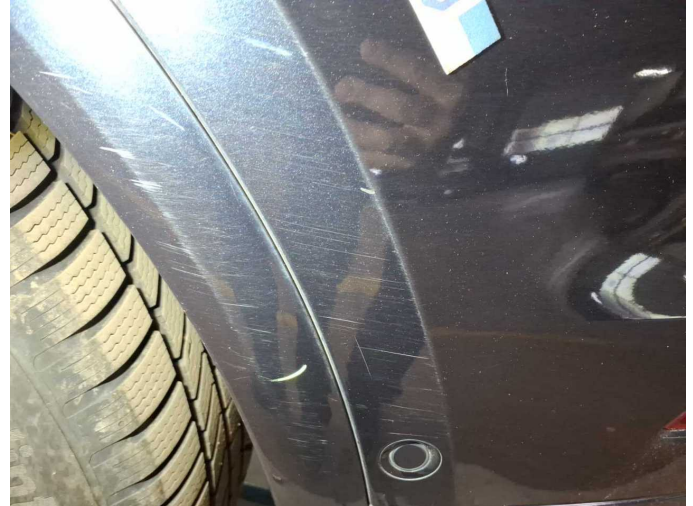
Damage 16: Rear bumper: Rear bumper (Radlauf) - Scratched - Paint

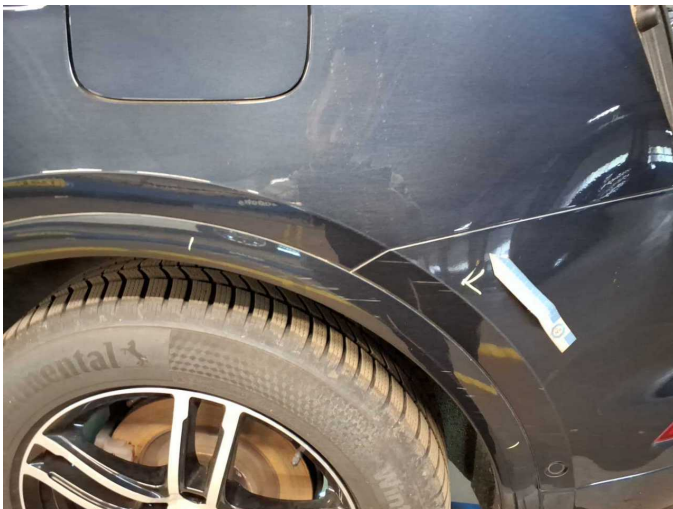
Damage 16: Rear bumper: Rear bumper (Radlauf) - Scratched - Paint

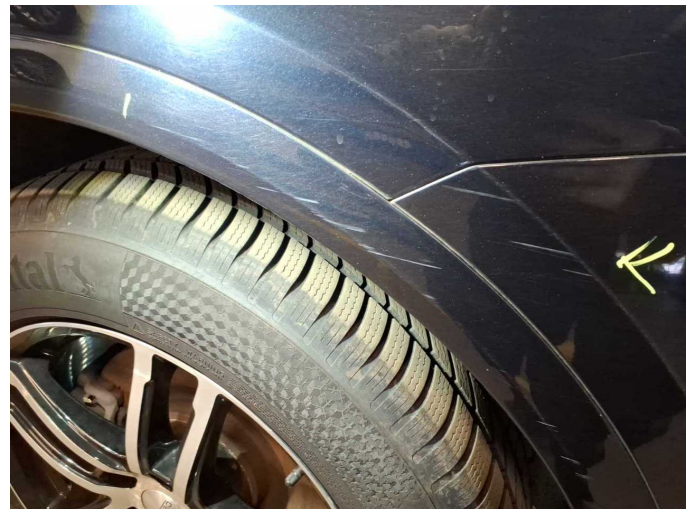
Damage 16: Rear bumper: Rear bumper (Radlauf) - Scratched - Paint

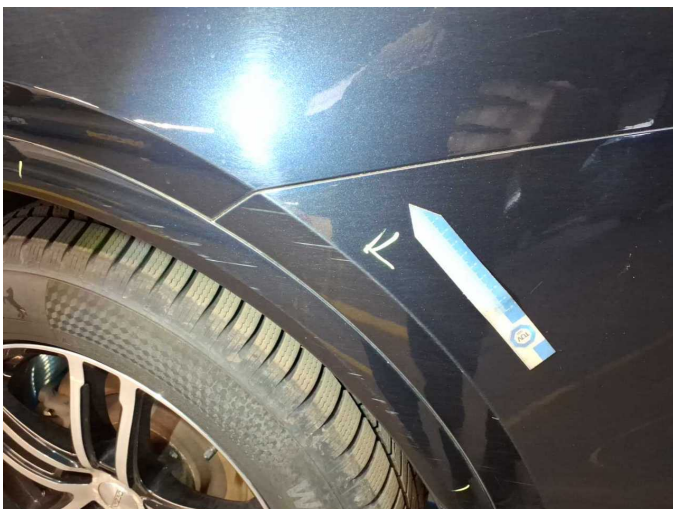
Damage 16: Rear bumper: Rear bumper (Radlauf) - Scratched - Paint

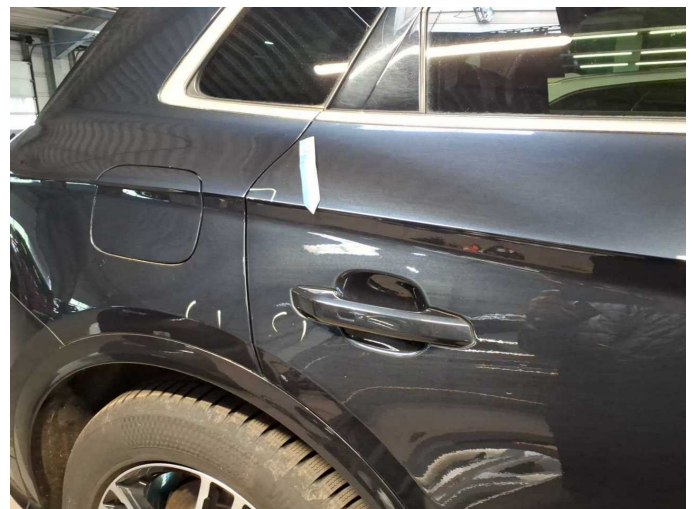
Damage 17: Door - rear right side: Door - Dent / paintcoat damage - Paint

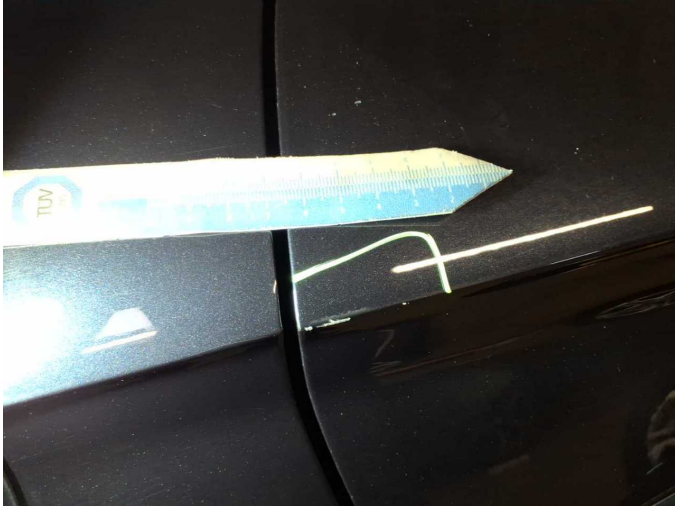
Damage 17: Door - rear right side: Door - Dent / paintcoat damage - Paint

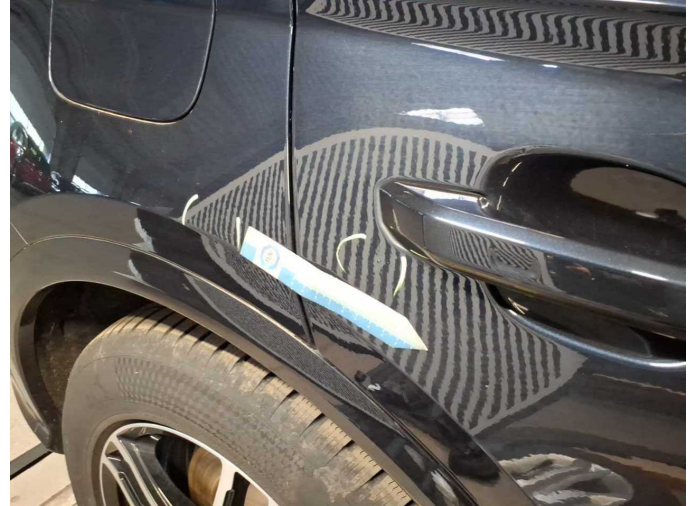
Damage 17: Door - rear right side: Door - Dent / paintcoat damage - Paint

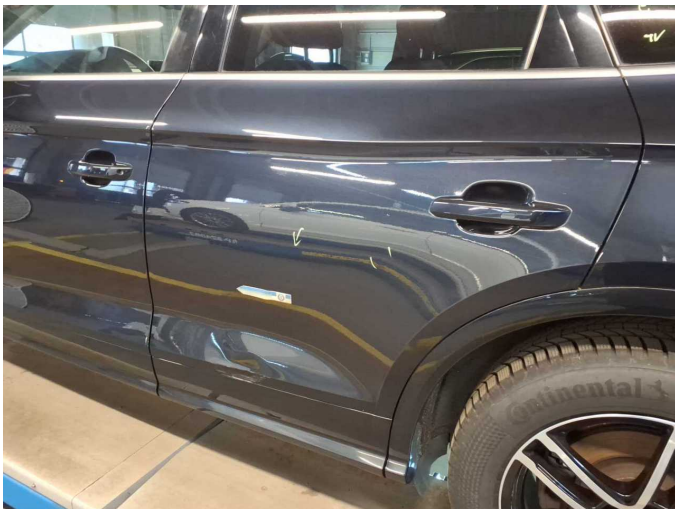
Damage 18: Door - rear left side: Door - Deformed - Repair and paint

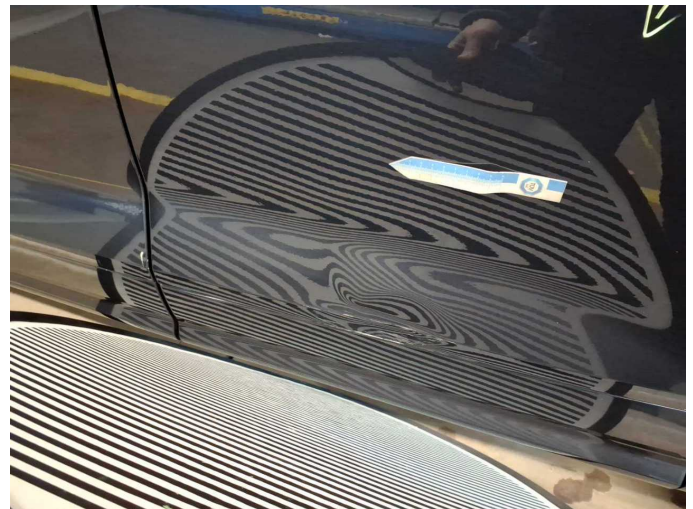
Damage 18: Door - rear left side: Door - Deformed - Repair and paint

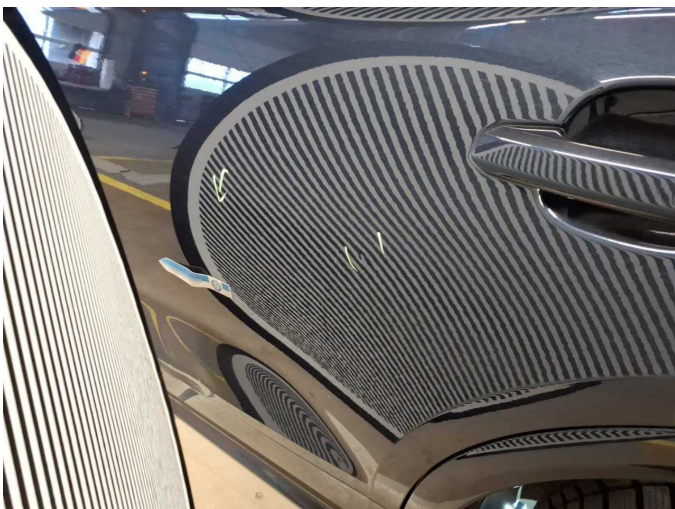
Damage 18: Door - rear left side: Door - Deformed - Repair and paint

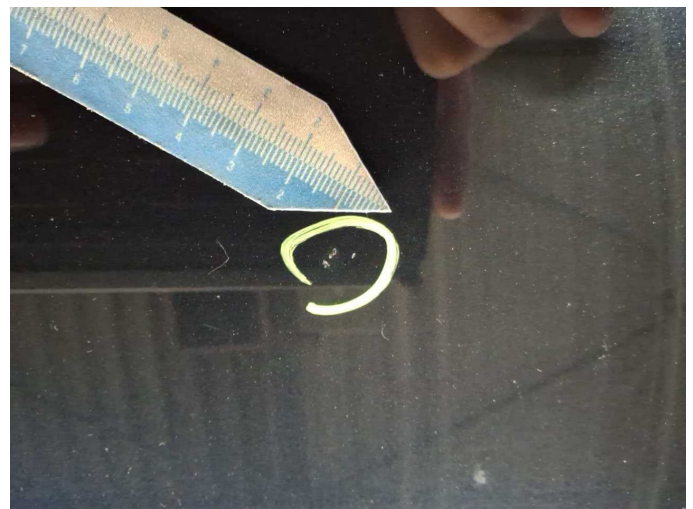
Damage 19: Bonnet: Bonnet - Scratch(es) - Paint

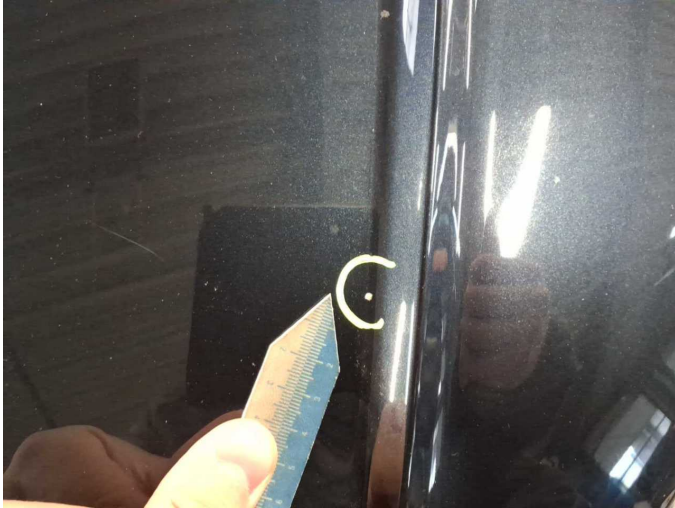
Damage 19: Bonnet: Bonnet - Scratch(es) - Paint

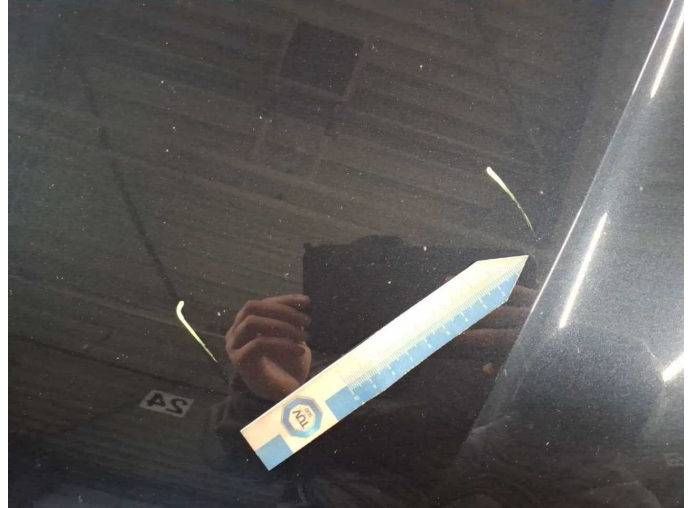
Damage 19: Bonnet: Bonnet - Scratch(es) - Paint

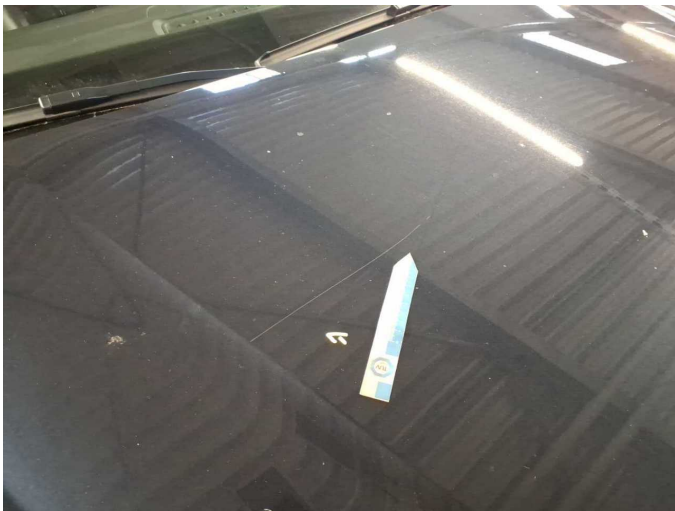
Damage 19: Bonnet: Bonnet - Scratch(es) - Paint

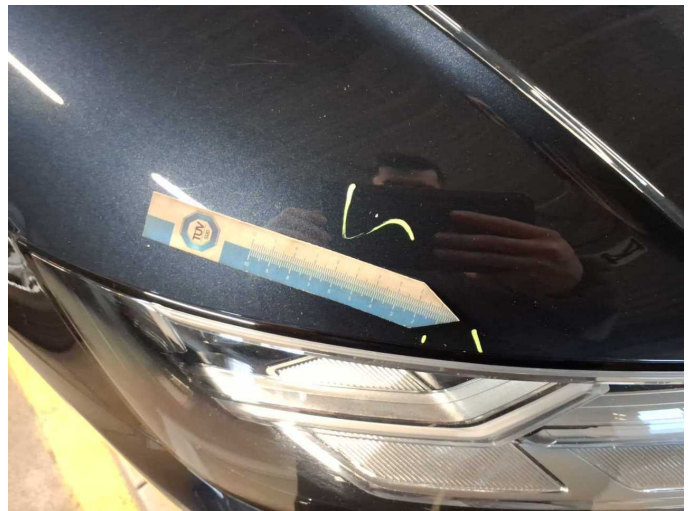
Damage 19: Bonnet: Bonnet - Scratch(es) - Paint

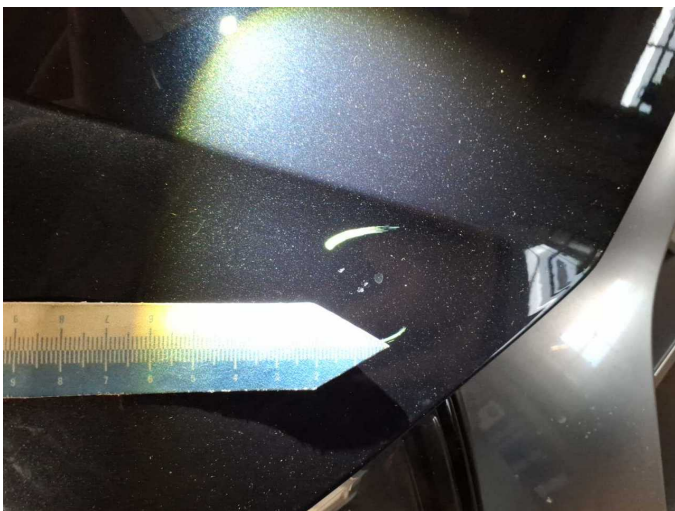
Damage 19: Bonnet: Bonnet - Scratch(es) - Paint

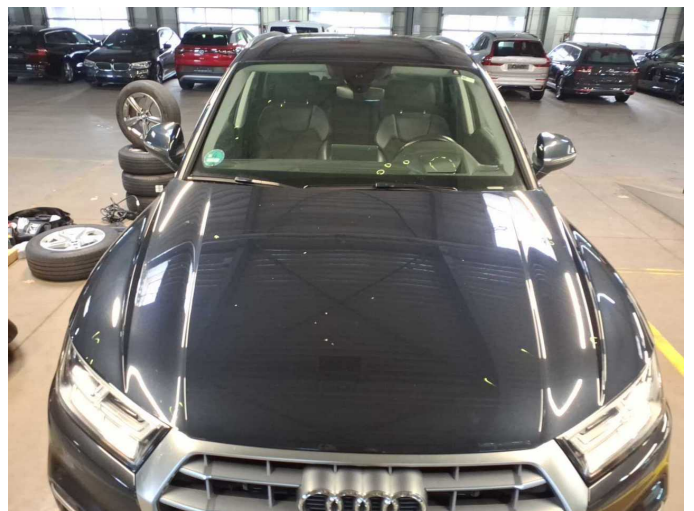
Damage 19: Bonnet: Bonnet - Scratch(es) - Paint

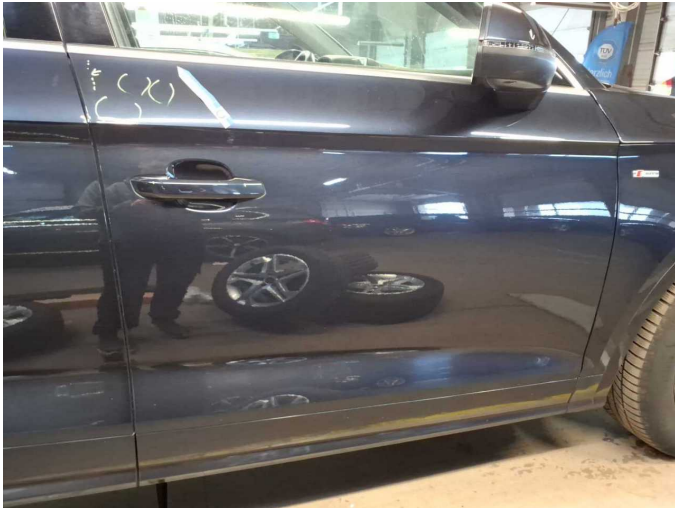
Damage 20: Door - front right side: Door - Deformed - Repair and paint

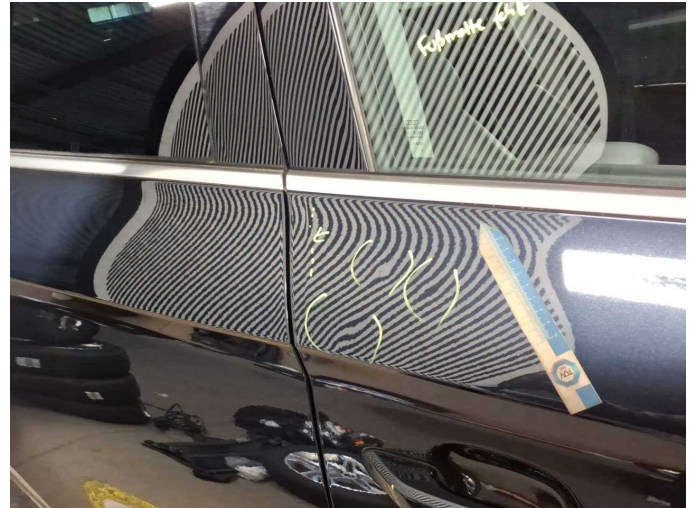
Damage 20: Door - front right side: Door - Deformed - Repair and paint

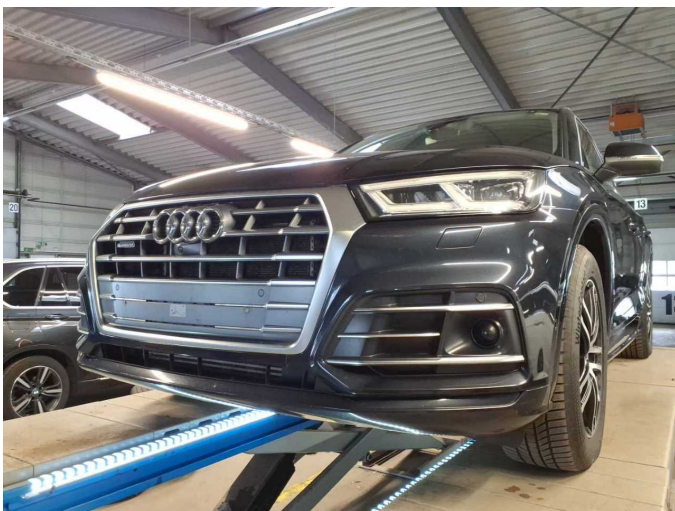
Damage 21: Front bumper: Front bumper - Deformed - Repair and paint

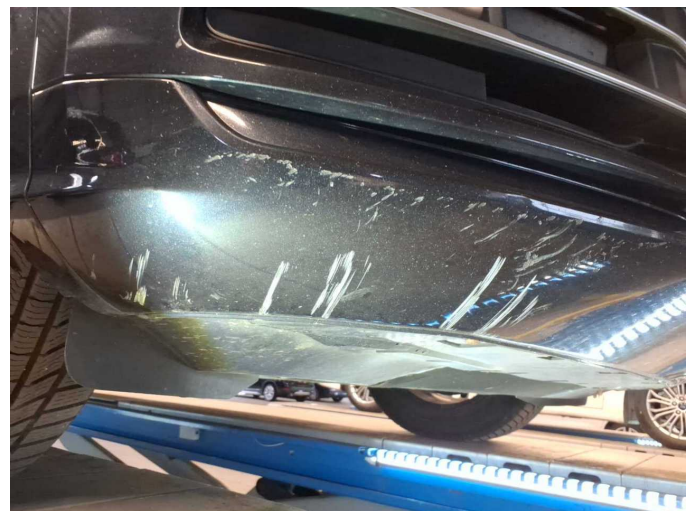
Damage 21: Front bumper: Front bumper - Deformed - Repair and paint

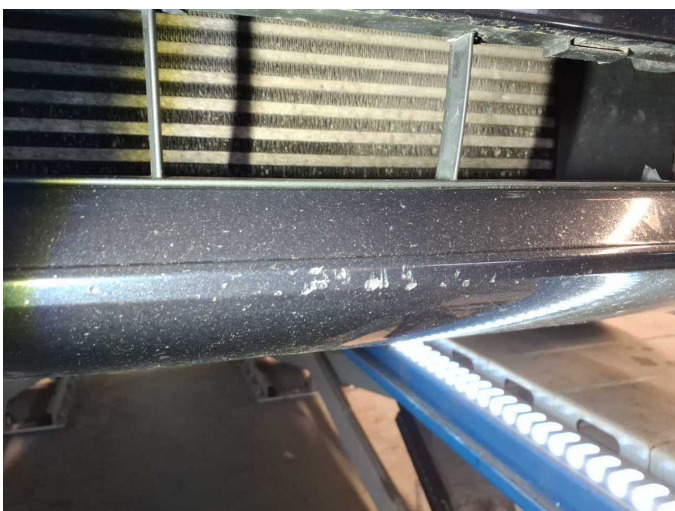
Damage 21: Front bumper: Front bumper - Deformed - Repair and paint

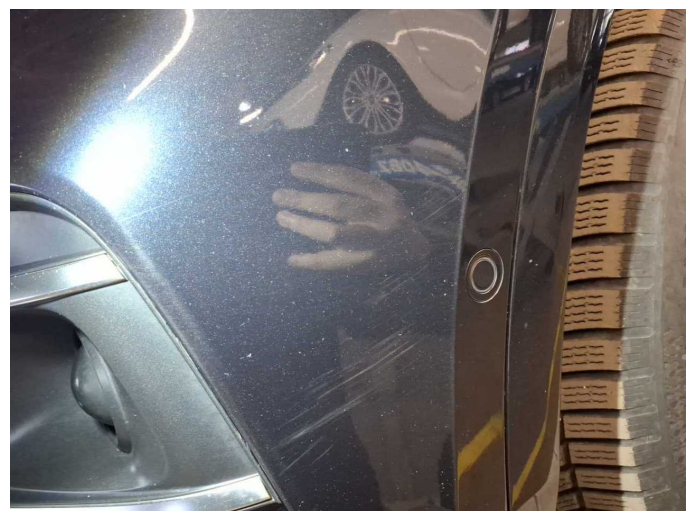
Damage 21: Front bumper: Front bumper - Deformed - Repair and paint

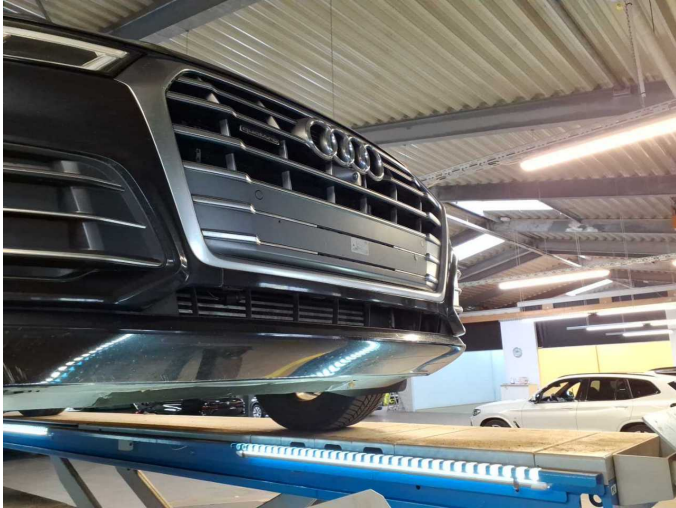
Damage 21: Front bumper: Front bumper - Deformed - Repair and paint

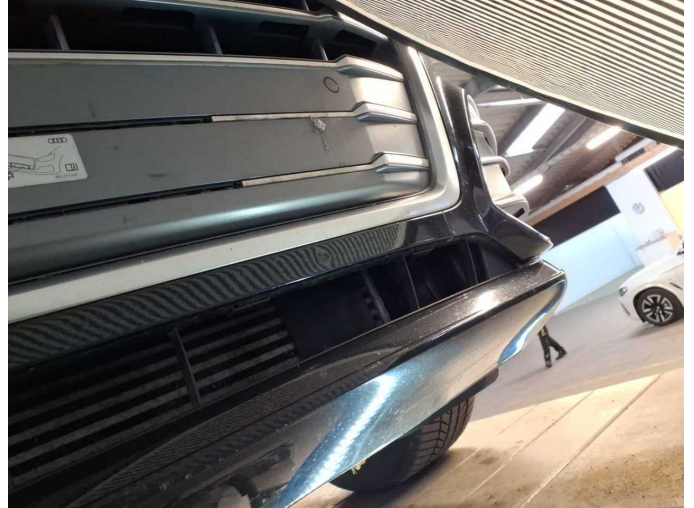
Damage 21: Front bumper: Front bumper - Deformed - Repair and paint
