Protocol number: 45484776
Order No. / Reference: 26044159
Inspection date: 15 May 2026

Manufacturer: Audi

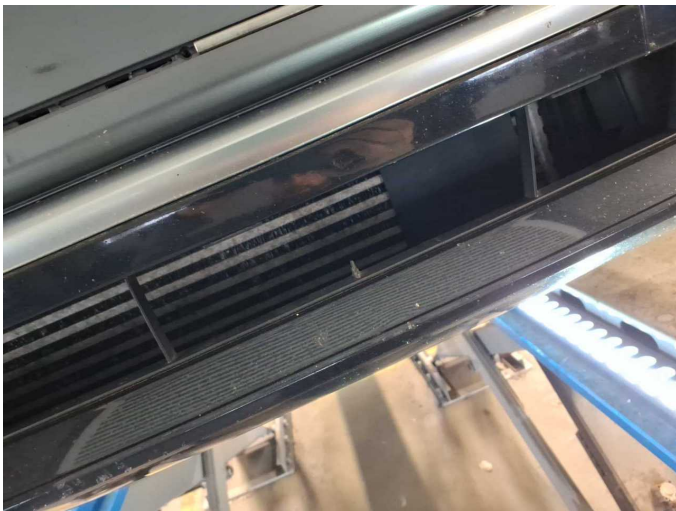
Damage 21: Front bumper: Front bumper - Deformed - Repair and paint

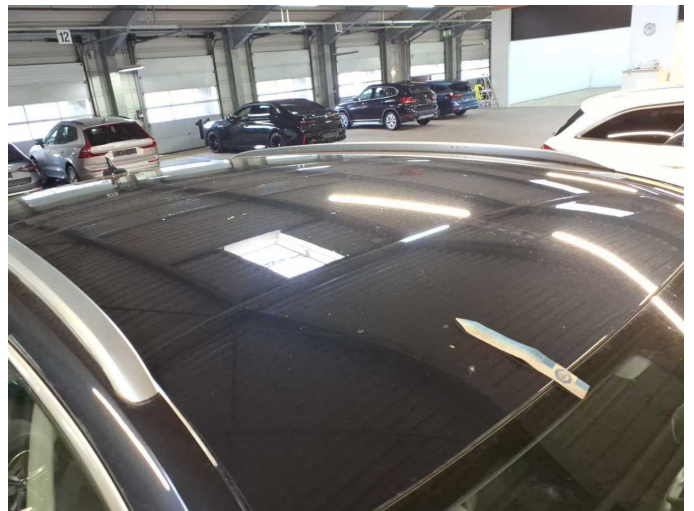
Damage 22: Roof: Roof - Dent / paintcoat damage - Paint

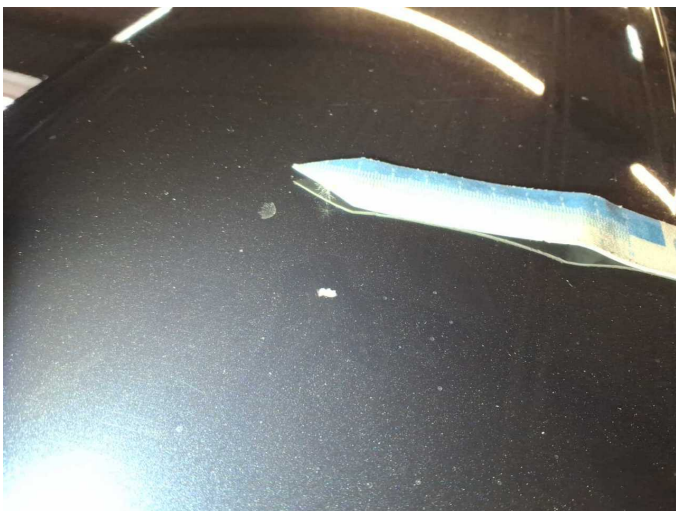
Damage 22: Roof: Roof - Dent / paintcoat damage - Paint

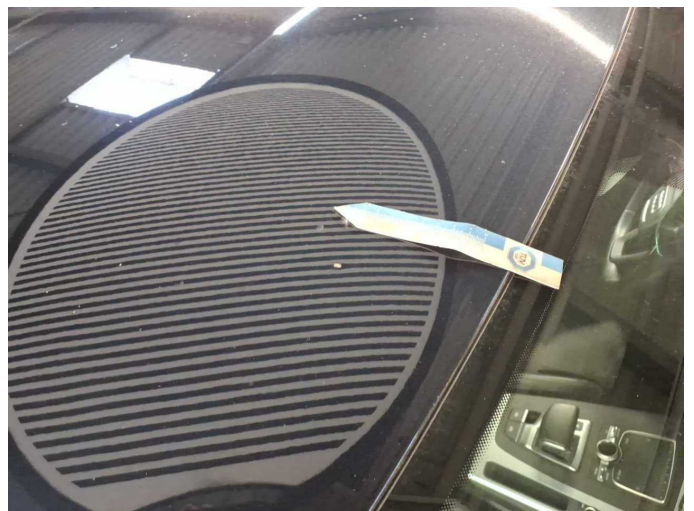
Damage 22: Roof: Roof - Dent / paintcoat damage - Paint

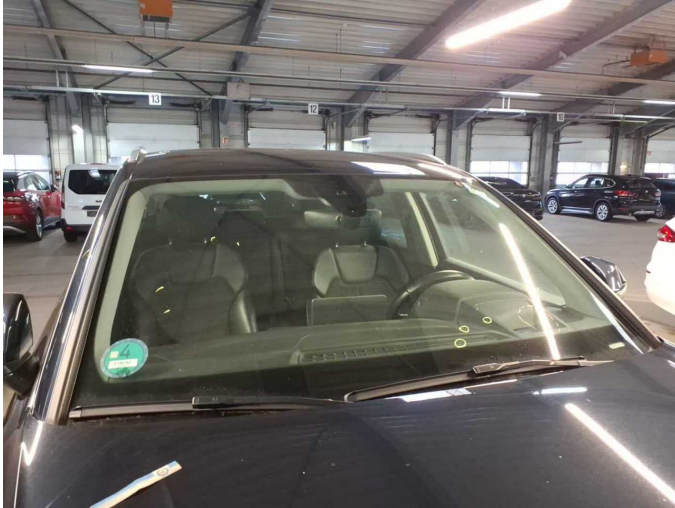
Wear and tear 1: Vehicle glazing: Windscreen - Stone chips - No deduction

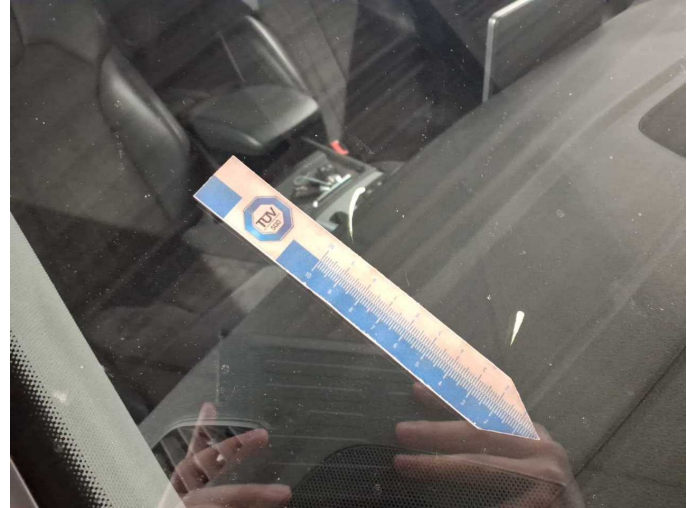
Wear and tear 1: Vehicle glazing: Windscreen - Stone chips - No deduction

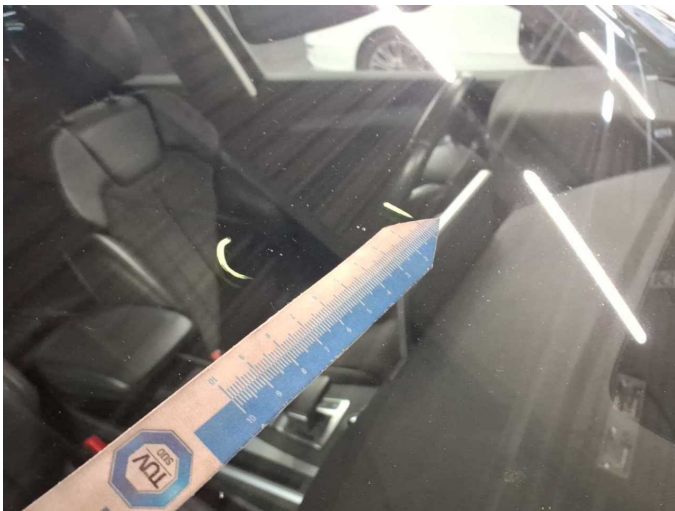
Wear and tear 1: Vehicle glazing: Windscreen - Stone chips - No deduction

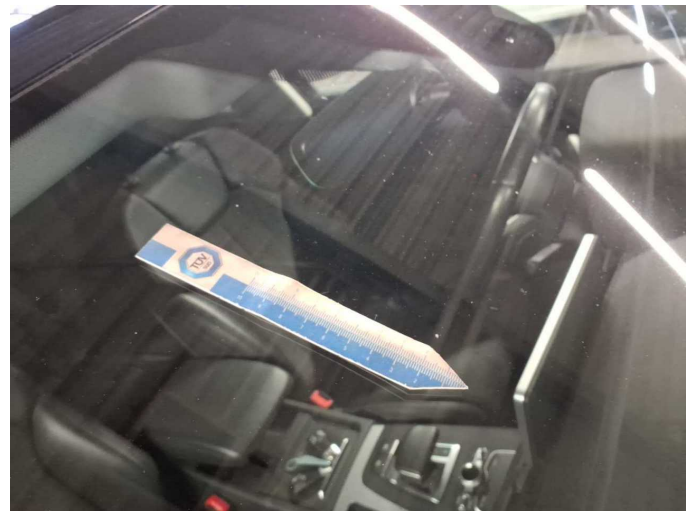
Wear and tear 1: Vehicle glazing: Windscreen - Stone chips - No deduction

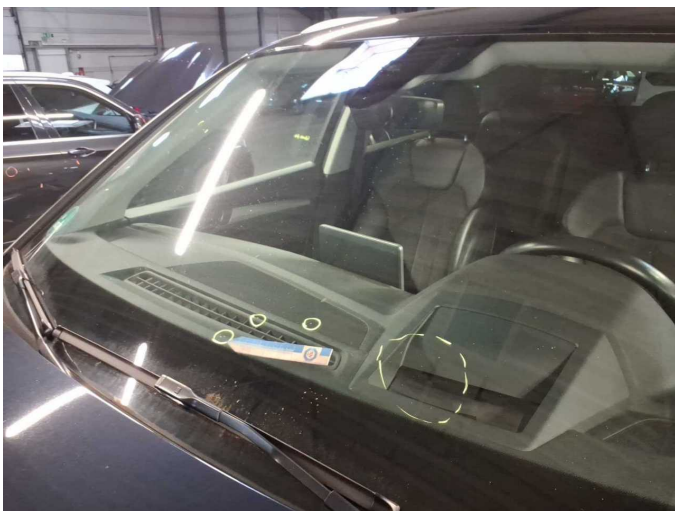
Wear and tear 1: Vehicle glazing: Windscreen - Stone chips - No deduction

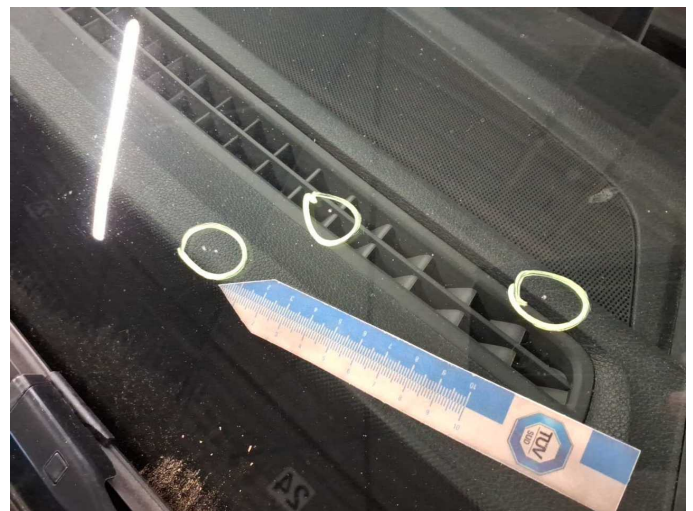
Wear and tear 1: Vehicle glazing: Windscreen - Stone chips - No deduction

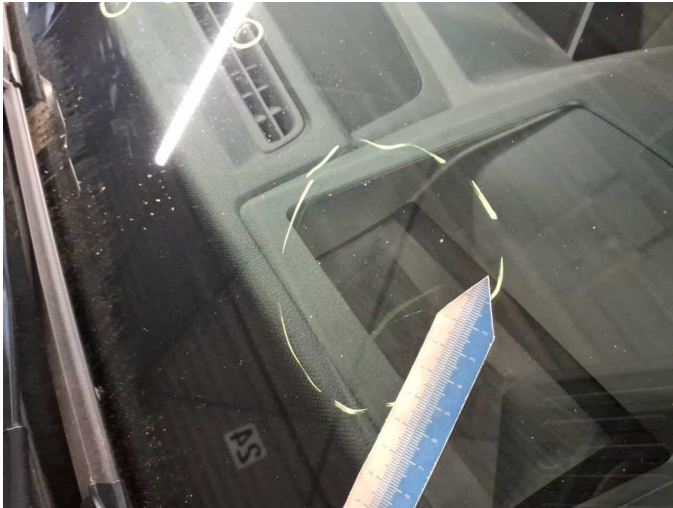
Wear and tear 1: Vehicle glazing: Windscreen - Stone chips - No deduction

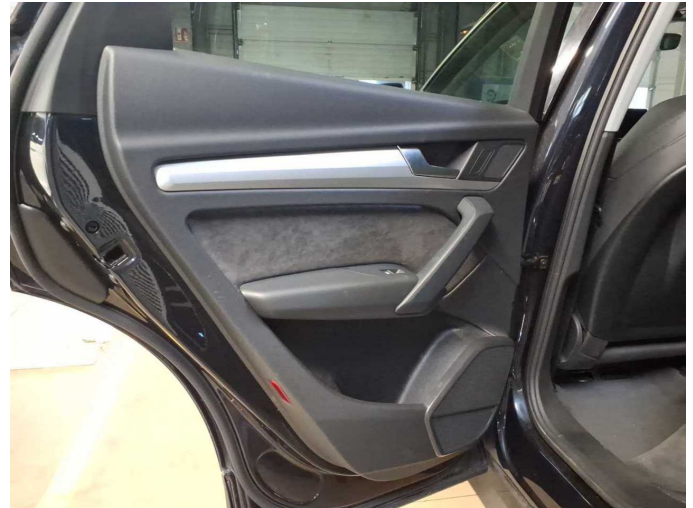
Wear and tear 2: Trim / covers: Door trim - rear left side - Deformed - No deduction

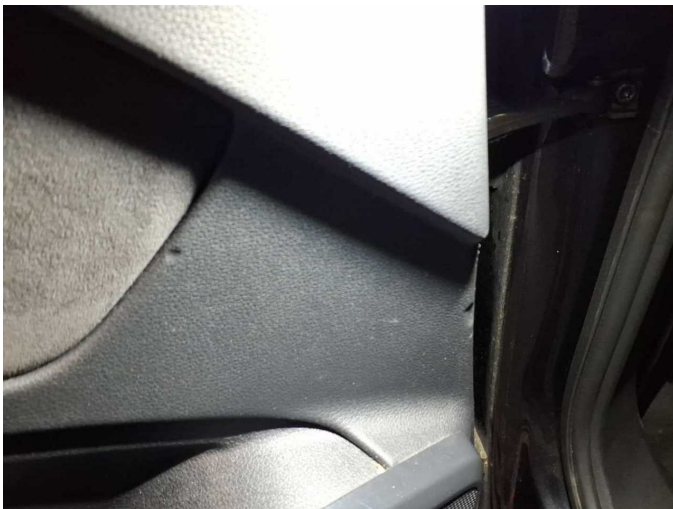
Wear and tear 2: Trim / covers: Door trim - rear left side - Deformed - No deduction

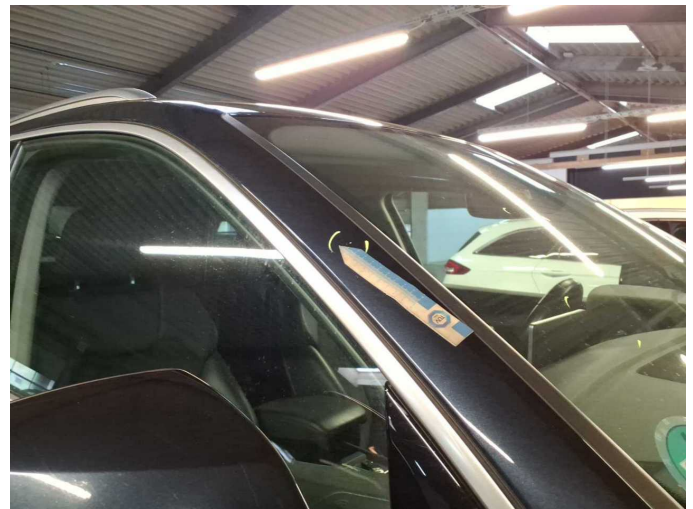
Wear and tear 3: Body: A-pillar - right side - Stone chips - No deduction

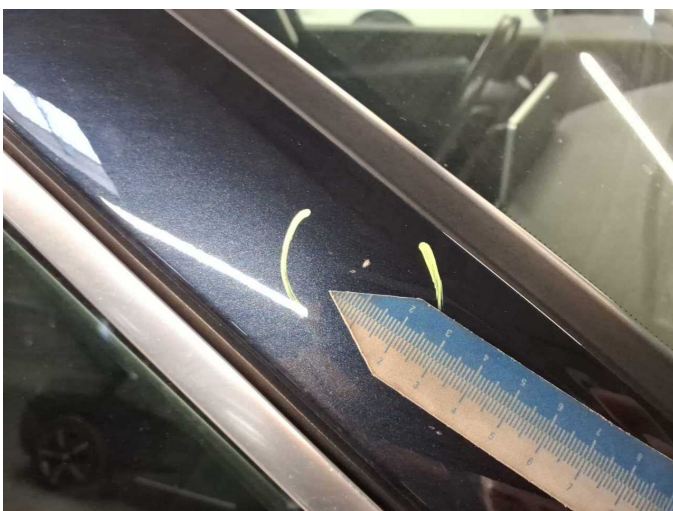
Wear and tear 3: Body: A-pillar - right side - Stone chips - No deduction

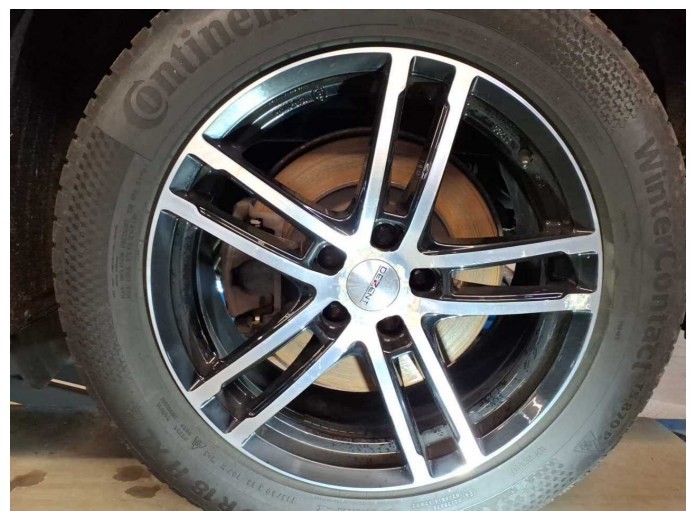
Wear and tear 4: Wheel / tyres: Wheel rim - rear left side - Scratch(es) - No deduction

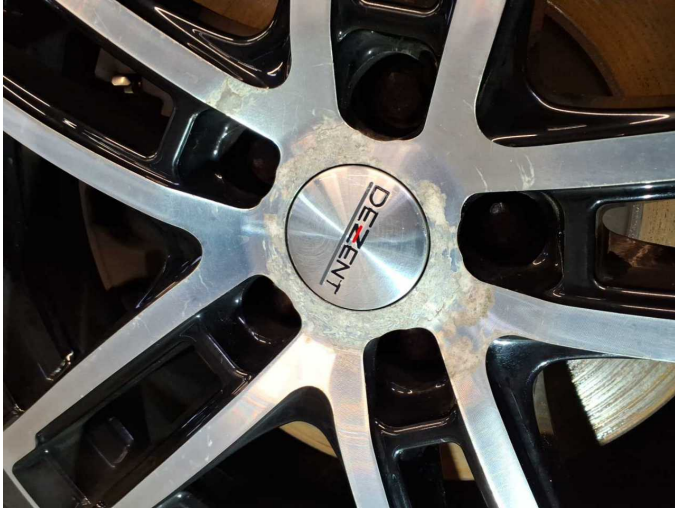
Wear and tear 4: Wheel / tyres: Wheel rim - rear left side - Scratch(es) - No deduction

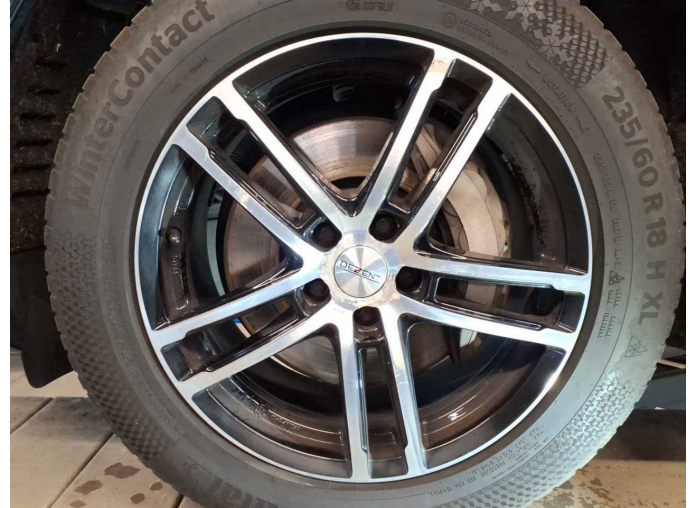
Wear and tear 5: Wheel / tyres: Wheel rim - front left side - Scratch(es) - No deduction

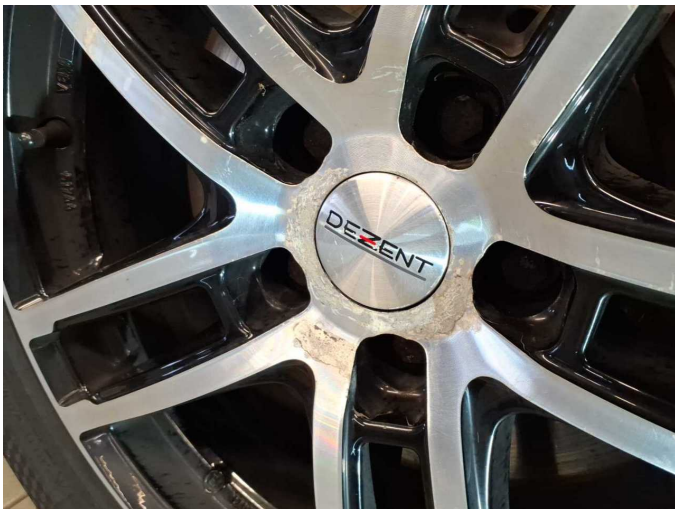
Wear and tear 5: Wheel / tyres: Wheel rim - front left side - Scratch(es) - No deduction

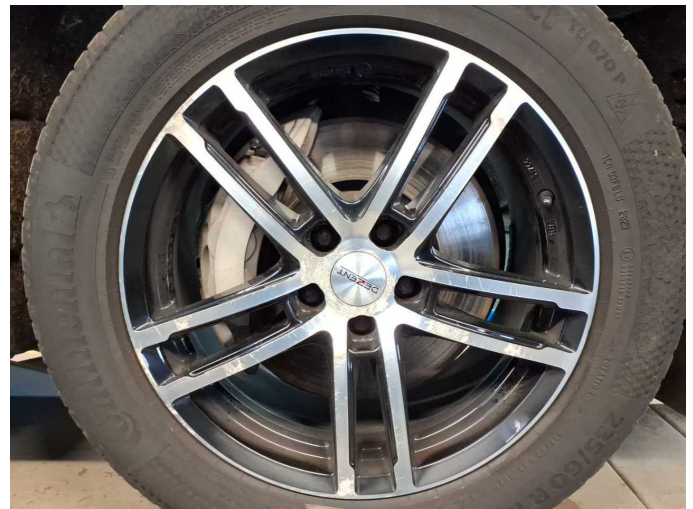
Wear and tear 6: Wheel / tyres: Wheel rim - front right side - Scratch(es) - No deduction

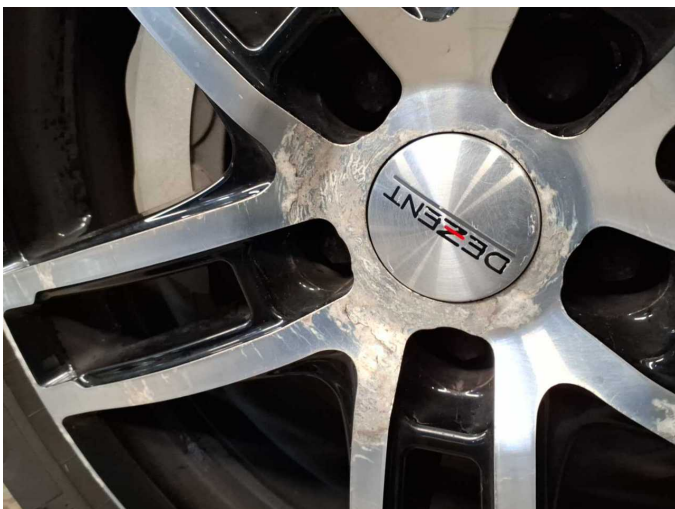
Wear and tear 6: Wheel / tyres: Wheel rim - front right side - Scratch(es) - No deduction

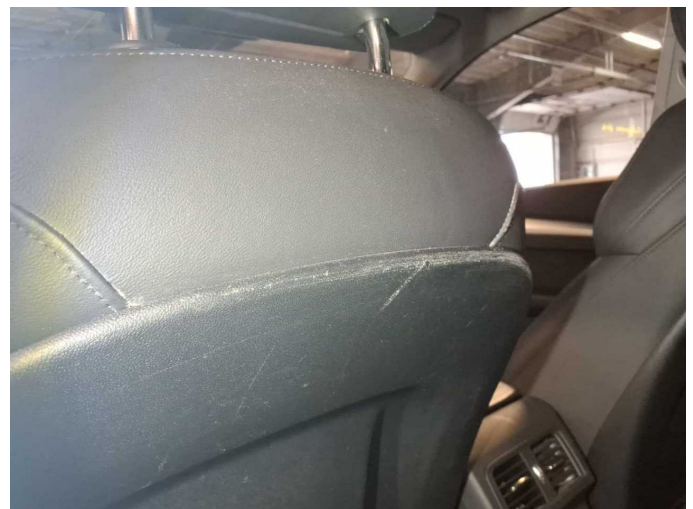
Wear and tear 7: Seat - front: Seat cover - left side - Scratch(es) - No deduction

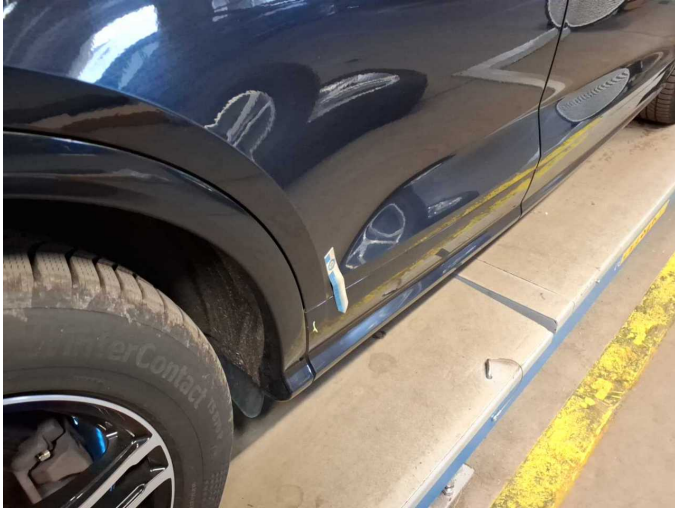
Wear and tear 8: Door - rear right side: Brightware - lower - Scratch(es) - No deduction

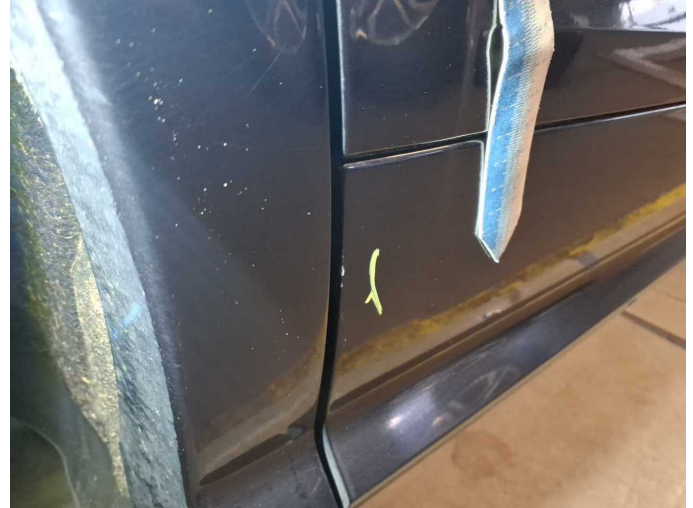
Wear and tear 8: Door - rear right side: Brightware - lower - Scratch(es) - No deduction

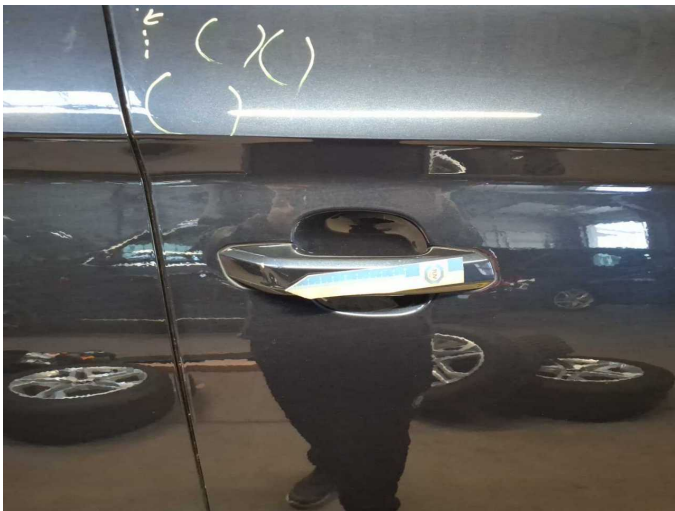
Wear and tear 9: Door - front right side: Door handle - outside - Scratch(es) - No deduction

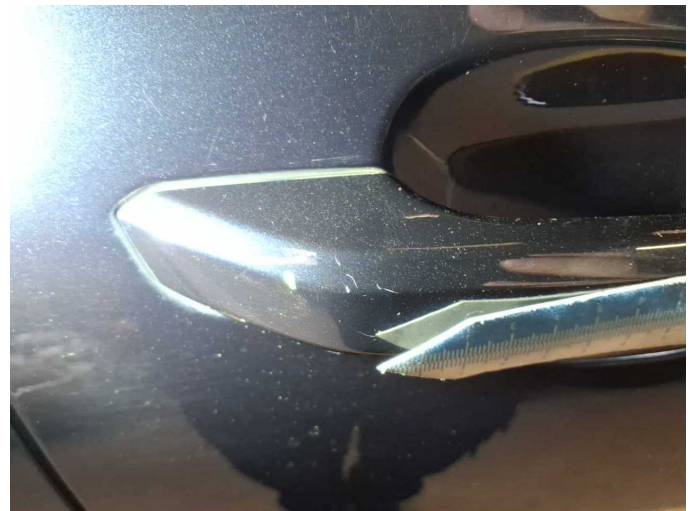
Wear and tear 9: Door - front right side: Door handle - outside - Scratch(es) - No deduction

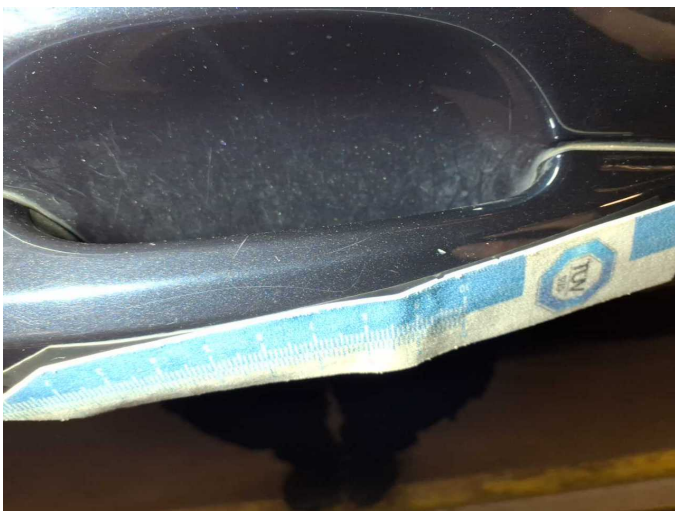
Wear and tear 9: Door - front right side: Door handle - outside - Scratch(es) - No deduction

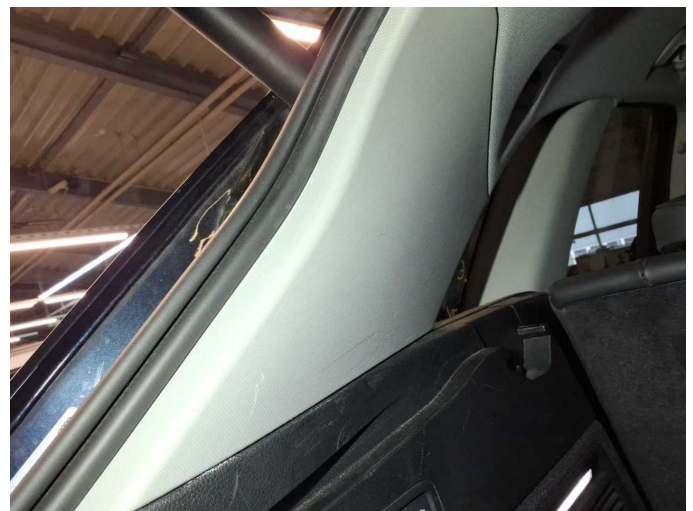
Wear and tear 10: Trim / covers: Boot lining - Scratch(es) - No deduction

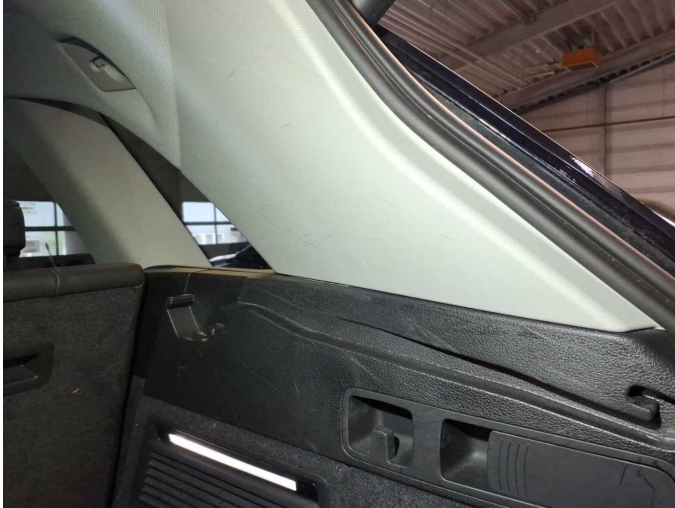
Wear and tear 10: Trim / covers: Boot lining - Scratch(es) - No deduction

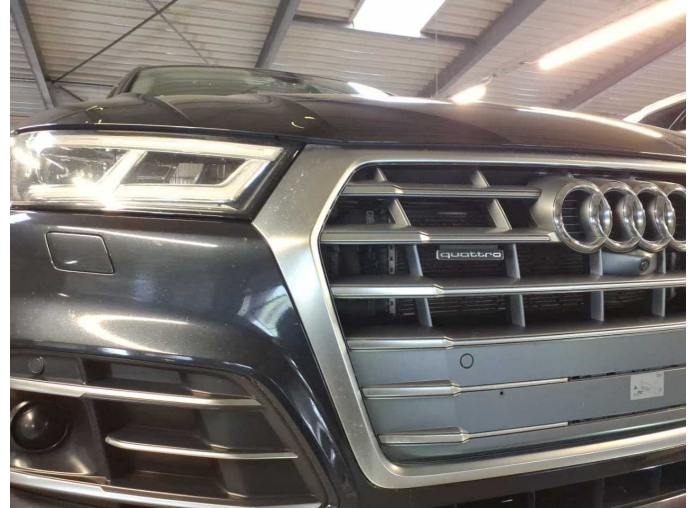
Wear and tear 11: Bonnet: Radiator grille - Stone chips - No deduction

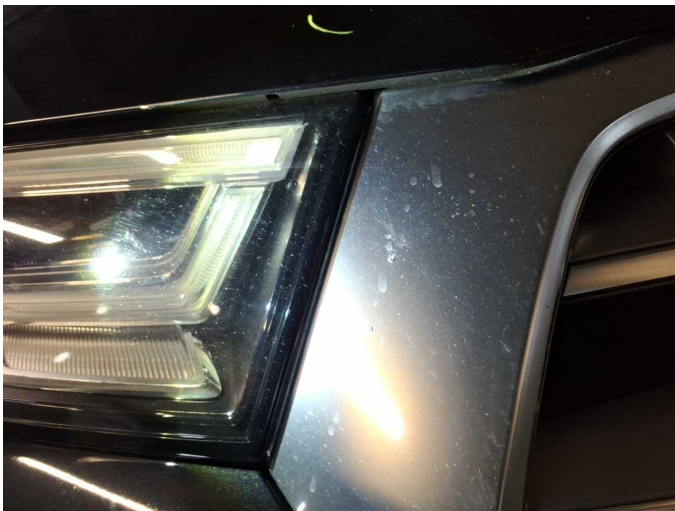
Wear and tear 11: Bonnet: Radiator grille - Stone chips - No deduction

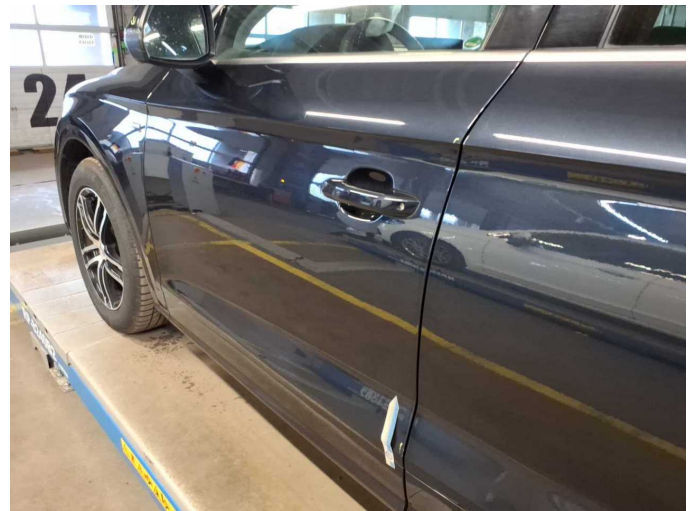
Wear and tear 12: Door - front left side: Door - Scratch(es) - Cover / polish

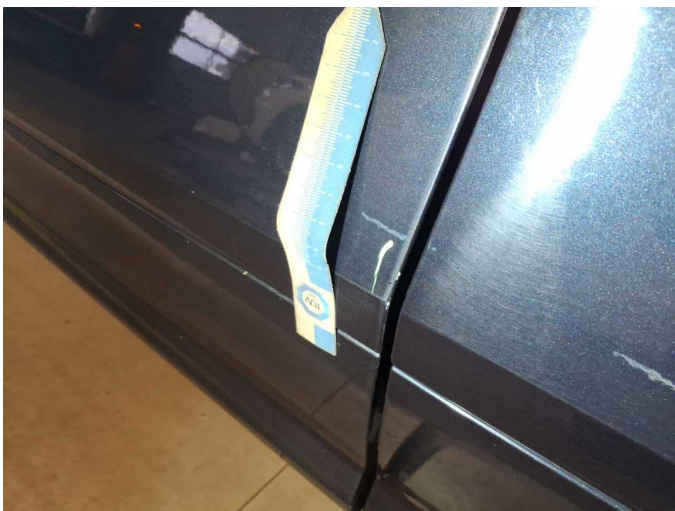
Wear and tear 12: Door - front left side: Door - Scratch(es) - Cover / polish

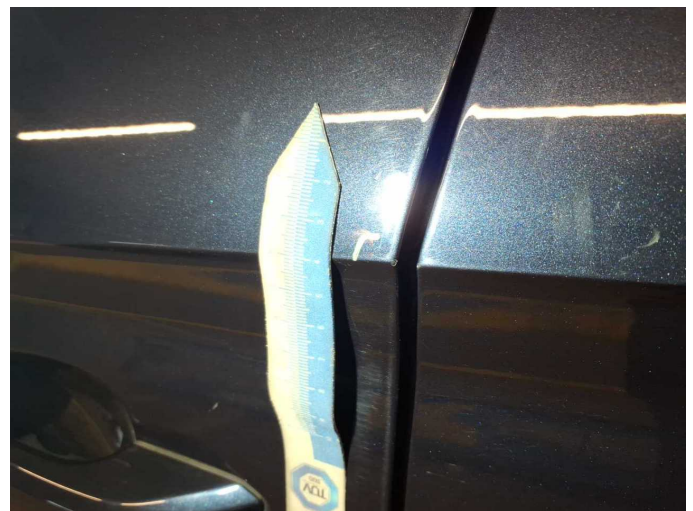
Wear and tear 12: Door - front left side: Door - Scratch(es) - Cover / polish

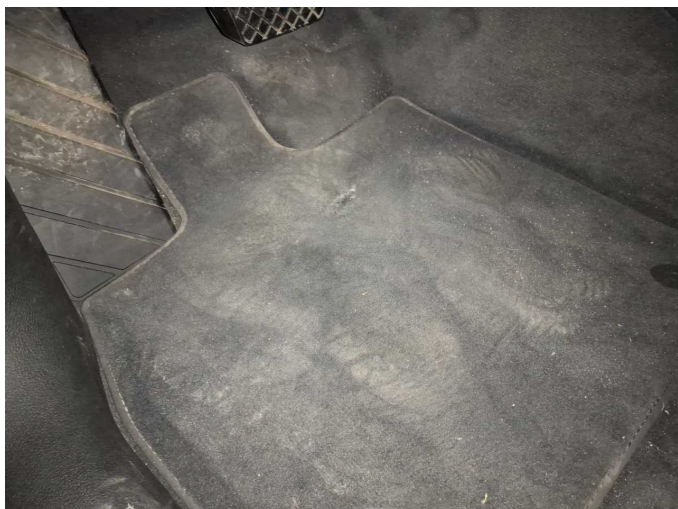
Wear and tear 13: Trim / covers: Floor mats - Broken / torn - No deduction

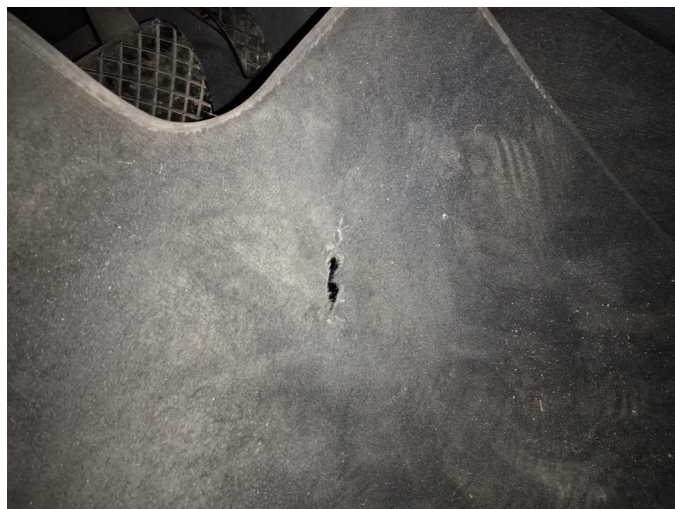
Wear and tear 13: Trim / covers: Floor mats - Broken / torn - No deduction
