Expertise

Protocol number: 46606902  
Order No. / Reference: 26692301  
Inspection date: 14 Jul 2026

Manufacturer: Skoda  
VIN: TMBJJ7NEXL0144318

Model: Octavia Combi 2.0 TDI DSG Style

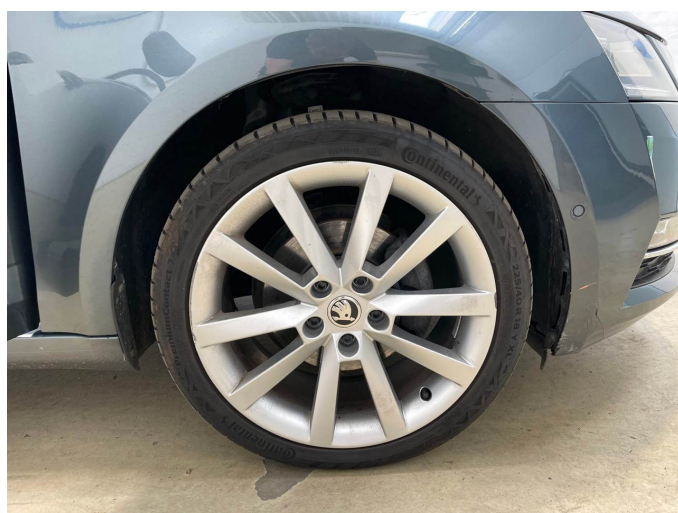
| # | Tyre size | Type of tyre | Manufacturer | Tread depth |
|---|---|---|---|---|
| 1) | 225/40 R18 92Y | Summer tyres on Light alloy | Continental | 5mm / 5mm |
| 2) | 225/40 R18 92Y | Summer tyres on Light alloy | Continental | 5mm / 5mm |

Figure 12: Mounted tyres

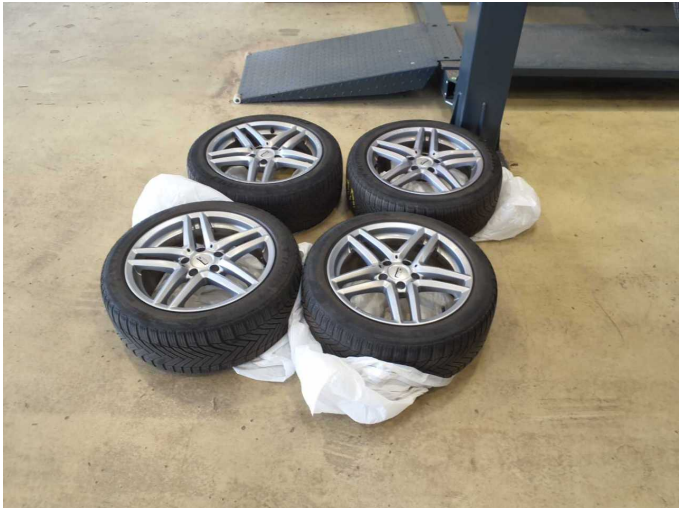
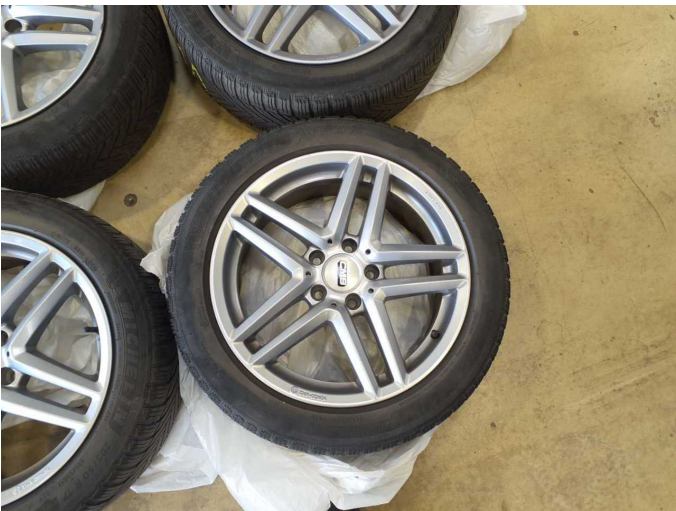
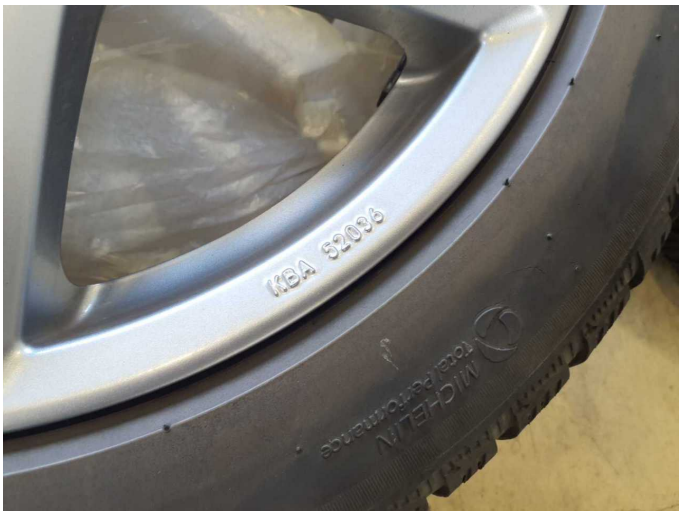
| # | Tyre size | Type of tyre | Manufacturer | Tread depth |
|---|---|---|---|---|
| 1) | 205/50 R17 93V | Winter tyres on Light alloy | Michelin | 3mm / 3mm |
| 2) | 205/50 R17 93V | Winter tyres on Light alloy | Michelin | 2mm / 2mm |

Figure 14: Additional tyres

Figure 15: Additional tyres

Figure 16: Additional tyres

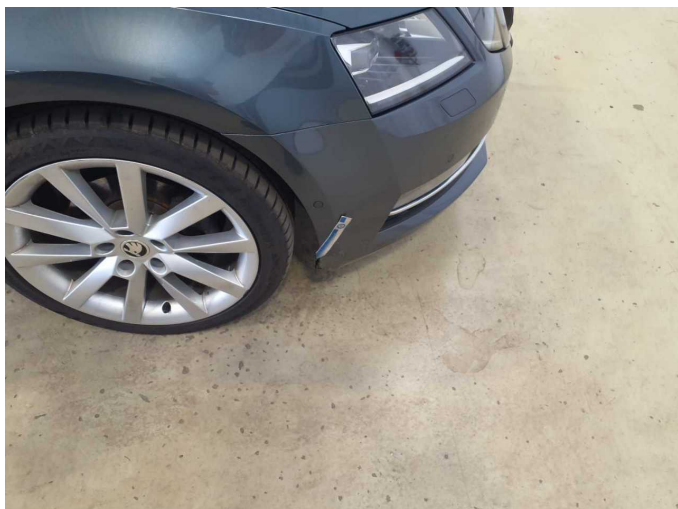
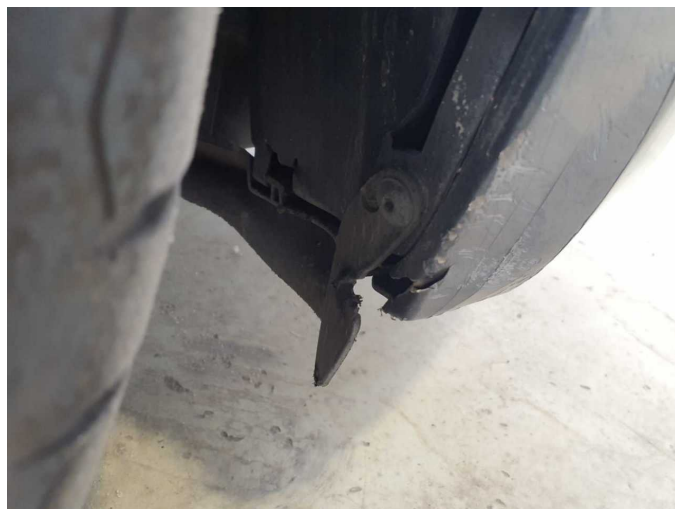
| No. | Component group | Description |
|---|---|---|
| 2 | Body | Wheel well - front right side - Broken / torn - Replace |

**Damage 2:** Body: Wheel well - front right side - Broken / torn - Replace

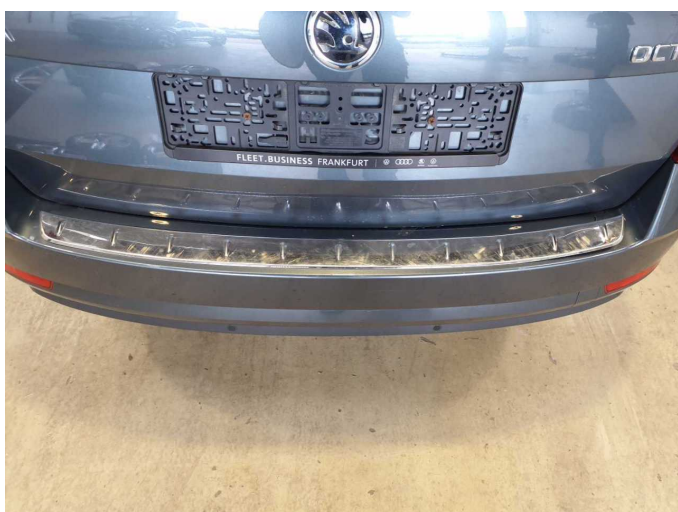
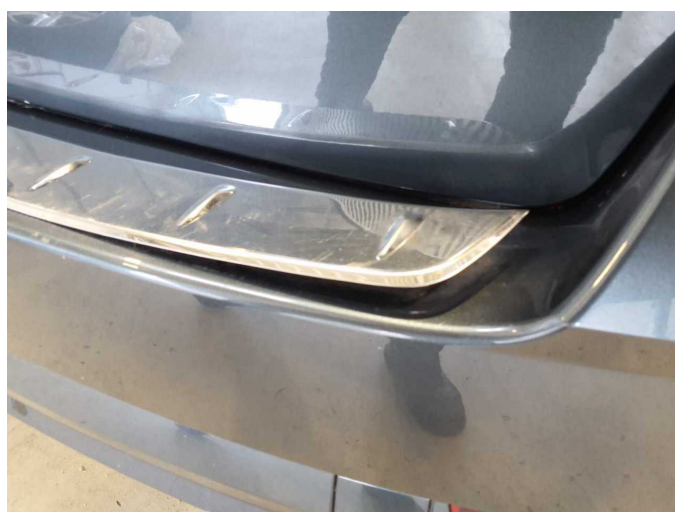
| No. | Component group | Description |
|---|---|---|
| 3 | Trim / covers | Boot sill cover - Loose - Replace |

**Damage 3:** Trim / covers: Boot sill cover - Loose - Replace

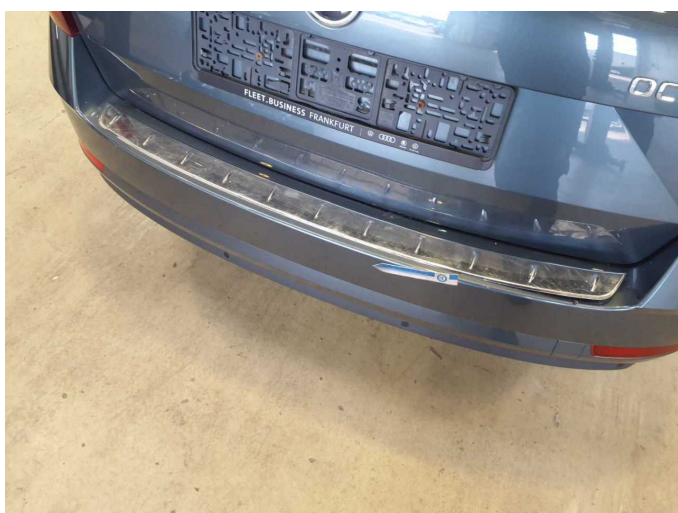
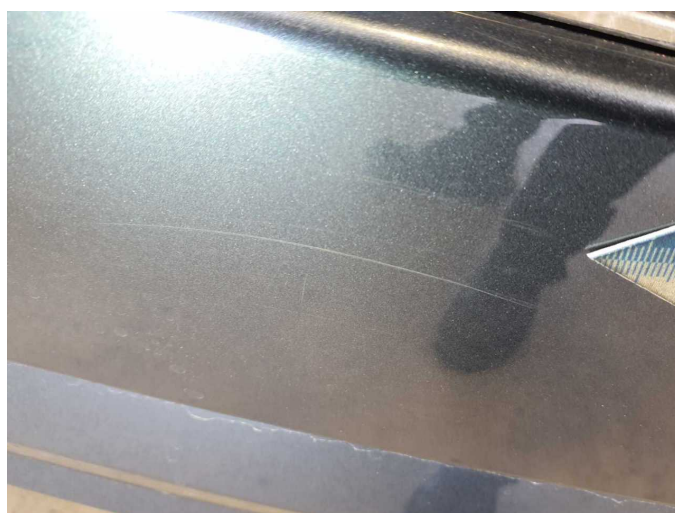
| No. | Component group | Description |
|---|---|---|
| 4 | Rear bumper | Rear bumper - Scratch(es) - Smart repair |

**Damage 4:** Rear bumper: Rear bumper - Scratch(es) - Smart repair

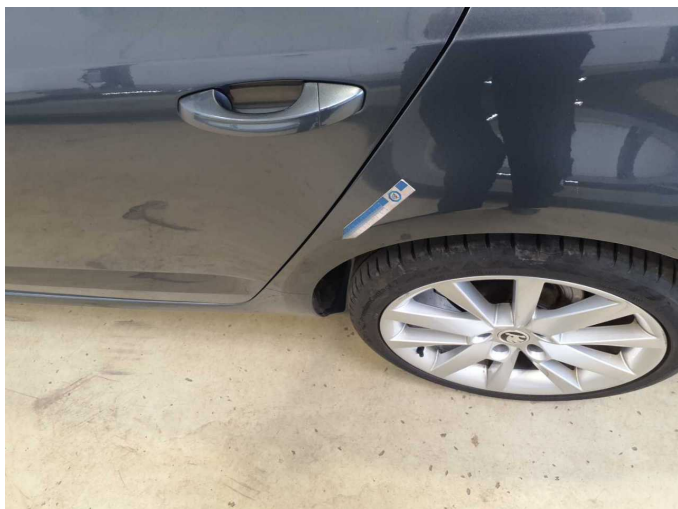
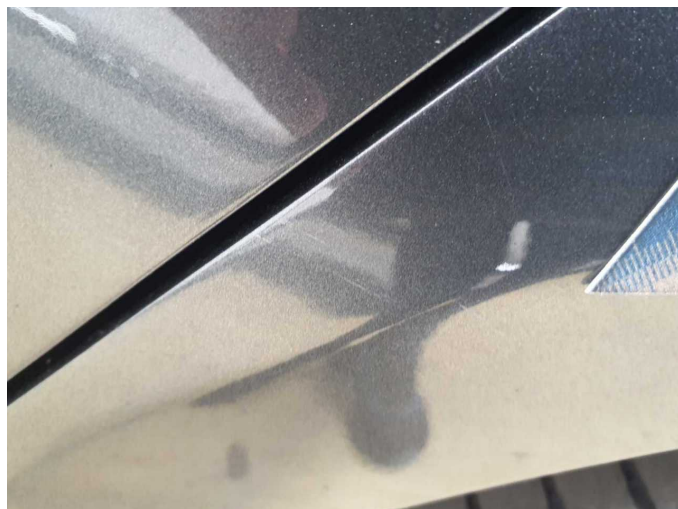
| No. | Component group | Description |
|---|---|---|
| 5 | Side panel - rear left side | Side panel - Scratch(es) - Smart repair |

**Damage 5:** Side panel - rear left side: Side panel - Scratch(es) - Smart repair

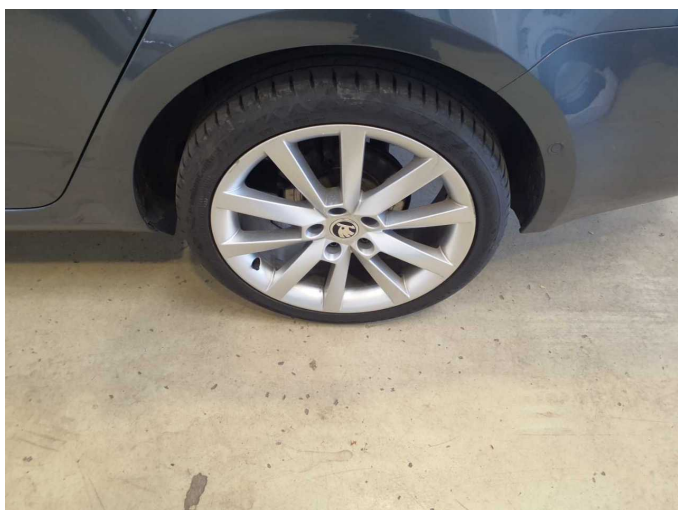
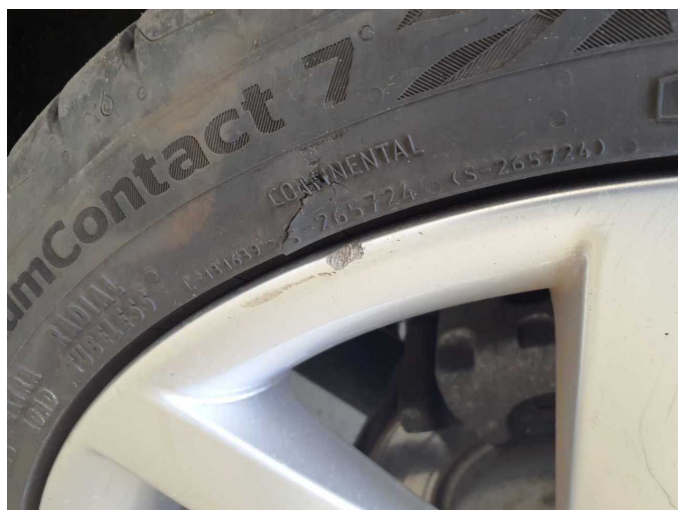
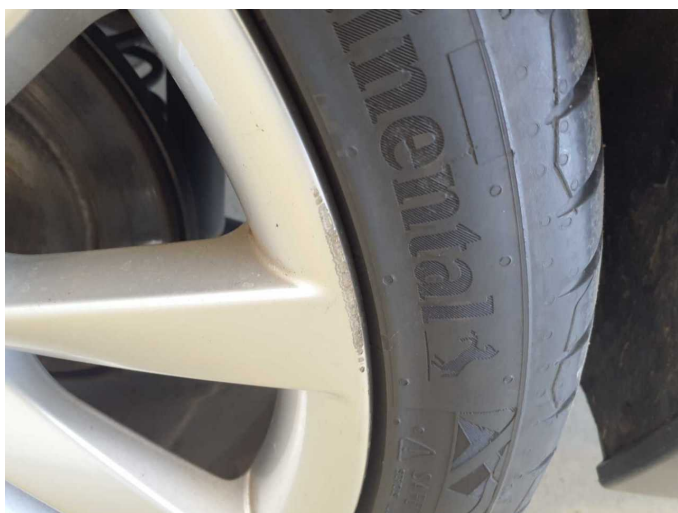
| No. | Component group | Description |
|---|---|---|
| 6 | Wheel / tyres | Alloy rim - rear left side - Scratch(es) - Loss in value |

**Damage 6:** Wheel / tyres: Alloy rim - rear left side - Scratch(es) - Loss in value

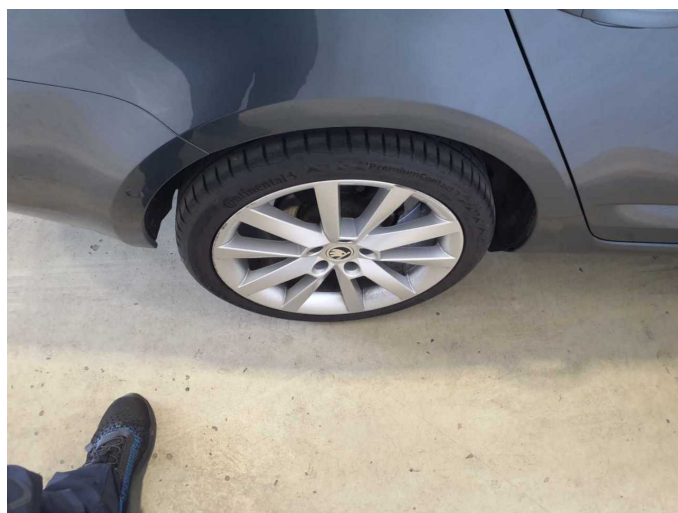
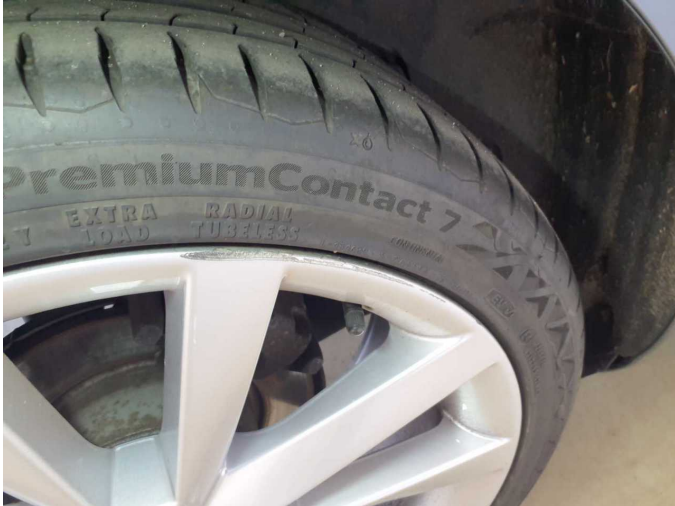
| No. | Component group | Description |
|---|---|---|
| 7 | Wheel / tyres | Alloy rim - rear right side - Scratch(es) - Loss in value |

**Damage 7:** Wheel / tyres: Alloy rim - rear right side - Scratch(es) - Loss in value

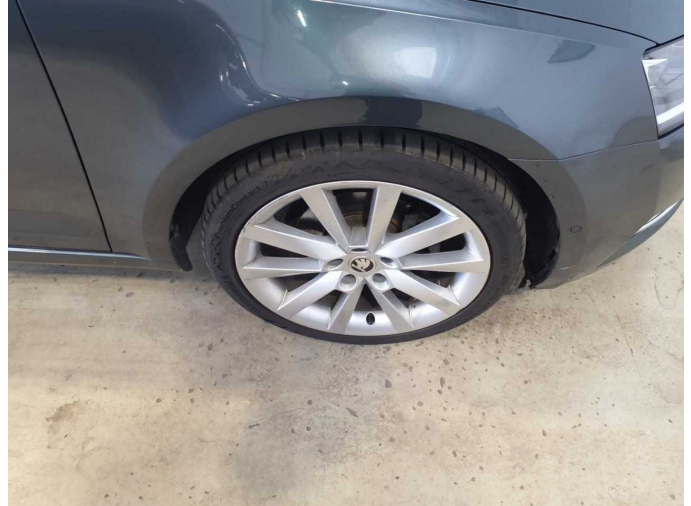
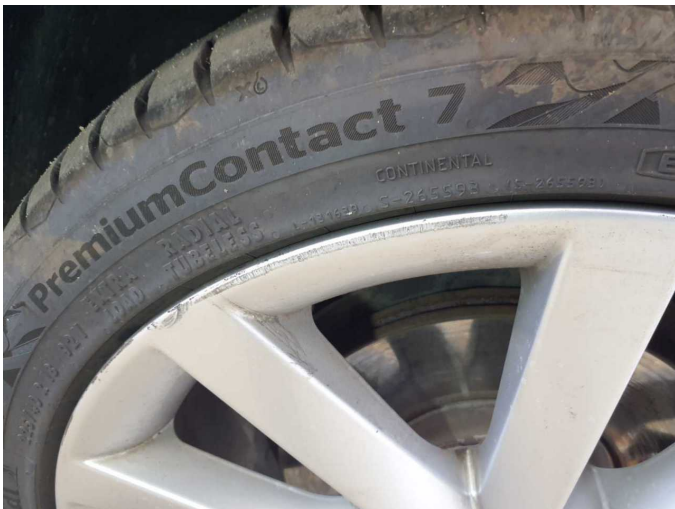
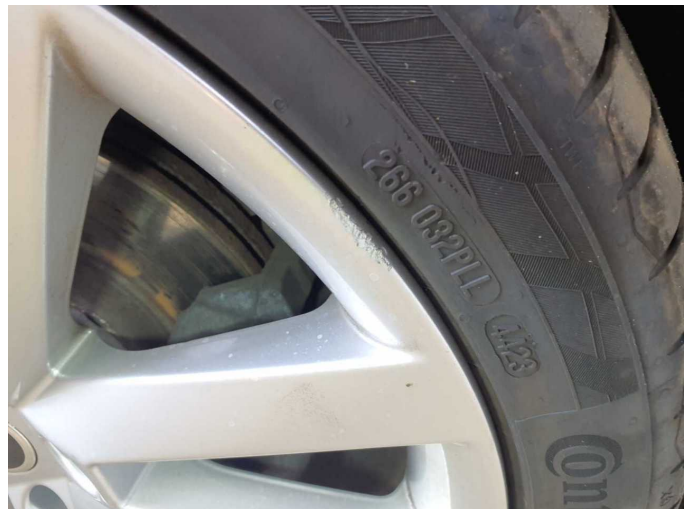
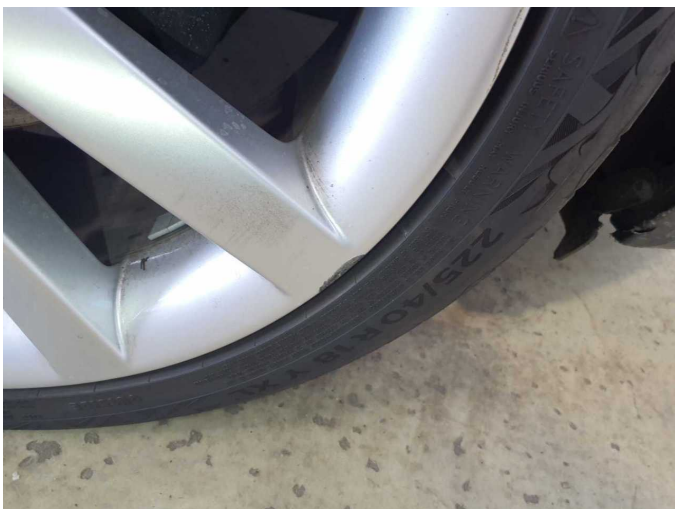
| No. | Component group | Description |
|---|---|---|
| 8 | Wheel / tyres | Alloy rim - front right side - Scratch(es) - Loss in value |

**Damage 8:** Wheel / tyres: Alloy rim - front right side - Scratch(es) - Loss in value

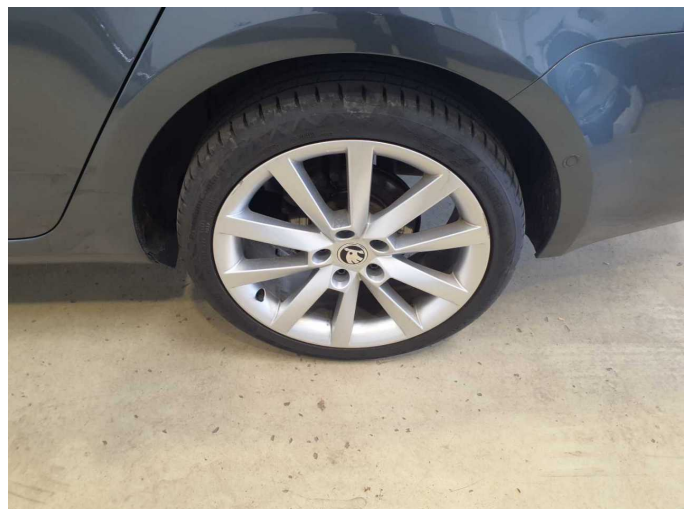
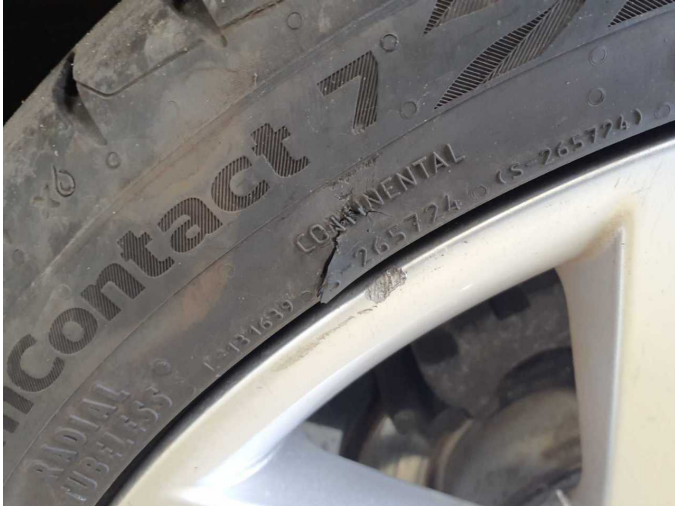
| No. | Component group | Description |
|---|---|---|
| 9 | Wheel / tyres | Tyre - rear left side - Broken / torn - Replace |

**Damage 9:** Wheel / tyres: Tyre - rear left side - Broken / torn - Replace

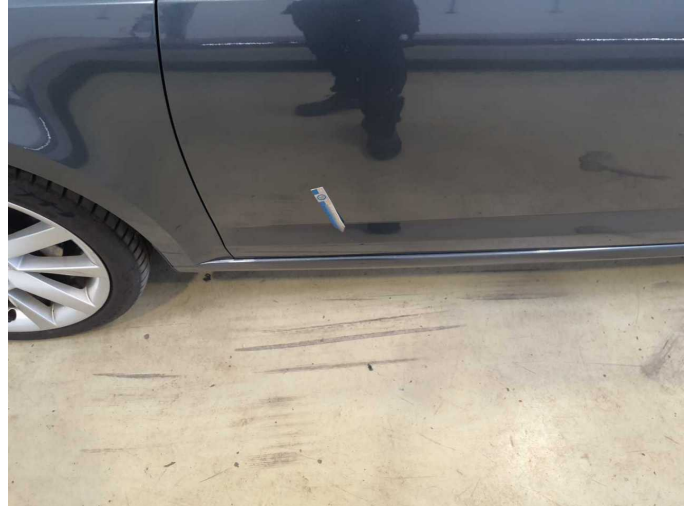
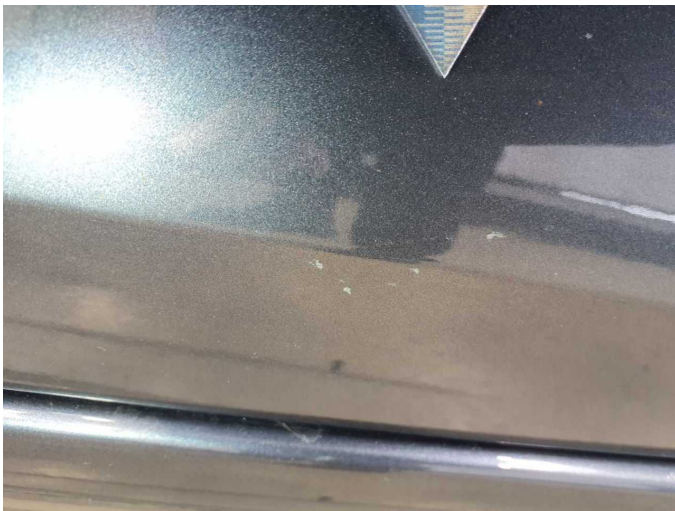
| No. | Component group | Description |
|---|---|---|
| 10 | Door - front left side | Door - Scratch(es) - Paint |

**Damage 10:** Door - front left side: Door - Scratch(es) - Paint

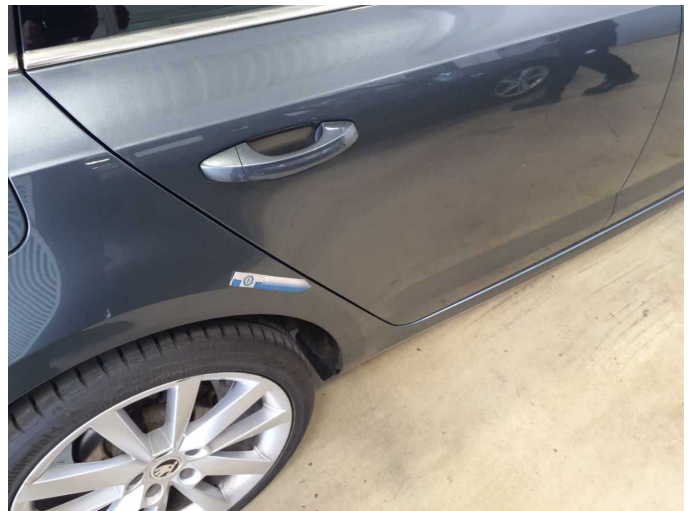
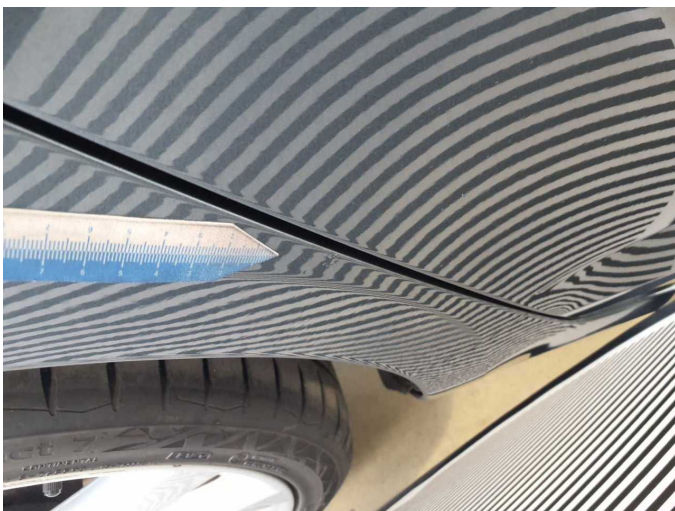
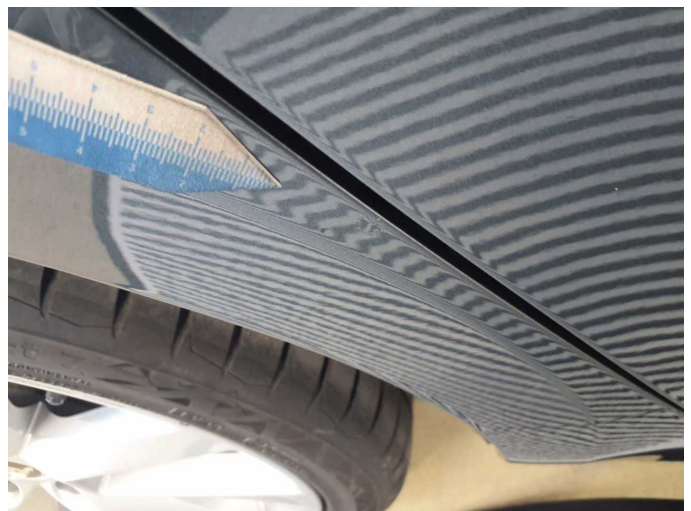
| No. | Component group | Description |
|---|---|---|
| 11 | Side panel - rear right side | Side panel - Corrosion - Repair and paint |

**Damage 11:** Side panel - rear right side: Side panel - Corrosion - Repair and paint

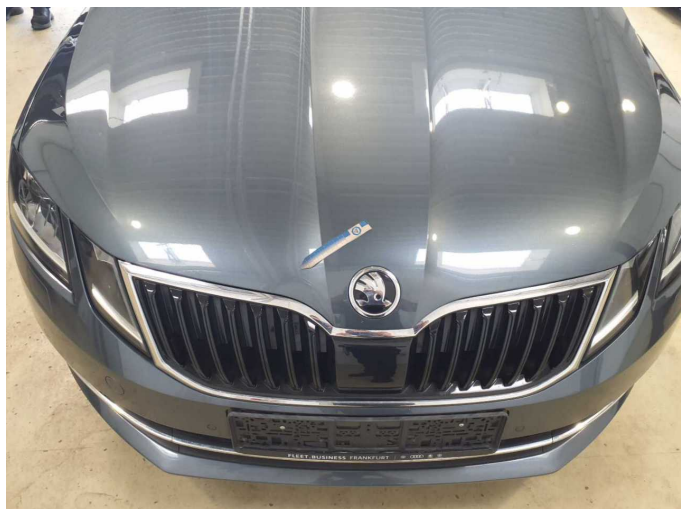
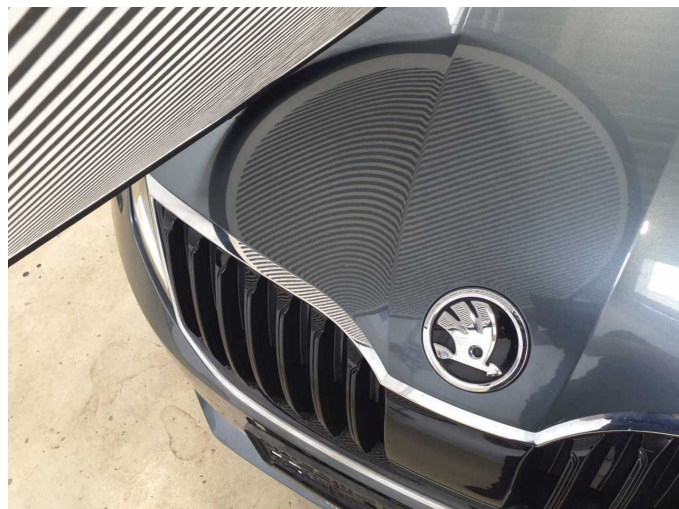
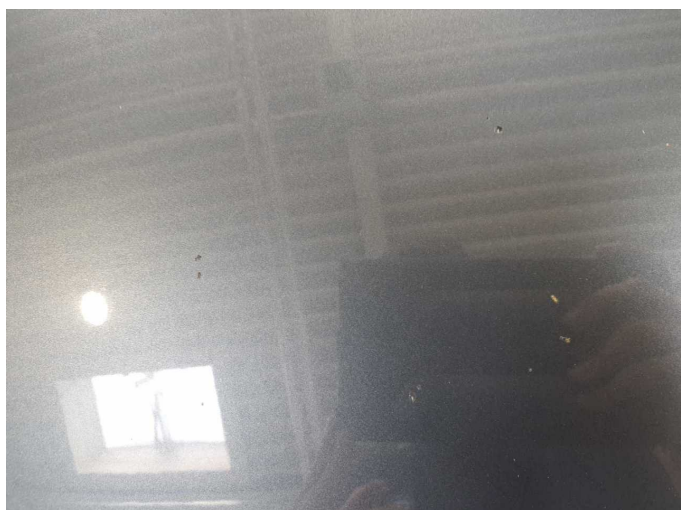
| No. | Component group | Description |
|---|---|---|
| 12 | Bonnet | Bonnet (+ Steinschläge) - Dent / paintcoat damage - Paint |

**Damage 12:** Bonnet: Bonnet (+ Steinschläge) - Dent / paintcoat damage - Paint

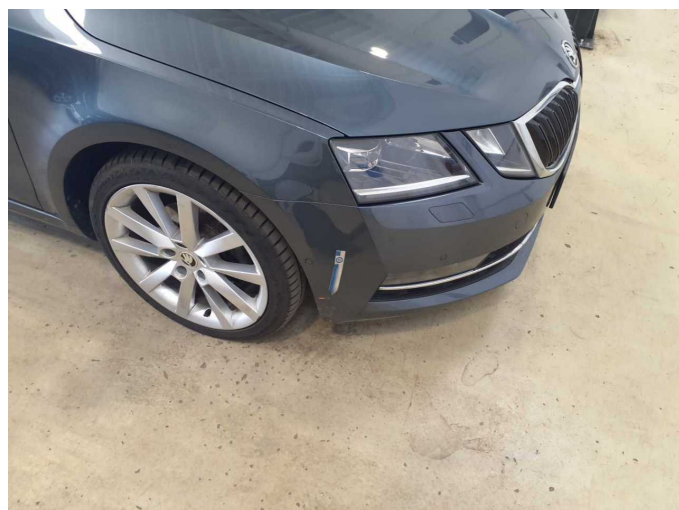
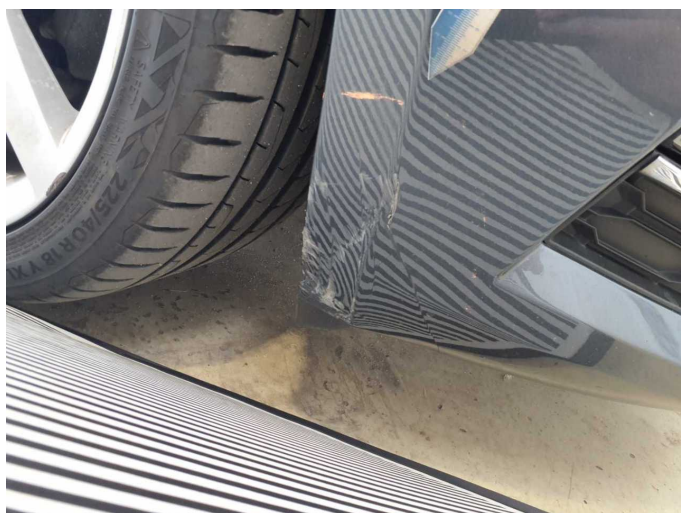
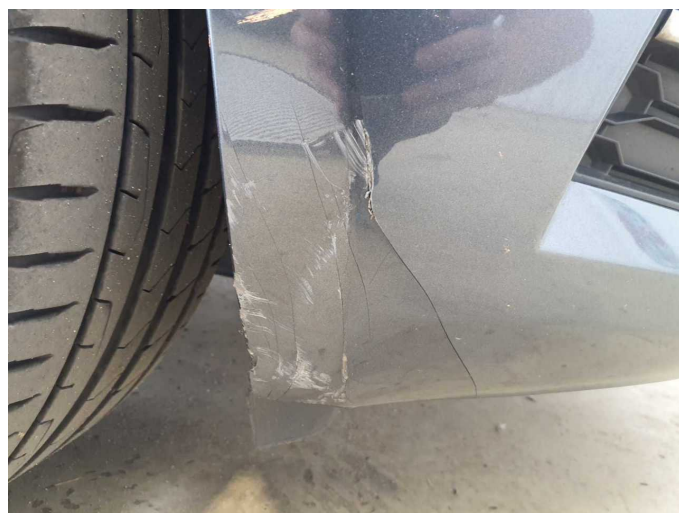
| No. | Component group | Description |
|---|---|---|
| 13 | Front bumper | Front bumper - Broken / torn - Replace |

**Damage 13:** Front bumper: Front bumper - Broken / torn - Replace

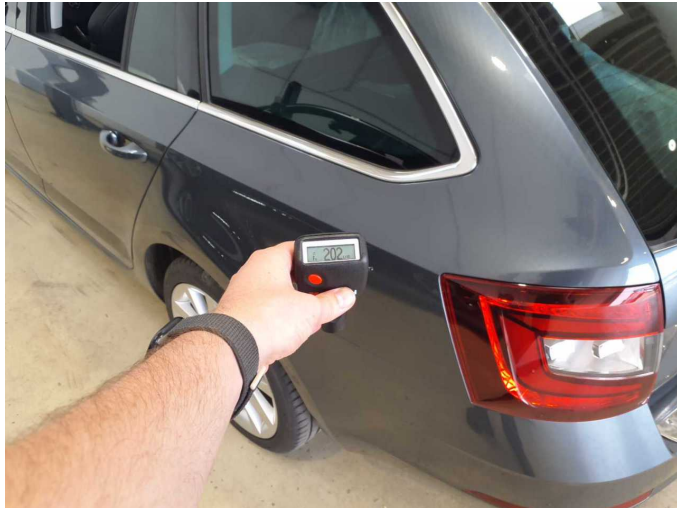
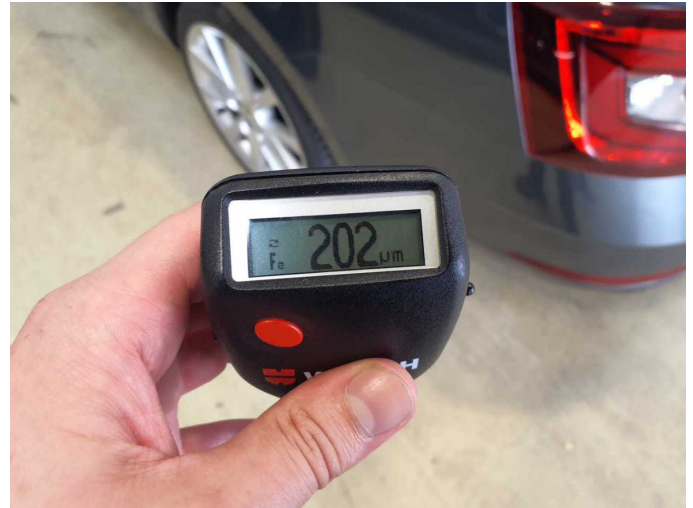
| 1 | Side panel - rear left side, Professionally carried out, Invoice of repair done Non-existent |

| Side panel - rear left side | 202 µm | Door - rear left side | 167 µm |

**Repainting 1:** Side panel - rear left side

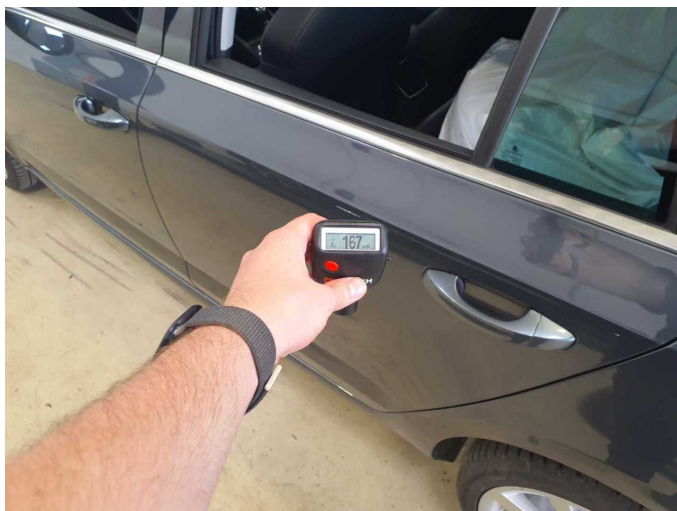
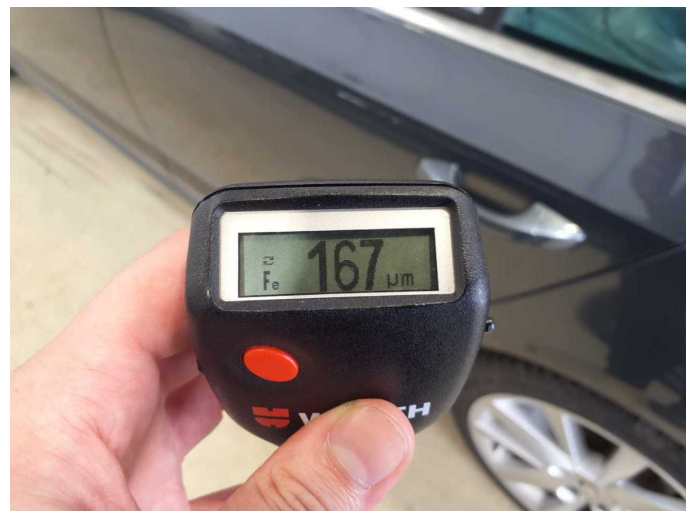
| 2 | Door - rear left side, Professionally carried out, Invoice of repair done Non-existent |

**Repainting 2:** Door - rear left side
